PERFORMANCE VERIFICATION STATEMENT

for the YSI Inc. Rapid Pulse Dissolved Oxygen Sensor

UMCES Technical Report Series: TS-457-04-CBL / Ref. No. [UMCES]CBL 04-120

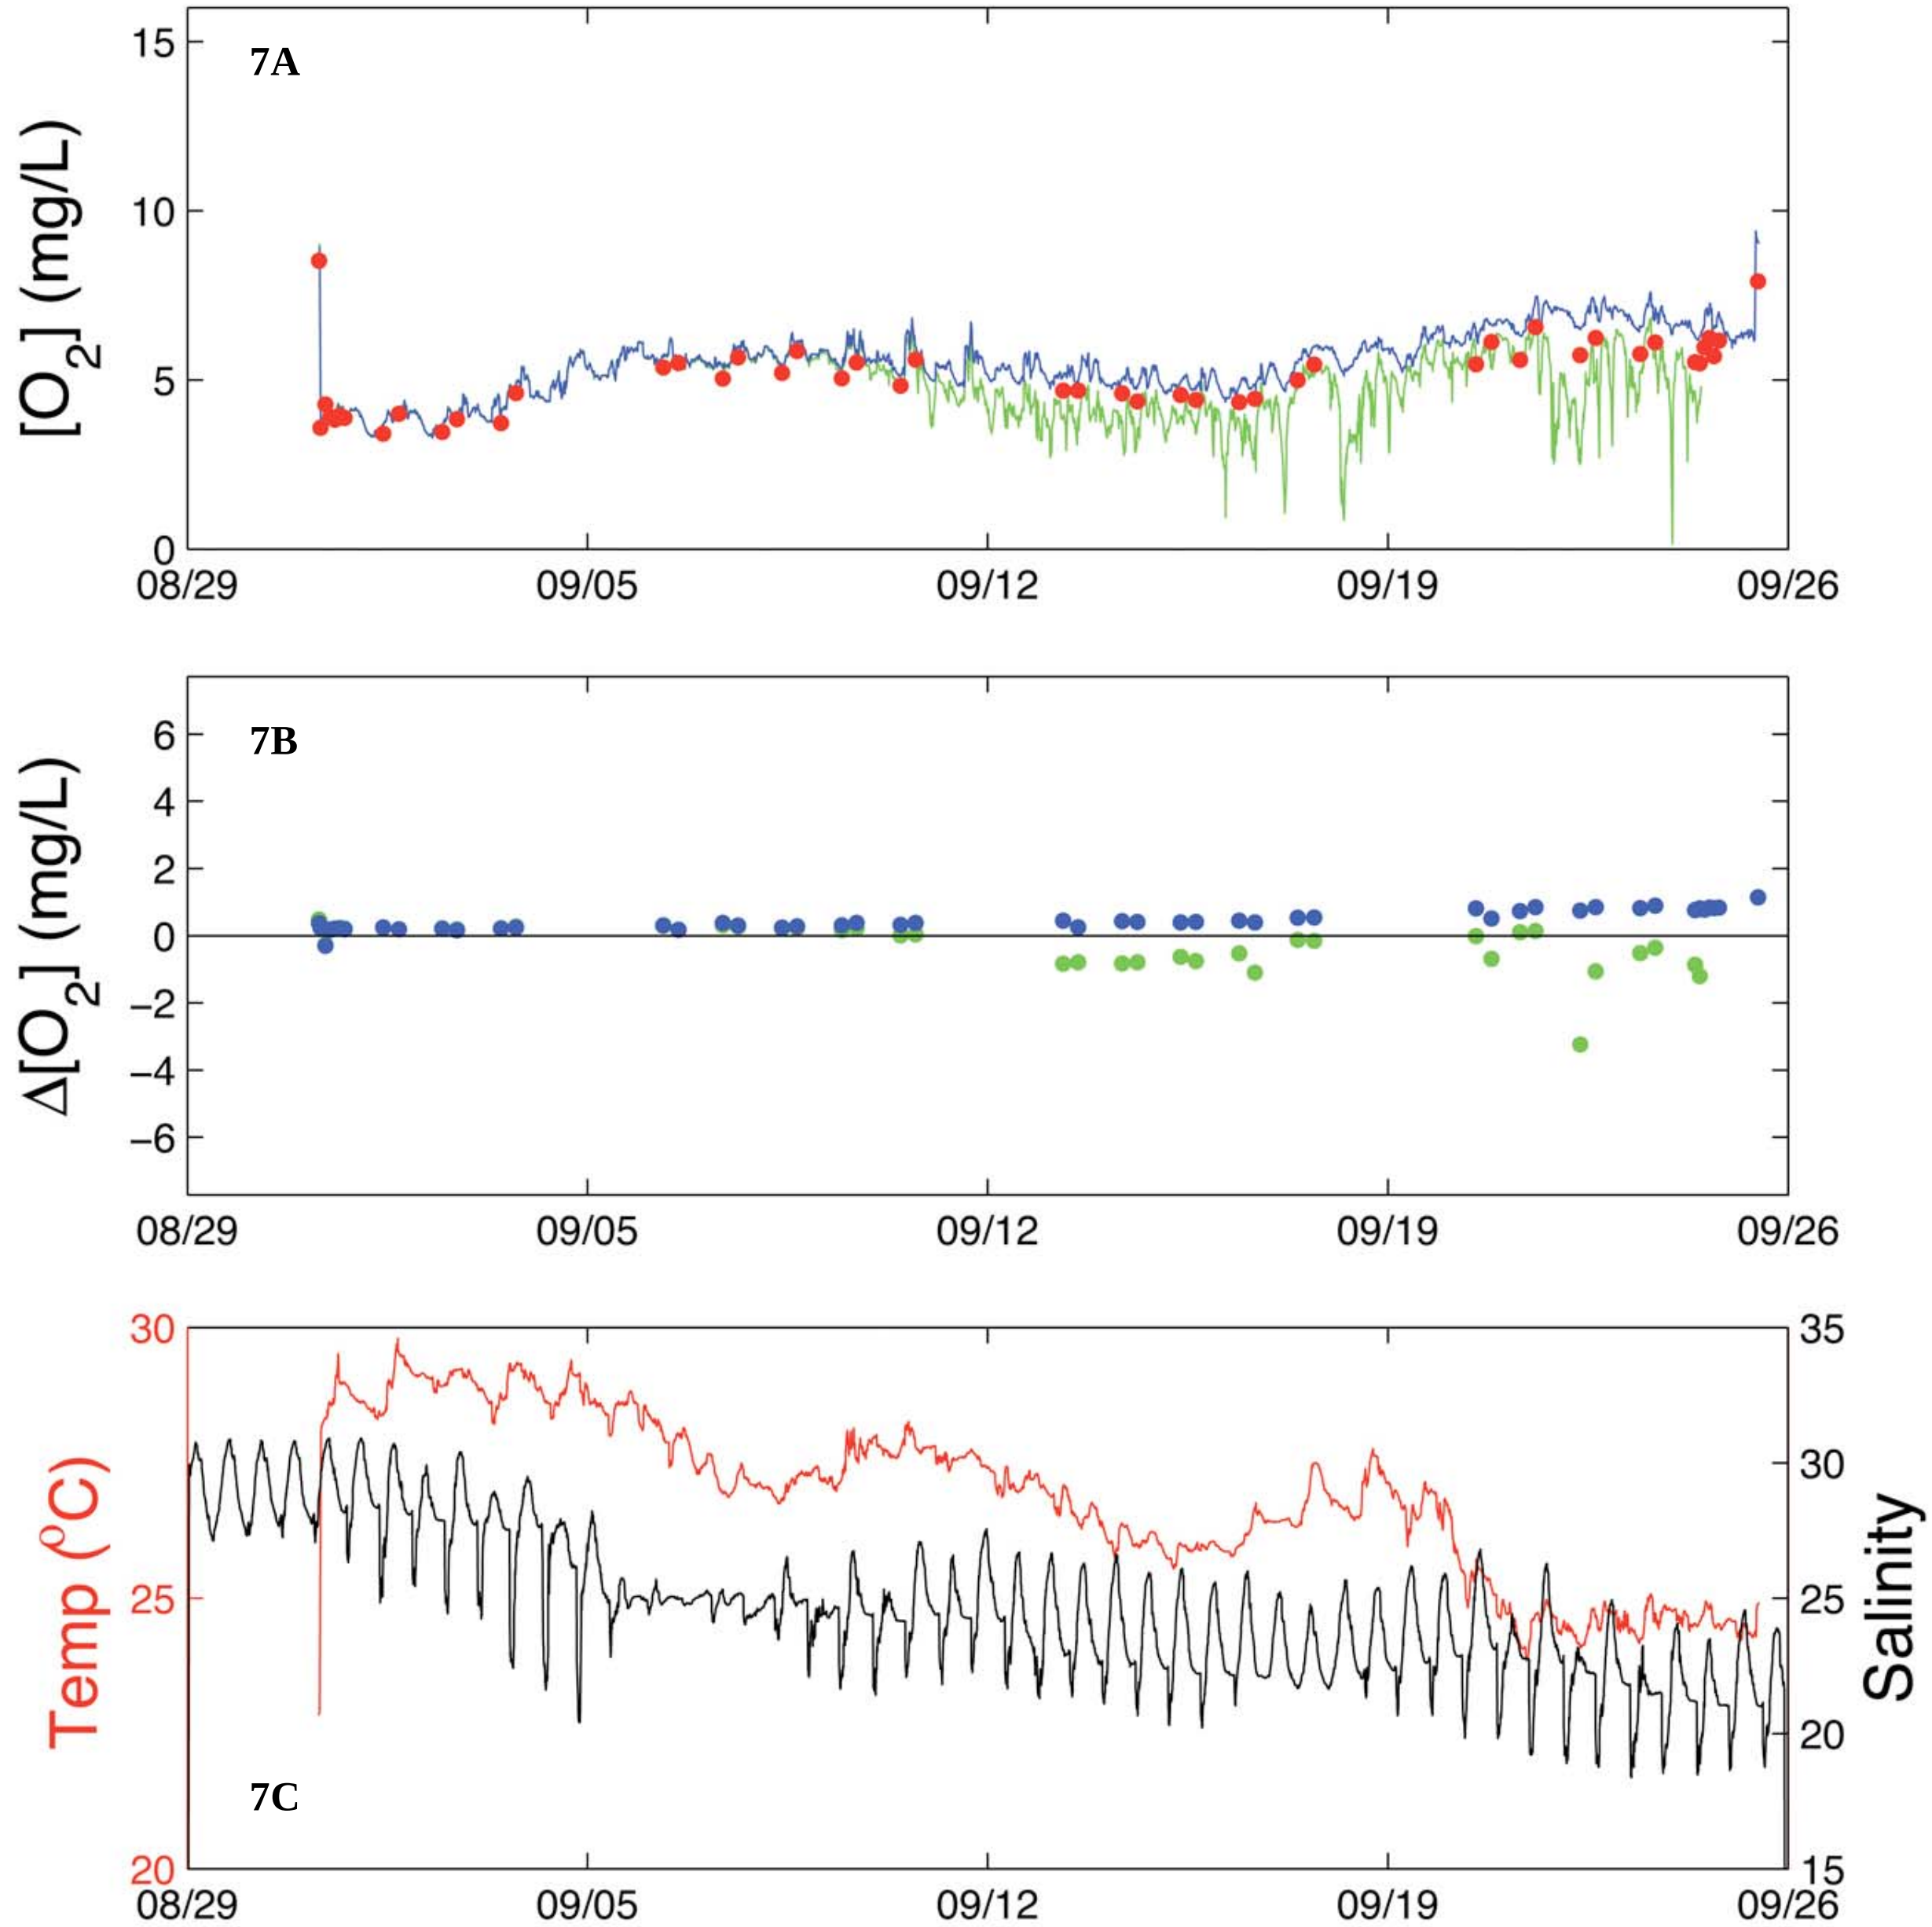
Figures 7A and 7B. Instrument drift at Skidaway Island, GA, 7C (SkIO).

Sensor <u>without</u> the biofouling prevention system after four-week field deployment.

Sensor <u>with</u> the biofouling prevention system after four-week field deployment.

Skidaway Island GA – Both instruments performed very well.

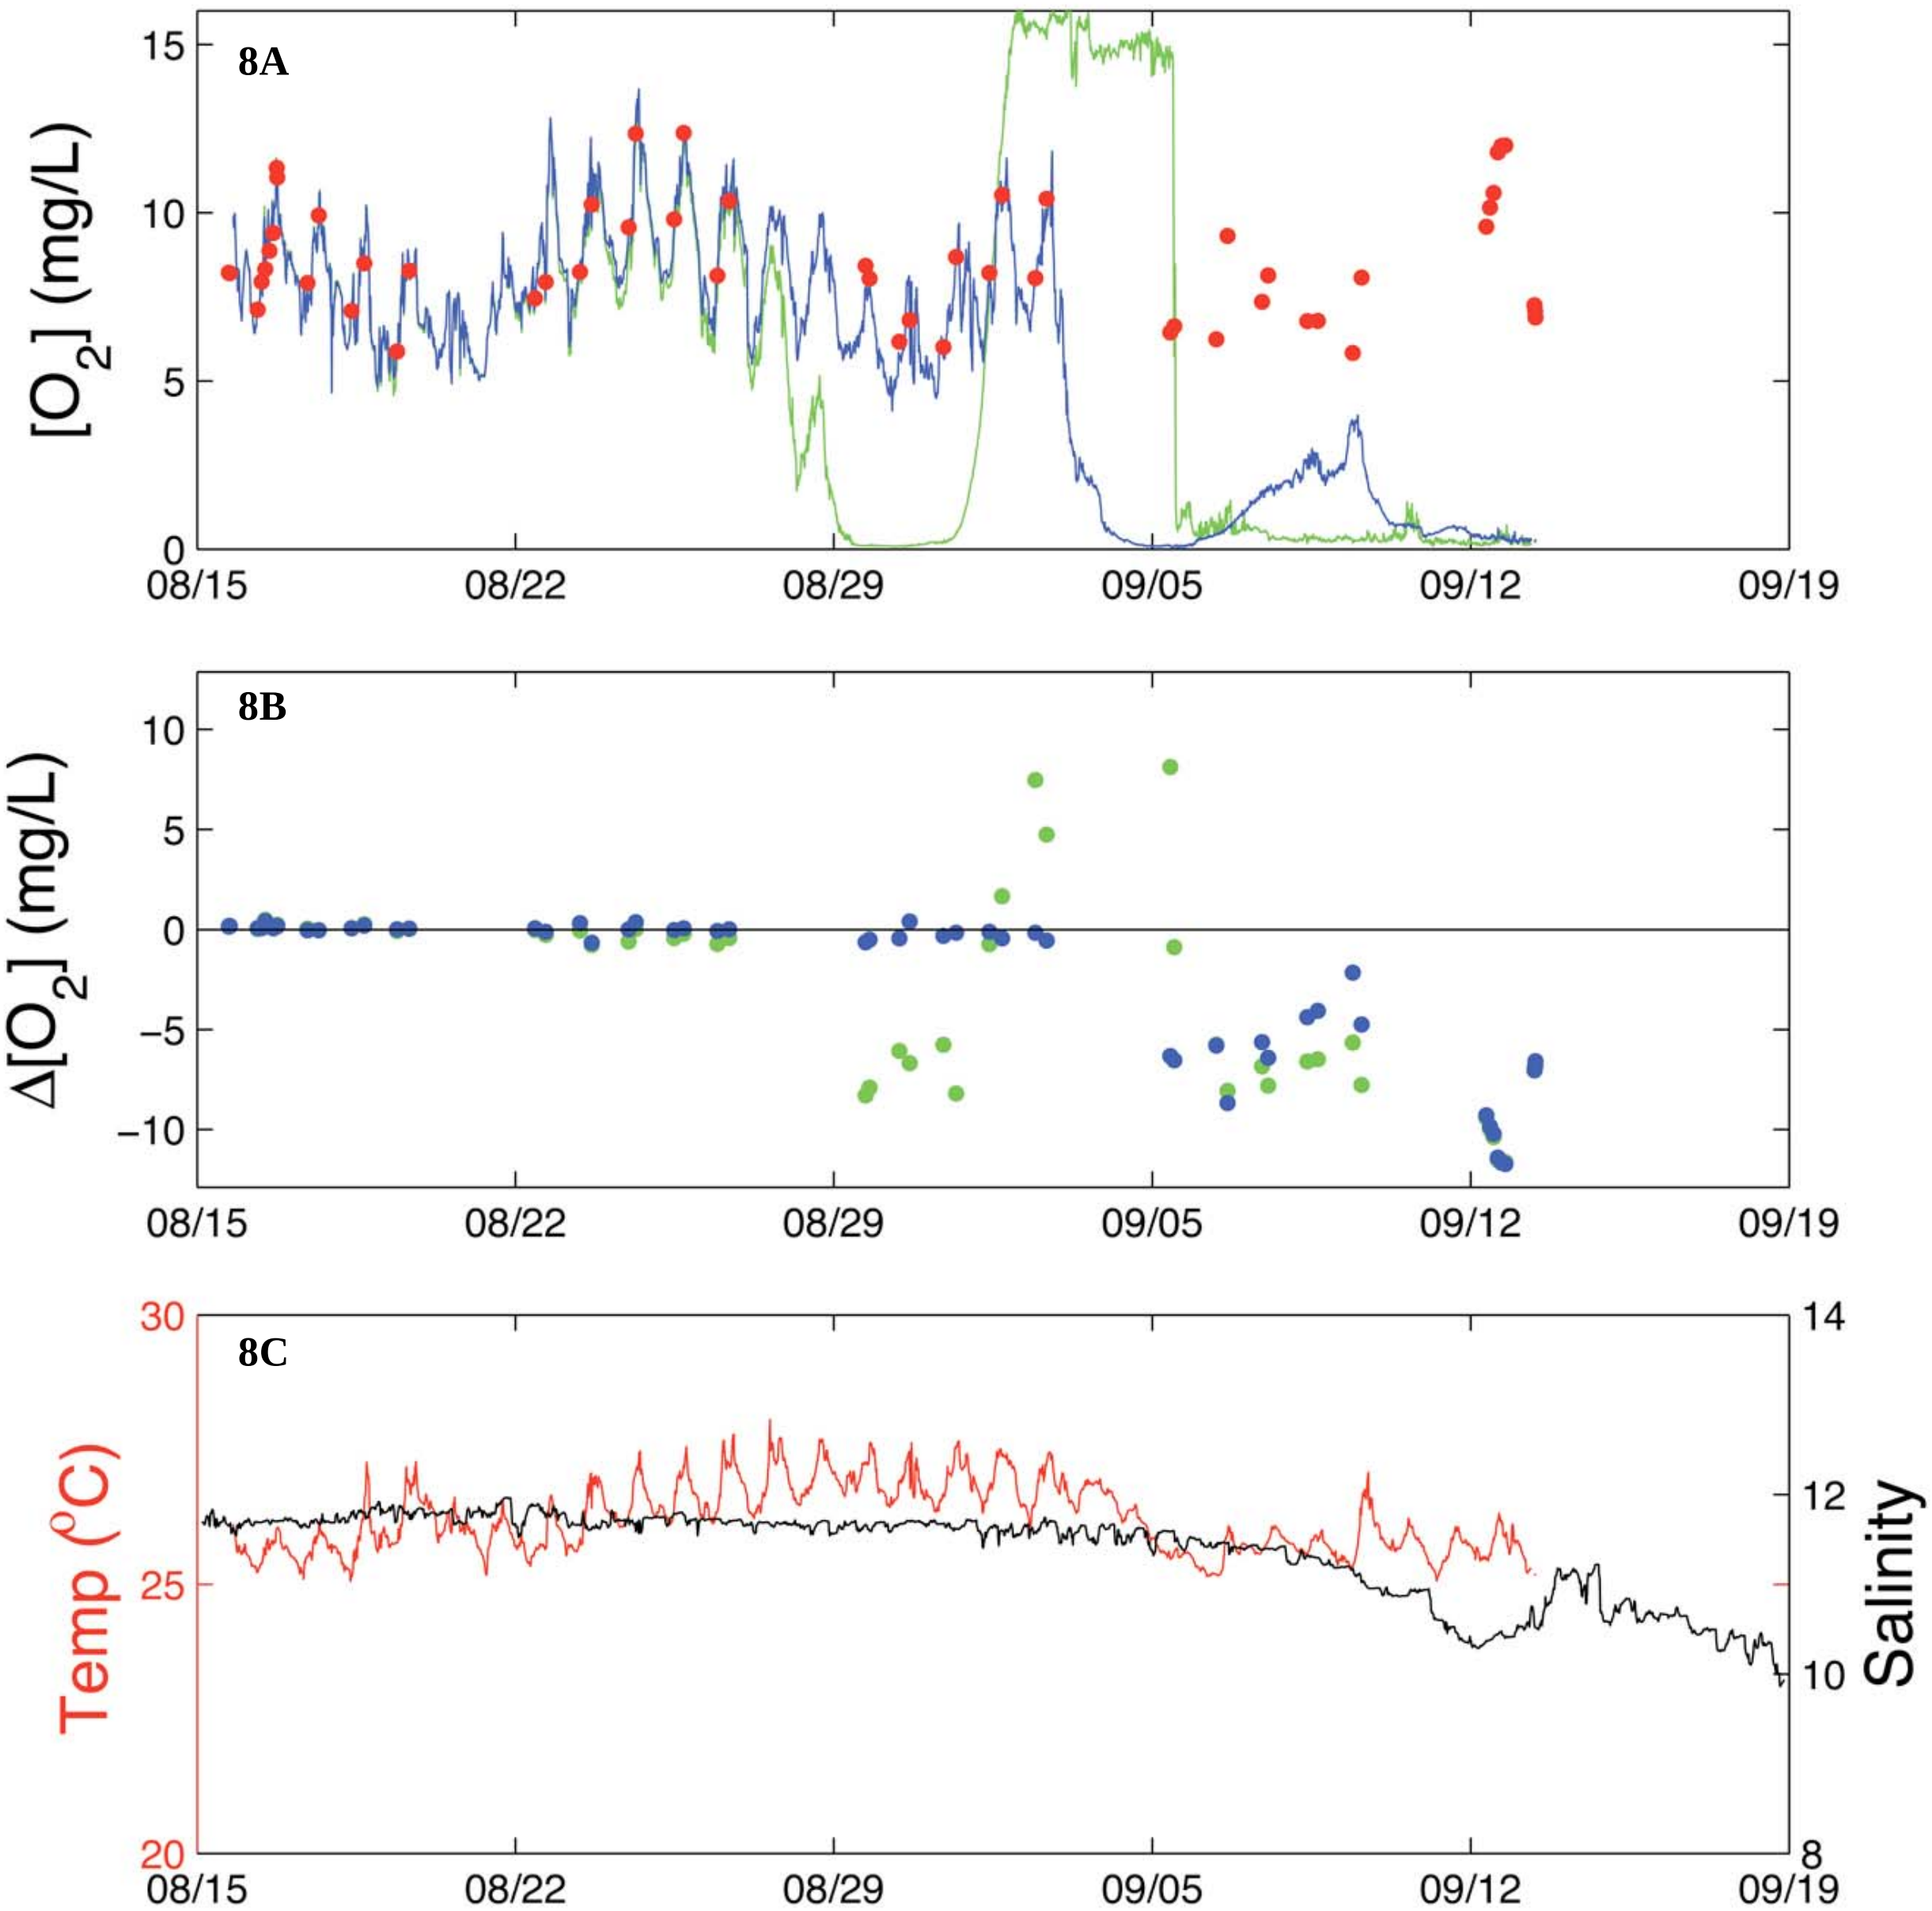
Figures 8A and 8B. Instrument drift at Solomons, MD, 8C (CBL).

Sensor <u>without</u> the biofouling prevention system after four-week field deployment.

Sensor <u>with</u> the biofouling prevention system after four-week field deployment.

Solomons, MD – The EDS sonde was affected by fouling after 19 days, the standard sonde in 12.

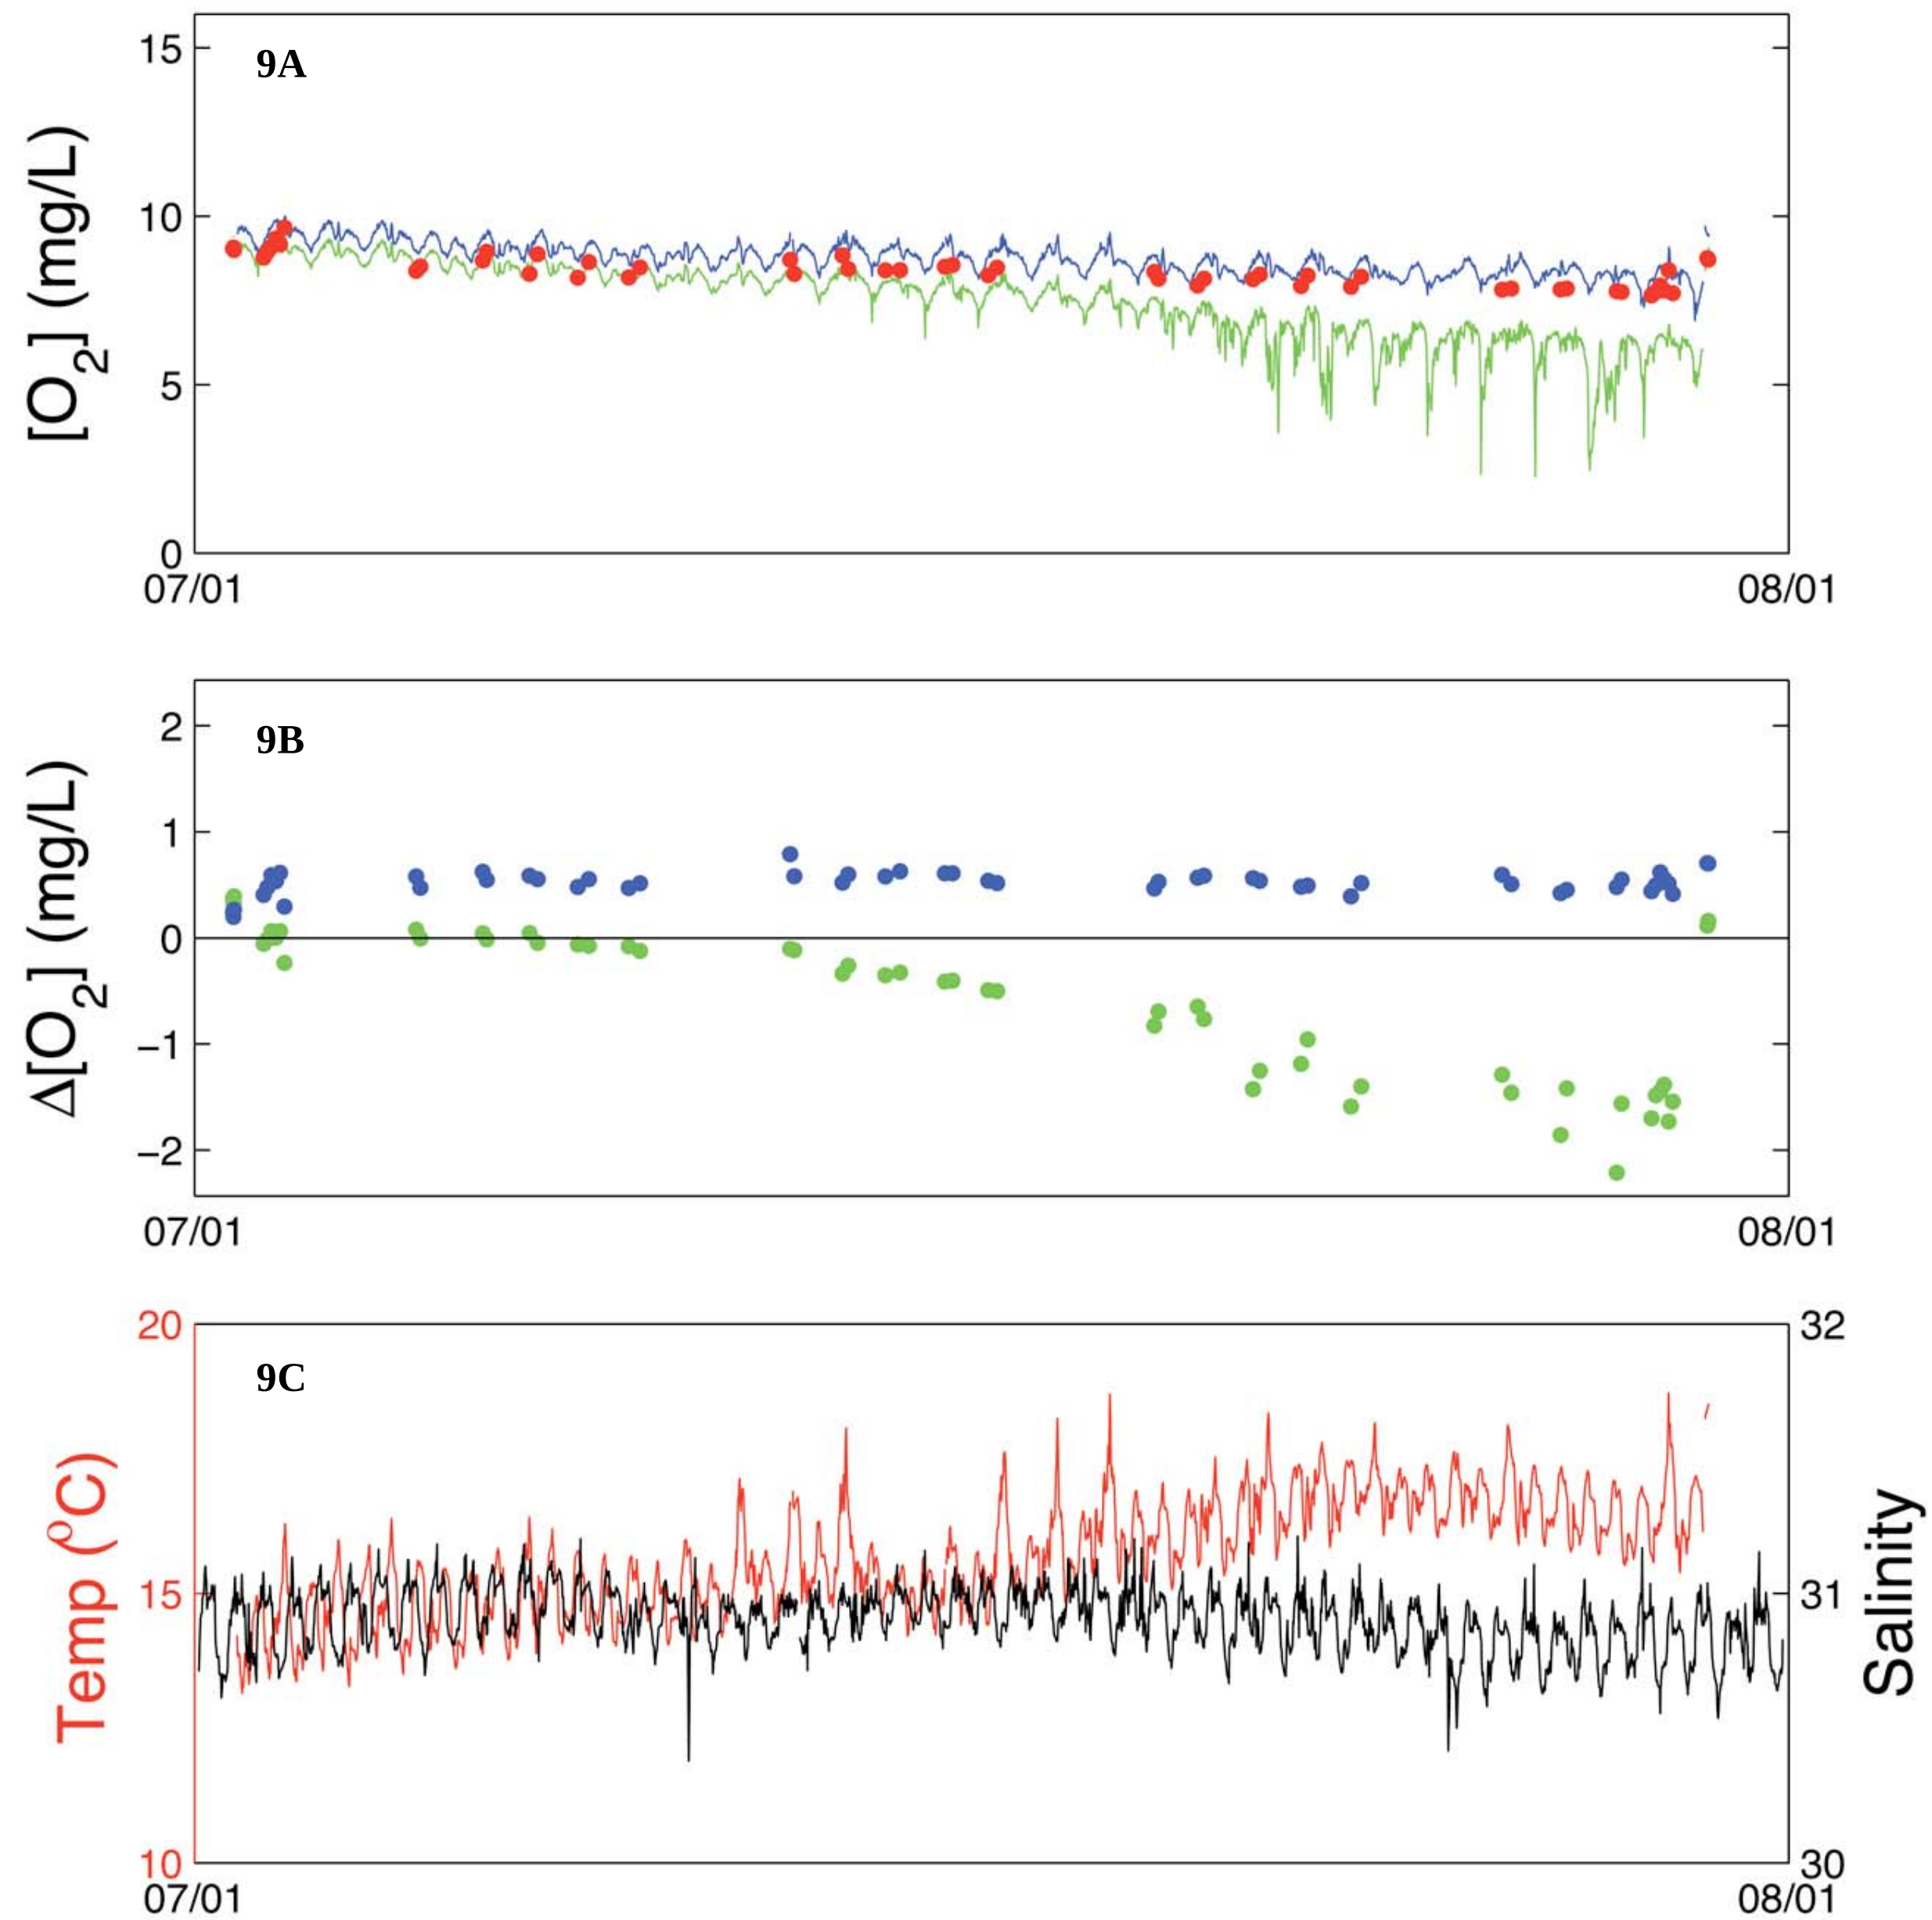
Figures 9A and 9B. Instrument drift at Walpole, ME, 9C (GoMOOS/University of Maine).

Sensor without the biofouling prevention system after four-week field deployment.

Sensor with the biofouling prevention system after four-week field deployment.

Walpole, ME – The EDS sonde performed well, but the standard unit started drifting after 7 days
