Assessment of chemo-mechanical degradation of concrete sewer pipes through an integrated experimental approach

R.A. Luimes [a], I.C. Scheperboer [a], A.S.J. Suiker [a],[*], E. Bosco [a], F.H.L.R. Clemens [b,c]

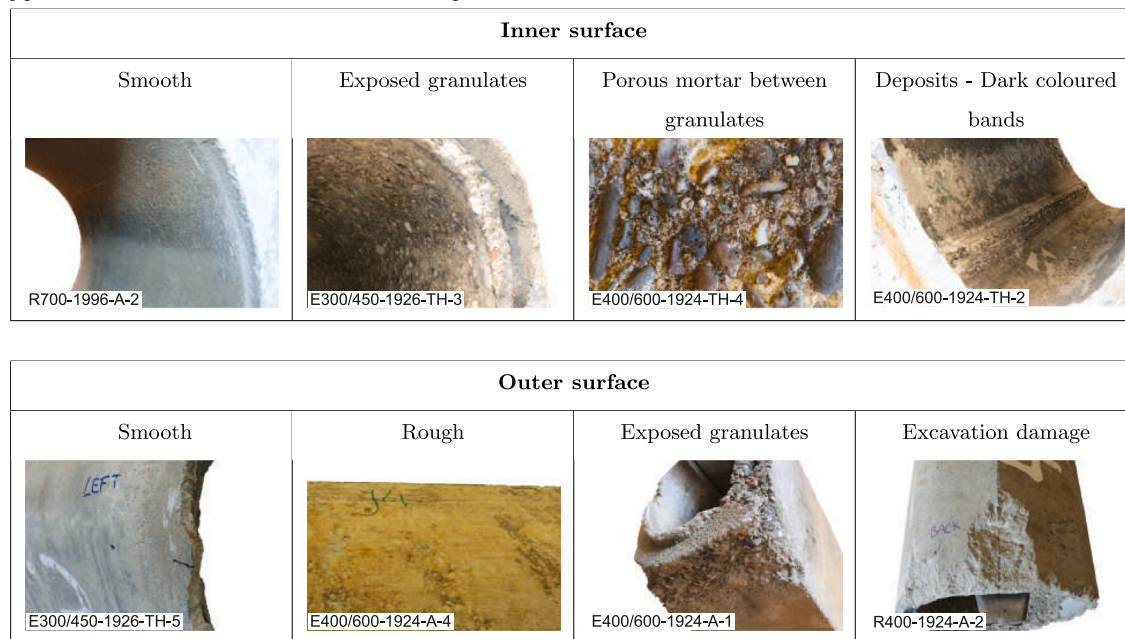
Fig. 1. A selection of unreinforced, used concrete sewer pipe specimens considered in the experimental program. Different surface conditions can be identified at the inner surface of the sewer pipes.

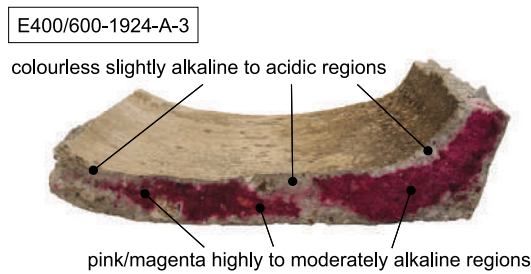
Fig. 2. Residual alkalinity in concrete sewer pipe E400/600-1924-A-3. The pipe cross-section was sprayed with a 1%-phenolphthalein solution, whereby the highly to moderately alkaline regions (pH > 9.2) correspond to the parts for which the solution turns pink/magenta, and the slightly alkaline to acidic regions (pH ≤ 9.2) to the parts for which the solution remains colourless. The photograph was taken 24 h after the phenolphthalein solution was applied. (For interpretation of the references to colour in this figure legend, the reader is referred to the web version of this article.)

which were taken after a 24 h exposure to the phenolphthalein solution. Fig. 2 shows an example of a cross-section sprayed with the phenolph-thalein solution. The highly to moderately alkaline regions (pH > 9.2) correspond to the parts in which the solution turns pink/magenta, and the slightly alkaline to acidic regions (pH ≤ 9.2) to the parts in which the solution remains colourless. From the discolouration profiles, the thicknesses of the deteriorated layers at the inside and outside of the pipe were measured at 20 equidistant locations along one vertical half of the pipe cross-section, as indicated by the letters *a* to *t* in Fig. 3. The average, minimum and maximum thickness profiles of the deterioration layers were subsequently determined per sewer pipe type. Further, the average thicknesses of the deterioration layers were computed per age category, whereby a total number of three age categories was considered, in correspondence with the three decades in which the used sewer pipes were installed, i.e., 1920s, 1950s, 1990s, see Table 1. The thicknesses of the deteriorated layers were subsequently averaged (i) within 4 distinct areas of the sewer pipe cross-section, as indicated in Fig. 3 for the round and egg-shaped pipes, and (ii) over the complete half cross-section of the pipes. Each of the 4 areas includes 5 measurement locations, namely *a* to *e* in area 1, *f* to *j* in area 2, *k* to *o* in area 3 and *p* to *t* in area 4. Note that the measured thickness of a deteriorated layer is somewhat underestimated if spallation of (chemically affected) mortar and/or granulates has occurred during service/excavation of the pipe.

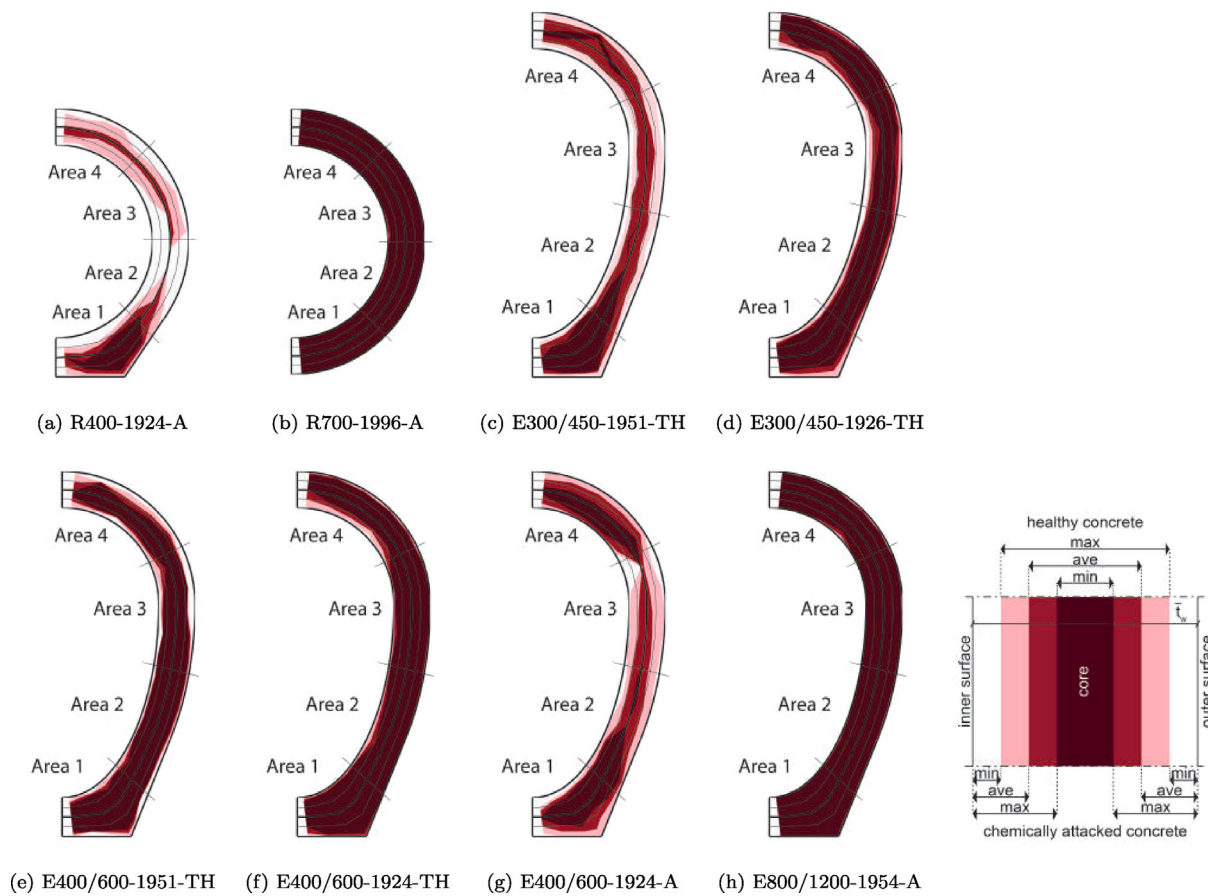
From Fig. 8 and Table 5 it can be concluded that *all* sewer pipes from the 1920s and 1950s show (bio-)chemical attack at the inside and outside. The degree of chemical attack varies per sewer pipe type, and generally is non-uniform along the inner and outer circumferences of the pipes. The relatively old sewer pipe type R400-1924-A from the 1920s clearly shows the largest chemical attack, with substantial corrosion present along the *complete* inner and outer circumferences. Specifically, along the inner circumference a maximum corrosion depth of approximately 23 mm is observed in areas 2 and 3, which corresponds to 43% of the average wall thickness $\bar{t}_w$ of pipe R400-1924-A. In areas 4 (bottom) and 1 (top) the corrosion depth is somewhat smaller and equal to 20.5 mm (= $0.38\bar{t}_w$) and 19.1 mm (= $0.35\bar{t}_w$), respectively. Note that the above values do not account for a possible material spallation. Along the outer circumference of the R400-1924-A pipe, a substantial amount of corrosion can be identified in areas 2, 3 and 4, whereby the corrosion depths are comparable, and approximately equal to 22 mm (= $0.4\bar{t}_w$). Conversely, area 1 located at the bottom of the pipe shows less chemical attack, in correspondence with a corrosion depth of 5.7 mm (= $0.11\bar{t}_w$). In summary, the above results indicate that in areas 2, 3 and 4 almost the entire wall of the R400-1924-A pipes is corroded.

Observe further from Fig. 8 and Table 5 that the other, relatively old sewer pipes from the 1920s and 1950s mostly show non-uniform chemical corrosion in all 4 areas, although the extent is a factor of two or more less than for pipe type R400-1924-A considered above. In contrast, for the relatively new pipes from the 1990s the chemical attack is negligible, both at the inside and outside, which is probably due to the relatively short service life of these pipes. In order to obtain more insight into this aspect, in Figs. 9(a) and 9(b) the average corrosion depth $\bar{t}_{chem}$ at respectively the inner and outer pipe surface (as reported in Table 5) is plotted against the average year of pipe installation per decade, i.e., 1925, 1952 and 1997 for the pipes from the 1920s, 1950s and 1990s, respectively (as indicated by the black solid squares). Here, the error bars for $\bar{t}_{chem}$ correspond to the minimum and maximum corrosion depths measured (as following from Table 5). Further, the dashed line denotes the linear trend obtained after fitting the measured values of the average corrosion depth. The good agreement between the trend lines and the average corrosion depths indicates that the amount of chemical degradation increases approximately linearly over time. A linear increase of the corrosion depth at the inner surface of sewer pipes over their lifetime has also been reported in Wells and Melchers [14]. In this work, the corrosion loss for a variety of concrete sewer pipes near Melbourne, Australia was evaluated, which had been in service for different periods, up to 18 years. From the measurement results, it was concluded that the corrosion rate at the inner pipe surface remains approximately constant with time, provided that the exposure conditions remain more or less the same.

Fig. 8. Residual alkalinity of concrete measured on the cross-section of various types of used sewer pipes by means of phenolphthalein tests. The transitions from the minimum, average and maximum thickness of the healthy concrete to respectively the maximum, average and minimum thickness of the chemically attacked layer are indicated in the colour scheme shown in the inset at the bottom right. (For interpretation of the references to colour in this figure legend, the reader is referred to the web version of this article.)

- *Inside of sewer pipes*: From the results of the phenolphthalein tests illustrated in Fig. 8, it becomes clear that large parts at the inside of the pipes installed in the 1920s and 1950s are slightly alkaline to acidic with a pH $\leq$ 9.2, which denotes a certain type of chemical attack. Further, the XRD analyses show the presence of gypsum at the inner surface of some of the pipe specimens, and generally indicate the dissolution of calcium hydroxide that provides the calcium ions necessary for gypsum formation, see Table 6. Gypsum is a highly porous material that easily spalls off if a critical thickness is achieved [16,17], or simply may be washed off by the wastewater. This explains why the inner surfaces of most of the relatively old sewer pipes show substantial signs of deterioration by *Exposed granulates* and *Porous mortar between granulates*, see Table 4, and that gypsum was not found in all older sewer pipes, see Table 6. The formation of gypsum at the inner pipe surface typically is caused by *biogenic sulphide*

- *Outside of sewer pipes:* The results of the phenolphthalein tests depicted in Fig. 8 illustrate that for several pipes large parts at the outer surfaces are slightly alkaline to acidic with a pH ≤ 9.2, and thus are chemically affected. In addition, the XRD analyses indicate the presence of calcite at the outer surface of all sewer pipe types, see Table 6, which, in combination with the observed surface conditions *Smooth* and *Rough* listed in Table 3, suggest chemical attack by *carbonation*. Carbonation is due to the diffusion of carbon dioxide naturally present in soil towards the outer surface of concrete sewer pipes, at which it can react with hydrated cement in the presence of moisture [22,25]. Although this process may cause the strength and stiffness properties to increase as a result of a decrease in porosity and structural changes in calcium silicate hydrates, this positive effect can be mitigated, or even reversed, in a negative effect by carbonation shrinkage and consequent crack formation [25]. The complex combination of these two mechanisms essentially makes it difficult to a priori assess the influence of carbonation on the mechanical and functional properties of the sewer pipe, as a result of which its effect currently is a topic of debate in the concrete engineering community [25]. Moreover, from the pipe surface conditions presented in Table 3, it may be deduced that the net result of carbonation is less harmful to the integrity of the sewer system compared to chemical attack by biogenic sulphide corrosion at the inner pipe surface. This conclusion is further supported by the fact that only mild concentrations of soil pollutants that potentially stimulate outer pipe corrosion were found at the *in-situ* locations of the sewer pipes, such as mineral oil [70], see Table 2 and the discussion in Section 2.1.2.

- Chemical attack by biogenic sulphide corrosion turned out to be most severe in the tidal zone and the crown of the sewer pipe, as can be observed from areas 2 and 3 (tidal zone) and area 4 (crown) in Fig. 8. This can be explained from the broad availability of nutrients for bacteria in the tidal zone under a varying wastewater level, and the upward flow to the crown of the hydrogen sulphide gas released by the wastewater.

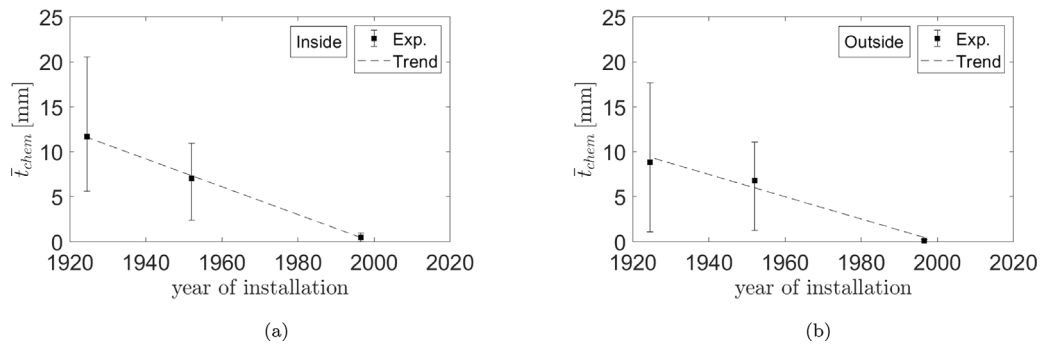
A comparison of the slopes of the trend lines depicted in Figs. 9(a) and (b) illustrates that the rate of chemical attack at the inside of the pipe on average is about 1.3 times higher than at the outside. Observe further that both trend lines intersect the horizontal axis $\bar{t}_{chem} = 0$ close to the year 1997, which indeed implies that for the relatively new sewer pipes installed in 1997 no significant chemical degradation can be expected, see also Table 5. Finally, the relatively large error bars in Figs. 9(a) and (b) indicate a substantial variability in the mean corrosion depth over the different types of sewer pipes, from which it is concluded that the linearity of the fitted trendline should be treated with some caution. Essentially, a unique, explicit relation between the age of the pipe and the degree of chemical degradation may not be deduced from the measurement data; as indicated by the size of the error bars, the specific local environmental conditions and the geometrical and material characteristics of a pipe also have a substantial influence on the time development of chemical corrosion.

Fig. 9. Average corrosion depth $\bar{t}_{chem}$ as a function of the year of pipe installation, measured at the (a) inside and (b) outside of the sewer pipes. The black solid squares indicate the measured average corrosion depths, with the error bars reflecting the minimum and maximum experimental values. The dashed line represents the linear trend obtained after fitting the measured average corrosion depths.

- The time development of corrosion by biogenic sulphide corrosion (at the inside of the pipe) and carbonation (at the outside of the pipe) on average follows a linear trend, see Figs. 9(a) and (b), respectively. The corrosion rate for biogenic sulphide corrosion appears to be about 1.3 times larger than for carbonation, whereby the combination of the two processes has caused that for one of the old pipes from 1924 almost the entire pipe wall has corroded, see Fig. 8(a). It is emphasized, however, that a unique, explicit relation between the age of the pipe and the degree of chemical attack may not be deduced from the results in Fig. 9; as indicated by the size of the error bars, the specific local environmental conditions and the geometrical and material characteristics of the pipe also have a significant influence on the time development of chemical corrosion.

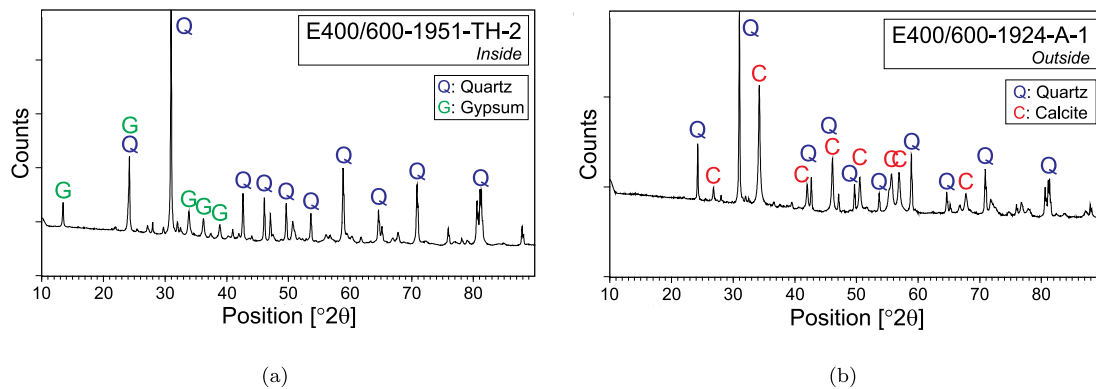
XRD analyses were carried out to identify characteristic chemical compounds in the concrete material of used sewer pipes, from which a specific type of chemical attack may be identified. Fig. 10 shows two representative diffraction patterns, whereby the position and the intensity (i.e., the counts) of the peaks are determined for crystalline structures present in the sample. Observe from Fig. 10(a) that the diffraction pattern of the sample located at the inside of sewer pipe E400/600-1951-TH-2 shows traces of quartz and gypsum and that the sample located at the outside of sewer pipe E400/600-1924-A-1 (Fig. 10(b)) reveals the presence of quartz and calcite.

Fig. 10. XRD patterns for sewer pipes (a) E400/600-1951-TH-2 (at the inside of the pipe) and (b) E400/600-1924-A-1 (at the outside of the pipe). The peaks corresponding to quartz, gypsum and calcite are indicated by a blue "Q", a green "G" and a red "C", respectively. (For interpretation of the references to colour in this figure legend, the reader is referred to the web version of this article.)

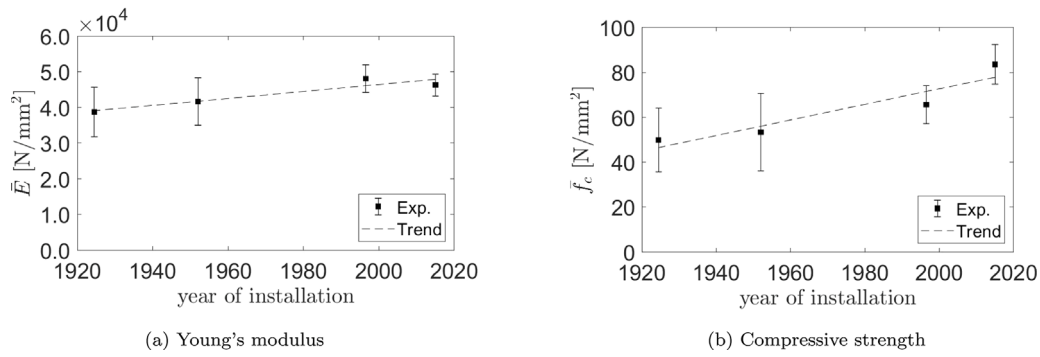
Table 7 lists the average value and corresponding standard deviation of the Young's modulus ($\bar{E}$, S_E) and compressive strength ($\bar{f}_c$, S_{f_c}), as obtained from the uniaxial compression tests. The measurement results are averaged per sewer pipe type (top of the table) and per age category (bottom of the table). The values listed for the standard deviation of the Young's modulus and compressive strength indicate that the spread of these material parameters for each sewer pipe type and for each age category is significant, which may be ascribed to differences in the concrete composition and *in-situ* conditions of individual sewer pipes, as well as the material heterogeneity of concrete within a single sewer pipe. The measured values are comparable to those reported in other experimental works, see Hu et al. [71],Fan et al. [72] for the Young's modulus and Davis et al. [17],Oualit et al. [22],Ortega et al. [73] for the compressive strength. Observe further from the table that the average values of the two material parameters tend to decrease with age. This aspect is revealed in more detail in Figs. 11(a) and (b), which respectively illustrate the average Young's modulus and compressive strength of the concrete material as a function of the year of installation of the corresponding sewer pipes. Here, the linear trends (dashed line) follow from fitting the average measurement values, and the spread in measurement results designated by the errors bars corresponds to one time the standard deviation. The decrease of the concrete Young's modulus with age is rather mild, and in fact can be assessed as negligible when considering the substantial spread in the experimental values. Conversely, the decrease of the average concrete compressive strength with age is significant: the measured concrete strength of the sewer pipes from the 1920s equals $\bar{f}_c$ = 49.9 N/mm^2, and is a factor of 1.7 lower than the measured concrete strength $\bar{f}_c$ = 83.6 N/mm^2 of the new sewer pipes from 2015. The linear time decrease of the average compressive strength probably mostly is due to the linear time increase of the inner corrosion layer, as induced by the process of biogenic sulphide corrosion, see Fig. 9(a). A decrease of the concrete compressive strength due to biogenic sulphide corrosion has also been reported in other works [12,16,17,22,23], and may be attributed to the increase in material porosity (i.e., damage) and the relatively low strength properties of gypsum.

Fig. 11. Concrete material properties versus the year of installation of the corresponding group of sewer pipes. (a) Average Young's modulus $\bar{E}$, and (b) average compressive strength $\bar{f}_c$. The black solid squares indicate the average experimental values, with the error bars representing one time the standard deviation of the measurement results. The dashed line represents the linear trend obtained after fitting the average experimental values.

- Material tests performed on samples taken from the sewer pipes indicated that the mechanical properties of the concrete may significantly depend on the age of the sewer pipe. In particular, the average compressive strength and tensile strength decrease approximately linearly with the age of the pipe, see Figs. 11(b) and 14(a), in correspondence with a respective reduction of a factor of 1.7 and 1.5 over a period of almost 100 years (i.e., from the 1920s to 2015). Conversely, the age dependency of the concrete Young's modulus and mode I toughness is mild to negligible, see Figs. 11(a) and 14(b). The reduction in concrete compressive and tensile strengths with age mostly may be attributed to the process of biogenic sulphide corrosion, as characterized by an increase in material porosity (i.e., damage) and the relatively low strength properties of gypsum.

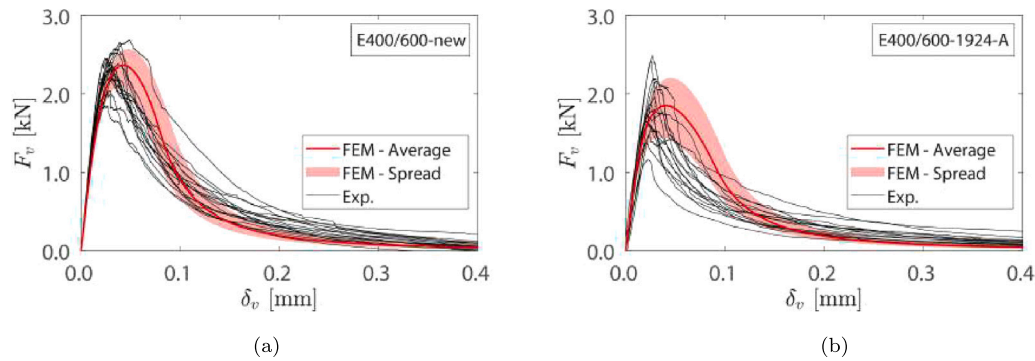
The tensile strength and mode I toughness were calibrated from the failure response of concrete specimens subjected to three-point bending, as depicted in Fig. 12(a) and (b) for samples taken from new (E400/600-new) and old (E400/600-1924-A) sewer pipes. The

Fig. 12. Load–displacement response of the notched beam specimens under three-point bending, showing the vertical load F_v as a function of the load point deflection δ_v at the mid-span of the beam. (a) E400/600-new pipe, and (b) E400/600-1924-A pipe. The experimental responses are shown by the black lines, the calibrated average response is indicated by the thick red line, and the corresponding spread is represented by the red hatched area. The outer limits of the spread have been determined in accordance with one time the standard deviation of the peak load and mode I toughness measured for the specimen. Table 8 lists the average values of the concrete tensile strength and mode I toughness used for computing the average specimen response, and their maximum and minimum values used for computing the outer limits of the spread. (For interpretation of the references to colour in this figure legend, the reader is referred to the web version of this article.)

experimental responses of the various samples are shown by the black lines, the average response as obtained from the calibration procedure is indicated by the thick red line, and the spread is represented by the red hatched area; Table 8 lists the average values for the concrete tensile strength $\bar{t}_1^u$ and mode I toughness $\bar{G}_{I,c}$ used for computing the average response, and the minimum and maximum values ($t_{1;min}^u$, $t_{1;max}^u$) and ($G_{I,c;min}$, $G_{I,c;max}$) used for computing the outer limits of the spread. It can be observed that the spread in the numerical simulations captures the variation in the experimental responses reasonably well. The response initially is elastic, whereby the load point deflection δ_v increases proportionally with the applied load F_v. After reaching the maximum load, softening occurs whereby the load point deflection increases under a continuous decrease in the applied load, up to the stage where the load becomes zero and the specimen fails completely. For all concrete test specimens, the catastrophic failure crack characterizing the softening branch developed approximately vertically, from the central notch towards the upper specimen boundary, with a local occurrence of small oscillations due to the presence of material heterogeneities (i.e., aggregates), see Fig. 13(a) for the E400/600-new sewer pipe and the E400/600-1924-A sewer pipe. The FEM simulation used for the calibration of the fracture parameters shows a comparable crack trajectory, see Fig. 13(b), whereby local crack oscillations remain absent due to the assumption of a homogeneous material.

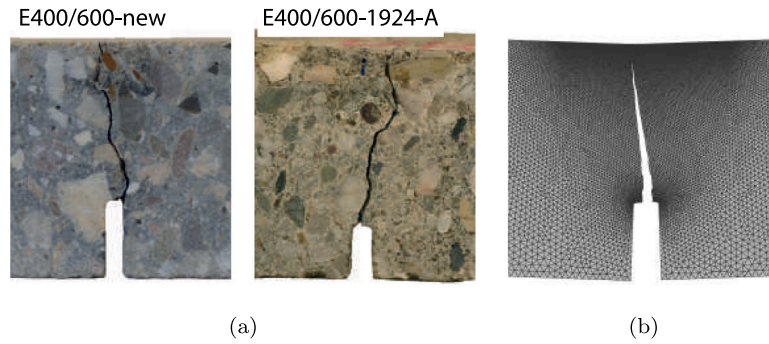
Fig. 13. Fracture path leading to failure of the three-point bending specimen. (a) Specimens taken from the E400/600-new (left) and E400/600-1924-A (right) sewer pipes, and (b) FEM result representative of a specimen taken from the R400-new sewer pipe, whereby the deformations are magnified by a factor of 10 for clarification.

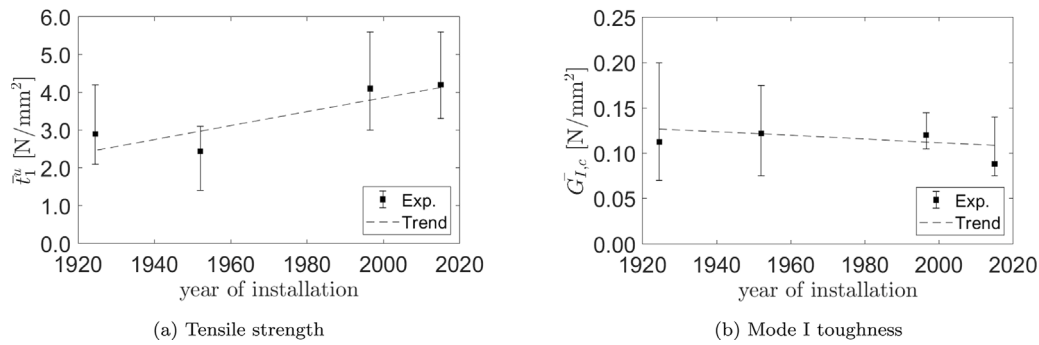
(bottom of the table). As observed for the Young's modulus and compressive strength, the spread in values of the tensile strength and mode I toughness is considerable for each sewer pipe type and age category, due to variations in material composition and the *in-situ* conditions of the sewer pipes, as well as the material heterogeneity of concrete within a single sewer pipe. The change of the fracture parameters with age is further clarified in Fig. 14, showing that the average tensile strength $\bar{t}_1^u$ substantially decreases with age, while the average mode I toughness $\bar{G}_{I,c}$ remains almost constant. The relative decrease with age for the concrete tensile strength is somewhat less than for the compressive strength illustrated in Fig. 11(b), and over a period of almost 100 years corresponds to a factor of about 1.5, as computed from the average concrete tensile strengths measured for the new sewer pipes from 2015 ($\bar{t}_1^u = 4.2$ N/mm^2) and the old pipes from the 1920s ($\bar{t}_1^u = 2.9$ N/mm^2). Again, the origin of this decrease lies in the process of biogenic sulphide corrosion, and contributes to the fact that the ultimate bearing strength of the old sewer pipes from the 1920s in principle can be more than a factor of two lower than that of the new sewer pipes from 2015, see Luimes et al. [38] for more details on this aspect.

Fig. 14. Concrete material properties versus the year of installation of the corresponding group of sewer pipes. (a) Average tensile strength $\bar{t}_u^1$, and (b) average mode I toughness $\bar{G}_{I,c}$. The black solid squares indicate the average experimental values, with the error bars representing the spread in measurement results. The dashed line represents the linear trend obtained after fitting the average experimental values.
