A Geochemical and Geophysical Characterization of Sulfide Mine Ponds at the Iberian Pyrite Belt (Spain)

Tomás Martín-Crespo · Silvia Martín-Velázquez ·
David Gómez-Ortiz ·
Cristina De Ignacio-San José · Javier Lillo-Ramos

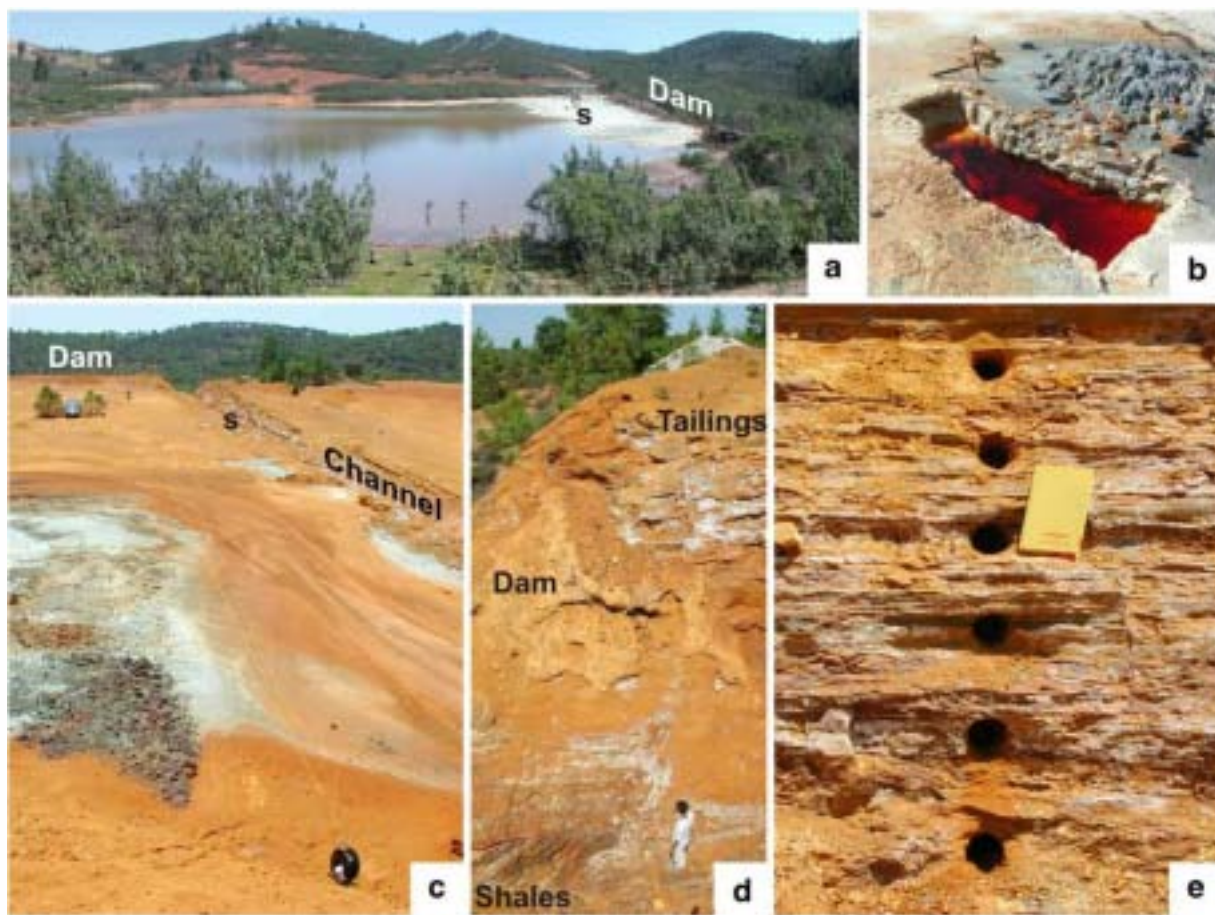
Fig. 2 a General view of the western Monte Romero mine pond. The tailings sampling(s) was done in a previous survey with a lower level of the ponded water, b a ditch in the mine sludges of Monte Romero shows the shallow water table in the tailings and the acid nature of the water, denoted by the characteristic red color; c general view of the La Naya mine pond and its long discharge channel, where the tailings sampling (s) was performed; d La Naya dam and impoundment deposited over the Devonian shales; e detail of the sampling in the laminated tailings of the channel wall in the la Naya mine pond

1998). Its northernmost part lies directly over Carboniferous basic lava flows and tuffs, whereas the southern part of the pond is located over a succession of Devonian shales, greywackes, and quartzites. A significant feature of these tailings is the marked contrast between their yellow to light brown color and the dark green color of the surrounding environment. A raised embankment was constructed using an upstream method with a valley dam configuration (IGME 1998). This deposit is one of the largest ponds in the Riotinto district, and visual integration with the environment has not been achieved. The pond includes drainage systems to control the phreatic surface and to minimize the chance of a build-up of pore-water pressures. Thus, chimney drains were installed within the slurry impoundment. This kind of structure is well suited to conditions where large volumes of water may be stored along with solid tailings (Vick 1990). Regardless of these drainage systems, the tailings dam shows a marked evidence of rain water erosion.

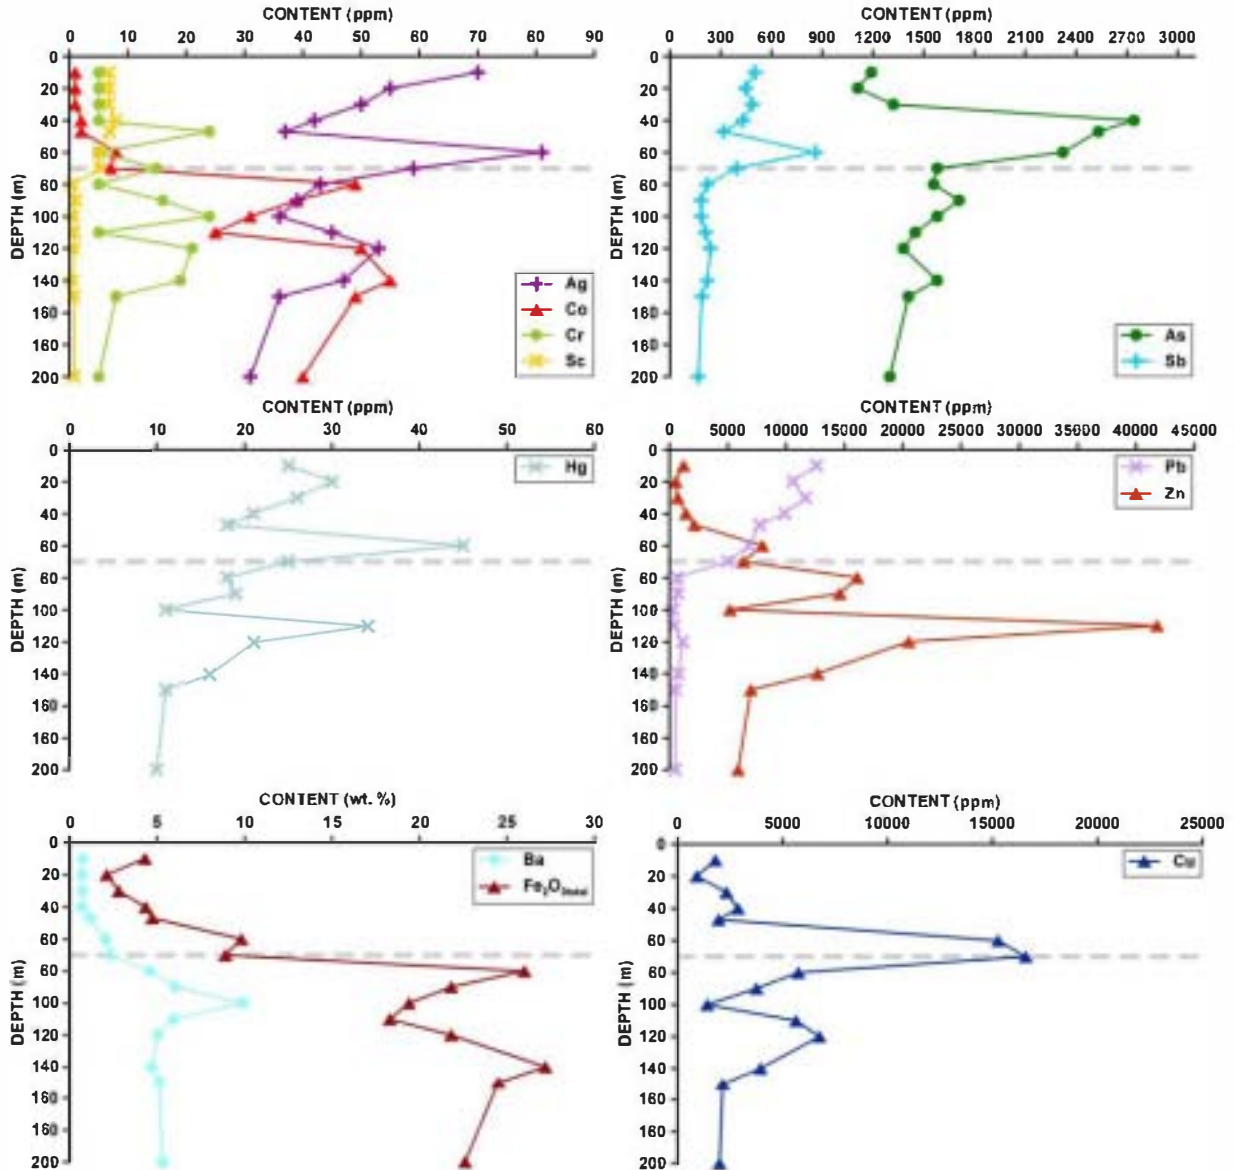
accompanied by the highest Sb and Ag contents. Cobalt, Ba, Fe_2O_3 total, and Zn showed a significant increase in their contents in the 80-200 cm depth interval when compared to the moderate increase of Au. Mercury and Ag, however, showed an irregular distribution with depth, displaying their maximum concentrations at 60 cm, and their second relative maxima located, respectively, at 110 and 120 cm.

Fig. 3 Distribution-with-depth profiles for total ferric iron and trace elements concentrations from Monte Romero mine tailings

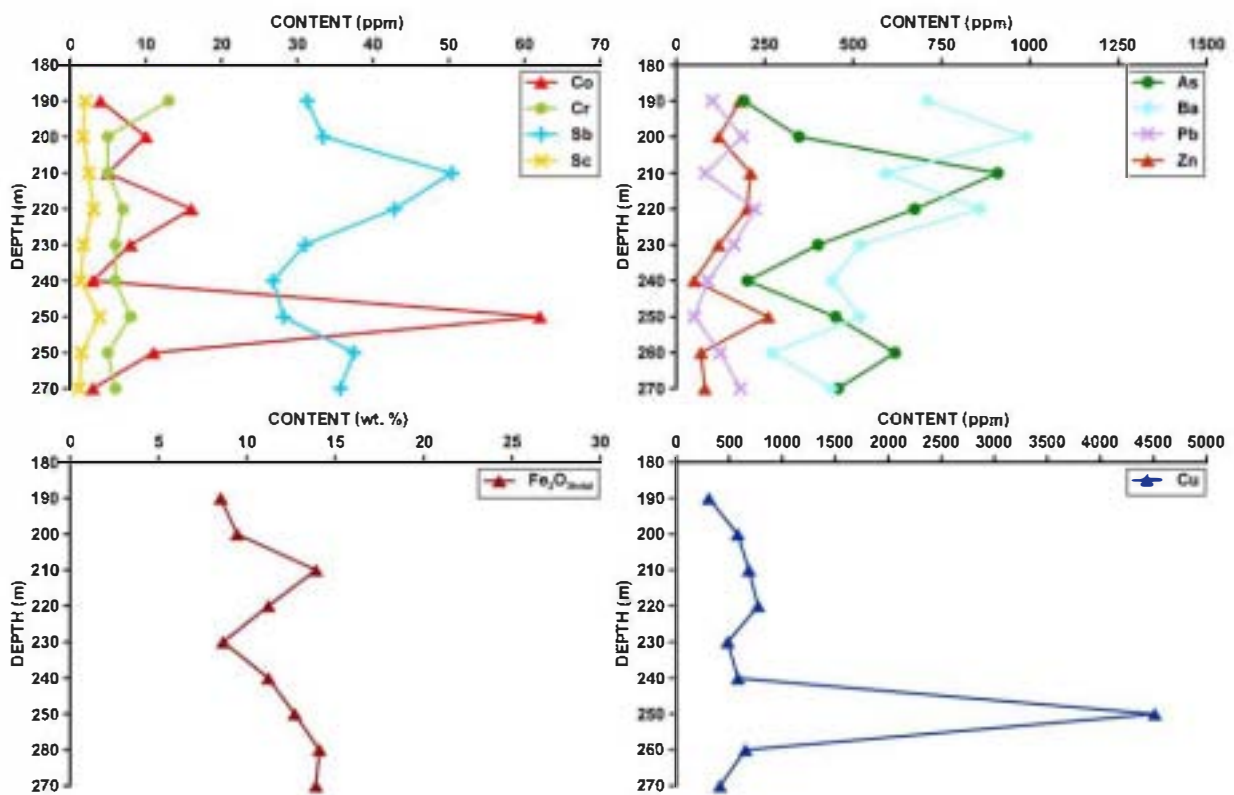
The geochemical composition of the La Naya mine sludge was also characterized by high contents of heavy and transitional metals, but they were at least one order of magnitude lower than the Monte Romero values (Table 2, Fig. 4). The contents of Fe$_2$O$_{3\ total}$

Fig. 4 Distribution-with-depth profiles for total ferric iron and trace elements concentrations from La Naya mine tailings

and Sc were similar to the Monte Romero mine pond values, ranging between 8.5 and 14.1 wt.% and <4 ppm, respectively. The absence of elements such as Ag, Hg and Ni, and the absence of variations in the contents with depth, are significant features of these tailings (Lillo et al. 2008), contrasting with the geochemical features of the Monte Romero mine ponds. Arsenic, Sb and Fe_2O_3 total contents displayed a slight increase with depth whereas Au and Ba showed an inverse pattern (Fig. 4). Sample N-250 showed the highest Cu, Co, Sc and Zn contents and the lowest Au, Pb, and Sb contents. The contents of Ni were below the detection limit (20 ppm) in all of the analyzed samples.

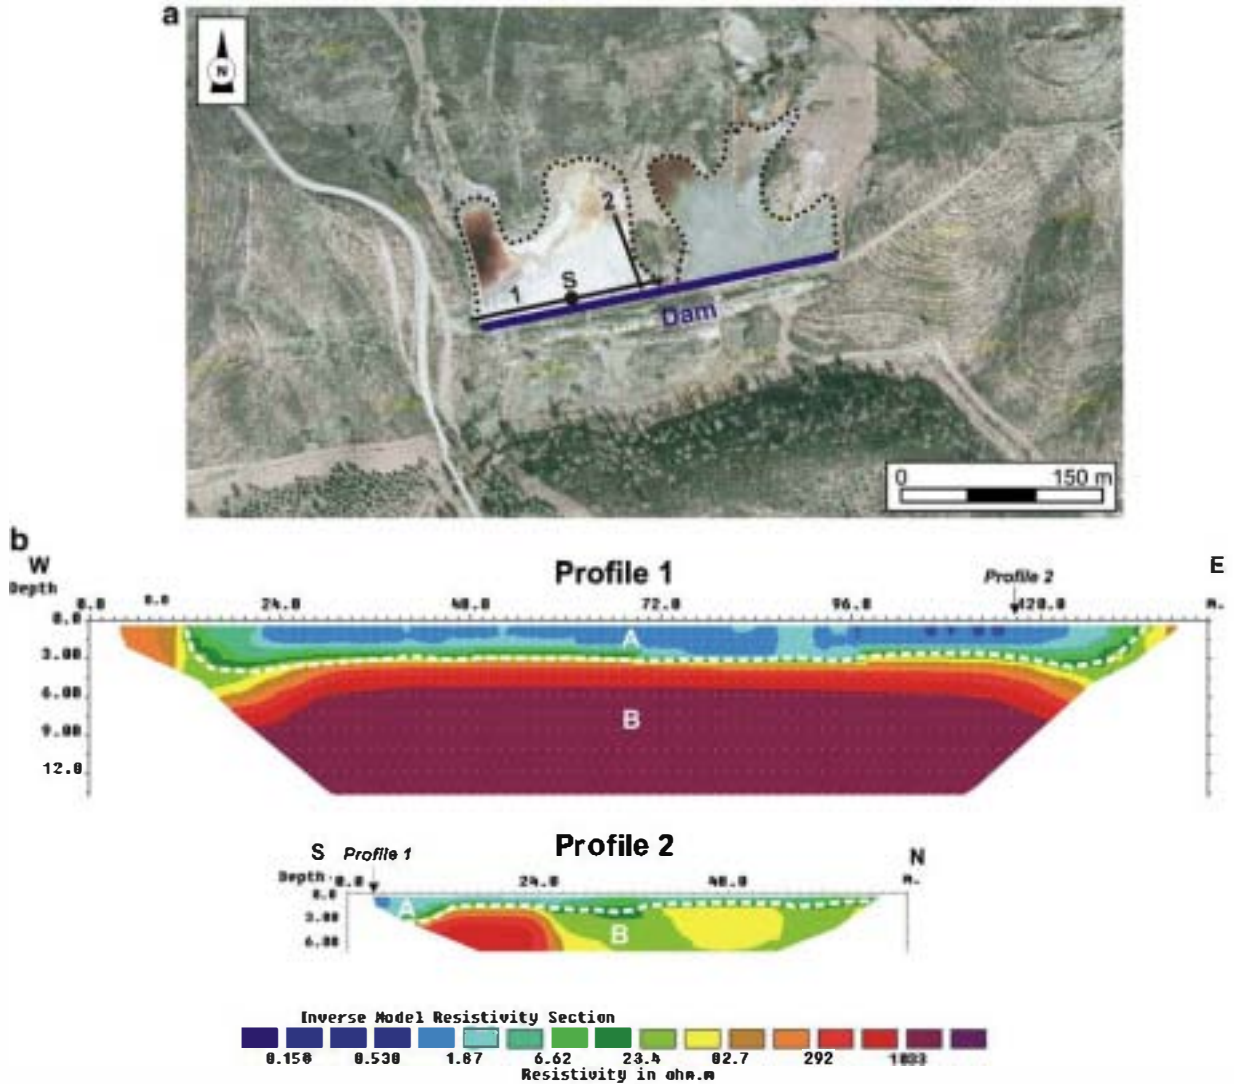
The ERT profiles for the westernmost Monte Romero pond, where the tailings sampling was performed, are shown in Fig. 5. Profile 1 (longitudinal to the dyke) has a length of 141 m, with an electrode spacing of 3 m. The minimum absolute error during the inversion process was 7.8%, reached during the seventh iteration. The maximum penetration depth obtained was 13.5 m, and two units with very different resistivity values were identified (Fig. 5a).

The upper unit A extended from 12 to 135 m along the profile, with lateral boundaries dipping steeply at the surface and flattening towards increasing depths, and exhibited the lowest resistivity values ranging from <1 to 25 ohm m. The lower unit B showed resistivity values ranging from 25 to >2,000 ohm m. The slightly undulating boundary between the two units was located, on average, at a depth of 3 m.

The length of the transverse profile 2 was 70.5 m, with an electrode spacing of 1.5 m and a maximum penetration depth of 7 m (Fig. 5b). The absolute error obtained during the inversion process was 2.3%, reached during the sixth iteration. In this profile, the thickness of unit A decreased from 3.5 m near the dam to 1.5 m far away from it. Furthermore, unit B was not as homogeneous as in profile 1, in such a way that two sectors with different resistivity values could be distinguished, which probably indicated differences in the degree of weathering of the shales: >88 ohm m southwards, and 25–88 ohm m from 25 m towards the north.

Fig. 5 a Location of ERT profiles (*lines 1–2*) and the tailings sampling (*s*) in the Monte Romero mine pond (*dotted line*); b Longitudinal (*1*) and transverse (*2*) ERT profiles. *White dashed lines* indicate the boundary between the tailings impoundment (unit *A*) and the Carboniferous shales (unit *B*)

The survey carried out at the Monte Romero mine pond showed that most of its unit A, interpreted as the pond infilling, showed resistivity values lower than 2 ohm m (Fig. 5b). These low values corresponded to water-saturated silt and clay materials with an abundance of sulfides, mainly pyrite. Moreover, the existence of a small trench in the western pond allowed us to identify the presence of the acid water table at a depth of 0.5 m (Fig. 2b). In addition to this, unit B, interpreted as being related to the Carboniferous shales which constitute

the base of the mine pond, exhibited very high and homogeneous resistivity values. This fact corroborates the theory that no acid water drainage occurred across the bedrock of the pond.

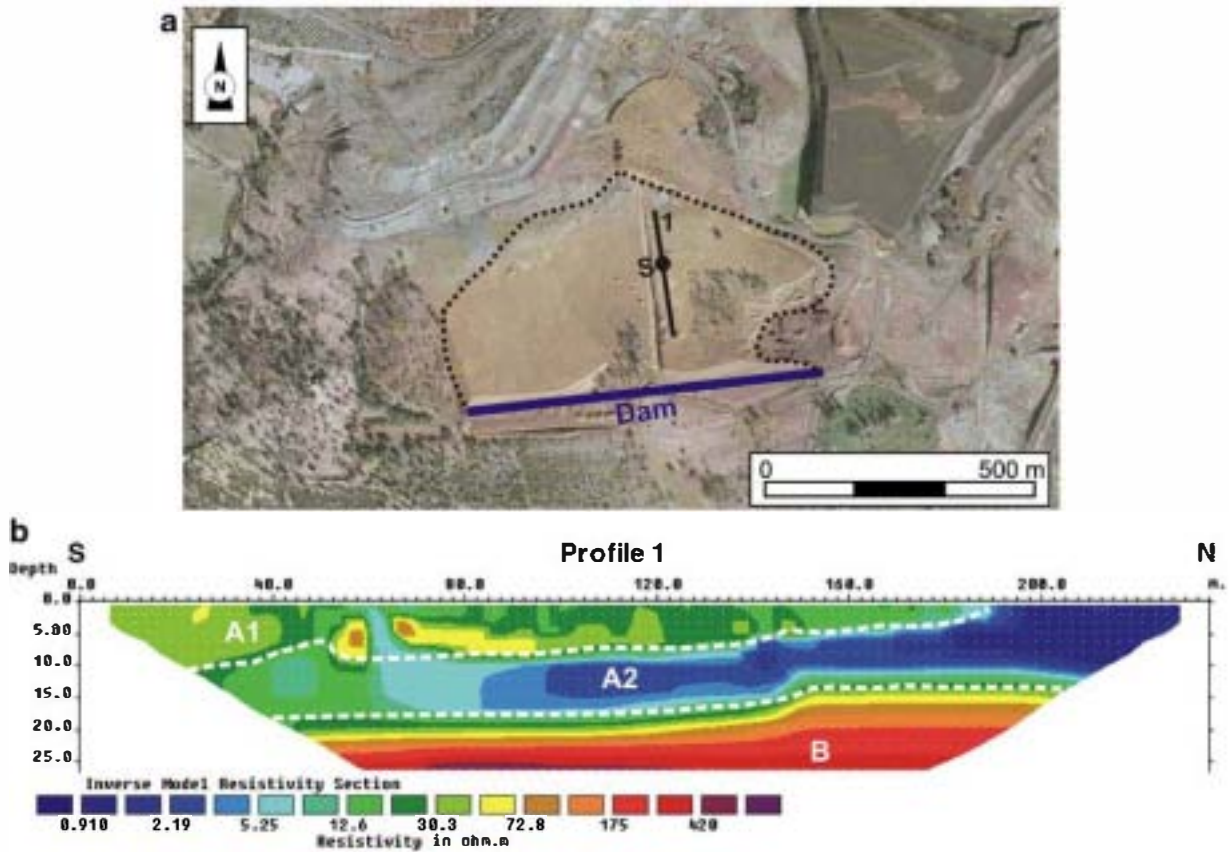
Due to its greater dimensions in comparison to the Monte Romero mine ponds, the La Naya mine pond was surveyed in a single ERT profile, transverse to the dam (Fig. 6). This profile had a length of 235 m with an electrode spacing of 5 m, and reached a maximum penetration depth of 25 m. The minimum absolute error during the inversion process was 8.9%, reached during the sixth iteration. As in the Monte Romero mine ponds, two units with very different resistivity values were observed (Fig. 6b): an upper unit (unit A) located along the whole profile with resistivity values ranging from <1 to 30 ohm m; and a lower unit (unit B), with resistivity values ranging from 30 to 650 ohm m. However, in contrast to the Monte Romero mine ponds, unit A from La Naya was not homogeneous and two different subunits were identified: the first one (A1) extended from the beginning of the profile up to 185 m and was defined by resistivity values ranging from 10 to 70 ohm m. This subunit showed a maximum thickness of 10 m, decreasing towards the north. Below it, subunit A2 extended laterally from 185 m to the end of the profile and vertically down to 20 m depth. Subunit A2 exhibited a gradual change in resistivity values from 20 ohm m at the southern end to <1 ohm m towards the north. It is noteworthy that the lowest resistivity values were found along the 185–235 m interval of the profile. During the field survey, secondary sulfate patches were observed on the surface of the pond at this section of the profile. This is important since the relationship between the sulfate patches and the low resistivity values, indicating patches corresponding to surface areas with high water contents, define the recharge area of the pond. During the summer, when evaporation rates are at a maximum, evapotranspiration promotes oversaturation and the precipitation of sulfates in recharge areas. Unit A did not have a constant thickness: the maximum value (20 m) corresponded to the first 135 m of the profile, whereas at a distance of 150 m a sharp step existed in the base of the pond which decreased the thickness of unit A from 20 to 15 m.

In contrast, the infilling of the La Naya mine pond had a more heterogeneous character. Its upper unit (unit A) could be divided into two different subunits (A1 and A2) according to their resistivity ranges (Fig. 6b). Subunit A2 exhibited the lowest resistivity values (<5 ohm m), extending from 65 m to the end of the profile. This was interpreted in terms of the

Fig. 6 a Location of the transverse ERT profile (*line 1*) and the tailings sampling (*s*) in the La Naya mine pond (*dotted line*); b ERT profile where are distinguished the tailings impoundment (*units A1–A2*) and the metamorphic-volcanic materials at the base (*unit B*)

occurrence of an inner groundwater flow which recharged the pond at its northeasternmost end, moved deeper into the pond towards the south, and finally emerged at the surface (at 65 m from the origin of the profile) due to the occurrence of a vertical low-permeability barrier. This barrier corresponded to an abandoned evacuation chimney constructed inside the mine pond that could be easily recognized on the surface. This interpretation agrees well with the occurrence of a small swamped zone in the field, located just on the low resistivity area (at 65 m from the origin of the profile). Unit B was much more homogeneous and corresponded to the metamorphic and volcanic rocks which constitute the base of the mine pond. Its high resistivity values, as was the case for the Monte Romero ponds, were also interpreted as being indicative of an absence of leakage through the bedrock; therefore, the internal groundwater flow described from the interpretation of unit A was confined to the interior of the pond.

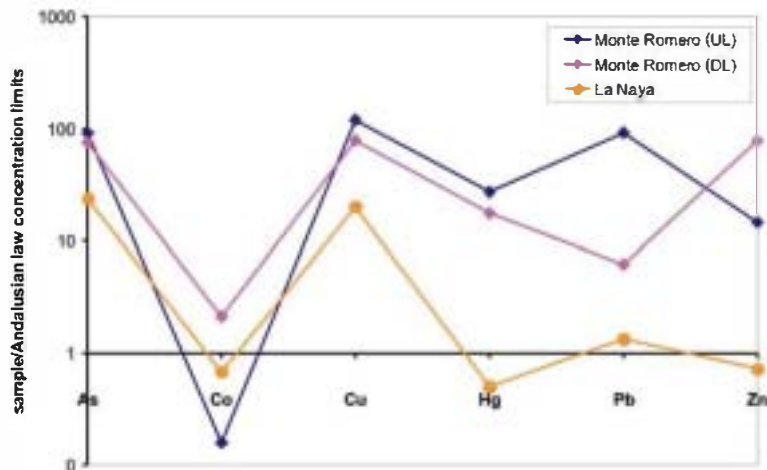
The metal contents in the Monte Romero levels (upper and deeper) significantly exceeded the Andalusian regional government legal limits for As, Cu, Hg, Pb, and Zn (Fig. 7) in agricultural soils (Aguilar et al. 1999). In contrast, the contaminant contents in the La Naya samples only exceeded the legal limits for As and Cu. It is important to determine how these metals can still be found. If they are present in the primary phases (sulfides, gangue, and host rock minerals) they represent a potential hazard when these minerals become affected by AMD processes. If the metals are incorporated in the secondary phases, it is important to evaluate the ability of these minerals to stably store these elements. The mineralogical characterization and the positive correlations confirmed that the metals are mostly present within sulfides in the deeper level of the Monte Romero ponds and that they can be released during weathering of the material containing them. The low metal content and the negative correlations reflect the nature of the dumped material in La Naya (poorly mineralized sludge and volcanic-bearing waste rocks), with a lower potential for the metals to be released.

Fig. 7 Composition of Monte Romero (*UL* upper level, *DL* deep level) and La Naya samples (selected hazardous minor and trace elements) normalized to the Andalusian law limits for concentrations in agricultural soils (from Aguilar et al. 1999)
