Damage of multilayer optics with varying capping layers induced by focused extreme ultraviolet beam

Alain Jody Corso,[1,2] Paola Zuppella,[1] Frank Barkusky,[3,4] Klaus Mann,[3] Matthias Müller,[3] Piergiorgio Nicolosi,[1,2] Marco Nardello,[1,2] and Maria Guglielmina Pelizzo[1,2]

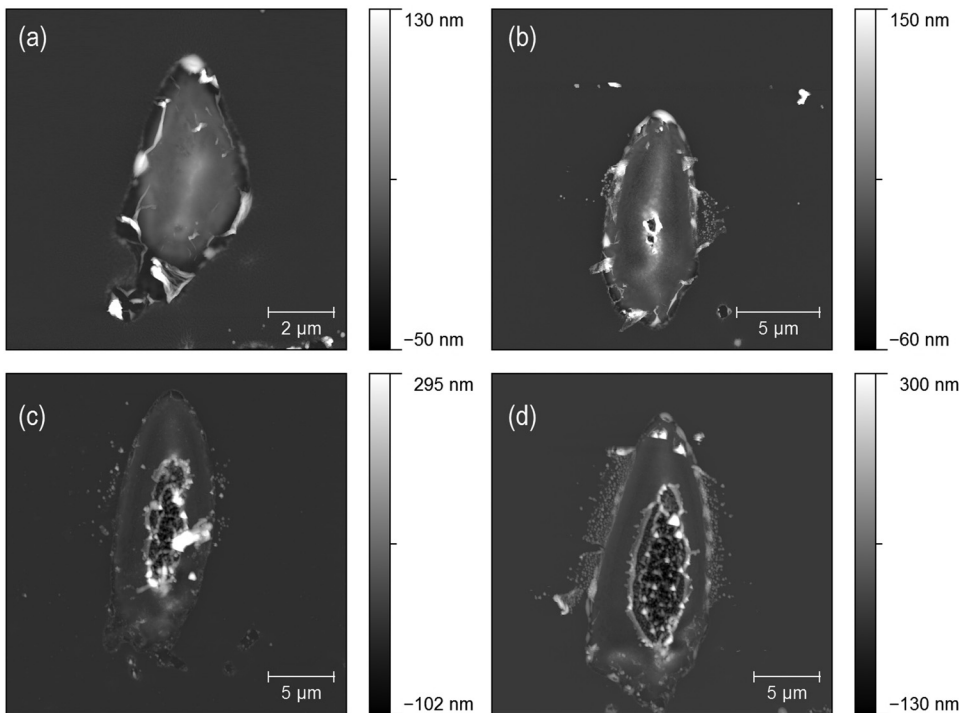
The appearance of the damage areas on CL1, CL2, and CL3 samples is very similar, and for this reason the AFM topographies taken for the Pd/a-Si capped sample and reported in Fig. 3 can be considered as representative for all Pt- and Pd-based MLs; in Fig. 4 a sequence of selected height profiles is also reported. The images show that at lower fluencies the damage appears as a smooth swelling of the samples surface, with subsequent formation of a bump of molten material; only at higher fluencies evaporation is present with a potential formation of a crater. Build-up of

splashes of fused material is also present at the border of the damaged spot. This behavior can be possibly attributed to a thermal damage mechanism, with fusion and then evaporation of material, probably favored by the presence of heavy metals with low stiffness and relatively low melting point (Table III).

FIG. 3. Topography for CL2 damaged areas, taken at different fluencies: (a) A4 at $F = 330\,mJ/cm^2$; (b) B1 at $F = 750\,mJ/cm^2$; (c) D4 at $F = 1720\,mJ/cm^2$; (d) E2 at $F = 2220\,mJ/cm^2$.

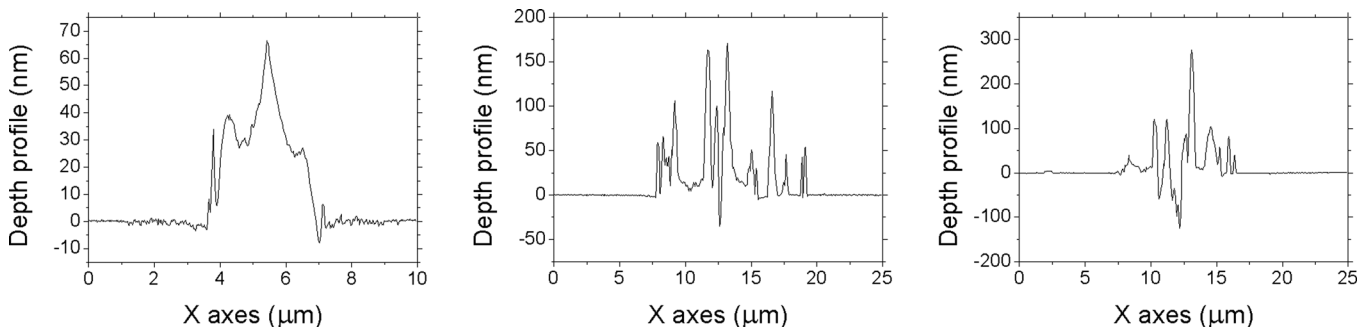
FIG. 4. Selected height profiles for CL2 damaged areas, taken at different fluencies: (a) A4 at $F = 330\,mJ/cm^2$; (b) C2 at $F = 1220\,mJ/cm^2$; (c) D4 at $F = 1720\,mJ/cm^2$.

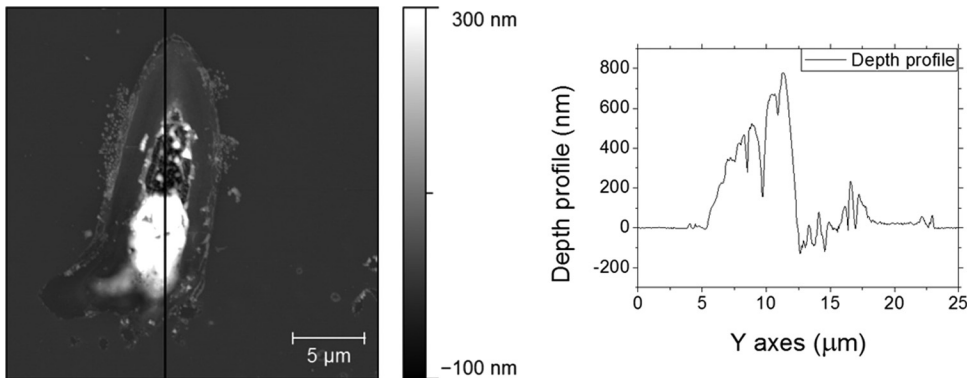
At highest fluencies some images indicate the presence of big bubbles (Fig. 5) on the irradiated area (CL1: spots E3 and E4; CL2: spots D1, D3, E1, E3, and E4). Such phenomenon involves a bigger amount of material than for the simple fusion process and seems to involve an explosive process; the different morphology could therefore be related to a change in the damage mechanisms.

FIG. 5. CL2-D3, $F = 1720 \, \text{mJ/cm}^2$ topography and depth profile.

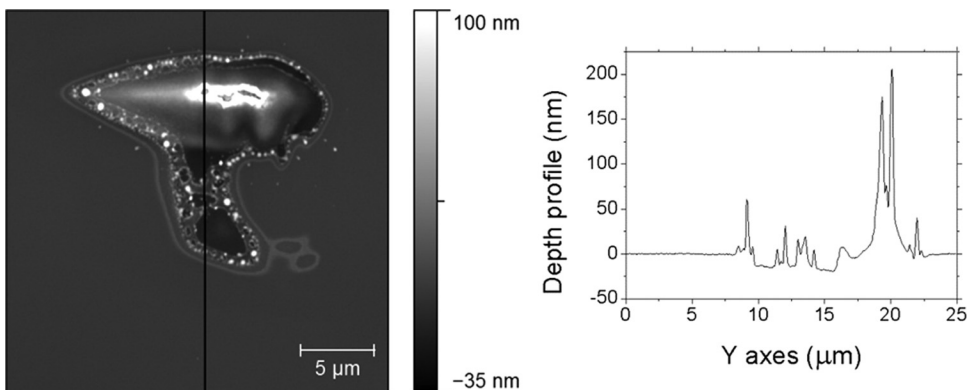
As said, in the case of CL3, the morphology of the damage areas is similar to those described for CL1 and CL2, so characterized by fusion and bump formation. Nevertheless, in this case the craters are smaller and form only at higher fluencies, indicating a higher damage threshold. However, in contrast with the previous cases, at high fluencies an erosion mechanism creates flat and shallow craters around the spots (Fig. 6).

FIG. 6. CL3-E4 at $F = 2220 \, \text{mJ/cm}^2$ topography and depth profile for $F = 2220 \, \text{mJ/cm}^2$.

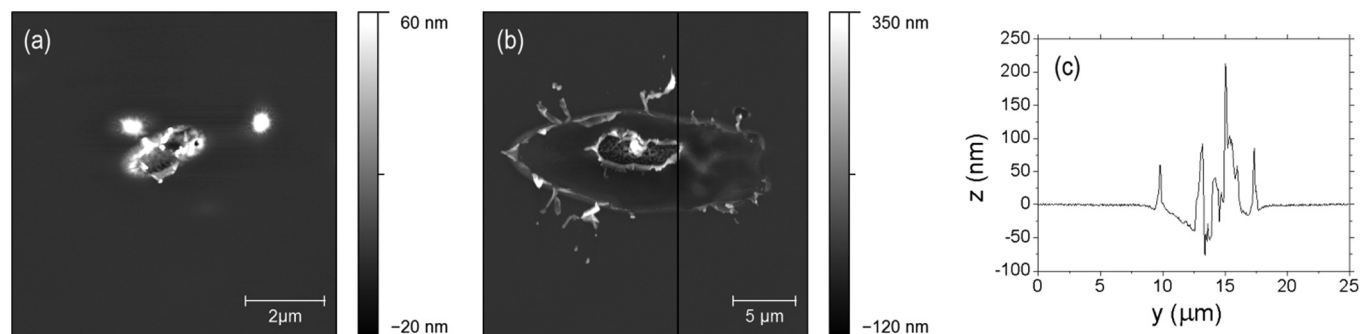
In the case of B_4C capping-layer (CL4), damages of irregular shape are visible at low fluencies, while at higher fluencies depression areas around the centre of the spot are present (Fig. 7). This morphology is similar to those observed in the case of uncapped Mo/Si multilayer[19] with a Si top layer. It can be concluded that the damage in CL4

FIG. 7. CL4-A4, $F = 330 \, \text{mJ/cm}^2$ (a) and CL4-E1, $F = 2220 \, \text{mJ/cm}^2$ topography and depth profile.

occurs with a different process than in the case of CL1, CL2, and CL3, being B_4C (and also Si) a non-metallic material.

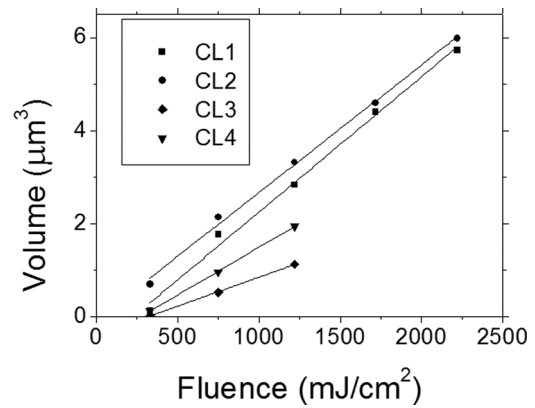
FIG. 9. Volume versus fluence.

In order to define a damage threshold for the different samples, in Fig. 9 a plot of the average volume V versus the irradiation fluencies is reported. The spot considered for the determination of the averaged V are those for which the damaging process is of the same nature, being this fusion of the material with low ablation and absence of explosive behavior. Therefore, the volumes V for fluencies $>1720\,mJ/cm^2$ have been discharged in the case of CL3 and CL4, for what just discussed. Moreover, in the case of CL1 and CL2 and for fluencies above $1720\,mJ/cm^2$, two V values have been calculated: V1, which is the average obtained excluding the damage spots CL1:E3-E4 and CL2:D1-D3-E1-E3-E4, and V2, which is calculated taking into account only these same spots. V1 has

V2 values are two times than V1, due to the big amount of materials displaced in the presence of large bubbles; this confirms the conclusions of the morphologic analysis for which a change in the damage mechanism was observed. In order to determine the damage threshold, a linear fit of the data reported in Fig. 9 has been carried out, and the results are reported in Table VI. CL3 shows the highest damage threshold, while CL2 has a significantly lower one.
