Microstructural Coarsening during Thermomechanical Fatigue and Annealing of Micro Flip-Chip Solder Joints

Monica Michele Barney

December 1998

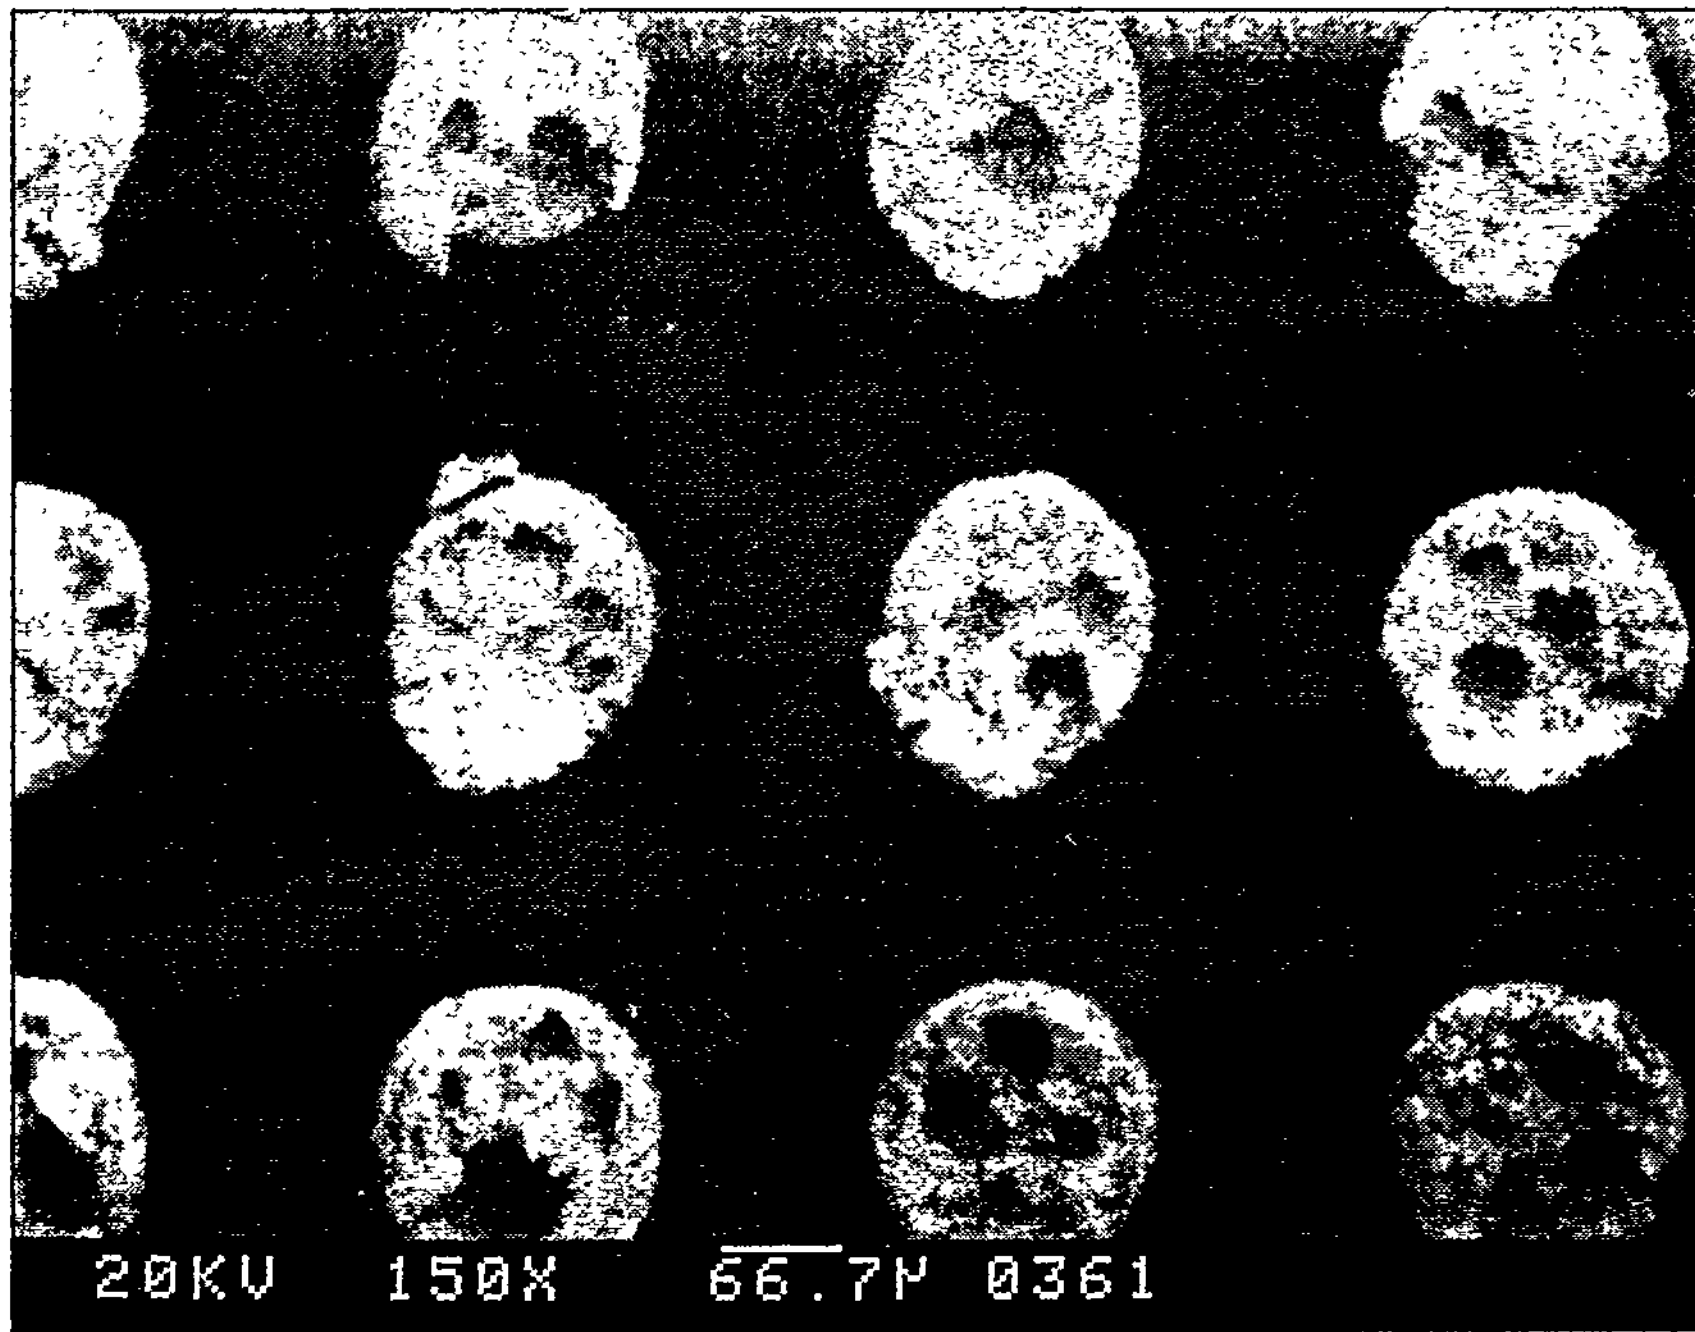
Figure 4.2.2-4: *Fracture surface showing void content of the failed low-strain samples*

It was assumed that the origin of all voids observed was from processing. Therefore, the total void content would not change with time, only the distribution may be effected. However, creep is coupled with fatigue in this type of testing, and creep mechanisms of void formation and coalescence could be occurring. The occurrence of creep microvoid coalescence damage could explain why the fatigue cracks observed were wider than would be expected for fatigue. These voids would be expected to be smaller than those observed, but they could play a role in the failure and could be effecting the void size measurements. The possible effect of creep was not studied in this work.
