INL/CON-05-00761
PREPRINT

Underground Corrosion Of Activated Metals 6-Year Exposure Analysis

National Association of Corrosion Engineers 2006 Annual Conference

March 2006

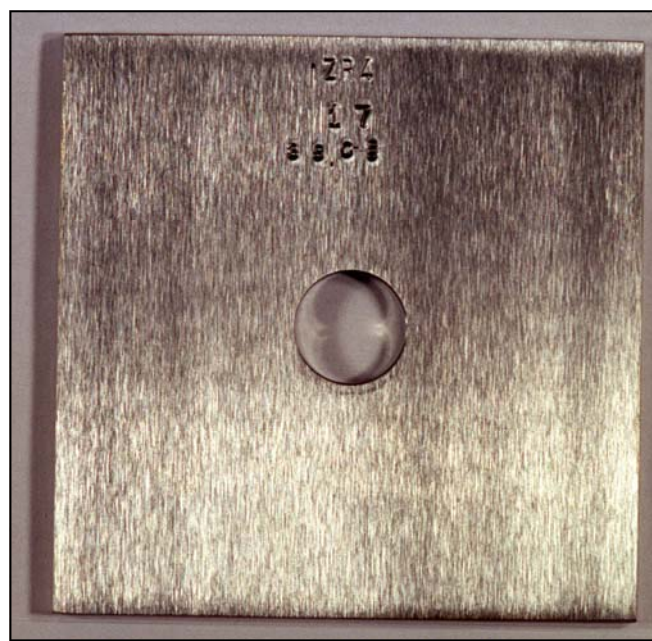
The duplex stainless steel, 304L stainless steel, 316L stainless steel, nickel-chromium alloy, and zirconium alloy coupons required no further cleaning. Figure 1 shows a typical zirconium alloy coupon after 6-years of exposure and Figure 2 shows the same coupon after cleaning (color differences are an artifact of lighting). The carbon steel, aluminum, and beryllium coupons were chemically cleaned according to the appropriate method defined in Table A1 of ASTM G 1 (in addition to the wash/brush process) as follows: carbon steel — C.3.5, aluminum — C.1.1, and beryllium (as recommended by the material vendor) — C.5.2 (for the coupons exposed 1 year) and C.1.1 (for the coupons exposed 3 and 6 years).

Pitting was evident in the aluminum, beryllium, and carbon steel coupons. Figures 3 and 4 are photographs of one carbon steel coupon, before and after cleaning (from the 10-ft (3.05-m)). Likewise, Figures 5 and 6 are photographs of beryllium coupons before and after cleaning (from the 10-ft (3.05-m)). Figures 7 and 8 are photographs of aluminum coupons before and after cleaning (from the 4-ft (1.22 m) depth. Table 4 details the pit depth measurements from 16 coupons with visibly deep-pitted surfaces. Aluminum exposed for one year showed no evidence of pitting and was not measured.

**FIGURE 1 – Zirconium Alloy Before Cleaning, 6-year exposure at 1.22 m**

FIGURE 2 – Zirconium Alloy After Cleaning, 6-year exposure at 1.22 m

FIGURE 3 - Carbon Steel Coupon Before Cleaning, 6-year exposure at 3.05-m

FIGURE 4 - Carbon Steel Coupon After Cleaning, 6-year exposure at 3.05-m

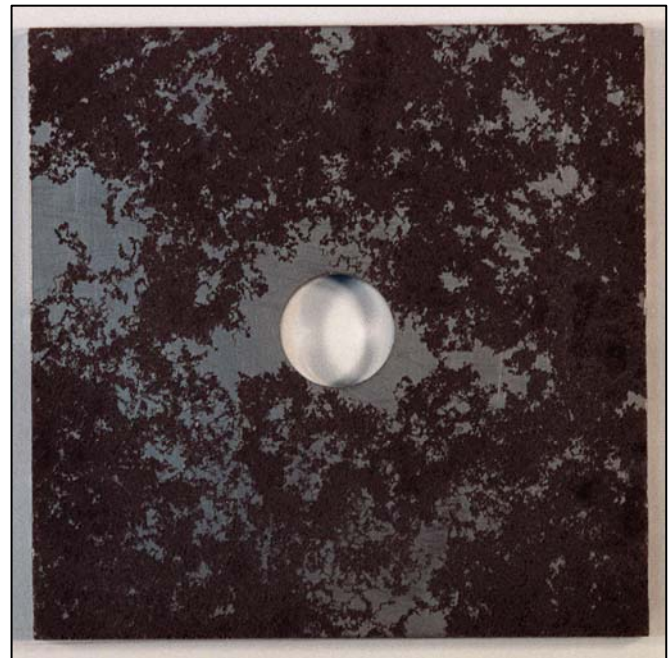
**FIGURE 5 - Beryllium Coupon Before Cleaning, 6-year exposure at 3.05-m**

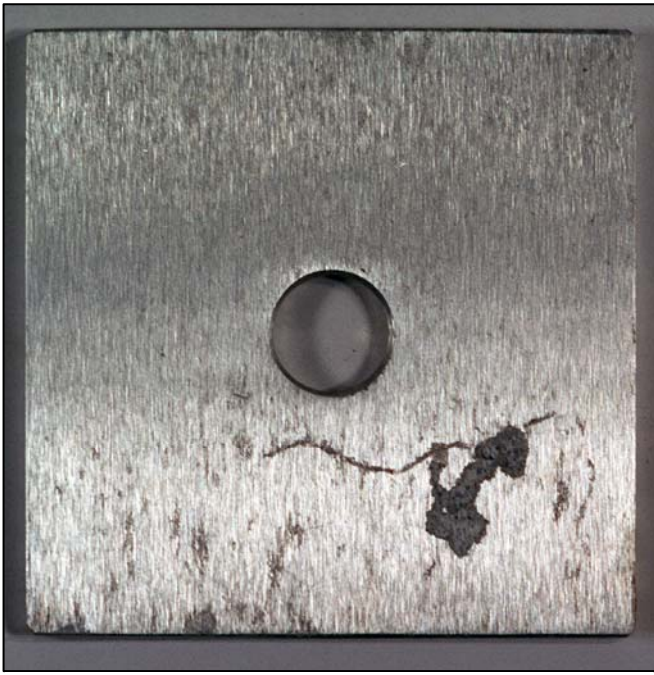
**FIGURE 6 - Beryllium Coupon After Cleaning, 6-year exposure at 3.05-m**

FIGURE 7 - Aluminum Coupon Before Cleaning, 6- year exposure at 3.05-m

FIGURE 8 - Aluminum Coupon After Cleaning, 6-year exposure at 3.05-m
