CORROSION OF LEAD SHIELDING IN NUCLEAR MATERIALS PACKAGES

ABSTRACT

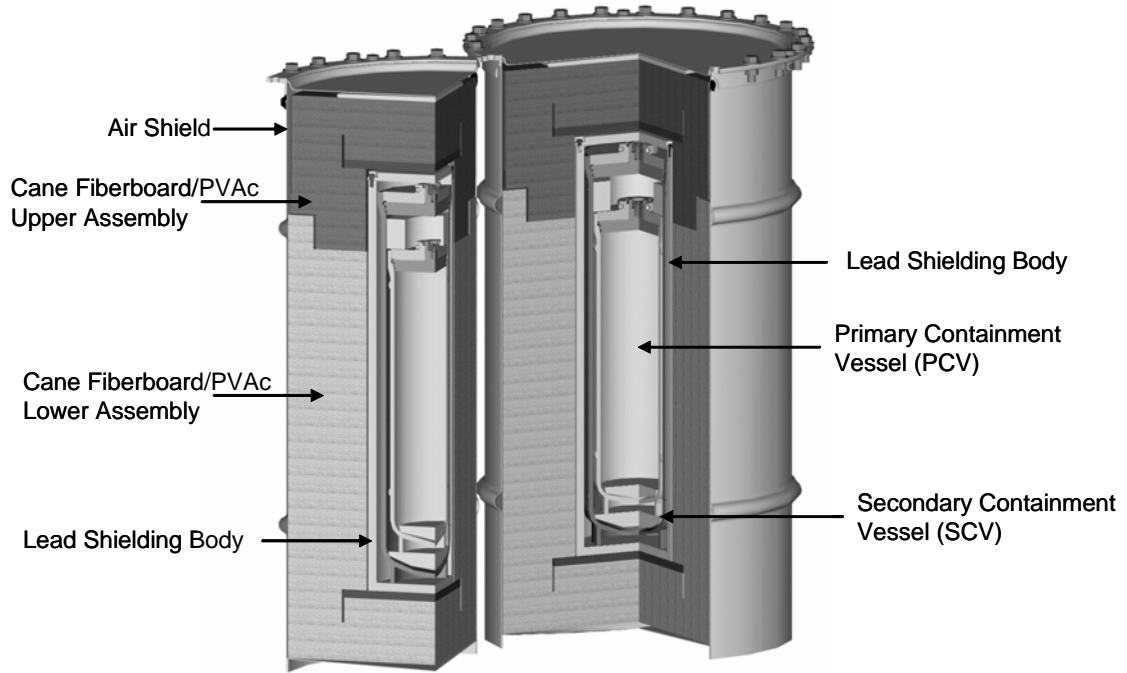
Figure 1: 9975 Package Isometric

The 9975 package is shown in Figure 1 with the materials of construction for each of the major features listed in Table 1.

The primary containment vessel (PCV), secondary containment vessel (SCV), and the outer drum are made of 304L-stainless steel. The containment vessels are placed in a shielding body made of lead which, in turn, is encased in the cane-fiberboard/PVAc laminate comprised of the upper and lower sub-assemblies. The cane-fiberboard, which adheres to ASTM C208-95:Type IV, Grade I wall sheathing, provides three safety functions: thermal insulation to limit PCV/SCV temperature during a fire, mechanical resistance to package crushing, and criticality. Layers of the cane-fiberboard are laminated together with wood glue, a water-based polyvinyl acetate (PVAc) glue The cane-fiberboard, per the ASTM standard, is nominally composed of cellulose ($\leq$96%), starch ($\leq$10%), clay ($\leq$2%), carbon black (<0.5%), paraffin wax binder ($\leq$2%) and a lamination adhesive ($\leq$3.5%). The air shield is attached to the cane-fiberboard insulation sub-assembly with a room temperature vulcanizing (RTV) silicone sealant.

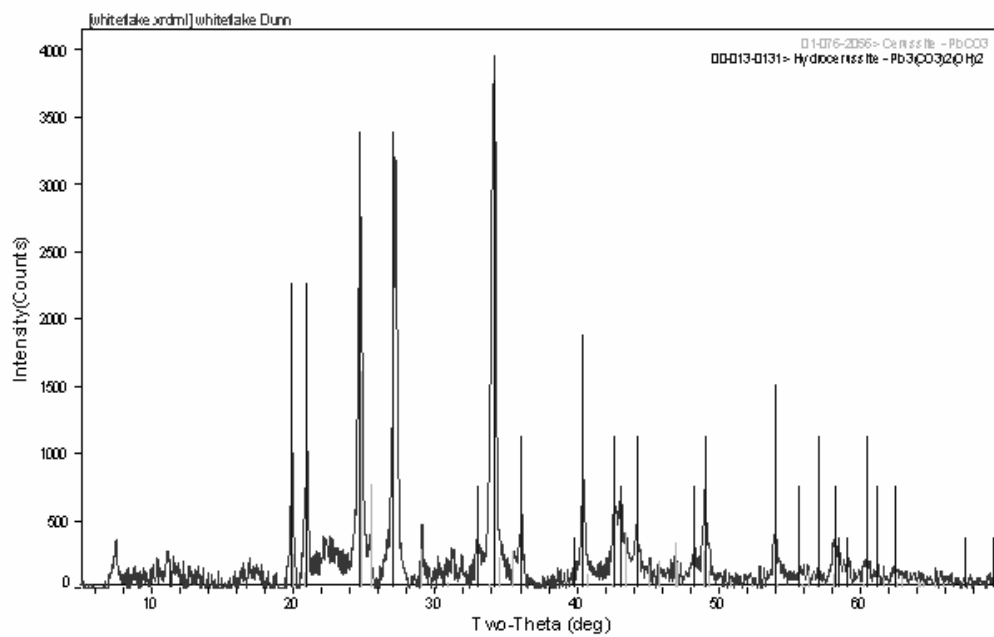
Inspections of several 9975 packages revealed a white coating on the exterior surface of the lead shielding, as shown in Figure 2. X-ray diffraction (XRD) analysis taken from a white flake embedded in the cane-fiberboard revealed lead carbonate (cerrusite, $PbCO_3$) and basic lead carbonate (hydrocerrusite, $Pb_3(CO_3)_2(OH)_2$), typically indicative of corrosion of lead by acetic acid.[2] Although lead is highly resistant to corrosion in many environments due to the insolubility and self-healing nature of its primary protective film, PbO, lead is known to be susceptible to corrosion in the presence of acetic and chloroacetic, oxalic acid, and formic acids.[3] In this case, acetic acid is the specific corrodant of interest because the RTV, PVAc, and the cellulosic organic materials can off-gas acetic acid due to completion of the curing process of subsequent environmental degradation.

with corrosion by acetic acid, in the presence of carbon dioxide, as shown in Equation 1. Acetic acid reacts with lead to produce lead acetate and lead hydroxide, which in turn react with carbon dioxide and form lead carbonate or basic lead carbonate. Lead carbonate then releases acetic acid and the process becomes self-sustaining.[4] In fact, the traditional method of formulating "white lead" (basic lead carbonate) for use as a white pigment, i.e. the "Dutch process", is to expose lead to acetic acid.[5]

The corrosion of the lead shielding in the 9975 package is thought to be primarily atmospheric in nature, or under thin films, as opposed to an immersed condition. The unexpected corrosion of lead due to acetic acid has been primarily reported in the context of atmospheric corrosion as seen in the museum and artifact preservation community.[7] However, as with all atmospheric corrosion mechanisms, this is a complex function of the condensate on the lead material. The acetic acid condenses in an aqueous surface film leading to the formation of lead acetate/lead hydroxide, which subsequently reacts with carbon dioxide to form lead carbonates. The subsequent formation and migration of the lead acetate/hydroxide compounds into the cracks of the carbonate layer towards the metal surface leads to the dissolution of the PbO under layer, the oxidation of lead, and subsequent peeling of the carbonate layer. The corrosion of lead reacting with acetic acid is typically a self-sustaining process because the reaction of the lead acetate/hydroxides with carbon dioxide to form lead carbonate releases acetic acid thereby sustaining the corrosion processes.[4]

**Figure 2: Lead Shielding Coated with White Materials**

In light of these corrosion mechanisms, the lead shielding was sheathed in a stainless steel liner to mitigate against corrosion. The safety case analyses and documentation are being revised for the additonal stainless steel liner.

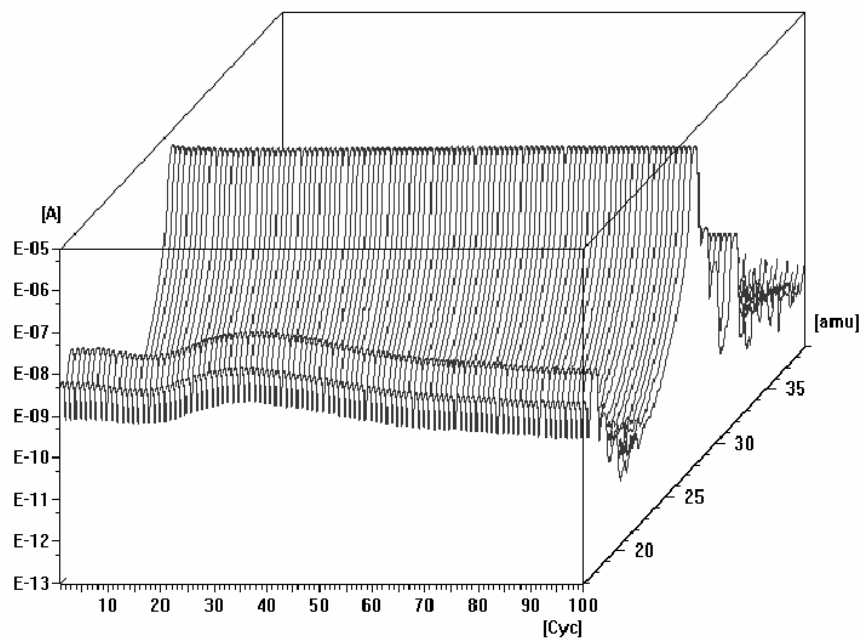
**Figure 4: TGA-MS of Cane Fiberboard Sample Indicating Physiosorbed Water Content**

analysis, shown in Figure 4, of the CF indicated water physisorbed onto the surface in addition to the humidity. Measurements of the moisture content of CF in the 9975 package shows typical levels of 12-14% wood moisture equivalent to equilibrium with an atmospheric humidity level of 65-75% at 70°F.[17] This is compliance with ASTM Standard C208, "Standard Specification for Cellulosic Fiber Insulating Board", which allows a maximum water absorption of 7-15% depending upon thickness of the wall sheathing materials.

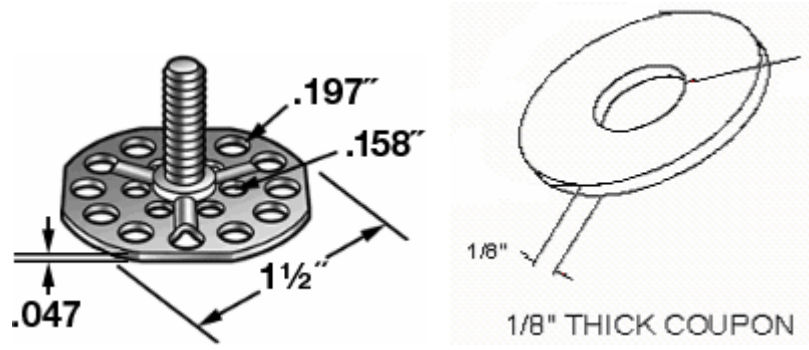
Testing for each unique condition was done in a 125-mL clear glass septa bottle at temperature within an oven. The lead coupons, nominally 3.175 mm, were mounted on a stainless steel rack perforated base stud (Figure 5) with the organic assemblies. The organic assemblies were assembled by cutting individual test materials into a pre-designated pattern for mounting by screw onto the coupon stud. The lead coupon was exposed to the assemblies on both sides but were separated using Teflon washers and nuts to allow for air exchange in the interface and prevent galvanic coupling with the base stud. Coupons were weighed, measured, and photographed before and after exposures.

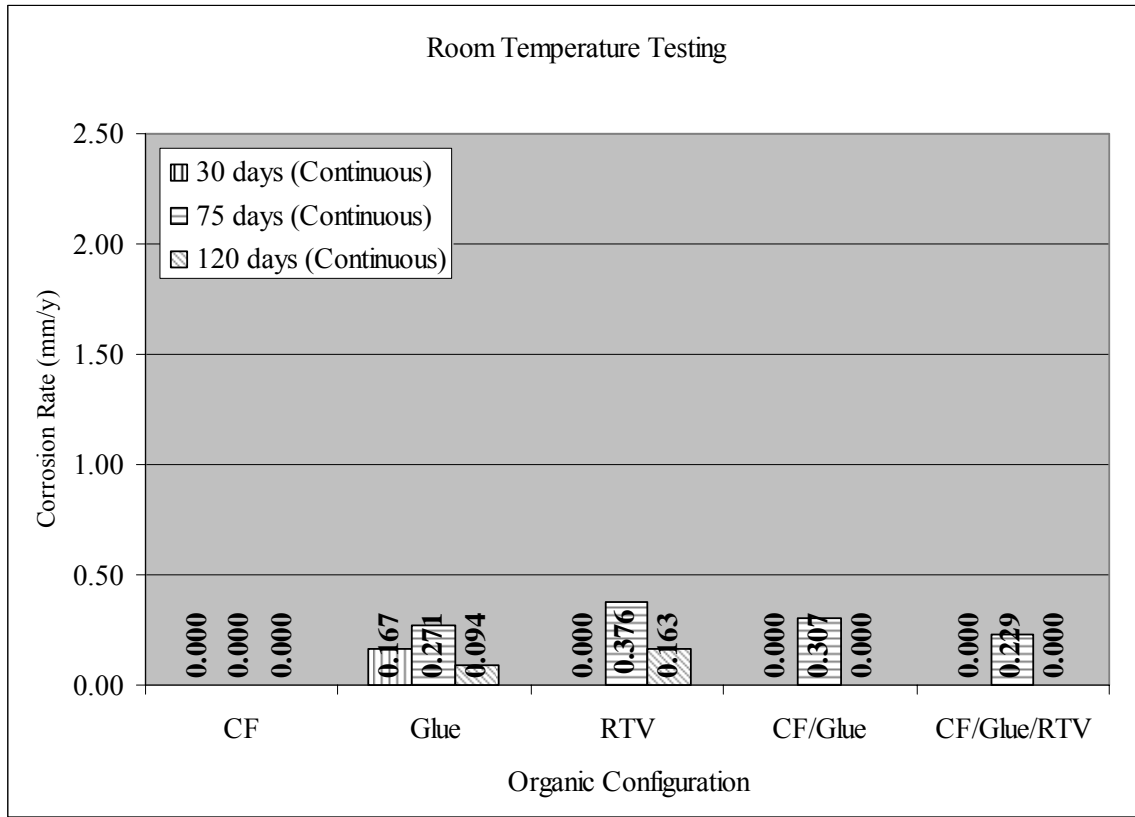
The corrosion rates (mm/year) for the lead coupons exposed in the condensed water cells for the complete duration of exposure are shown in Figure 6 to 8, for room temperature, 50°C, and 75°C respectively.

Figure 6: Corrosion Rates for Lead Coupons Exposed to Condensed Water Cells at Room Temperature for Continuous Duration of Exposure

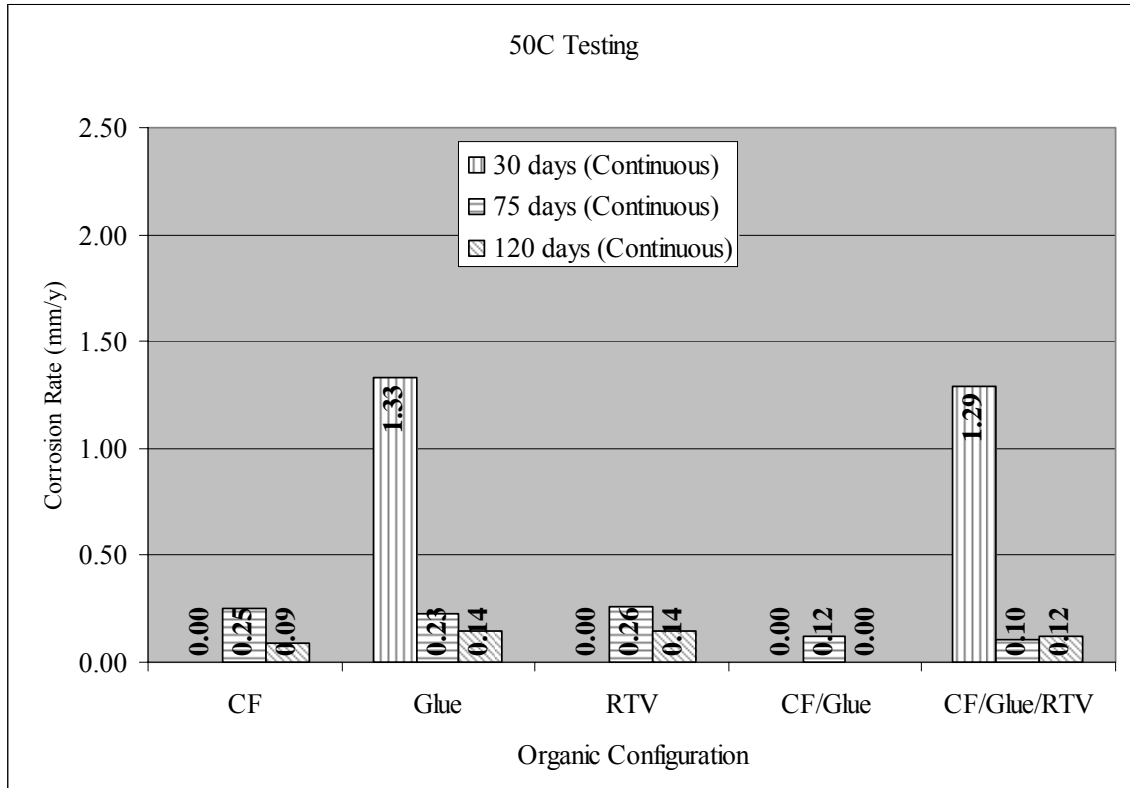
Figure 7: Corrosion Rates for Lead Coupons to Condensed Water Cells at 50°C for Continuous Duration of Exposure

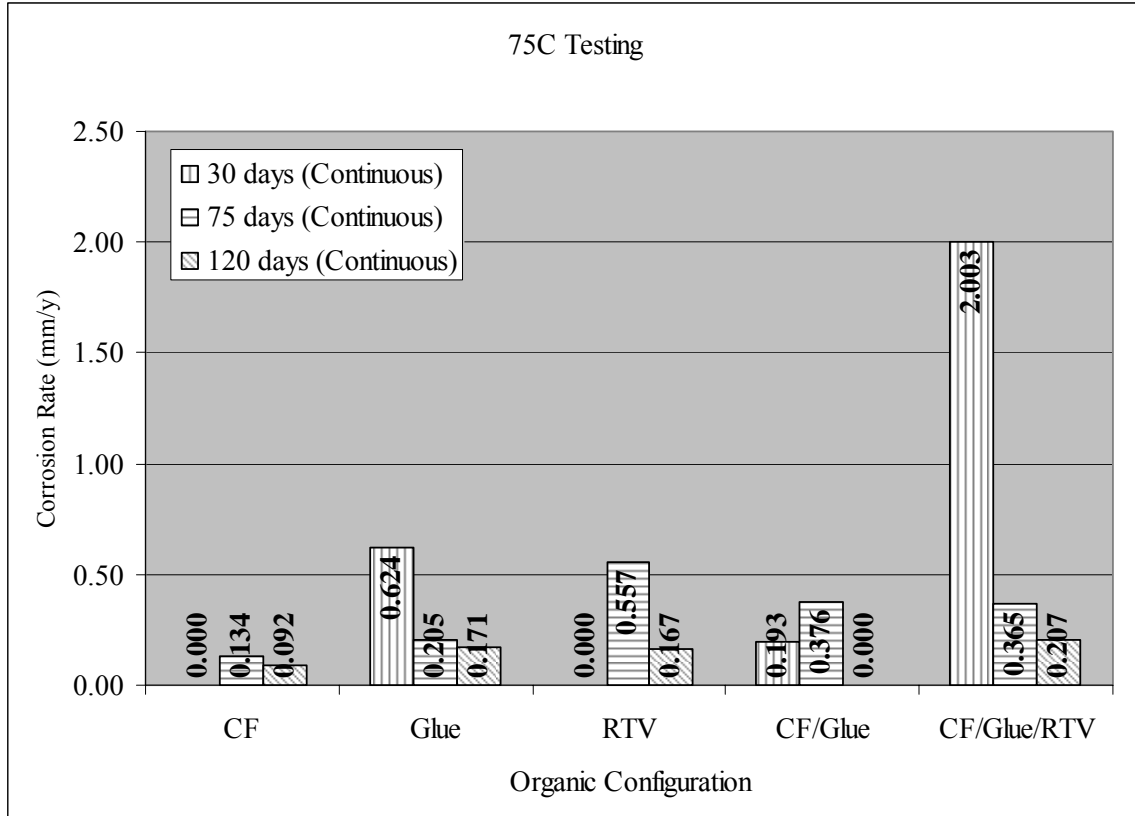
Figure 8: Corrosion Rates for Lead Coupons Exposed to Condensed Water Cells at 75°C for Continuous Duration of Exposure

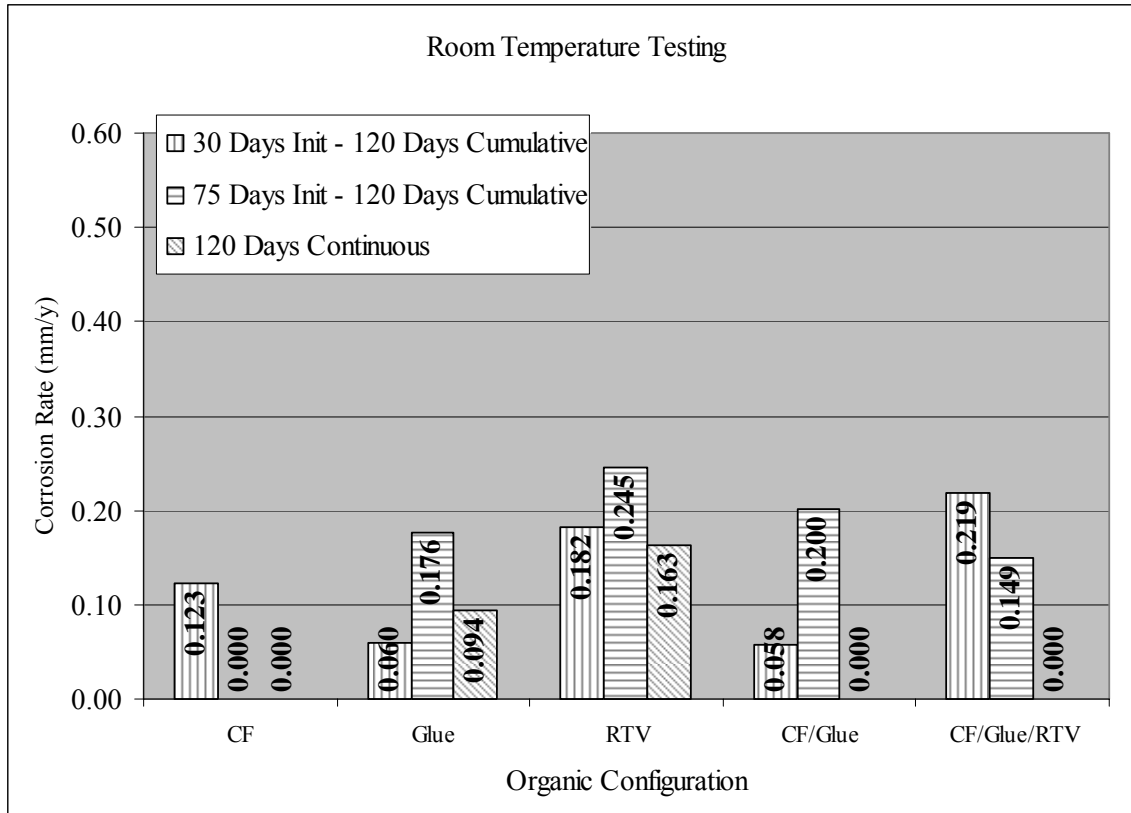
The corrosion rate data for the lead coupons exposed to the condensed water cells for the re-exposed coupons are shown in Figure 9 to 11, for exposure at room temperature, 50°C, and 75°C respectively. The continuous 120-day coupons are included for comparison purposes. In contrast to the initial 30-day exposures, re-exposure and replenishment of reactionary species at room temperature induced corrosion in the CF sample for the 30-day test.

Figure 9: Corrosion Rates for Lead Coupons Exposed to Condensed Water Cells at Room Temperature for Re-Exposed Coupons and Continuously Exposed 120-Day Coupons

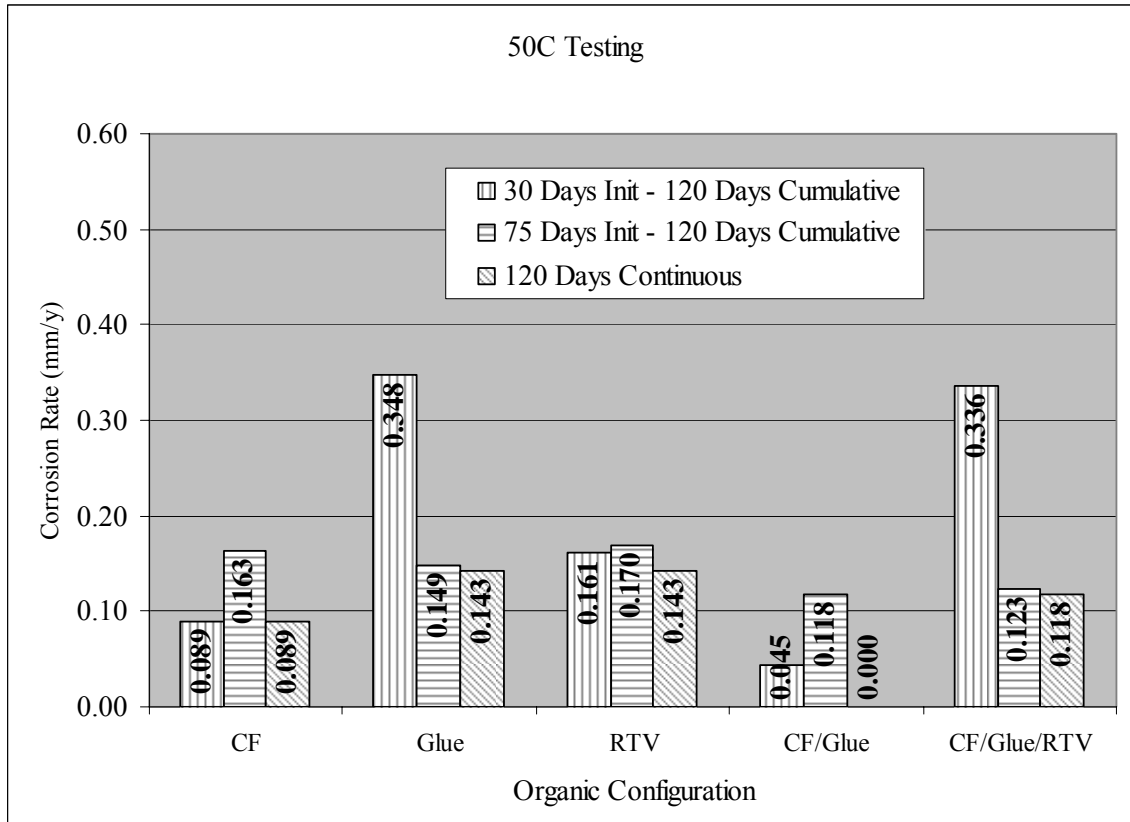
Figure 10: Corrosion Rates for Lead Coupons Exposed to Condensed Water Cells at 50°C for Re-Exposed Coupons and Continuously Exposed 120-Day Coupons

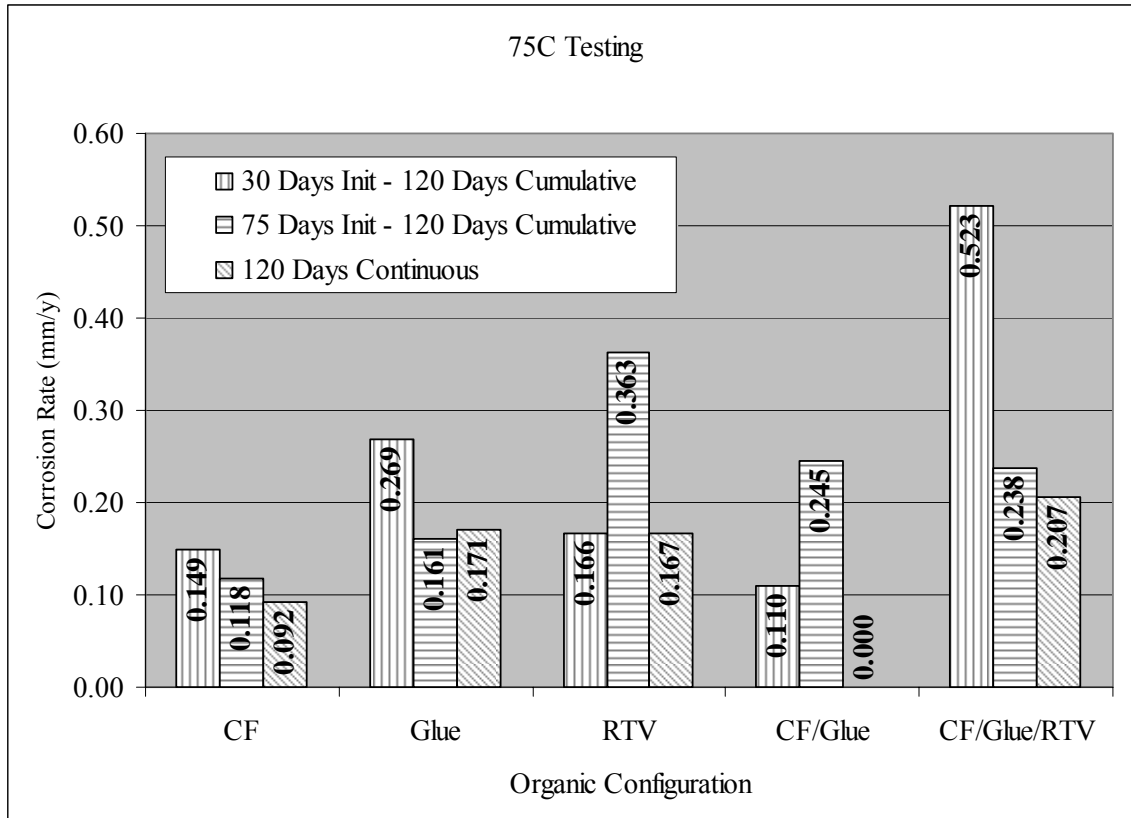
Figure 11: Corrosion Rates for Lead Coupons Exposed to Condensed Water Cells at 75°C for Re-Exposed Coupons and Continuously Exposed 120-Day Coupons

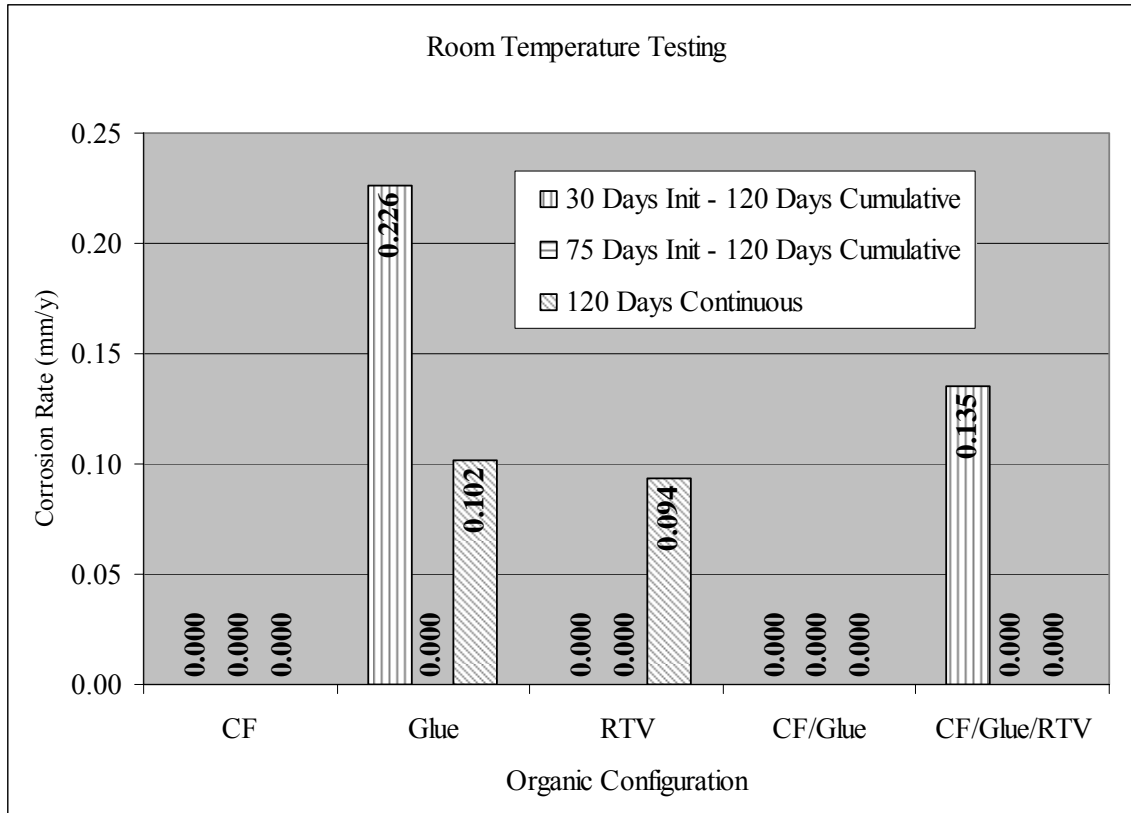
The corrosion rates for the ambient humidity cells were measured and calculated when possible. The lead coupons that were initially exposed for the 30/75 day cycles, and then re-exposed, were the only coupons that exhibited any measurable corrosion. The corrosion rate data for the lead coupons exposed to the ambient humidity cells for the re-exposed coupons are shown in Figure 12 to 14, for exposure at room temperature, 50°C, and 75°C respectively. Measurable corrosion occurred on lead coupons exposed to the glue samples in both the 30-day re-exposed coupon and the continously exposed 120-day coupon.

Figure 12: Corrosion Rates for Lead Coupons Exposed to Ambient Humidity Cells at Room Temperature for Re-Exposed Coupons and Continuously Exposed 120-Day Coupons

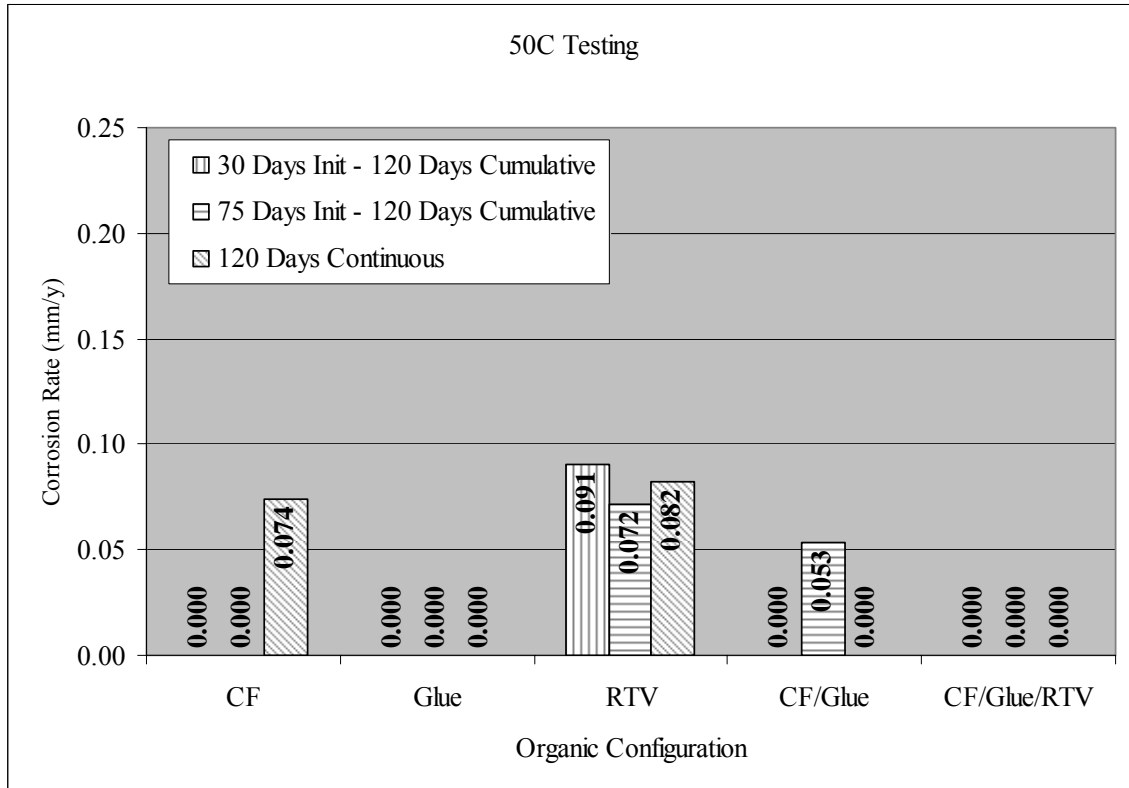
Figure 13: Corrosion Rates for Lead Coupons Exposed to Condensed Water Cells at 50°C for Re-Exposed Coupons and Continuously Exposed 120-Day Coupons

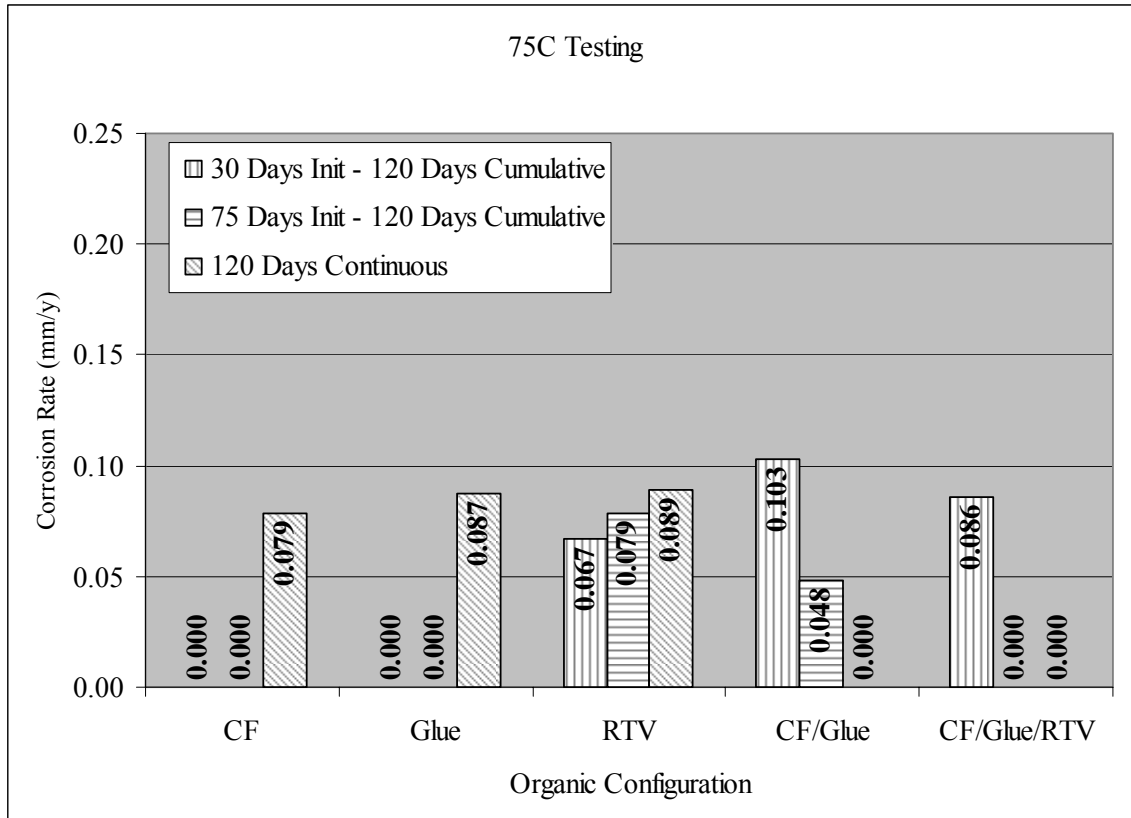
Figure 14: Corrosion Rates for Lead Coupons Exposed to Condensed Water Cells at 75°C for Re-Exposed Coupons and Continuously Exposed 120-Day Coupons
