Scientific basis for safely shutting in the Macondo Well after the April 20, 2010 Deepwater Horizon blowout

Scientific basis for safely shutting in the Macondo Well after the April 20, 2010 *Deepwater Horizon* blowout

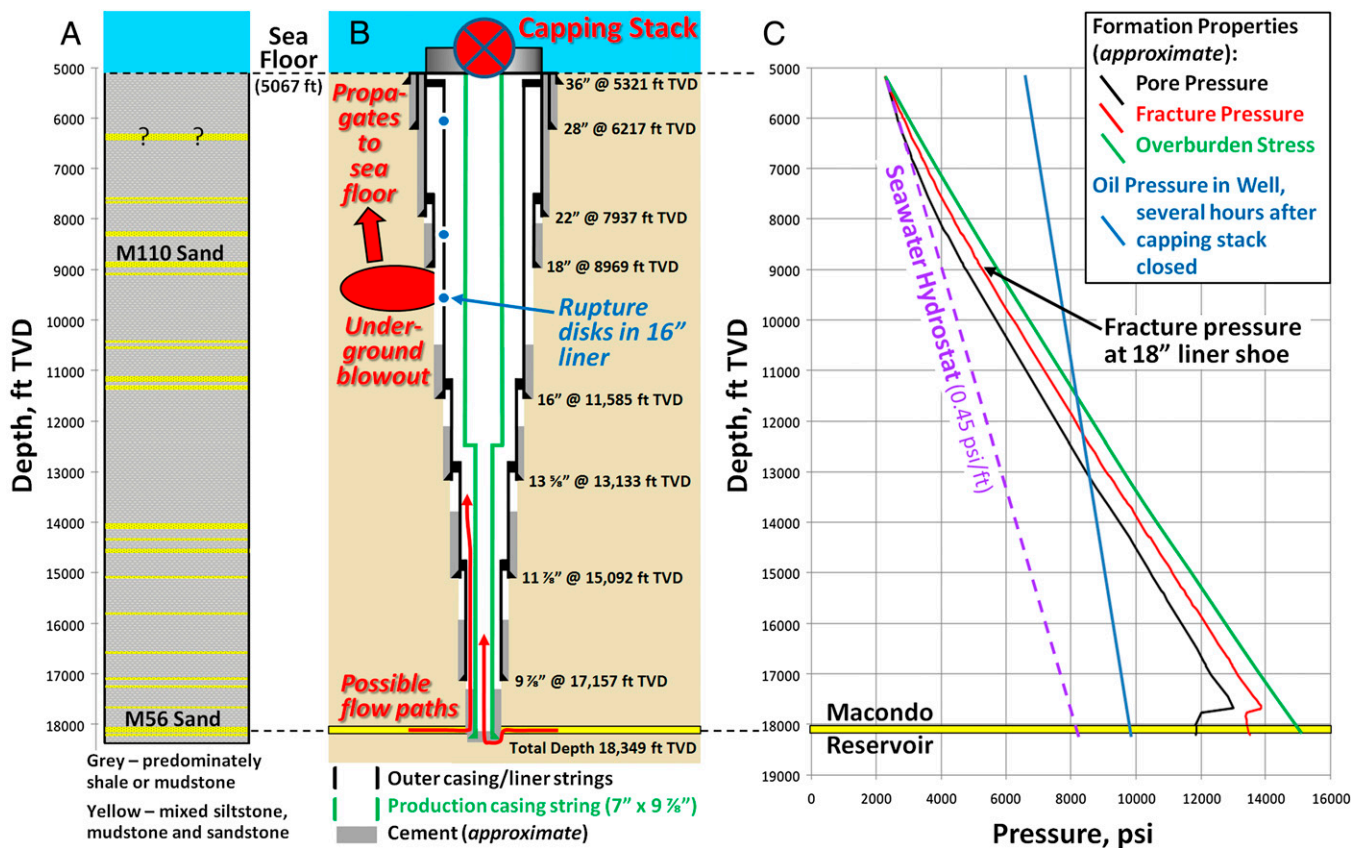
The Macondo (MC 252–1) Well is located ~50 mi (80 km) east–southeast of the Mississippi River Delta in a region of the deepwater Gulf of Mexico experiencing very rapid sedimentation. The Macondo oil reservoir lies at a depth of about 18,000 ft (5,500 m) below sea level in channelized turbidite deposits (sandstones) of middle Miocene age (M56 unit) (Fig. 1*A*). The upper portion of the well, which received the attention of the WIT, penetrates poorly consolidated shale, mudstone, siltstone, sandstone, and marl of Pleistocene through late Miocene age. The rapid deposition of fine-grained, low-permeability sediments creates an overpressured scenario commonly encountered in the Gulf of Mexico (2, 3), with pore fluid pressure increasing steadily with depth at a rate substantially greater than the oceanic (seawater) hydrostatic gradient (Fig. 1*C*). These high pore pressures, when coupled with the low intrinsic shear strength of these clay-rich sediments, lead to very low differential stresses (4). Throughout much of the Macondo Well, the pore pressure is, thus, only ~600 psi (4.1 MPa) less than the fracture pressure, which is the pressure at which the least principle stress is exceeded and a hydraulic fracture is formed (5). The fracture pressure, in turn, is only ~500 psi (3.5 MPa) less than the overburden stress (Fig. 1*C*).

Fig. 1. (*A*) Schematic lithologic section for the Macondo Well based upon analysis of data acquired during drilling (Source: BP). Depths are total vertical depth (TVD) below the *Deepwater Horizon* rig floor [75 ft (23 m) above mean sea level]. (*B*) Completion diagram for the Macondo Well showing outer nested casing and liner strings cemented in place during drilling and production casing cemented across the Macondo Reservoir (M56 sand, yellow). Possible oil flow paths during the blowout are shown in red, which were either inside the production casing, between the production casing and the outer casing/liner strings, or both. (Based on data from ref. 30.) (*C*) Approximate in situ pore pressure, fracture pressure, and overburden stress profile for the Macondo Well showing that pore fluid pressures at the Macondo site are overpressured relative to a seawater hydrostat. The blue line shows the approximate oil pressure in the wellbore corresponding to a capping stack pressure of 6,600 psi, which was observed several hours after the well was shut in (calculated for an oil pressure gradient in the well of 0.25 psi/ft). (Modified from ref. 31. Overburden stress and oil pressure gradient from BP.).

16-in liner had, indeed, failed, then shutting the well in at the capping stack would lead to an underground blowout (6) when pressure outside the 16-in liner exceeded the formation fracture pressure just below the 18-in liner shoe at 8,969 ft (Fig. 1 *B* and *C*). In this scenario, a hydraulic fracture would initiate at the 18-in liner shoe and propagate upward until it was either arrested by shallower geologic units (see below) or broached the seafloor. In the latter case, the consequences would be disastrous.

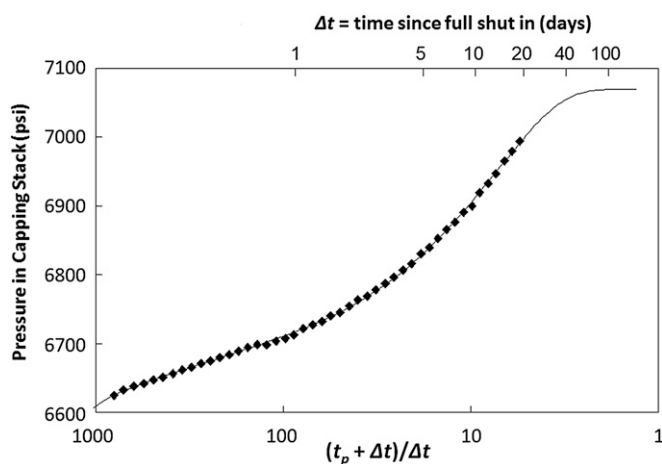
Fig. 2 compares the measured and simulated pressures in the capping stack on July 15, 2010. The step-like rises in pressure correspond to successive turns of the valve to choke back the oil discharge rate. After full shut in was achieved with the final valve turn, the simulated shut-in pressure quickly approached the observed shut-in pressure of 6,600 psi (46 MPa). The close match between observed and simulated pressures indicated that there was a reasonable scenario in which the Macondo Well had full integrity (i.e., no leakage after shut in), but the oil reservoir had been significantly depleted during the blowout. Although the possibility of a leak could not be ruled out, the decision was made by the government to extend the shut in beyond 24 h, with reevaluation of that decision at regular intervals. At this same time, an intense geophysical surveillance effort (described below) was begun to monitor for signs of leakage from the well. Wellhead pressure and geophysical monitoring data were independently reviewed and discussed by BP and the government oversight team, initially at 6-h intervals and then at 12- and 24-h intervals, to determine if the well should remain shut in. If signs of leakage were detected, then the Macondo Well would be immediately reopened.

Fig. 2. Wellhead pressure measured during and immediately after closure of the capping stack on the Macondo Well on July 15, 2010 as measured by pressure gauges installed on the capping stack (PT_3K_1 and PT_3K_2). The pink line denotes pressure simulated by the initial (square) reservoir model assuming a well with no leaks. (Modified from ref. 18 with permission of the National Ground Water Association, Copyright 2011.)

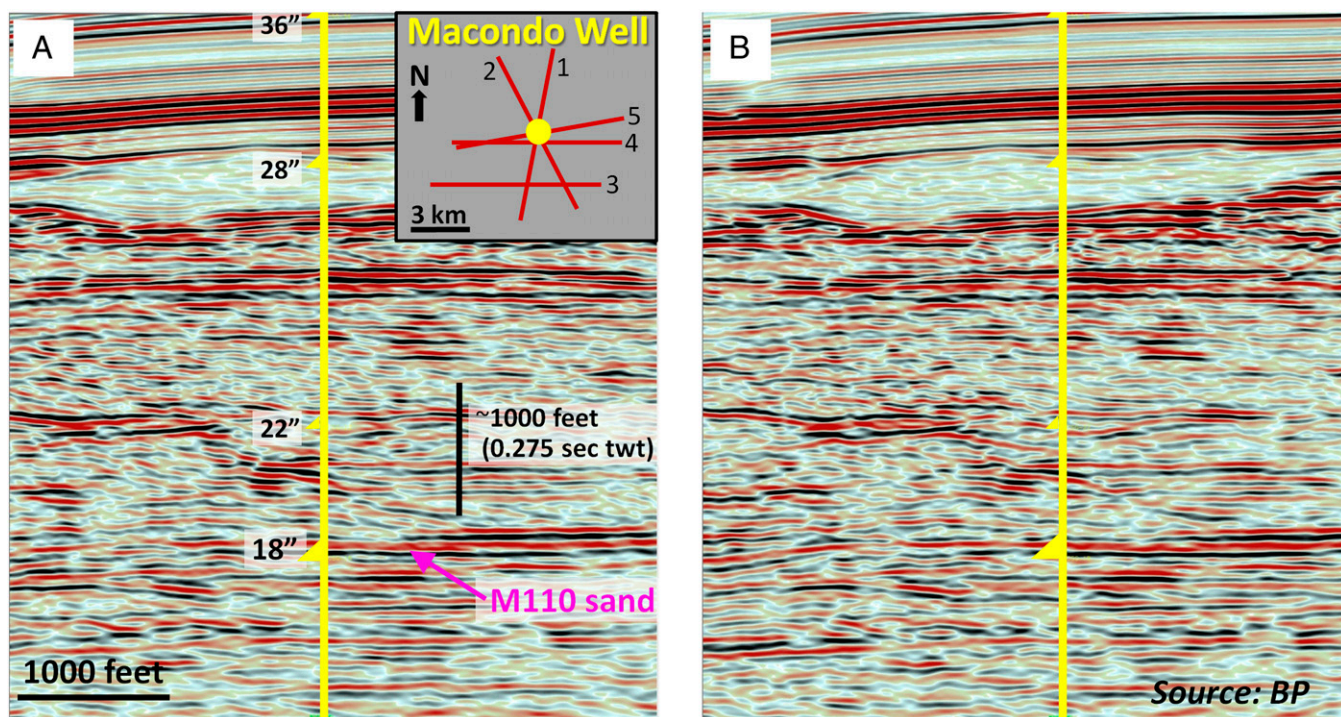
Using a horizontal detection threshold of 150 ft (46 m), which is slightly greater than 3 cmp, the WIT calculated the minimum volume of leaked hydrocarbons that could be imaged with seismic reflection. Two geometries were assumed for the lateral extent of hydrocarbons in the 20-ft-thick (6-m-thick) M110 sand: (*i*) a circular region centered on the well or (*ii*) an elliptical region with a 10:1 aspect ratio fed by a vertical hydraulic fracture located midway between two seismic lines. The amount of oil contained within such a region, subject to assumptions regarding the amount of gas dissolved in the oil and the water saturation, ranged from ~6,000 to 14,000 bbl. Because no anomaly had been detected by the 11th day after shut in, the leak rate could be no more than ~1,300 bbl/d. Thus, the conclusion reached was that

Fig. 4. (*A Inset*) Location map showing transects for seismic lines acquired to test for leakage of the Macondo Well below the seafloor after closure with the capping stack. (*A*) 2D seismic section acquired by the vessel *Geco Topaz* along line 1 on July 13, 2010 (2 d before closing the capping stack and shutting in the well). Approximate horizontal and vertical scales are shown, with the latter derived from two-way travel time (twt) and a sediment velocity model. (*B*) Same as in *A* but acquired on July 19, 2010 (4 d after the well was shut in). Within each section, the projection of the Macondo Well and locations of the various liner/casing shoes are shown as a yellow line and triangles, respectively.

the Macondo Well either had no leak at the 18-in liner shoe or had a leak less than ~1,300 bbl/d, which is below the level of detectability with high-resolution seismic methods.

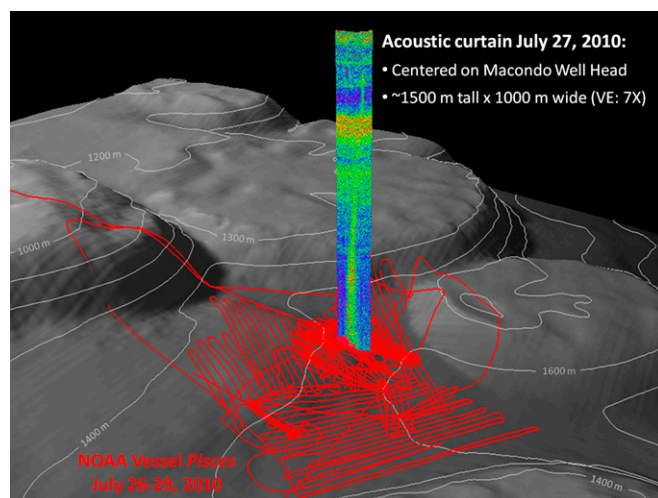
forming on and then breaking away from the wellhead cap. Subsequent visual inspection by remotely operated vehicles found the source of both the bubbles and the methane hydrate formation (which was also seen at the wellhead) to be a small leak

Fig. 5. Track line of the NOAA vessel *Pisces* for July 26–29, 2010 shown superimposed on an oblique view of seafloor topography surrounding the Macondo Well. Three different NOAA vessels (*Pisces*, *Gordon Gunter*, and *Henry Bigelow*) provided near-continuous sonar coverage over and around the Macondo Well during shut in to look for evidence of gas emanations that might be related to leakage from the well, but only this track line is shown for clarity. The acoustic curtain shown reflects a small stream of gas bubbles rising from the Macondo wellhead on July 27, 2010 (discussed in the text). Depth contours are at 100-m intervals, and vertical exaggeration is 7×.

from a flange-to-flange metal seal in the blowout preventer/capping stack assembly, which was judged to be inconsequential.
