Non-destructive testing and assessment of a piping system with excessive vibration and recurrence crack issue: An industrial case study

Zhi Chao Ong, Hoe Cheng Eng, Siamak Noroozi

High vibration was observed during routine maintenance, in a 30 m high, 24 inch diameter amine pipes at an oil and gas processing plant in southern Thailand (Fig. 1). The processing pipe acts as a CO_2 removal unit where the transporting mediums consist of H_2O, CO_2 and Methyl Diethanolamine (MDEA). The inlet, i.e. stream 216 is the liquid mixture of the mentioned three products where the outlet, i.e. stream 217 is a 2-phase mixture of vapor and liquid. The detailed operating parameters and mixture composition are tabulated in the mass balance table shown in Table 1.

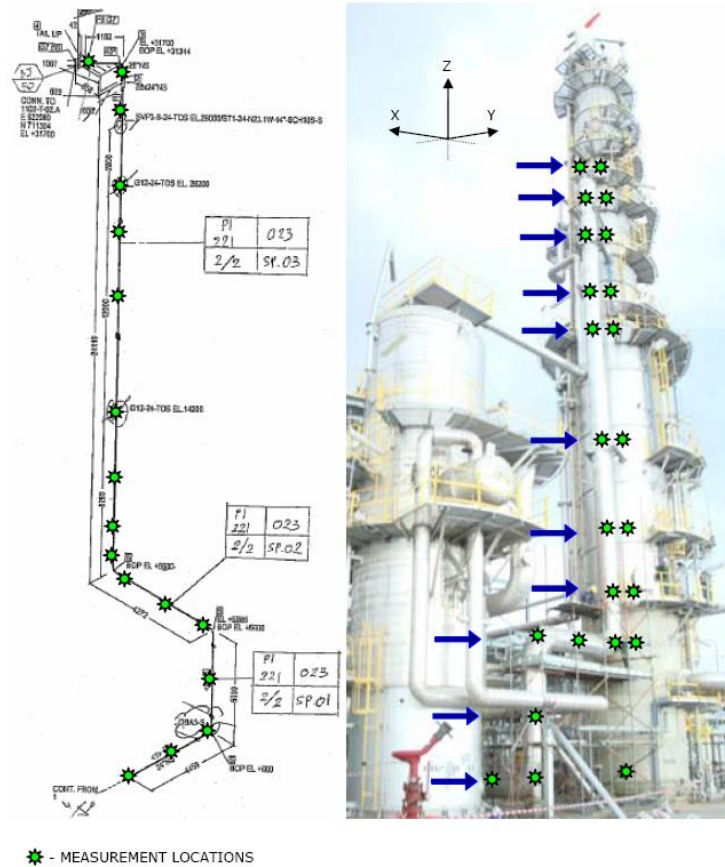
Fig. 2: Measurement locations for ODS on amine pipe and stripper

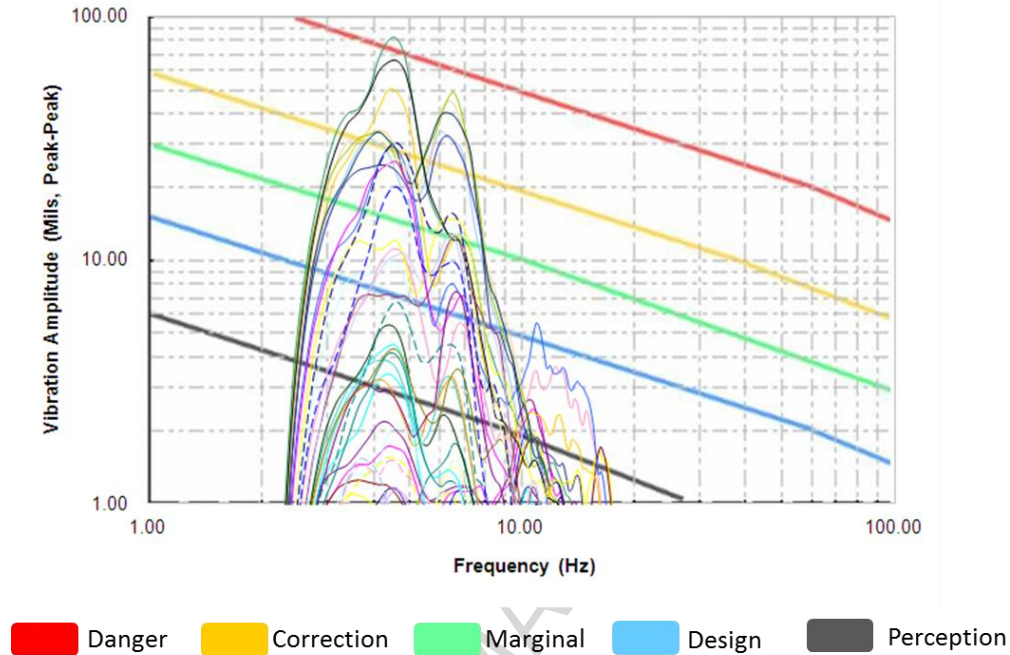
All the measured locations in X, Y and Z axes were plotted into the Allowable Piping Vibration Level (in mils peak to peak) versus Frequency for comparison. Fig. 4 shows the overlaid ODS spectral for amine pipeline. In general, vibration levels for amine pipeline are high and most of the vibration levels along the pipe exceed the Design line. Vibration level is near to Danger region for few measured locations. This might be due to improper pipe design which does not comply with OEM / API guideline. Furthermore, bends along the pipelines also may create acceleration head loss and line pulsations which induce high vibration.

Fig. 4: Vibration assessment of in-service amine piping system

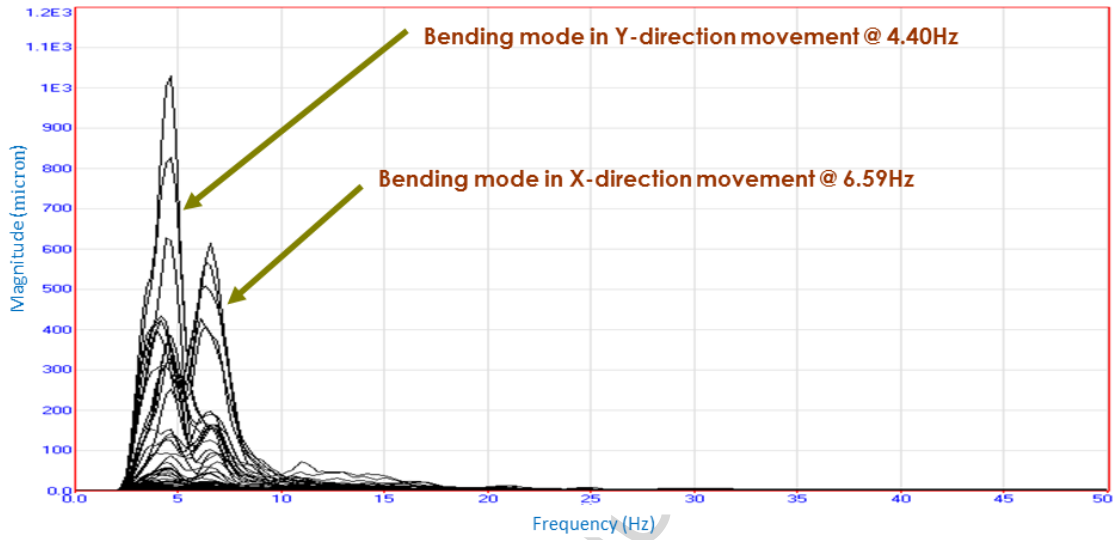
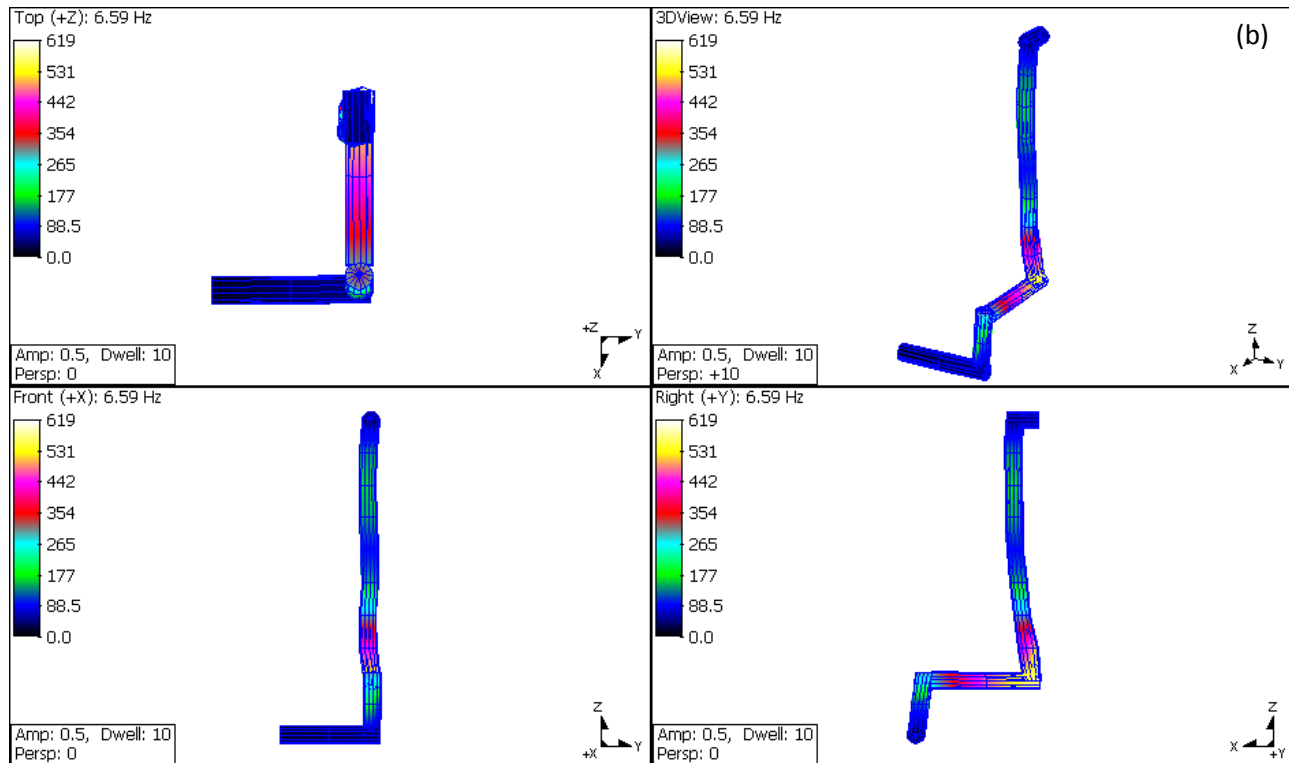
Fig. 5: ODS FRF of amine pipe in displacement (micron)

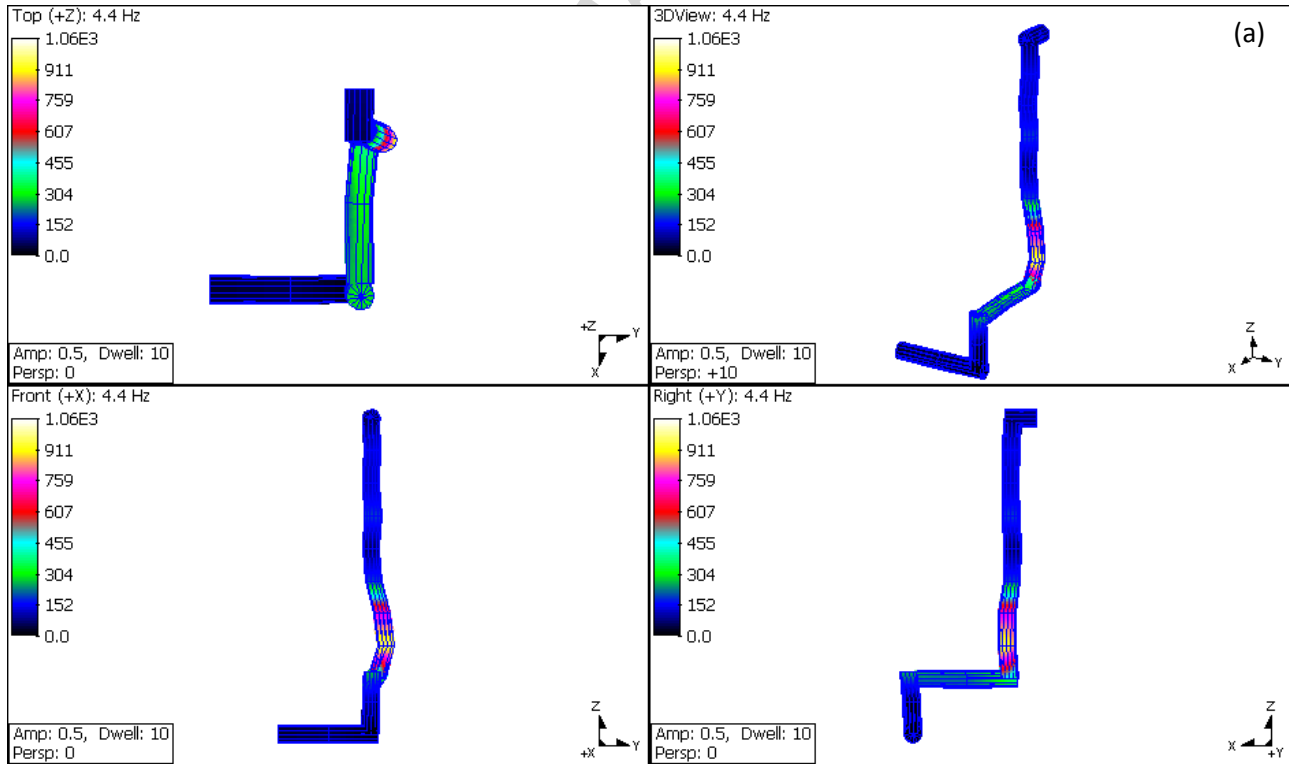
Fig. 6: (a) ODS of amine pipe @ 4.4 Hz, (b) ODS of amine pipe @ 6.59 Hz

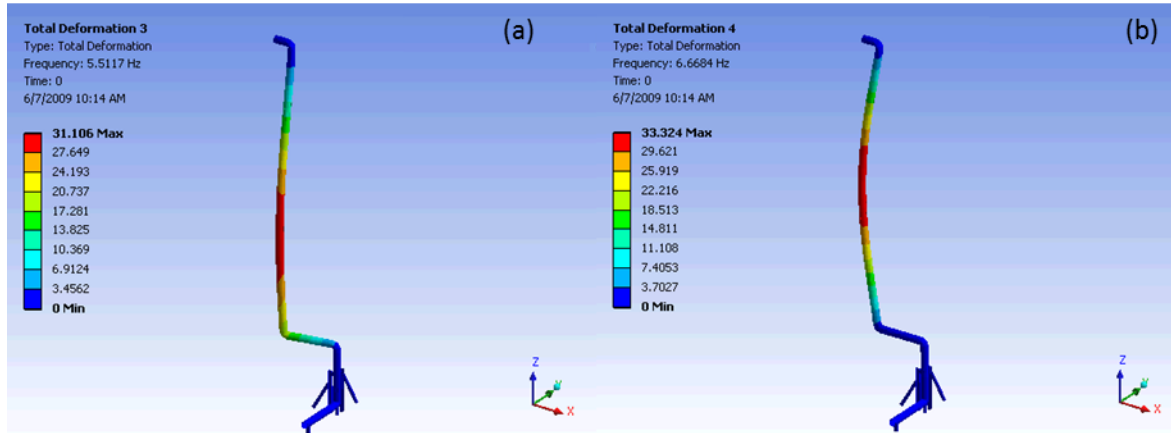
Fig. 7: Pipe bending mode along (a) Y-direction @ 5.5 Hz, (b) along X-direction @ 6.6 Hz

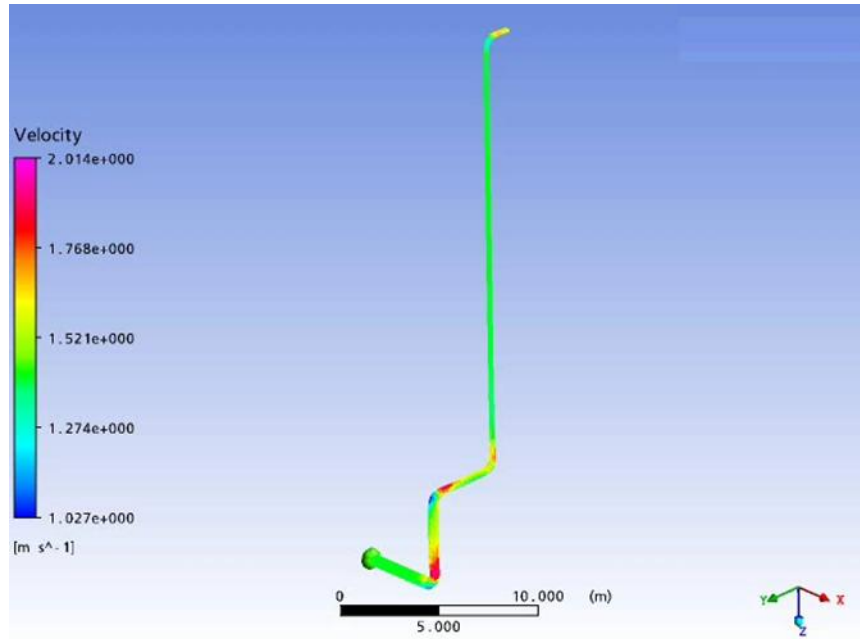
Fig. 8: Fluid flow pattern of amine pipe

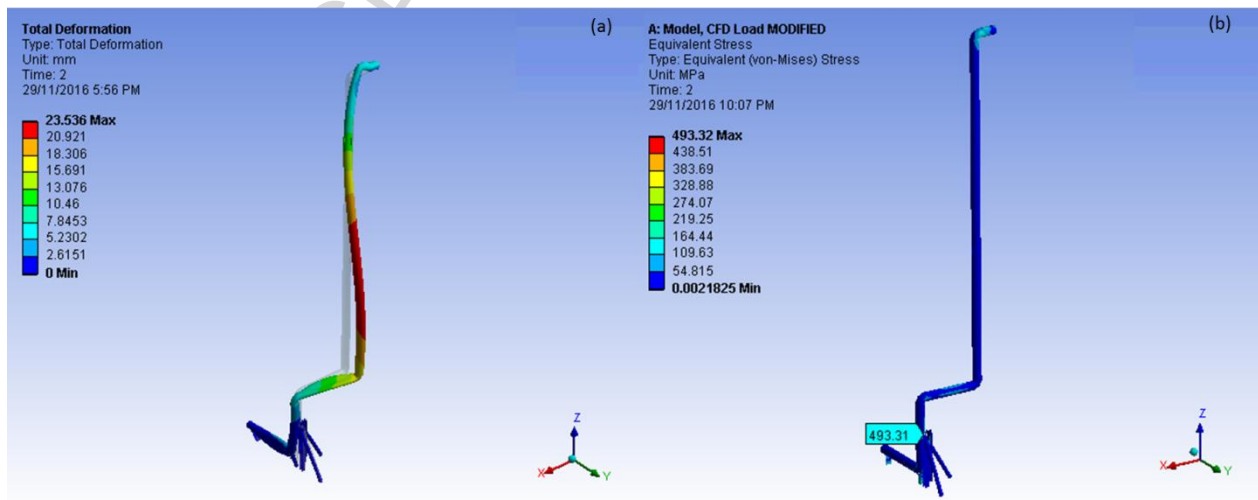
The total head (pressure) pattern generated in CFD analysis is used as loading to pipe. The deformation (i.e. displacements) and stress contours are obtained and shown Fig.9. FSI analysis gives the static deformation of 23.54 mm at the pipe where the final deformation is the combination of the two modes of deflections in X and Y directions.

Fig. 9: (a) Deformation of amine pipe, (b) Stress contour of amine pipe

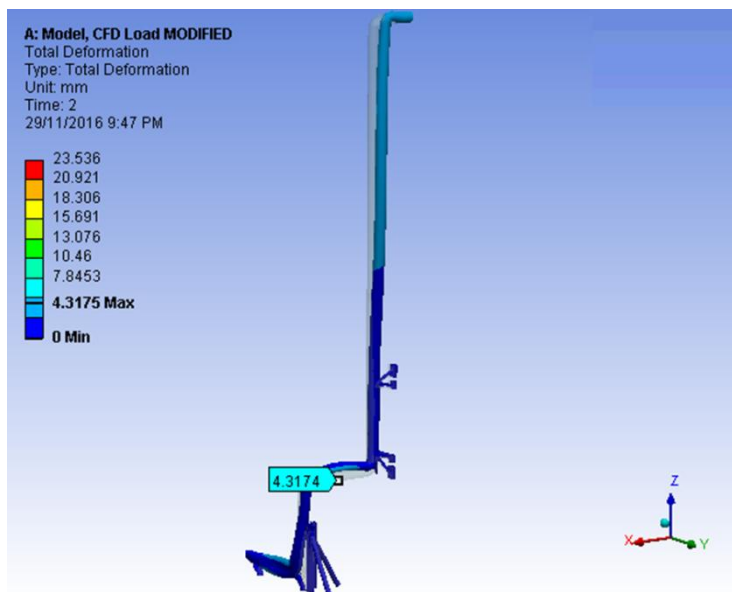
FSI analysis is repeated with the same input parameter on the modified structure to obtain the new deformation (i.e. displacements) and stress contours. FSI reveals that the deflection in FE model drops from 23.54 mm to 4.32 mm which is 82 % of reduction after introducing the two new supports (Fig. 12). In stress analysis, stress level is studied on pipe before and after modification and the new supports. It is noted that there is a minimum change in the stress level and pattern of pipe before and after modification and thus focus is shifted to investigate the stress level on the newly proposed supports. Although high stress concentration occurred at the new upper support (i.e. 175.38 MPa) and lower support (i.e. 131.82 MPa) as shown in Fig. 13 and Fig. 14 respectively, but they were still under the ultimate tension and yield tension limit which are 400 MPa and 248 MPa.

Fig. 12: Maximum deformation of 4.32 mm by SDM#1

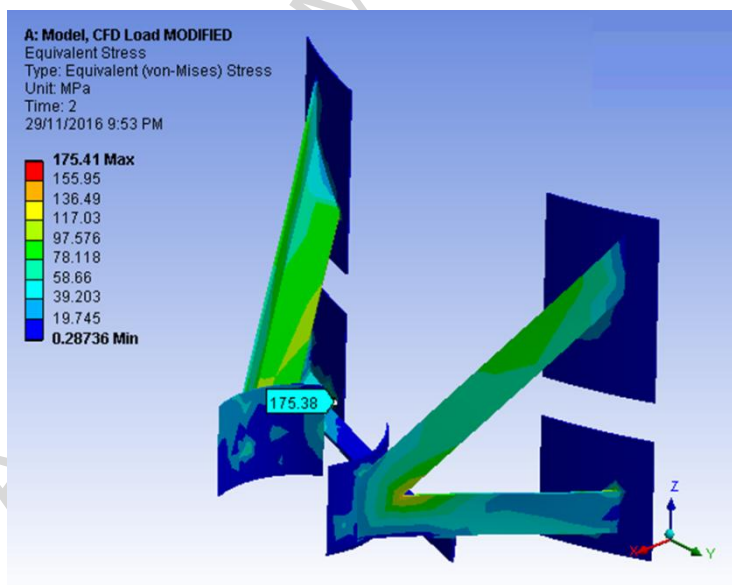
Fig. 13: Maximum stress of 175.38 MPa at new upper support by SDM#1

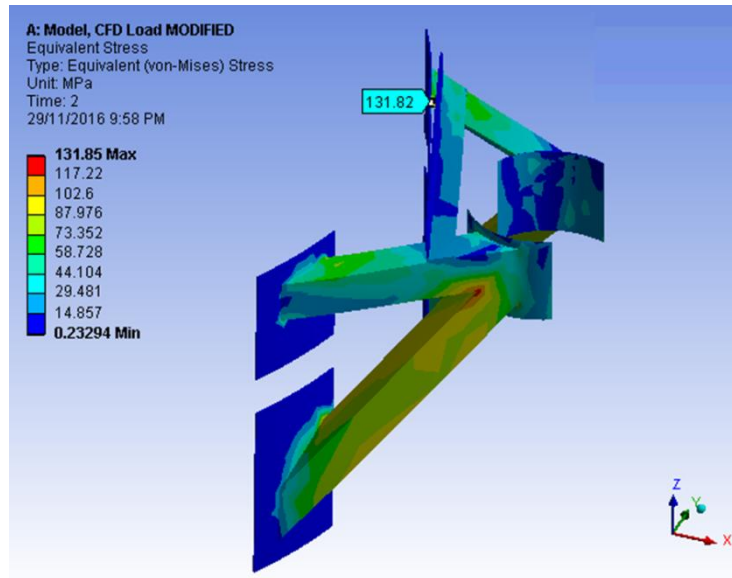
Fig. 14: Maximum stress of 131.82 MPa at new lower support by SDM#1

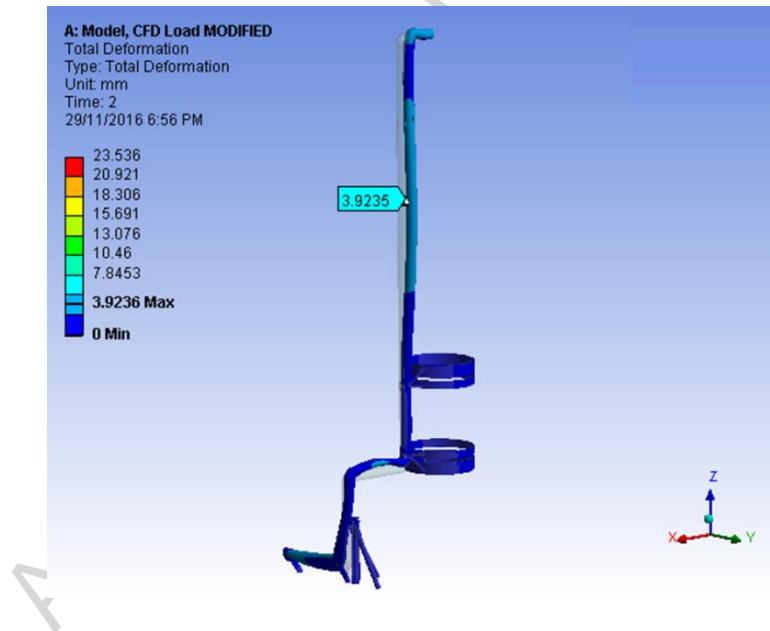
FSI analysis is repeated with the same input parameter on the modified structure to obtain the new deformation (i.e. displacements) and stress contours. FSI reveals that the deflection in FE model drops from 23.54 mm to 3.92 mm which is 83 % of reduction after introducing the two new supports which clamped at both the pipe and stripper (Fig. 16). In stress analysis, the stress level is studied on new supports after modification. However, as shown in Fig. 17 and Fig. 18, higher stress concentration occurred at the new upper support (i.e. 189.20 MPa) and lower support (i.e. 195.68 MPa) compared to SDM#1, but they are still under the ultimate tension and yield tension limit which are 400 MPa and 248 MPa.

Fig. 16: Maximum deformation of 3.92 mm by SDM#2

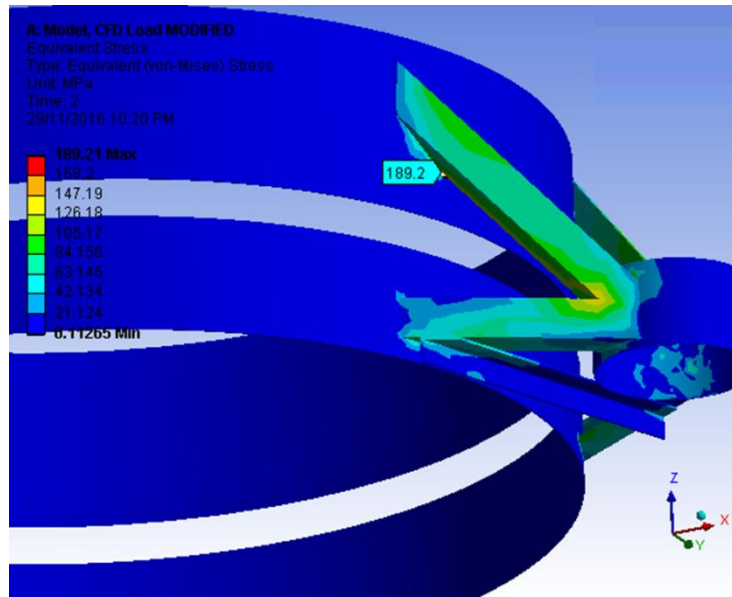
Fig. 17: Maximum stress of 189.2 MPa at new upper support by SDM#2

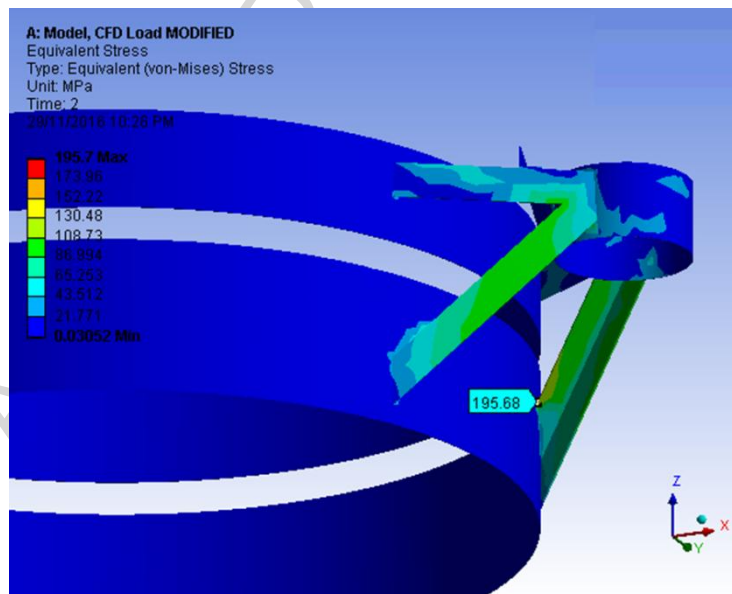
Fig. 18: Maximum stress of 195.68 MPa at new lower support by SDM#2

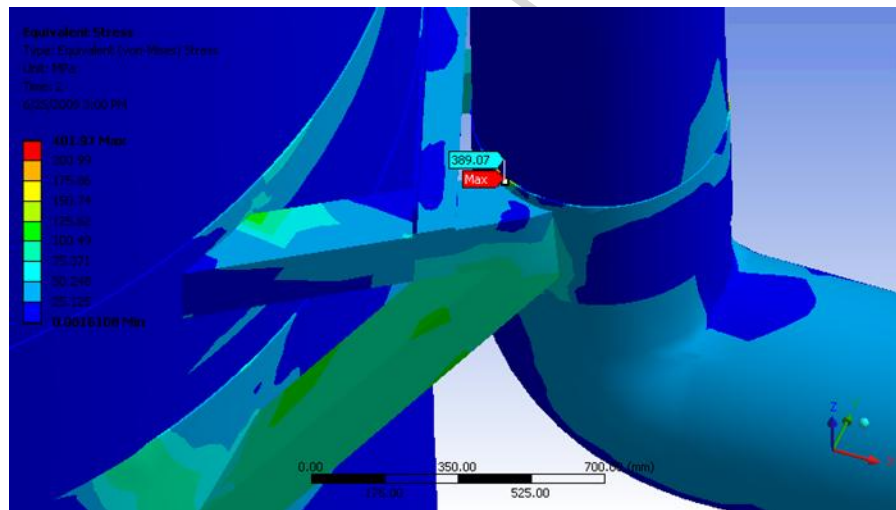
It is noted that the clamp must be firmly fixed to the pipe or stripper without any play. Any play between the clamp and pipe or clamp and stripper could increase the stress level at new support. Fig. 19 shows the simulation when there is a play between the clamp and pipe or clamp and stripper created in SDM#2, high stress concentration, i.e. 389.07 MPa is generated at the lower support and it shows more than 100 % increment in stress at the lower support as compared to when the clamping device is intact with the piping system.

Fig. 19: Maximum stress of 389.07MPa at new lower support with separation on clamps by SDM#2
