Investigating lithium-ion battery materials during overcharge-induced thermal runaway: an *operando* and multi-scale X-ray CT study†

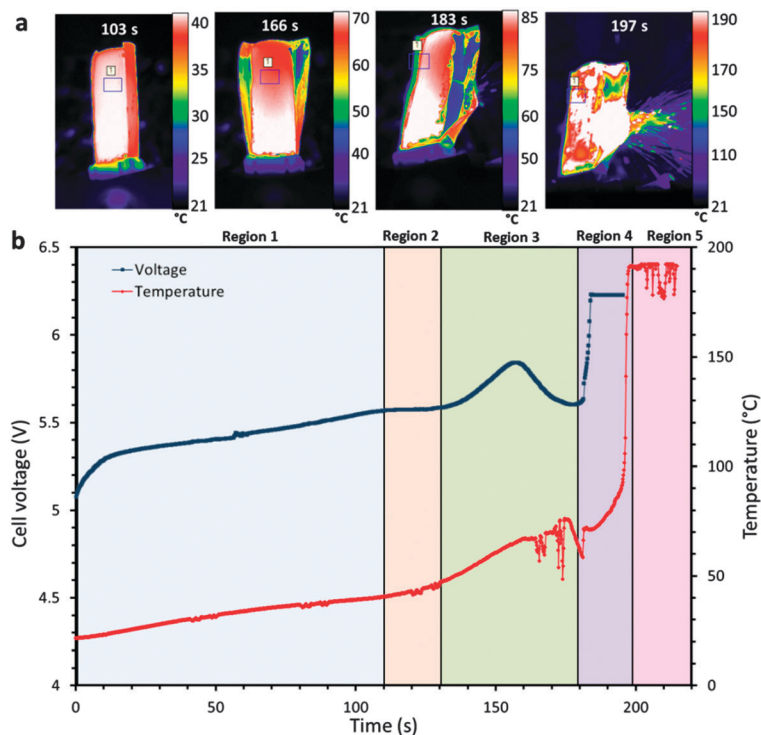
Fig. 1 (a) Sequence of time-stamped thermal images showing the increasing surface temperature of the $LiCoO_2$ pouch cell leading up to thermal runaway. The average temperature within the labelled square is plotted. (b) Plot of the cell voltage and surface temperature, leading up to and during thermal runaway. The battery was charged at a constant current of 3 A (18.75 C), from 100% SOC (4.2 V) until failure. Real time thermal images are presented in Movie S1 (ESI†).

Fluctuations in the surface temperature of the cell occur after around 160 s as the cell ruptures (Movie S1, ESI†), at which point the unstable electrodes are exposed to air and the process of thermal runaway is accelerated. The heat generated from the reaction between the LiCoO$_2$ and electrolyte, along with the decomposition of the SEI layer provide heat for the occurrence of thermal runaway which soon ensues, following which the surface temperature of the cell exceeds the limit of the thermal camera's calibrated range (Region 5 in Fig. 1b).

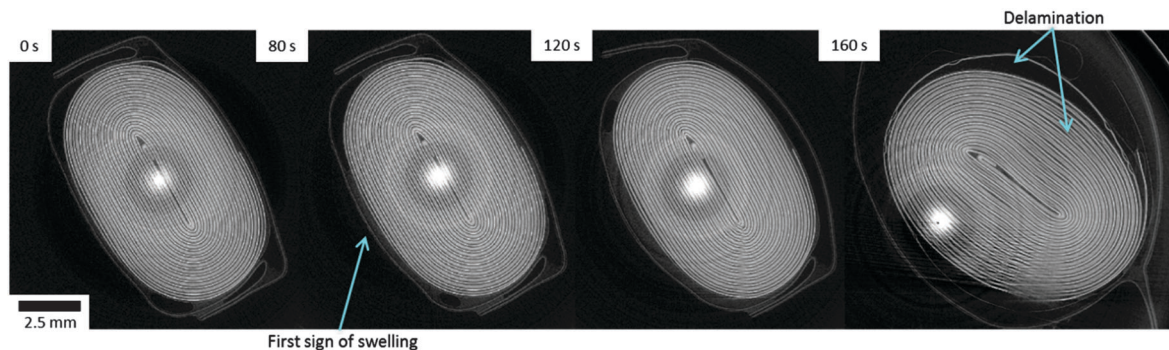
After *ca.* 80 s, corresponding to an external temperature of 40 °C, the pouch of the cell has begun to swell (Fig. 2) as gas is generated from reduction of the electrolyte and decomposition of the SEI.[36–38] After 120 s, severe delamination is observed around the separator regions in the outer layers. Within Region 3 in Fig. 1b, a distinctive peak in cell voltage occurs over the space of *ca.* 40 s, consistent with the behaviour observed by Belov and Yang.[39] In Movie S1 (ESI†), the pouch structure is seen to diverge from its original packaged structure, which corresponds with this voltage peak, as observed in Fig. 1b. It is expected that the rise in voltage is caused by the resistance increase associated with the gas pockets forming between the active layers, and the subsequent fall in voltage by the decrease in resistance when the pouch bursts and the gases are channelled away. The tightly wound active layers channel gases out into the

Fig. 2 Time-stamped horizontal slices taken from sequential tomograms during electrical overcharge of the LiCoO$_2$ cell. Pouch swelling begins after 80 s (blue arrow), and the electrode layers begin to deform and delaminate after 160 s. The LiCoO$_2$ electrode also delaminates from the Al current collector after 160 s (blue arrow pointing to inner region).

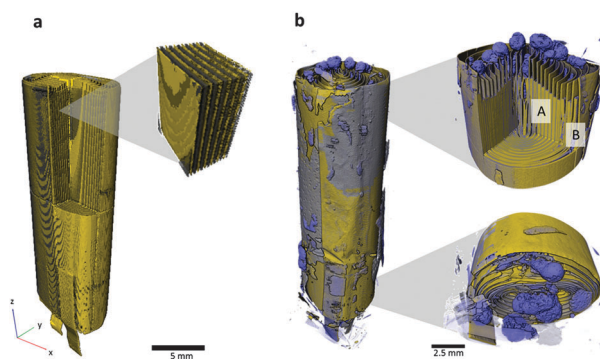
For comparison, the full cell was imaged in its fresh state (Fig. 3a) and also post-mortem (Fig. 3b), with a pixel size of 7.92 μm. The structure of the complete cell before and after thermal runaway is compared and the extent of structural damage and material degradation investigated. The aluminium (Al) phase was segmented (blue phase in Fig. 3b), and is shown to have agglomerated at the top and bottom of the wound electrode layers. The rapid gas generation from the decomposition of the LiCoO$_2$ and electrolyte is likely to have carried the molten Al to the ends of the roll as the gas was channeled from the inner layers to the outer pouch. The porous structure of the Al globules at either end of the cell supports the hypothesis that gas played a part in carrying the molten metal. The uneven gas generation may also have had a peristaltic effect between the tightly wound layers, forcing the molten Al to either end.

Fig. 3 (a) 3D reconstruction of the pouch cell in its fresh state. The LiCoO$_2$ electrode is displayed as grey, and the copper current collector and tabs are shown in yellow. (b) 3D reconstruction showing the pouch cell after overcharge-induced thermal runaway. Copper and LiCoO$_2$ phases are labelled as yellow and aluminium is shown in blue. Samples were taken from regions A and B for further analysis using micro-X-ray CT.

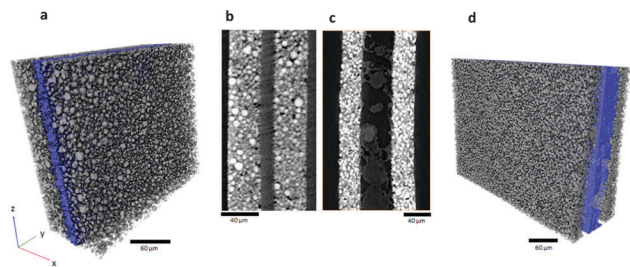
Fig. 4a–d compares the structure of the LiCoO$_2$ electrode before and after thermal runaway. The pixel sizes for the fresh and post-mortem tomograms in Fig. 4 were 0.424 μm and 0.36 μm respectively. In its fresh state the LiCoO$_2$ is coated uniformly onto the Al current collector (Fig. 4a and b) which is *ca.* 13 μm thick. As seen in Fig. 4c and d, the Al layer between the remains of the

Fig. 4 (a) 3D reconstruction of aluminium current collector (blue) coated with LiCoO$_2$ (grey) in its fresh state alongside an *XZ* orthoslice (b). (c) and (d) show an *XZ* orthoslice and 3D reconstruction of the current collector and the remains of LiCoO$_2$ after thermal runaway.

LiCoO$_2$ is highly porous following thermal runaway and cooling. The LiCoO$_2$ layers are much further apart, now *ca.* 40–50 μm, which would have aided the escape of gases generated during the thermal runaway process. The high specific heat and thermal conductivity of Al would also have enhanced the heat dissipation of local exothermic reactions leading up to and during thermal runaway. The melting point of Al is 660 °C and hence the distribution of molten aluminium remnants in Fig. 3 and 4 demonstrates that the interior of the cell reached in excess of 660 °C. As seen at the bottom of the cell in Fig. 3b, only a small portion of the cell in the region of the current collecting tab appears to have reached the melting point of copper (1085 °C). The temperature range between 660 °C and 1085 °C presents the possibility of further decomposition reactions occurring, evidence of which is found upon further investigation of the individual LiCoO$_2$ particles post-mortem.

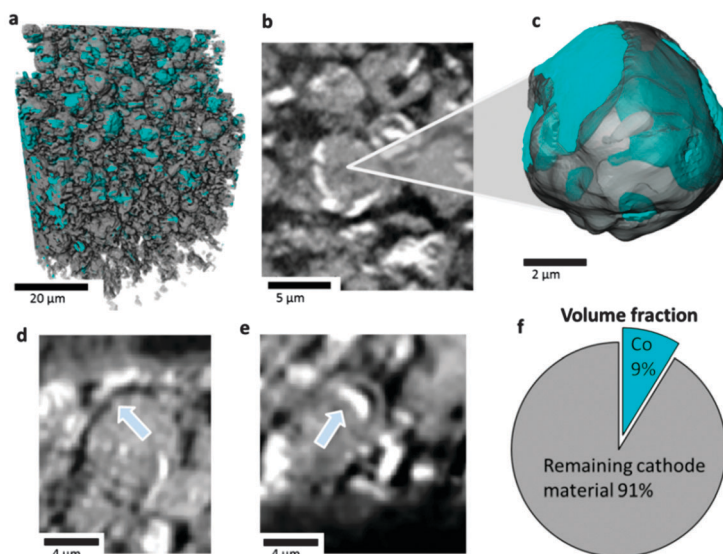
Fig. 5 (a) 3D rendering of a portion of LiCoO$_2$ electrode showing isolated Co phase (teal); (b) greyscale slice view of LiCoO$_2$ particle showing evidence of phase separation based on attenuation and (c) semi-transparent 3D visualisation of LiCoO$_2$ particle (grey) showing surface and sub-surface presence of Co (teal); (d and e) greyscale slice views showing delamination of Co metal surface layer; (f) 2D representation of the volume fraction of Co within the remaining LiCoO$_2$ electrode material. This sample was extracted from an inner region labelled as A in Fig. 3.

rendering of the particle (Fig. 5c) shows the presence of Co (teal) on the surface and Co channels within the particle. As a result of changes in density of materials during decomposition, a reduction in particle volume and delamination of phases is expected to occur. The density of Co metal is almost twice that of $LiCoO_2$ and accordingly, there is evidence of delamination of the Co layer from the bulk of the particle, shown in Fig. 5(d and e). During thermal runaway, this delamination would have exposed further surface material to exothermic reduction.

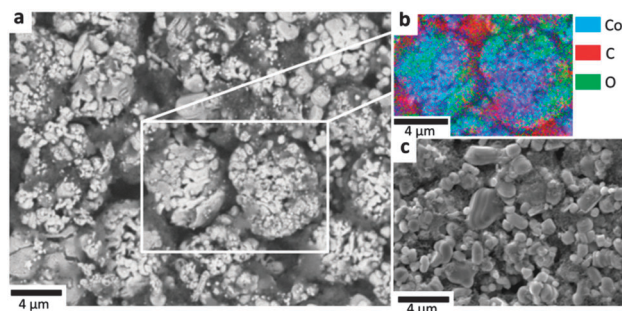
Fig. 6 (a) SEM micrograph of the $LiCoO_2$ material after overcharge and thermal runaway, (b) EDS of the highlighted region showing that the surface layer consists of Co metal, and (c) SEM micrograph of the fresh $LiCoO_2$ particles.

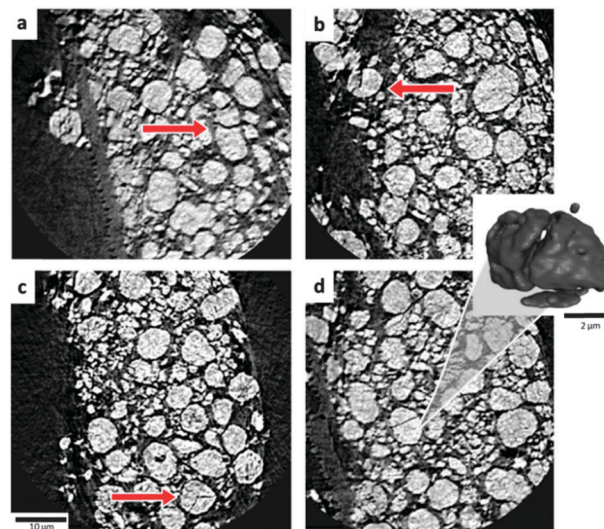
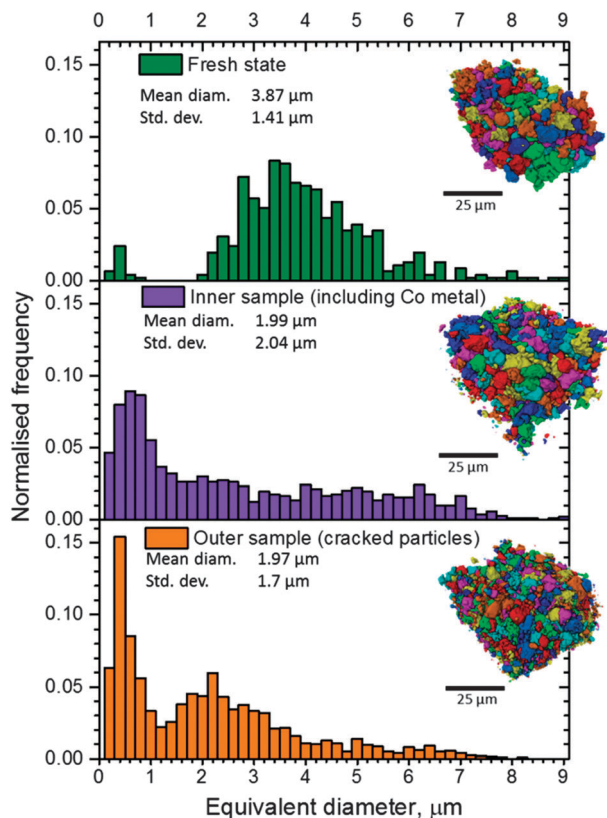
Fig. 8 Particle size distributions for LiCoO$_2$ particles from a fresh sample (top), a sample taken from the inner regions of the failed overcharged cell showing evidence of complete reduction to Co metal (middle), and a sample taken from the outer region of the failed overcharged cell showing evidence of particle cracking with no formation of Co (bottom).

observed for the outer sample (cracked particles). When compared to the PSD of the fresh sample, the twin peaks correspond to the occurrence of particle cracking, where the majority of the distribution is shifted to a smaller equivalent particle diameter. However, a second peak which consists of particles <1 μm in diameter contains the highest frequency of particles. This second peak may reflect smaller particle fragments from the fractured larger particles. Due to the limited resolution of the X-ray CT technique, the specific surface area of the particles could not be accurately determined; however, the dramatic reduction in particle size observed between the fresh and outer samples is expected to significantly affect the rate of decomposition of the electrode at elevated temperatures. Additional surface area would be exposed to reaction with the electrolyte and the smaller fragmented particles would exhibit a lower onset temperature.[16,17] For example, as demonstrated by Jiang and Dahn,[16] a reduction in particle size of LiCoO$_2$ from 5 μm to 0.8 μm results in decreased thermal stability, with lower onset temperatures.
