Performance Degradation of Grid-Tied Photovoltaic Modules in a

Desert Climatic Condition

Adam Alfred Suleske

A Thesis Presented in Partial Fulfillment
of the Requirements for the Degree
Master of Science in Technology

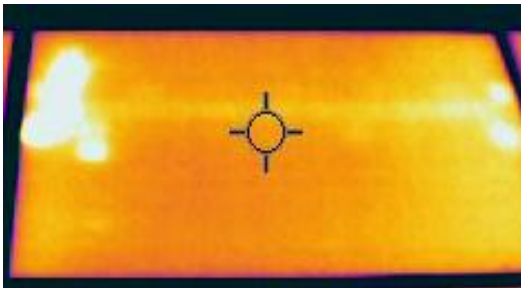
Figure 3. IR image of module hot spot

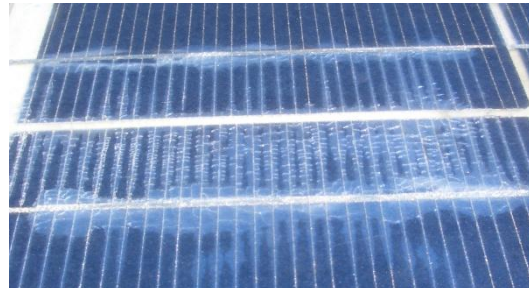
Figure 4. Delamination of encapsulant

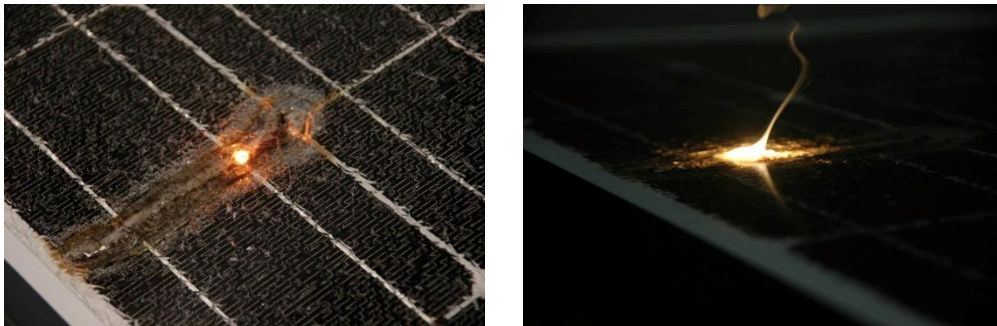
The loss of dielectric properties is not the only cause of DC arcing. Broken interconnects between cells can also establish the conditions necessary for a DC arc to form [13]. Images of DC arcing can be referenced in Figures 7 and 8.

Figure 7. DC arc under superstrate [12] Figure 8. DC arc burning through superstrate [12]

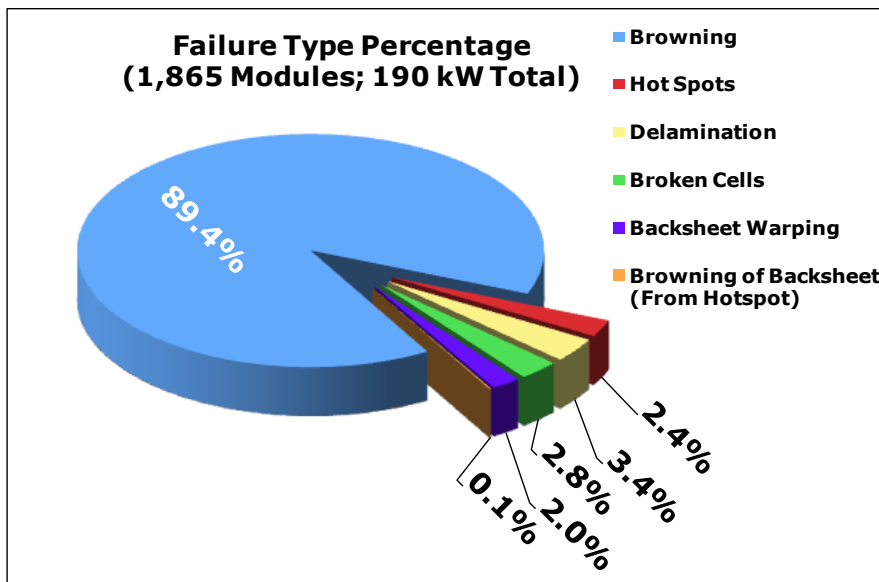
Figure 20. Failure type percentages out of 1,865 modules

Browning of the encapsulant near the center of the cell was the most widely observed failure type at 89.1%. Encapsulant browning can have an effect on the power output. Figures 21 through 23 show the encapsulant browning in the center of the cells in Module A, B, and C.

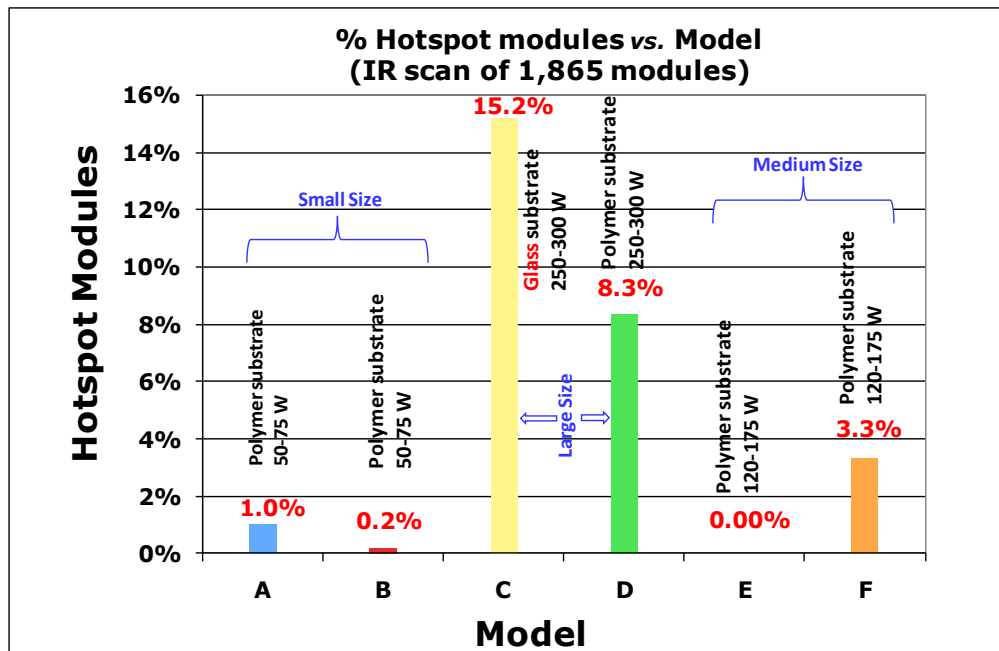
Figure 26. Breakdown of hotspot modules by model

It is immediately obvious that Model C has the highest percentage of hot spots. It is believed that the thermal stress of the glass/glass construction and large size could be primary causes for this failure type. The second highest percentage of hot spots is found in Model D. Model D was also made of large size modules. As expected, the large size modules are more susceptible to thermal expansion and contraction of cell components including interconnects, superstrate/substrate and frames. Higher thermal expansion and contraction is expected to lead to higher hotspot issues.

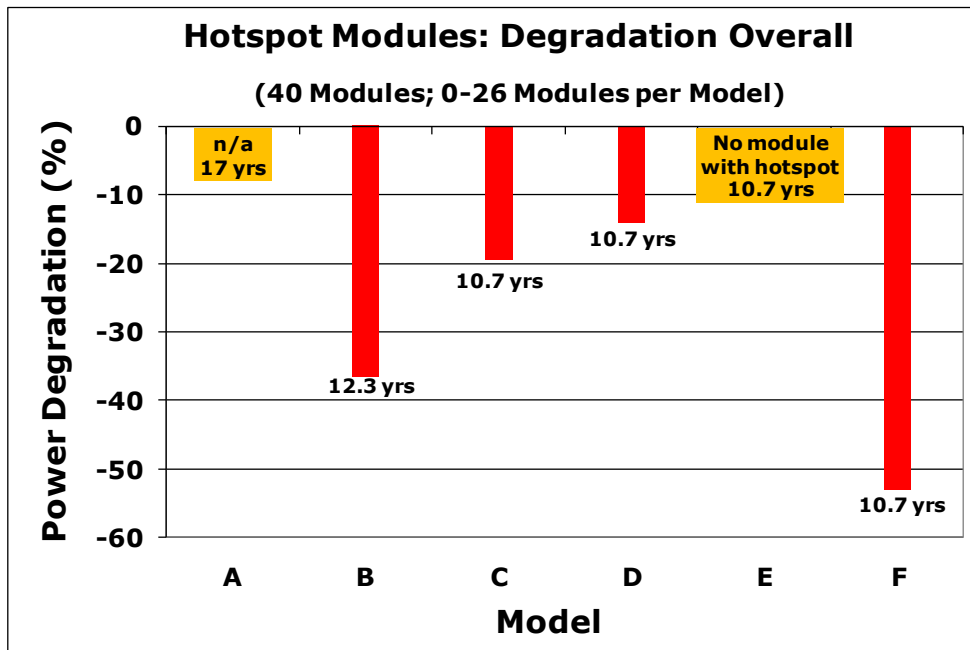
Figure 28. Degradation of hotspot modules (all years)

Figure 28 shows the average power drop from the nameplate rating of the models. There does not appear to be any discernable correlation between the age and extent of hotspots. The modules of Model C (10.7 years old) experienced about 15% (highest) hotspot occurrences and

about 19.5% power degradation whereas the modules of Model F (10.7 years old) experienced only about 3% hotspot occurrences but about 53% power degradation. This indicates that there is no direct correlation between hotspot severity, age, and power degradation unless the location/type of hotspot is sensitive to power generation issue (rather than safety issue). It seems that the hotspot modules of Model A are a special case. According to the data obtained from the I-V curve tracer, the power output of Model A had no power drop over the 17 years of fielding. Not knowing if it was human error during measurements by test personnel or labeling/binning (mixing higher power binned modules with lower power binned modules) by the manufacturer, it is felt that these findings deserve further attention and further study. These results will not be discussed in the remainder of this report.

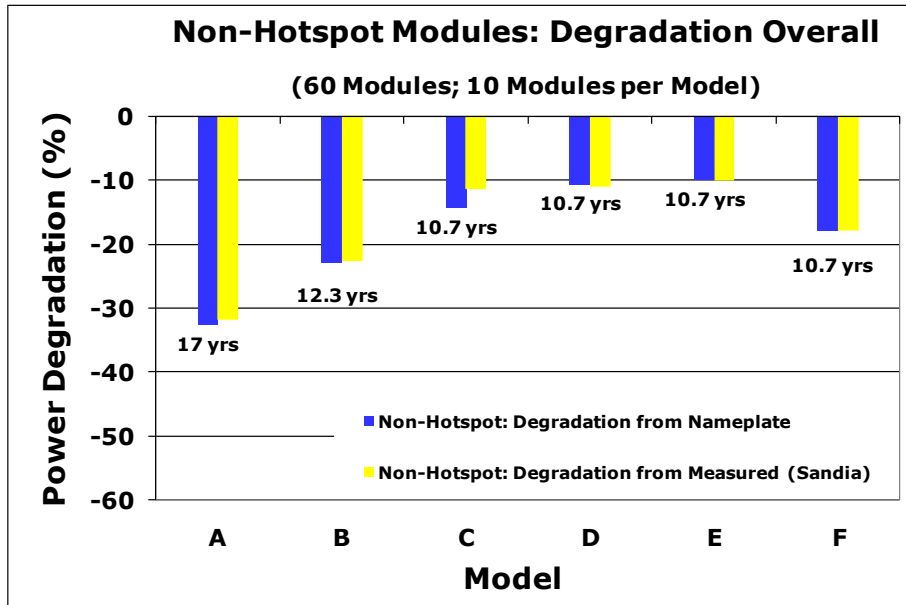
Figure 29. Degradation of non-hotspot modules (all years)

Figure 29 shows the average percent loss in power output of non-hotspot modules for each model in this study. For uniform comparison among the six models, all the modules considered in this performance degradation analysis were 1-axis tracker mounted modules excluding the fixed-tilt modules of Model A. All models had expected declines in power output, however, the magnitude of decline was surprisingly high. From this figure it becomes apparent that age is a primary factor in power loss amongst non-hotspot modules (about 98% of 1965 modules) – 12.3 and 17 years old modules, respectively, experienced about 23 and 33% power degradations; 10.7 years old modules experienced between 10 and 18% power degradations. From this figure, it is apparent that a large number of these fielded modules may not meet the commonly provided warranty requirements of less than 20% performance drop over 20-25 years. In the absence of initial performance data of all the modules tested in this project, the performance degradation calculations were performed assuming that the nameplate ratings of the manufacturers were accurate. In order to cross check if this assumption is valid, the performance degradations were calculated again with the data obtained from Sandia National Laboratories "Photovoltaic Module Database." Sandia had, fortunately, independently measured and published the STC data of all these models and they were used in these calculations. As shown in

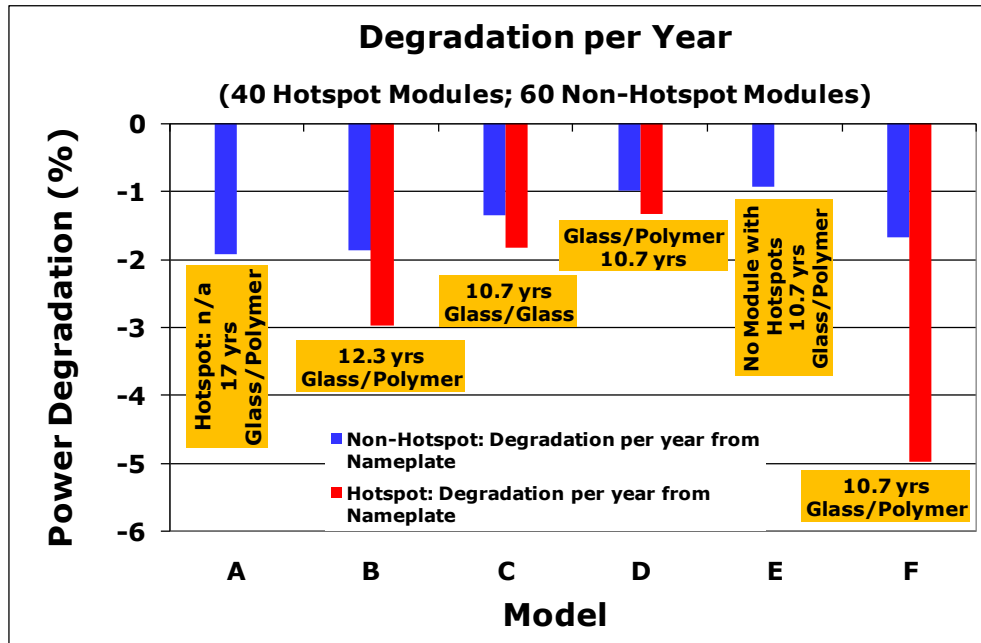
be any direct correlation between annual power degradation and hot spot severity unless the hotspot location/type is sensitive to power generation (rather than safety). The modules of Model C experienced about 15% (highest) hotspot issues and only about 3% annual power degradation whereas the modules of Model F experienced only about 3% hotspot issues but about 5% annual power degradation. Also, power degradation rate of Model C (highest % of hotspot modules) increased from 1.3% for non-hotspot modules to only 1.8% for hotspot modules whereas the power degradation of Model F increased from 1.7% for non-hotspot modules to surprisingly 5% for hotspot modules. This indicates again that there is no direct correlation between the extent of hotspots and power degradation rate. It seems the location and type (low shunt or high shunt) of hotspots in Model C is less sensitive to power degradation as compared to the location/type of hotspots in Model F.

Figure 30. Degradation rate of hotspot and non-hotspot modules (per year)

To delve further into the annual degradation rates, one can notice that the annual degradation rates obtained in this study are higher than those previously reported. In a study performed by NREL [9] in Golden, Colorado, different modules were individually held at maximum power to study degradation. From the NREL and other module level long-term studies performed at ASU, it is seen that the crystalline silicon PV modules degrade at less than 0.5% per year. However, from the current study one could determine that c-Si modules degrade between -0.93% and -1.92% per year. This significant difference in degradation rate may lie in the system voltage levels, module mismatch and insolation levels (1-axis vs. fixed-tilt) of the systems investigated in this study.

The OPV 1 and OPV 2 systems consist of a large number of modules connected in series. This series connection brings about two possible issues for the increased degradation rate: a system voltage of 400V and module mismatch. When modules are connected in series they must all have equal current outputs, if not, a bottleneck effect can occur in the module with the least current output. This bottleneck effect causes the module to dissipate the backed up current as heat energy, degrading the module.

In regards to the high system voltage, the high voltage can reduce the effectiveness of the encapsulant dielectric properties allowing a slight leakage current between the cells and frame/grounding. This leakage current comes out of the photovoltaic cells causing an electrochemical corrosion of cell components (especially metallic components) at the interface between the cell and encapsulant. The electrochemical corrosion becomes photoelectrochemical corrosion in the presence of sunlight and it is known to be much worse than simple chemical or electrochemical corrosion. Neither (high voltage and mismatch) of these effects can take place unless the module is connected in series such as in the case of a system composed of large arrays studied in this project.
