Rehabilitation of Secondary Heating and Cooling Systems – Case Study

Energy Systems Laboratory, Texas A&M University System

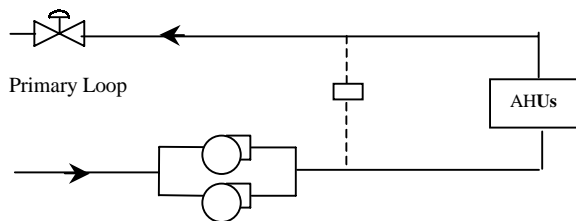
Figure 2: Schematic diagram of building chilled water system

A schematic diagram of the chilled water system in the building is shown in Figure 2. A schematic diagram of the heating water system in the building is also shown in Figure 3. The campus plant provides chilled water and heating water to the building. In addition there are two (2) parallel chilled water pumps (2×50 hp) and two (2) parallel heating water pumps (2×25 hp). The other two parallel heating water pumps supply a relatively low, constant temperature, supply water to reheat coils in interior zones of buildings. All the pumps in this hospital are with VFD control.

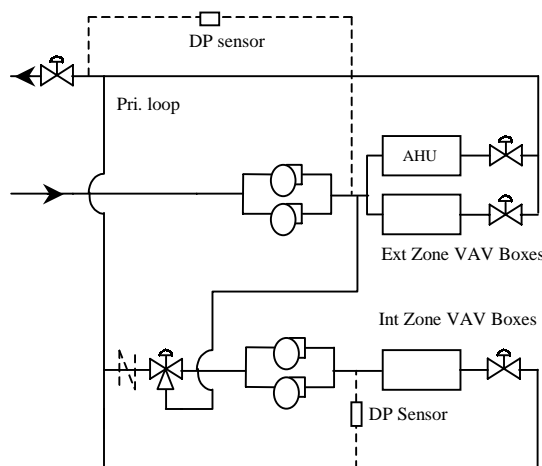
Figure 3: Schematic diagram of building heating water system

Figure 3 shows the original reheat-pumping diagram. Whenever the control program tried modulate the 3-way valve, water hammer noise would result from the valve operation. To bypass this issue the facility staff opened the supply water port allowing it flow fully through the valve and therefore shut off return water to the valve. The supply water was unrestrained fed directly to the reheat coils. This problem has been an issue since the building was built some 10 years ago. Other such 3-way valve systems do not work either. Several investigations were performed over the years without finding a solution to this problem.

The 3-way control valve for this reheat system is designed to be a mixing valve. As figure 2 shows, the common line of the 3-way valve to the reheat pumps and the supply water line to the valve is normally open and return water port is normally closed. Supply water (150°F ~ 170°F) supposedly mixes with return water in the valve and then the mixed water (about 140°F) travels through the common line to the coil. The differential pressure between supply water and return water around the 3-way valve is at least 15 psi ~ 18 psi. Whenever the controller sent a signal to the valve to modulate the valve's position for mixing water temperature, the 15 to 18 psi of differential pressure generated the hammer noise. It was found that the design and installation of a check valve was neglected on the secondary return water line to the 3-way control valve. The missing check valve proved detrimental to controlling flow into this tertiary loop.

CC Measures & Follow-up
In one recent piping renovation, the three-way control valve was removed and replaced with a two-way control valve for the variable speed pumping system. Figure 9 shows the repiped layout of the reheat pumping system. The pumping control program was modified based on the renovation.

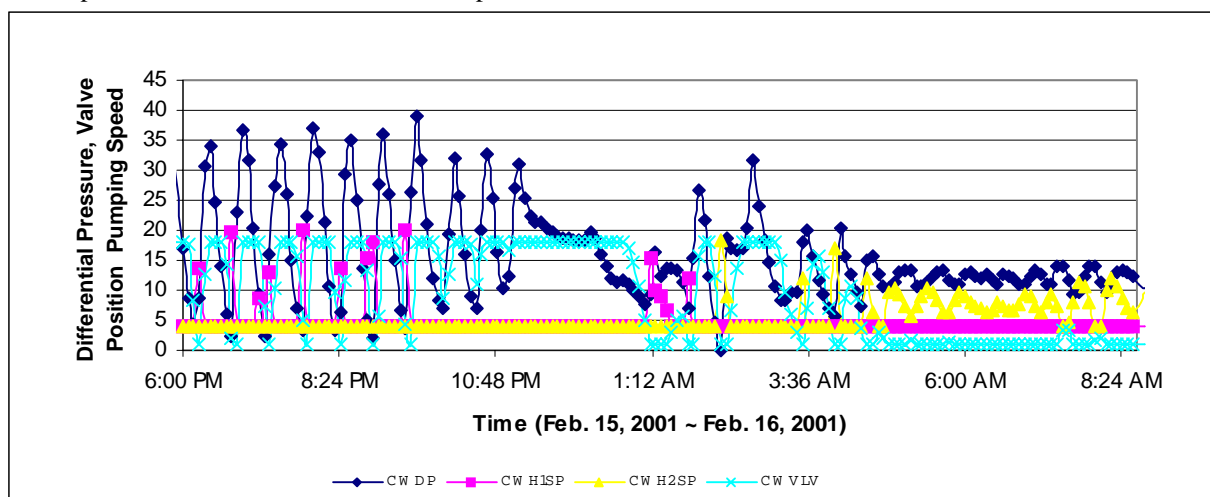
Figure 4 illustrates the building differential pressure fluctuations, chilled water set points, and valve positions in the Large Animal Hospital from February 15, 2001 to February 16, 2001. These drastic fluctuations create intense valve and pumping speed control problems. One can observe that the primary loop differential pressure is usually high, spiking to almost 40 psi and fluctuated all year long. The figure 4 also shows that the main building control valve was constantly hunting and could not modulate well under fluctuating high primary loop differential pressure.

Figure 4: Building differential pressure, pumping speed and valve position in the Large Animal Hospital during February 15, 2001 to February 16, 2001

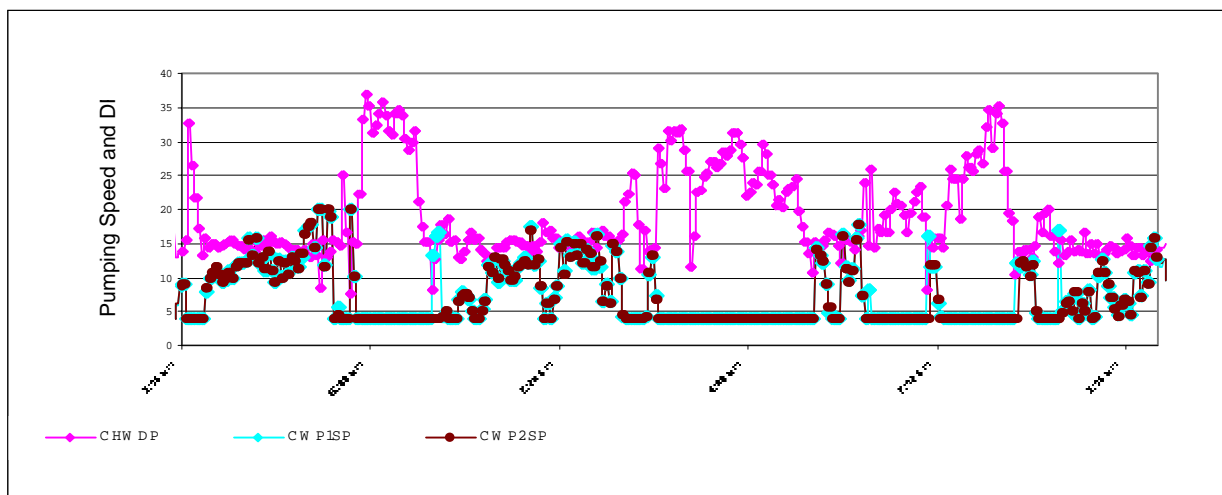
Figure 5: Primary loop differential pressure and pumping speed control in the Veterinary Research Tower during February 13, 2001 to February 16, 2001

Figure 5 shows how the primary loop differential pressure fluctuated nearby the Large Animal Hospital during February 13, 2001 to February 16, 2001. The trended differential pressure data were from the Veterinary Research Tower, which is located in front of the Large Animal Hospital on the north side of west campus. When the main building control valve was commanded to the fully open position, building pumps were used to maintain chilled water differential pressure at a set point of 14 psi. Differential pressures higher that 14 psi (such as those caused by the oscillations of the primary loop) caused the pumps to stop. When the differential pressure from the primary loop was lower than set point, the pumps were commanded to run again. The figure shows that the primary loop differential pressure was oscillating dramatically and sometimes reached as high as 37 psi.

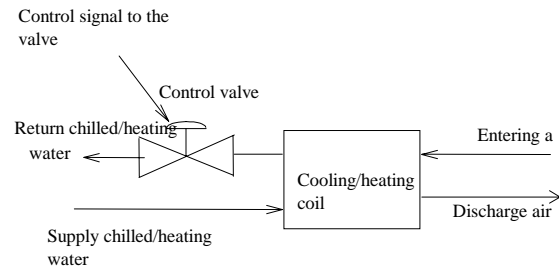
Figure 6: Schematic diagram of a cooling/heating coil

The coil and its associated piping (except control valves) constitute a relatively small system (see Figure 6: schematic diagram of a cooling/heating coil). The pressure drop through the system then varies as the square of the flow according to the law of hydraulics:

Based on above theoretical formulas, calculation and simulation were performed for valve differential pressure (ΔP_v) and system pressure drop (ΔP_s) at the design flow rate and over the design flow rate. An existing 4-inch valve (C_v: 160) with an 8-inch pneumatic actuator (from AHU HP-6) was used for a sample calculation and simulation. The ratio of ΔP_v to ΔP_s in this case is assumed to be 0.5 and ΔP_s to be 12 psi when at the design flow rate. For the simulation, ΔP_v will be 6 psi and ΔP_m will be 18 psi. Recall that ΔP_m is assumed to be constant. The design fluid flow rate for the system is 392 gpm, and C_v for the control valve will be 160 gpm. If the coil load were to decrease to a point where a flow rate of 352 GPM is needed, the ΔP_s would also decrease to 9.7 psi. Then ΔP_v will reach 8.3 psi because ΔP_m must remain a constant 18 psi. C_v must then be 122.6 gpm. This shows a decrease of 76% in the value of C_v and a decrease of 80% in the value of ΔP_s. Figure 7 illustrates the above ΔP_v and ΔP_s at different percentages of design flow.

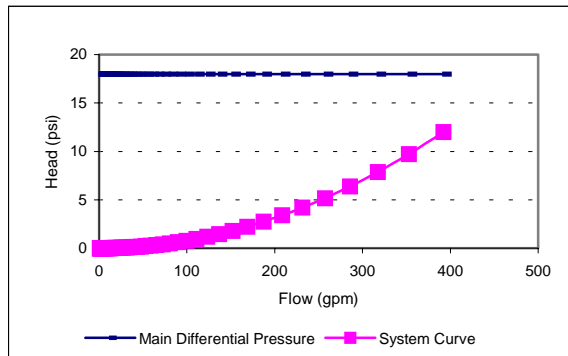
Figure 7: Valve and coil system performance curve under design conditions (initial design ratio: $\Delta P_v / \Delta P_s = 0.5$)

Compare the design simulation result (Figure 7) with the huge building pressure situation (Figure 8). A 4-inch control valve consumes more than 30 psi at different flow rates under the 35 psi of building differential pressure. The control valve only consumes from 6 ~ 18 psi at different flow rates under the original design settings.

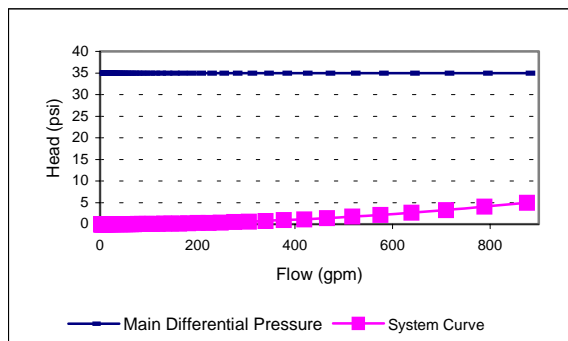
Field survey and trended data shows that the building constantly experiences immense differential pressures - around 35 psi or higher. A simulation for the same valve under an excessive building differential pressure of 35 psi was performed while keeping the valve information the same as the simulation at a different design flow rate. Figure 8 shows the system (coil and pipe) pressure drop and the valve pressure drop versus flow rate at excessive building pressure ΔP_m. Even though the differential pressure for the coils was not a stable 35 psi, the simulation assumes 35 psi for simplification.

Figure 8: Valve and coil system performance curve under huge building pressure

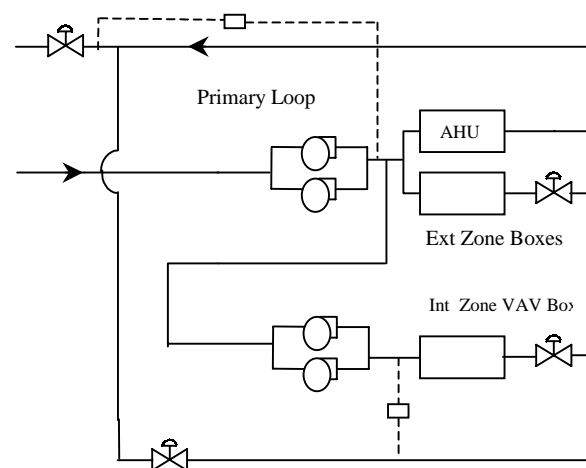
Figure 9: Schematic diagram of building hot water system after CC follow-up

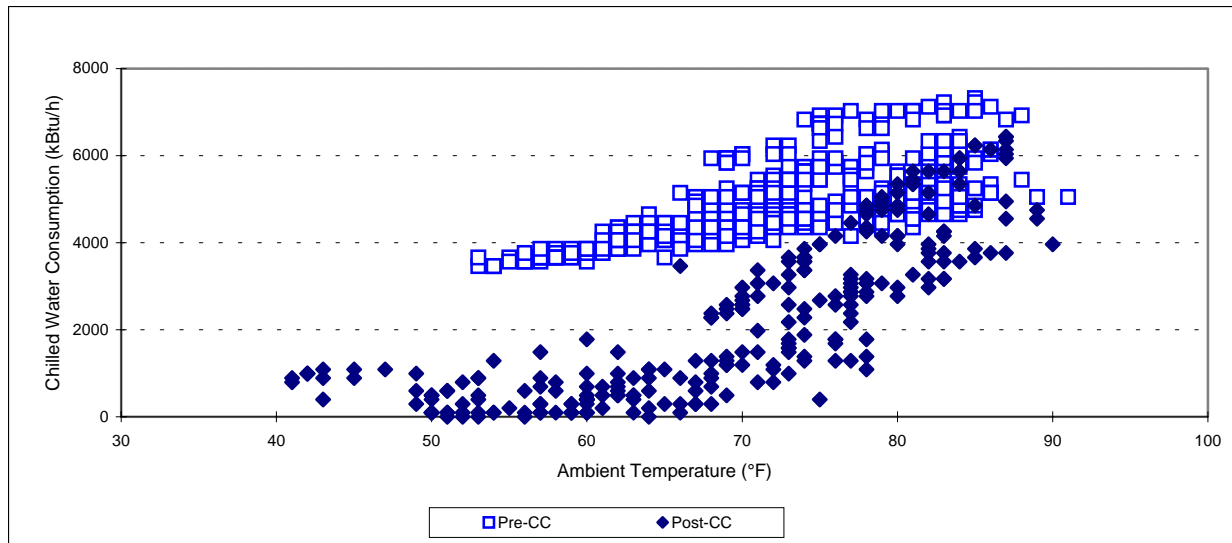
management database to quantify the verification. Figures 10 – 11 show the energy consumption difference between pre- & post - rehabilitating the secondary heating and cooling systems. It is obvious that the energy consumptions of post – CC follow-up

for both chilled water and hot water are less than the values of the pre – CC follow-up. The different data pattern affirms the savings though the retrieved data is over a short period (a month).

Figure 10: Chilled water consumption versus ambient temperature for pre- & post - rehabilitating the secondary heating and cooling systems

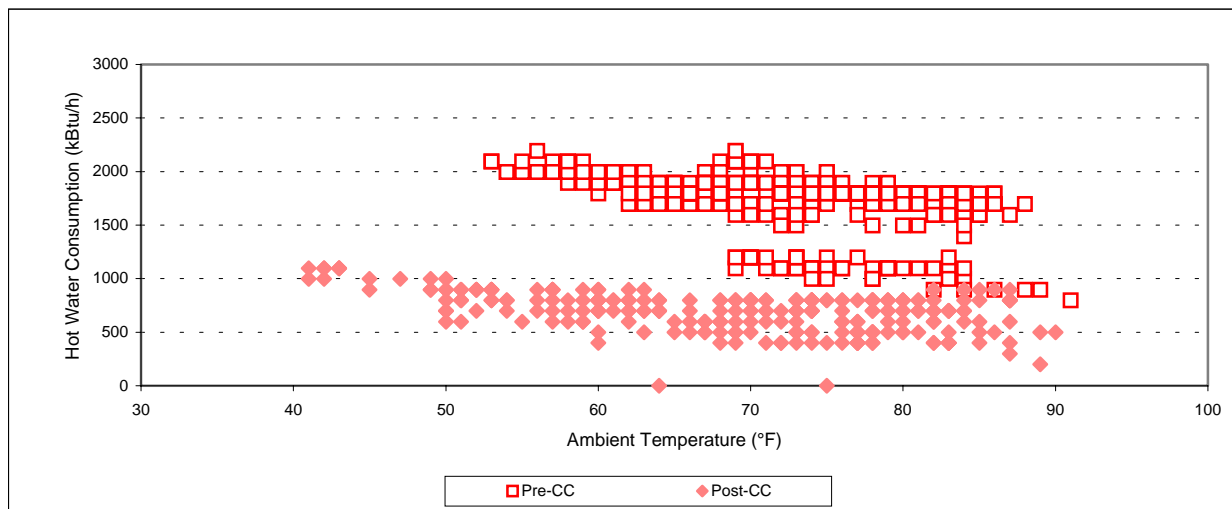
Figure 11: Heating water consumption versus ambient temperature for pre- & post - rehabilitating the secondary heating and cooling systems
