21st European Conference on Fracture, ECF21, 20-24 June 2016, Catania, Italy

Detection, characterization and sizing of hydrogen induced cracking in pressure vessels using phased array ultrasonic data processing

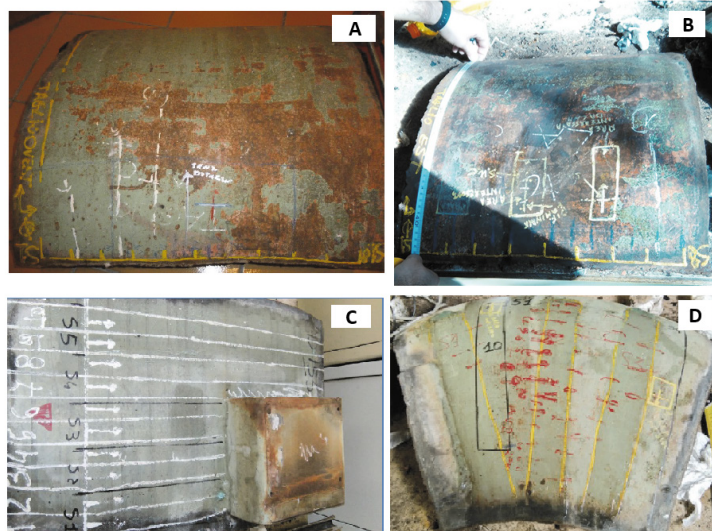
Fig. 1. Test pieces

NDT have been performed at ambient temperature with the surface of the test pieces being painted and/or oxidized to simulate the actual inspection conditions on site (see figure 1).

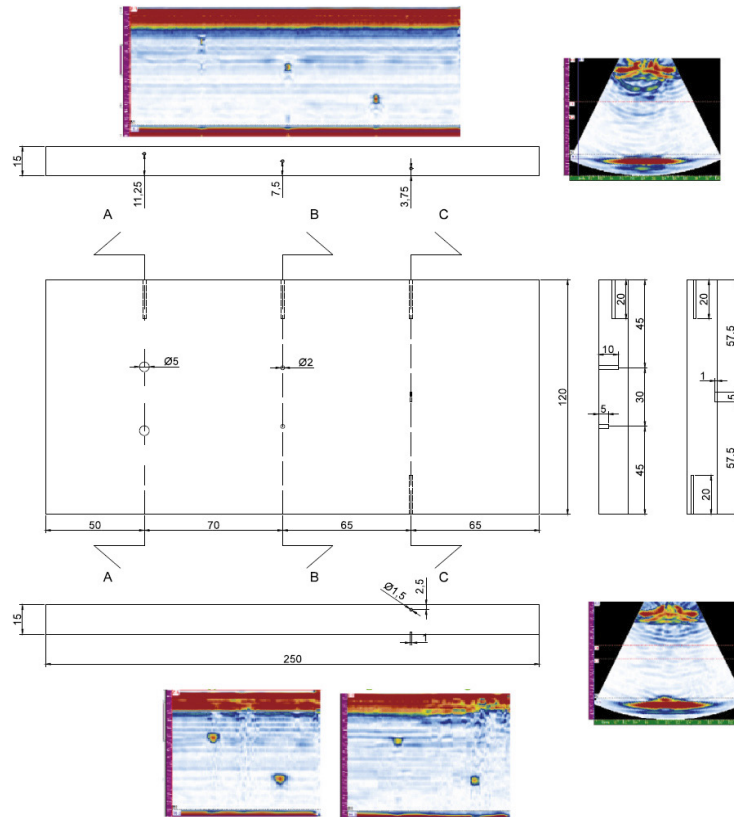
Fig. 2. Calibration block design and related PA scan

A specific reference block, made of material ultrasonically equivalent of the samples to be inspected, has been designed and machined (see figure 2). Sensitivity has been setup creating a Time Corrected Gain (TCG) curve using 1.5mm diameter side drilled holes at different depths. A series of no. 4 flat bottom holes with different diameters and at different depths have been used to develop amplitude based sizing tables.

Electrical discharge machining (EDM) notches with dimensions of 5mm x 1mm x 1mm on both the internal and external surfaces have been used in order to verify the capability in detecting near-surface defects. An analysis using different focusing depth and algorithms has been conducted in order to optimize the setup while being able to correctly detect all the reflectors included in the reference block.

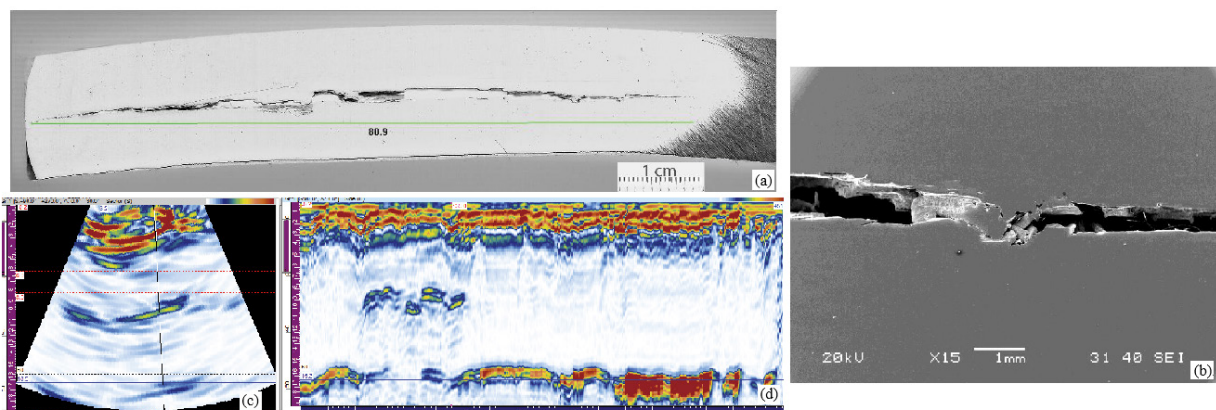
Several areas of the samples "A" and "B" present HIC type defects. Those cracks have been correctly detected by both standard PA and FMC/TFM scans. Suspected areas have been subject to macro-sectioning and then micro analysis for confirming the nature of the defects and the actual size.

It must be noted, however, that whilst the depth is accurately measured thanks to the evaluation in A or B-scan of the time of flight and the planar dimensions (length and width) using the 6dB drop technique, the height of the "stepwise" crack can be sensibly over-sized with this approach if not analyzing correctly the depth of the echoes coming from the top and the bottom of the defects in A-Scan.

Fig. 3. HIC Sample B. S-scan (c) and B-scan (d) vs macro (a) vs micro (b).

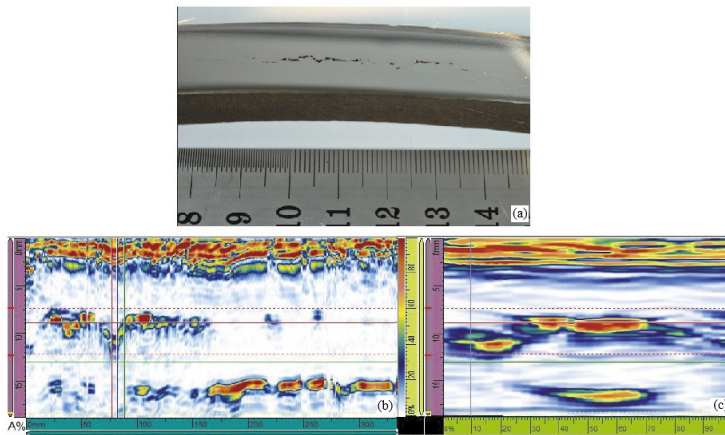
As it can be seen in figures 3 and 4, using a combination of both linear and sectorial scanning and analyzing Sectoral scan (S-Scan) (also called End-scan or E-scan for the linear focal law), B-scan and C-scan it is possible to accurately size these defects.

Fig. 4. HIC Sample A. B-Scan (b) and E-scan (c) vs Macro (a).

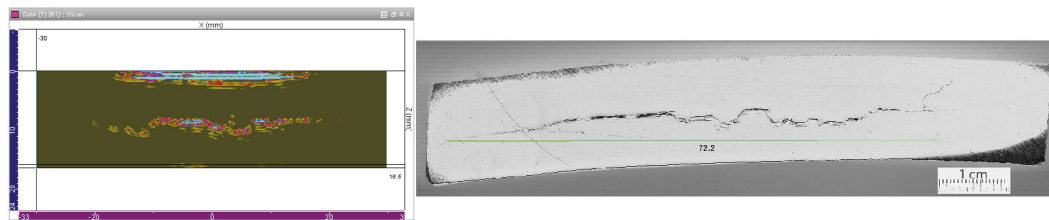
HIC type defect is correctly detected also when using FMC/TFM (see figure 5). This approach, although is reducing the scan speed and increasing sensibly the data to be acquired and evaluated, shows a much more clear geometry of the defect in the E-Scan. Also, from the comparison with the standard PA technique, it is possible to note how, even if the same PA probe and wedge are used, the dead zone under the external surface is sensibly smaller (1.2÷1.6 mm vs 2.5÷3.5 mm).

Fig. 5. HIC detected with FMC/TFM. Sample B

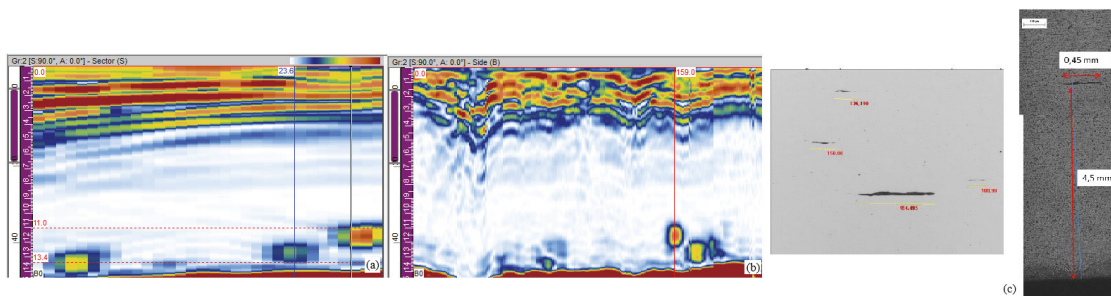
The sample "D" does not present HIC type defects. However, the presence of several indications in the inner diameter (ID) area (bottom 4.5mm of the plate) could induce to false calls (see figure 6). Standard "laminar" indications are normally present in the mid-thickness area on a metal sheet. Macro and subsequent Scanning Electron Microscope (SEM) and Energy Dispersive Spectroscopy (EDS) analysis showed that these indications were nonmetallic inclusions and no cracks were present in the sample.

Fig. 6. Planar inclusions (nonmetallic). E-Scan (a) and B-scan (b) vs macro (c). Sample D

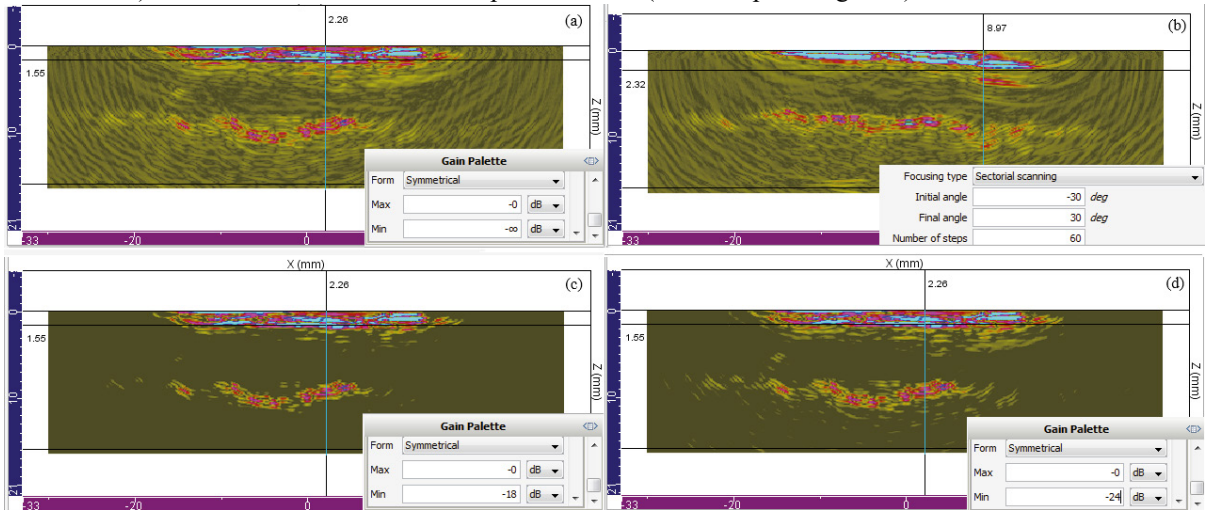
FMC/TFM data have been post-processed using different filtering (note that CIVA refers all the amplitude to the max amplitude within the scan that is considered 0dB). Also, using FMC data, classical beam forming tools (sectorial scan) have been used and results compared to TFM (see example in figure 7).

Fig. 7. Post processing of a FMC/TFM scan. Original scan (a); FMC data post processed with sectorial scanning (b); FMC/TFM data within -18dB (c) and -24dB (d) from max amplitude

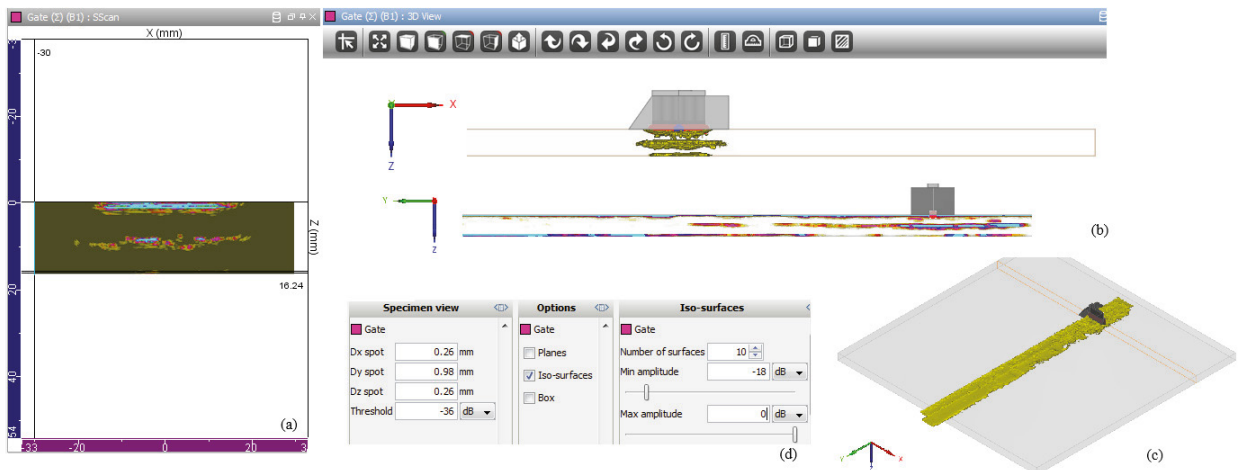
Post processing analysis included also the 3D reconstruction of the scans that is an imaging function of the software that allows an easier interpretation and a better visualization of the data (see fig. 8). The mechanism of reconstruction of the volume is based on the creation of iso-surfaces. An iso-surface is a 3D surface representation of points with equal values in a 3D data distribution. This function can be particularly useful for the subsequent FFS analysis since it allows having a "drawing" that can be exported. However, in order to have reliable results, the reconstruction procedure used and the determination of the optimum in terms of number of iso-surfaces used and the filtering applied shall be validated through a statistically relevant number of tests. Looking in longer terms, this could become a relevant interpretation aid tool for the NDT technicians first and the base to develop a software for the automatic recognition/sizing of the defects after.

Fig. 8. 3D reconstruction of an HIC type defect. Data view (a), 2D views (b), 3D view (c), Parameter settings and filtering applied (d)
