SEISMIC VULNERABILITY ASSESSMENT OF A MILITARY DRY DOCK IN MESSINA

The paper summarizes the studies conducted on the military dry dock in the Port of Messina (built in 1861), to assess the seismic vulnerability.

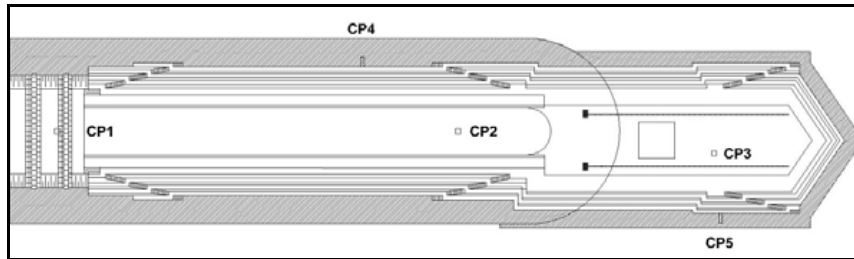
Figure 4. Dry Dock planimetry with the points of investigations execution

The study of the characteristics of conglomerate, with which it was made the dry dock, was performed during the same investigations for the geomechanical characterization of soils. In particular have been performed 5 drawings from which they are subsequently 15 test pieces. The results are show in Table 2 while in Figure 4 are identified the points of investigations execution.

| drilling	Structural element	n° drawings	$f_{opera, m}$ [MPa]	f_{ck} [MPa]
CP1	Floor of "gargame"	3	9.00	2.58
CP2	Floor of old dock	3	6.50	N.D.
CP3	Floor of new dock	3	30.20	27.53
CP4	Old dock walls	3	41.20	40.48
CP5	New dock walls	3	16.70	11.65

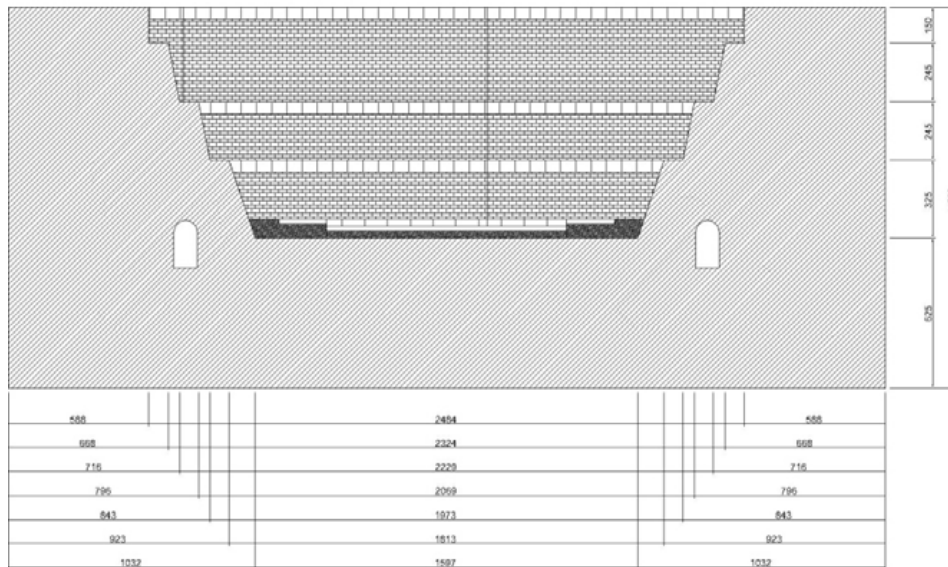
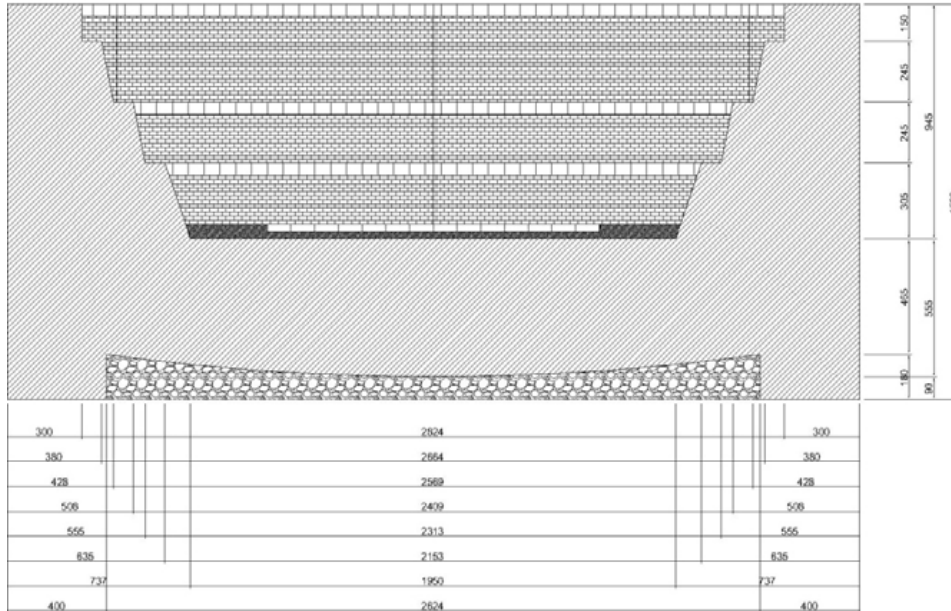
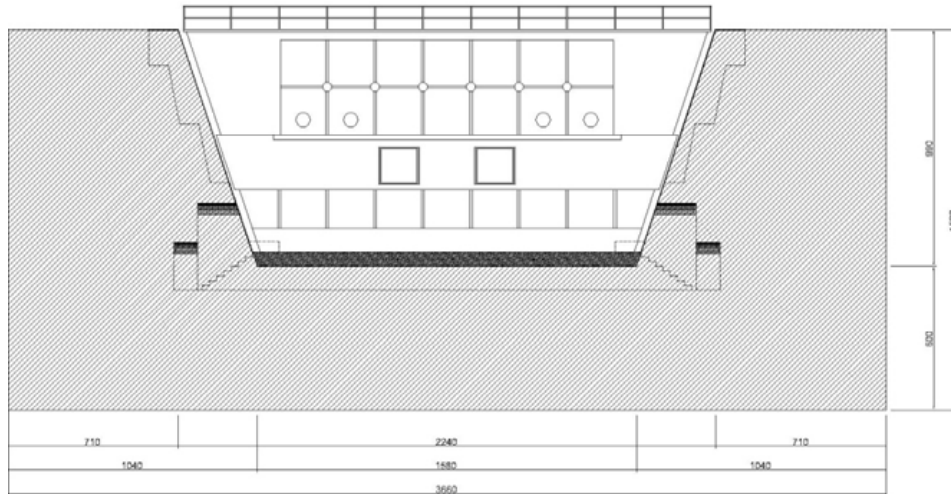
Figure 8. Section AA, named "gargame area"

Section AA, named "gargame area", shows the dry dock entrance. This section is characterized by the absence of a backing arch, to reinforce the beaten seats where the ship-door is scarfed. The absence of this backing arch, generally present in other dry docks (among these, the "twin" in La Spezia), induces a high stress on the foundation that shows severe swellings under the closure site. To temporarily solve the problem a number of concrete blocks have been positioned on the foundation. Moreover the zone has been reinforced applying steel plates anchored with ties to the sides of the dry dock.

Section AA, named "*gargame area*", shows the dry dock entrance. This section is characterized by the absence of a backing arch, to reinforce the beaten seats where the ship-door is scarfed. The absence of this backing arch, generally present in other dry docks (among these, the "twin" in La Spezia), induces a high stress on the foundation that shows severe swellings under the closure site. To temporarily solve the problem a number of concrete blocks have been positioned

on the foundation. Moreover the zone has been reinforced applying steel plates anchored with ties to the sides of the dry dock.

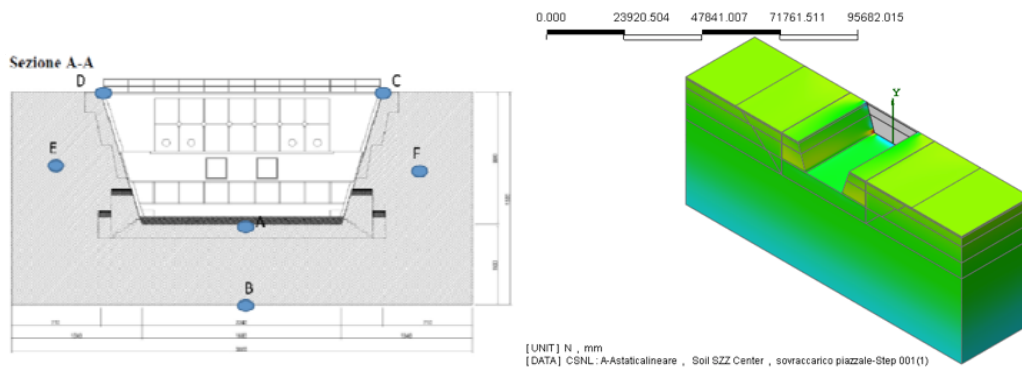
Figure 11. Section AA, named gargame area

Taking into account the geometry and the charge conditions, a 3D model has been applied to this section (Figure 11). Table 9 shows the obtained results as stress condition and displacement. These results evidence that, on the longitudinal direction to the dry dock (the "z" axis) in the point "A" of contact section, the bending stresses induce tensile stresses of about 0.3 MPa. This value is very close to the maximum tensile stress of the pozzolanic conglomerate used for the foundation floor. The load condition examined here provides for the absence of the ship, since this area is always left free from obstructions for the boat - door

In conclusion, despite most of the volume of conglomerate in this area of the dry-dock is subject to widely acceptable compression stresses, the foundation floor of the gargame area is very damaged, so concrete blocks, acting as counterweights, have been used to stabilize the bulge of the foundation floor.

Otherwise, the problem does not occur on the shoulders of the dry dock where, in recent years, has been reinforced applying steel plates anchored with ties to the structure

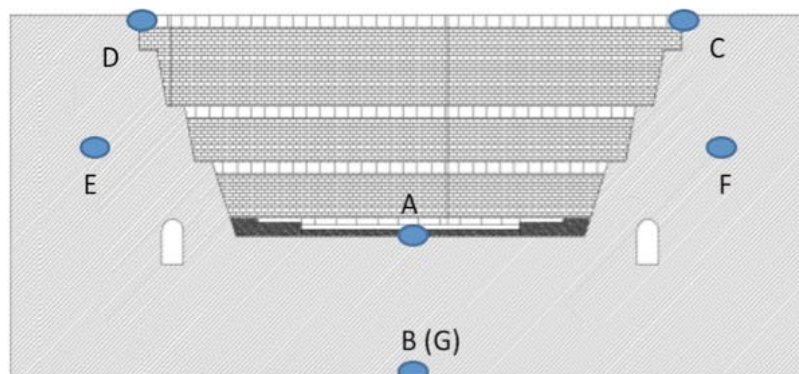
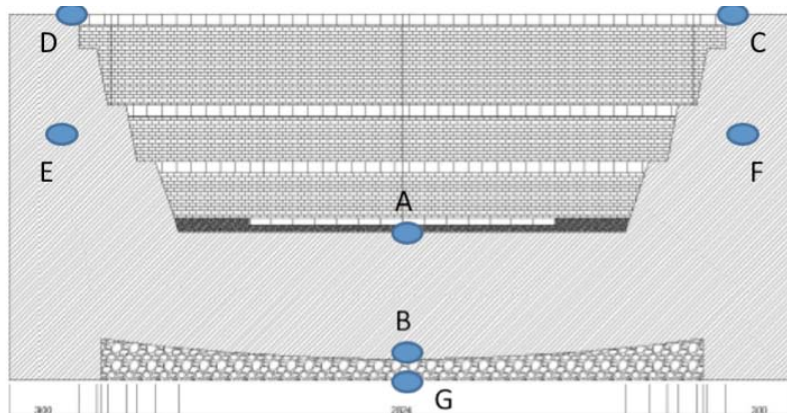
As can be seen from table 11, in dry dock condition, without water and ship, the state of deformation of the dry-dock generates a state of compression stress at the extrados and tensile stress at the intrados. Also in this situation kinematic motion tends to cause the "opening" of the dry dock and to dismiss each other points "C" and "D". This section suffers an expansion much more pronounced than the previous BB so to register many cracks both on the floor plan and on vertical walls. The cracks along these walls are directed from the top down just to signify the presence of differential movement between the various sections, concentrated mainly in the area of contact between the new and the old dock.

The condition in which there is the simultaneous presence of the ship along with all other loads presents re-balancing of the kinematic motion described above, with a subsidence movement of about 20 mm. This depends on the presence of curved extrados and loads spread over the three points (placement of the docking blocks), which reduces the yield differentials between the various load conditions.
