The Forensic Reconstruction of Road Traffic Accidents

Simon J. Urquhart

A thesis submitted in partial fulfilment of the requirements of
Sheffield Hallam University
For the degree of Master of Philosophy

September 2015

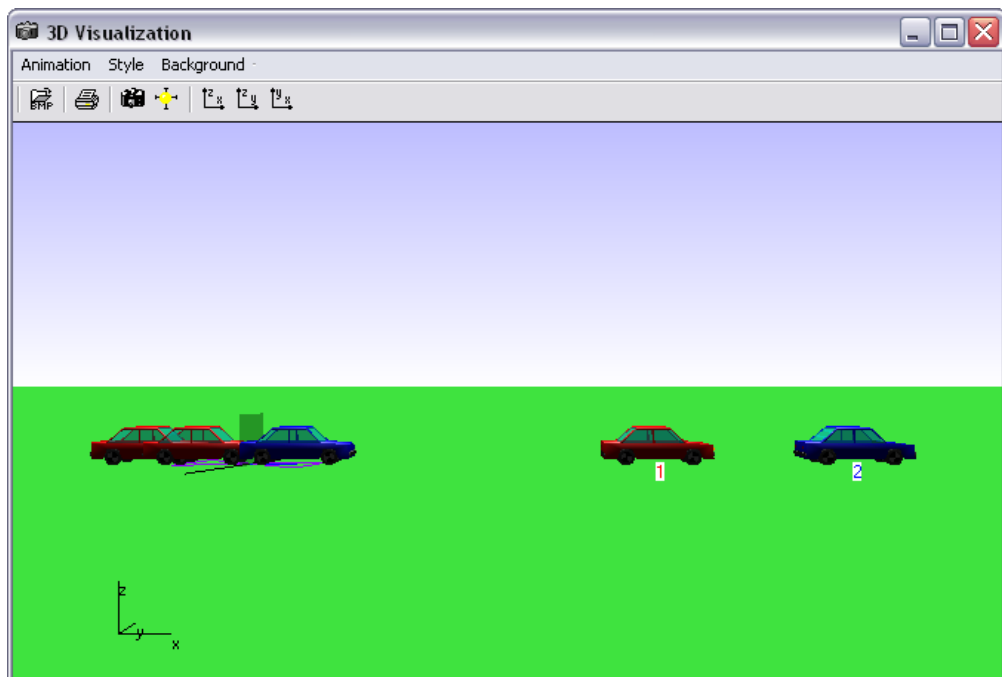
Figure 5.1(i): 2-Car Example

Outcome [SJU]: The momentum is transferred between the two identical vehicles. The point of impact is slightly off-centre as the cars are not perfectly parallel. This causes the plane of contact between the two cars to be at an angle to the vertical, although this discrepancy is not of large

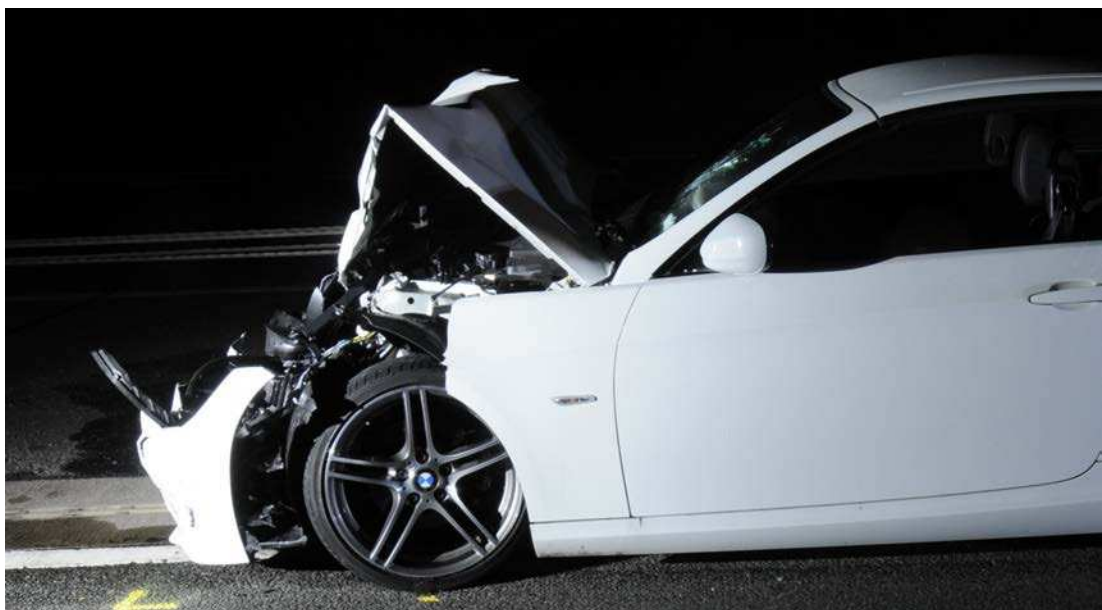
Figure 5.5(i): Usk High-Speed Collision [GP]

Scenario [GP]: Two vehicles had collided on an unlit stretch of dual carriageway. A car had impacted a van at high speed, resulting in a fatality. The van had come to rest over a crash barrier, in the trees to the far side of the grass verge.

This two vehicle collision occurred on the northbound carriageway of the A449. A Ford Transit camper van had been struck in the rear by a BMW, which then left the road and collided with a large sign. The driver of the

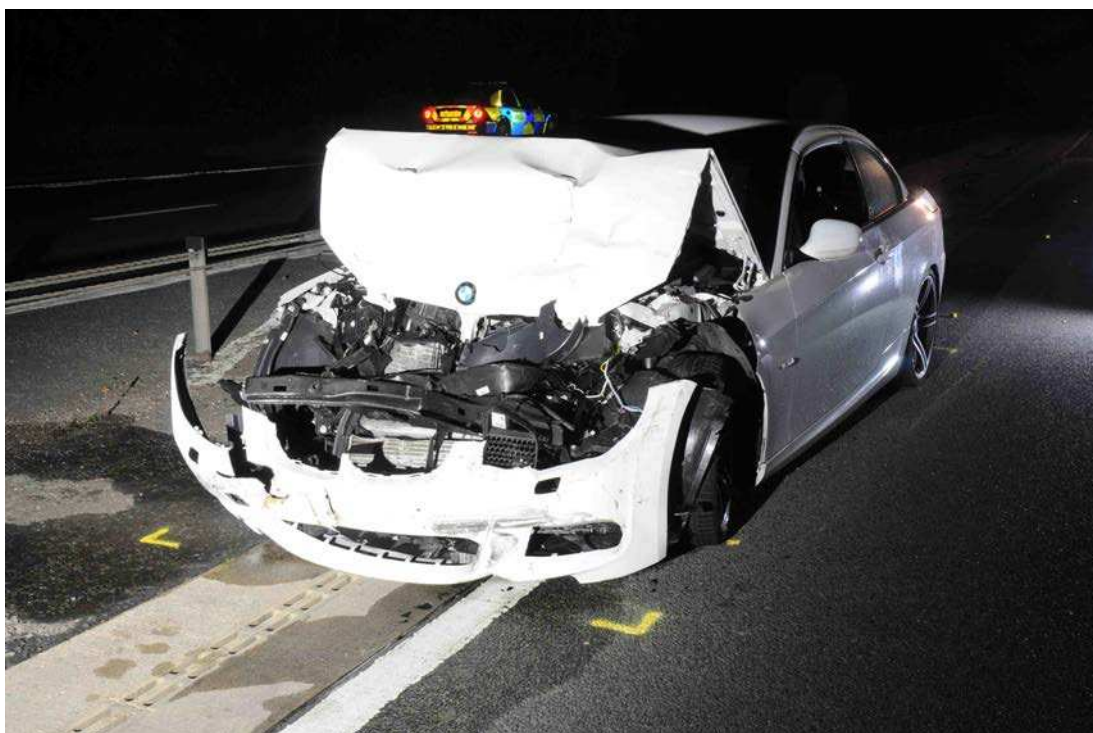
Figure 5.5(iv): Front of impacted BMW [GP]

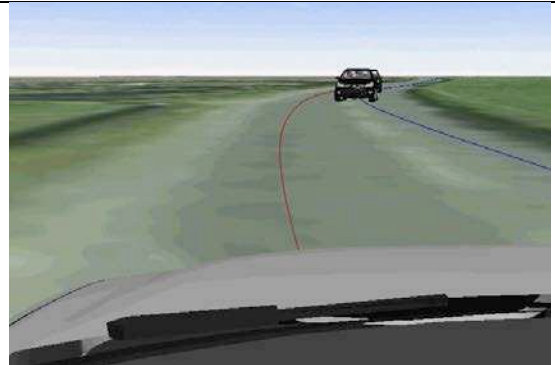
From the point of view of the Mazda in the oncoming lane: Imminently before the collision, there is no reason to suspect an accident is about to occur. As the distance between the cars decreases, it becomes evident that the Focus will not halt or evade impact with the Citroen.

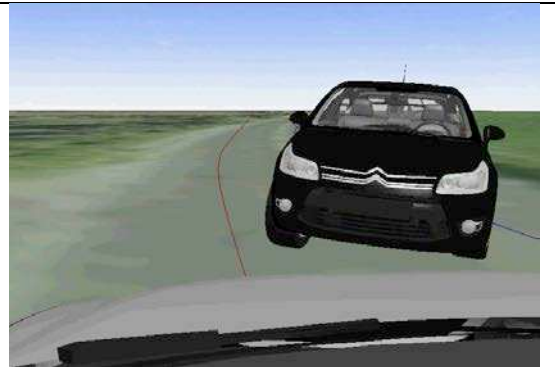
The Citroen can now be seen to be proceeding across the median point of the road, with some right steering lock. Note that the rear impact from the Focus moves the Citroen's suspension down at the front passenger side.

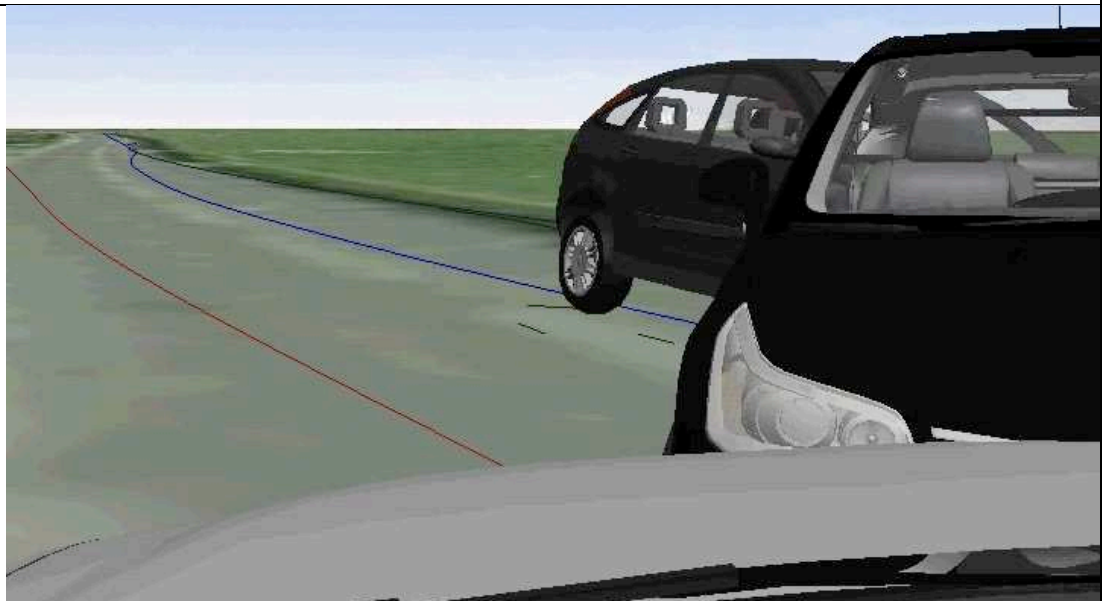
As contact is made with the front bumper of the Mazda and Citroen, the Mazda spins round from the angle of contact of the two vehicles and the sudden deceleration. Note that at this point in the impact, the suspension of the Focus has caused it to yaw to the passenger side.

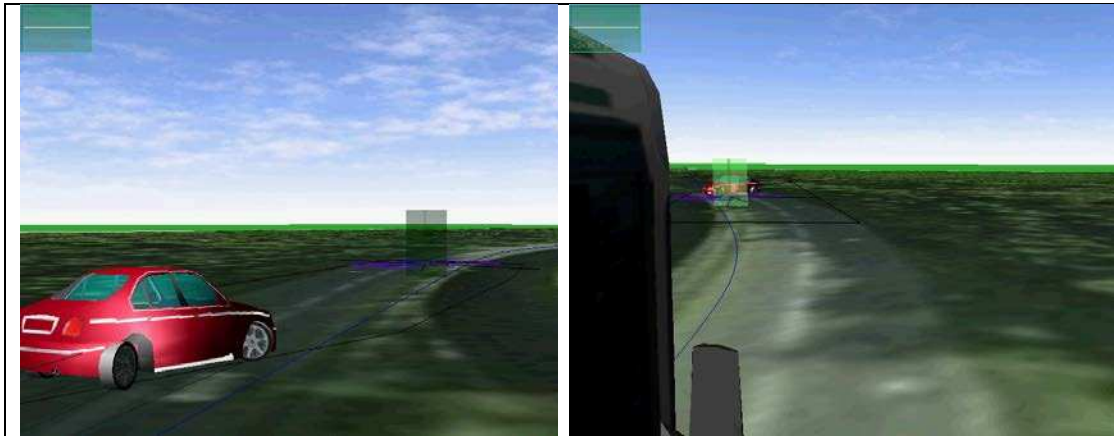
The car is travelling round the curve of the road and begins to lose control, with right lock being applied to the steering. At this point all four wheels have made contact with the low-friction portion of the road designated as ice. This portion can be seen as a black-lined polygon. From the opposing point of view of the bus driver, the car is now becoming visible.

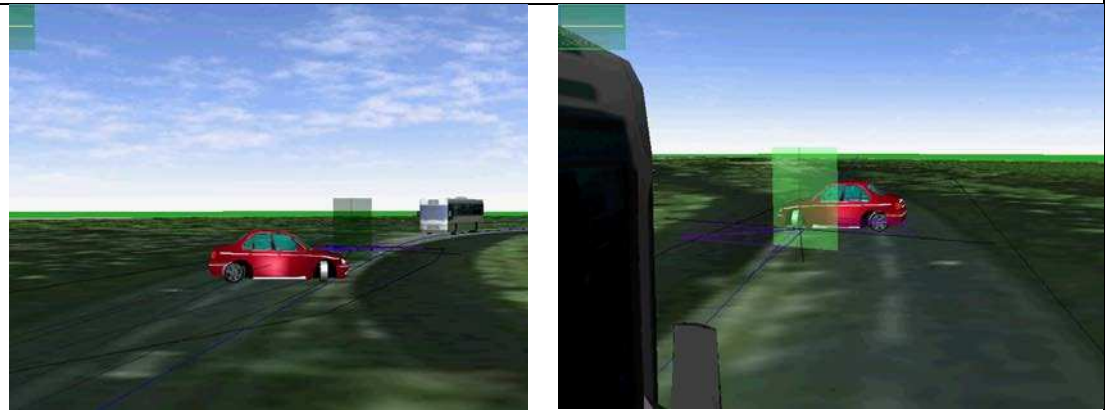
The momentum of the car continues as further right wheel lock and full braking is applied. The car is now out of control and continues to skid across the ice over to the right-hand side of the road. This point now represents the image of the bus CCTV footage included in the appendix. The exact reaction point of the bus driver is not known but this position would be a reasonable estimate.

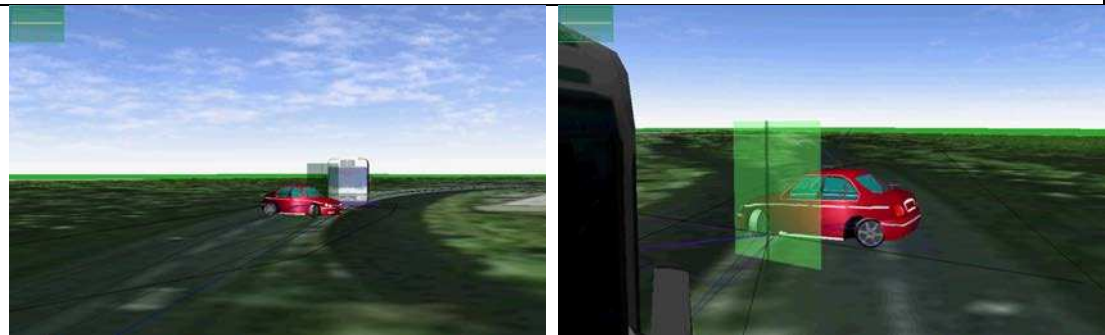
The car continues along its trajectory, rotating clockwise as it does. Imminently before the collision the car is about to contact the opposing grass verge. Note that the contact plane at the POI is almost parallel to the car body.

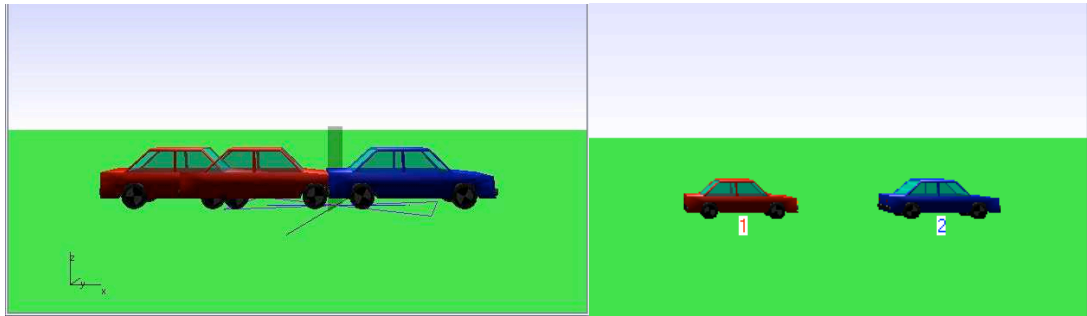
Figure 6.1: RTA1, Example

[CG]: This is a very simple example so it is difficult to comment. It isn't a real case so it simply appears that the impact is just that. There is <u>movement in the car suspension</u> which is appropriate, but there is not really more to add.

[SJU]: This is indeed an 'example case'. The note of vehicle suspension is worth commentary as this is one of the advantages of the PC-Crash software, given that suspension is modelled realistically and may be adjusted widely.

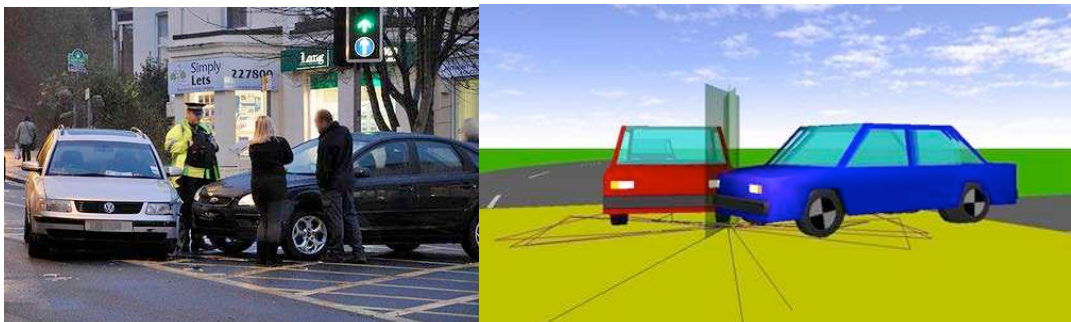
Figure 6.2: RTA2, Plymouth Low-Velocity Collision

[CG]: It would be beneficial to know if there was any displacement of the red vehicle (the stationary car on the left). A lot of the impact at low speed will be absorbed by the suspension alone. It appears that the red car has not moved
