Investigation of shallow leakage zones in a small embankment dam using repeated resistivity measurements

Pontus Sjödahl [1], Sam Johansson [2], Torleif Dahlin [3]

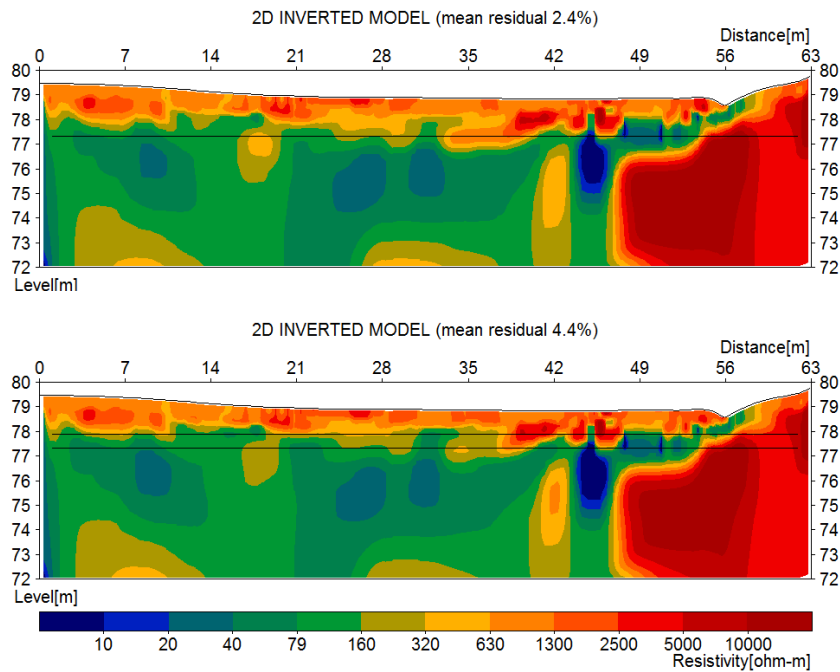
The resistivity distribution in the dam indicates homogeneous conditions along most part of the dam (Fig. 4). In the shallow parts there is an approximately 2 m deep layer with higher resistivity (ca 1000 Ωm), which most likely is representing dry earth material above the groundwater level. Due to the asphalt covering the ground this material has been protected from rainwater. Consequently, there is a rather large contrast in resistivity to the underlying material where the resistivity is significantly lower (ca 100 Ωm).

Fig. 4 Resistivity distribution in the dam from the first measurement 2010-08-16, 22:32 (above) and the last measurement 2010-08-18, 05:56 (below). Marked lines show reservoir level at first and actual measurement.

Between distance 0 and 40 m the resistivity is uniform down to El. 72-73 m, where an increase in resistivity can be inferred. In the right part of the measured line (ca distance >46 m) there is an extensive zone with very high resistivity, which is interpreted as bedrock. At the end of the line the bedrock can be seen at the ground surface, which coincides with the interpretation as the high resistivity zone is clearly reaching the surface in this part.

At distance 44-45 m there is a small zone with very low resistivity. There are no observations or documentation to explain this zone. Rather, it is likely an artefact from the inverse modelling. In the inversion process it is often difficult to correctly map zones with large such high contrast in resistivity as is likely to appear close to a bedrock soil interface. In such zones the model may overshoot and produce resistivities lower than what would be expected. Similar tendencies can be seen in the area above the supposed bedrock level around distance 47-55 m.

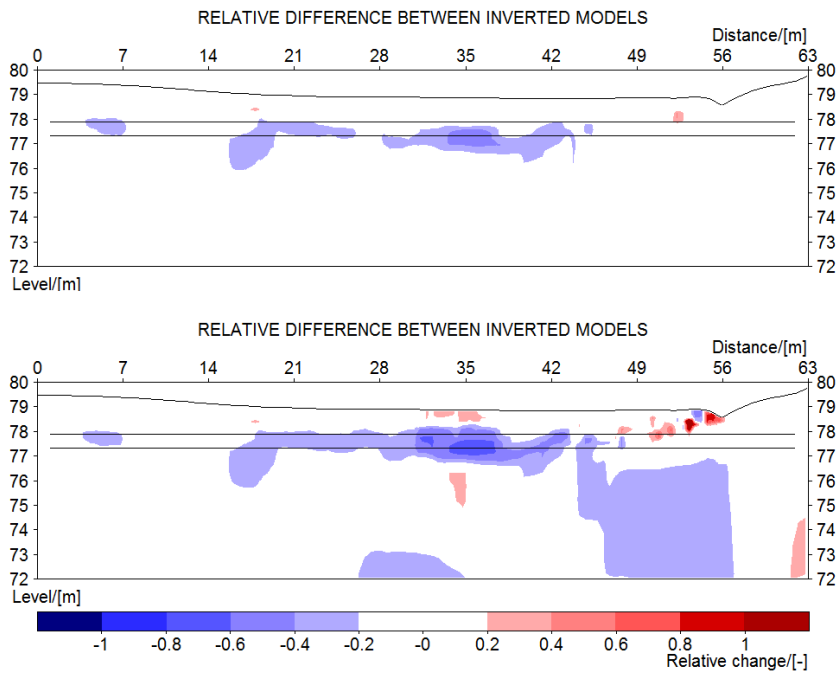
Fig. 5 Above: Difference plot between first and fifth measurement (after approx. 2 hours). Below: Difference plot between first and last measurement (after 21 hours). Marked lines show reservoir level at first and actual measurement.

Almost immediately after raising the reservoir the resistivity started to decrease along the dam at El. 77.34-77.89 m. The difference at this level, corresponding to the raise in reservoir level between the two measurements, is definitely the most apparent. This resistivity decrease corresponds well with the anticipated change in resistivity due to wetting of the soil and may be related to seepage. At this elevation the most prominent zone with decreasing resistivity is found with the centre at distance 35 m. By analysing the differences from all measurements one after another, the wetting process can be followed. A quick response is noticed at distances 5-6 m, 15-20 m and 30-40 m. The resistivity continued to decrease throughout the monitoring period in the area at distance 35, while in other areas the decrease stagnated.

The resistivity decrease in the presumed bedrock is probably caused by 3D effects, or inversion artefacts. In a few small areas a resistivity increase was noted. It might be due to drying out of shallow soil that was wetted by the intense rain that occurred in the days before the measurements started, as these areas were all situated outside the asphalt that protected most of the line from being wetted by the rain. Other possible explanations are noise or inversion artefacts in connection with the high contrast zones.
