FIELD VERIFICATION OF LATERAL-TORSIONAL COUPLING EFFECTS ON ROTOR INSTABILITIES IN CENTRIFUGAL COMPRESSORS

J. C. Wachel and F. R. Szenasi
Southwest Research Institute
San Antonio, Texas 78284

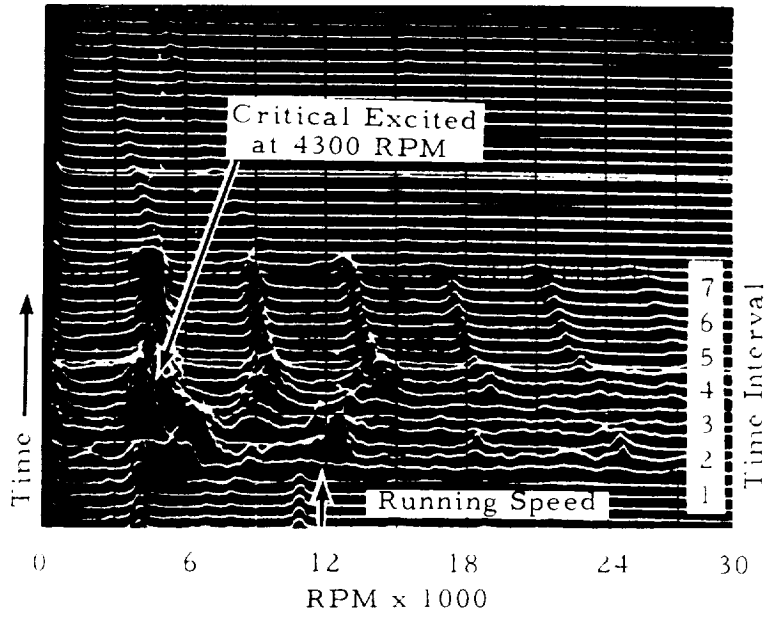
Figure 3

The spectral time history of the compressor instability presented in figure 3 was for a 13000 horsepower, 10600 rpm, 8 stage compressor with back-to-back impellers. The compressor had a 163 cm (64 inch) bearing span with a critical speed of 3800 cpm and a rigid bearing critical of 4300 cpm. The suction pressure was 10.3 bars (150 psi) and the discharge pressure 34.5 bars (500 psi). The complex wave (figure 2) shows that the instability component at 4300 cpm increased from 25.4 μm to 101 μm (1 mil to 4 mils) over about a 1 second interval, and then sharply increased to 406 μm (16 mils) in approximately 0.2 seconds. The vibrations then shifted to 6000 cpm and then locked in on 4300 cpm (406 μm, or 16 mils) until the compressor speed was below 4000 rpm. The inboard vertical probe had slightly different characteristics, emphasizing the need for full instrumentation. This compressor failed eight times due to these nonsynchronous vibrations. The seals and labyrinths were wiped in an increasing bow pattern such that the inner labyrinths had approximately 2.5 mm (0.10 inches) of material removed. The vibration orbit was so circular that the pieces appeared to have been turned in a lathe.

SPECTRAL TIME HISTORY OF COMPRESSOR
TRIPOUT SHOWING INSTABILITIES

Several modifications were required to improve the machine's stability characteristics. The impeller hubs were undercut to reduce the hysteresis effects at the mating surfaces. The clearances in the seals and labyrinths were increased. The five-shoe tilted pad bearings were modified by reducing the pad areas on the side and by increasing the radial clearance to force the rotor to vibrate in a horizontal elliptical orbit. In this compressor the installed recommended changes were sufficient; and the machine has run for several years without further nonsynchronous vibrations.

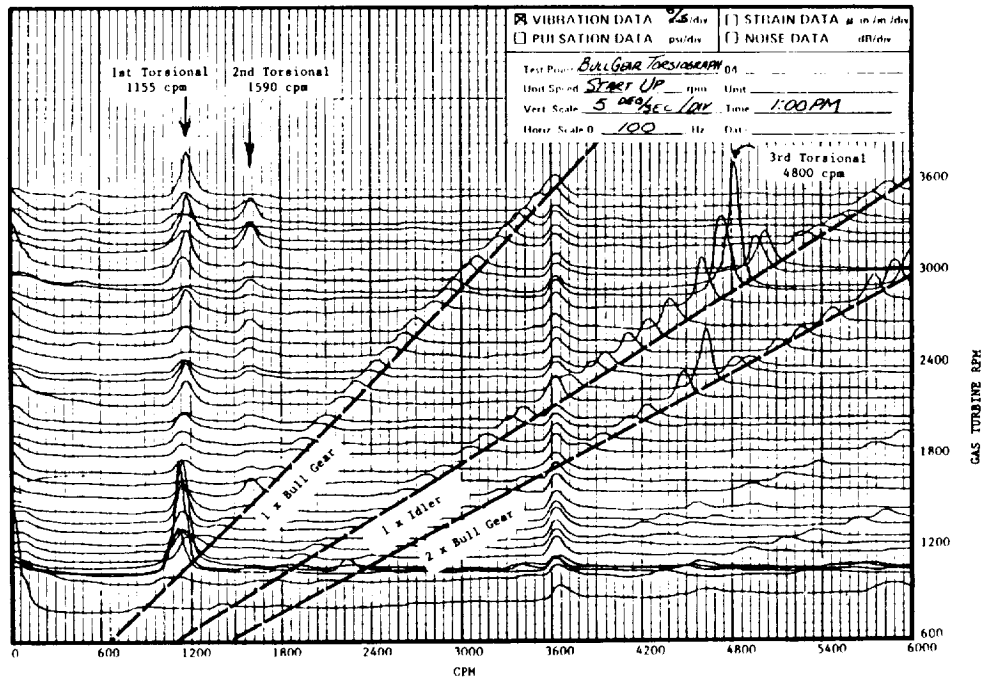
Figure 9

The torsional natural frequencies of the train can be seen from the Campbell diagram generated from the bull gear torsiograph signal (figure 9). The first three torsional critical speeds occurred at 1155 cpm, 1590 cpm, and 4760 cpm. One interesting phenomenon to note is that the first and second torsional critical speeds are always present, and modulate with fairly high amplitudes. Note that the third torsional natural frequency at 4800 cpm corresponds with the lateral instability frequency of the fourth stage compressor.

BULL GEAR TORSIONAL VIBRATIONS
SOUTHWEST RESEARCH INSTITUTE – APPLIED PHYSICS DIVISION

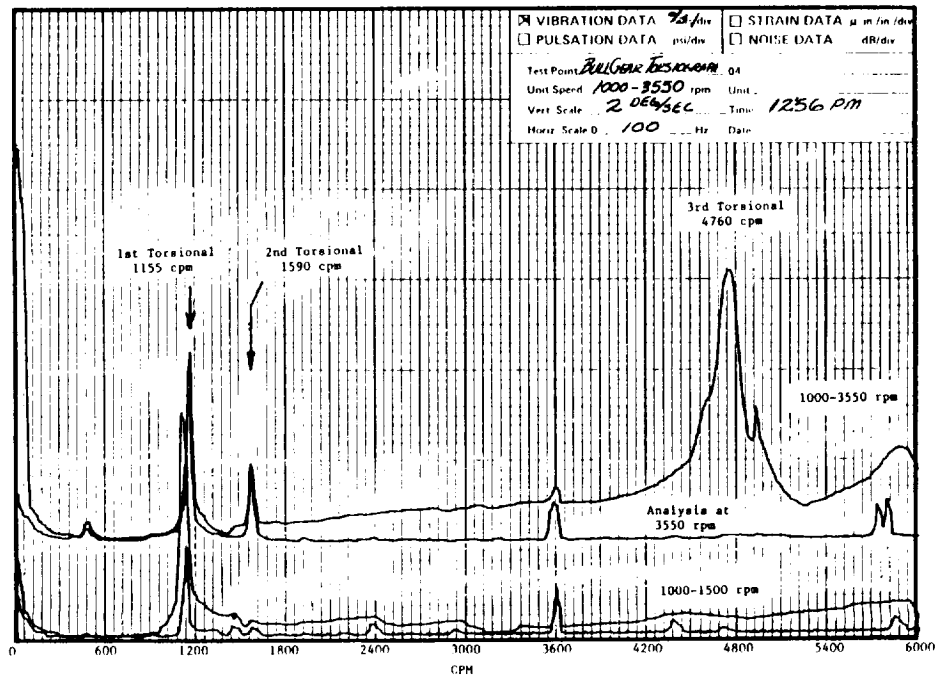
The maximum amplitude measured over the entire running speed range is recorded by the peak store envelope (figure 10). Figure 11 illustrates the correlation of the natural frequencies measured from the pinion gear torsiograph. The torsiograph on the pinion gives the same frequency information and also shows modulation of the first and second torsional critical speeds.

TORSIONAL VIBRATIONS MEASURED ON PINION

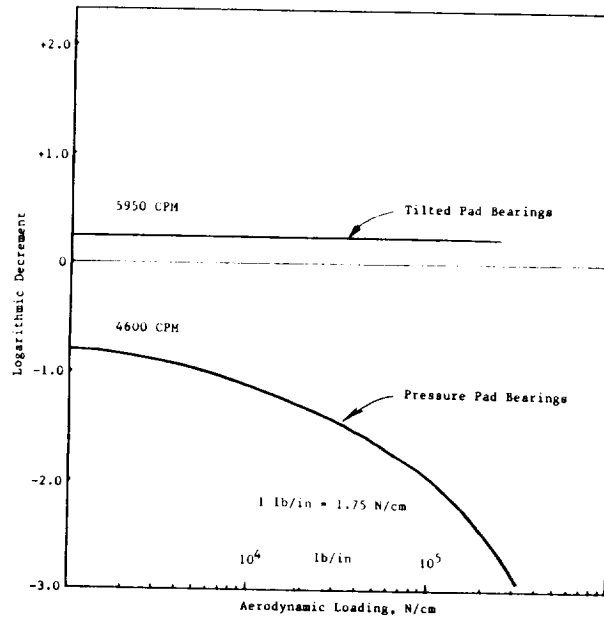
Figure 14

It has been found that to determine if proposed bearing modifications will be satisfactory from a stability standpoint, it is necessary to analyze the system for the fluid or aerodynamic loading that the compressor will be experiencing. To ensure that an adequate range of loading is covered, normally the log decrement versus effective aerodynamic loading is evaluated as plotted in figure 13. The lowest calculated instability forward mode near 4600 cpm agreed with the 4800 cpm which was actually measured (figure 7). The compressor stability is lowered as the effective aerodynamic cross coupling loading increases. With the new bearings, significant improvement in the log decrement is apparent and the tendency toward instability as a function of load is not evident. This calculated stability data indicates that the unit should be stable. The field data supports this analytical prediction, as can be seen from figure 14 which shows that as the gas turbine speed increases above 3000 rpm, no instabilities were found. Under maximum operating conditions, maximum pressure, and rated flow, vibrations in the low frequency range were carefully examined for all types of incipient instabilities and none was found. Therefore, from a stability standpoint, the changes made in the unit were satisfactory.

FOURTH STAGE COMPRESSOR VIBRATIONS
WITH TILTED PAD BEARINGS
SOUTHWEST RESEARCH INSTITUTE — APPLIED PHYSICS DIVISION

No Instabilities Present

The fourth stage compressor originally had pressure pad bearings. At this high speed of 17000 rpm, it was suspected that a change to tilted pad bearings would be sufficient to solve the instability problem; however, to ensure that the system would still operate satisfactorily under design loading conditions, stability calculations were made for the original system and the system with tilted pad bearings. Also the effect of the change to tilted pad bearings upon the lateral critical speed response was investigated. The critical speed map was generated and forced vibration analyses were performed to verify that the location of the new critical speeds would be acceptable. The critical speed map in figure 12 has the presure pad and tilted pad bearing curves superimposed. The new bearings were four-shoe, load-between-pad bearings. The new system critical speeds are near the horizontal critical speeds for the original system. The compressor running speed is above the fourth critical speed; therefore, the change to tilted pad bearings would not definitely solve the problem since there are many systems which have tilted pad bearings and still have instabilities.

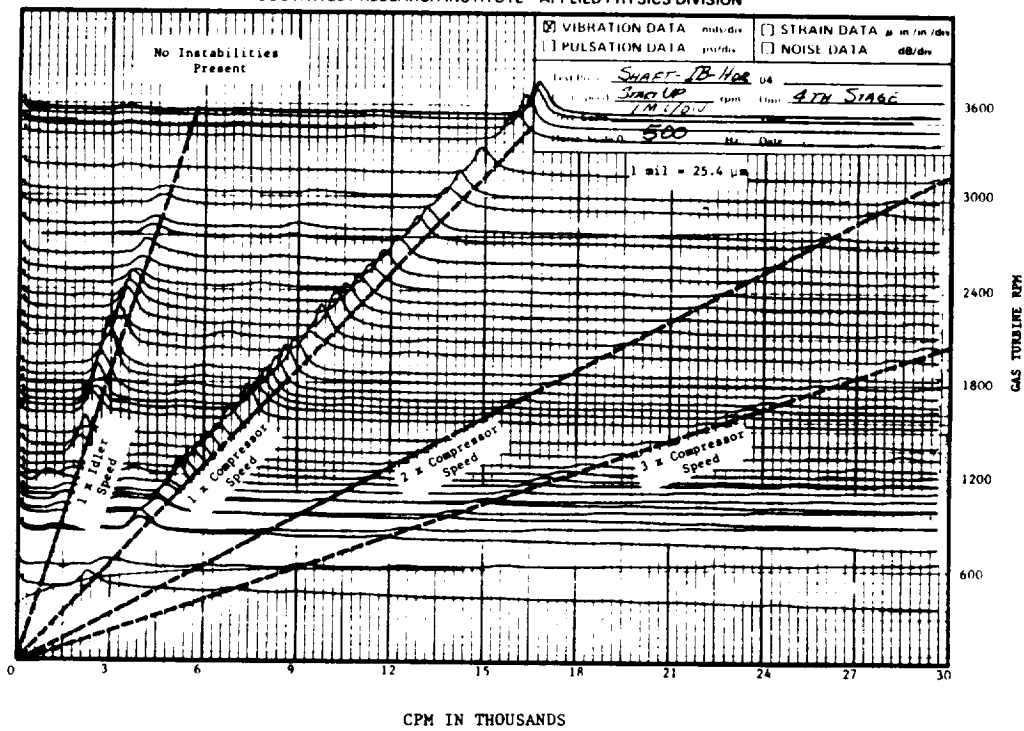
One interesting phenomenon that occurred on startup was the excitation of lateral vibrations in the fourth stage compressor due to the idler gear frequency excitation as it passed through the compressor shaft critical speeds. In figure 15 (the peak-store plot of the compressor shaft vibrations, as compressor speed went from 5700 rpm to 13300 rpm), the excitation of the shaft criticals at 3000-4450 cpm can be seen. These measured critical speeds match those determined from the critical speed map. On this initial startup, the high amplitude, low frequency vibrations measured on the fourth stage compressor were unexpected due to the predicted improvement in the stability

characteristics for the rotor with the tilted pad bearings. When the experimental Campbell diagram of the vibrations was displayed, it was found that the instability was not the classical type of instability. The low frequency vibrations were a result of the idler gear frequency exciting the lateral critical speeds of the fourth stage compressor. The cause of the excitation was the lack of steady-state loading on the gears in the gearbox. Subsequent runs were made with higher suction pressures which significantly reduced the idler gear excitation. These characteristics were shown in figure 14 for increased suction pressure. These data show that in closely coupled systems the lateral energy can be transmitted throughout the train.

COMPRESSOR SUBSYNCHRONOUS VIBRATIONS
EXCITED BY IDLER GEARS
SOUTHWEST RESEARCH INSTITUTE – APPLIED PHYSICS DIVISION

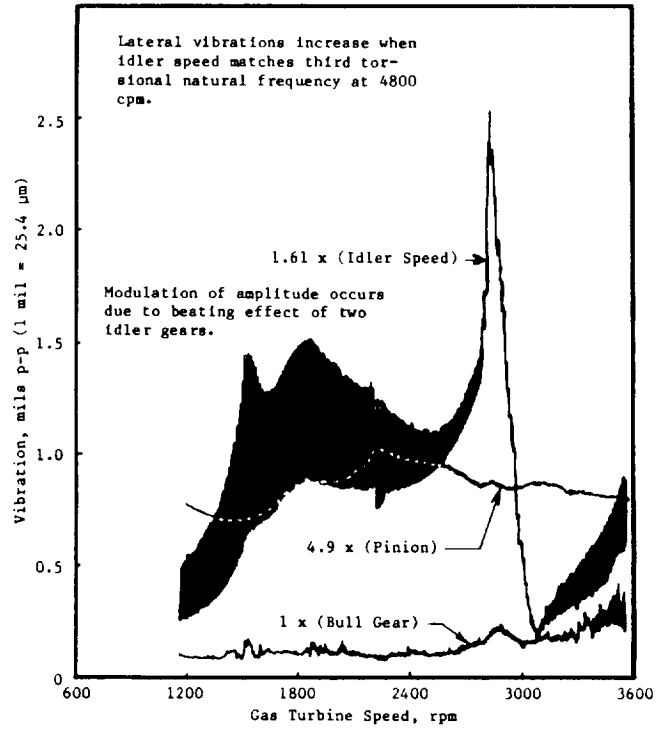
Figure 16

For the pinion driving the fourth stage compressor, the Campbell diagram in figure 16 shows that whenever one of the excitation sources matches a torsional natural frequency, the lateral vibrations drastically increase. The energy from the idlers can couple directly into compressor shaft lateral vibrations; therefore, it can be surmised that any time the idler gear, bull gear, or one of the excitation sources is coincident with the torsional natural frequency, increased lateral vibration would occur and this could be transmitted to the compressors.

PINION LATERAL VIBRATIONS
CAUSED BY TORSIONAL-LATERAL COUPLING

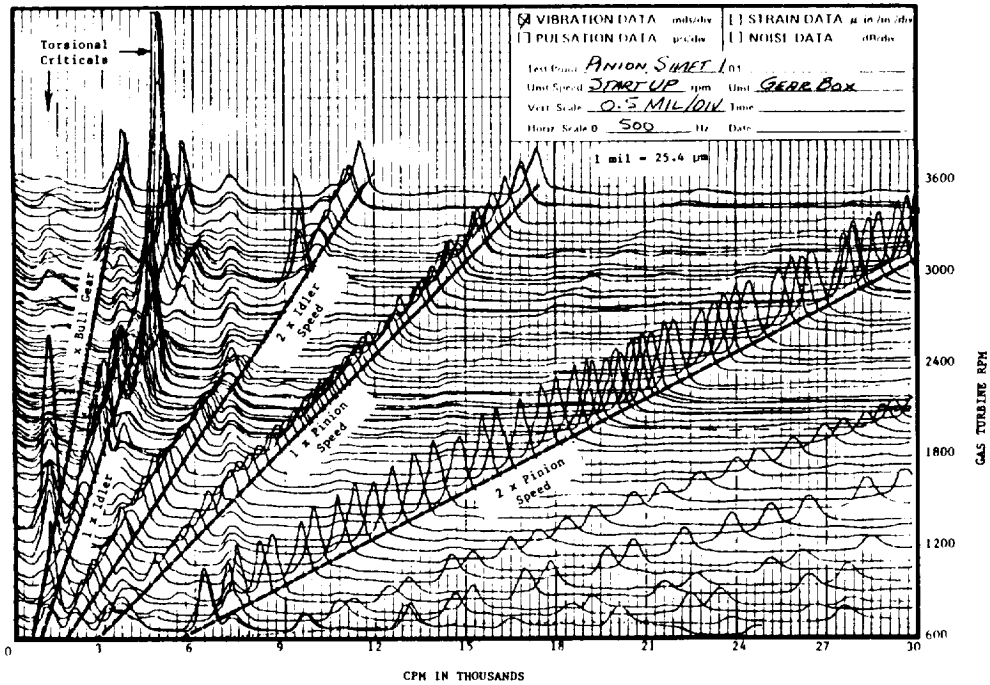
Figure 18

The Campbell diagram for the other pinion lateral vibrations (figure 18) shows that the torsional energy is transferred laterally throughout the train. Again there are similar characteristics on the pinion with large responses at the first and the third torsional critical speeds, indicating that this excitation can cause large lateral vibrations.

FIRST STAGE PINION LATERAL VIBRATIONS

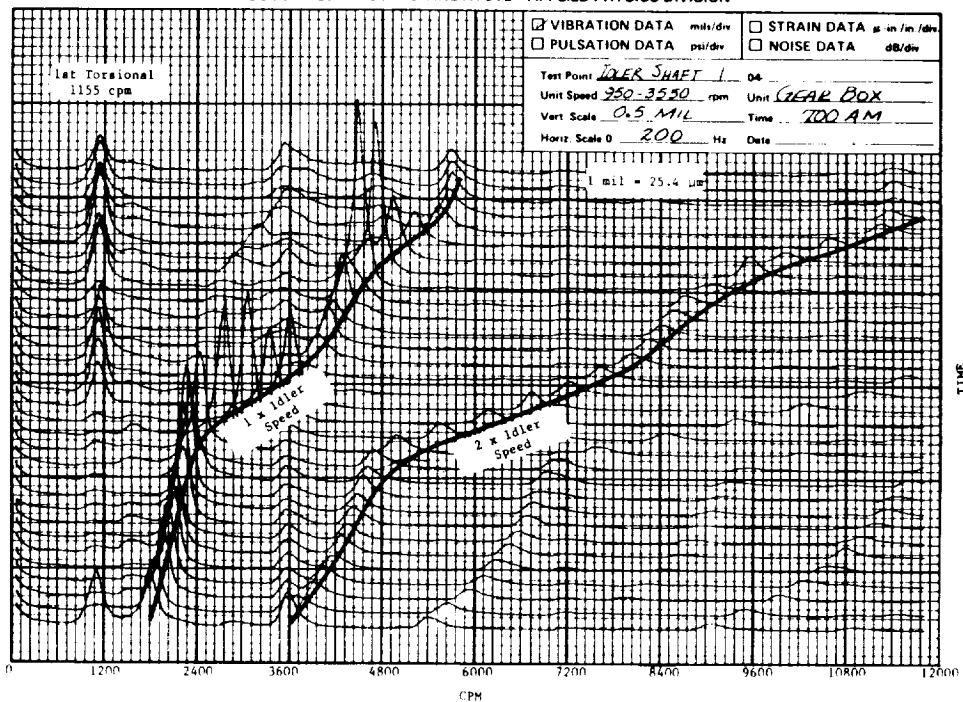
Figure 19

The effect on the idler gear horizontal vibration is shown in figure 19. This is a time raster rather than a Campbell diagram. The increase in lateral vibration can be seen when the idler gear frequency approaches 4800 cpm. This data is pertinent relative to the two problems experienced: the instability and the gear tooth failures. Notice that every time one of the excitation frequencies is coincident with the torsional natural frequency, the torsional vibrations and the lateral vibrations increase. This energy is transmitted through the shafts to the first and second stage compressors, as can be seen in figure 20 which gives the second stage compressor inboard vibrations. There were large vibrations excited even on the second stage compressor; however, this compressor also had a lateral critical speed near 4800 rpm which may have caused some amplification. This data shows that if a compressor had a potential instability, it would be easy for the torsional resonances to act as perpetrators for instabilities.

IDLER GEAR LATERAL VIBRATIONS
