AN INVESTIGATION OF ARC DISCHARGING ON NEGATIVELY BIASED DIELECTRIC-CONDUCTOR SAMPLES IN A PLASMA*

William L. Miller
National Aeronautics and Space Administration
Lewis Research Center
Cleveland, Ohio 44135

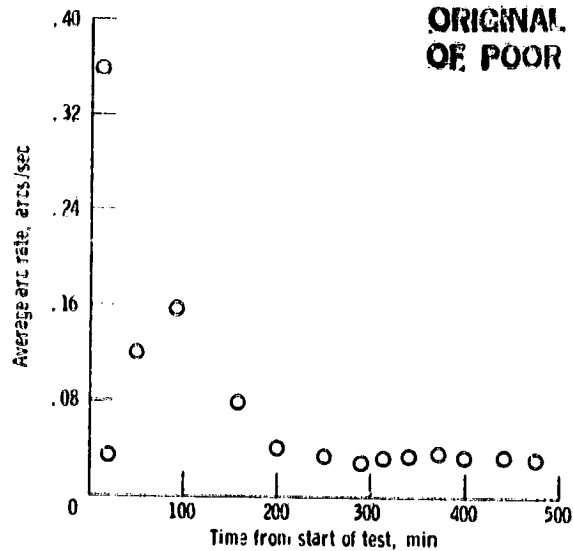
Visible damage to the solar cell array as a result of arcing (fig. 4) appeared to be limited to a roughening of interconnect surfaces, mostly concentrated in spots near interconnect edges and protrusions. In addition, coloration of the interconnect surfaces occurred along the length of several interconnects. The coloration may be the result of vacuum pump oil contamination, although this is not certain. It is not known to what extent a film of oil might affect the test results.

Figure 4. - Comparison of untested solar cell module and one that underwent extensive arcing tests without current-limiting resistance.

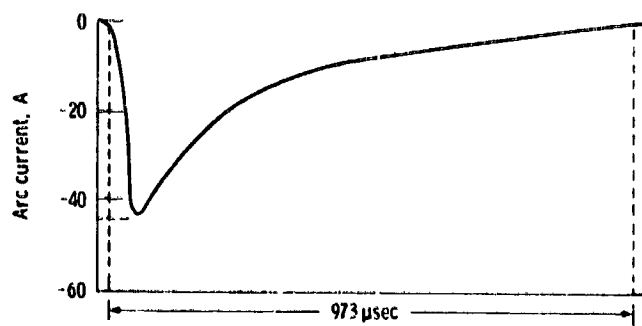
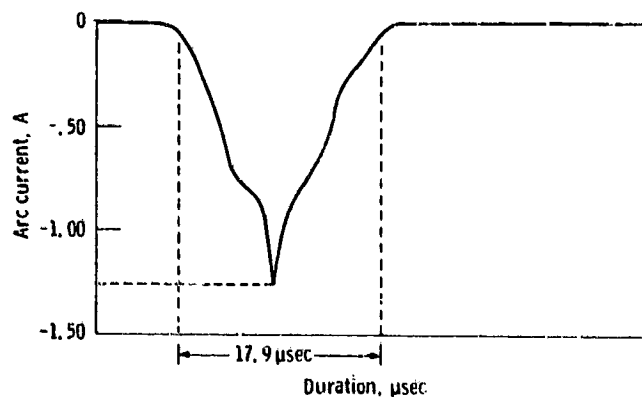
Oscilloscope traces of current pulses were recorded during arc events on various samples. The traces (fig. 7) represent negative charge leaving the capacitor in the electrical system during an arc event. The arc duration was about 10 ~ 30 μsec with the 21.1-MΩ resistance in series, and greater than 1 msec without the resistance. Arc peak current was generally 0.5 to 2 A with the resistance, and about 40 A or more without it. The fact that arc peak current decreased with series resistance may indicate a cutoff point at which the available current would not be enough to sustain arcing.

(a) Fully exposed solar module. Applied voltage, -600 V; capacitance, 0.01 µf.

(c) Tungsten pin/disk with Kapton tape. Applied voltage, -800 V, capacitance, 0.01 µF.

Figure 7. - Illustrations of oscilloscope traces recorded during arc events, showing peak current and duration of arcs.

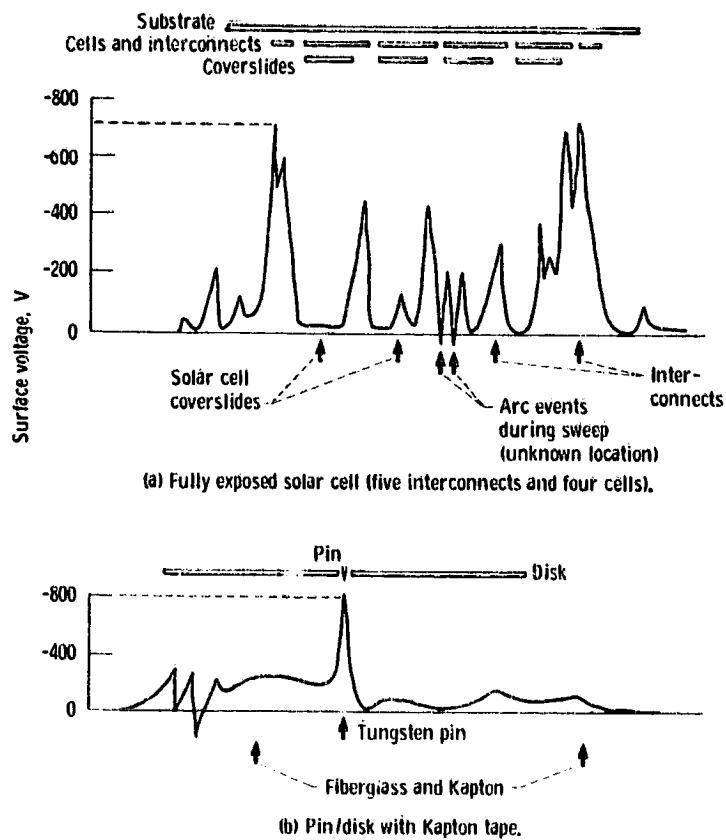
Strip-chart records of typical surface potential profiles were obtained by sweeping the electrostatic probe (fig. 9). Characteristics of these profiles include large voltage readings over exposed metal regions and lower potential readings over dielectric areas. During the electrostatic probe's sweep, discharges would often occur as the probe moved over an exposed metal region. This behavior suggests that the probe could have induced some discharges. It is thought that localized solar cell arcs affect the surface potentials of the rest of an array (ref. 3). The potential profiles made in this investigation indicate that the test-sample response time to an arc event was probably shorter than the response times of the electrostatic probe and the strip chart.

Figure 9. - Surface voltage profiles made with sweeping electrostatic probe.
Exposed metal regions at high voltages; dielectric at lower potentials.
