NASA/TM-2006-213921
ARL-TR-3638

Flow Liner Slot Edge Replication Feasibility Study

John A. Newman
U.S. Army Research Laboratory
Vehicle Technology Directorate
Langley Research Center, Hampton, Virginia

February 2006

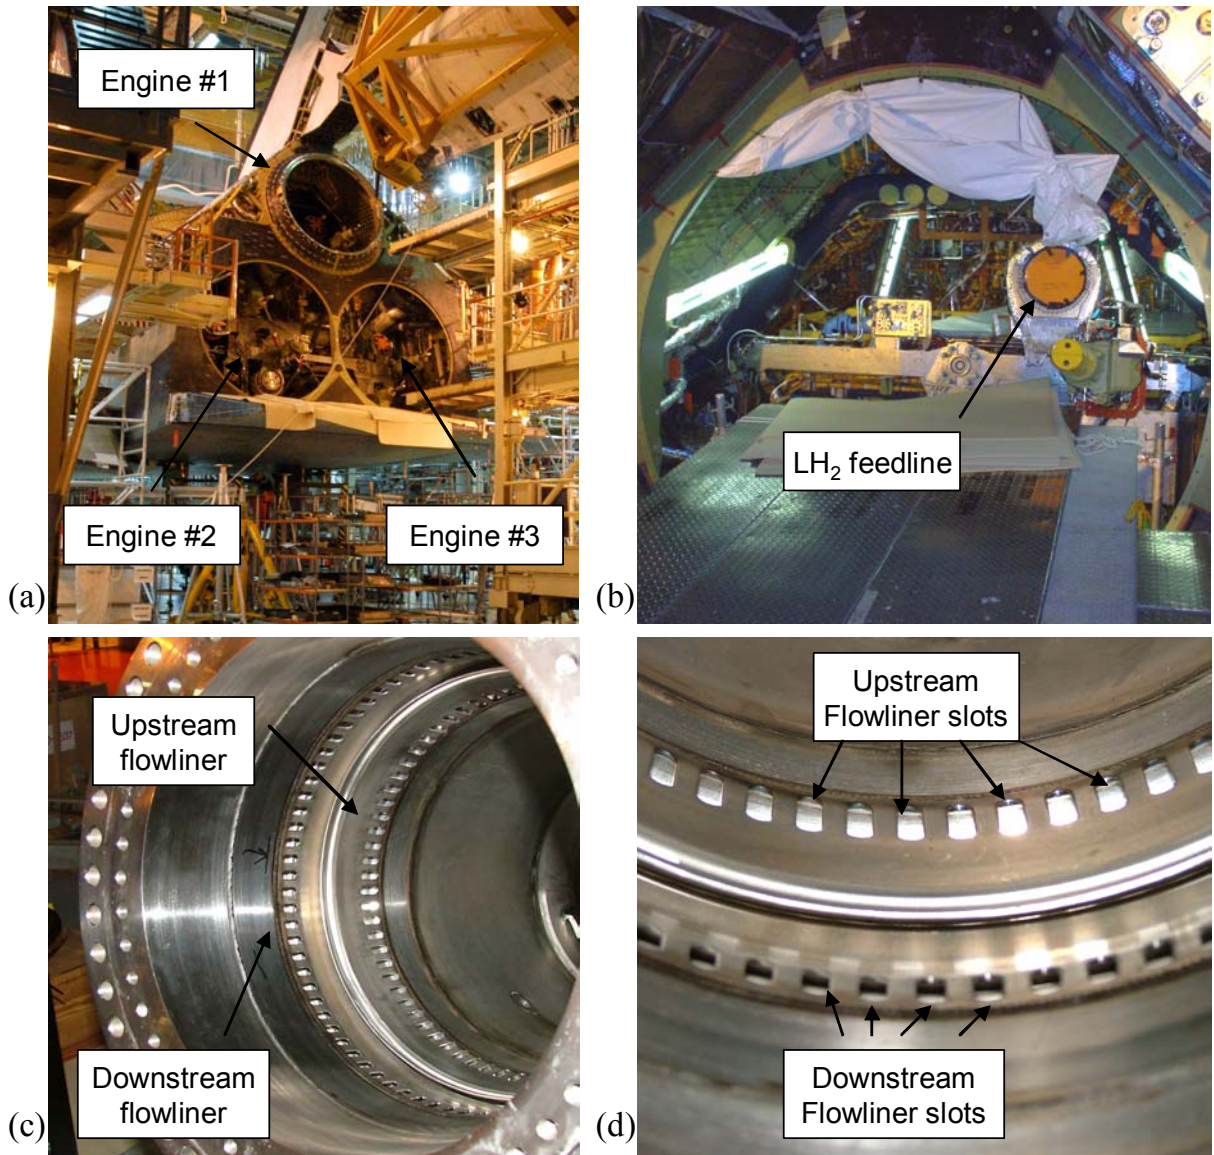
Cracks have been found at slots in space-shuttle orbiter main engine liquid hydrogen (LH_2) feed line gimbal-joint flowliners (refs. 1, 2). These flowliners are located in the aft end of the orbiters (See Figure 1a) inside the LH2 feedlines (See Figure 1b). Flowliners are constructed of Inconel 718 sheet material (0.05 inches thick) and are designed to provide a smooth flow of fuel over the bellows of the gimbal joint. The upstream and downstream flowliners, shown in Figure 1c, each contain 38 slots. The upstream flowliner slots are nominally 1.00 inch (25.4 mm) long and 0.25 inches (6.35 mm) wide, and the downstream slots are nominally 0.75 inches (19.1 mm) long and 0.25 inches (6.35) wide (See Figure 1d).

Figure 1. The flowliner locations on the space shuttle orbiter are shown in a series of photographs. (a) Orbiter aft end shown with main engines removed. (b) LH$_2$ feedline is shown in the main engine orifice. (c) Flowliners are shown inside the LH$_2$ feedline. (d) Flowliner slots.

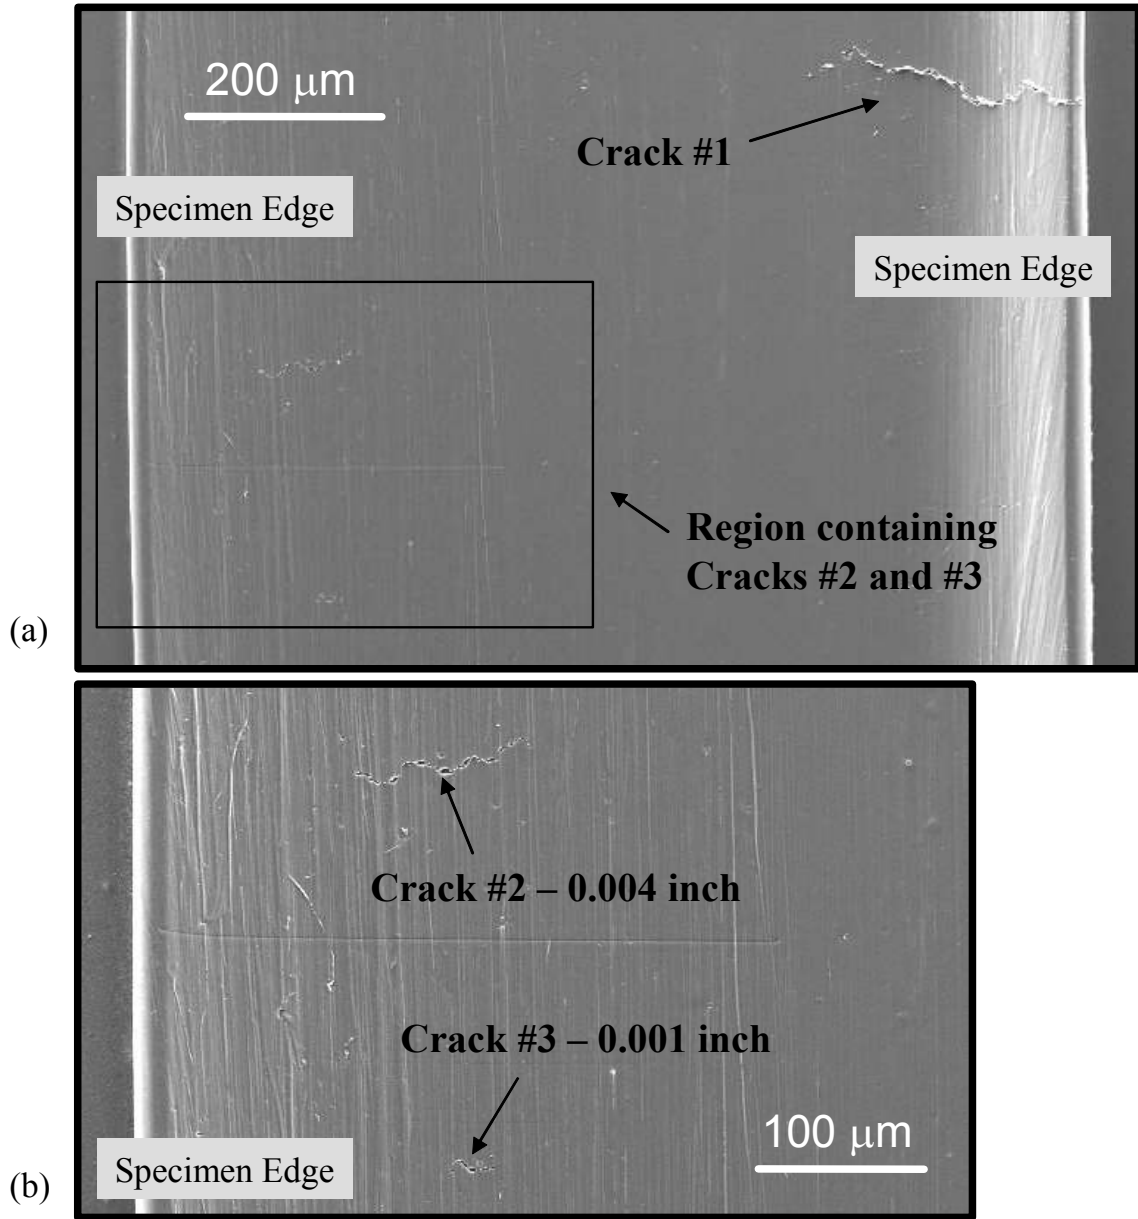
Specimen P1 was the first specimen tested and was originally fatigue loaded at a notch stress of 140 ksi (R = 0.1). After 147,000 cycles no cracks were detected and loads were increased to a notch stress of 160 ksi. All other specimens were strictly loaded at a notch stress of 160 ksi and R = 0.1. Three cracks were detected on replicas made at a cumulative cycle count of 270,000 (123,000 cycles at 160 ksi notch stress). The largest crack was a corner crack with an approximate length of 0.014 inch (350 μm). Two smaller surface cracks of lengths 0.004 inch (110 μm) and 0.001 inch (27 μm) were also detected.[3] The large crack can be seen in an SEM image of an acetate tape replica. See Figure 5a. The two smaller cracks can be seen at higher magnification (Figure 5b).

Figure 5. SEM images of specimen P1 acetate tape replica. (a) Low magnification. (b) High magnification of region containing cracks #2 and #3.

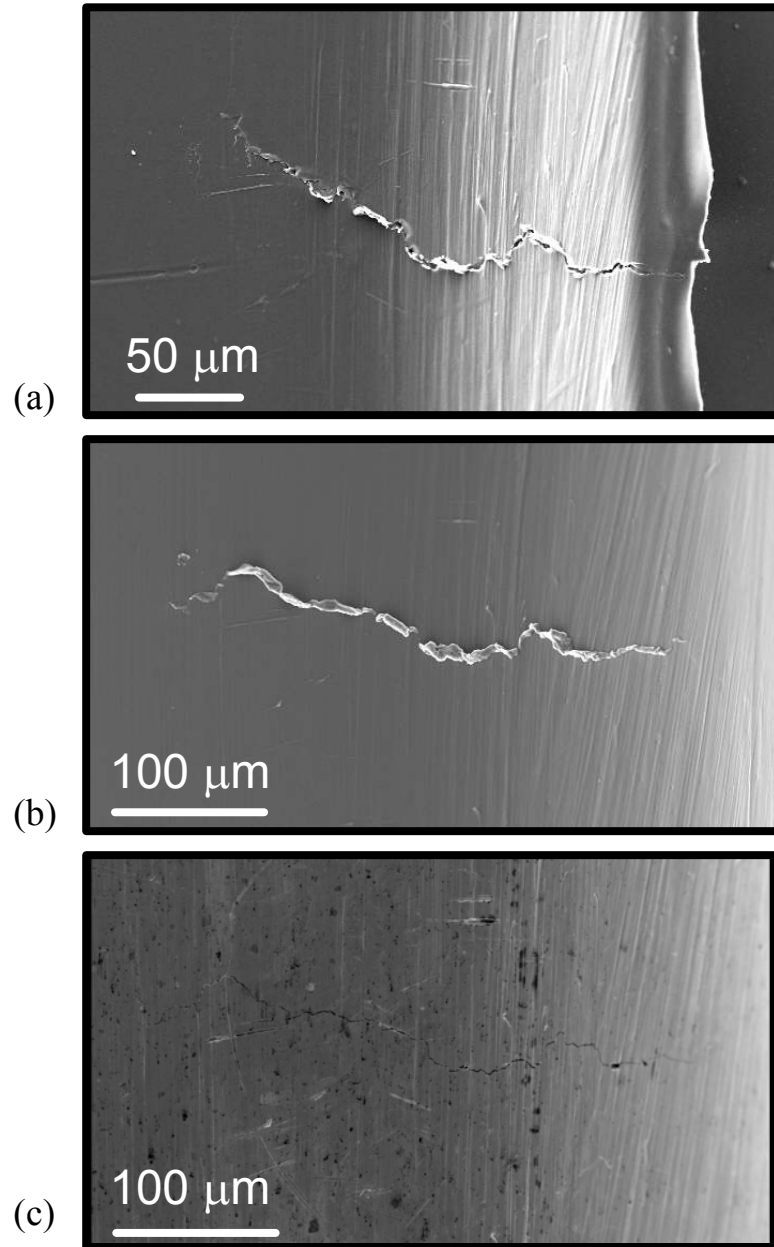
SEM micrographs of crack #1 are shown for an acetate tape replica taken at max load (Figure 6a), a Repliset replica taken at zero load (Figure 6b), and of the actual specimen (Figure 6c) also taken at zero load.[4] A qualitative comparison shows that the same subtle crack features appear in all three images. From the acetate tape replica the crack length was determined to be 0.0110 inches long (280 µm). The result from the Repliset was 0.0135 inches (343 µm). The crack length from the specimen, somewhat difficult to determine because the crack tip was difficult to locate, was in the range of 0.0093-0.0138 inches (236-350 µm). Here the Repliset method, which was handicapped because replicas were taken at zero load, indicated a longer crack was present than the acetate tape method. This 22% difference suggests that features are shown on Repliset replicas that are missed on the acetate tape replicas.

Figure 6. SEM images of crack #1 on specimen P1, a 0.012-inch-long corner crack. (a) Acetate tape replica (maximum load). (b) Repliset replica (unloaded). (c) Specimen (unloaded).

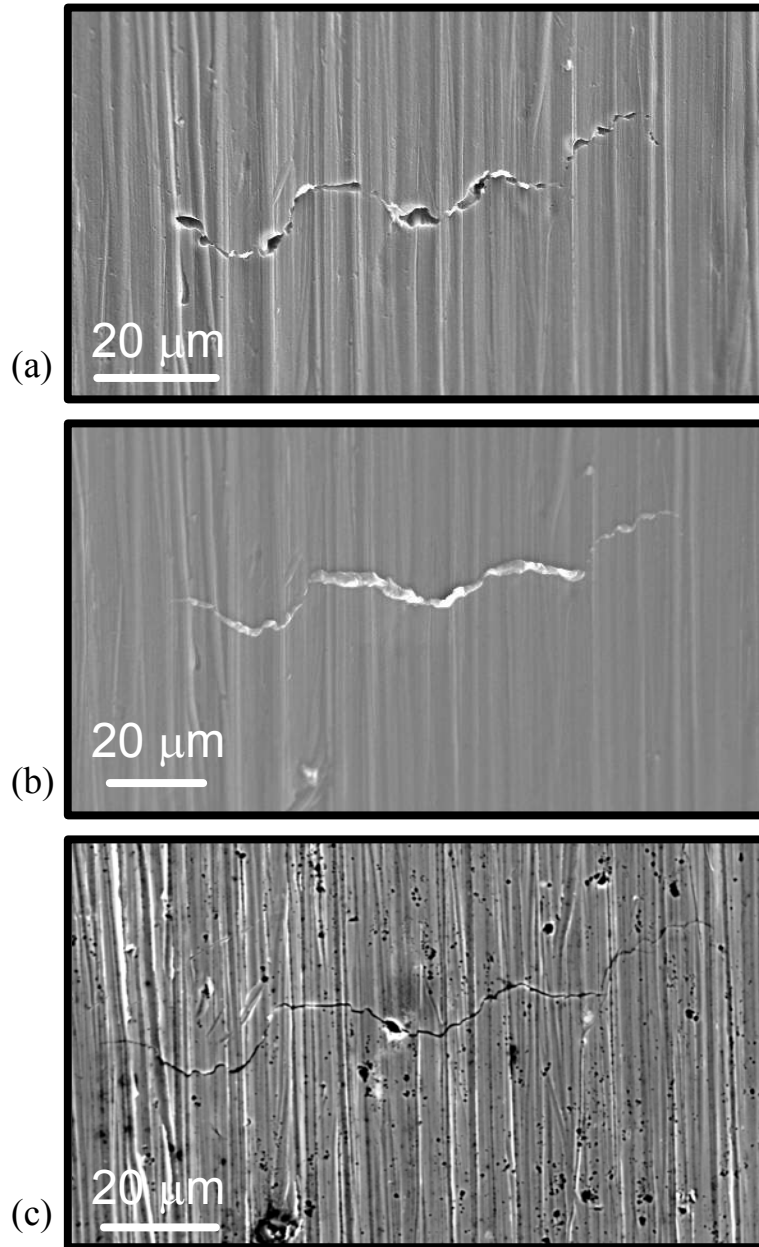
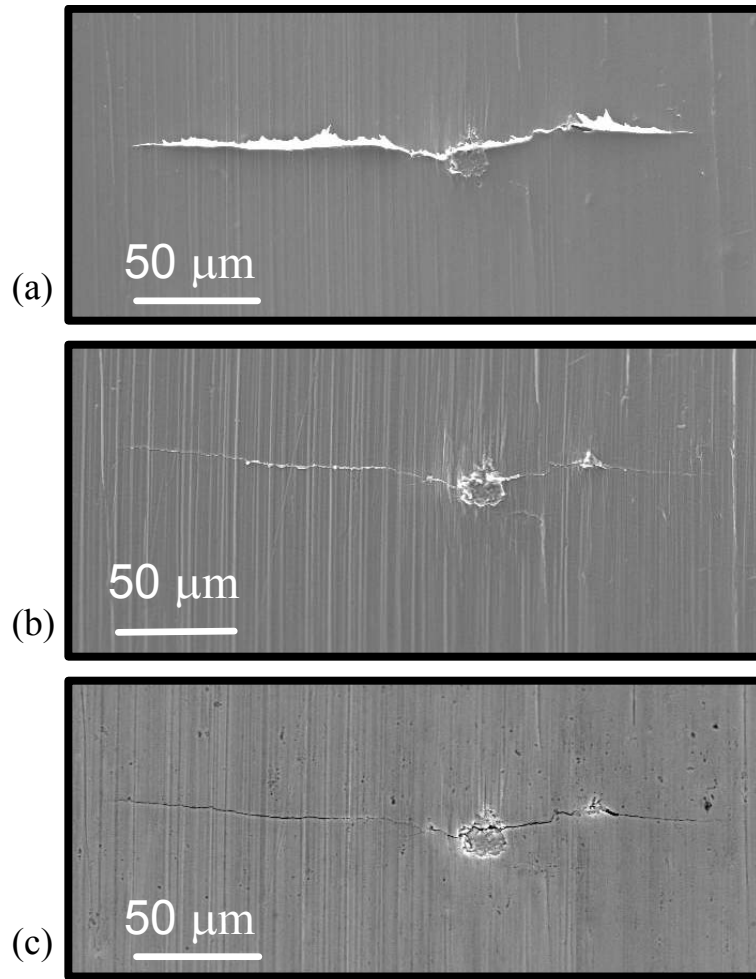
Images for cracks #2 and #3 are shown in Figures 7 and 8, respectively. For crack #2, the crack lengths determined from the acetate tape (Figure 7a), Repliset (Figure 7b), and the specimen (Figure 7c) are 0.0032 inch (81 µm), 0.0041 inch (104 µm) and 0.0043 inch (110 µm), respectively. Here, the acetate tape crack determination is approximately 22% less than the Repliset determination, and both replica measurements are less than the specimen indication. For crack #3, the crack length measurements for

Figure 7. SEM images of crack #2 on specimen P1, a 0.004-inch-long surface crack. (a) Acetate tape replica (maximum load). (b) Repliset replica (unloaded). (c) Specimen (unloaded).

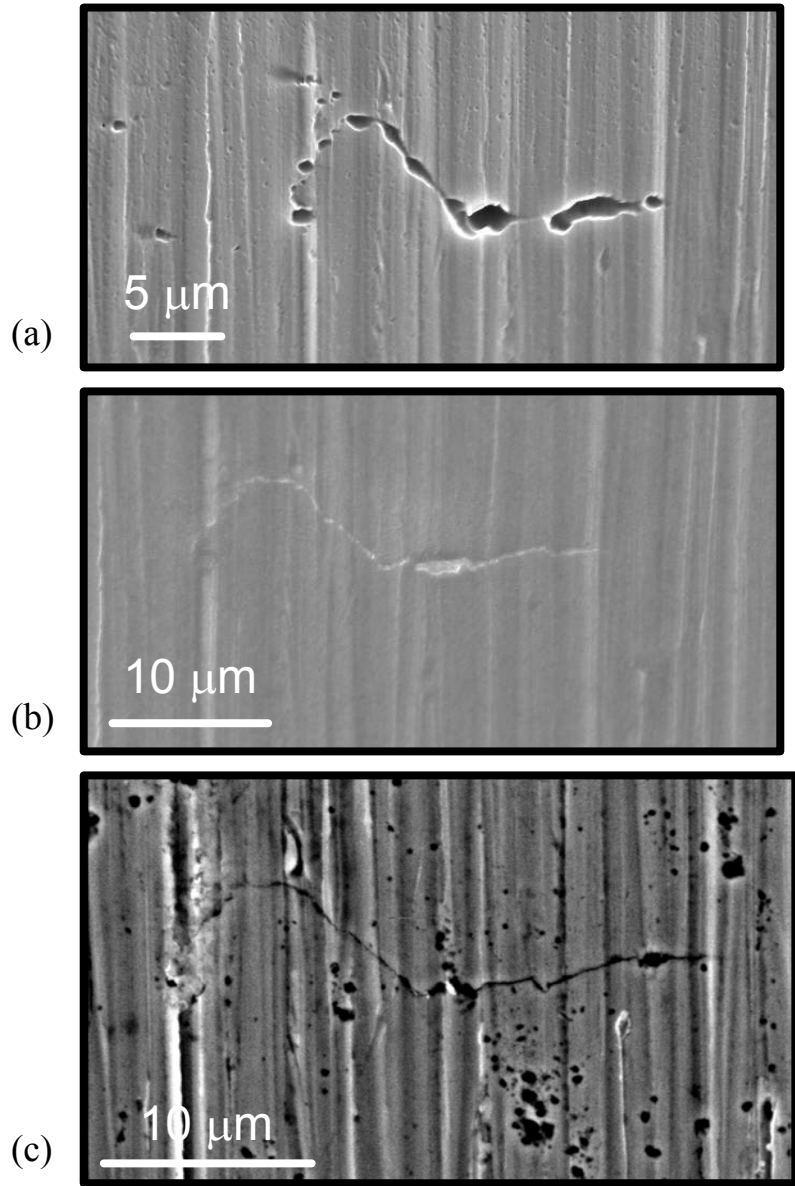
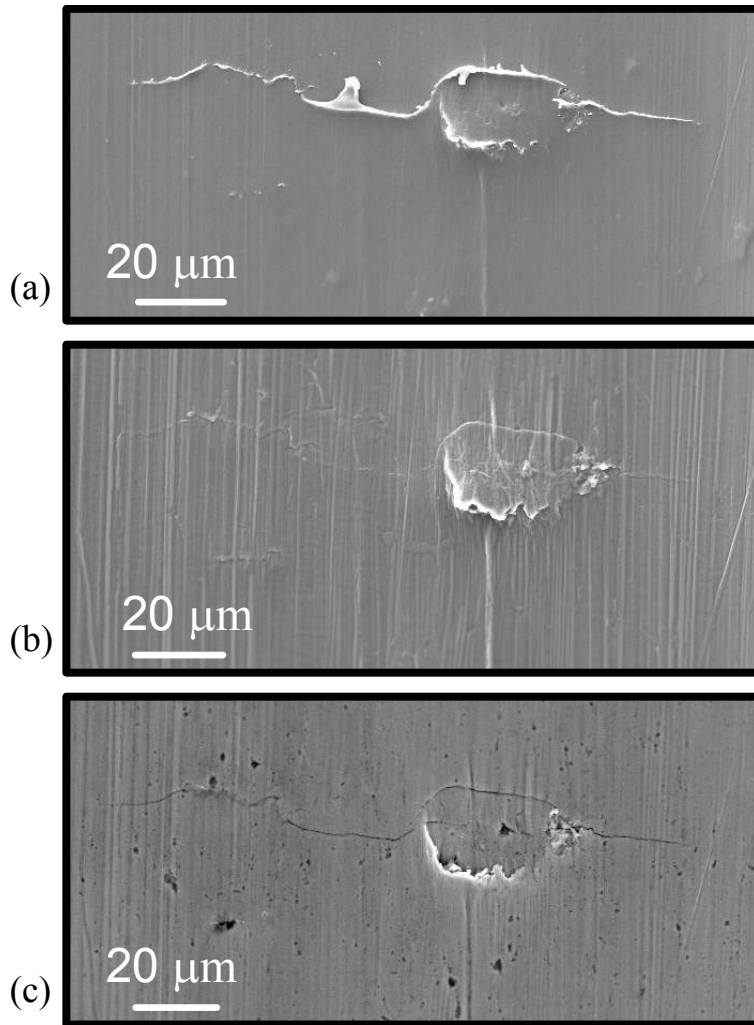
acetate tape (Figure 8a), Repliset (Figure 8b), and the specimen (Figure 8c) are 0.0010 inch (26 μm), 0.0008 inch (20 μm), and 0.0011 inch (28 μm), respectively. Again, the Repliset crack length measurement is greater than the acetate tape value, but slightly less than from a destructive specimen examination.

Figure 8. SEM images of crack #3 on specimen P1, a 0.001-inch-long surface crack. (a) Acetate tape replica (maximum load). (b) Repliset replica (unloaded). (c) Specimen (unloaded).

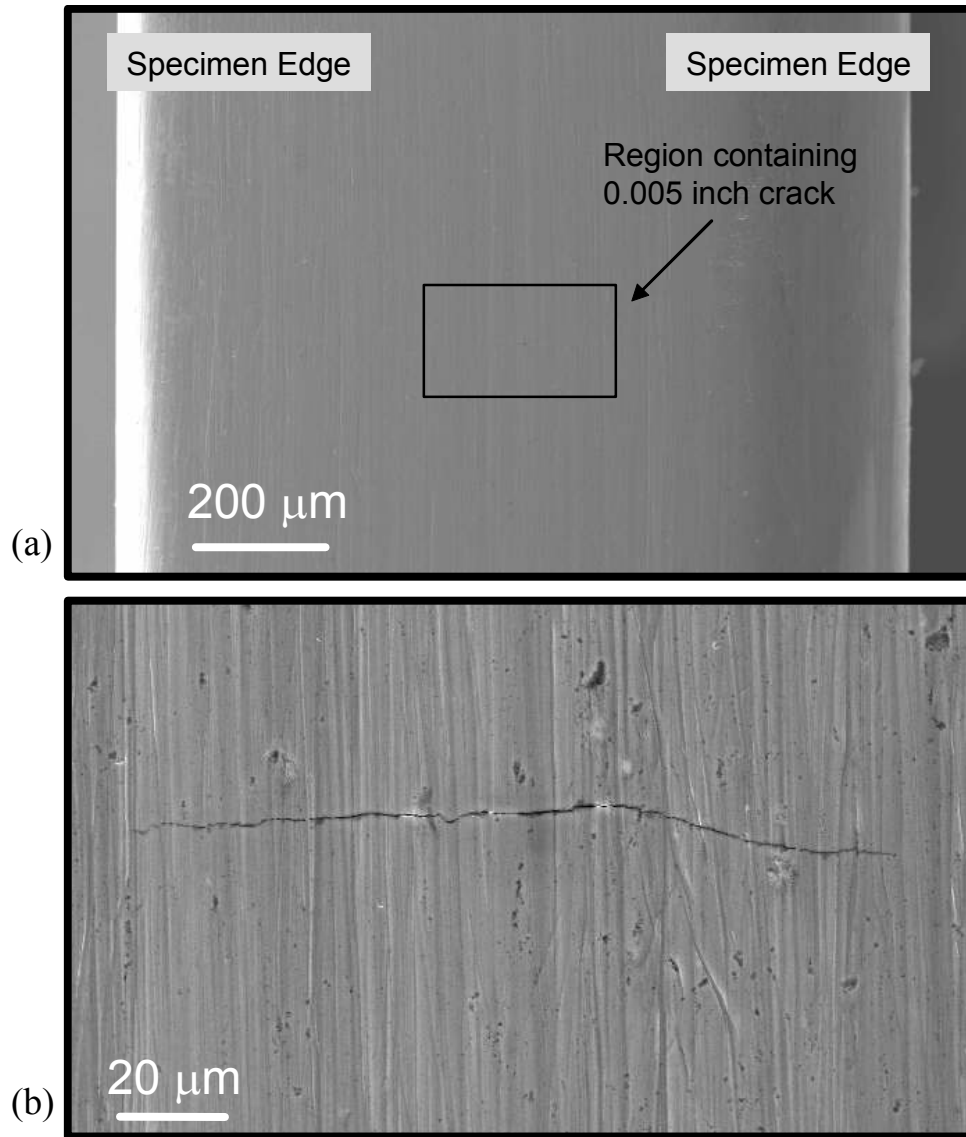
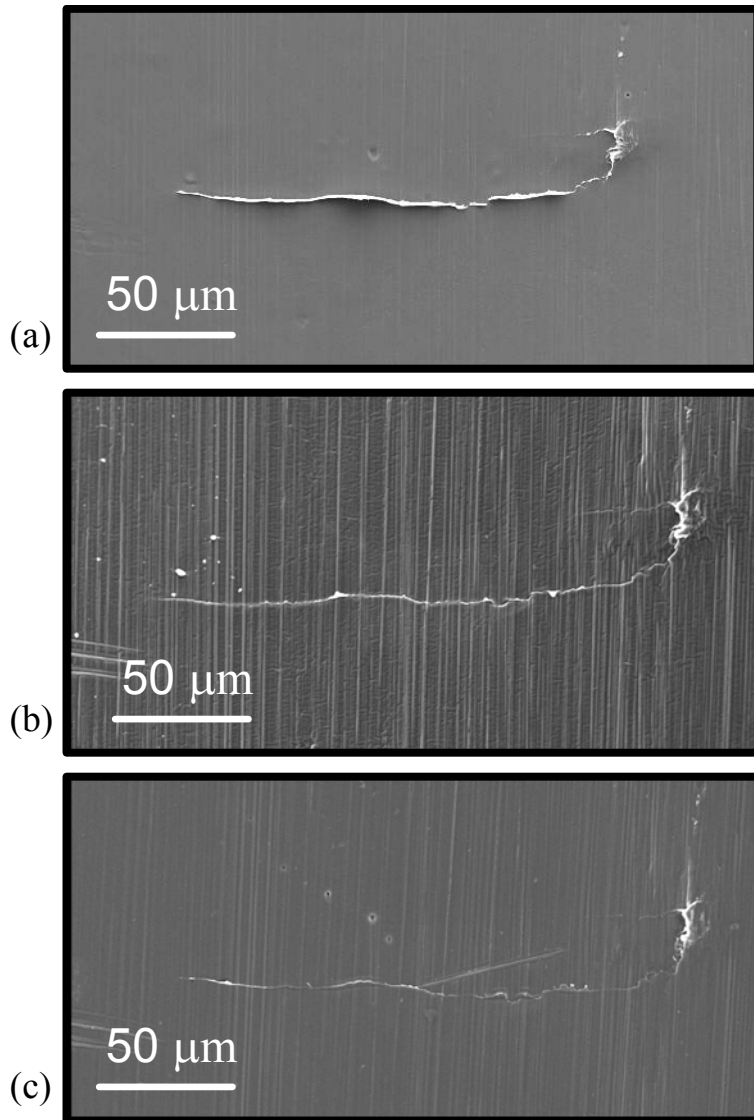
Specimen P2 was fatigue loaded at a notch stress of 160 ksi (R = 0.1). After 115,000 cycles a 0.005-inch-long surface crack was found. As shown in Figure 9a, crack initiation occurred near the mid-thickness of the slot. This crack is shown at higher magnification in Figure 9b. SEM images of this crack are shown for an acetate tape replica (Figure 10a), Repliset (Figure 10b), and the specimen (Figure 10c). A comparison of these images reveals that the qualitative features (e.g., shape of the crack) in each image are similar to the other images of the same crack. Comparison of the crack length measurements reveals that the Repliset measurement of 0.0054 inch (137 μm) is bounded by the acetate tape measurement of 0.0052 inch (132 μm) and the destructive examination value of 0.0056 inch (143 μm).

Figure 9. SEM images of specimen P2 acetate tape replica. (a) Low magnification. (b) High magnification of the region containing a 0.005-inch-long surface crack.

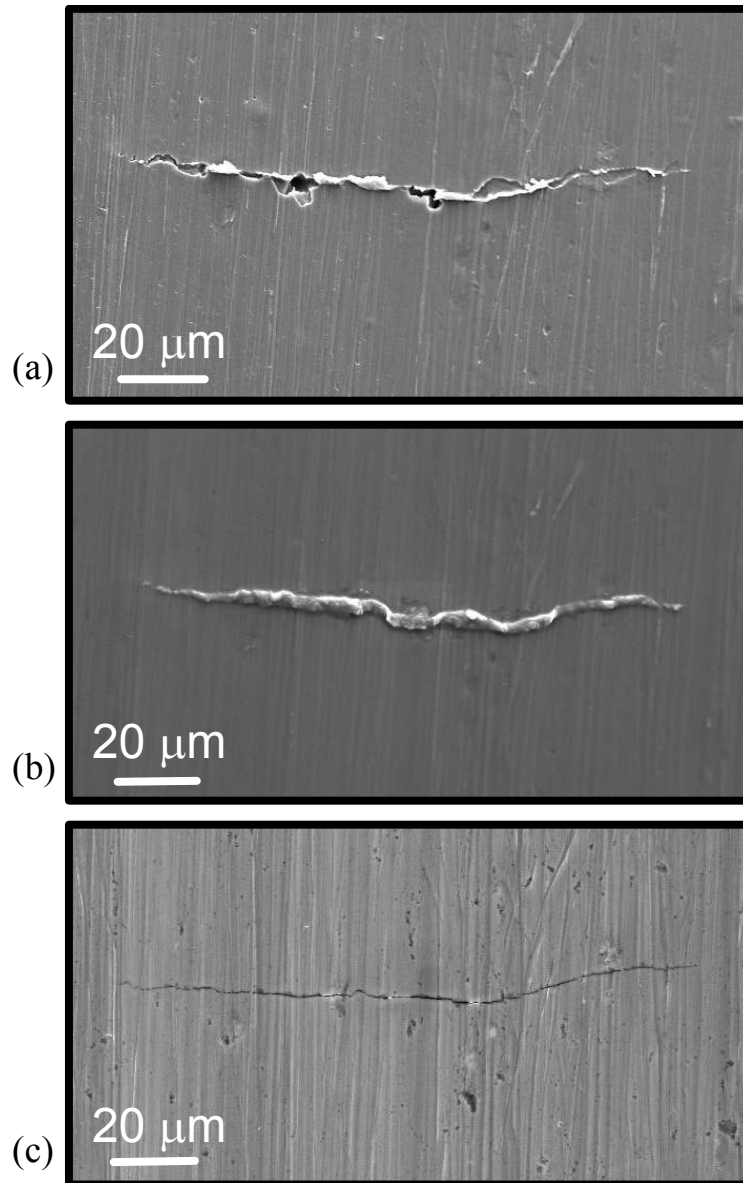
Figure 10. SEM images of the 0.005-inch-long surface crack on specimen P2. (a) Acetate tape replica (maximum load). (b) Repliset replica (unloaded). (c) Specimen (unloaded).

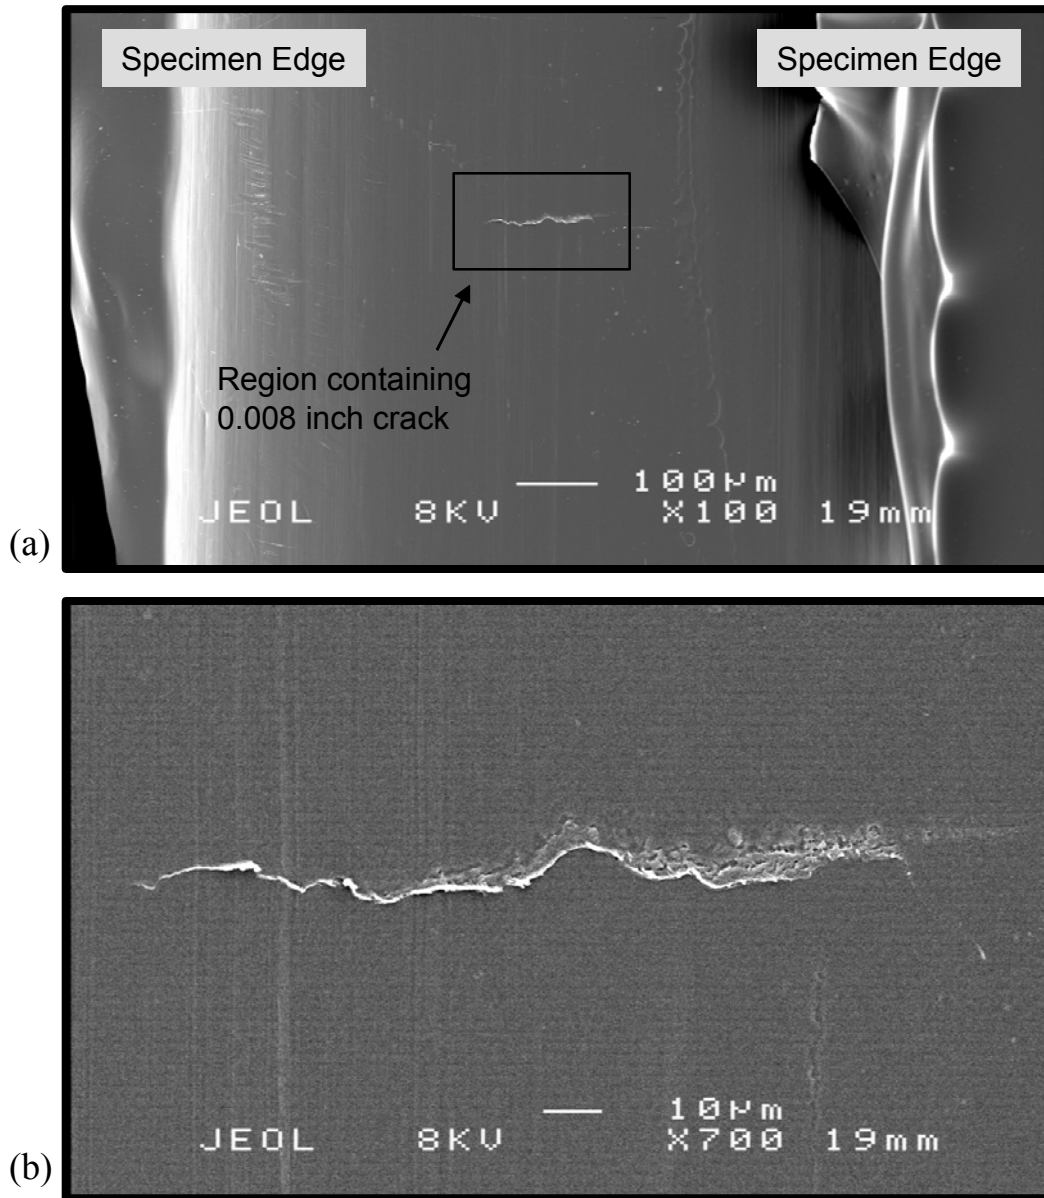
After 165,000 cycles at a notch stress of 160 ksi, a 0.008-inch-long surface crack was found in specimen C3. This crack is shown at low magnification in Figure 11a and at higher magnification in Figure 11b. SEM images of this crack obtained from acetate tape (max load), Repliset (unloaded), and the specimen (unloaded) are shown in Figures 12a, 12b, and 12c, respectively. In all three images the cracks appear to be remarkably similar. The crack length determination from acetate tape is 0.0072 inch (183 μm), and the determination from Repliset is 0.0078 inch (199 μm). Again, the Repliset crack length determination is slightly longer than the acetate tape value, despite the disadvantage of being taken in the unloaded state. Curiously, the Repliset crack length measurement is slightly longer than the value from the destructive exam, which is 0.0076 inch (194 μm).

Figure 11. SEM images of specimen C3 acetate tape replica. (a) Low magnification. (b) High magnification of the region containing a 0.008-inch-long surface crack.

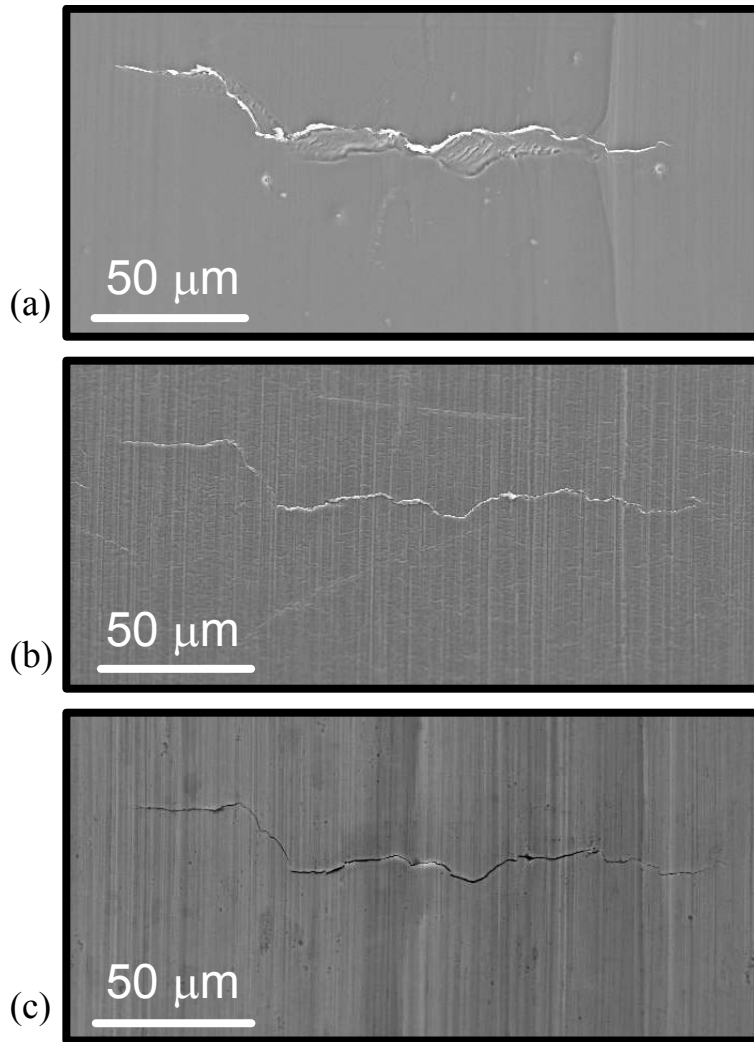
Figure 12. SEM images of the 0.008-inch-long surface crack on specimen C3. (a) Acetate tape replica (maximum load). (b) Repliset replica (unloaded). (c) Specimen (unloaded).

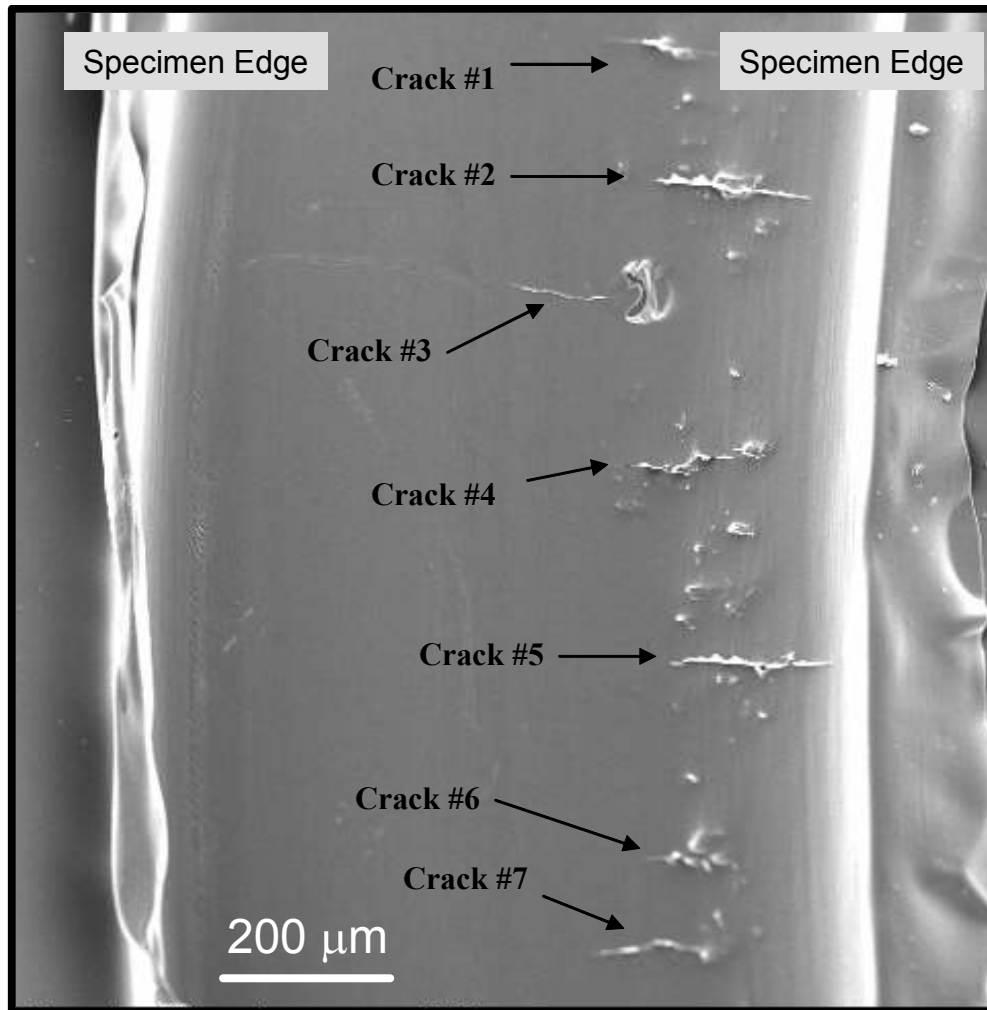
Specimen C6 was fatigue loaded at a notch stress of 160 ksi (R = 0.1). At 50,000 cycles at least seven fatigue cracks were found as indicated in Figure 13. Presumably these cracks initiated at pit-like damage sites that were not completely removed during the polishing process. The effect of surface finish on fatigue life will be discussed later in this paper. Each crack is shown at higher magnification using acetate tape replicas, Repliset replicas, and the through direct examination of the specimen (See Figures 14-20).

Figure 13. SEM image of specimen C6 acetate tape replica.

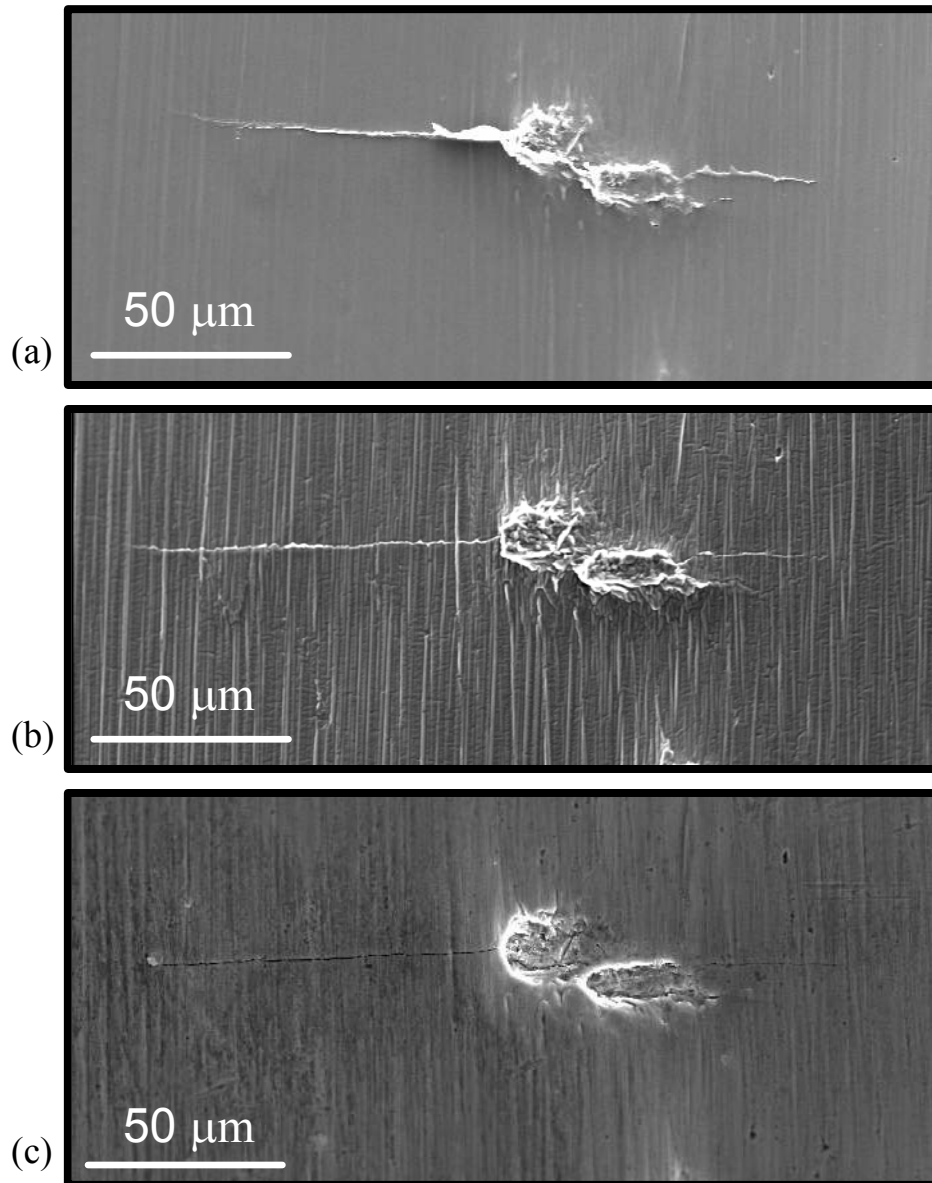
Images of crack #1, a 0.006-inch-long surface crack are shown in Figure 14. In all three images, the pit-like damage is readily seen with the fatigue crack growing out on both sides. The crack length determinations from acetate tape, Repliset, and a specimen examination are 0.0064 inch (163 μm), 0.0067 inch (170 μm), and 0.0067 inch (171 μm), respectively.

Figure 14. SEM images of crack #1 on specimen C6, a 0.006-inch-long surface crack. (a) Acetate tape replica (maximum load). (b) Repliset replica (unloaded). (c) Specimen (unloaded).

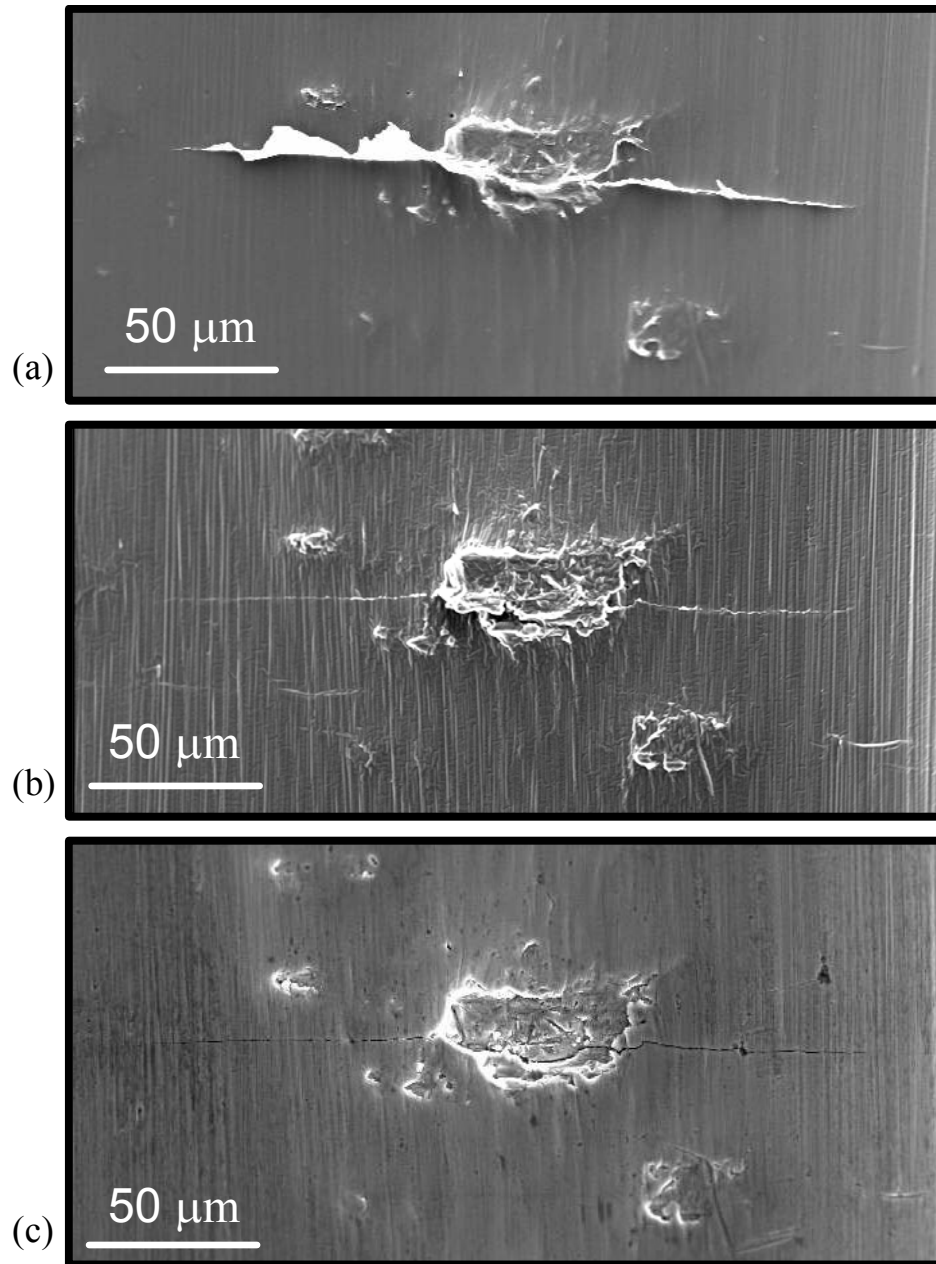
Images of crack #2, a 0.008-inch-long surface crack are shown in Figure 15. In all three images, the pit-like damage is readily seen in the center of each image, with the fatigue crack growing out on both sides. The crack length determinations from acetate tape, Repliset, and a specimen examination are 0.0081 inch (206 μm), 0.0086 inch (218 μm), and 0.0086 inch (218 μm), respectively.

Figure 15. SEM images of crack #2 on specimen C6, a 0.008-inch-long surface crack. (a) Acetate tape replica (maximum load). (b) Repliset replica (unloaded). (c) Specimen (unloaded).

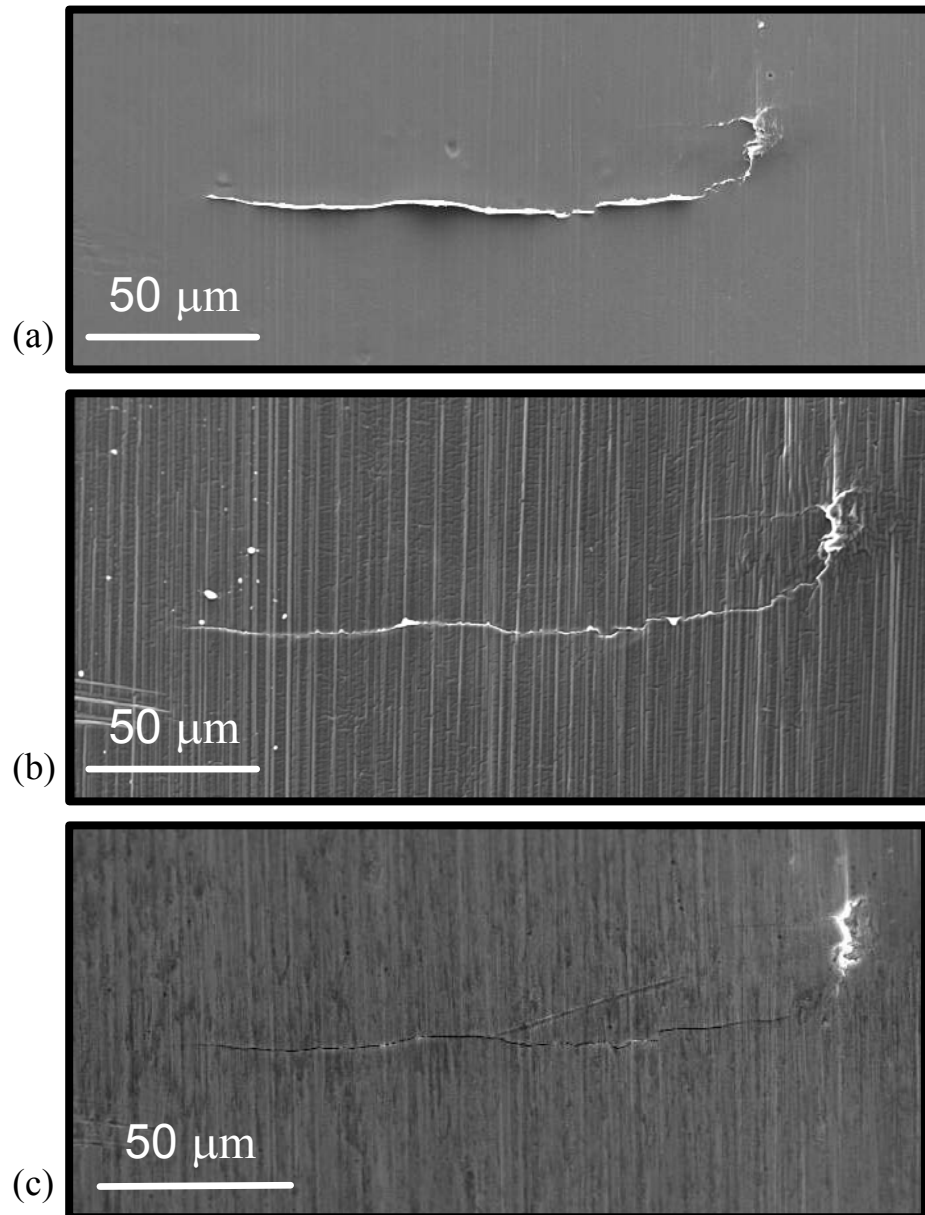
Images of crack #3, a 0.006-inch-long surface crack are shown in Figure 16. In all three images, a small amount of pit-like damage is seen on the far right of the image with the fatigue crack propagating towards the left. The crack length determinations from acetate tape, Repliset, and a specimen examination are 0.0064 inch (162 μm), 0.0067 inch (170 μm), and 0.0067 inch (171 μm), respectively.

Figure 16. SEM images of crack #3 on specimen C6, a 0.007-inch-long surface crack. (a) Acetate tape replica (maximum load). (b) Repliset replica (unloaded). (c) Specimen (unloaded).

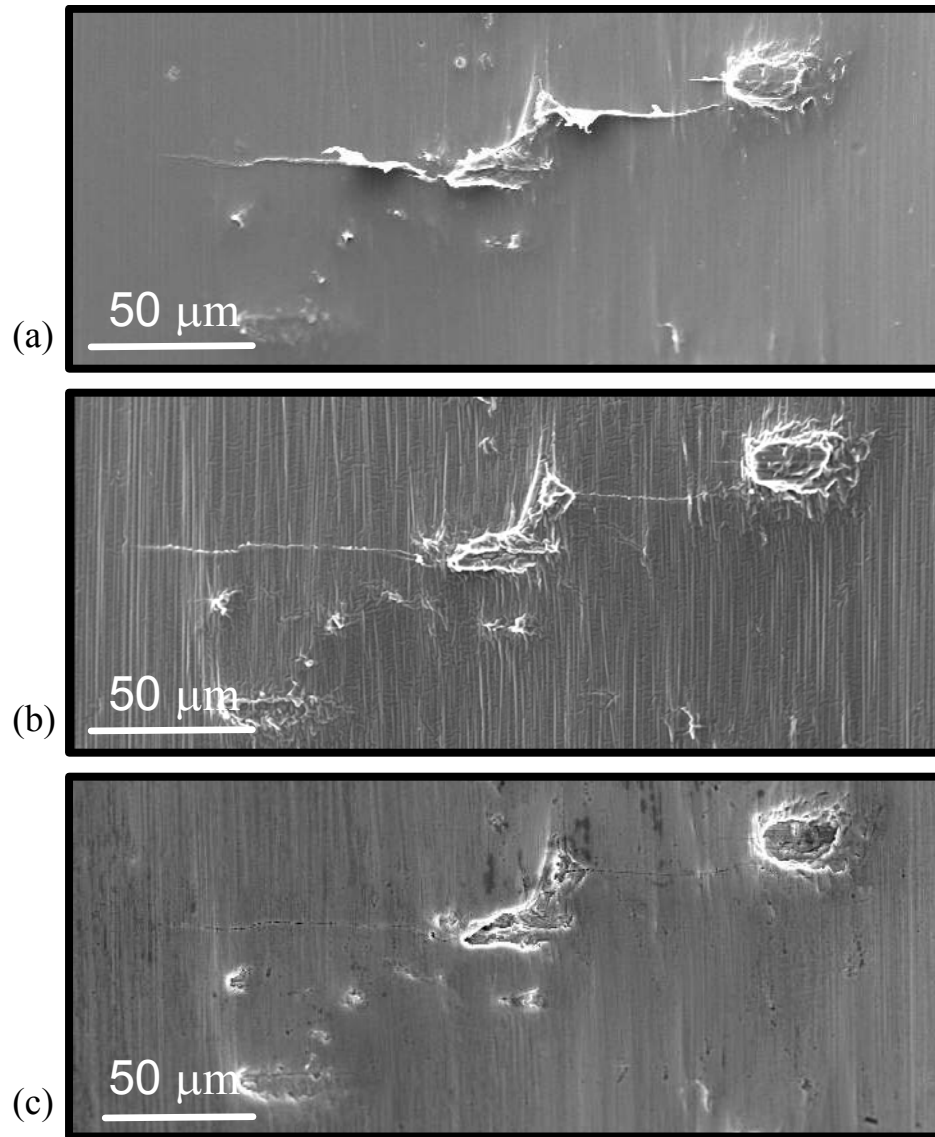
Images of crack #4, a 0.008-inch-long surface crack are shown in Figure 17. In all three images, two regions of pit-like damage are seen, one near the center of the images and another on the far right side of the images. It is not known if crack #4 is the result of a single crack that initiated at one damage site and propagated to the other, or if it is the results of two smaller cracks that grew together to form a larger crack. The crack length determinations from acetate tape, Repliset, and a specimen examination are 0.0076 inch (193 μm), 0.0079 inch (201 μm), and 0.0079 inch (201 μm), respectively.

Figure 17. SEM images of crack #4 on specimen C6, a 0.008-inch-long surface crack. (a) Acetate tape replica (maximum load). (b) Repliset replica (unloaded). (c) Specimen (unloaded).

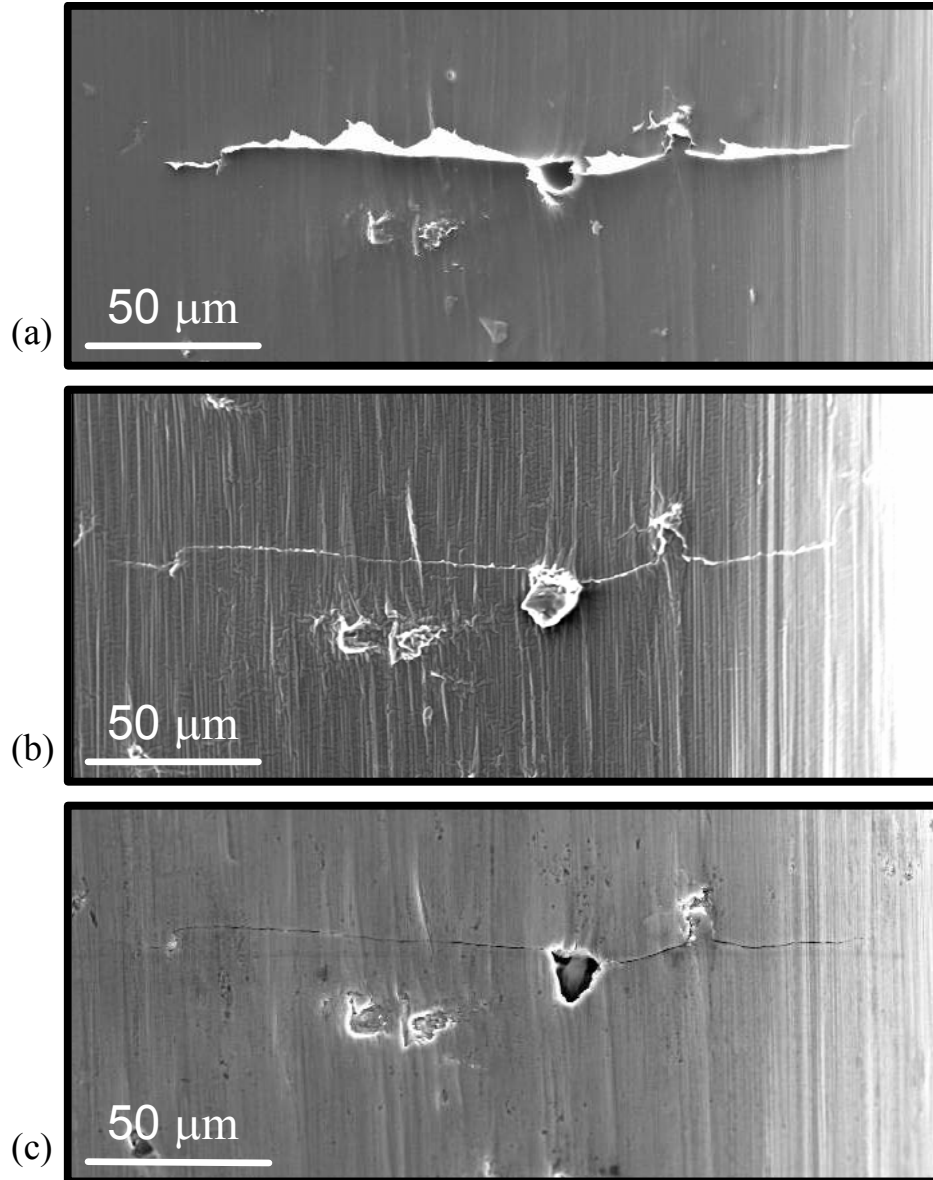
Images of crack #5, a 0.008-inch-long surface crack are shown in Figure 18. In all three images, a small pit-like damage site is readily seen near the center of each image, with the fatigue crack growing out on both sides. The crack length determinations from acetate tape, Repliset, and the specimen are 0.0081 inch (206 μm), 0.0083 inch (211 μm), and 0.0083 inch (211 μm), respectively.

Figure 18. SEM images of crack #5 on specimen C6, a 0.008-inch-long surface crack. (a) Acetate tape replica (maximum load). (b) Repliset replica (unloaded). (c) Specimen (unloaded).

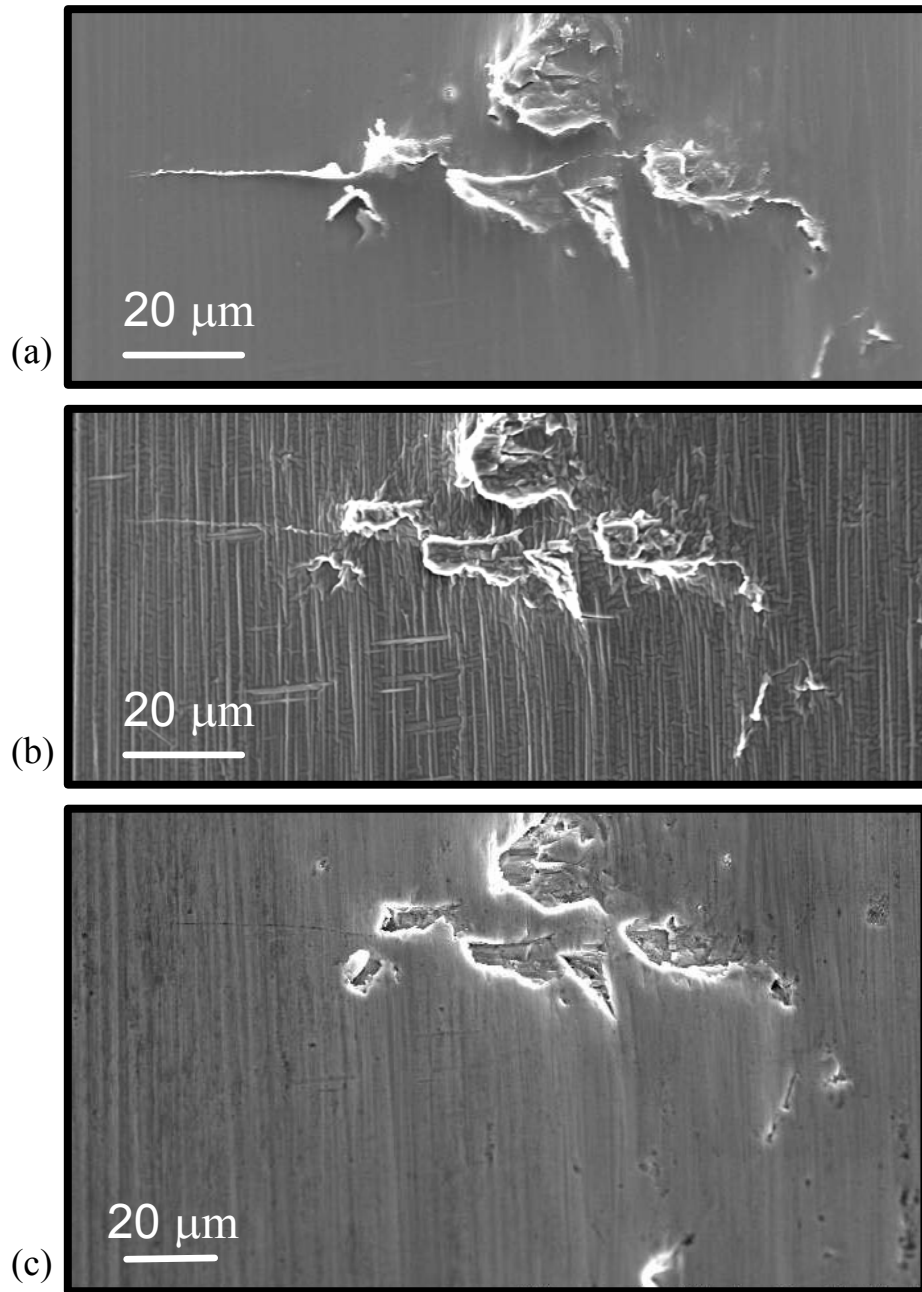
Images of crack #6, a 0.002-inch-long surface crack are shown in Figure 19. In all three images, a cluster of pit-like damage sites are readily seen in the center of each image. The fatigue crack can be seen primarily growing on the left side of the damage zone. The crack length determinations from acetate tape, Repliset, and a specimen examination are 0.0017 inch (43 μm), 0.0018 inch (45 μm), and 0.0018 inch (45 μm), respectively.

Figure 19. SEM images of crack #6 on specimen C6, a 0.002-inch-long surface crack. (a) Acetate tape replica (maximum load). (b) Repliset replica (unloaded). (c) Specimen (unloaded).
