NASA/TM-2006-213921
ARL-TR-3638

Flow Liner Slot Edge Replication Feasibility Study

John A. Newman
U.S. Army Research Laboratory
Vehicle Technology Directorate
Langley Research Center, Hampton, Virginia

February 2006

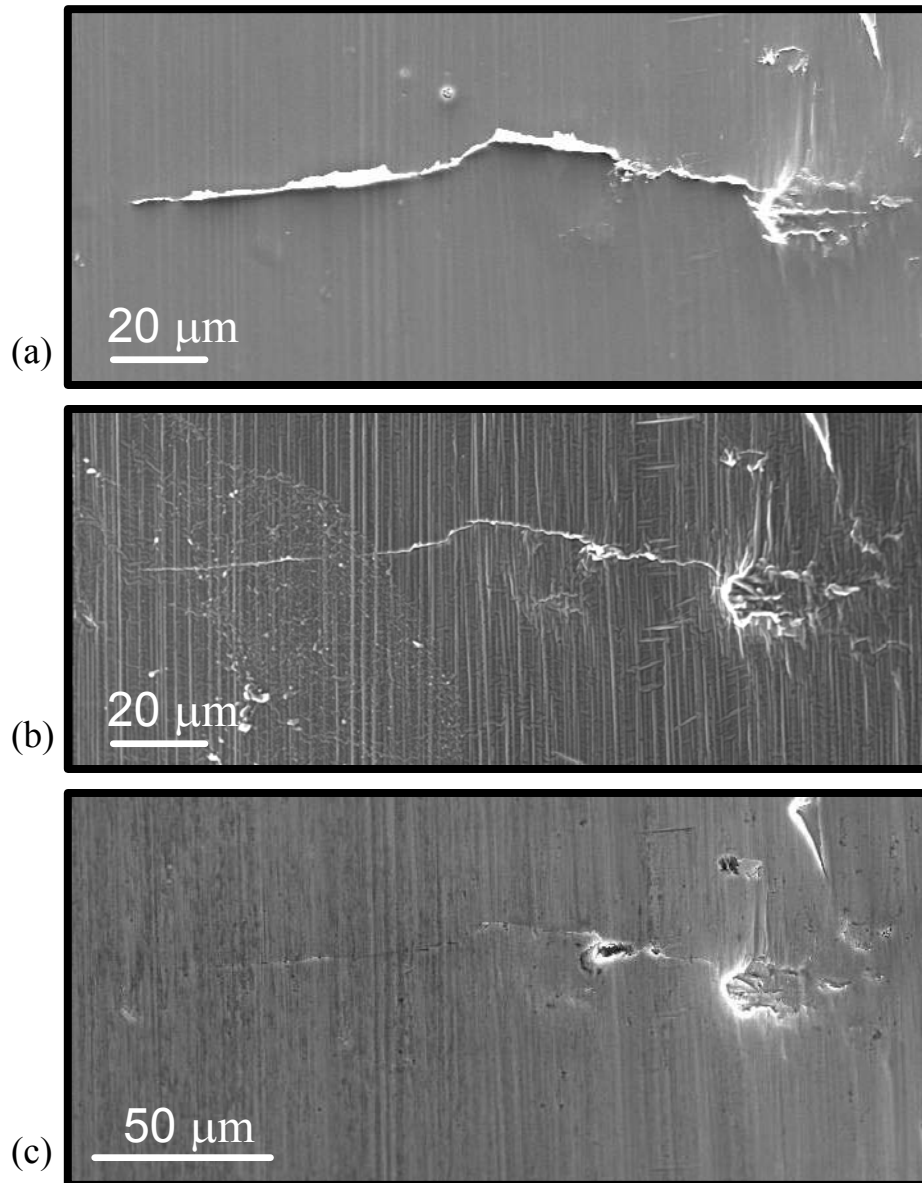
Images of crack #7, a 0.006-inch-long surface crack are shown in Figure 20. In all three images, pit-like damage is readily seen on the far right side of each image, with the fatigue crack propagating toward the left. The crack length determinations from acetate tape, Repliset, and a specimen examination are 0.0059 inch (149 μm), 0.0061 inch (156 μm), and 0.0061 inch (156 μm), respectively. For all seven cracks in specimen C6, the crack length determinations obtained from the acetate tape replicas were less than the Repliset values, and the Repliset values were nearly the same as the crack lengths determined by destructive examination.

Figure 20. SEM images of crack #7 on specimen C6, a 0.006-inch-long surface crack. (a) Acetate tape replica (maximum load). (b) Repliset replica (unloaded). (c) Specimen (unloaded).

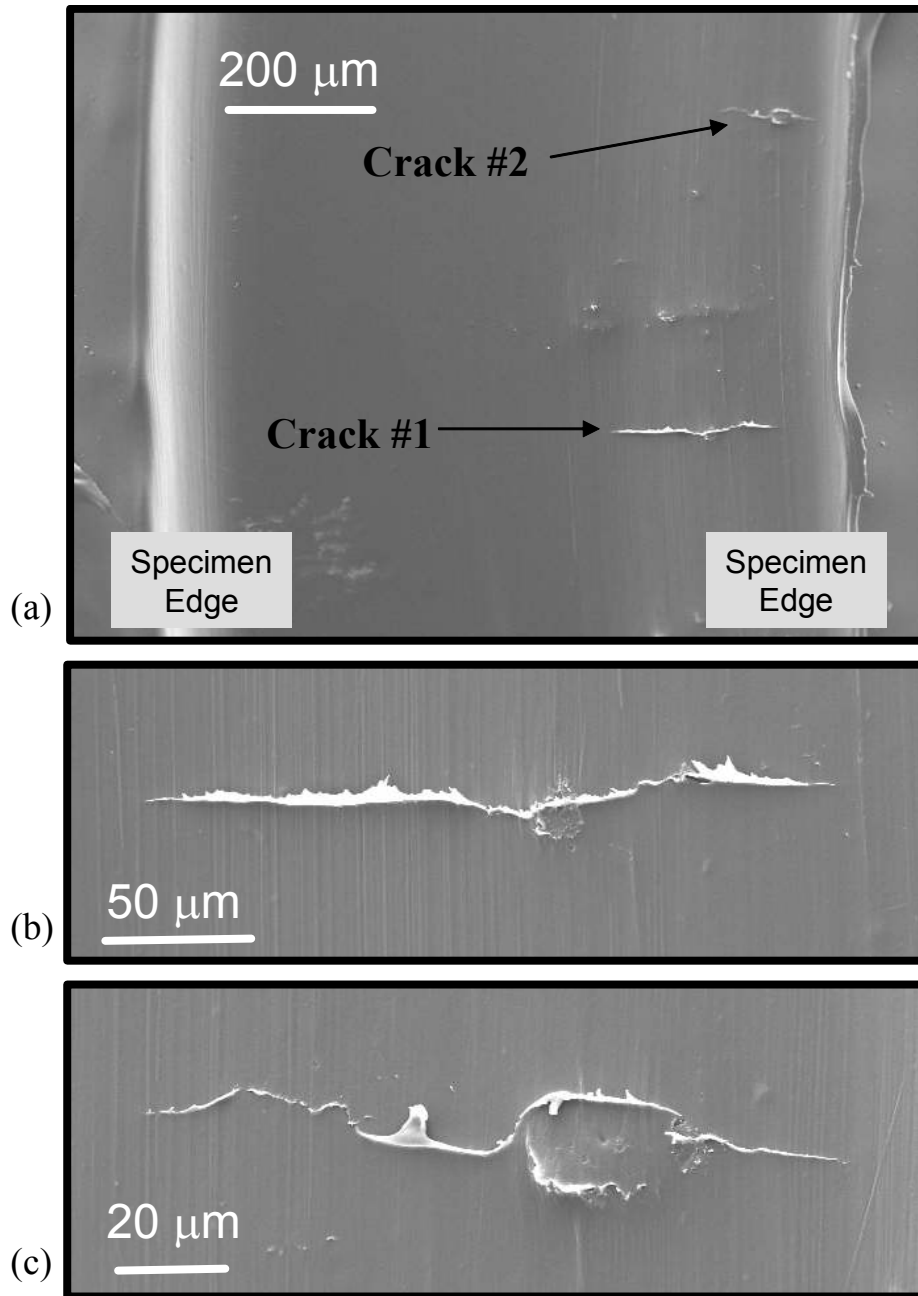
Specimen C8 was fatigue loaded at a notch stress of 160 ksi (R = 0.1). At 50,000 cycles two surface cracks were found as indicated in Figure 21a. Crack #1, a 0.008-inch-long surface crack, is shown at higher magnification in Figure 21b, and crack #2, a 0.005-inch-long surface crack, is shown at higher magnification in Figure 21c. Each of these cracks is shown at higher magnification using acetate tape replicas, Repliset replicas, and the actual specimen, as was done for the previous specimens. For each of the images of crack #1 (acetate replica, Repliset replica, and direct imaging of the specimen) shown in Figure 22, a small amount of pit-like damage can be seen near the center of the image with the crack propagating on either side. The crack length determinations from acetate tape, Repliset, and a specimen examination are 0.0089 inch (226 μm), 0.0098 inch (249 μm), and 0.0098 inch (250 μm), respectively. A small amount of pit-like damage has also been revealed for the three different images produced for crack #2 (See Figure 23). The crack length determinations from acetate tape, Repliset, and a specimen examination are 0.0052 inch (131 μm), 0.0051 inch (129 μm), and 0.0055 inch (140 μm), respectively. Unlike any of the other previous examples, here the acetate tape crack length is slightly larger (approximately 2% difference) than the Repliset value.

Figure 21. SEM images of specimen C8. (a) Low magnification. (b) High magnification of crack #1, a 0.008-inch-long surface crack. (c) High magnification of crack #2, a 0.005-inch-long surface crack.

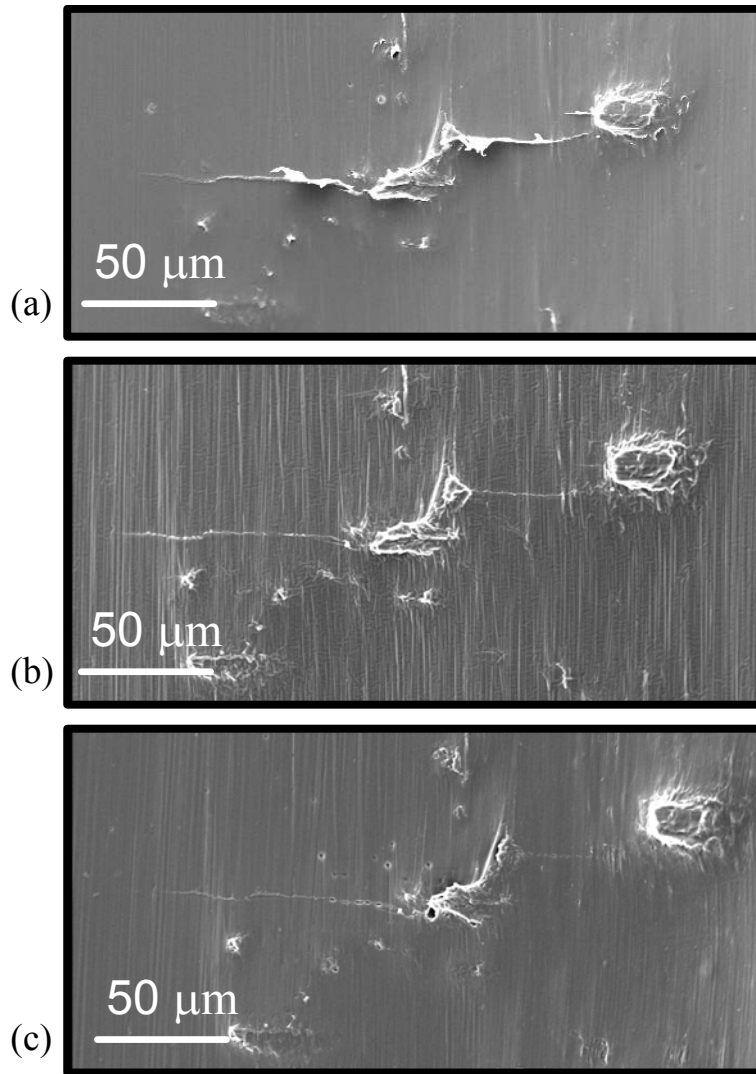
Figure 25. SEM images of crack #4 on specimen C6. (a) Acetate tape replica. (b) First Repliset replica. (c) Fifth Repliset replica.

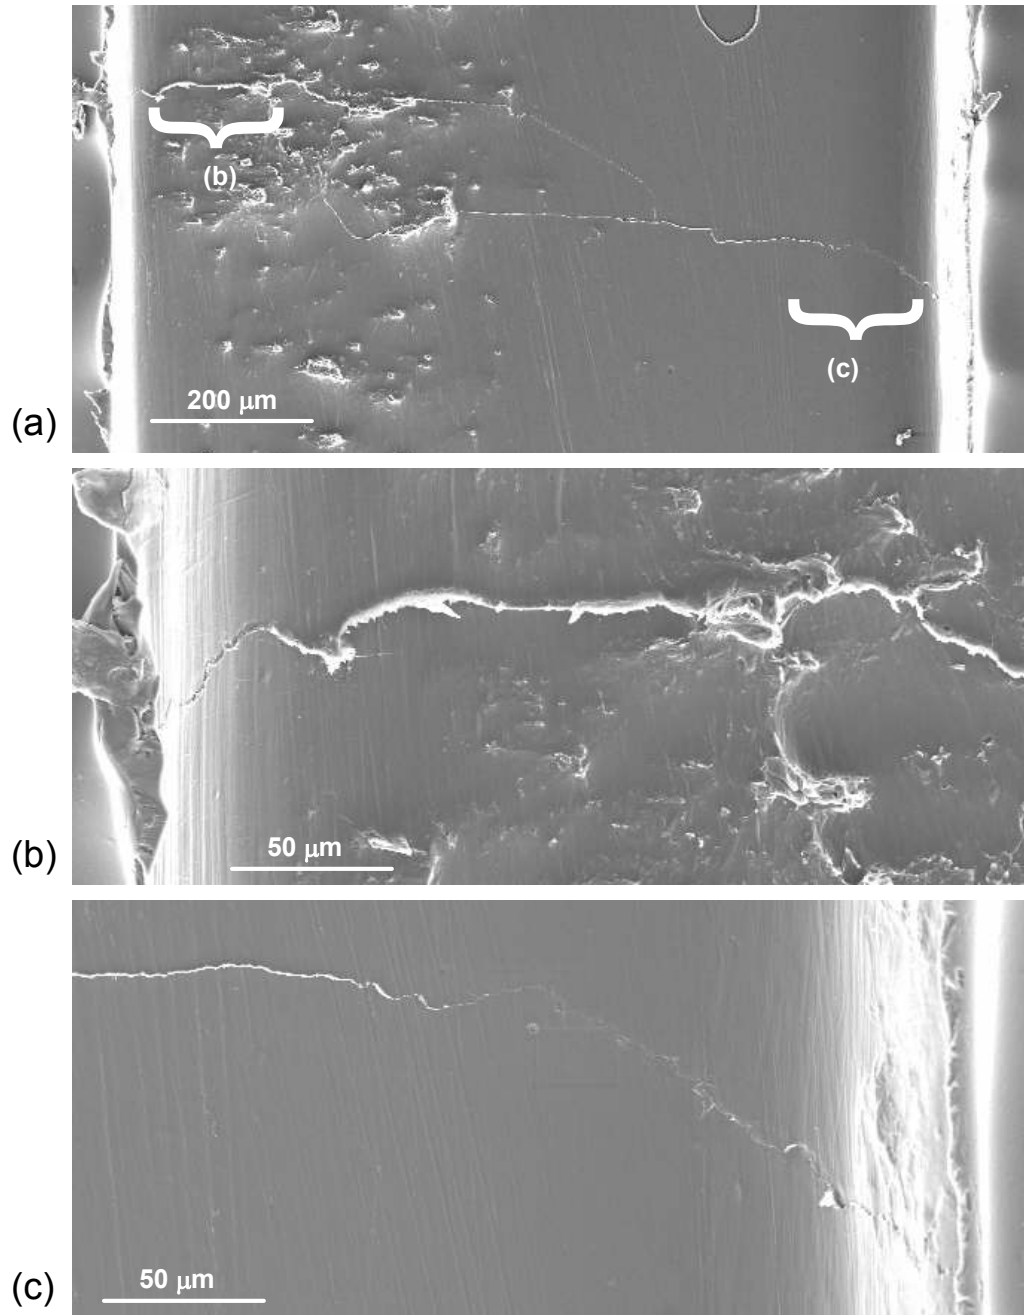
Specimen C1 was fatigue loaded at a notch stress of 160 ksi (R = 0.1) for 75,000 cycles. By this time a fatigue crack had initiated and propagated to a through-thickness crack that was approximately 0.145 inches deep (about 3 times the sheet thickness). The through-thickness crack can be seen in the SEM image of an acetate tape replica shown in Figure 26a. This crack appears to have a jog or discontinuous change between the regions labeled (b) and (c), which is consistent with the initiation of multiple cracks or damage sites and the subsequent coalescing of cracks as they grow together. Higher magnification images of regions (b) and (c) are shown in Figures 26b and 26c, respectively. This crack is clearly a through-thickness crack because it is seen propagating around both corners.

Figure 26. SEM images of specimen C1 before polishing (unloaded). (a) Low magnification. (b) High magnification image of region (b). (c) High magnification image of region (c).

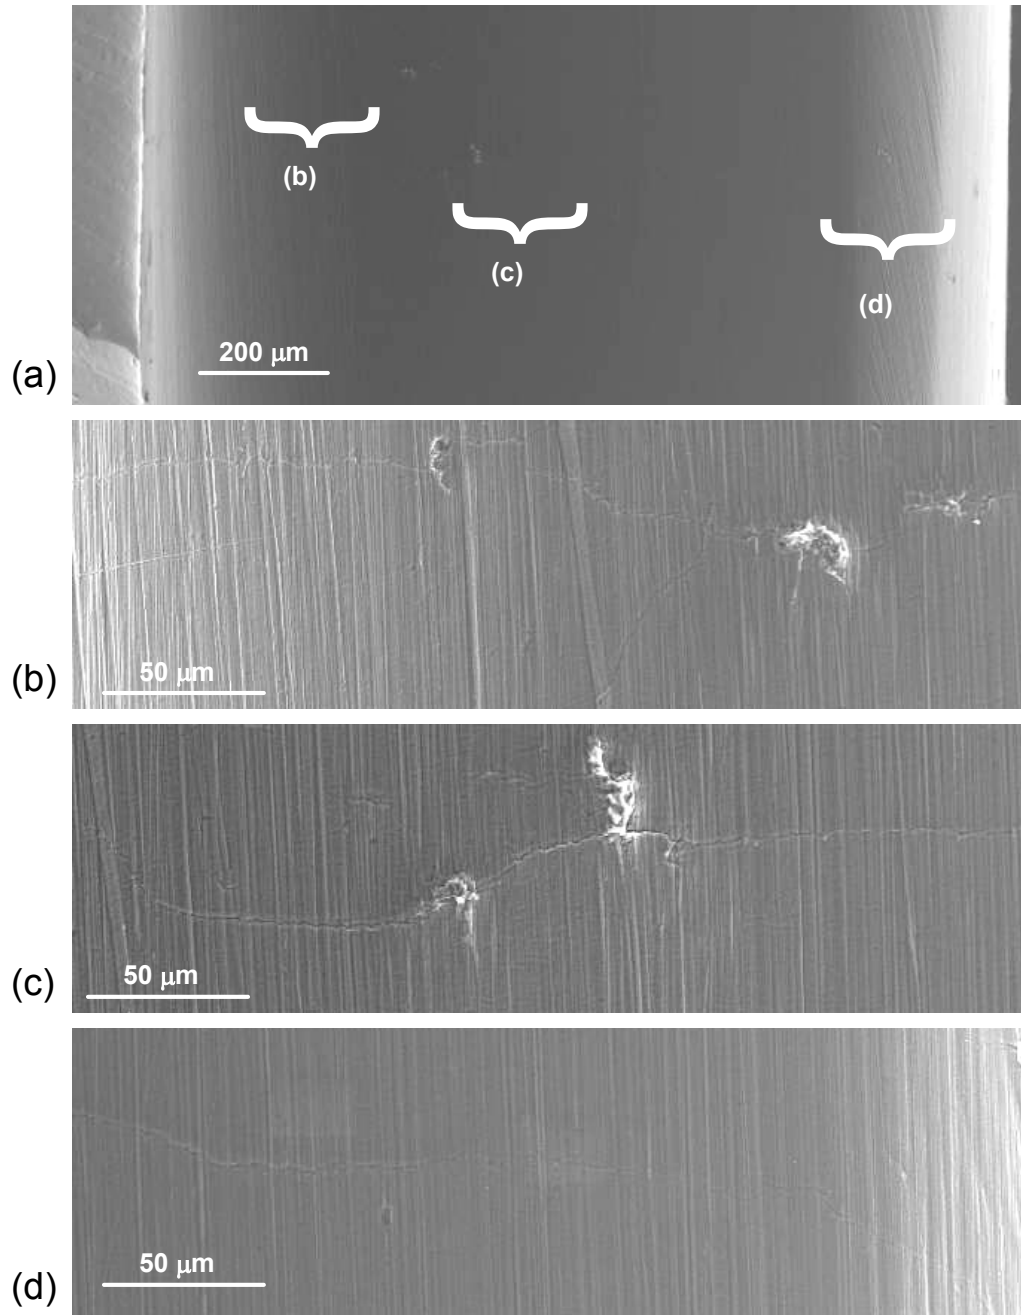
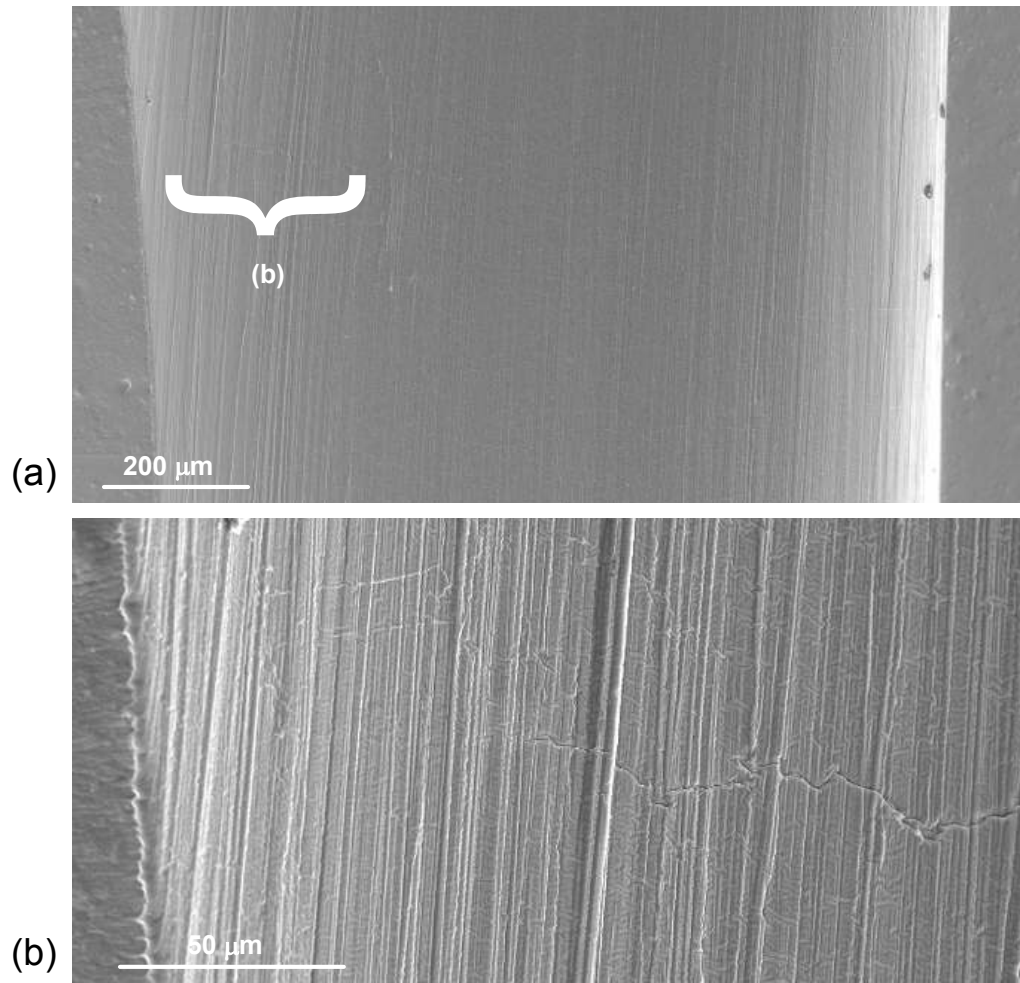
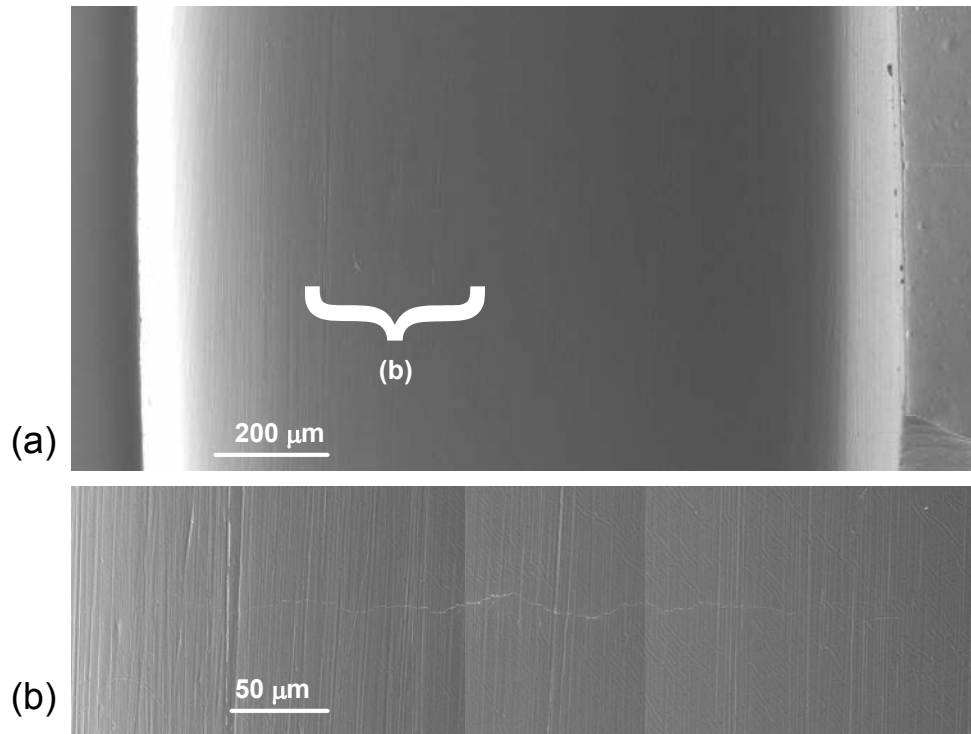
The slot was then polished, removing approximately 0.002 inches (0.05 mm) of material. Replicas were taken of the previously cracked area, and the crack was still detected on a Repliset replica, as shown in Figure 27a. It should be noted that the crack is much less pronounced following the polishing procedure. Higher magnification images of the regions labeled (b), (c), and (d) are shown in Figures 27b, 27c, and 27d, respectively. The crack is found to be continuous across the entire surface when examining the higher magnification images (See Figures 27b through d). Therefore, this crack can be detected and is recognized as a through-thickness crack using Repliset replicas after polishing.

Figure 27. SEM images of specimen C1 after polishing (unloaded). (a) Low magnification. (b) High magnification image of region (b). (c) High magnification image of region (c). (d) High magnification of region (d).

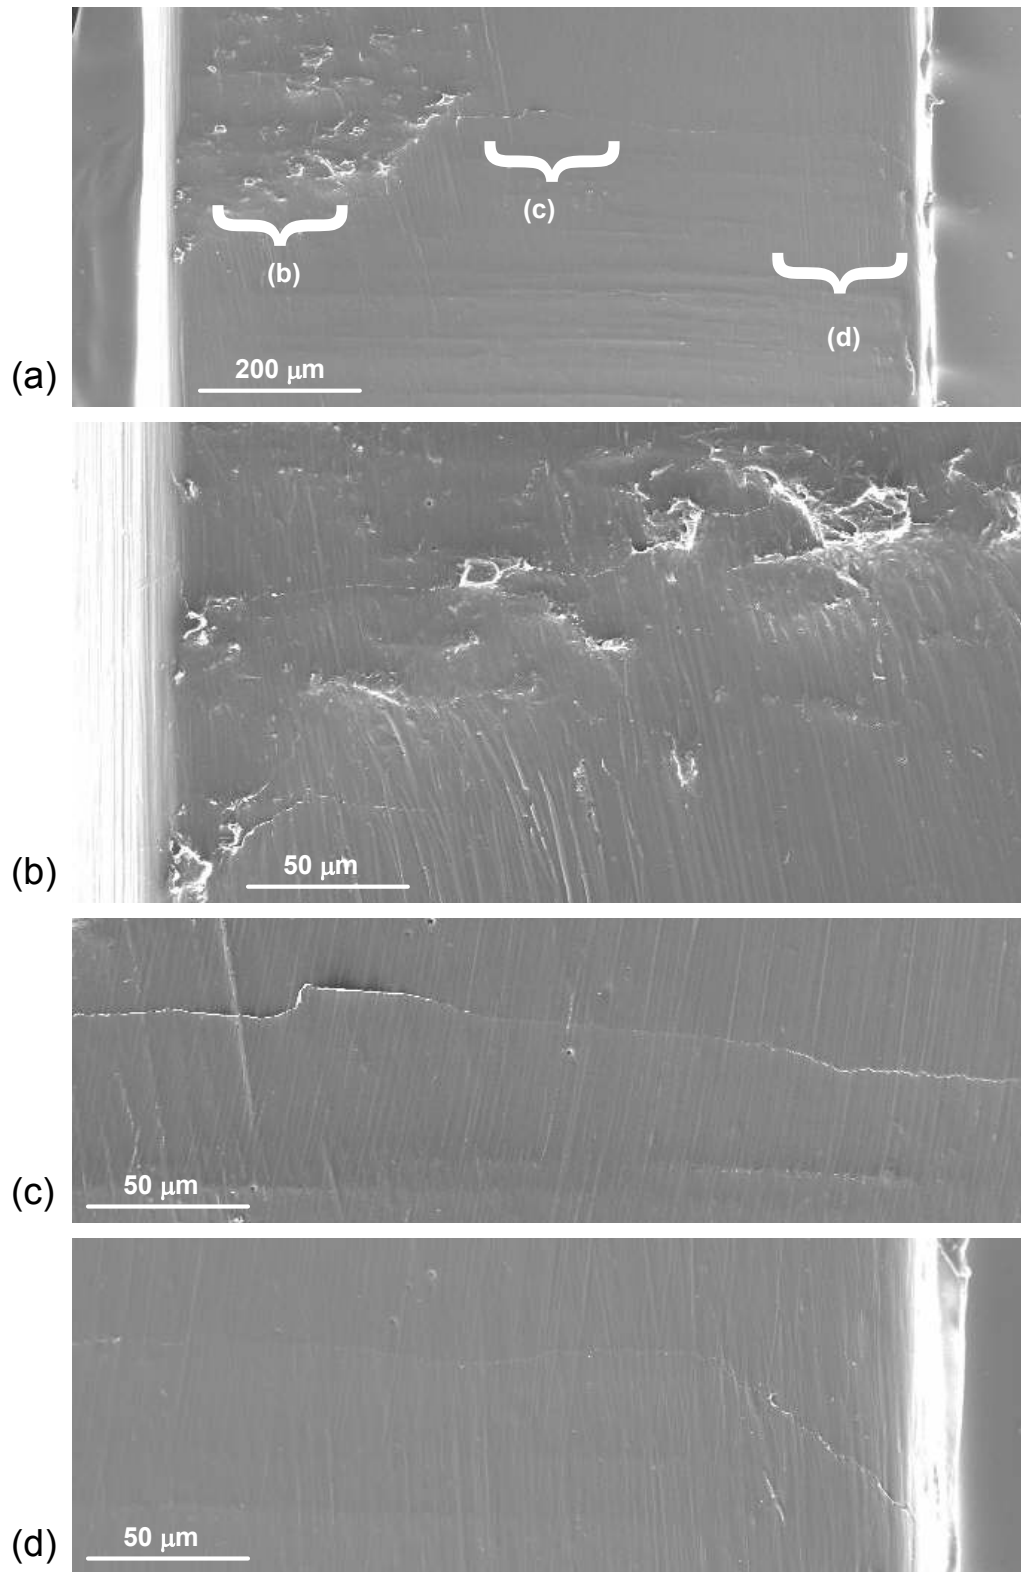
Specimen C2 was fatigue loaded at a notch stress of 160 ksi (R = 0.1) for 50,000 cycles. A fatigue crack initiated and propagated to a through-thickness crack that was 0.015 inches deep on one side and 0.023 inches deep on the other (less than 50% of the sheet thickness). The through-thickness crack can be seen in the SEM image of an acetate tape replica shown in Figure 28a. Higher magnification images of the regions labeled (b), (c), and (d) are shown in Figures 28b-d, respectively. In these images a continuous crack can be seen rounding both corners and is therefore identified as a through-thickness crack.

Figure 28. SEM images of specimen C2 before polishing (unloaded). (a) Low magnification. (b) High magnification of region (b). (c) High magnification of region (c). (d) High magnification of region (d).

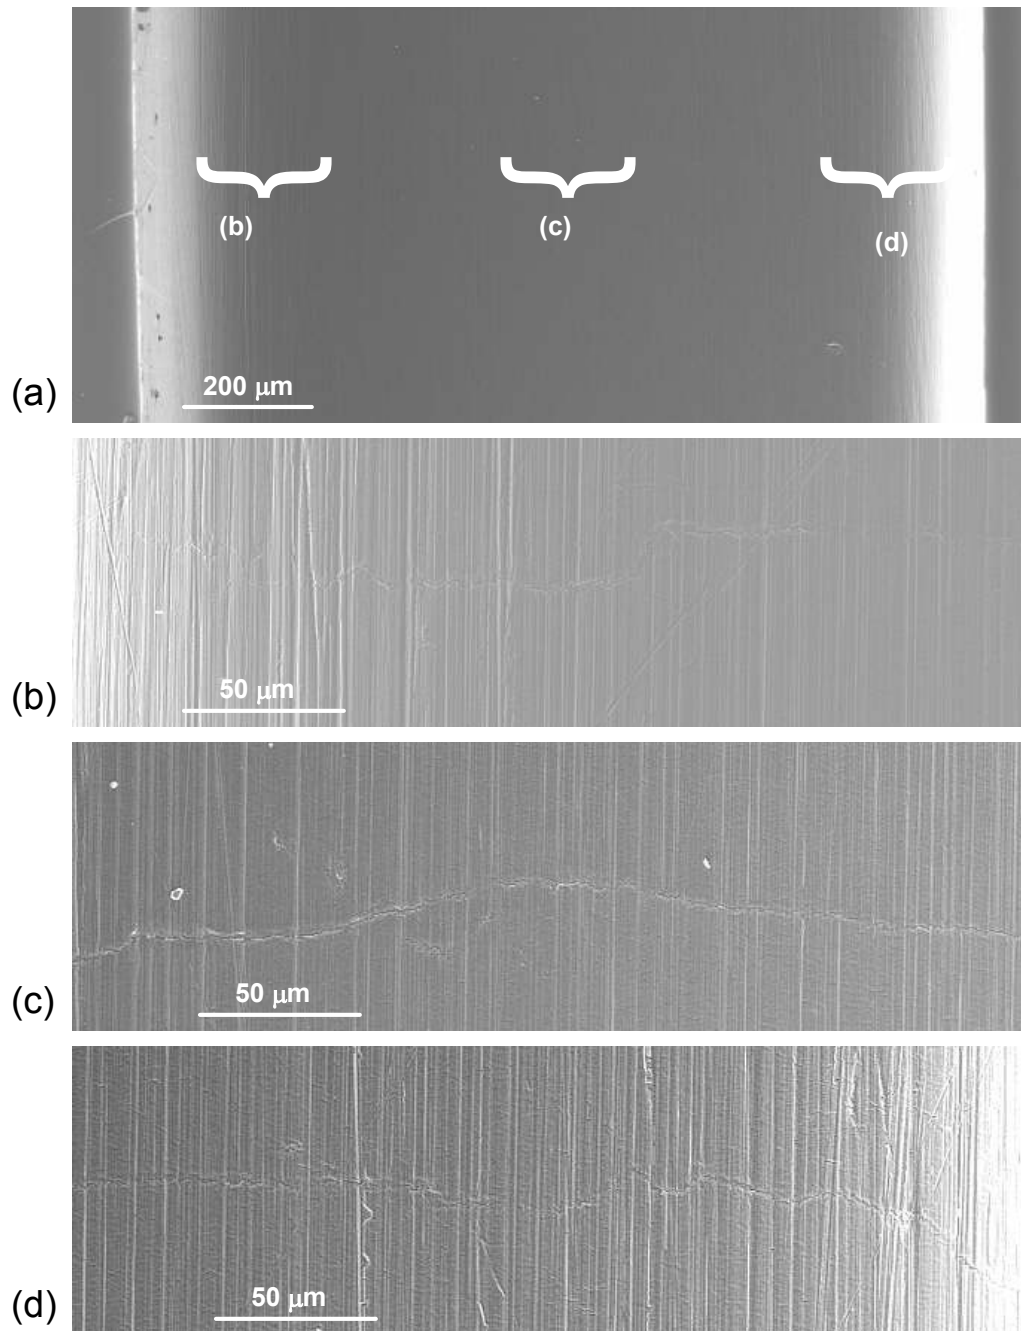
Following the identification of the through-thickness crack, the slot was polished, removing approximately 0.002 inches (0.05 mm) of material. The crack can still be detected on a Repliset replica, as shown in Figure 29a, although the crack is much less pronounced after polishing. Higher

magnification images of the regions labeled (b), (c), and (d) are shown in Figures 29b-d, respectively. Here, the crack can be observed to be continuous across the entire slot surface. Therefore, after polishing this crack can be detected and is recognized as a through-thickness crack using Repliset replicas.

Figure 29. SEM images of specimen C2 after polishing (unloaded). (a) Low magnification. (b) High magnification of region (b). (c) High magnification of region (c). (d) High magnification of region (d).

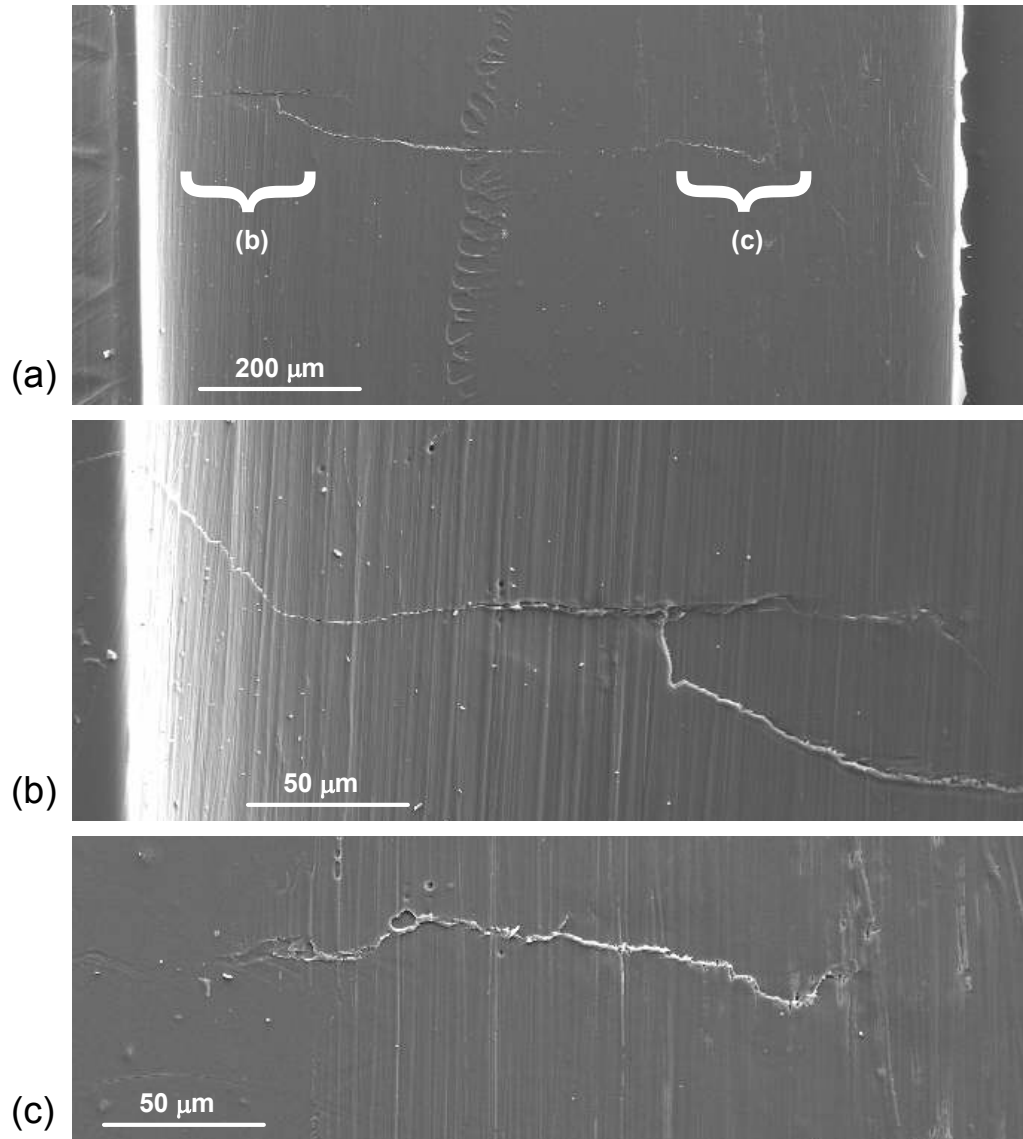
Specimen C9 was fatigue loaded at a notch stress of 160 ksi (R = 0.1) for 64,000 cycles. A fatigue crack initiated and propagated to become a corner crack measuring 0.039 inches (833 μm) in length on the slot surface and 0.015 inches (380 μm) in length on the side of the specimen. An SEM micrograph (acetate tape replica) of the slot surface is shown as Figure 30a. The crack is seen to have propagated from one corner (region (b)) through nearly 80% of the sheet thickness (to region (c)). Higher magnification images of regions (b) and (c) are shown in Figure 30b and 30c, respectively. Figure 30b reveals that the crack has propagated around the edge on the left. The crack tip is shown in Figure 30c, indicating that the crack has yet to grow to the corner on the right side. Therefore this crack is identified as a corner crack (i.e., propagated around one corner) rather than a through-thickness crack (i.e., propagated around both corners).

Figure 30. SEM images of specimen C9 before polishing (unloaded). (a) Low magnification. (b) High magnification image of region (b). (c) High magnification image of region (c).

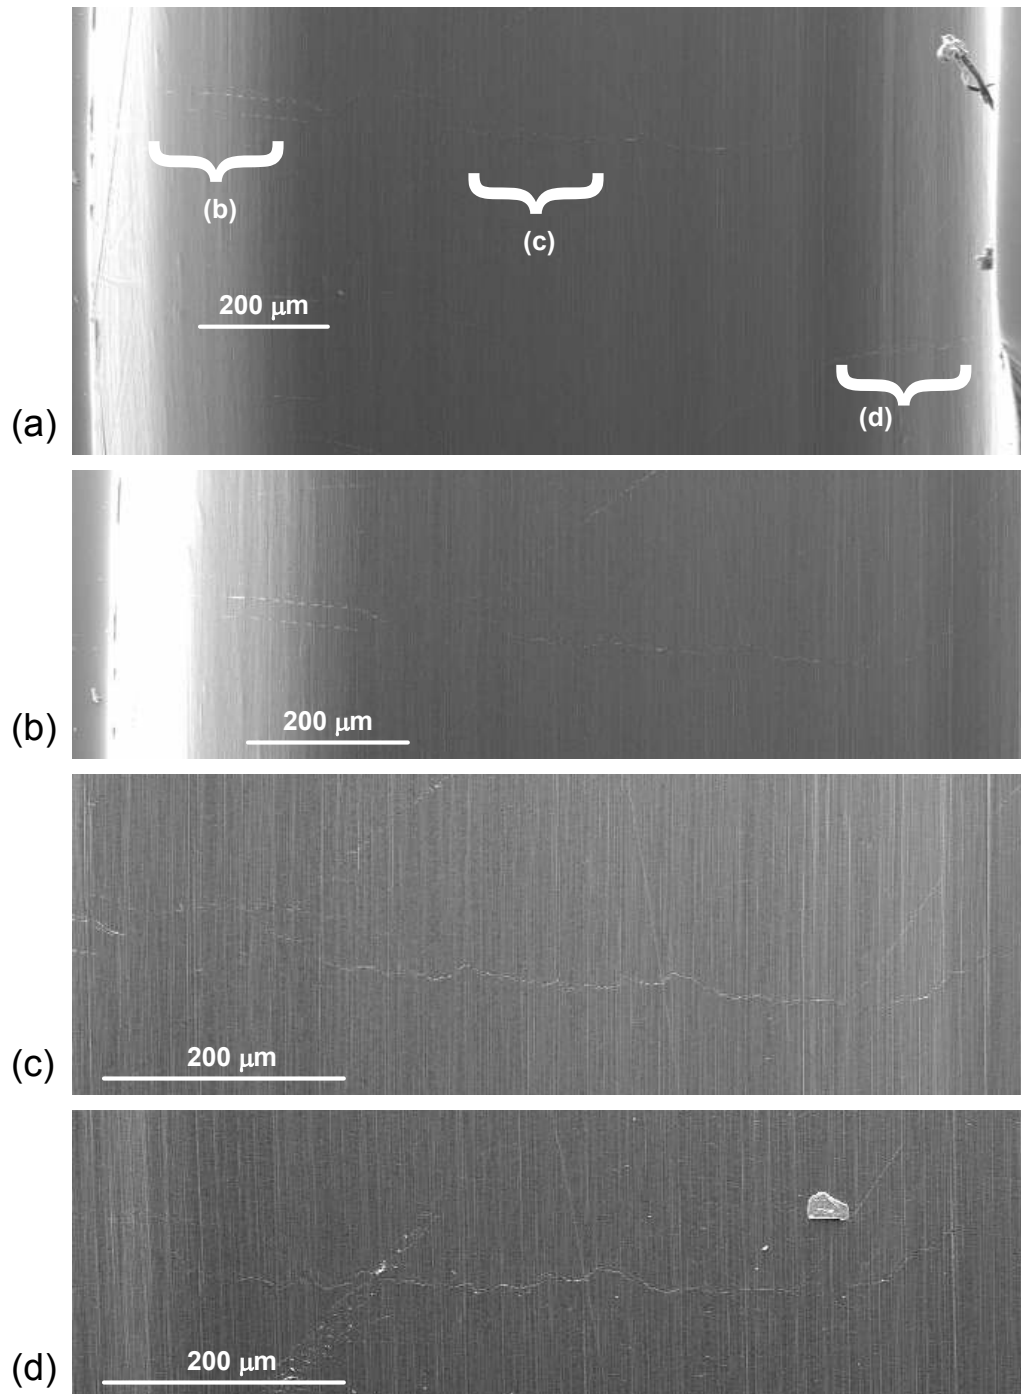
The slot surface was polished, removing approximately 0.002 inches (0.05 mm) of material. The crack can still be detected on a Repliset replica, as shown in Figure 31a, although the crack is much less pronounced than before. Higher magnification images of the regions labeled (b), (c), and (d) are shown in Figures 31b-d, respectively. The crack can be readily identified from the left-side corner to at least 50% through the sheet thickness (0.025 inches). It is difficult to identify the crack tip and quantify the crack size. However, this crack remains detectable after polishing and is identified as a corner crack. A small crack-like feature is shown in Figure 31d, although no connection is found with the previously mentioned corner crack.

Figure 31. SEM images of specimen C9 after polishing (unloaded). (a) Low magnification. (b) High magnification image of region (b). (c) High magnification image of region (c). (d) High magnification of region (d).

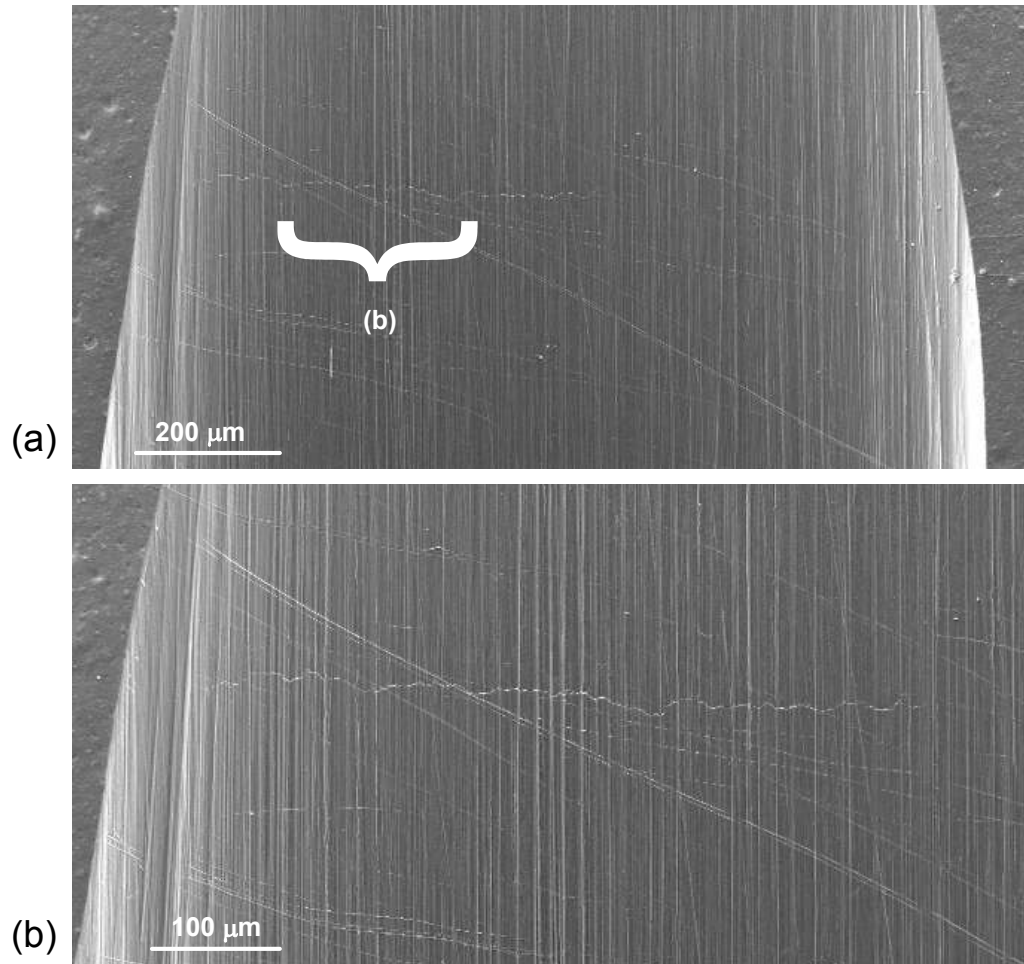
Specimen C12 was fatigue loaded at a notch stress of 160 ksi (R = 0.1) for 50,000 cycles. A 0.022-inch-long (560 μm) surface crack was found on the slot surface of this specimen. SEM micrographs of this crack are shown in Figure 32. As indicated in Figure 32a, the crack is to the left of center in the region labeled (b). A high magnification image of this crack is shown in Figure 32b. After polishing away approximately 0.002 inches (0.05 mm) of material from the slot, this crack was not detected. Assuming a semi-circular aspect ratio, the expected depth of this crack was originally 0.011 inch, and after polishing is expected to be approximately 0.009 inches deep.

Figure 32. SEM images of specimen C12 before polishing (unloaded). (a) Low magnification. (b) High magnification image of region (b).

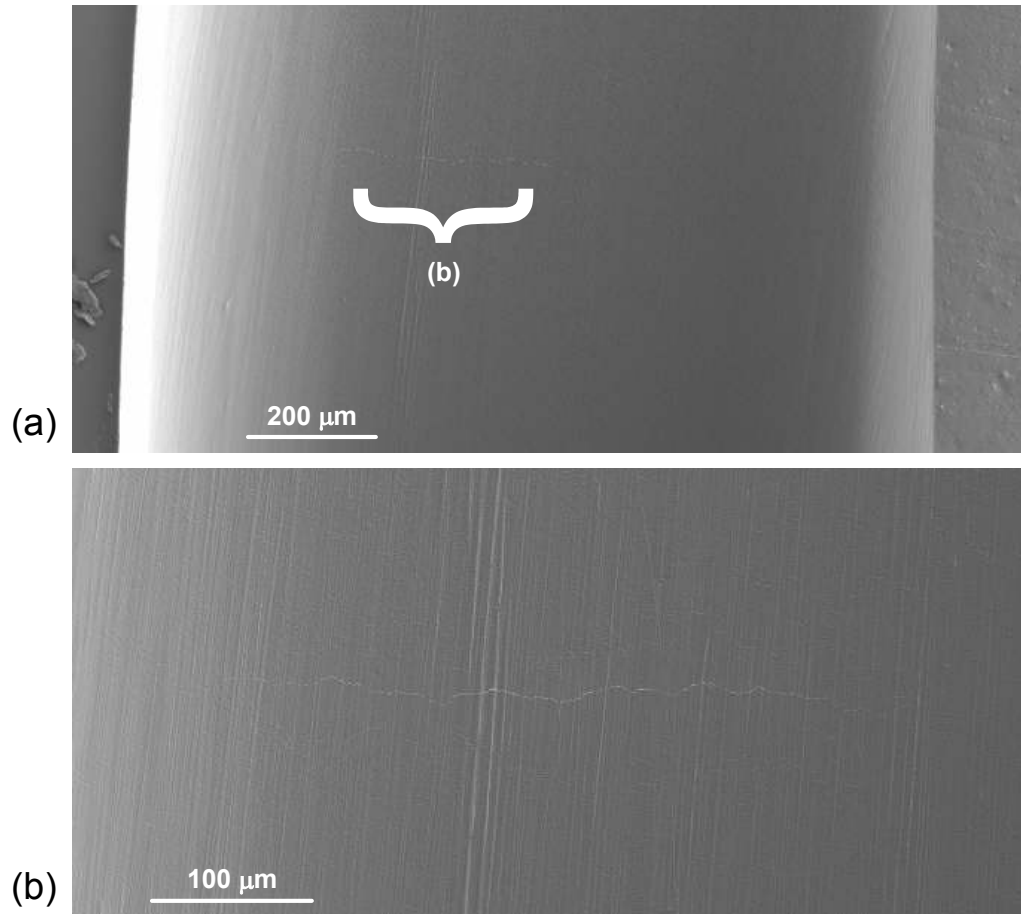
of the crack region (labeled (b)) shown as Figure 34b. SEM images of specimen C13 (Repliset replica) are shown in Figure 35a for the specimen loaded to a notch stress of 50 ksi. This crack can also be seen at higher magnification, as shown in Figure 35b.

Figure 35. SEM images of specimen C13 after polishing, loaded to a notch stress of 160 ksi. (a) Low magnification.
(b) High magnification image of region (b).

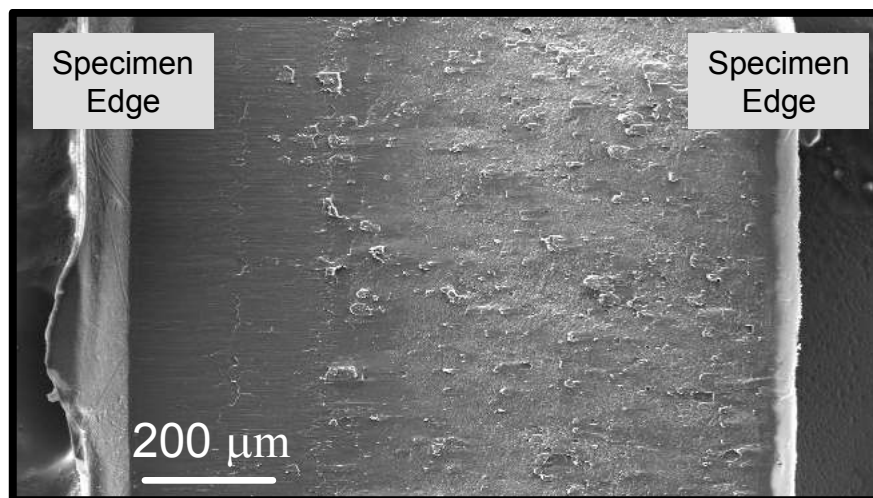
Figure 36. SEM image (acetate replica) showing the rough morphology of as-punched slot surfaces.

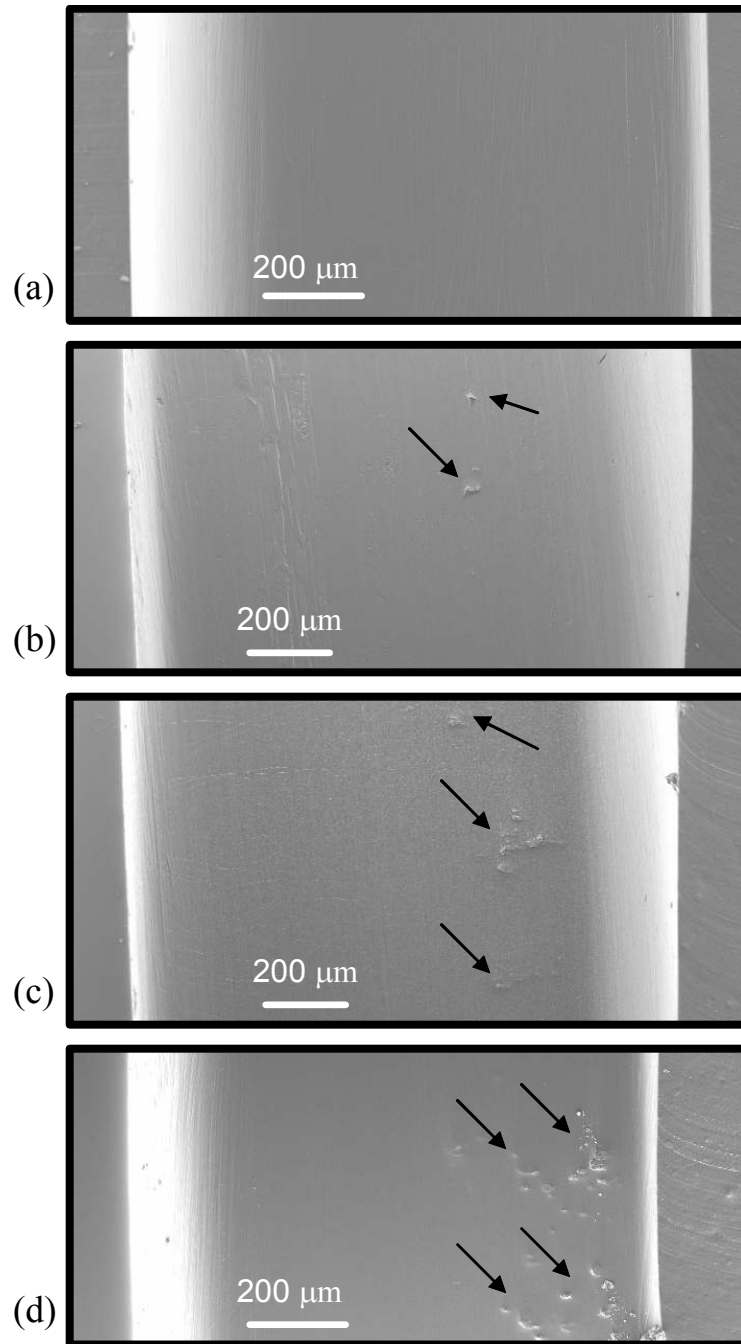
Figure 37. SEM images (acetate replicas) of four slot surfaces that were polished using the flight-hardware-approved polishing method are shown. (a) No visible damage. (b) Localized single pit damage. (c) Localized multi-pit damage. (d) Widespread pit damage.

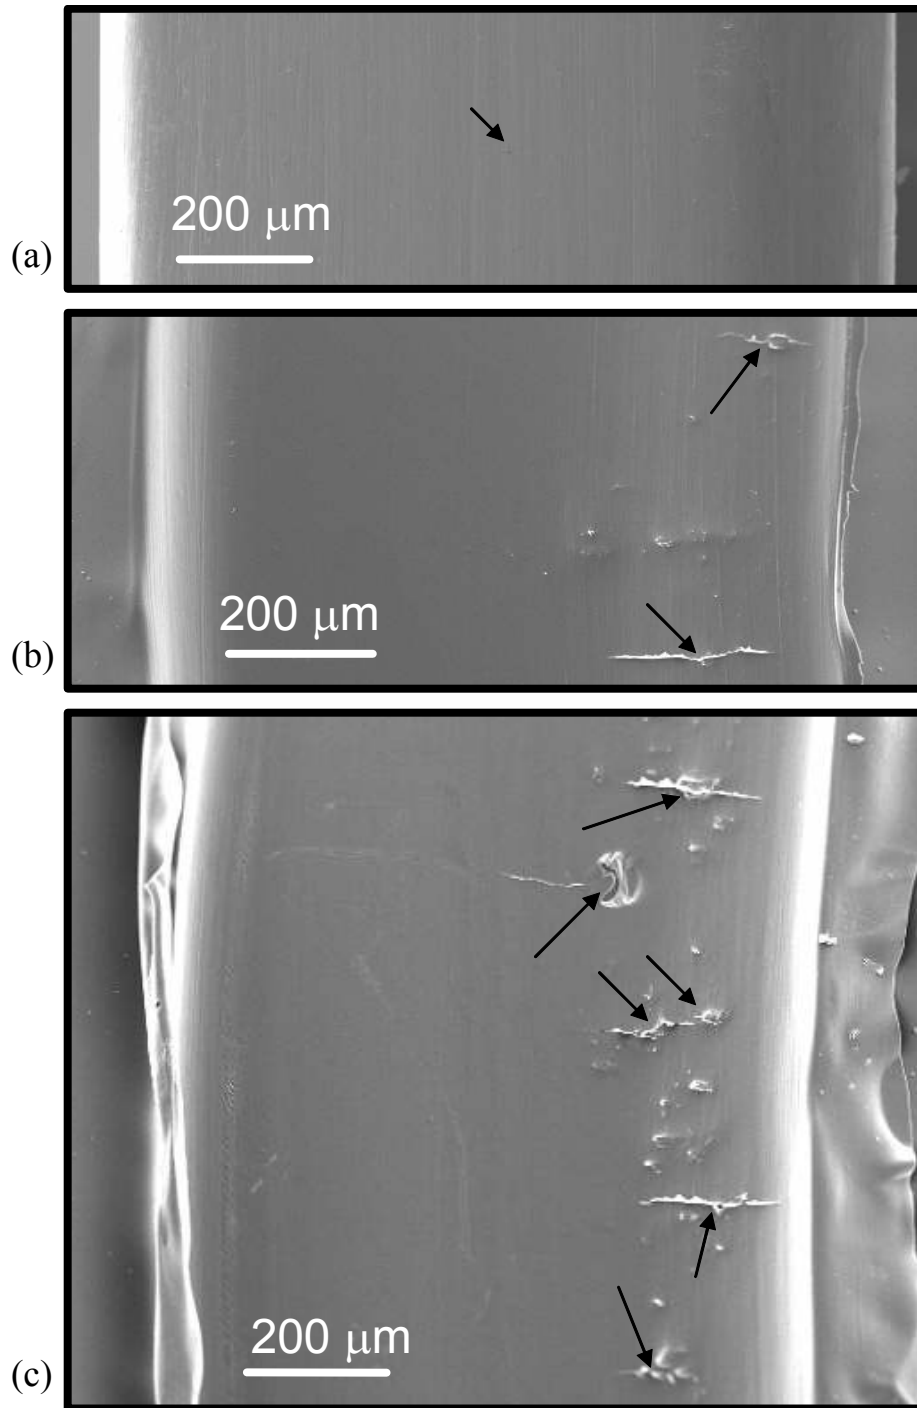
Figure 38. SEM images (acetate replicas) showing the effects of surface finish quality on fatigue-crack-initiation life. (a) For a high-quality finish (specimen P2), a single 0.005-inch-long surface crack was found after 115,000 cycles. (b) For localized single-pit damage (specimen C8), two surface cracks (0.008 and 0.005 inches long) were found at 50,000 cycles. (c) For widespread fatigue damage (specimen C6), at least seven cracks were found at 50,000 cycles; three cracks were 0.008 inches long.

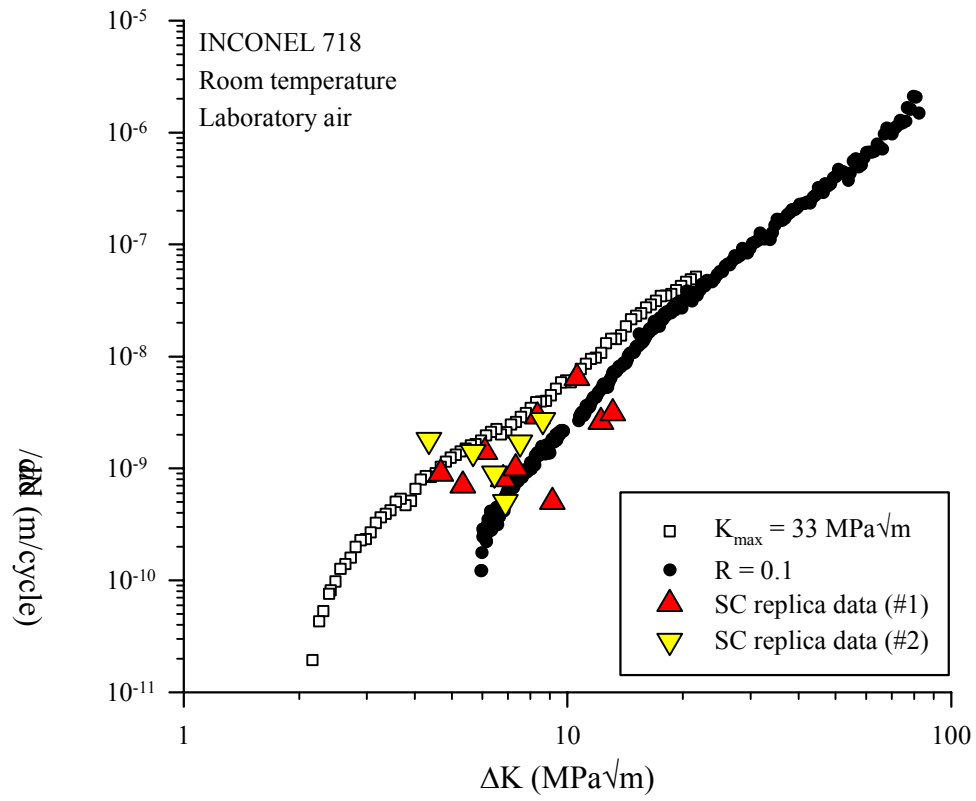
Figure 39. Small crack growth data and long crack growth data are plotted together for comparison.

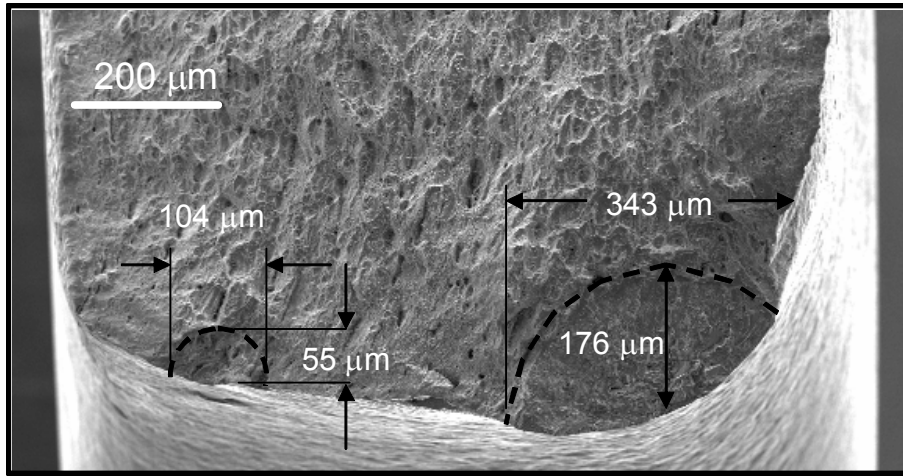
Figure 40. SEM micrograph of crack surfaces for specimen P1.

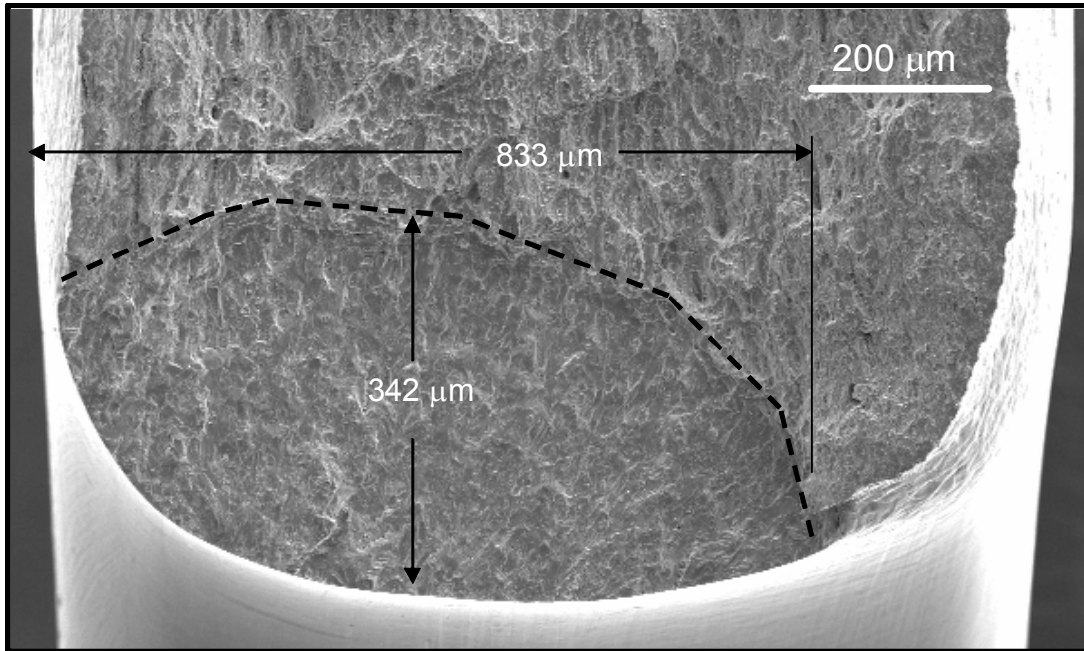
Figure 41. SEM micrograph of crack surface for specimen C9.
