NASA/TM—2007–215075

Study of Radiographic Linear Indications and Subsequent Microstructural Features in Gas Tungsten Arc Welds of Inconel 718

September 2007

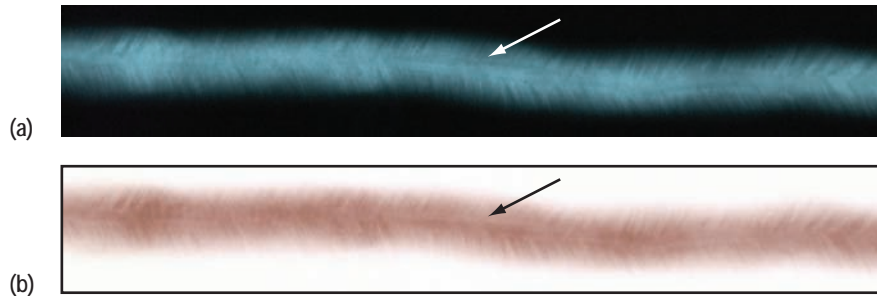
and radial indications on either side of the parallel indication as shown in figure 5. The radiographs from the nominal weld speed showed only radial indications (fig. 6). These radial indications are caused by columnar grain structures with a dendritic core elongated in the direction of solidification. The fastest travel speed produced no radiographic linear or radial indication (fig. 7).

Figure 5. Round-puddle weld (JT-03) showing (a) radiographic and (b) reverse contrast images. Notice the linear indication running the length of the weld pointed out by the arrows, and the radial feathering indications of columnar grains on either side. Weld direction is from right to left.

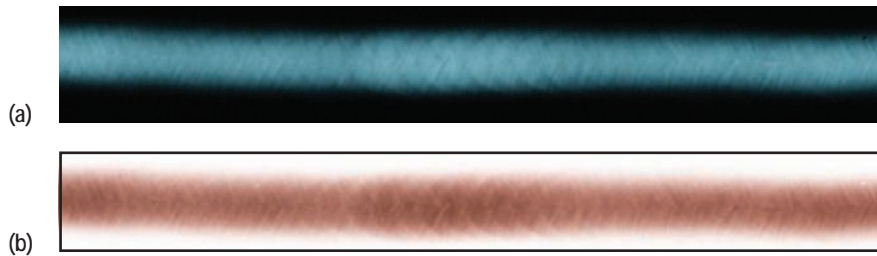
Figure 6. Nominal weld (JT-02) showing (a) radiographic and (b) reverse contrast images. Notice the radial feathering indications caused by columnar grain formation. Weld direction is from left to right.

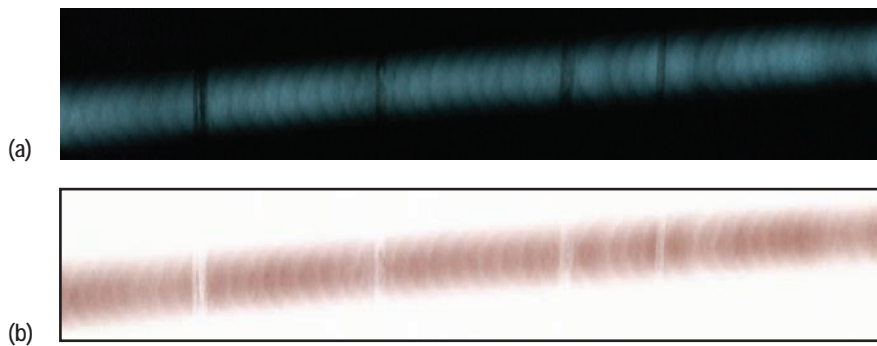
Figure 7. Tear-drop weld (JT-04) showing (a) radiographic and (b) reverse contrast images; no visible lateral indications or linear indications. Vertical lines are grease pencil markings. Weld direction is from left to right.

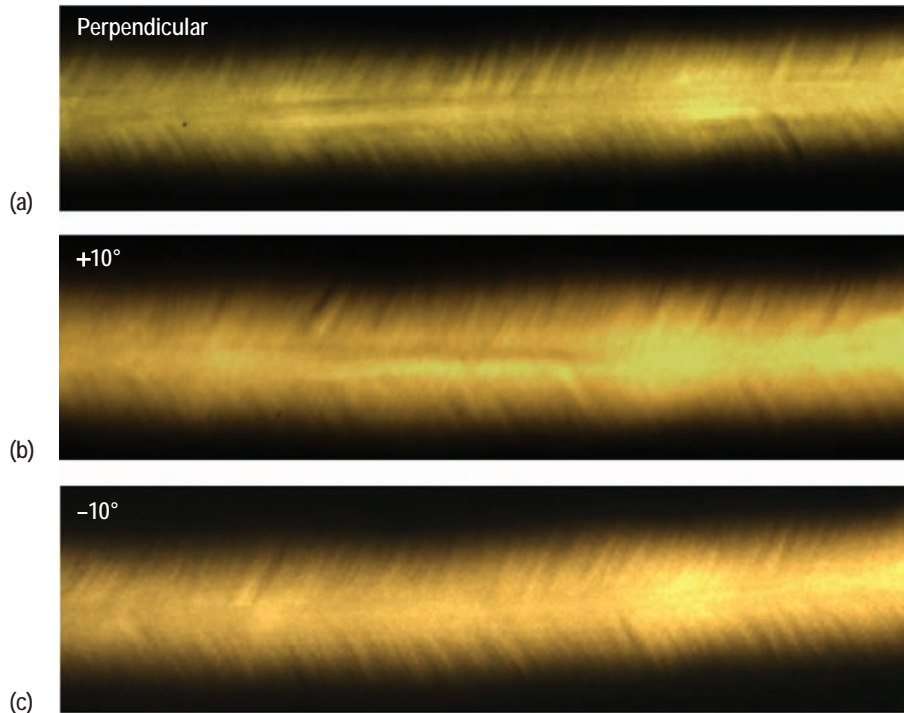
The radiographs seen in figure 8 were then taken of JT-03 with the x-ray source oriented at ±10° to the original perpendicular position. The three different x-ray source angles produced three different images at the same location in the weld joint. The indications never disappeared or changed location, but they did change size and clarity. Measurements on overall thickness of the indications were taken and summarized in table 2. They showed that the thickness of the linear indication increased as the x-ray source was moved from –10° to 0° to +10° orientations.

Figure 8. Radiographic images of JT-03. The x-ray source was oriented: (a) perpendicular, (b) +10°, and (c) –10° to the weld panel. The contrast between the dark and light indications changes with the x-ray source orientation. Weld direction is still right to left.

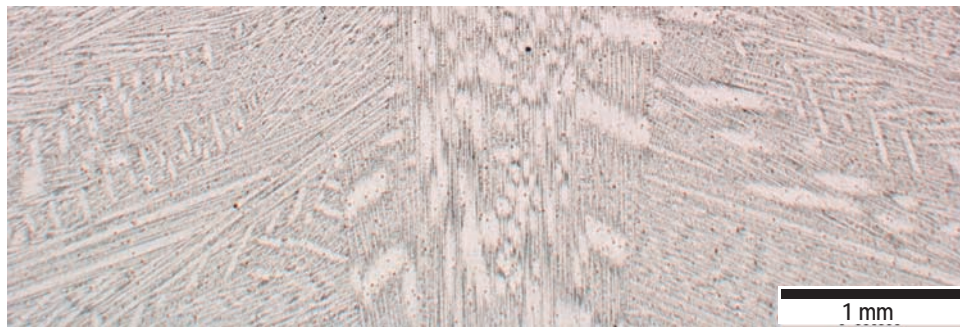
Figure 10. Crown macro of JT-03_2 region. The linear region in the center is a grain comprised of dendrite formations. The weld direction is from bottom to top.

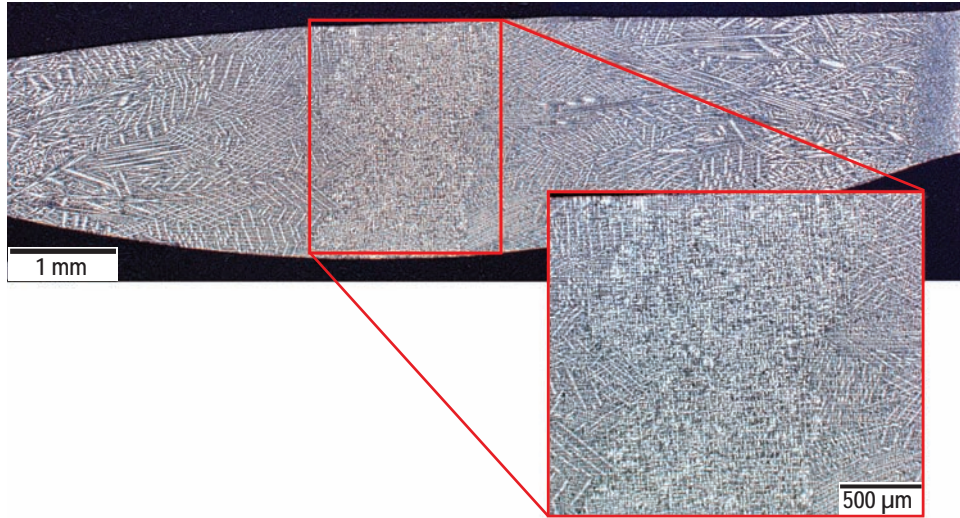
Figure 11. Transverse macro of JT-03_1. Notice that the large dendrite structure (grain) in the center extends through the depth of the weld. Crown side is up.

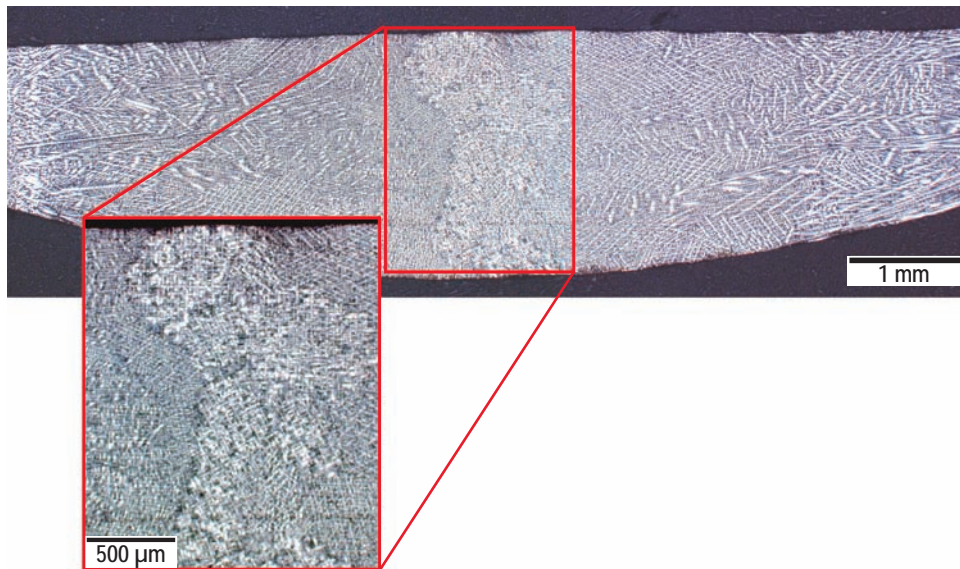
Figure 12. Transverse macro of JT-03_2. Notice that the center of the weld lacks a consistent large dendritic structure (grain) extending through the weld as seen in figure 11. Crown side is up.

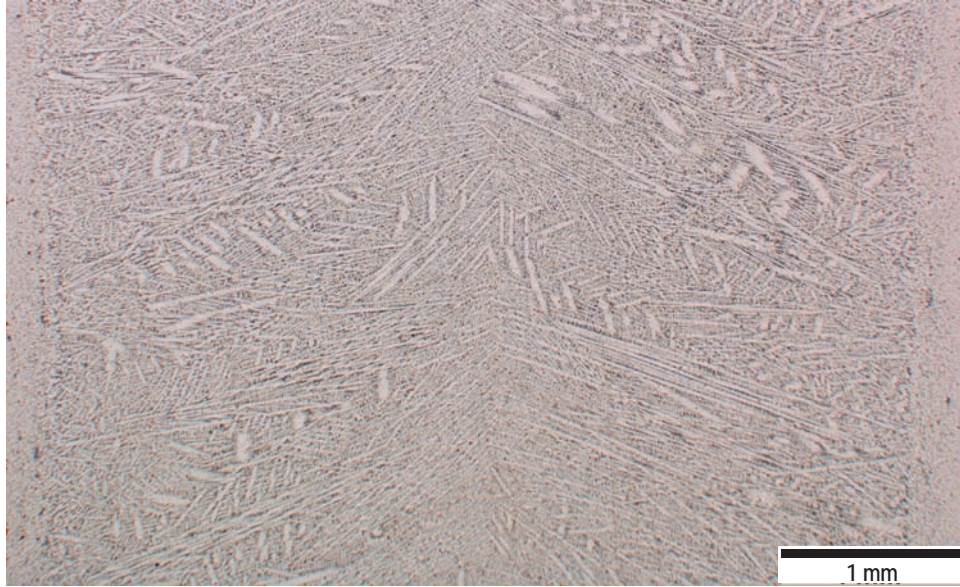
The crown macro (fig. 13) for the nominal weld speed (JT-02) shows that the lateral dendrite formations come together at the center of the weld and create a disjoint microstructure in the absence of any longitudinal dendrite formations. At higher magnification (fig. 14), it can be seen that these dendrites produce a visible boundary. This implies that the weld speed is somewhat higher than the rate of freezing, even though the puddle appeared to have an elliptical shape with a flat perimeter at the trailing edge.

Figure 13. Crown macro of JT-02, nominal weld speed. The lateral dendrites meet with almost disjoint mirror symmetry at the center of the weld joint.

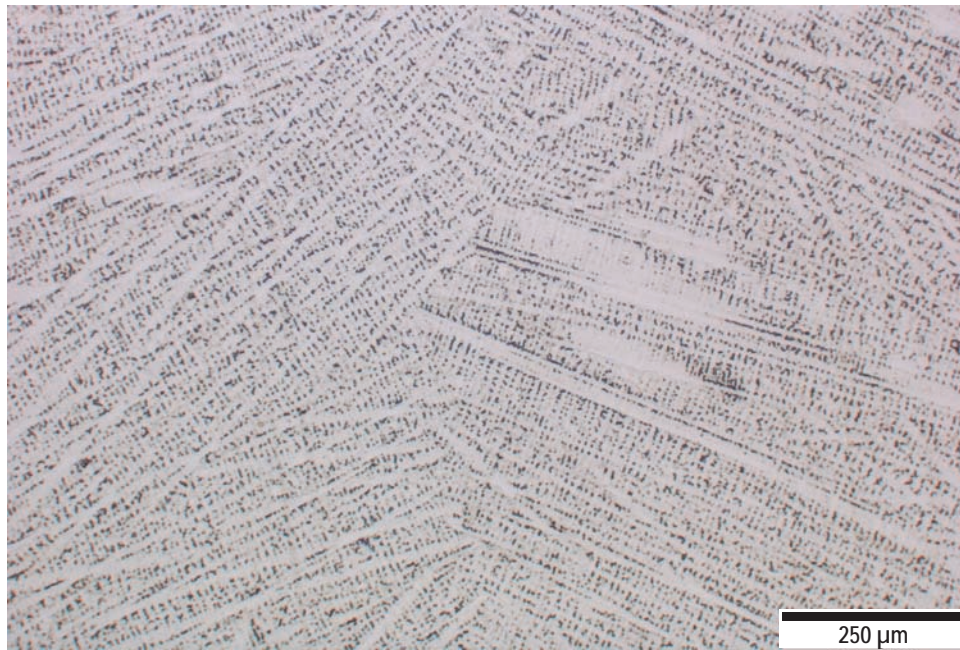
Figure 14. Crown macro enlarged of JT-02, nominal weld speed. Notice conjunction of lateral dendrites at the center of the weld. The weld direction is from bottom to top.

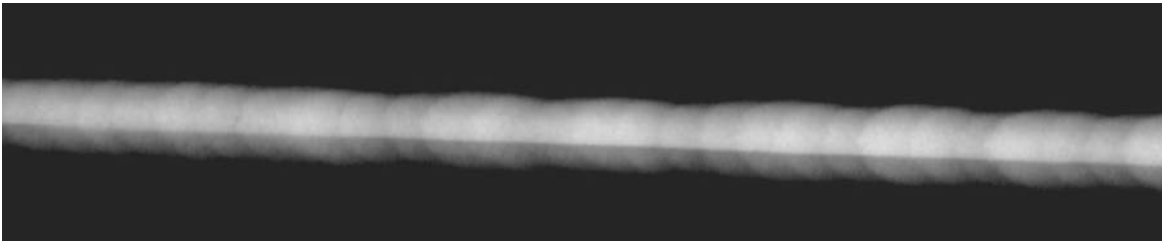
By varying the clamping pressure on the panels during welding, the welders were able to produce a joint with significant mismatch, near the end of the panel. From the radiographic image (fig. 17), it can be seen that this mismatch created an indication in the form of an ~0.01-in light and dark region on either side of a boundary running approximately along the middle of the weld. The macro image of figure 18 explains the indication. The crown is flat, but there is a step at the weld root, such that the thickness penetrated by the x-ray beam is significantly different on opposing sides of the step.

Figure 17. Radiographic image of JT-05. The mismatch indication can be seen as a light image with a darker image superimposed over the lower part of the weld. Weld direction is left to right.

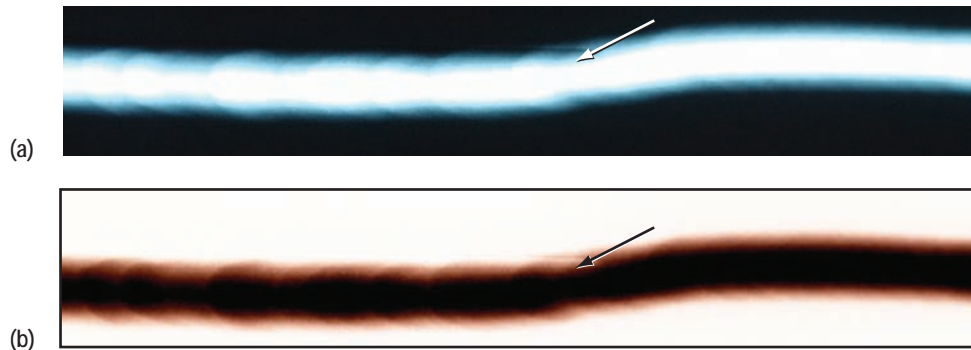
Figure 20. Radiographic image of JT-08 showing lack of fusion at the arrow where the cross-slide motion was used to move the bead back toward the center of the joint: (a) is the radiographic image; (b) is the reverse contrast image. Under the radiographic contrast conditions shown, the unwelded joint extending to the left from the visible indication is not visible. Weld direction is from left to right.

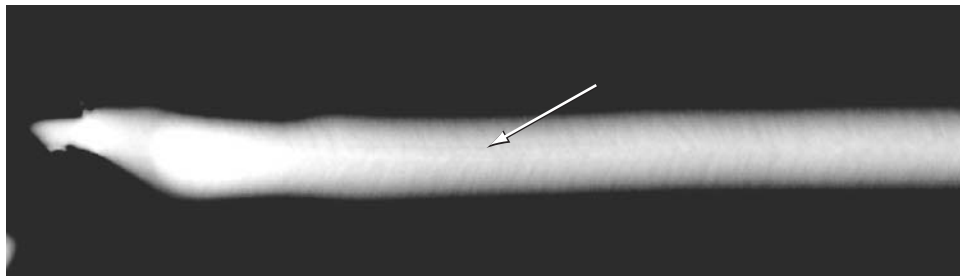
X-rays of JT-08 were also taken at ±10° of the original x ray. The –10° panel did not show a linear indication for the lack of fusion, but it did produce a linear enigma indication near the beginning of the weld that was not observed of either the perpendicular or +10° radiograph (fig. 22). The +10° panel showed a dark linear indication produced by the lack of fusion under the crown reinforcement along the length of the weld (fig. 23).

Figure 22. Radiograph of JT-08 taken at –10° off perpendicular. A faint enigma
indication can be seen near the start of the weld joint. Weld direction
is left to right.

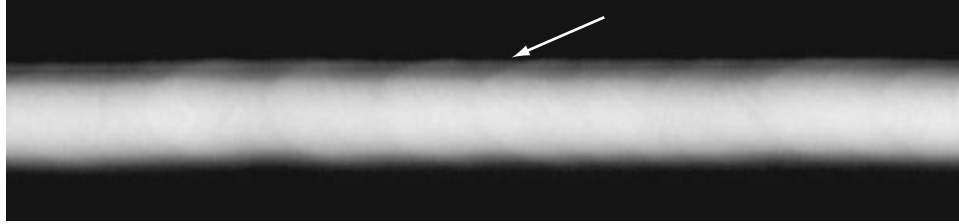
Figure 23. Radiograph of JT-08 taken +10° off perpendicular. The linear indication caused by lack of fusion can be seen along the top of the crown reinforcement. Weld direction is left to right.

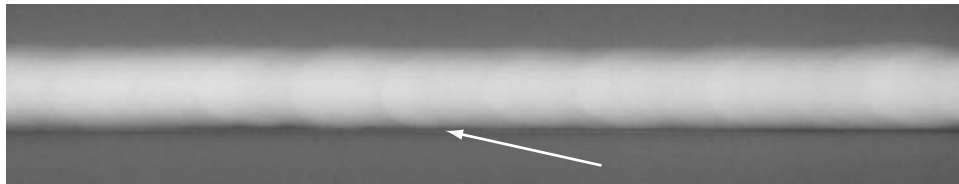
When the proper radiographic standards are followed, and the image density of the parent metal is within the 2 to 4 density range, the missed joint is clearly visible in the radiograph taken perpendicular to the joint (fig. 24).

Figure 24. Radiograph of JT-08 with x-ray source oriented perpendicular to the joint. The lack of fusion, missed joint can be seen as a blurry dark line along the bottom of the image. This image has been reversed with respect to the previous image.

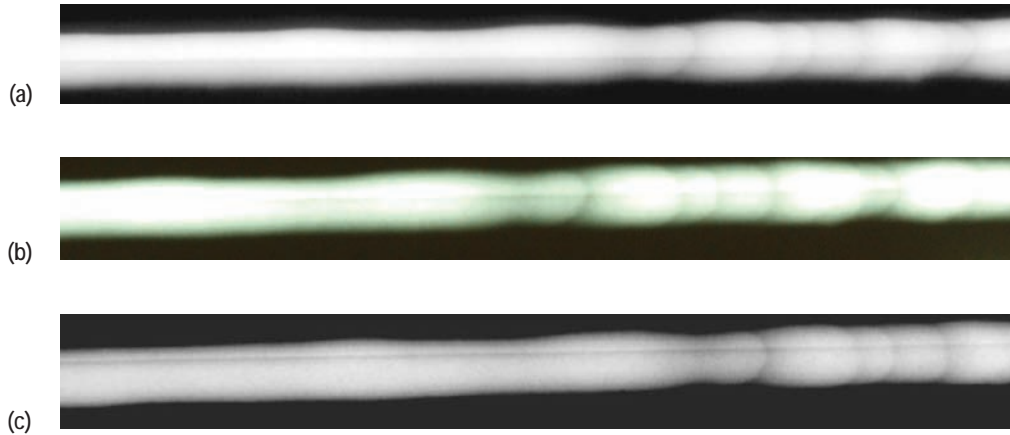
Lack of penetration in the center of the weld joint was created by reducing the weld current enough to decrease the penetration depth while still maintaining a stable puddle. Lack of penetration in weld JT-09 produced a dark indication of the weld joint (fig. 25(b)). X-ray orientations at ±10° of perpendicular produced the radiographs seen in figure 25(a) and (c), respectively. The linear indication moved up and down, above and below the center of the weld joint, but did not change intensity or appearance appreciably at these low angle change increments. Figure 26 shows the lack of penetration responsible for these indications.

Figure 25. A comparison of radiographs with x-ray source at (a) +10°, (b) perpendicular, and (c) –10°. Notice that the linear indication caused by lack of penetration moves in the weld puddle but does not substantially change clarity or size. Weld direction is right to left.

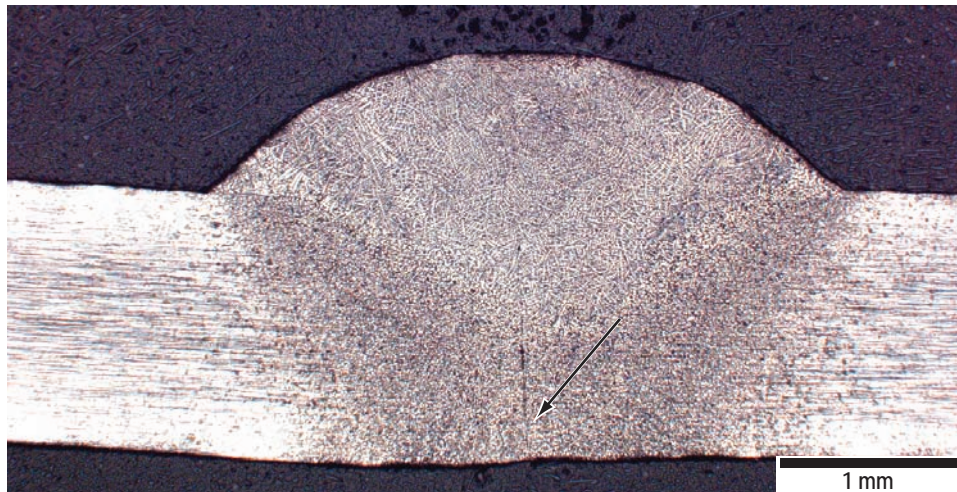
Figure 26. Transverse macro of JT-09. The lack of penetration can be seen in the center of the weld near the root side.
