Elastic-Plastic Nonlinear Response of a Space Shuttle External Tank Stringer: Part 2 – Thermal and Mechanical Loadings

Norman F. Knight, Jr.[1]
General Dynamics Information Technology, Herndon, Virginia

Jerry E. Warren[2], and Kenny B. Elliott[3]
NASA Langley Research Center, Hampton, Virginia

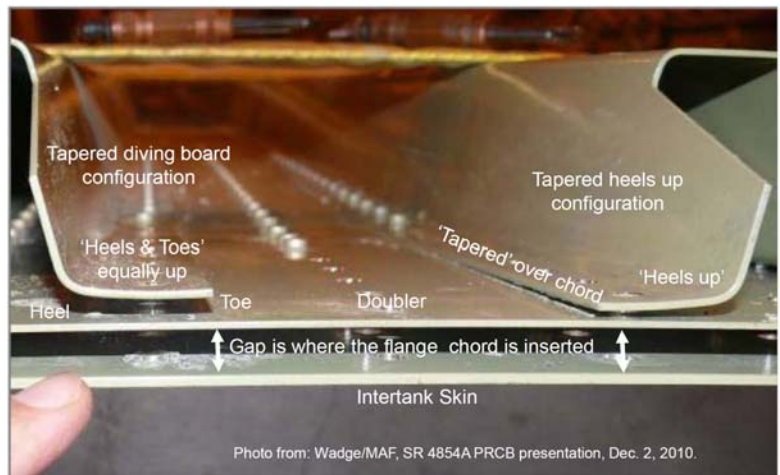
The fabrication of the IT external hat-shaped stringers is a multi-step process that starts with a sheet that is cold rolled to a general hat shape, and then hot formed to the specific dimensions and final shape. An added installation complication is that the stringer is fabricated with an upward bend on both ends to accommodate tapered IT chord flanges on the LOX and LH$_2$ ends of the IT. This bend occurs roughly at Fastener 7 for regions with a forward long chord[*]. From Fastener 7 to the front end, different stringer-feet imperfections may occur with the peak imperfection possibly occurring at the stringer ends and tapered linearly down to the flat-feet configuration at Fastener 7

Figure 7. Various stringer-feet imperfections. Photograph courtesy of Mr. G. Wadge/LM-ET.

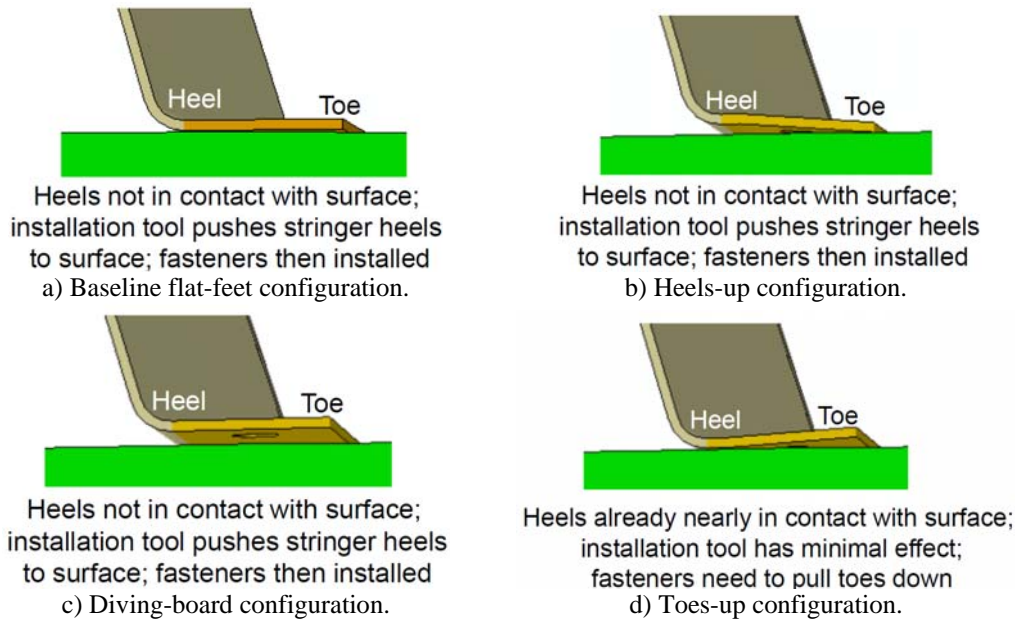
Figure 8. Baseline and three stringer-feet imperfection configurations.

The baseline flat-feet configuration and three stringer-feet imperfection configurations are shown in Fig. 8. The baseline flat-feet configuration shown in Fig. 8a exhibits a toes-up condition due to the IT curvature. The heels-up configuration shown in Fig. 8b is defined as when the heels of the stringer feet at the end of the stringer are offset 60 mils further from the flat-feet configuration, while the stringer toes remain in the flat-feet configuration (linearly tapered across the stringer foot). In this configuration, the stringer toes are in the flat-feet configuration. The diving-board configuration shown in Fig. 8c has the heels and toes offset 70 mils from the flat-feet configuration (i.e., uniform offset with no tapering across the stringer foot). The toes-up configuration shown in Fig. 8d is when the toes of the stringer feet at the end of the stringer are offset 60 mils further away from the flat-feet configuration, while the stringer heels remain in the flat-feet configuration (linearly tapered across the stringer foot).

Heels not in contact with surface; installation tool pushes stringer heels to surface; fasteners then installed

Heels already nearly in contact with surface; installation tool has minimal effect; fasteners need to pull toes down

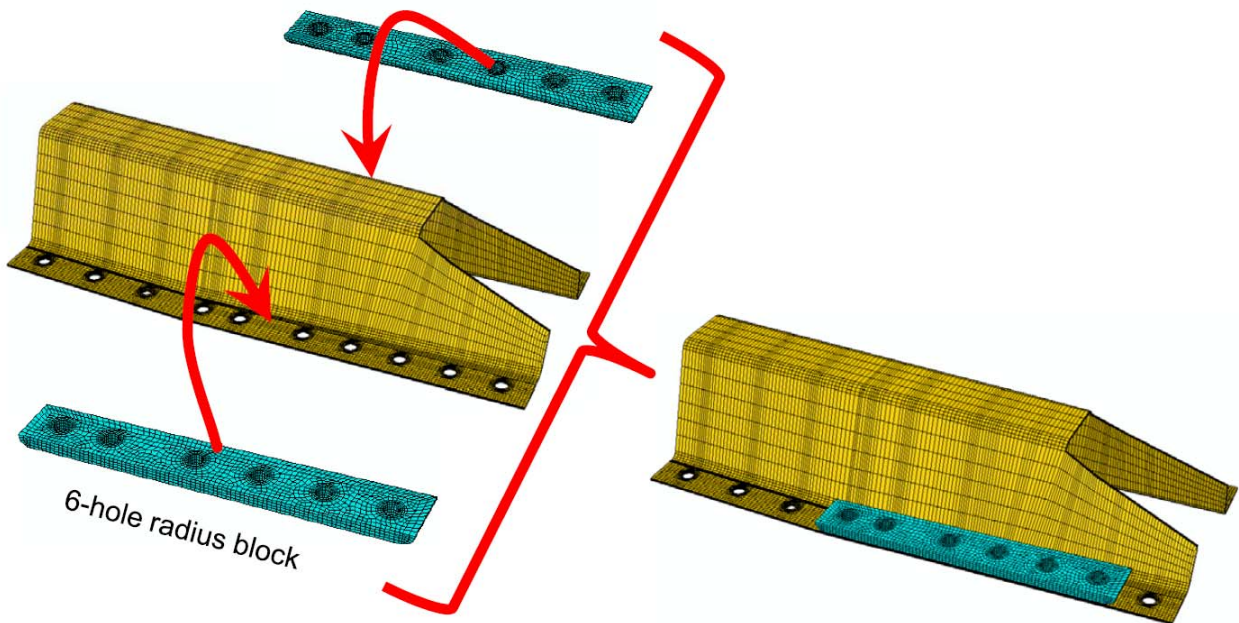
Two stringer configurations are analyzed in this paper. One configuration has just the stringer attached to the IT panel, which is the baseline configuration as shown in Fig. 10, and is referred to, in this paper, as the configuration *without* the radius blocks. The second configuration is a configuration *with* the radius blocks installed at the ends of the stringer as shown in Fig. 11. The radius blocks are 0.19-inch-thick Al-2024 blocks 0.935 inches wide at the forward end and 0.85 inches wide at the aft end. They are used to stiffen the stringer feet against local bending. The radius blocks have two different lengths depending of the IT forward chord length: 4-hole or 6-hole radius blocks. In this paper, only the 6-hole radius blocks (6.19 inches long) and the IT forward long chord are analyzed. These 6-hole radius blocks are installed after the stringers have been fully installed on an IT panel by removing Fasteners 2 through 7 (four GP® bolts and two Hi-lok® fasteners), inserting the radius blocks, and installing new blind fasteners. Fastener 1 holds the stringer against the IT surface and is not removed during the radius block installation process.

Figure 11.   Installation of the 6-hole radius blocks over Fasteners 2 through 7.

The analyses confirmed that the radius block modification increased the apparent capability of the stringers on the LOX tank end of the IT. While the installation of radius blocks reduced the peak strains, the strain level remained sufficiently high so that a failure may occur if a rogue stringer were present. The radius blocks do indicate an increase in capability, but do not eliminate the possibility of a local stringer failure.

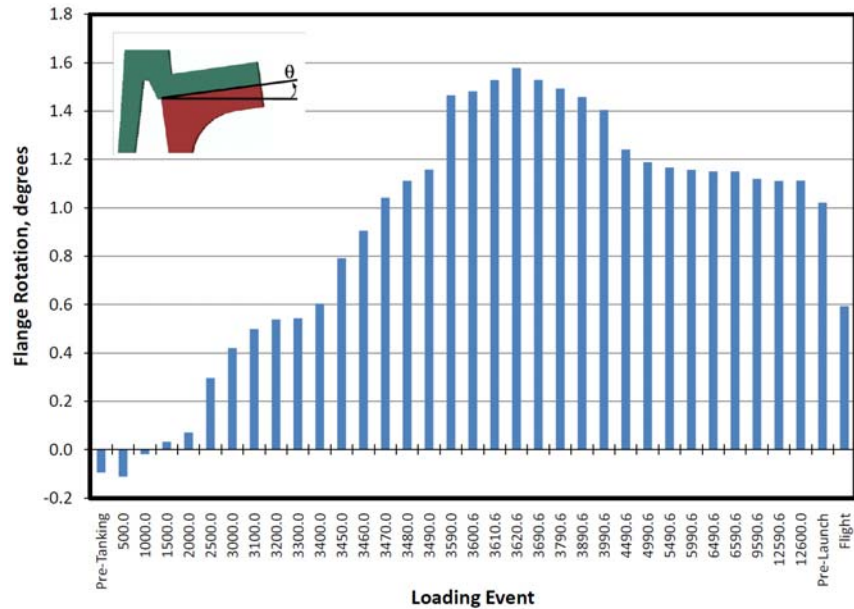
Qualitatively, the rotation of the IT chord flange has been previously found to occur due to the thermal gradient that develops during filling of the LOX tank (see Fig. 13). To quantify that influence, the flange rotation θ illustrated in Fig. 15 is calculated for each loading event from the global model simulation, and the results are shown in Fig. 16 for the baseline, flat-feet configuration *without* the radius blocks installed. The peak positive flange rotation[*] is approximately 1.58° (or 0.028 radians) CCW at 3620 seconds into the LOX tanking process, which agrees well with the value reported in Ref. 13.

Figure 16.   IT chord flange rotation for the flat-feet configuration *without* radius blocks installed for each loading event.

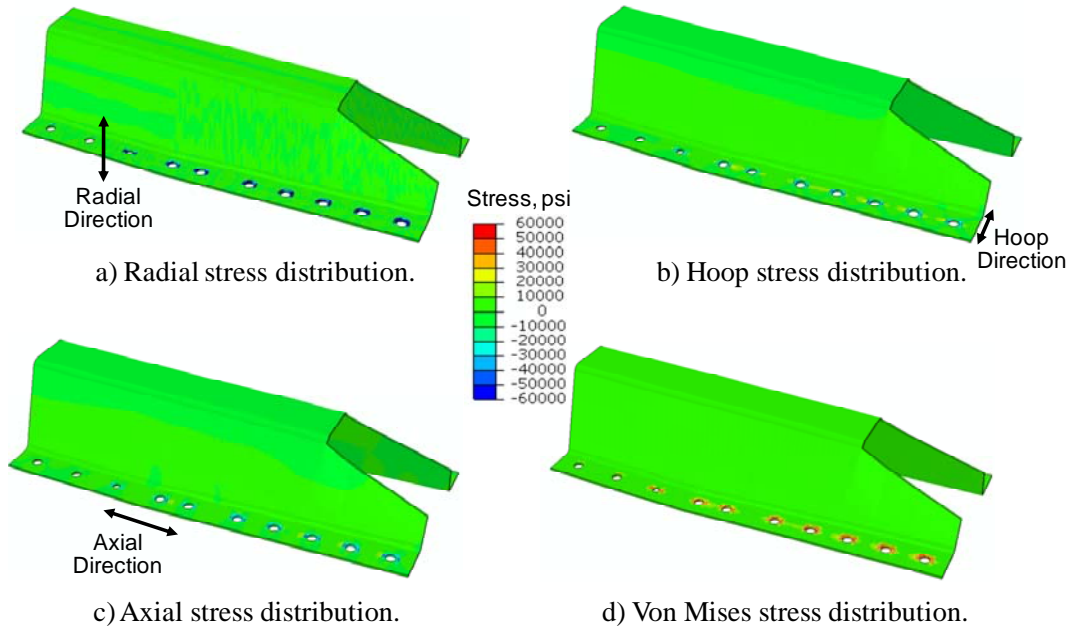
Figure 18. Stringer stress contours by component <u>after assembly</u> for the flat-feet configuration *without* radius blocks installed.

The stress distributions after completion of the assembly step are shown in Fig. 18 for the flat-feet configuration *without* the radius blocks installed. The radial stress component shown in Fig. 18a represents the through-the-thickness stress component, with high compressive values near each fastener hole as expected due to the high fastener preload forces. The hoop and axial stress distributions shown in Figs. 18b and 18c, respectively, indicate very localized effects due to assembly alone. However, the von Mises stress distribution indicates a stress magnitude approaching the uniaxial initial yield stress value near the fastener holes (see Fig. 18d). Recall that in a combined stress state, only the effective or von Mises stress needs to exceed the uniaxial initial yield stress for the individual strain components to exhibit plastic strain.

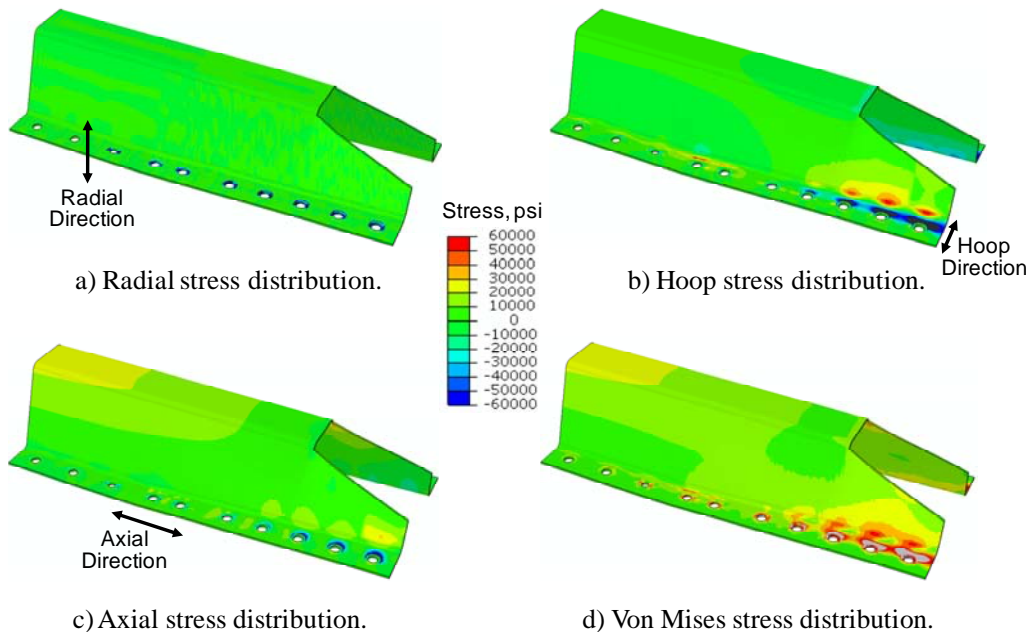
Figure 19.   Stringer stress contours by component <u>at 3620 seconds after starting tanking</u> for the flat-feet configuration *without* radius blocks installed.

The stress distributions at 3620 seconds after starting tanking are shown in Fig. 19 for the flat-feet configuration *without* the radius blocks installed. The radial stress component shown in Fig. 19a is essentially unchanged from the assembly step shown in Fig. 18a. As a result of the thermal gradient, the hoop stress component shown in Fig. 19b is significantly different from the assembly step. High compression values on the exposed surface of the stringer feet are noted along the first three fasteners, with a rapid transition from compression to tension as the stringer sidewall is approached. In addition, increased hoop stress levels are indicated near Fasteners 6 and 7 where the IT tapered chord ends. Tensile axial stresses are observed in Fig. 19c along the stringer hat (or cap), while high compressive values are noted near the first three fasteners. For the von Mises stress (a stress invariant), values exceeding the uniaxial initial yield stress are indicated in Fig. 19d by the gray regions in the contour plot near the first three fasteners.

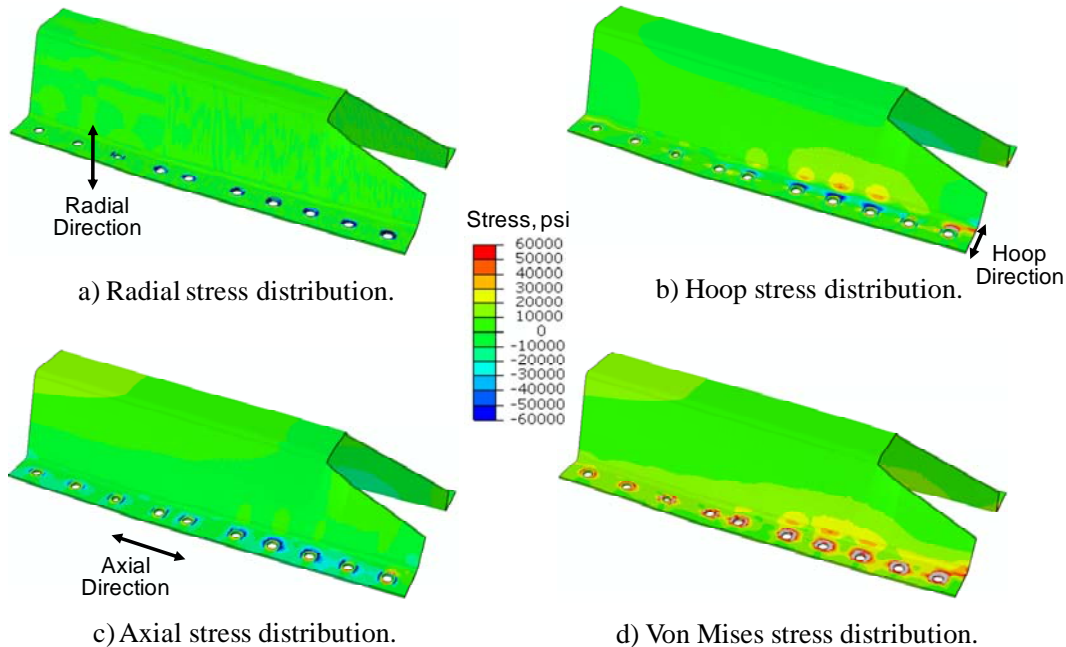
Figure 20.   Stringer stress contours by component <u>with flight loading applied</u> for the flat-feet configuration *without* radius blocks installed.

The stress distributions for the flight loading event are shown in Fig. 20 for the flat-feet configuration *without* the radius blocks installed. In this case, the peak flange rotation decreased due to steady-state thermal condition and due to the flight running loads imposed on the aft Y-joint flange. Again, the radial stress distribution in Fig. 20a shows minimal change when compared with the previous two loading events. However, the hoop stress distribution in Fig. 20b has been relieved somewhat with peak compressive values occurring near Fasteners 3 through 5. The axial stress distribution shown in Fig. 20c increases in the stringer feet rather than just peaking at the fastener holes as indicated previously. Finally, the von Mises stress distribution shown in Fig. 20d indicates that elastic-plastic response in the stringer feet has developed further as evident by the increased size of the gray regions in the contour plot.

Since the original stringer failure mode was a through-crack presumably initiating on the bottom surface of the stringer feet and extending from Fastener 1 to Fastener 5 (e.g., see Refs. 1 and 2), a tensile hoop strain on the bottom surface of the stringer feet would tend to open any defect perpendicular to the hoop direction. Hence, to mitigate any risk associated with the possible use of suspect stringer material[*], it has been suggested that the strain levels in the stringer feet should not exceed the elastic limit.

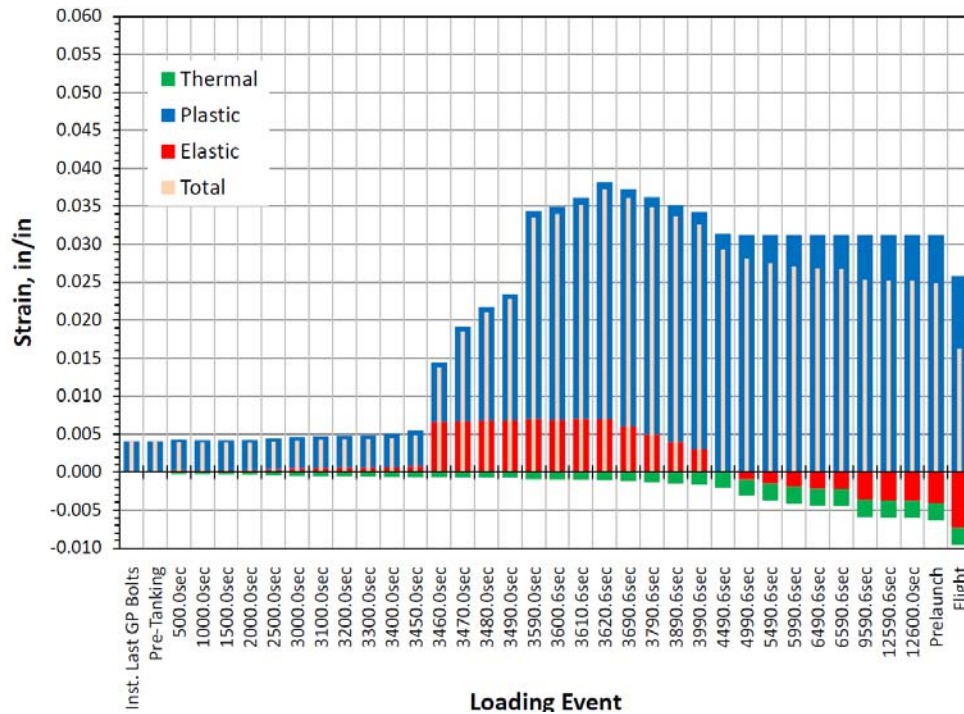
The peak hoop strain values shown in Fig. 22 are for the group of elements near the first fastener for each loading event analyzed using the flat-feet configuration *without* the 6-hole radius blocks. These hoop strain results indicate plastic strains occur near Fastener 1 after the initial installation of the stringer with flat feet. As the LOX tank filling process proceeds, the thermal gradient near the IT chord flange introduces significant cryogenic shrinkage that induced large plastic strains even though the thermal strain itself is small and compressive. The peak hoop strains occur after 3620 seconds into the tanking process. After 12600 seconds, steady-state thermal conditions exist for the IT. Mechanical loads due to prelaunch and flight are added to the steady-state thermal condition, and the resulting hoop strains are somewhat reduced due to the mechanical loads.

Figure 22. Peak hoop strains near Fastener 1 for the flat-feet configuration and different loading events: Without radius blocks installed.

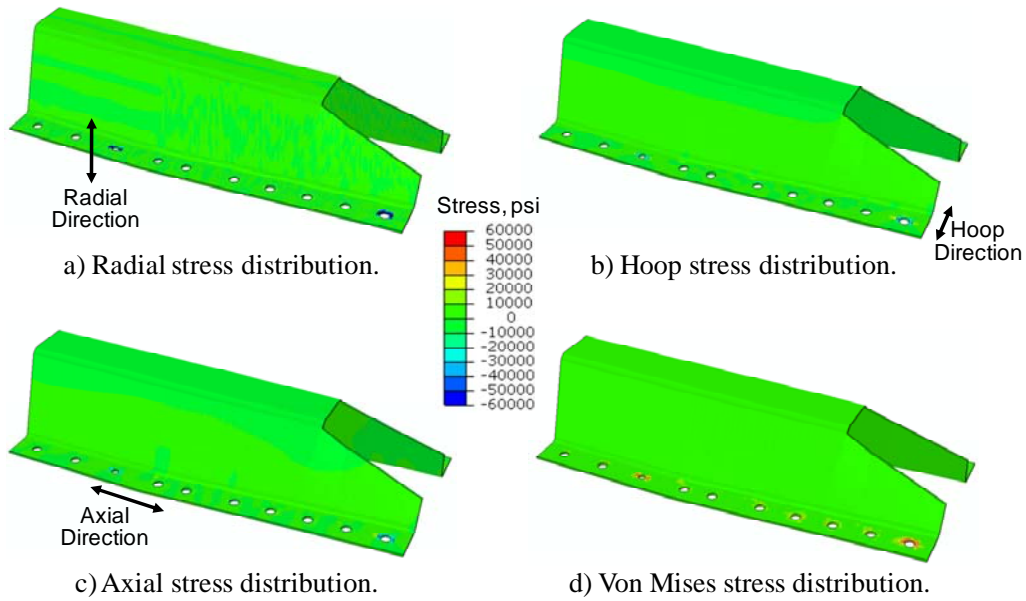
Figure 24. **Stringer stress contours by component <u>at 3620 seconds after starting tanking</u> for the flat-feet configuration *with* radius blocks. Stress values plotted as gray exceed the maximum tensile value, and values plotted as black exceed the maximum compressive value.**

The stress distributions at 3620 seconds after starting tanking are shown in Fig. 24 for the flat-feet configuration *with* the radius blocks. The radial stress distribution shown in Fig. 24a is essentially unchanged from the assembly step. As a result of the peak thermal gradient, the hoop stress component shown in Fig. 24b is significantly different from the assembly step. However, the hoop stress levels are reduced compared to those predicted when the radius blocks are not installed (i.e., compare Figs. 24b and 19b). Tensile axial stresses are observed in Fig. 24c along the stringer hat, while compressive values are noted near the first three fasteners. For the von Mises stress, values exceeding the uniaxial initial yield stress are indicated by the gray regions in the contour plot near the first three fasteners. However, the presence of the radius blocks has reduced the overall stress level in the stringer feet (i.e., compare Figs. 24d and 19d).

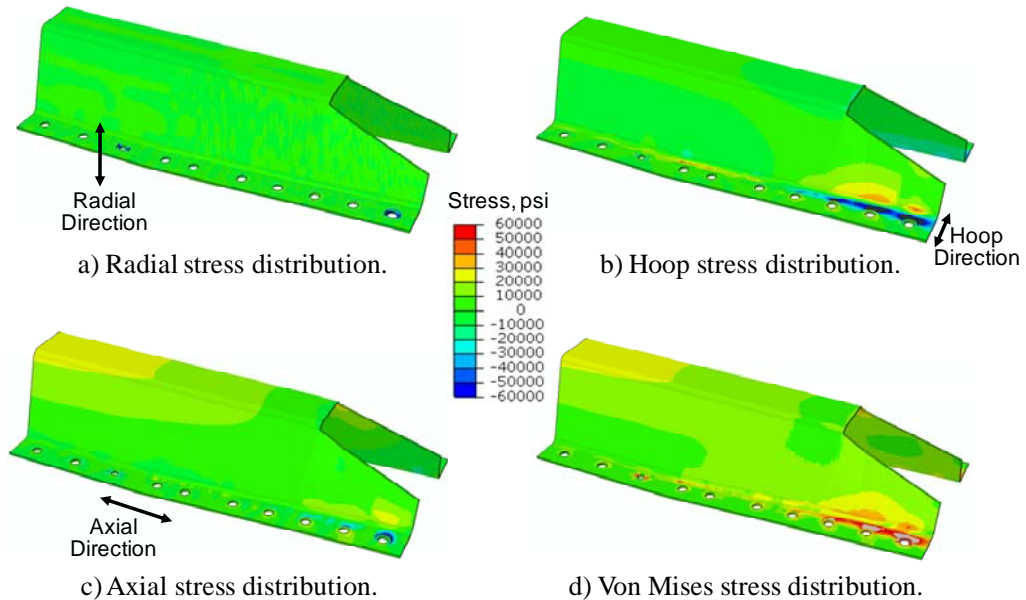
Figure 25. Stringer stress contours by component <u>with flight loading applied</u> for the flat-feet configuration *with* radius blocks. Stress values plotted as gray exceed the maximum tensile value, and values plotted as black exceed the maximum compressive value.

The stress distributions for the flight loading event are shown in Fig. 25. In this case, the peak flange rotation decreased due to the steady-state thermal condition and due to the increased flight axial running load imposed on the aft Y-joint flange. The radial stress distribution in Fig. 25a shows minimal change when compared with the previous two loading events. However, the hoop stress distribution in Fig. 25b has been relieved with the peak compressive values occurring near Fasteners 3 through 5, which are under the radius blocks. The axial stress distribution shown in Fig. 25c extends further in the stringer feet and not just peaking at the fastener holes. Finally, the von Mises stress distribution shown in Fig. 25d indicates that elastic-plastic response in the stringer feet has developed, but appears to be more localized to regions around the fasteners. The region near Fastener 1 has the highest stress.

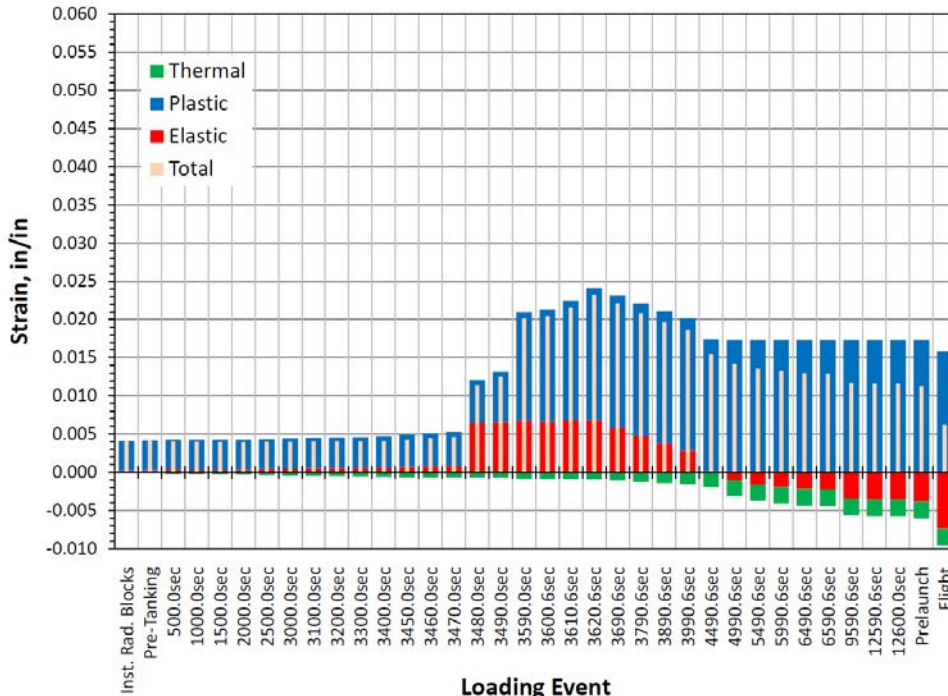
The peak hoop strain values shown in Fig. 26 are for the group of elements near the first fastener and for each loading event analyzed using the flat-feet configuration *with* the 6-hole radius blocks. These hoop strain results indicate plastic strains occur near Fastener 1 after the initial installation of the stringer with flat feet and not due to the installation of the radius blocks. The peak hoop strains again occur after 3620 seconds into the tanking process. After 12600 seconds, steady-state thermal conditions exist for the IT. Comparison of these results *with* the radius blocks installed to those in Fig. 22, *without* the radius blocks installed, reveals that the radius blocks do reduce the peak strain levels for the operational loading events.

Figure 26. Peak hoop strains near Fastener 1 for the flat-feet configuration and different loading events: With radius blocks installed.

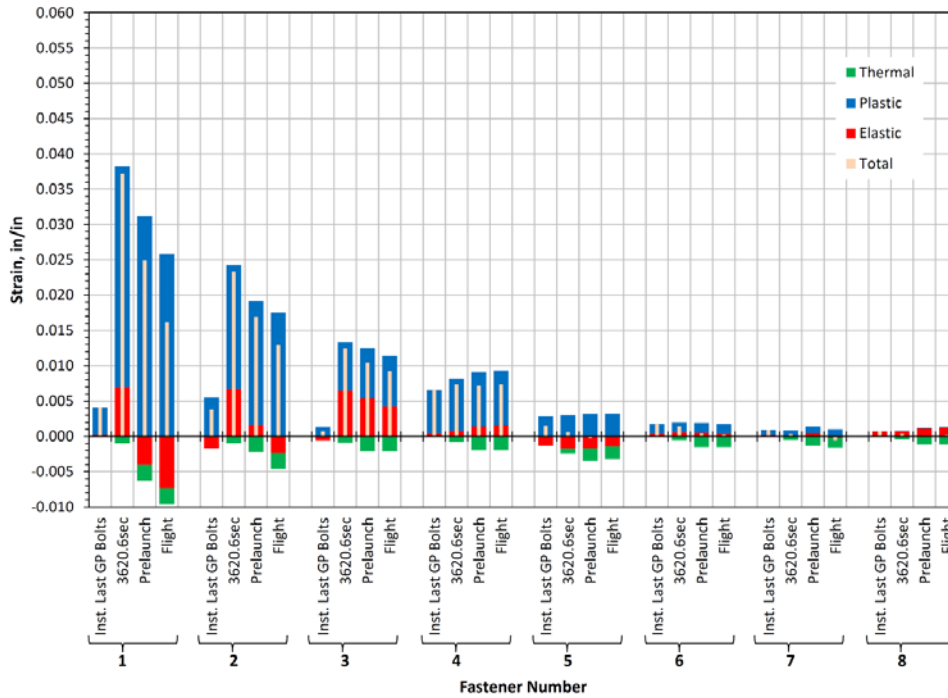
Figure 27. Peak hoop strains near the first eight fasteners for the four key loading events using the flat-feet configuration – without radius blocks installed.

The peak hoop strains near the first eight fasteners are shown in Figs. 27 and 28 for the four key loading events. The peak hoop strains for the stringer feet *without* the radius blocks are shown in Fig. 27. Peak values from each loading event are shown for each fastener region. With the exception of Fastener 8, each fastener region exhibits plastic strain with the higher values being near the first four fasteners, and the highest hoops strains occur near Fastener 1. The peak hoop strains for the stringer feet *with* the radius blocks are shown in Fig. 28. Again, peak values from each loading event are shown for each fastener region. Similar trends are seen in these results compared to the results *without* the radius blocks. However, the peak values are significantly reduced. Note that any plastic strain induced during the initial assembly remains locked in as the radius blocks are installed.

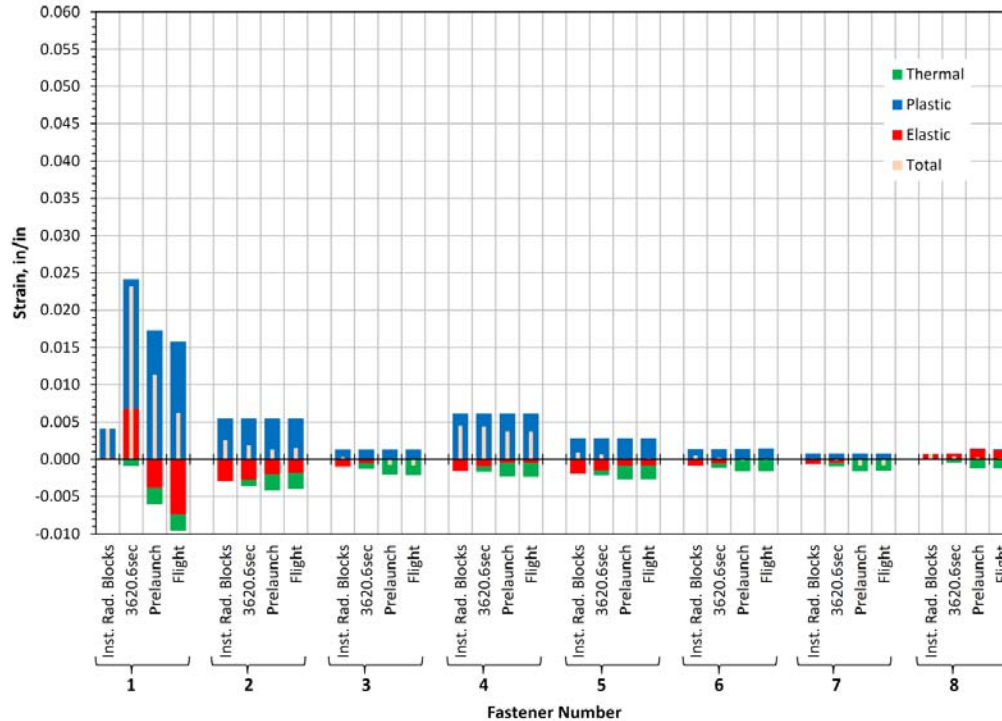
Figure 28. Peak hoop strains near the first eight fasteners for the four key loading events using the flat-feet configuration – with radius blocks installed.

A final observation is related to the different response expected near Fasteners 1, 2, and 3 compared to the other fasteners. The first three fasteners on the stringer are over a region where the stringer has no cap and its sidewalls are tapered in height as shown in Fig. 11. Because of the additional flexibility in this region, higher peak strains develop for the thermal and mechanical loading events. When the radius blocks are installed, the region near Fastener 1 is unsupported by the radius blocks and continues to exhibit higher peak strains than the remaining fasteners. However, those peak values are smaller than the peak values predicted when the radius blocks are not installed.
