Flight Systems Integration & Test: Lessons Learned for Future Success

Michael R. Wright
NASA Goddard Space Flight Center
michael.r.wright@nasa.gov

To be published in the conference proceedings for Space Ops 2018, The 15th International Conference on Space Operations, Marseille, France, May 28 to June 1, 2018.

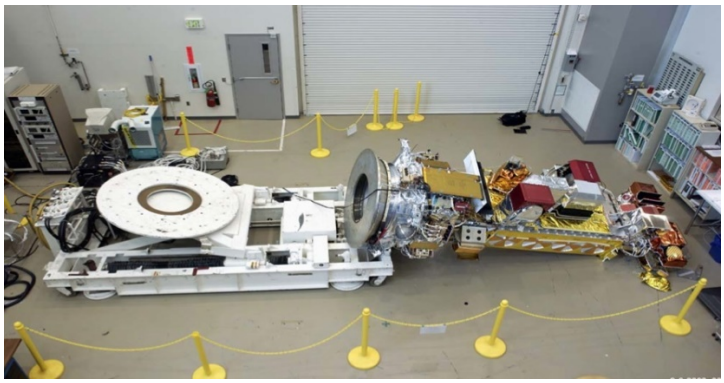
A well-known example of this is the National Oceanic and Atmospheric Adminstration (NOAA) N-Prime mishap in 2004, in which the satellite fell off a turn-over cart (TOC) during a normally "routine" rotation (Figure 1). The proximate cause was 24 missing bolts on the adapter ring, due to improper procedure execution. However, there were multiple root causes covering several categories mentioned above, including: team familiarization and communication, planning and scheduling, configuration management and documentation, and mechanical handling. Among the many reported deficiencies, the hastily planned task involved insufficient oversight and poor communication of team roles and responsibilities. It is instructive to read the actual MIB report [4] for details, including several "missed opportunities" to recognize the absence of the critical fasteners. This seeming blind-sightedness involves what the MIB cited as

a common error of highly structured, repetitive procedures, in which the operator has a narrow focus on the task at hand, without regard to the big picture.

Figure 1: NOAA N-Prime mishap scene [4].

Many other incidents in history could have been avoided had the advice or admonishment of technical experts been forwarded up the management chain, or even simply heeded by those involved. In the case of NOAA N-Prime, one of the root causes was that an earlier comment by the technician supervisor regarding the missing bolts was apparently dismissed [4]. Historical examples of advice being ignored include the shuttle SRB engineers' report of repeated "blow-by" of the viton o-rings under certain conditions, and their admonishment not to launch Challenger the morning of January 28, 1986 [7]. History eventually repeated itself 17 years later with the reinforced carbon-carbon (RCC) on Columbia – admittedly a different proximate cause, but nevertheless a common root cause involving management ignoring the advice of experts [8].

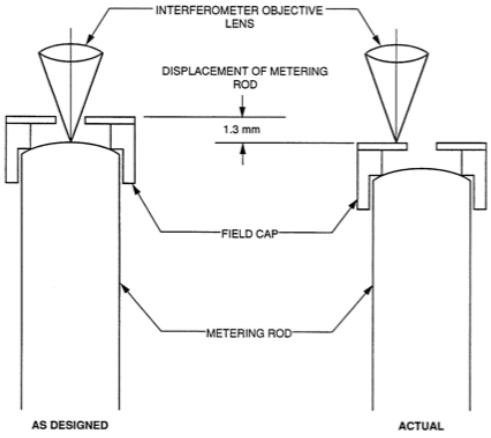
GSE is often underestimated with regards to its importance to spaceflight missions. Yet, as the equipment that directly interfaces with the flight system, GSE can mean the difference between mission success and failure. A prime example is the GSE that was used to measure the curvature of the Hubble Space Telescope (HST) primary mirror before installation, referred to as the reflective null corrector (RNC). In this case, the cause of the spherical aberration was incorrect assembly of the RNC's metering rods, including no staking of the adjustment mechanism and no postassembly dimensional verification (see Figure 4). Misconfiguration of the GSE setup and lack of independent verification resulted in a textbook case of spherical aberration [16].

Figure 4: Incorrect displacement of HST mirror RNC, with interferometer focus on field cap instead of metering rod [16].

Certainly, one of the most well-known failures in test and verification involved the HST primary mirror (see *GSE and Tools*). Interestingly, errors discovered using other GSE were reportedly discounted by the contractor as invalid. Further, budget and schedule constraints led to not conducting an independent or end-to-end test [16].

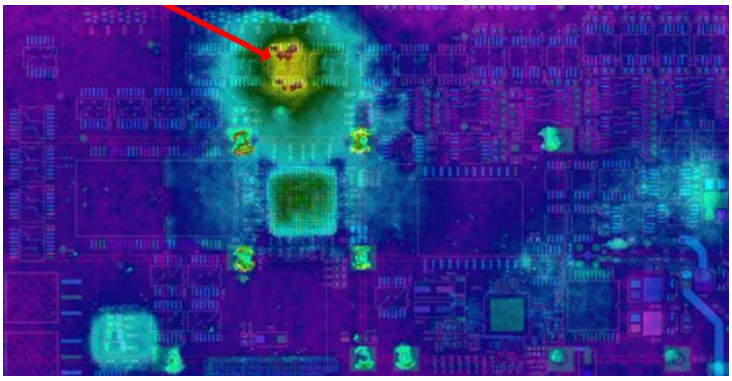
ESD events are also a common cause of electrical system failures (see Figure 5). Often, the failure goes undetected until much later (latent failure). Progressive level of integration makes it even more difficult to repair, with potential risk to other flight hardware. Implementing ESD-safe practices during I&T can mitigate risk to sensitive electronics.

Figure 5: IR image of ESD damage on flight PC board.
