Lessons Learned in the Flight Qualification of the S-NPP and NOAA-20 Solar Array Mechanisms

Daniel Helfrich* and Adam Sexton**

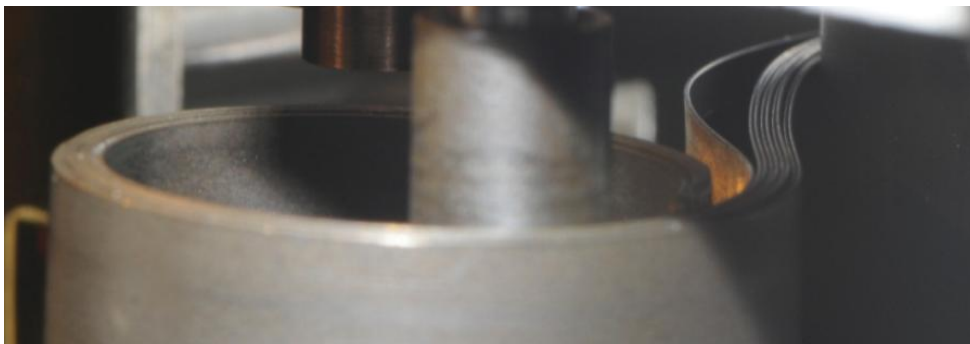
Figure 2. Gapping in the Leaf Spring of the Main Deployment Hinge

During the 2009 investigation on the characterization of the torque output of the hinges it was found that the constant torque springs were developing an unintended gap, shown in the right side of Figure 2. The gap signals too much frictional losses in the spring stack. A wet lubricant, Braycote 601VB, was applied to the both the roller and the spring stack to reduce friction and torque resistance. The roller shaft that should have been dry lubricated was found to be unprocessed, so a grease plate mixture of Braycote 601 VB and 30% molybdenum disulfide was applied to it.

The issues raised during the S-NPP torque margin investigation were addressed with design updates for JPSS-1. One significant update addressed a "rule of thumb" of the spring vendor to limit the number of springs in a stack to 3. The width and thickness of the springs were made larger to increase their torque and reduce the number needed to meet torque margin requirements. The hinges went through a test program, discussed below, that characterized the drag torques that must be overcome and satisfy the torque margin requirements. JPSS-1 had an increase of 32 wires crossing the MDH hinge line and 7 additional wires crossing each IPH hinge line. The number of springs was determined based on the drag torque characterization testing, then installed on the hinge and characterized over the range of motion.

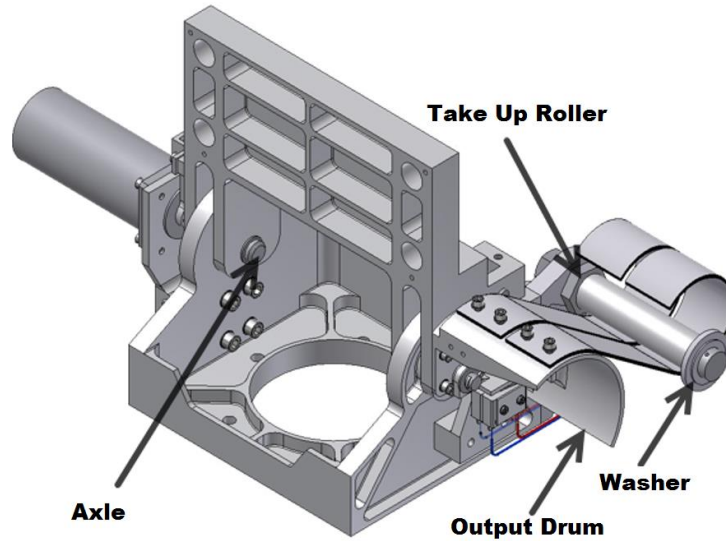
Figure 6. MDH in deployed orientation

Referring to Figure 6, the output drum was increased in diameter and arc length to accommodate the large constant torque spring. Two additional fasteners were added for load carrying capability and the ability to add a piece of MGSE that would make manual rotation of the hinge easier and to allow instrumented torque measurements. The change in the spring design required more spacing between the output drum and take up roller. The take up roller diameter was increased to reduce its deflection.

An additional Vespel washer was placed between the end of the roller sleeve and the washer on the end to minimize friction between the roller sleeve and the CRES washer. The MDH axles were changed from the S-NPP design by eliminating cotter pins from the central area of the MDH where the RDA harness routes to the connector bracket on the inner panel. This minimized the amount of sharp edges exposed to the harness. The pawl, not shown, was modified to have a spherical surface that would engage the bottom of the cam surface at the end of range of motion and would provide a point contact during lockout.

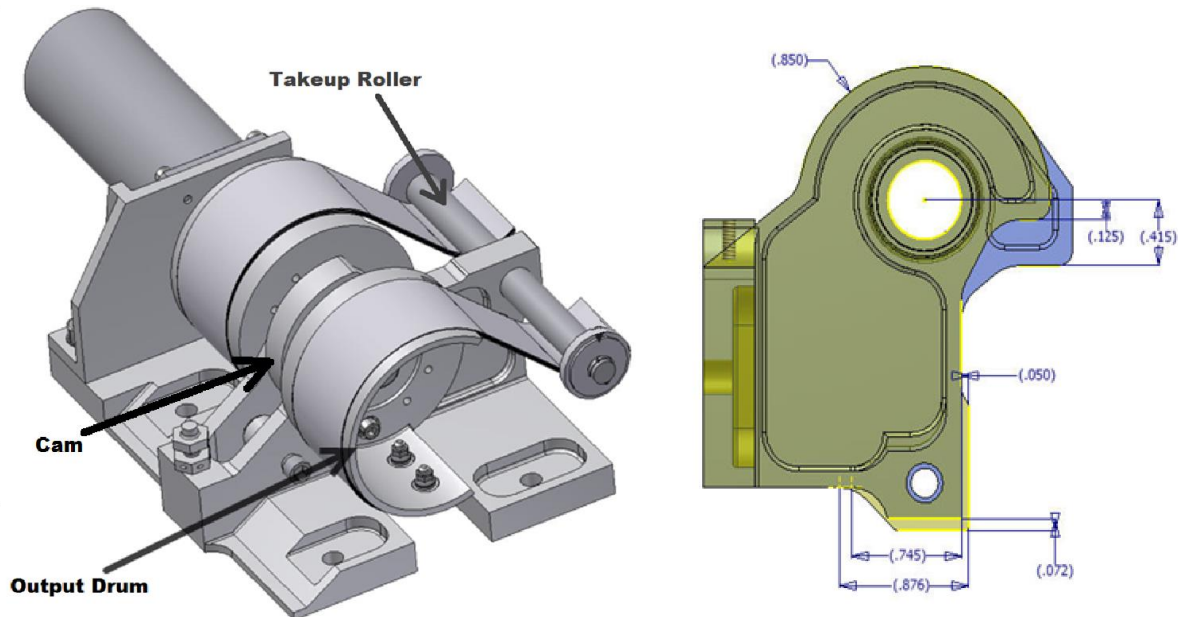
This IPH hinge design shown in Figure 7 also went through similar evolutions as the MDH. The output drum was increased in size to accommodate the larger constant torque spring. As with the MDH the take up roller was increased in diameter to minimize the deflection and accommodate the stronger spring sized for JPSS-1. The biggest change for the IPH design was the change in the design of the cam profile. The right side of Figure 7 shows the change from S-NPP, in blue, to JPSS-1 shown in yellow.

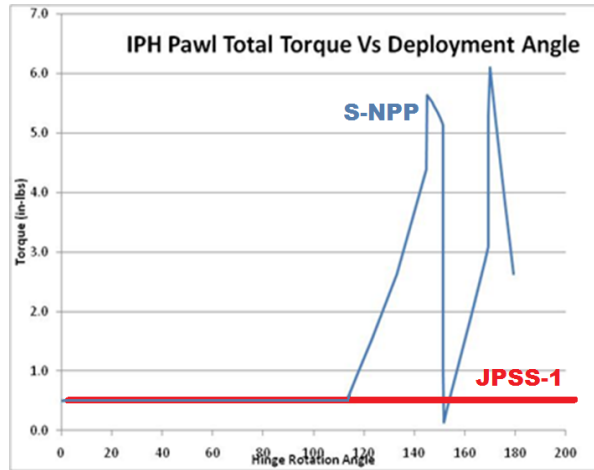
Figure 8. S-NPP variation in pawl drag torque over range of motion

Figure 8 shows how the previous cam profile resulted in a varying drag due to changes in the compression of the pawl spring across the range of motion. The modification to the cam profile achieved the value associated with the first 110 degrees, and JPSS-1 baseline, also shown in Figure 8. The blue line shows the S-NPP profile and the red line shows the JPSS-1 profile. This change in the cam profile made it consistent with the profile for the MDH, a constant resistive torque profile.

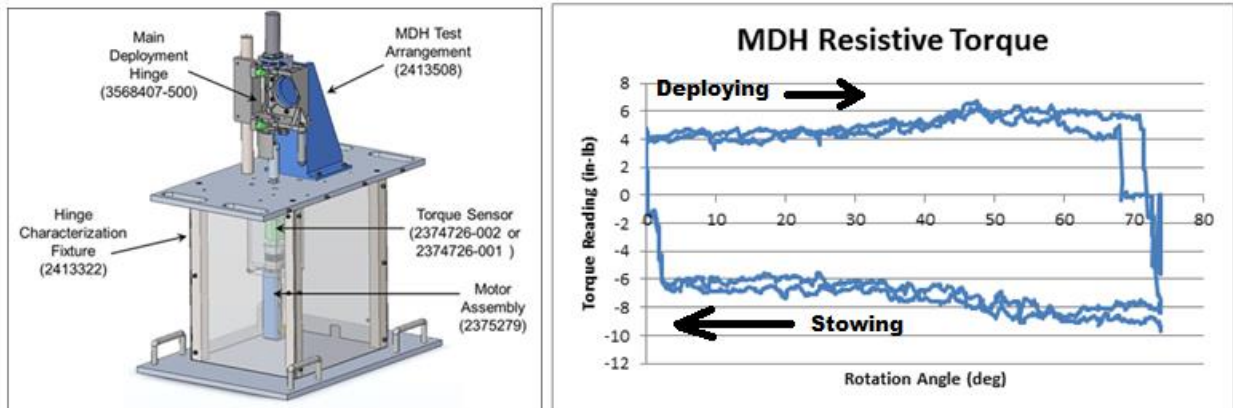
Figure 9. MDH Drag Torque Testing Apparatus and Results

The JPSS-1 MDH and IPH were both characterized for sources of drag torque in a much more consistent and repeatable method than S-NPP. Figure 9 shows the test set up used to characterize the MDH hinge. This apparatus consists of a drive motor in-line with a torque sensor and the unit under test. This test drove the hinge in both directions and had the pawls riding on the surface in both directions but did not go through the full range of motion to prevent the pawls from locking out. Figure 9 also shows an example data plot for the MDH hinge resistive torque test. In comparison, S-NPP characterized drag torque manually, with a torque watch and was not as repeatable nor as controllable over the range of travel.

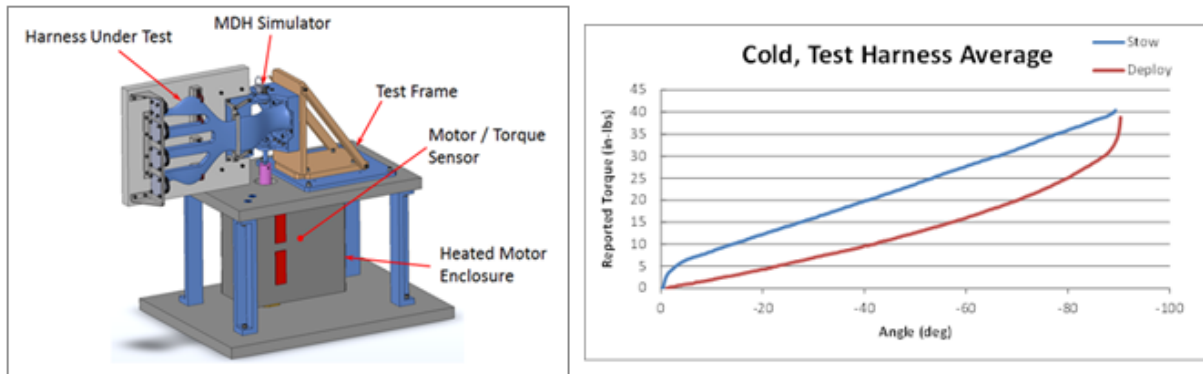
Figure 10 Harness Testing Apparatus and Results

An example data plot on the right side of Figure 10 shows the reduced data to account for the effects of the fixture and the resulting resistive torque of the harness over the range of motion. These results allowed engineering to determine the number springs that were required to meet the torque margin requirements. Once the springs were installed onto the mechanism, it was again attached to the fixture used to characterize the drag torque of the hinge to measure the output of the hinge and to directly measure the output torque of the hinge and validate the torque margin analysis.

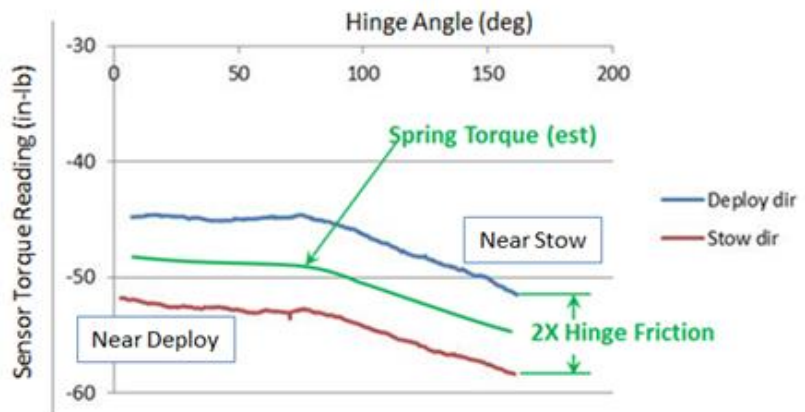
Figure 11. Typical Torque Data

Figure 11 shows a typical data plot and the slope of the data shows how the constant torque spring has some variation over the range of motion that the hinge rotates through. The friction in the system due to the applied load of the springs is the difference between the curves divided by two and the output torque of the spring is the average value of the curves. The minimum output torque is considered the available torque to the system for writing torque margin and the minimum value was found to always be at the end of travel.

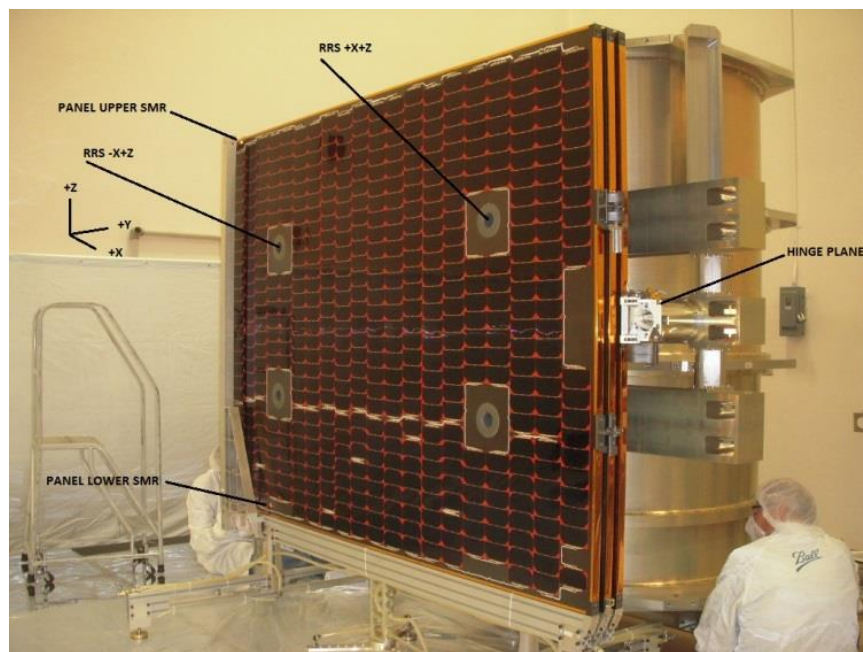
Figure 14. Setup for Alignment of MDH Hinge Axis

The deployment floor was aligned to gravity and it was possible to align the main deployment hinge axis to the deployment floor. This was done by placing two laser tracker nests onto the panel and rotating it 90 degrees. The resulting arc measurements allowed the hinge axis orientation to be determined. It was not possible to account for the orientation of the inter panel hinges to the deployment floor. The setup for the alignment of the hinge axis is shown in Figure 14.

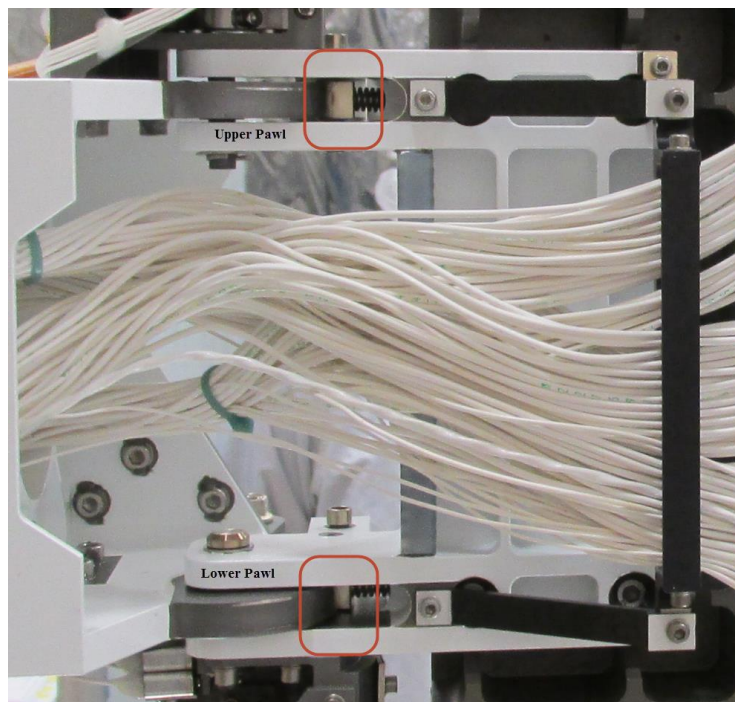
Figure 16. MDH Pawl Engagement Issue

After the deployment was completed each hinge line was inspect to verify that the pawls were engaging with the cams correctly. It can be seen in the left-side ovals in Figure 16 that the lower pawl of the MDH engages into the cam further than the upper pawl. This is a result of minor variations in the deployment floor height and the fact that the air bearings cannot be controlled to equally off-load the panel.
