EVALUATION OF 3D PLUS PACKAGING TEST STRUCTURES FOR NASA GODDARD SPACE FLIGHT CENTER

Abstract:
Environmental tests were performed on packaging test structures designed and manufactured for ESA and CNES by 3D Plus Electronics. The design provided circuit elements that acted as thermal, mechanical and moisture sensors. Other design features showed the compatibility of the packaging with chip passives, bare electronic dice and plastic encapsulated microcircuits packaged together in an innovative, stacked multichip module. The NASA GSFC testing augmented long duration testing on the same units carried out by ESA and CNES. The NASA portion demonstrated packaging stability over temperature, in moisture, with voltage stress, in shock and in vibration environments.

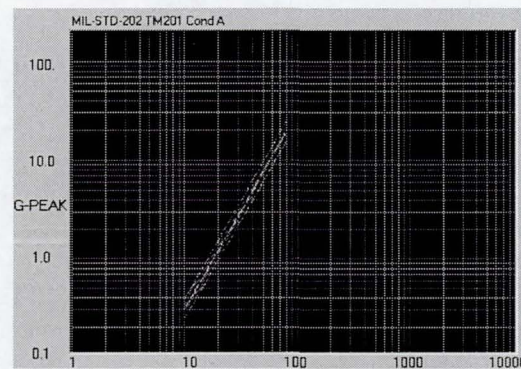
Figure 5. Sine Vibration Spectrum – test setting and achieved profile

4.3.5 Sine Vibration.
Sine vibration was done in accordance with MIL-STD-202, Method 201, Condition A. Figure 6 shows the sine vibration profile used.

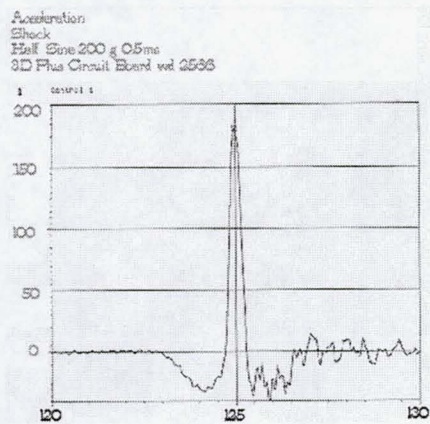
Figure 6. Shock Profile

4.3.6 Mechanical Shock
Mechanical shock was performed in accordance with MIL-STD-883, Method 2002, with a peak level of 200g and a pulse duration of 0.5 ms. Figure 6 shows that shock profile was applied both in the upward and downward direction. The parts were fixtured and tested in the X,Y and Z axis as well. All layers were electrically tested after the test.

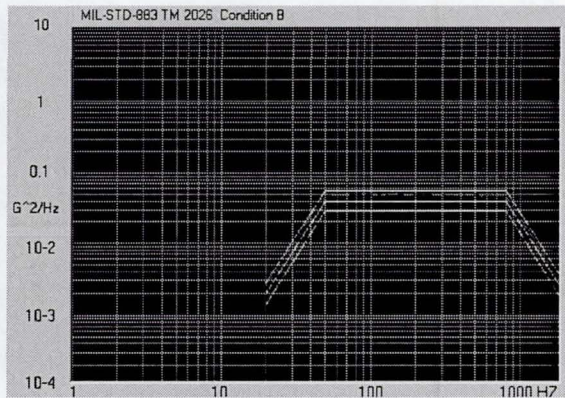
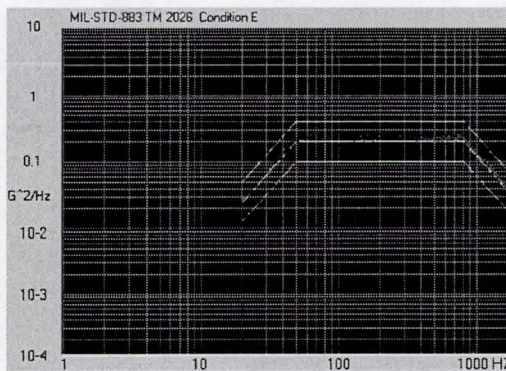
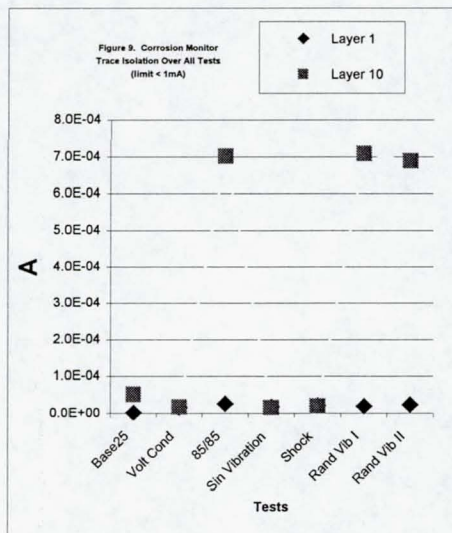
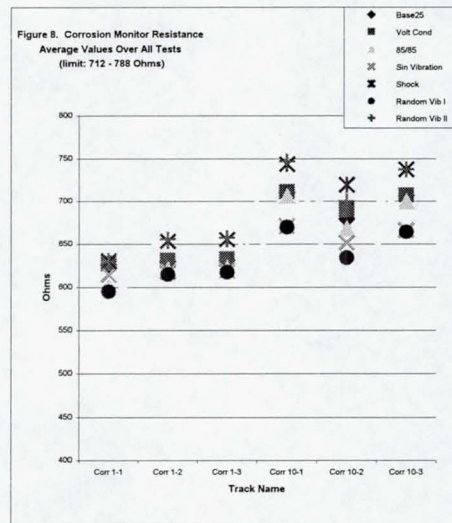
*Figure 7a. Random Vibration I – test and resulting profile*

4.3.7. Random Vibration
Random vibration testing was performed in accordance with MIL-STD-883, Method 2026 in the X,Y and Z-axes. The 4.5" x 4.5" test board was rigidly mounted at the corners and at the center to limit board effects. Random Vibration I uses Condition E (16.4 G) and Random Vibration II used Condition B (7.3 G). Figures 7a and 7b show the test conditions and the resulting profiles.

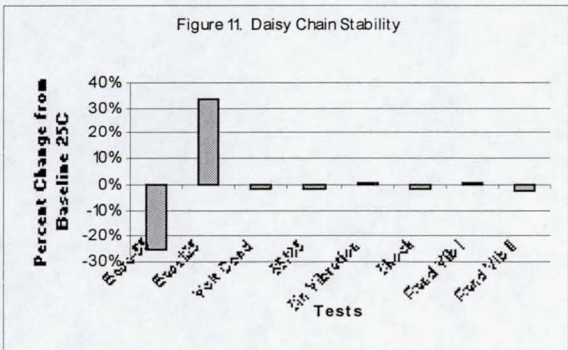
Figure 11. Daisy Chain Stability

4. Daisy Chain Wire Bonds: All measurements showed continuous circuits with no permanent sensitivity to moisture or other environment changes.
