# Energy and Seismic Recovering of Ancient Hamlets: the Case of Baia e Latina

**Abstract:** This research proposes the development of a diagnostic tool to separately inspect the energetic and seismic behaviour of buildings in the small hamlet of Baia e Latina (district of Caserta) in order to evaluate and implement retrofitting interventions from seismic, energetic, and functional points of view. Methods, approaches, and tools relating to the minimisation of seismic vulnerability and energy consumption have been increasingly used and tested in order to ensure both sustainability and safety, with a connection that may improve the performances of both cultural and environmental heritage. The diagnosis method, stemming from the energy audit and the energy imprint evaluations of the buildings system (and the envelope above all), aims to redesign the whole construction or some of its parts within an energetic framework. With reference to the seismic behaviour of building aggregates, the basic methodology that has been conceived for isolated masonry buildings through a survey form has represented the starting tool for the application of an appropriate quick evaluation form considered fo

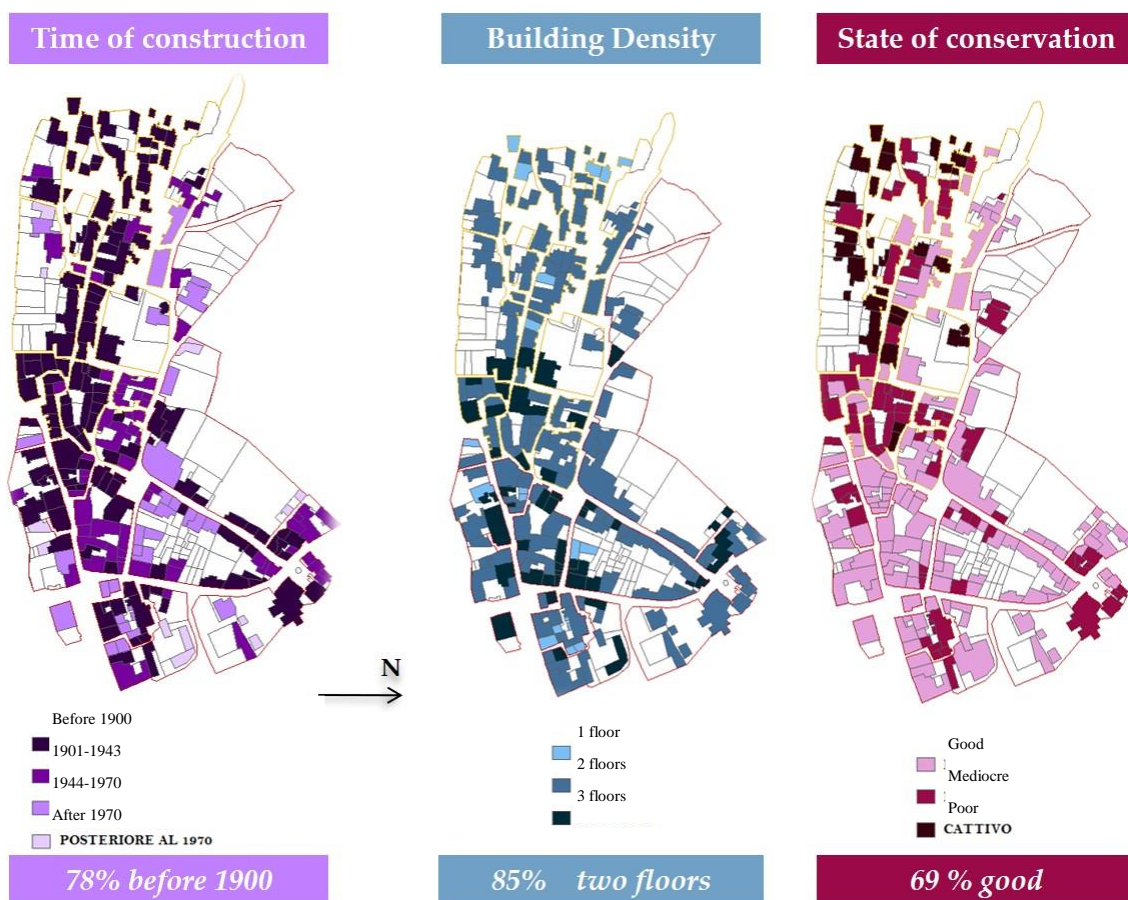
The assessment of the energy quality of the building heritage on a territorial scale, considering the time of construction, the building density, and the state of conservation, is the precondition for implementing an integrated planning of retrofit interventions on an urban scale (Figure 3).

**Figure 3.** Energy quality of the building heritage.

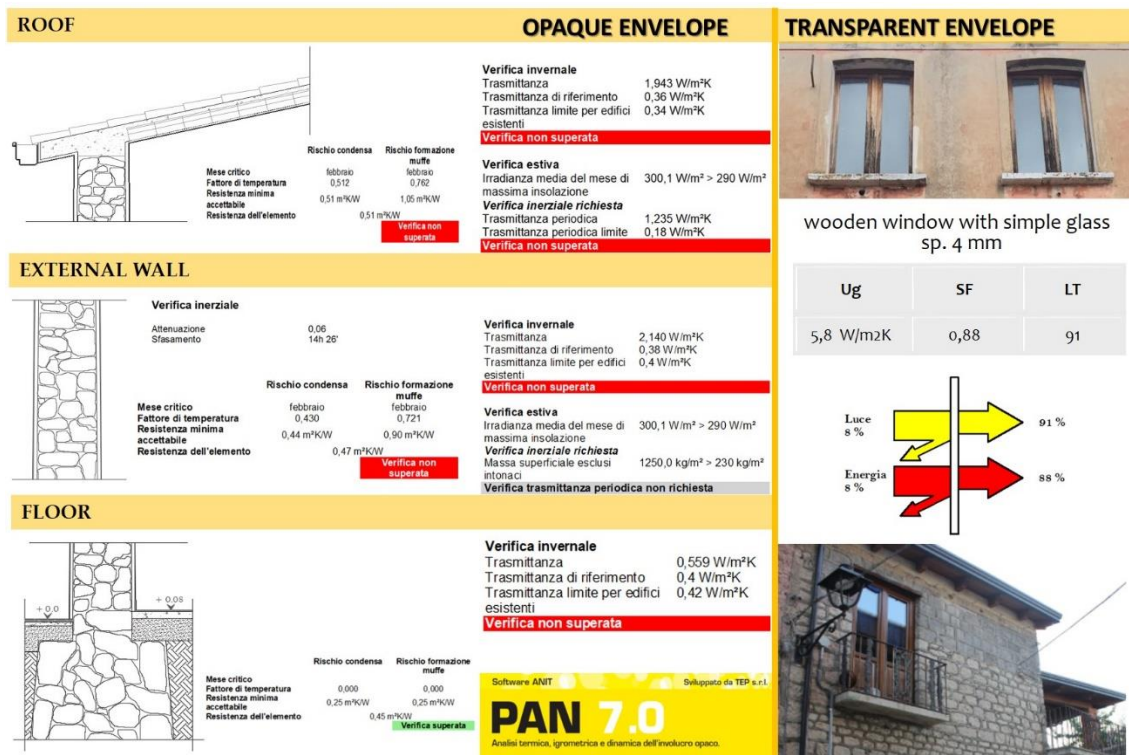
Control of the thermal energy quantity exchanged by the envelope with the outdoor environment is monitored through the calculation of both the stationary parameters of transmittance ($U < 0.40$ W/m$^2$K in climatic zone C) and surface mass ($M > 230$ kg/m$^2$), and the dynamic parameters of attenuation ($A < 0.10$) and shift ($S \geq 12$ h). Nevertheless, the risk of creating superficial mould and interstitial condensation are tested on the opaque envelope (Figure 4).

**Figure 4.** Energy performance of existing buildings.

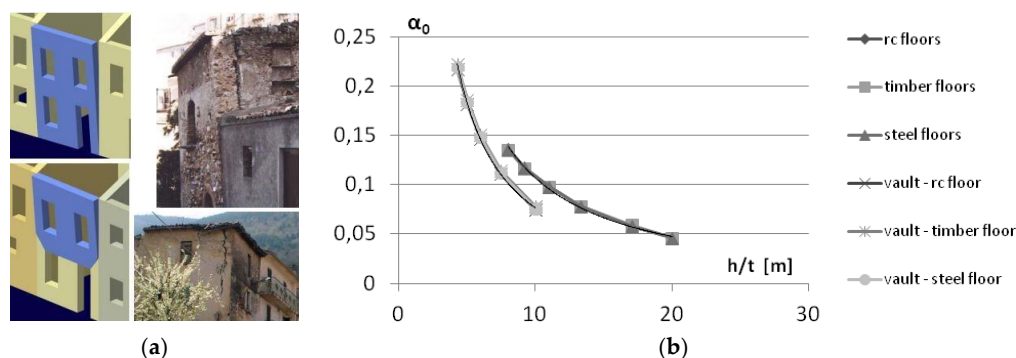
The most recurrent out-of-plane failure mechanism, namely the wall overturning, can be evaluated for masonry S.U. of historical centres on the basis of the principle of virtual work, which provides the collapse load multiplier $\alpha_0$ activating that mechanism. Based on the previous research activity illustrated in Formisano et al. [34], these multiplier factors were determined for several masonry walls, belonging to buildings with one to three storeys, by considering the variability of input data (mechanical properties of the masonry, wall thickness, number of floors, storey height, geometry of openings, and type of floors). As an example, these multipliers related to the building with two storeys have been plotted as a function of the wall slenderness (h/t) in Figure 6.

With reference to the overturning mechanism of structural unit masonry walls, the collapse load multipliers, representing their capacity accelerations, are determined first. Later on, the demand accelerations due to the earthquake expected in the historical centre site are computed for those walls. Finally, by comparing capacity accelerations with demand ones, the safety checks of masonry walls towards the investigated collapse mechanism can be done and, therefore, the most dangerous situations can be determined.

**Figure 6.** Multipliers related to the building with two storeys: (**a**) overturning mechanisms, (**b**) design chart for collapse load multipliers assessment of two-storey buildings.

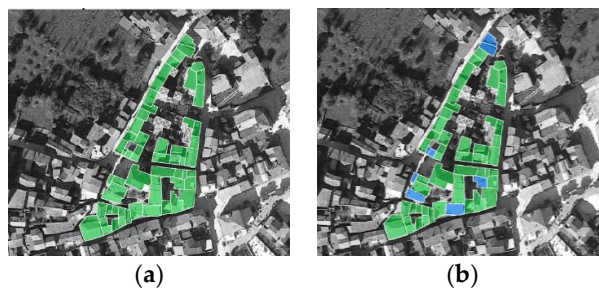
Figures 10–13 show some of the 18 damage maps. It is highlighted that increasing magnitude, at the same epicentre distance, corresponds to an increase in buildings that suffer serious damage, just as the increase in epicentre distance reduces the number of extremely damaged buildings. The buildings that develop the most damage are especially those that have a poorer planimetric interaction and a more irregular distribution of in-plan resistant elements. From the maps, it is apparent that the most damaged buildings, which are located in the lower part of the study area, are the most ancient ones, and have not been subjected to retrofitting interventions to improve their seismic behaviour.

**Figure 13.** Damage maps: (**a**) E.D. = 30 km and M = 4 and 5; (**b**) E.D. = 30 km and M = 6.
