NASA/TM—2019-219731

Wear Trends of the HERMeS Thruster as a Function of Throttle Point

George J. Williams, Jr., Hani Kamhawi, Maria Choi, Thomas W. Haag, Wensheng Huang, and Daniel A. Herman
Glenn Research Center, Cleveland, Ohio

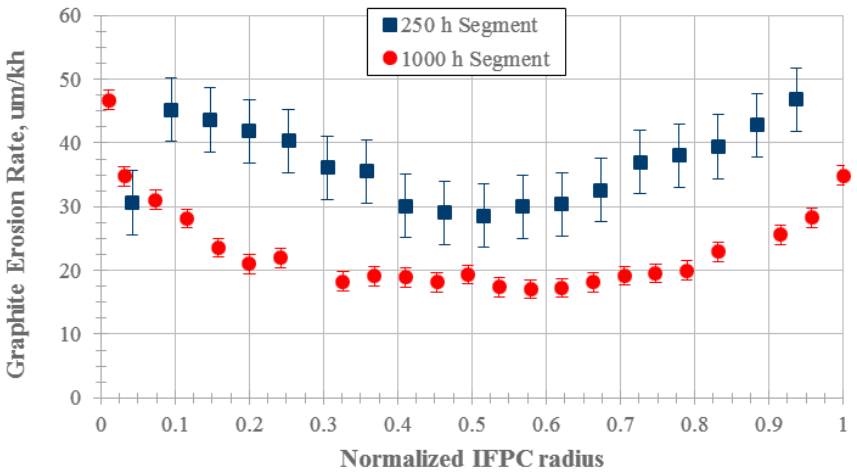
Figure 10.—Graphite erosion rates of the TDU-1 IFPC for two segments of the 2016 1700 h wear test (Ref. 9).

Recalling that the measurement resolution uncertainty is 1.0 μm (±0.5 μm) the error in graphite erosion depth is roughly ±1.2 μm which corresponds to ±6.0 μm/kh for a 200 h test extrapolated to 1000 h. Figure 10 compares the graphite erosion rates measured on the IFPC of TDU-1 during two segments of the 1700 h wear test in 2016 (Ref. 9). Note that the rates of the shorter duration have much larger uncertainties, but that the uncertainties are not sufficient to account for the difference in the rates measured in the two segments. The potential of a much larger source of uncertainty, initial rates versus sustained rates, is discussed in Section 4.0 and is shown to not explain the differences in the two trends in Figure 10.

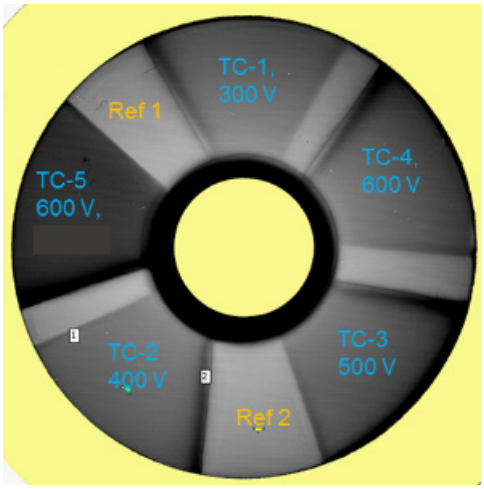
The keeper electrode in TDU-3 exhibited unexpectedly high levels of erosion. Figure 11 shows an image of the keeper post test formed by profilometer measurements and indicates which region corresponds to a particular segment of the testing. Note that there is a circular step forming an annulus around the inner aperture which was unmasked throughout the test campaign. This is a region of erosion roughly 50 μm deep and represents aggregate erosion over the 996 h of TDU-3 operation. An isometric image of the keeper face is given in Figure 12 and shows the relative depth of the different regions.

Figure 11.—Regions of TDU-3 keeper exposed during each of the short duration wear tests in VF-5.

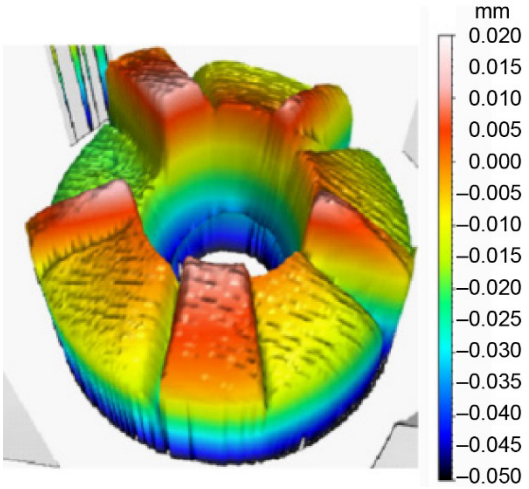
Figure 12.—Erosion of the TDU-3 keeper during each of the short duration wear tests in VF-5.

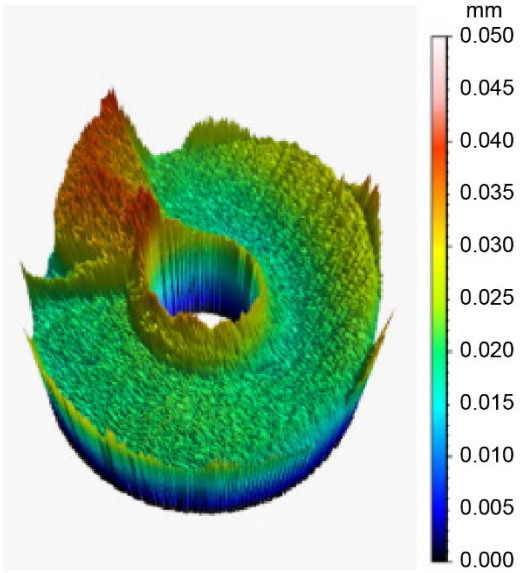
Figure 13 shows a profilometer image of the keeper face from TDU-1 which can be contrasted with that in Figure 12. Unlike the raised, reference regions in Figure 12 which correspond to protected segments of the TDU-3 keeper, the raised region in Figure 13 is the exposed region—showing net deposition. Note that the exposed segment was exposed for both wear tests in VF-6 in order to resolve the expected low erosion rates (measured on the keeper of TDU-1 in 2016 after 1700 h). The exposed regions (cutout and inner annulus) show net deposition of 15 and 8 μm, respectively (with no discernable radial variation). These correspond to deposition rates of 60 and 24 μm/kh, 50 to 100 times greater than the QCM-measured deposition rates from the facility. High-resolution imaging of the deposition shows the deposited graphite to be columnar and covering only ~ 30 percent of the Mo surface. This is radically different from the deposition observed on the QCM crystals and on the OFPC of TDU-1 which was densely packed (Ref. 9). The difference in the morphology of the deposited graphite is likely due to the dense plasma near the keeper orifice.

Figure 13.—Deposition on the TDU-1 keeper following the two short duration wear tests in VF-6.

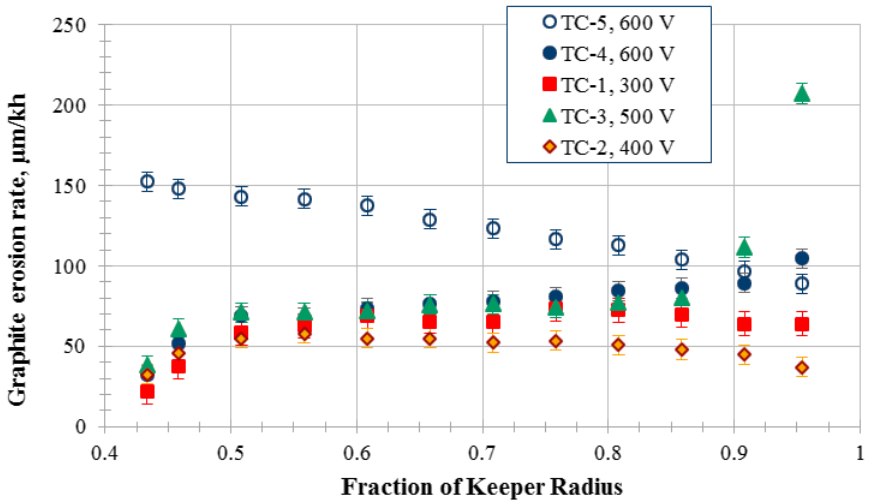
Figure 15 compares the erosion profiles of each exposed section of TDU-3's keeper with respect to the two "reference" sections (see Figure 11). Note that the high-magnetic field case (TC-5) has a significantly different erosion pattern. Except for the extreme outer radius, the rates for the other test conditions follow the same trends and nearly lay within the uncertainty of the measurement. The depth of the step at the inner radius of the TDU-3 keeper is 50 μm which corresponds to a time-weighted linear addition of the rates observed at the inner edges of the segments which were each exposed for only one of the tests. This implies there was no significant change in erosion rate over time and that the polished surface of the keeper did not accelerate the erosion observed in each segment.

Figure 15.—Erosion rates of the TDU-3 keeper as a function of keeper radius each of the short duration wear tests in VF-5.

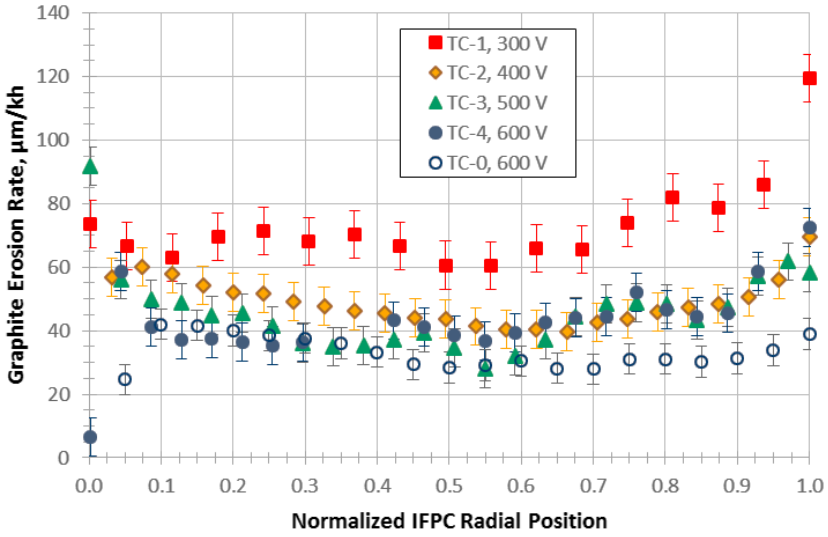
Figure 16.—Comparison of IFPC erosion as a function of discharge voltage.

The erosion of the inner front pole cover of TDU-3 as a function of discharge voltage is shown in Figure 16. All data is for the thruster being operated with the nominal magnetic field. For reference, the 250 h erosion pattern of TDU-1 (TC-0) is also shown. Error bars indicate that there is very little variation in erosion rates except for the 300 V data, which is between 50 and 100 percent greater than those for other discharge voltages. Exceptions to this rule occur at the extreme inner and outer radii. For comparison, the erosion rates measured following the performance characterization test (TC-4) are included. Figure 17 shows that the erosion trends of the Mo strips followed the same general trends as the graphite IFPC, though the rates, as discussed in detail below, were much higher, especially near the inner radius of the IFPC.

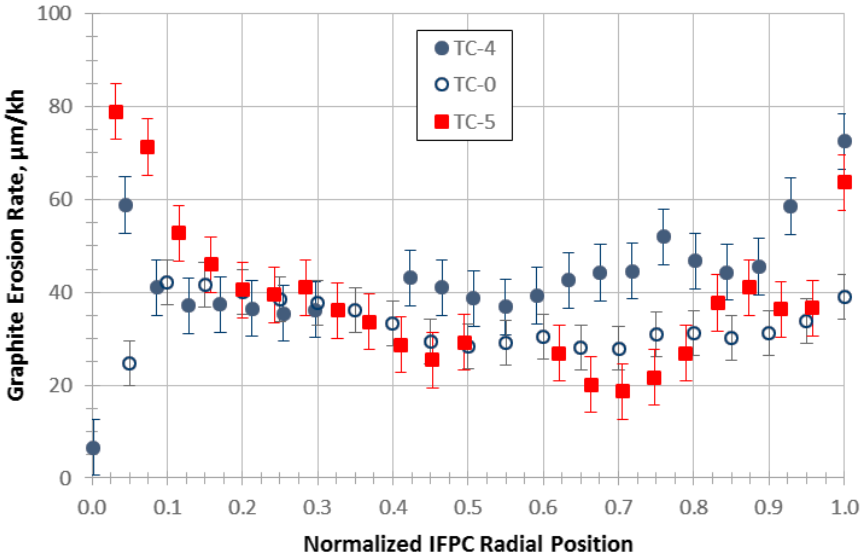
Figure 18.—Comparison of IFPC erosion as a function of magnetic field for V_d = 600 V in VF-5. Note that TC-5 has a 125 percent higher B-field.

Figure 18 shows that operating at a higher magnetic field had minimal impact on the IFPC (graphite) erosion rates except at the extreme inner radius. This is in clear contrast to the erosion rates of the Mo strips with nearly 20 times greater near the inner radius as shown in Figure 19. (Note that no Mo data were collected for TC-4.) The higher graphite erosion rate for TC-5 at the inner radius of the IFPC

contrasts with the dip seen in the TC-0 and TC-4. This may correlate with the higher erosion measured on the keeper which was much greater for this (TC-5) condition.

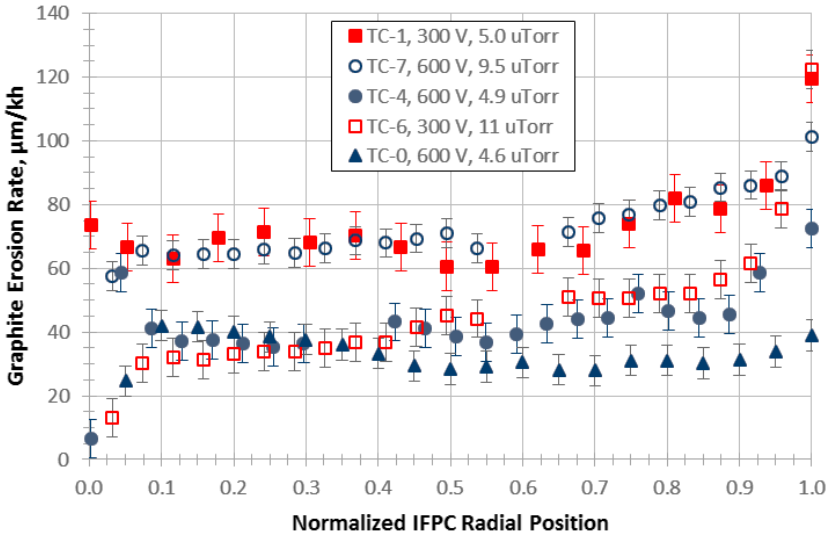
Figure 20 shows that there is a clear, but inconsistent, impact of pressure on IFPC erosion rates. As noted in Table I, TC-0 corresponds to TDU-1 operation in VF-5, TCs 1-5 correspond to TDU-3 operation in VF-5, and TCs 6-7 correspond to TDU-1 operation in VF-6. However, performance variations were negligible for operation at the same discharge voltage and power regardless of TDU or facility. Therefore, the significant changes are believed to be dominated by the change in facility pressures. The erosion rate of the 600 V case is much higher at higher pressure (TC-7 vs. TC-0 and TC-4) whereas the erosion rate of the 300 V case is significantly lower (TC-6 vs. TC-1) at higher pressure. However, the trends observed on Mo strips show consistently decreasing erosion rates with pressure. Figure 21 compares data for 600 V, 12.5 kW operation in several test campaigns over a range of pressures. The SLA data suggest a varied trend, with outliers on both the inner and outer IFPC radii (Ref. 11).

Figure 20.—Comparison of IFPC erosion as a function of facility pressure.

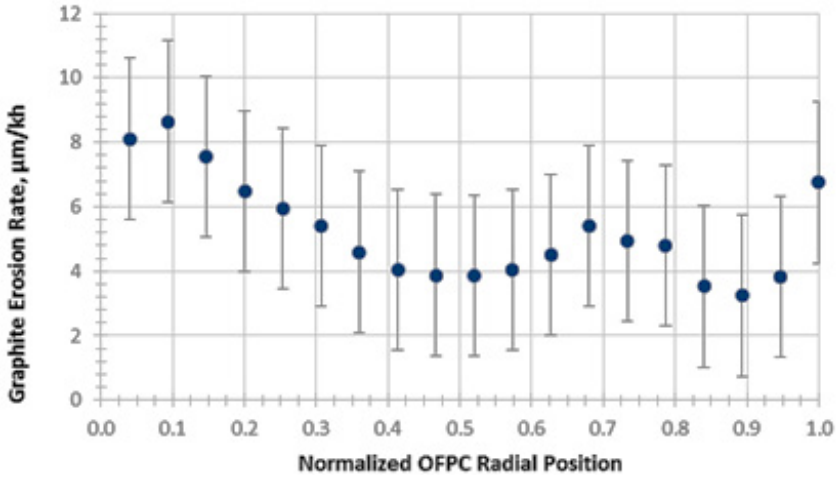
Figure 22.—OFPC erosion as a function normalized OFPC radius.

No erosion was measured on the outer front pole cover (OFPC) of TDU-1 during the 2016 wear testing. No deposition was measured on it either, suggesting a nearly unchanged surface. This was true for both graphite and alumina outer pole covers (Ref. 9). Erosion of the outer pole cover was measured following the completion of the TDU-3 wear testing (after 996 h). Figure 22 shows that the OFPC eroded at a rate between 2 and 10 μm/kh, with (slightly) greater erosion occurring on the inner channel-side of the OFPC.

Figure 23 shows the erosion rates measured on the Mo strip on the OFPC for TC-1, 2, 5, and 7 wear tests. These indicate that the erosion of the graphite OFPC varied with thruster operating condition and that the slightly greater erosion on the inner third of the OFPC (Figure 22) occurred during the 300 V operation. Small Mo erosion rates were observed on the Mo strips for the 600 V operating cases (TC-5 and TC-7; no Mo strips were incorporated for TC-4). Comparing to IFPC and keeper erosion rates, these low Mo rates would likely result in very small graphite erosion consistent with Figure 22 and the results of the 1700 h wear test (Ref. 9).

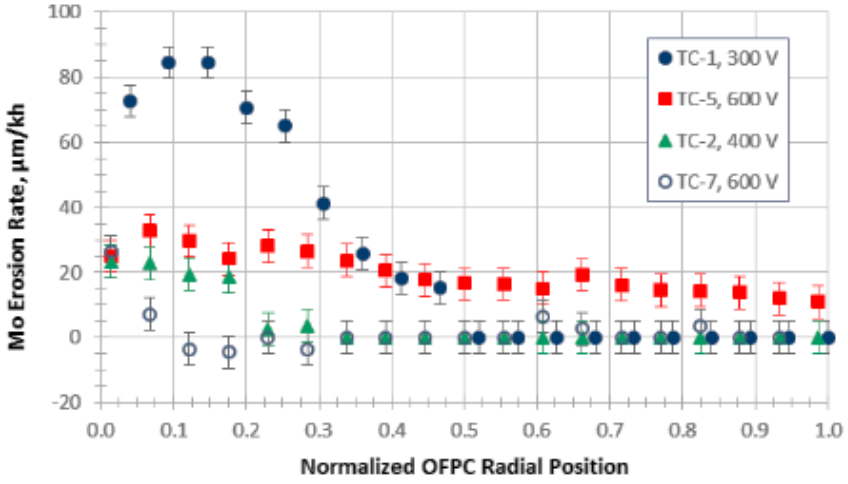
Figure 23.—OFPC Mo strip erosion as a function normalized OFPC radius for several test conditions.

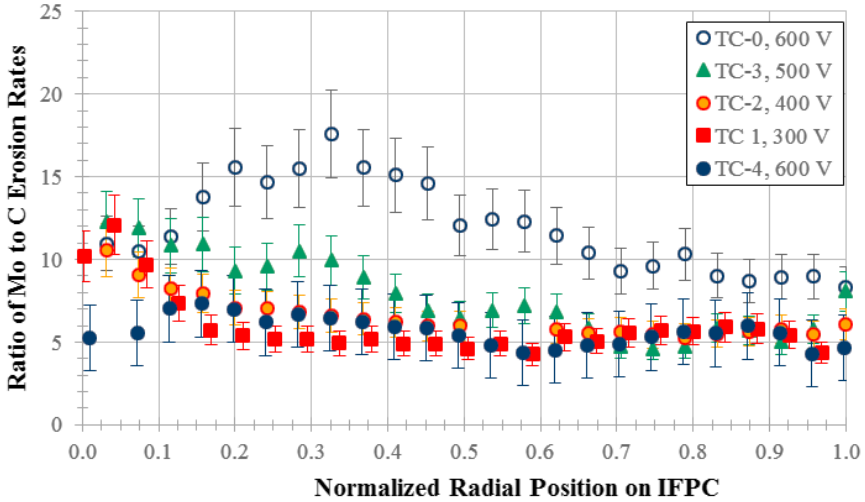
Figure 26.—Ratios of Mo to C IFPC erosion rates as a function of discharge voltage.

Figure 26 compares the ratio of TDU-3 IFPC Mo to C (graphite) erosion rates as a function of discharge voltage. Uncertainties have been increased reflecting the uncertainties associated with both Mo and C rates themselves. For TC-1, TC-2, and TC-3 data, the ratios are similar over the majority of the IFPC radius between values of 5 and 8. From Figure 25, this suggests incident ion angles above 45°, with no resolution of the ion energies themselves. However, protrusions on the IFPC including fastener heads, graphite masks, and bushings for the fasteners did not reveal any shadowed regions as were seen on the OFPC (Figure 6). Detailed profilometry near an IFPC bushing for TC-2, TC-3, and TC-5 showed masking where the bushing overlapped the IFPC but otherwise, in 360°, erosion consistent with the rest of the IFPC. This suggests the eroding ions were nearly normal in incidence. Unless the ions were in the high-energy tail of a high-temperature (many eV) distribution with a hundreds of eV mean energy, there is no corresponding region in Figure 25 that would have normally incident ions with that ratio of yields. If, however, the curves are overestimating the ratio values, then there would be two populations of ions that could result in the erosion, low-energy (sub 100 eV) and high-energy. Without further measurement, it is impossible to determine which population is dominant. However, the overlap of the curves suggest the same source and energy of ions are responsible for the IFPC erosion for TC-1, TC-2, and TC-3 (300 V to 500 V operation).

Since there was no dedicated 600 V, 20.83 A test using TDU-3, assessing whether this operating condition falls along the same trends is problematic. The ratio for TC-0 (TDU-1) is shown in Figure 26. Note that it has a fundamentally different trend. This may result from either the configuration differences between TDU-1 and TDU-3. A ratio of the graphite erosion observed during TC-4, 600 V and Mo erosion from TC-0, 600 V is also shown in Figure 26. Note that the ratio now trends with the other TC's except near the IFPC's inner radius. The difference in Mo erosion rate near the cathode very likely follows from the differences in TDU-1 and TDU-3 cathode location. The convergence of the TC-4 data with the other data over the rest of the radius suggests that there is a fundamental difference in IFPC erosion between the two configurations. Unfortunately, TC-7, 600 V ratios trend differently from both TC-0 and TC-4 data as shown in Figure 27. Lower graphite erosion relative to Mo erosion shown in Figure 16, Figure 17, and Figure 26 suggest TDU-1's IFPC was eroded by lower0energy ions (regardless of angle of incidence) than TDU-3's IFPC.

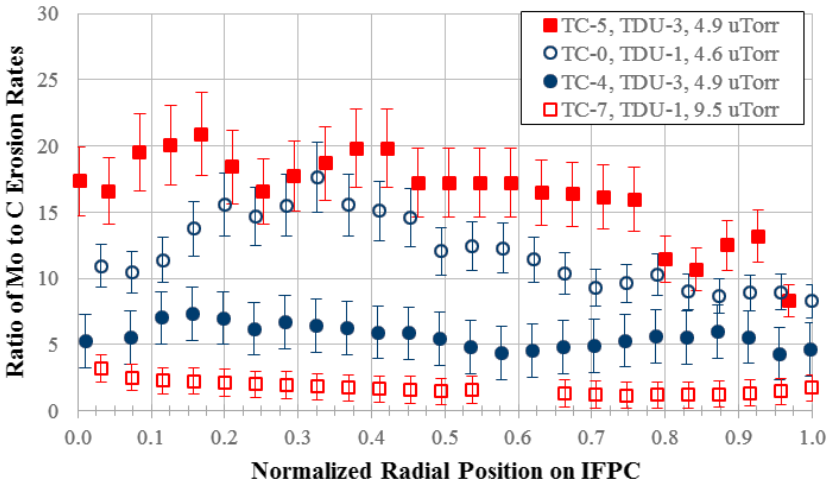
Figure 27.—Ratios of Mo to C IFPC erosion rates as a function of facility pressure and TDU configuration for V_d = 600 V.

Figure 27 compares all four sets of 600 V data (TC-0, 4, 5, and 7). TC-5's higher magnetic field significantly increases the ratio of Mo to graphite erosion without significantly changing the graphite erosion rate itself (cf. Figure 18). Indeed, the graphite erosion rates of TC-0, 4, and 5 are comparable except near the cathode. The variation in the ratios shown in Figure 27 indicate that there are more low-energy ions near the cathode (inner radius of the IFPC) for the higher magnetic field of TC-5. The increase in low-energy ions is also consistent with the ratio of regression rates shown in Figure 25, where values above 15 would likely lie in an extrapolation (within the uncertainty) near the threshold region of the curves. Again extrapolating within the uncertainties in Figure 25, the very low values of TC-7 in Figure 27 would suggest that the IFPC erosion is dominated by high-angle of incidence ions at higher pressures. This is consistent with some previous investigations (Refs. 10 and 13). Unfortunately, regardless of whether this explanation is valid, the TC-7 data do not support a conclusion regarding differences in the IFPC erosion of the two TDU configurations since the Mo rates trend in the opposite direction.

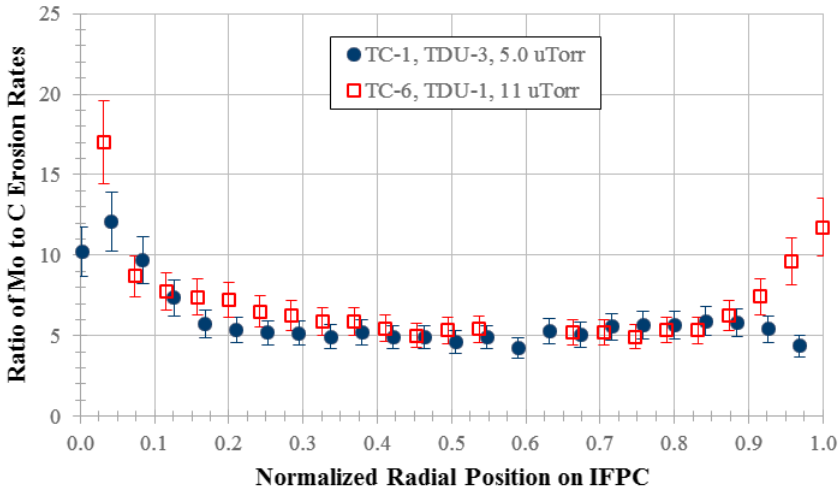
Figure 28.—Ratios of Mo to C IFPC erosion rates as a function of facility pressure and TDU configuration for V_d = 300 V.

Figure 28 compares the ratios of Mo to graphite (C) erosion rates for the two 300 V test conditions, TC-1 and TC-6. Recall from Figure 20 that the rates of graphite erosion of TC-6 are roughly 50 percent of those of TC-1. That the two sets of data in Figure 28 lie on nearly on top of each other over the majority of the IFPC radius suggests that the reduction in erosion associated with the higher background pressure is due to a reduction in overall flux of eroding ions and independent of a change in angle of incidence or mean energy. However, there could have been a proportional change in both that yielded the same values, but that is less likely. The differences in the ratios in Figure 28 near the outer radius suggest differences in the fluxes of low-energy ions.
