FRACTURE RESISTANCE OF EYEBARS ON THE LIBERTY BRIDGE

A Thesis

May 1978

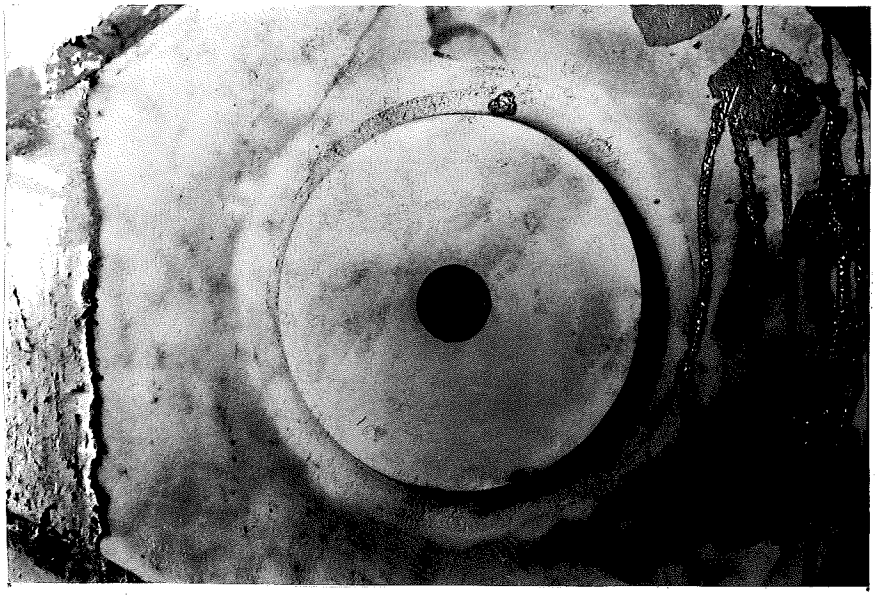
Fig. 4 Eyebar Head U 36A with Pin Cap Removed

The exposed eyebar head U 36A is shown in Fig. 4. Visual inspection with a magnifying glass did not reveal any cracks or sharp notches at the eyebar heads U 35A, U 35D, U 36A, U 36D and U 47A. The Acoustic Crack Detector (ACD) of the Federal Highway Administration was also used and did not find any cracks or flaws in the same eyebar heads. The eyebar head faces, however, had forging marks which could be seen after the faces were sandblasted clean. An example is shown in Fig. 5. These forging marks were not situated at the crucial points, nor were the directions of the marks perpendicular to the primary stresses in the heads. Since the ACD could not detect their presence, the depth of these marks were assumed to be shallow. Later examinations in the laboratory did not reveal any adverse condition.

The pins and pin holes at U 35 and U 36 appeared to be in fairly good condition by visual inspection after the eyebars were removed from the panel. The holes were slightly larger than the pins and were very slightly elongated under the dead weight of the bridge. When the dead loads were removed from eyebars U 35 - U 36A and D, there was no apparent permanent deformation at the holes. There was some indication of corrosion in the pins between eyebars at these two panel points, but was quite moderate when compared to the corroded condition of some steel parts of the deck system. The eyebar shanks generally were in fairly good condition except for the existence of bird droppings. Some eyebar heads, such as U 35 and U 36, have also been subjected to excessive moisture due to the deteriorated condition of the deck. The pin caps, bolts and nuts, however, were in excellent condition.

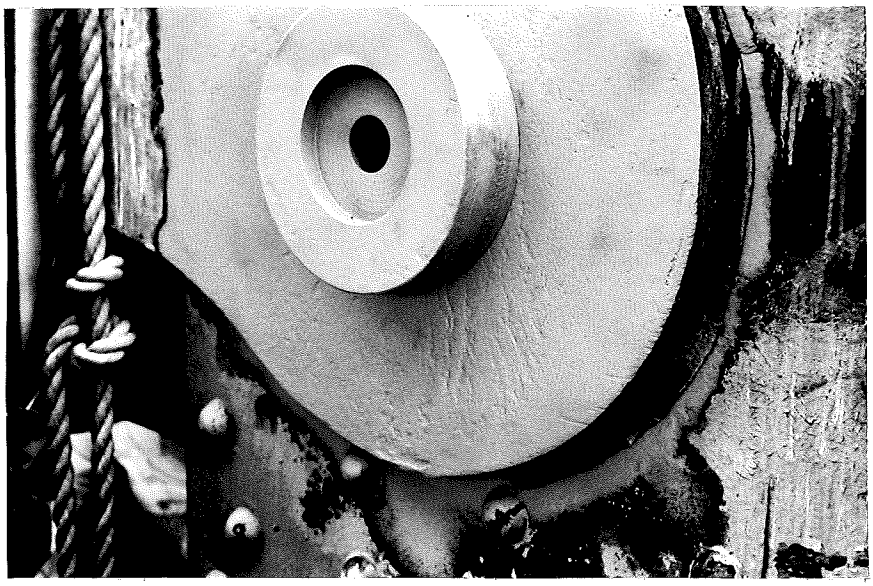
Fig. 5 Sandblasted Eyebar Head Showing Forging Marks

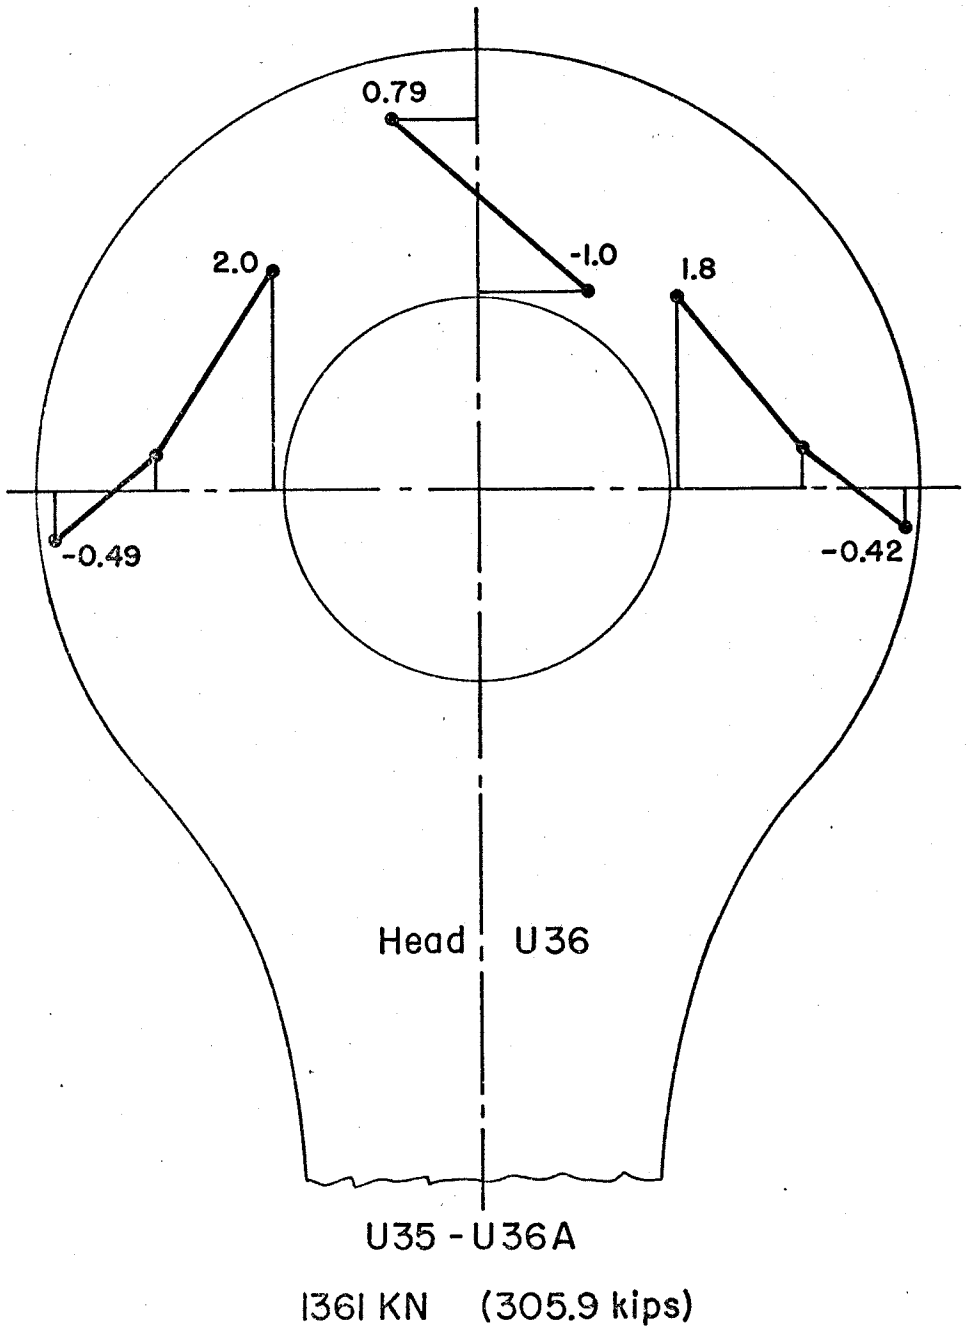
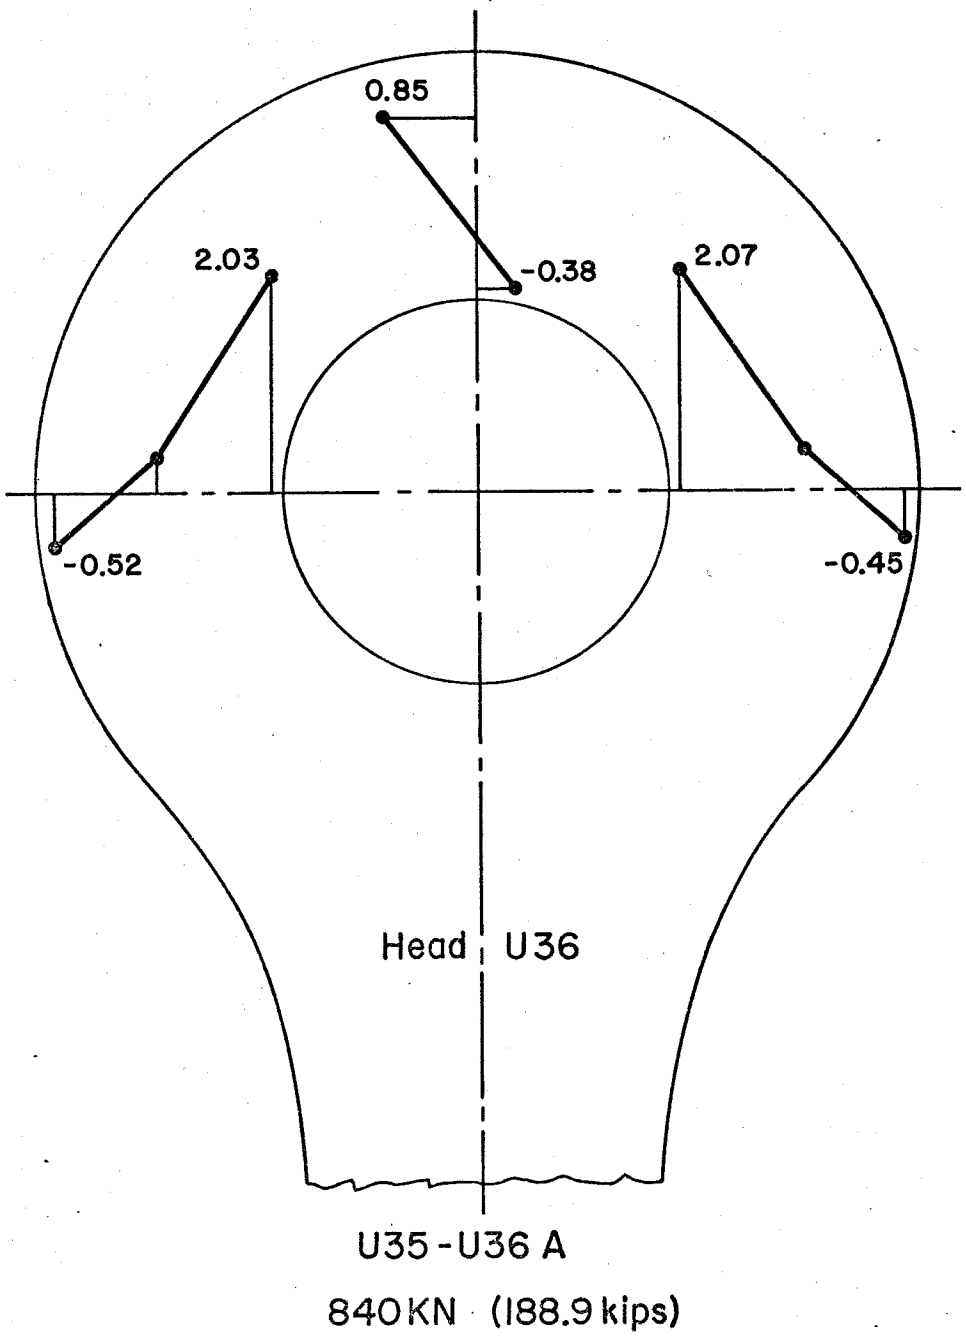
The measured stresses in the eyebar heads confirmed the condition of adhesion between eyebar head faces. The measured stress

distribution at U 36A, as shown in Figs. 10 and 11 agrees well with that obtained by stress analysis[4]. On the other hand, the recorded stress distribution in U 35A indicated a very moderate stress gradient and is shown in Figs. 12 and 13. The magnitude of stress at the pin hole was about the same as that in the shank of the eyebar. This condition implies that the force transmitted at U 35A was not through the pin, rather it was through the bond between the faces of joining eyebars U 34 - U 35A and U 35 - U 36A in adjacent panels.

Fig. 10 Non-dimensionalized Measured Stress Distribution - U 36A Dead Load

Fig. 11 Non-dimensionalized Measured Stress Distribution-

U 36A Partial Load

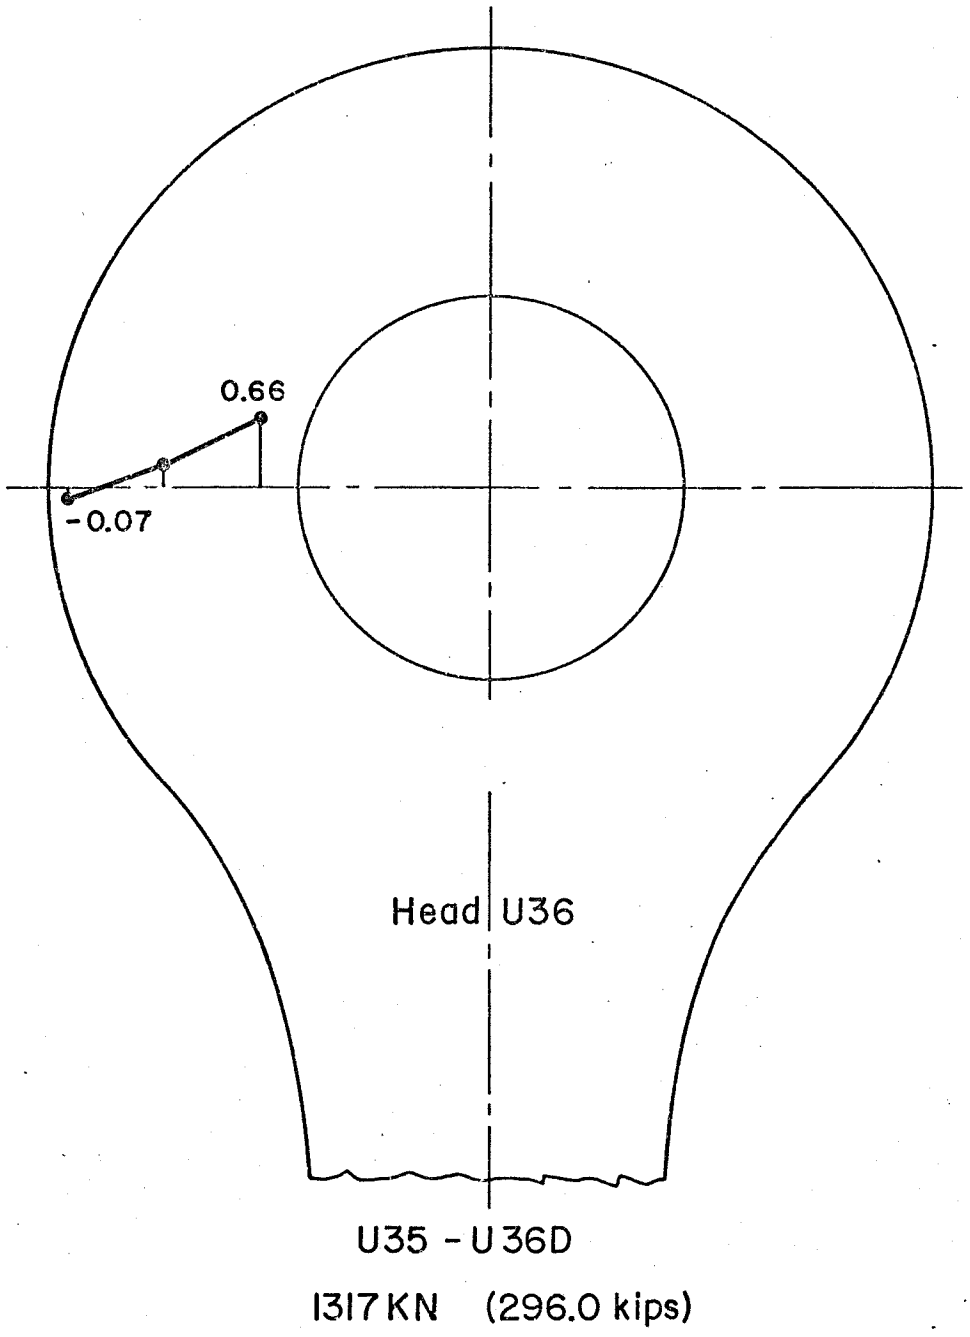
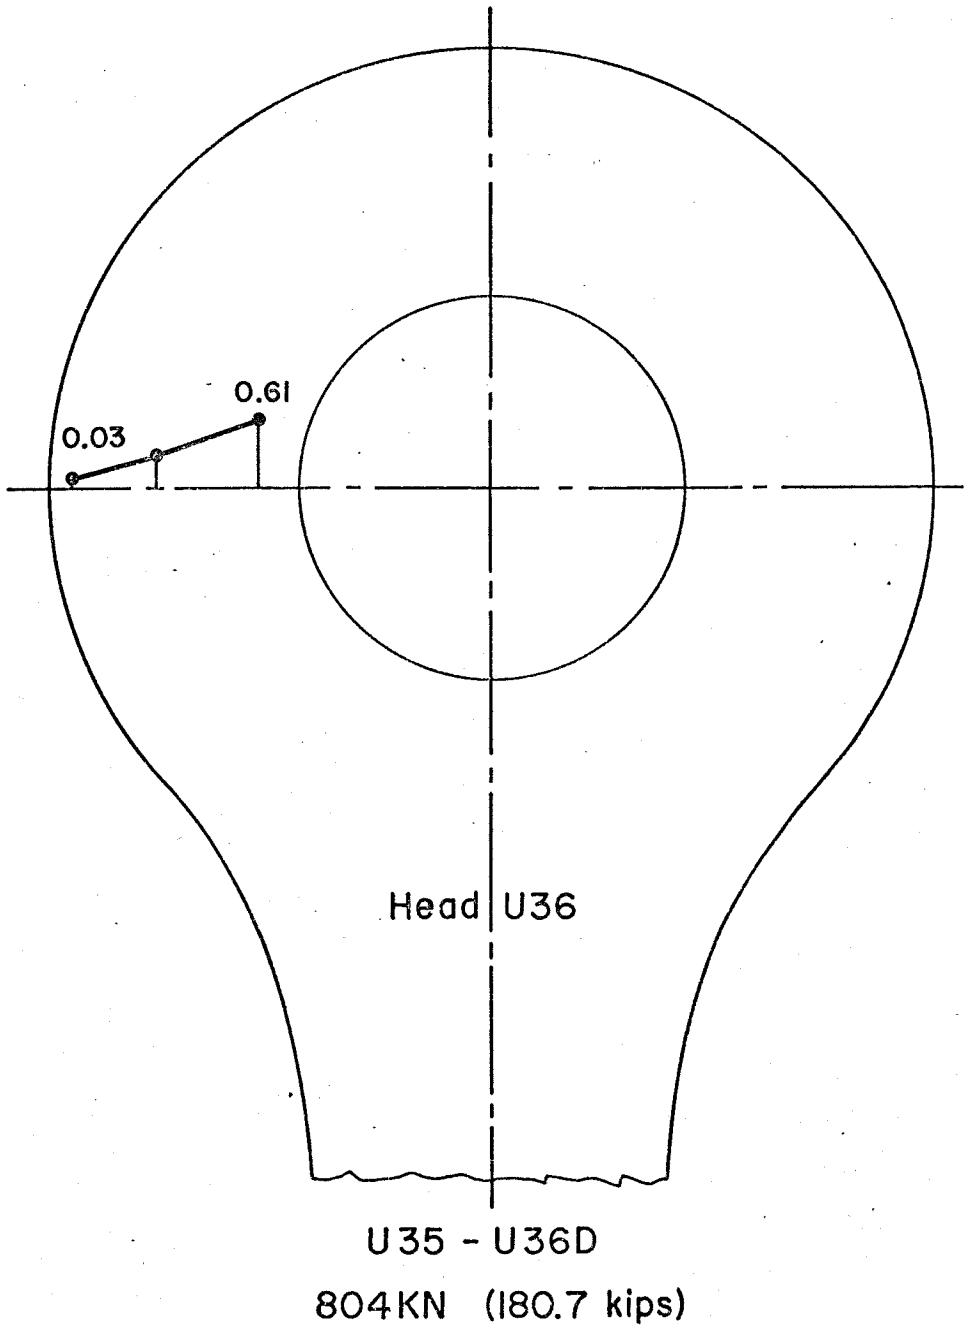
The measured stresses from the limited number of strain gages at eyebar head U 36D also revealed the same condition of force transmitted through surface bond. The stress distribution in this eyebar head is given in Figs. 14 and 15 for the same jacking force as for Figs. 10 to 13. The values presented are the stress non-dimensionalized by the average stress in the eyebar shank.

Fig. 14 Non-dimensionalized Measured Stress Distribution - U 36D Dead Load

Fig. 15 Non-dimensionalized Measured Stress Distribution - U 36D Partial Load

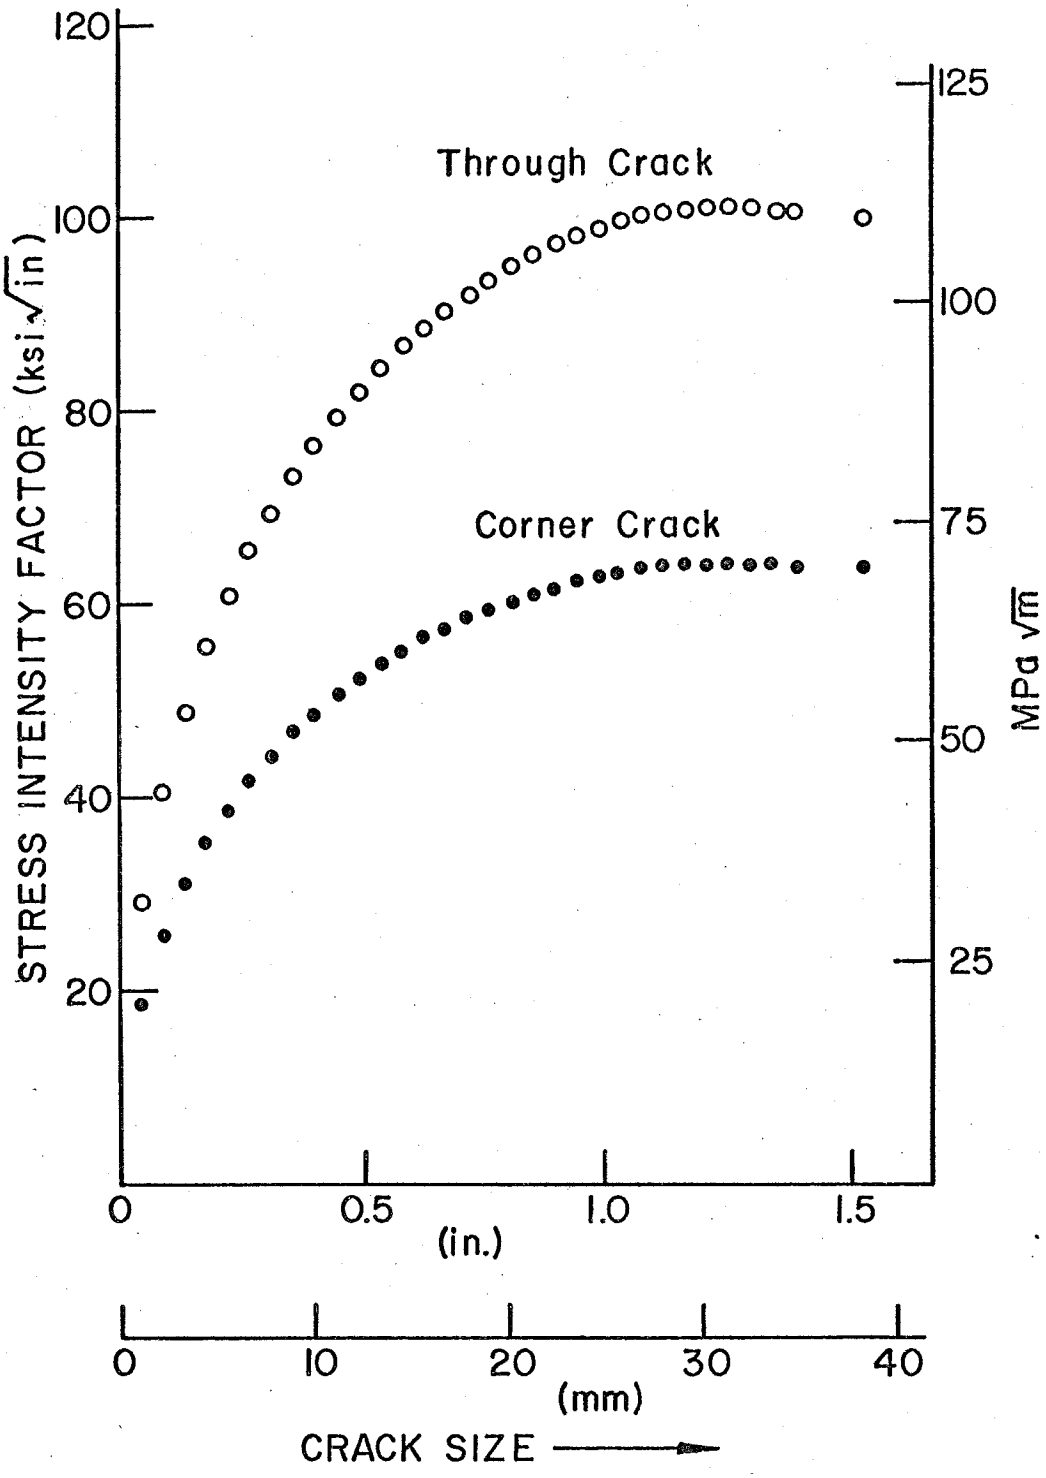
Fig. 33 Stress Intensity Factor as a Function of Crack Size

For eyebar U 35 - U 36 the measured dead load stress was 127 MPa (18.4 ksi) and the maximum measured live load stress was less than 7 MPa (1.0 ksi). The maximum total nominal stress was therefore 134 MPa (19.4 ksi). Figure 33 shows a plot of the stress intensity factor versus the size of a through crack (upper bound) and a corner crack (lower bound) in eyebar U 35 - U 36 if such cracks ever occur.

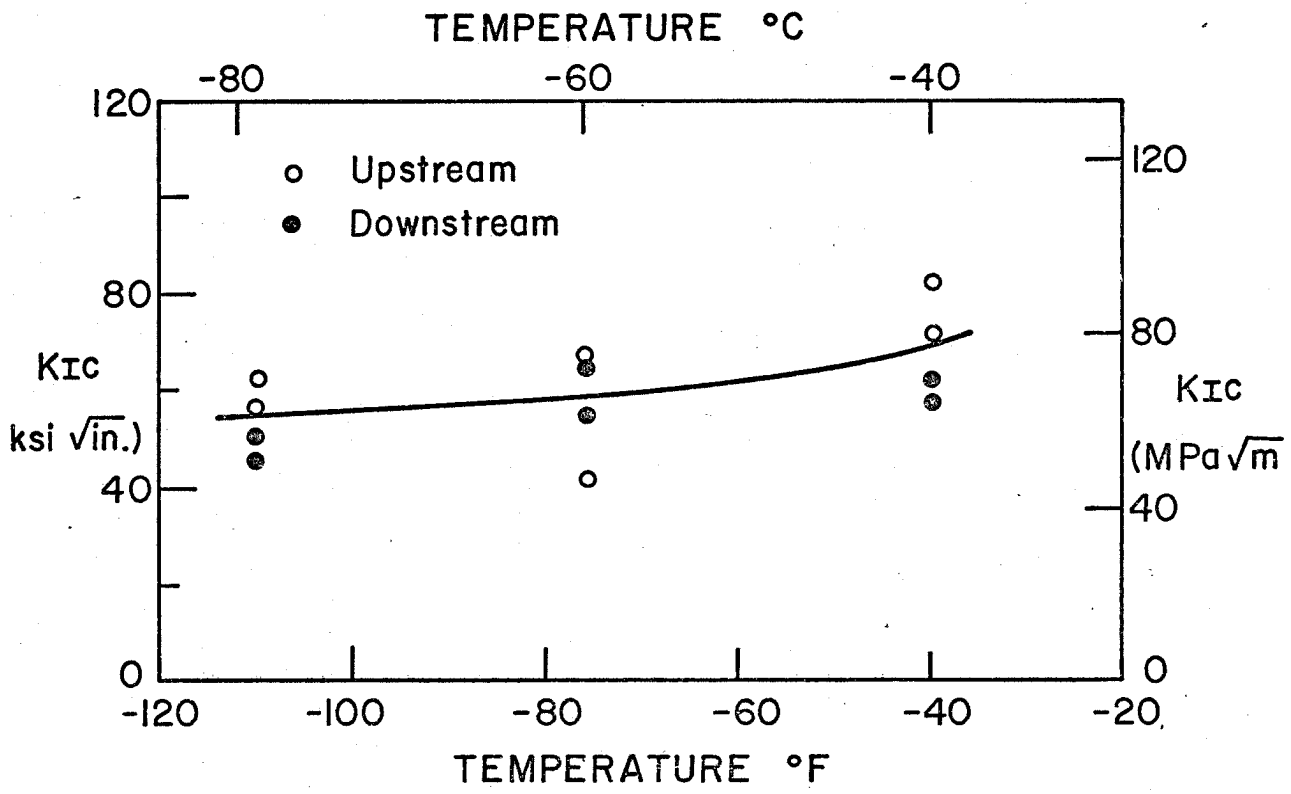
Fig. 34 Test Results of K_{Ic} for Eyebar Material (AISI 1035 Heat-Treated Steel)

results of fracture toughness tests to date are shown in Fig. 34. The K_{Ic} values from the slow-bend specimens are plotted against the test temperature. Specimens were cut from the two eyebars taken from the Liberty Bridge. The curve in the figure is arbitrarily drawn, based on comparison with fracture toughness data from the Carquinez West Bridge which also has AISI 1035 heat-treated eyebars[22]. At a temperature of -40^{o} F. the average value for the fracture toughness of the Liberty Bridge eyebars is estimated to be 76 MPa $\sqrt{m}$ (69 ksi $\sqrt{in}$. from Fig. 34. The corresponding critical crack size for failure is calculated to be 7.9 mm (0.31 in.) for the through crack. For the lower bound case of a corner crack, no brittle fracture would be expected before the crack grew to 47.6 mm (1.875 in.) and through the thickness of the eyebar.
