Fracture analyses of full size beams with welded details.

Keith Dale Boyer

A THESIS

Civil Engineering

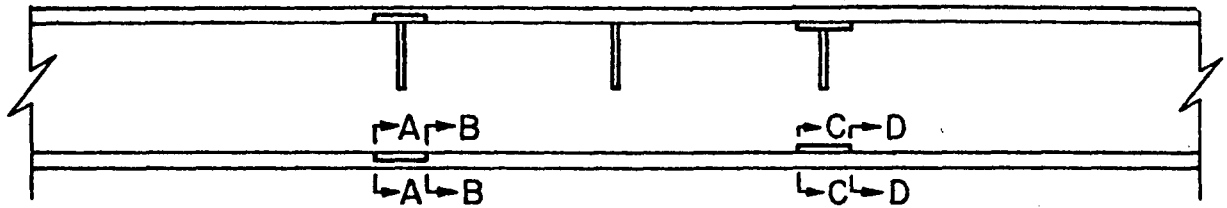
Fig. 4.7a   Fatigue Cracks at Two Million Cycles

Beam	Section AA	Section BB	Section CC	Section DD
B2	✳ 15.9 / 31.8 ... 9.5	6.4 ... 25.4	50.8 50.8 ... 19.1	38.1 44.5 ... 11.1
B2A	31.8 ... 22.2	✳ 19.1 ... 33.3 / 22.2	50.8 ... 22.2	25.4
B4	✳ 25.4 ... 35.7 / 12.7 38.1	7.9 ... 22.2 / 12.7 6.4	54.0 ... 6.4	12.7 57.2 ... 9.5
B4A		✳ 31.8 / 9.5		
B6	9.5 ... 22.2	15.9 / 4.8	50.8 44.5	38.1
B6A	25.4 ... 30.2 / 6.4 9.5	✳ 34.9 ... 31.8 / 15.9 19.1	25.4

✳ Beam Fractured At This Section
Crack Measurements In mm

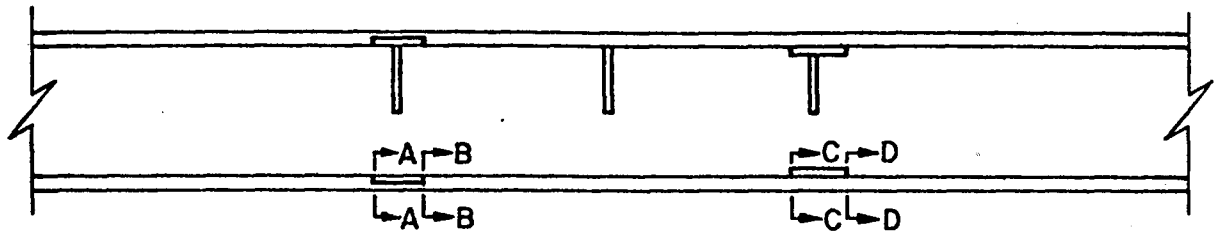
Fig. 4.8a Fatigue Cracks Prior to Last Fracture Test

Beam	Section AA	Section BB	Section CC	Section DD
B2	✱ 15.9 / 31.8 / 2.0 2.0	6.4 25.4 / 2.0 2.0	50.8 50.8 19.1 / 2.0 2.0	31.8 44.5 11.1 / 2.0 2.0
B2A	7.9 / 19.1 15.9 / 2.7 2.48	22.2 ✱ / 20.6 38.1 / 2.48 2.8	60.3 30.2 / 2.8 2.8	31.8 / 2.8 2.8
B4	50.8 ✱ / 28.6 12.7 69.9 / 2.37 2.37	38.1 19.1 / 2.37 2.37	58.7 9.5 / 2.37 2.37	47.6 57.2 9.5 / 2.37 2.37
B4A	31.8 34.9 / 9.5 9.5 / 3.3 3.3	53.5 ✱ / 9.5 76.2 / 3.3 3.3	50.8 31.8 / 3.3 3.3	31.8 15.9 9.5 / 3.3 3.3
B6	9.5 38.1 12.7 / 2.7 2.92	28.6 12.7 / 2.92 2.92	50.8 63.5 ✱ 44.5 / 2.7 2.92	28.6 44.5 / 2.7 2.7
B6A	28.6 34.9 38.1 15.9 / 2.8 2.8	✱ 15.9 34.9 44.5 34.9 / 2.8 2.8	25.4 54.0 6.4 / 2.8 2.8	2.8 2.8

Measurements Taken At Cycles Listed At Bottom
Of Cross Section (In millions of cycles)
✱ Beam Fractured At This Section
Crack Measurements In mm

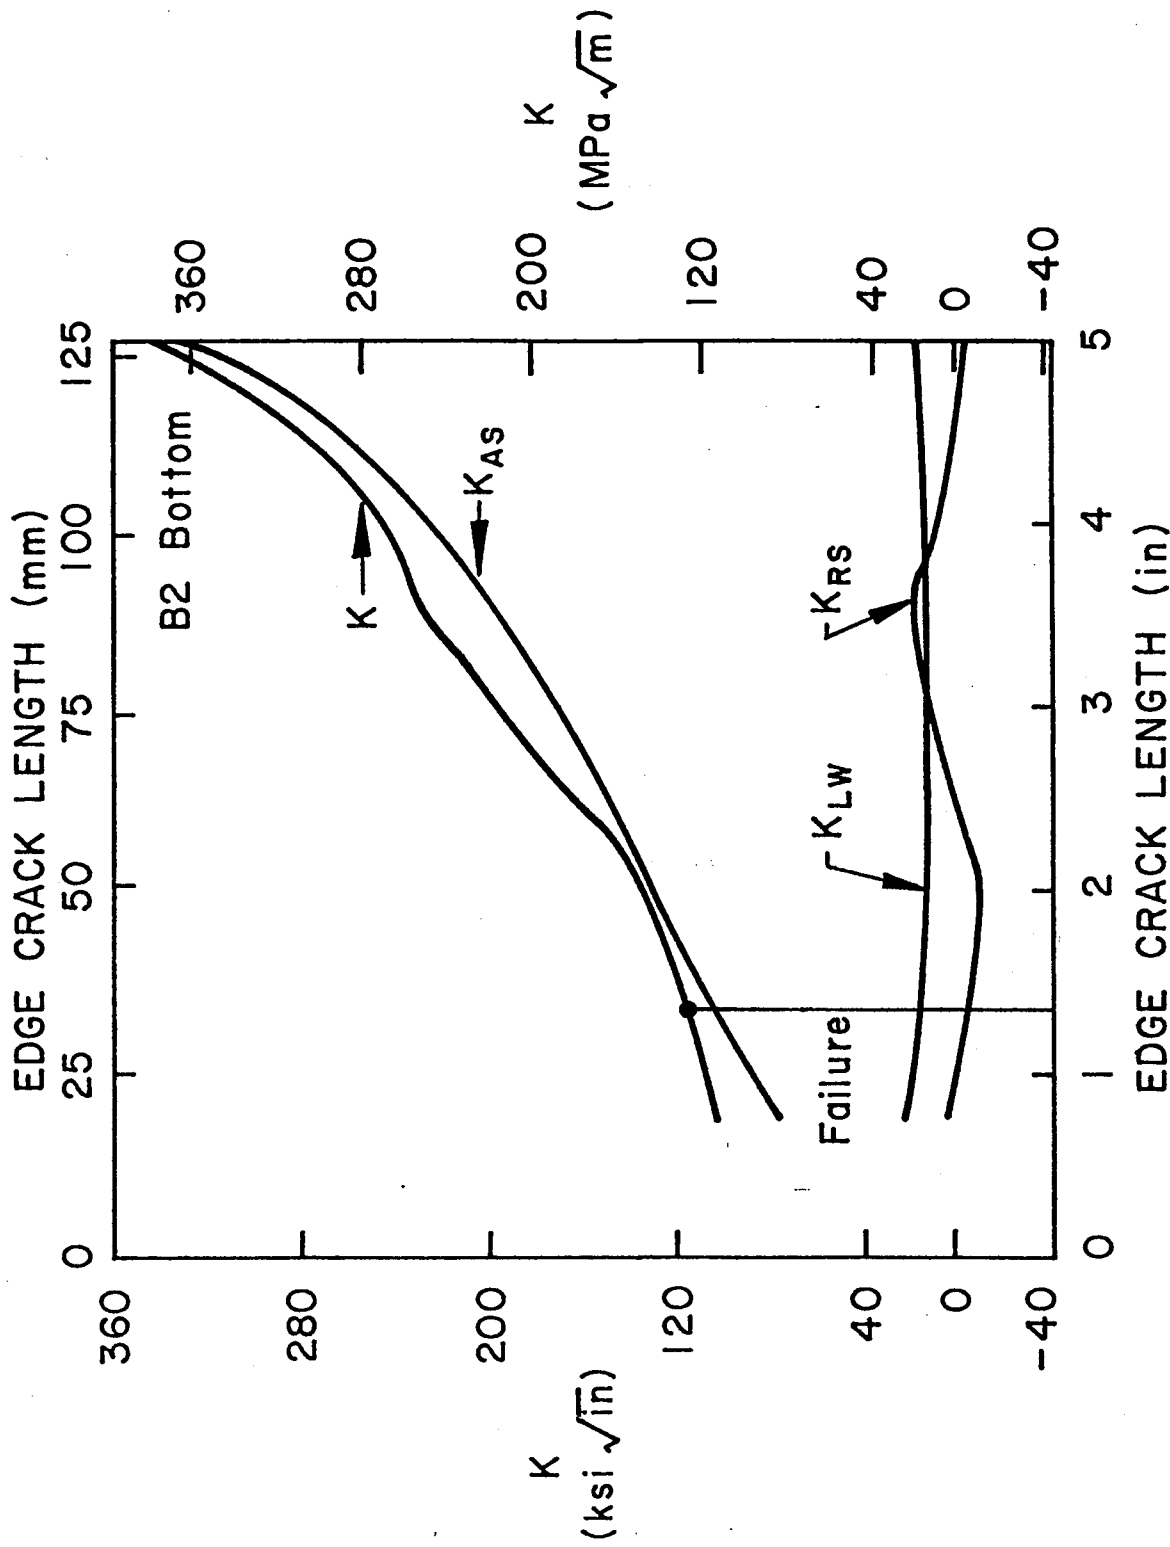
Fig. 4.18 K vs. Edge Crack Size (B2, A514)

K_{AS} increased at a near constant rate for edge crack growth. Since the applied stresses were very high in the A514 beams this parameter had an overriding effect on K_{RS} and K_{LW}. This is shown in the bottom one-third analysis for Beams B2 and B2A, Figs. 4.18 and 4.19 respectively.

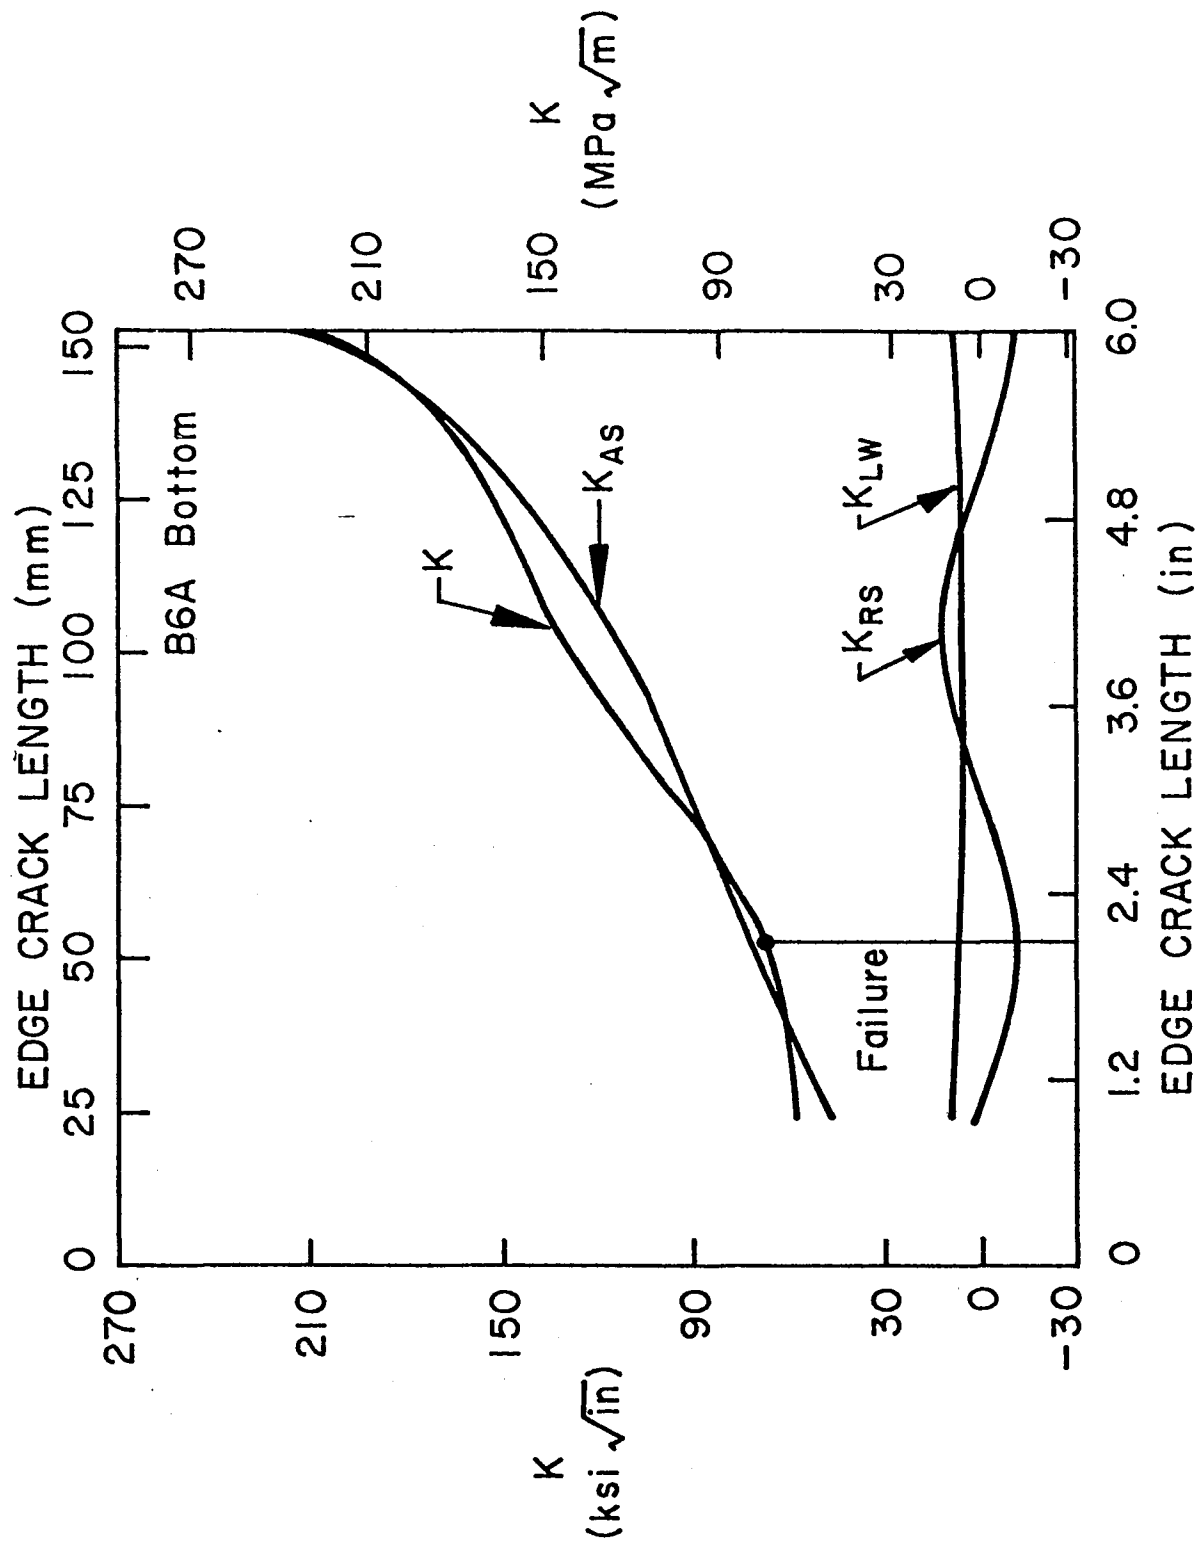
Fig. 4.23 K vs. Edge Crack Size (B6A, A588)

Continued crack growth resulted in a rapid increase in K_{RS} as the fatigue crack grew into the high tensile residual stress region caused by the web-to-flange fillet welds. This also caused K to increase rapidly. This residual stress influence on K greatly affected the fracture of Beam B4 (top one-third analysis, Fig. 4.20) and B6 (top one-third analysis, Fig. 4.22). Each beam fractured with a crack size at or near the peak K value caused by K_{RS}. The fracture of beam B6A, was caused by a rising K_{RS} and K, (see Fig. 4.23). The point of fracture is marked on each "K vs. a" plot.

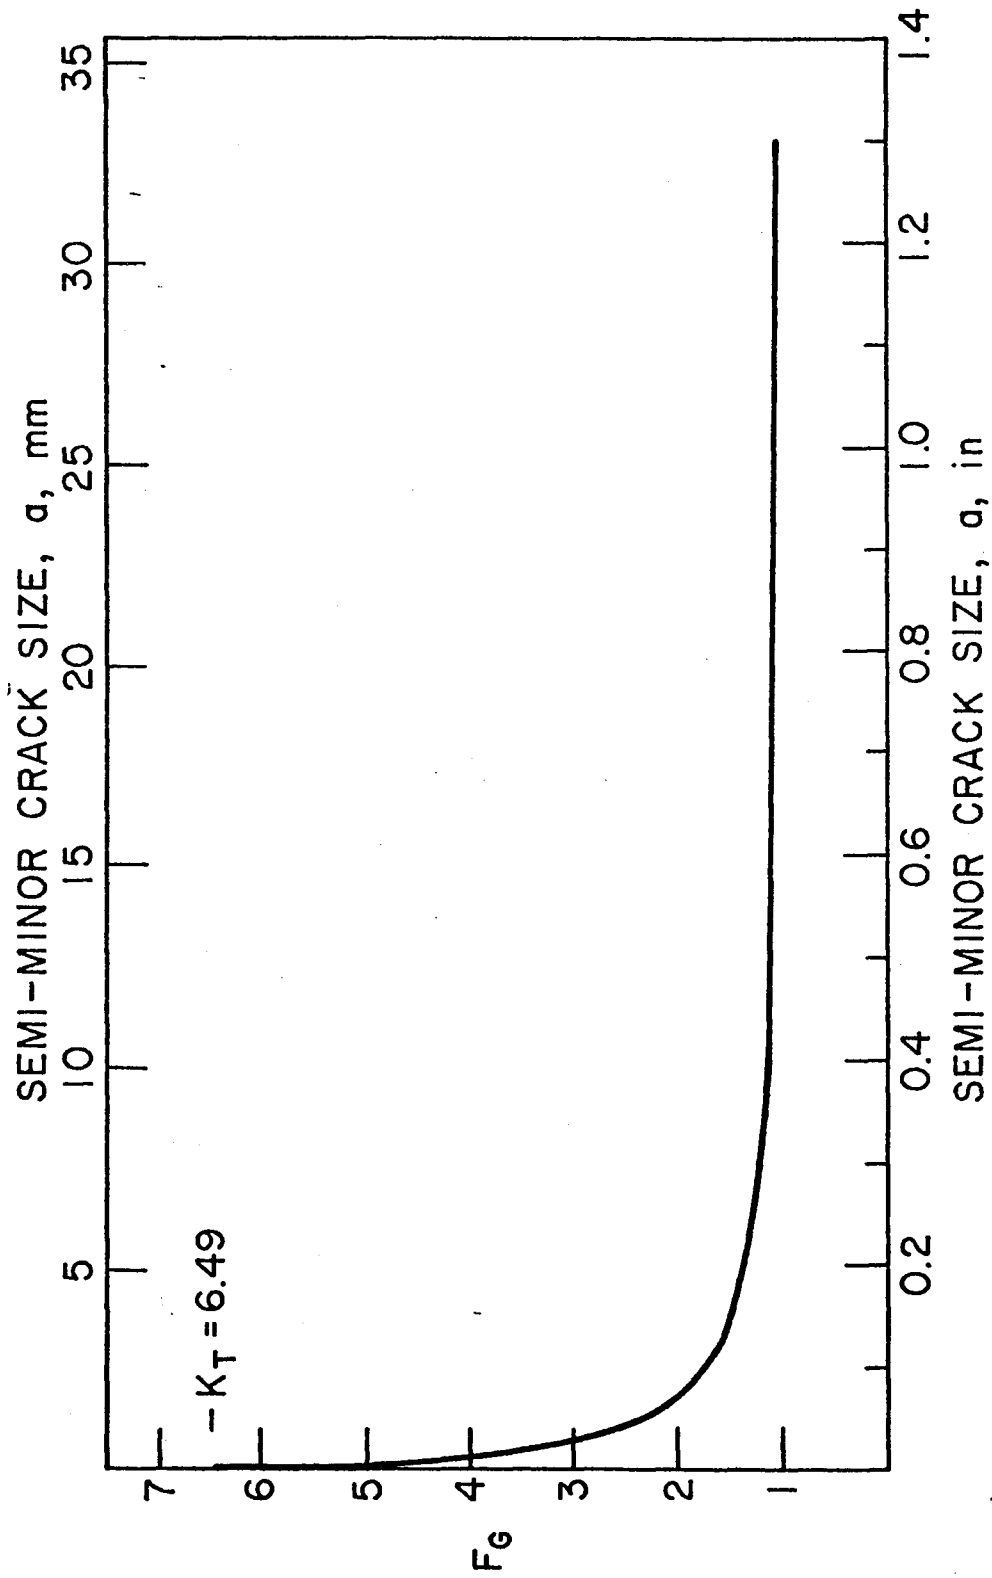
Fig. 5.13 Stress Concentration Decay With Crack Size (Beam B3)

The stress concentration effect decays rapidly as the crack size increases. This is discussed in more detail in Section 4.5.2. A plot of the decay with crack size, a, is shown in Fig. 5.13 for a typical end-weld cover plate beam specimen (W36x260). The decay is quite rapid. For crack sizes, a, of 0.01 in. (.3 mm) and 0.10 in. (3 mm), the stress concentration is 4.56 and 1.73 respectively.

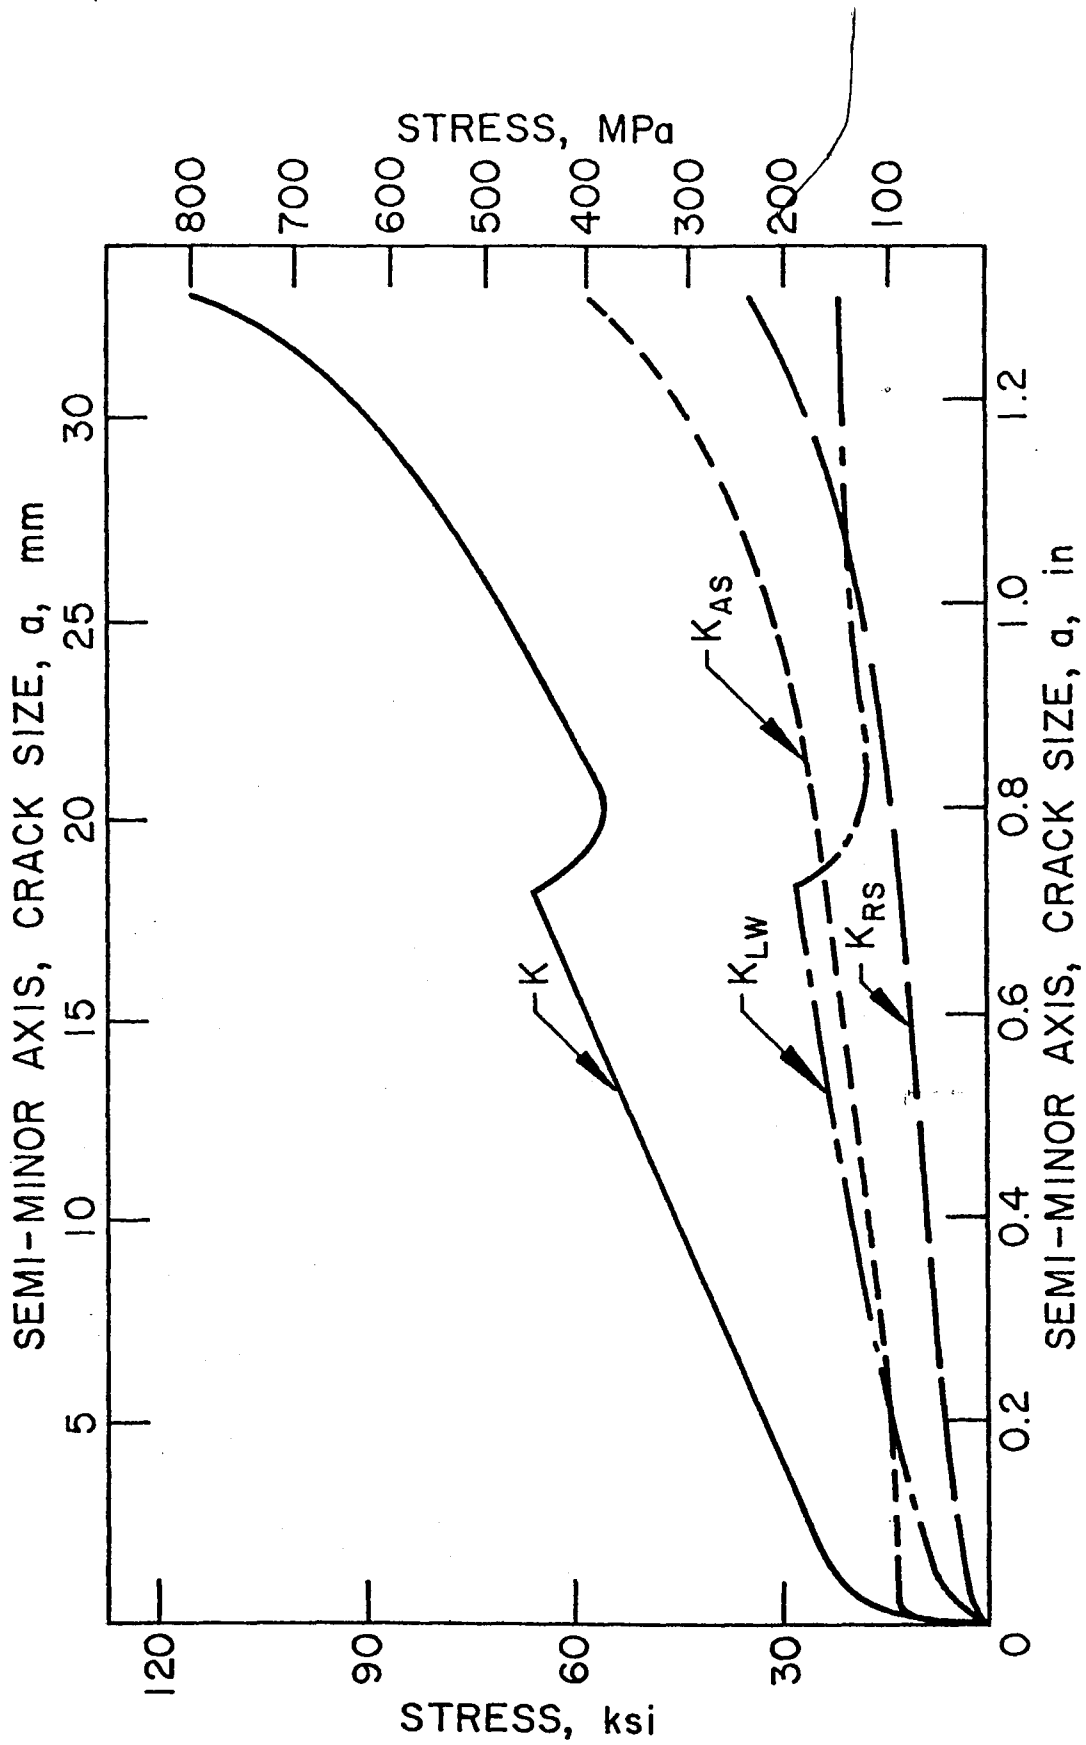
Fig. 5.14 Stress Intensity vs. Crack Size for Elliptical Surface Cracks (B3, A36, W36 x 260)

The effect of stress concentration on stress intensity is shown in Fig. 5.14 for an elliptical crack growing at the toe of an end-welded cover plate. Because of the rapid decay of the stress concentration, K_T, crack instability did not develop at small

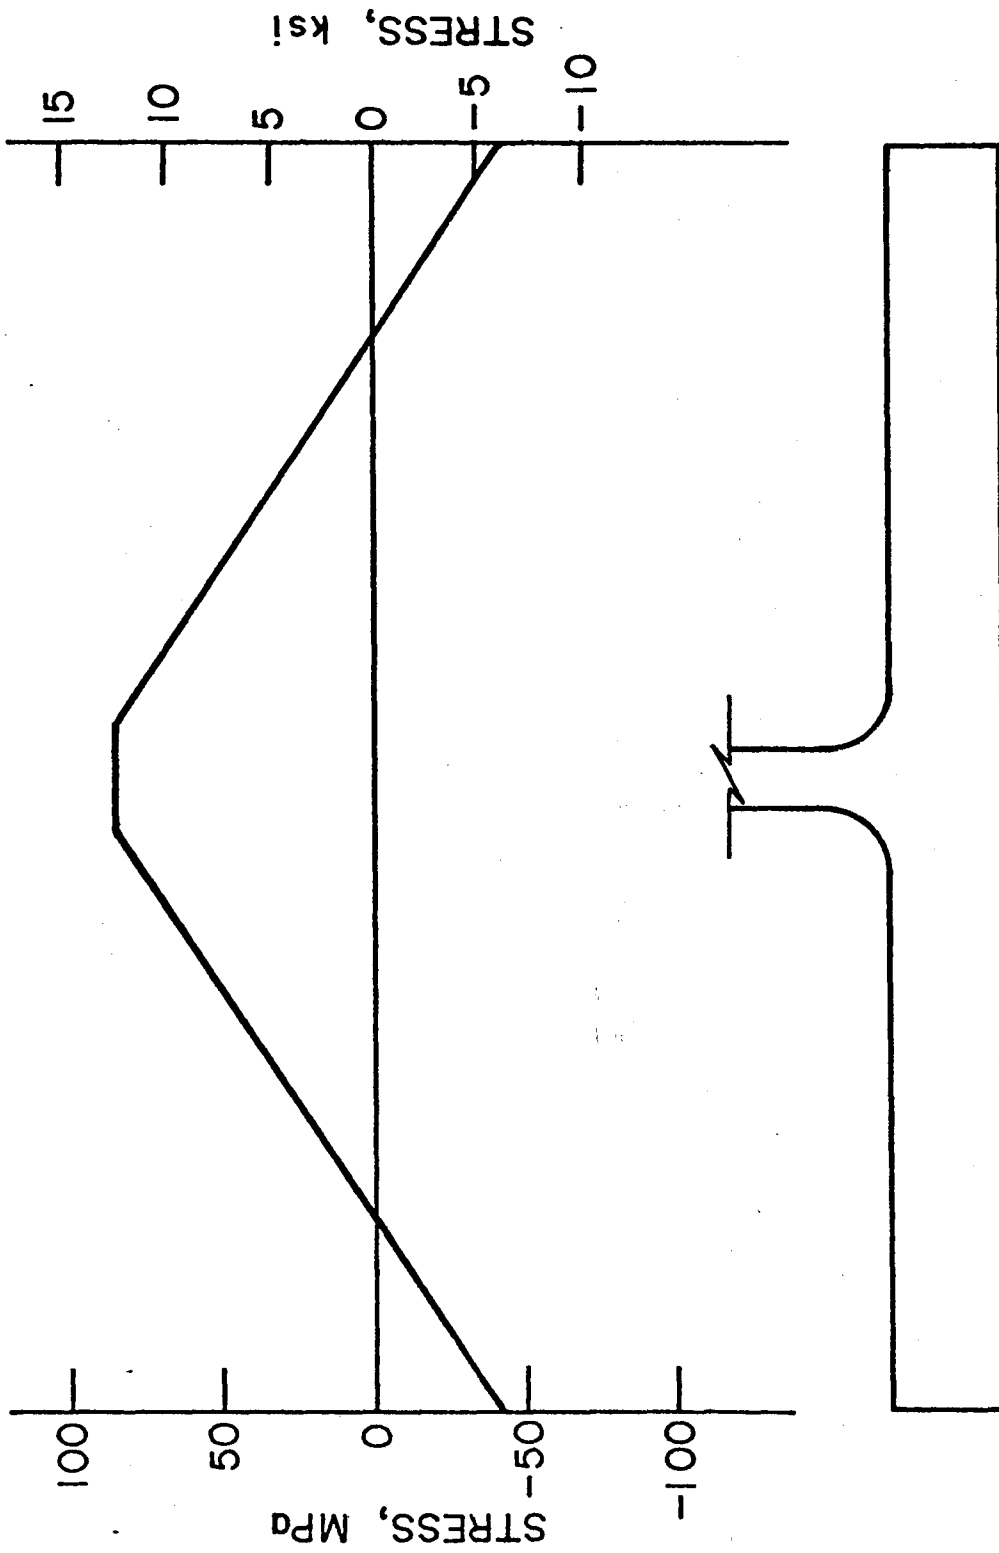
Fig. 5.16   Fracture Surface Sketches and Data Summary

| σ_{max}	= 27.5 ksi	= 190 MPa
σ_{YD}	= 87 ksi	= 600 MPa
a	= 1.13 in	= 28.7 mm
r_y	= N.A.	
T_c	= $-99°F$	= $-73°C$
K_c	= 125 ksi $\sqrt{in}$	= 138 MPa $\sqrt{m}$
N	= 2,017,500

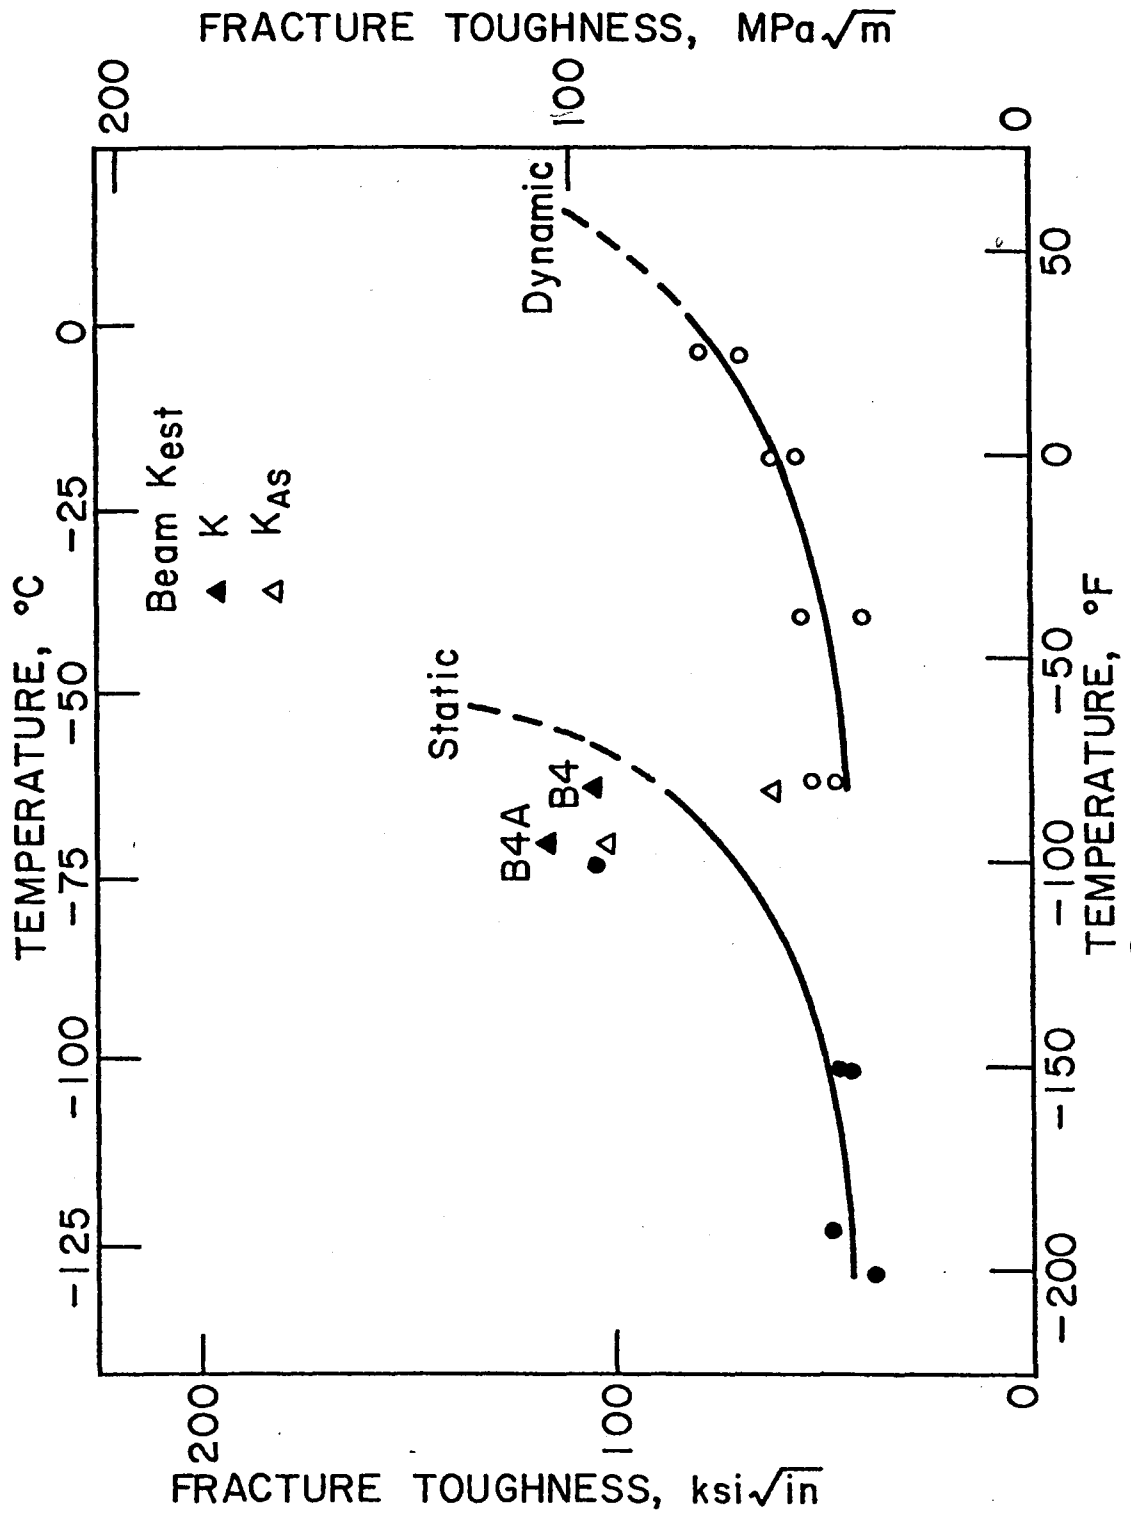
Fig. 6.1 Correlation of Beam K_{est} and Material Toughness Characterization, B4, B4A (A36)

The fracture of B4 was precipitated by the presence of the high tensile residual stress area at the web-to-flange welds. Beam B4A Beam B4A had a fatigue crack which grew through the same area during a fracture test and at a 6% higher applied stress but did not fail. This can only be explained by a difference in test temperatures when the fatigue cracks grew into this critical area. As can be seen from the material tests K vs. Temperature plot for A36 steel (Fig. 6.1), a slight difference in the test temperatures would cause a large change in the critical stress intensity factor, K_c. This was the case as the Beam B4A test temperature $\{-70° F (-57° C)\}$ was warmer than the temperature of Beam B4 $\{-80° F (-62° C)\}$ when the fatigue crack grew into this region. As the fatigue crack in Beam B4A grew through the web-to-flange welds K_{RS} was continually increasing. However, this was counter balanced by the flange crack opening restraint of the web. Only when the crack grew $\sim 1\frac{1}{4}$ in. (~ 32 mm) past the web did fracture

Also plotted in Figs. 6.1 to 6.3 are the beam stress intensity estimates from the applied stress alone (K_{AS}). There is good correlation between K_{AS} for Beams B2, B2A, B4A, and B6A and their respective slow bend material test results. This demonstrates that in these tests, the residual stresses from welding and flame cutting did not significantly alter the fracture resistance. However the contribution to the stress intensity estimate from the residual stress field, K_{RS} should be considered when the crack tip is in the high tensile residual stress region of the web-to-flange welds. This can readily be seen in Figs. 4.3 and 4.5 for Beams B4 and B6, respectively. In both of these cases K_{RS} was nearly 50% of the total stress intensity estimate.

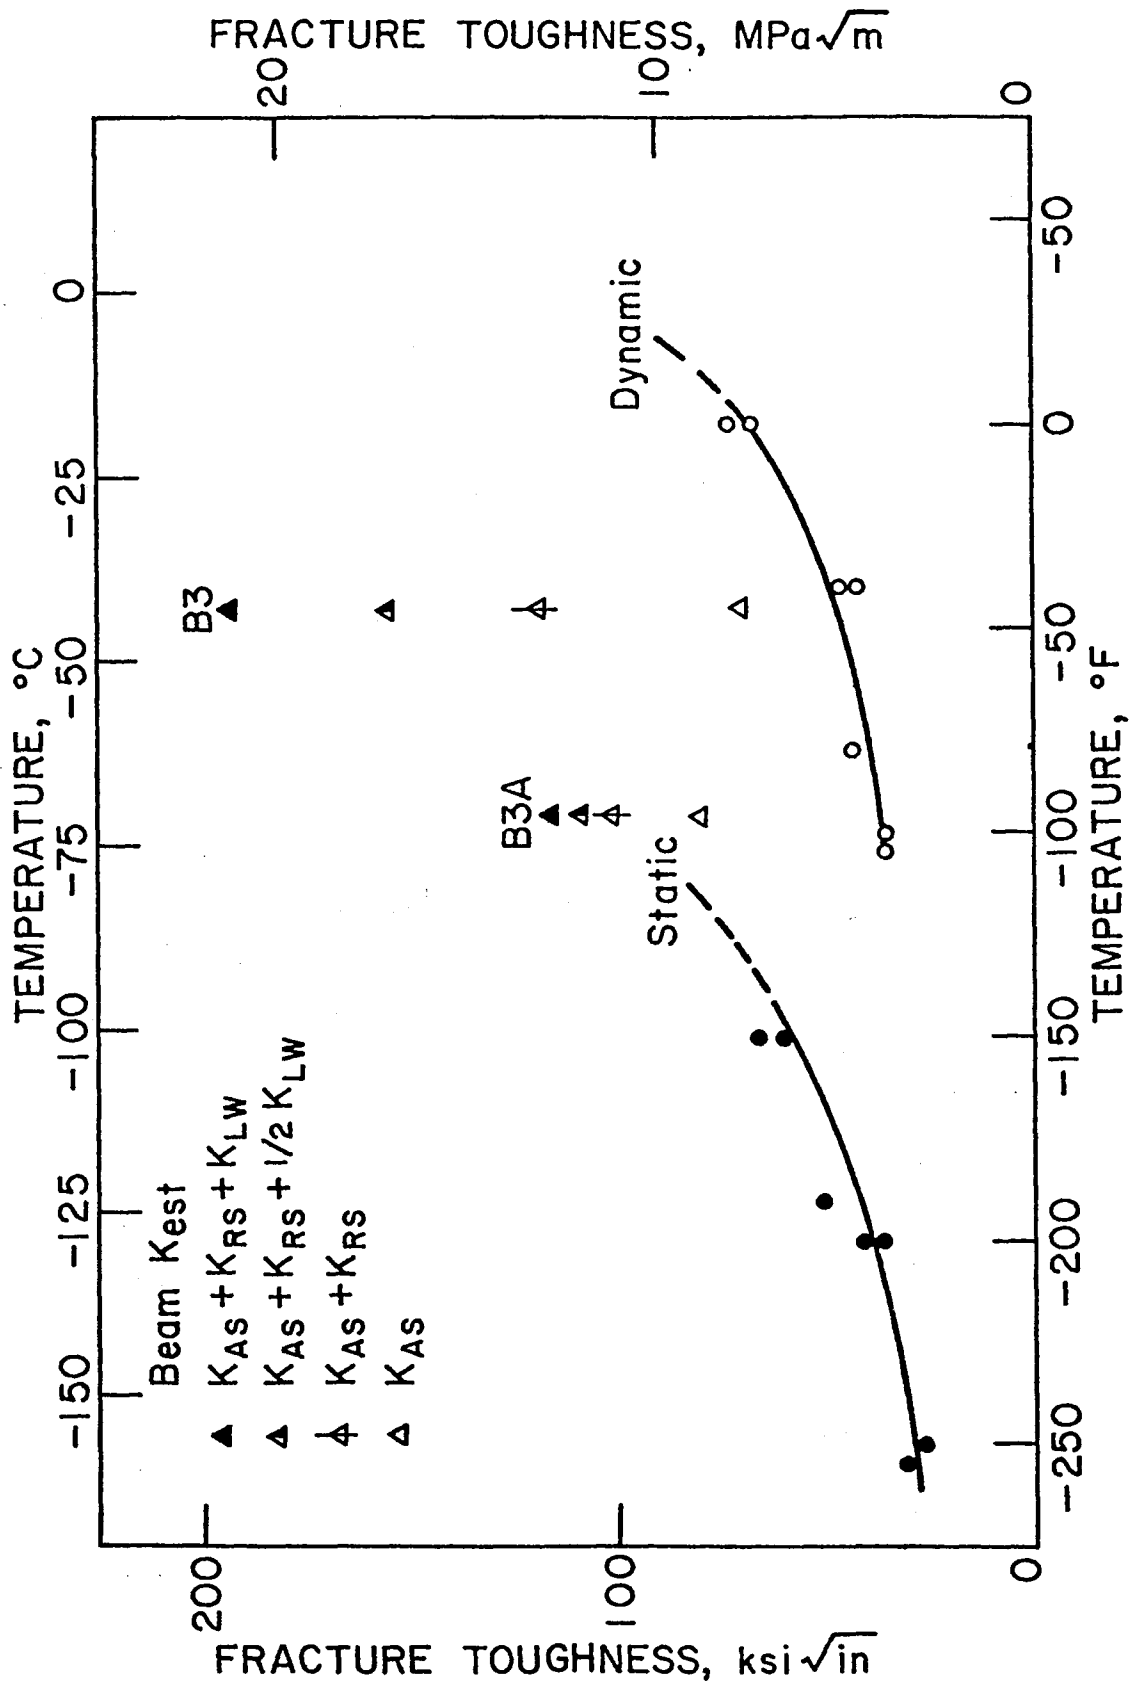
Fig. 6.4 Correlation of Beam K_{est} and Material Toughness Characterization, B3, B3A (A36, Rolled)

With the exception of Beam B3, the stress intensity estimates of beam fractures which precipitated from the large fatigue cracks in Beams B1, B1A, and B3A, were adequately predicted by K_{AS} alone (see Figs. 6.4 and 6.6). The stress intensity estimates of beam fractures which precipitated from small elliptical cracks (Beams B5 and B5A) were best estimated by including all of the residual stress contributions, K_{RS} and K_{LW} (see Fig. 6.5). Generally, a good estimation of stress intensity was obtained by considering only the applied stress contribution, K_{AS}, and the nominal section residual stress distribution, K_{RS}. These points are also shown in Figs. 6.4 to 6.6.

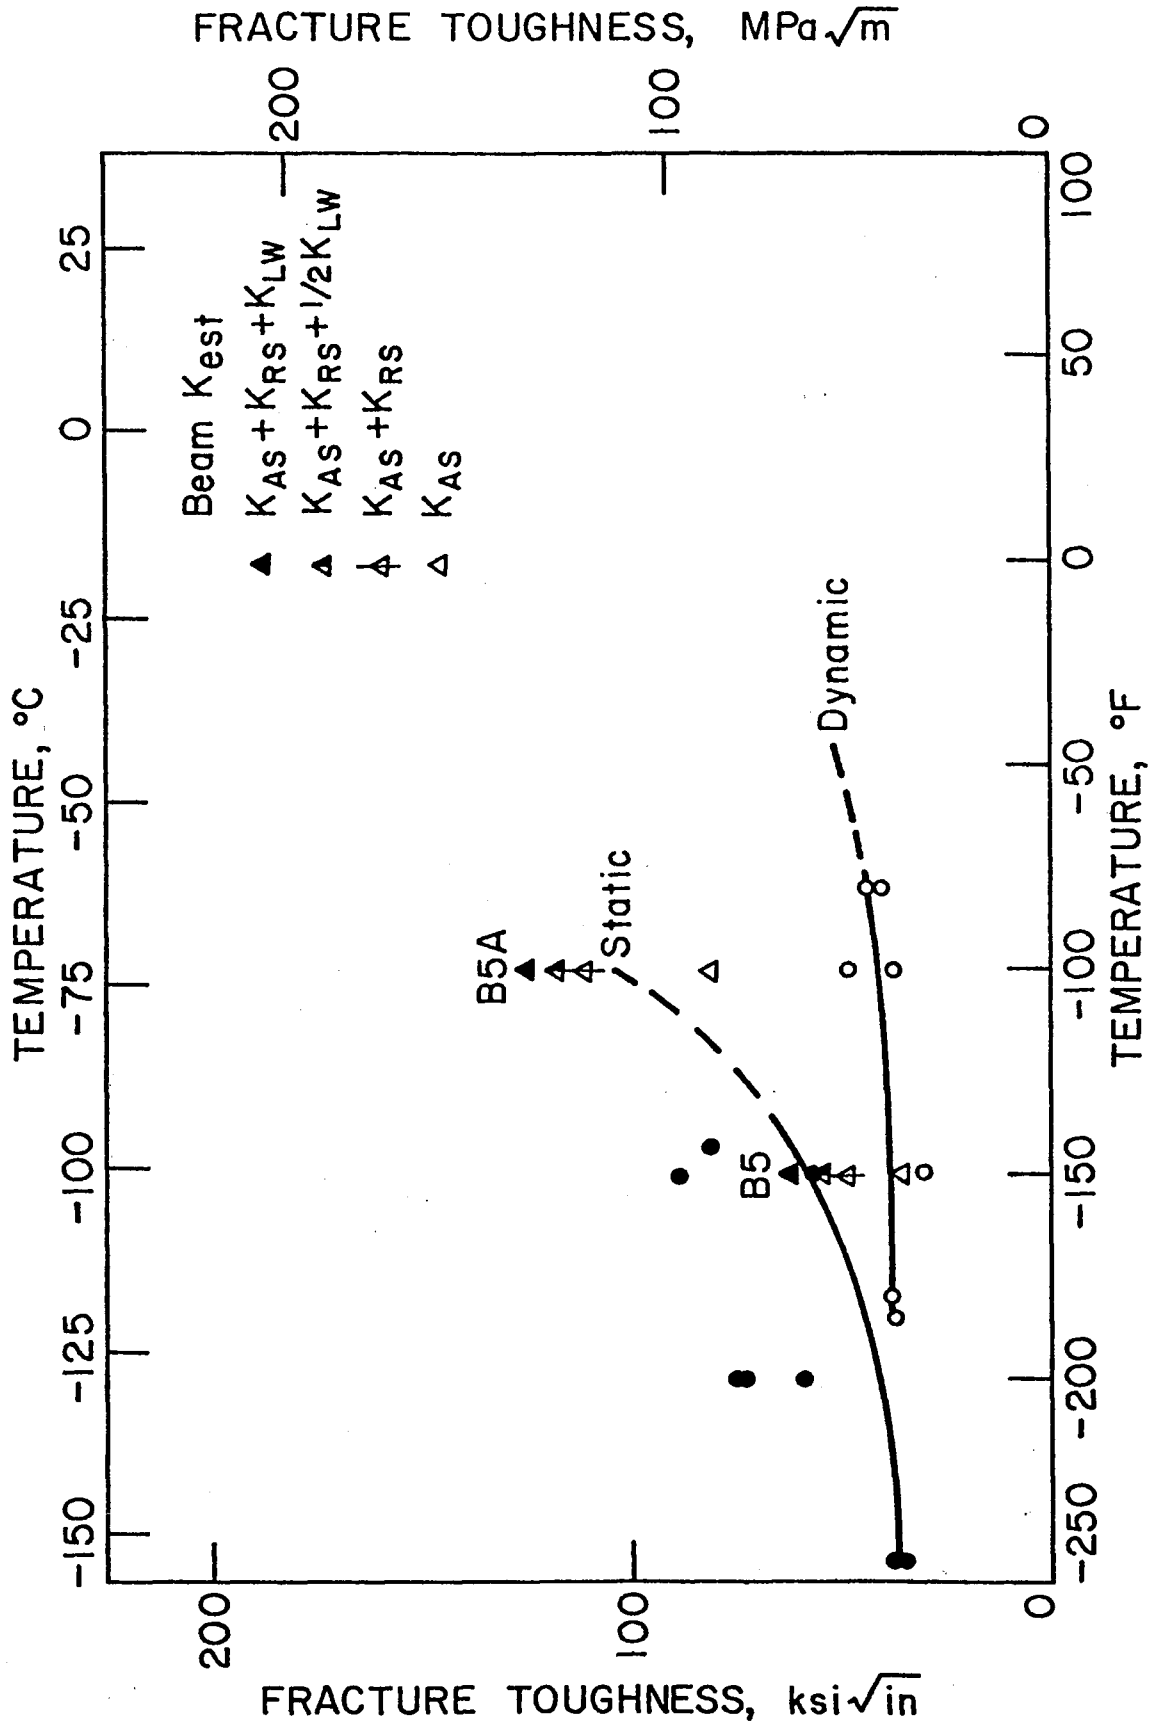
Fig. 6.5 Correlation of Beam K_{est} and Material Toughness Characterization, B5, B5A (A588, Rolled)

Both B1 (A514) and B5 (A588, rolled) fractured at temperatures lower than the transition temperatures for the slow bend material tests. The stress intensity estimate, K, for Beam B5 was in direct correlation with the K_{IC} material tests results (see Fig. 6.5). However, the stress intensity estimate, K, for Beam B1 was quite conservative (see Fig. 6.6).
