NASA/TM—2013-217876

Continued Evaluation of Gear Condition Indicator Performance on Rotorcraft Fleet

June 2013

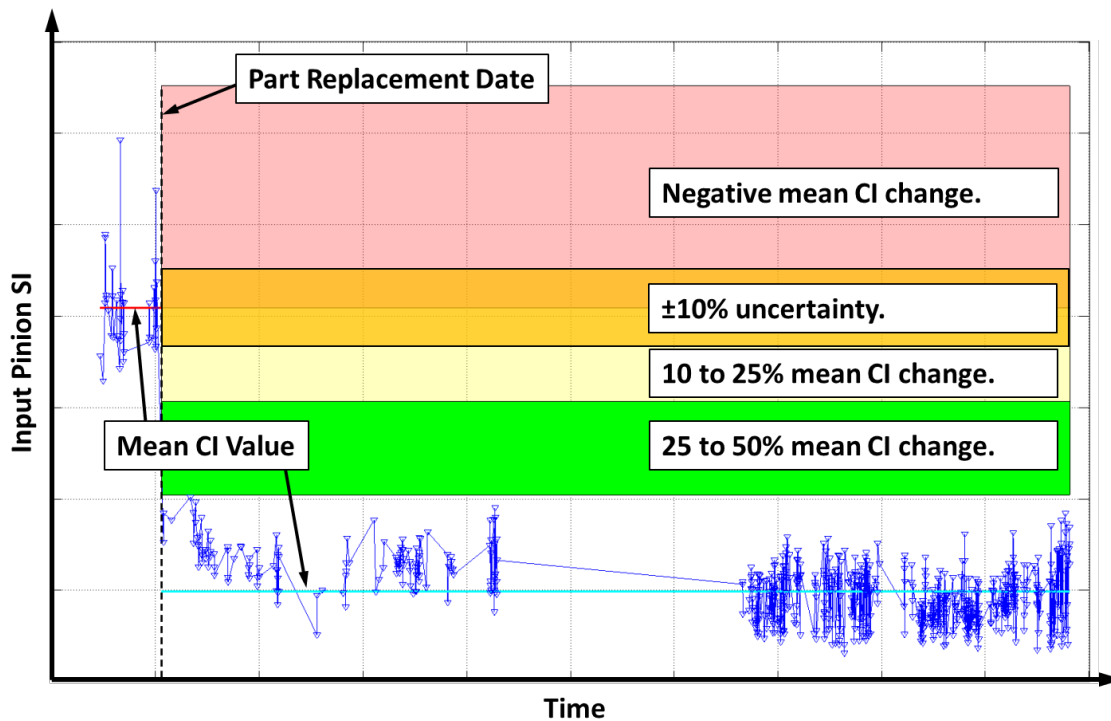
Figure 3.—Example mean CI analysis result for NGB Tail 04, Input Pinion SI.

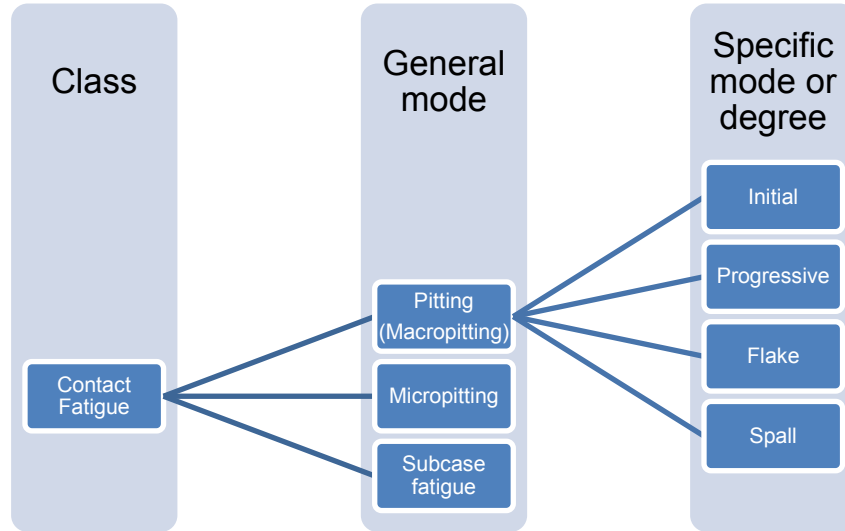
Figure 4.—Example gear failure mode nomenclature: Contact Fatigue.

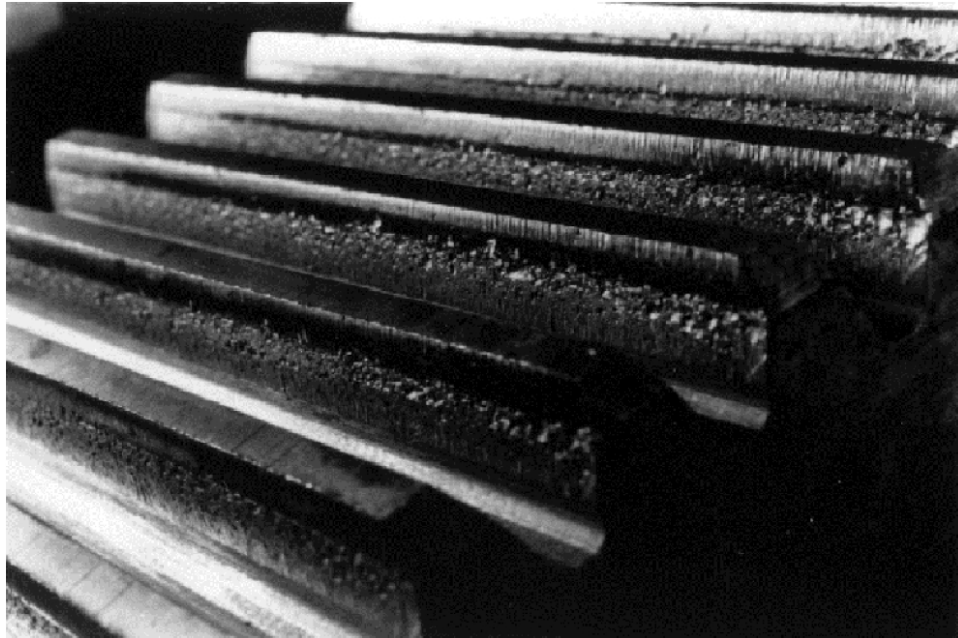
Figure 6.—Example of Progressive Pitting. Extracted from ANSI/AGMA 1010-E95, Appearance of Gear Teeth Terminology of Wear and Failure, with the permission of the publisher, the American Gear Manufacturers Association, 1500 King Street, Suite 201, Alexandria, Virginia 22314.

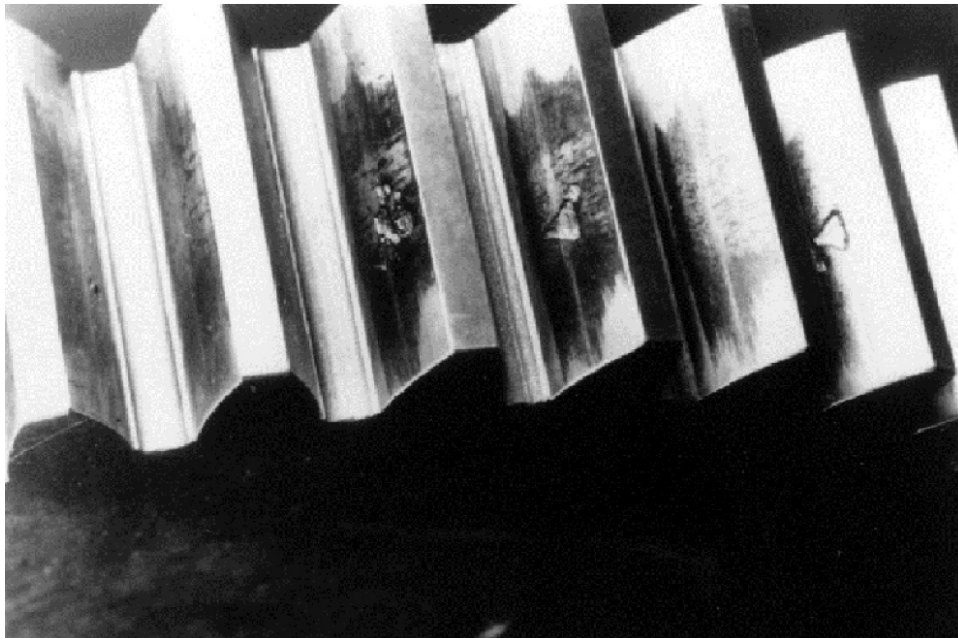
Figure 7.—Example of Flake Pitting. Extracted from ANSI/AGMA 1010-E95, Appearance of Gear Teeth Terminology of Wear and Failure, with the permission of the publisher, the American Gear Manufacturers Association, 1500 King Street, Suite 201, Alexandria, Virginia 22314.

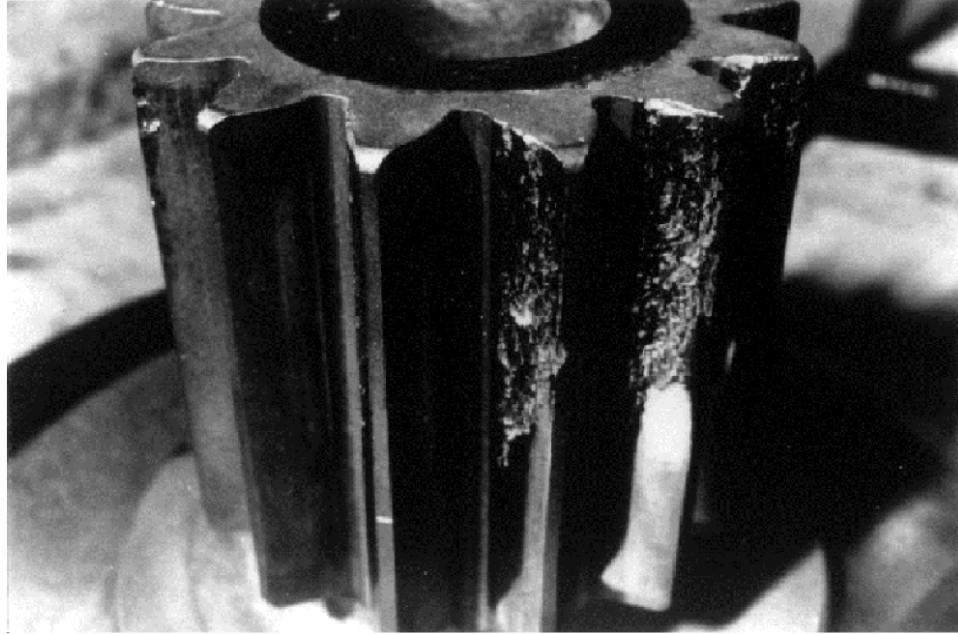
Figure 8.—Example of Spalling. Extracted from ANSI/AGMA 1010-E95, Appearance of Gear Teeth Terminology of Wear and Failure, with the permission of the publisher, the American Gear Manufacturers Association, 1500 King Street, Suite 201, Alexandria, Virginia 22314.

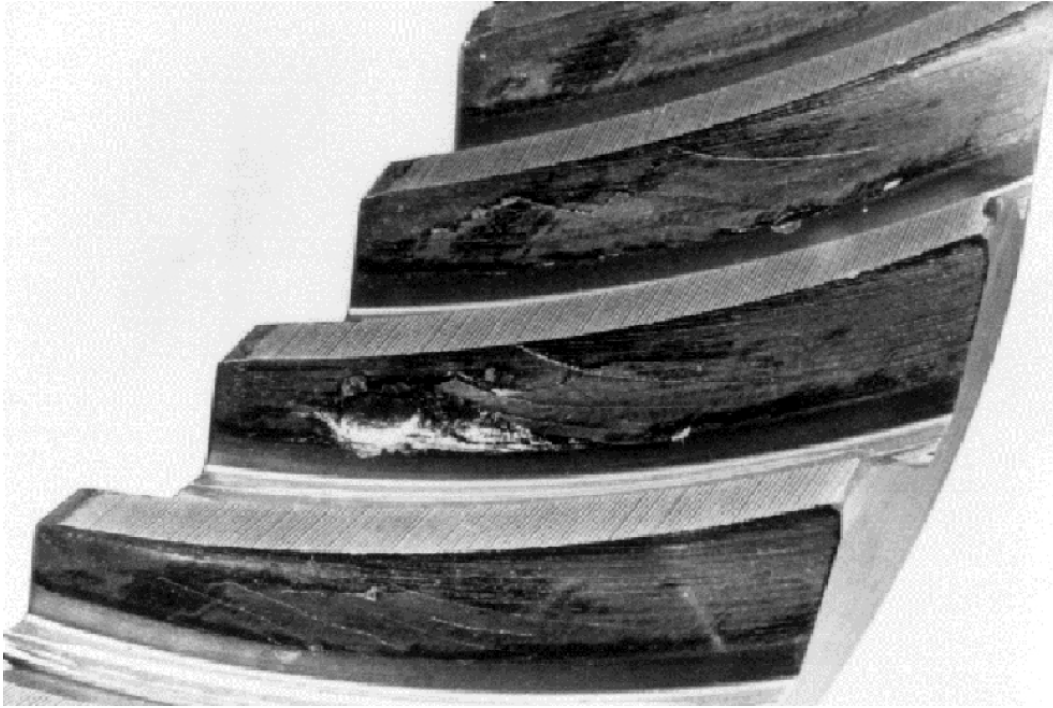
Figure 11.—Output gear damage—progressive pitting.

"The input gear and the output gear teeth both showed abnormal wear. Not only did they show abnormal wear but it was uneven wear and bluing that appears to be from excessive heating. The input gear was marked with … and is shown in Figures 6.3-1 thru 6.3-6. Figure 6.3-1 is an overall picture, Figures 6.3-2 to 6.3-5 show the uneven wear and Figure 6.3-6 is a close up of the teeth. The output gear was marked on one side with … and is shown in Figures 6.3-7 thru 6.3-21. Figure 6.3-7 is an overall view, Figures 6.3-8 to 6.3-12 shows the uneven wear, Figures 6.3-13, 14, and 15 are close ups, Figures 6.3-16 to 6.3-20 are taken under a low power microscope, and Figure 6.3-21 shows the heating on the gear. DMWR 1-3010-204 Page 0057 00-6 shows the loaded contact pattern limits. The splines on the output gear also showed wear and is shown in Figures 6.3-22 and 6.3-23. A Non Destructive Inspection (NDI) of the output gear did not show evidence of cracks."

Figure 6.3-16 of the TDA shown below as Figure 11 could be further classified, at least on one of the output gear teeth, as either progressive pitting or micropitting. A dimension marker on the original wear photo would aid in better estimating damage feature dimensions. Further, the use of a numbering scheme could streamline the identification of gear damage particularly during tear-down analyses at a U.S. Army

1. It is possible that not all gear teeth were photographed in the tear-down analysis reports. Thus actual damage levels may differ than from what was reported. It is suggested that all gear teeth on damaged nose gear box be photographed in a consistent manner such that the type of damaged can be documented per ANSI/AGMA 1010-E95 standards.
2. If not already implemented, any damaged gears should be stored for further analysis.
