NASA TM X-34

ELEVATED-TEMPERATURE TESTS UNDER STATIC AND AERODYNAMIC CONDITIONS ON CORRUGATED-STIFFENED PANELS

By Joseph M. Groen and Richard Rosecrans

Langley Research Center
Langley Field, Va.

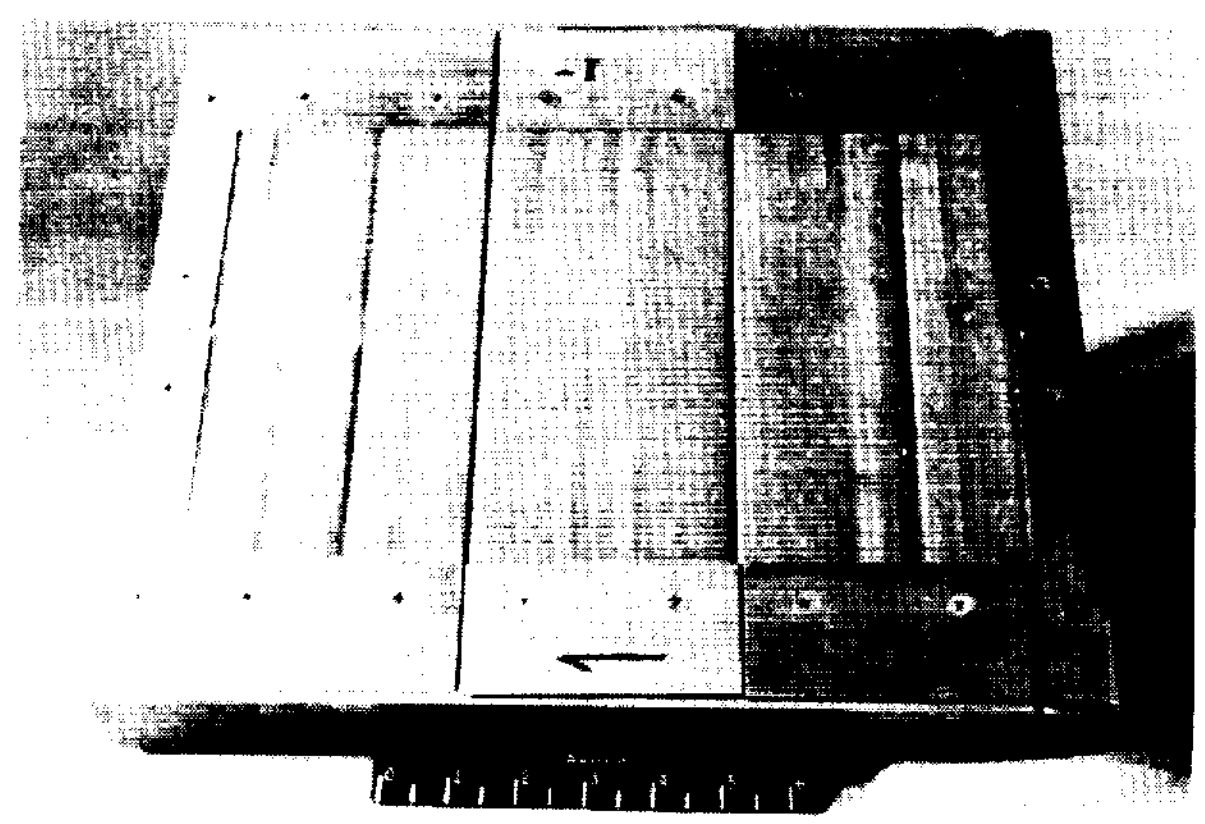
Creases (similar in appearance to the V-type expansion joints, see figs. 5(a) and 5(b)) began to form in each of the three skin sections at temperatures of approximately 900° F. In all cases, the creases first appeared at the panel edges and grew parallel to the seam welds with increasing temperatures. As a result of the application of various stress-relief techniques in the form of skin edge conditions (2) and (3), and in particular condition (4), (see section titled "Edge Conditions") the creases were alleviated up to a temperature of 1,800° F.

(b) Panel B-3 after tests 11 to 13 (maximum skin temperature 1,675° F).
