NASA/TP-1998-207645

Evaluation of Composite Honeycomb Sandwich Panels Under Compressive Loads at Elevated Temperatures

Sandra Walker
Langley Research Center, Hampton, Virginia

April 1998

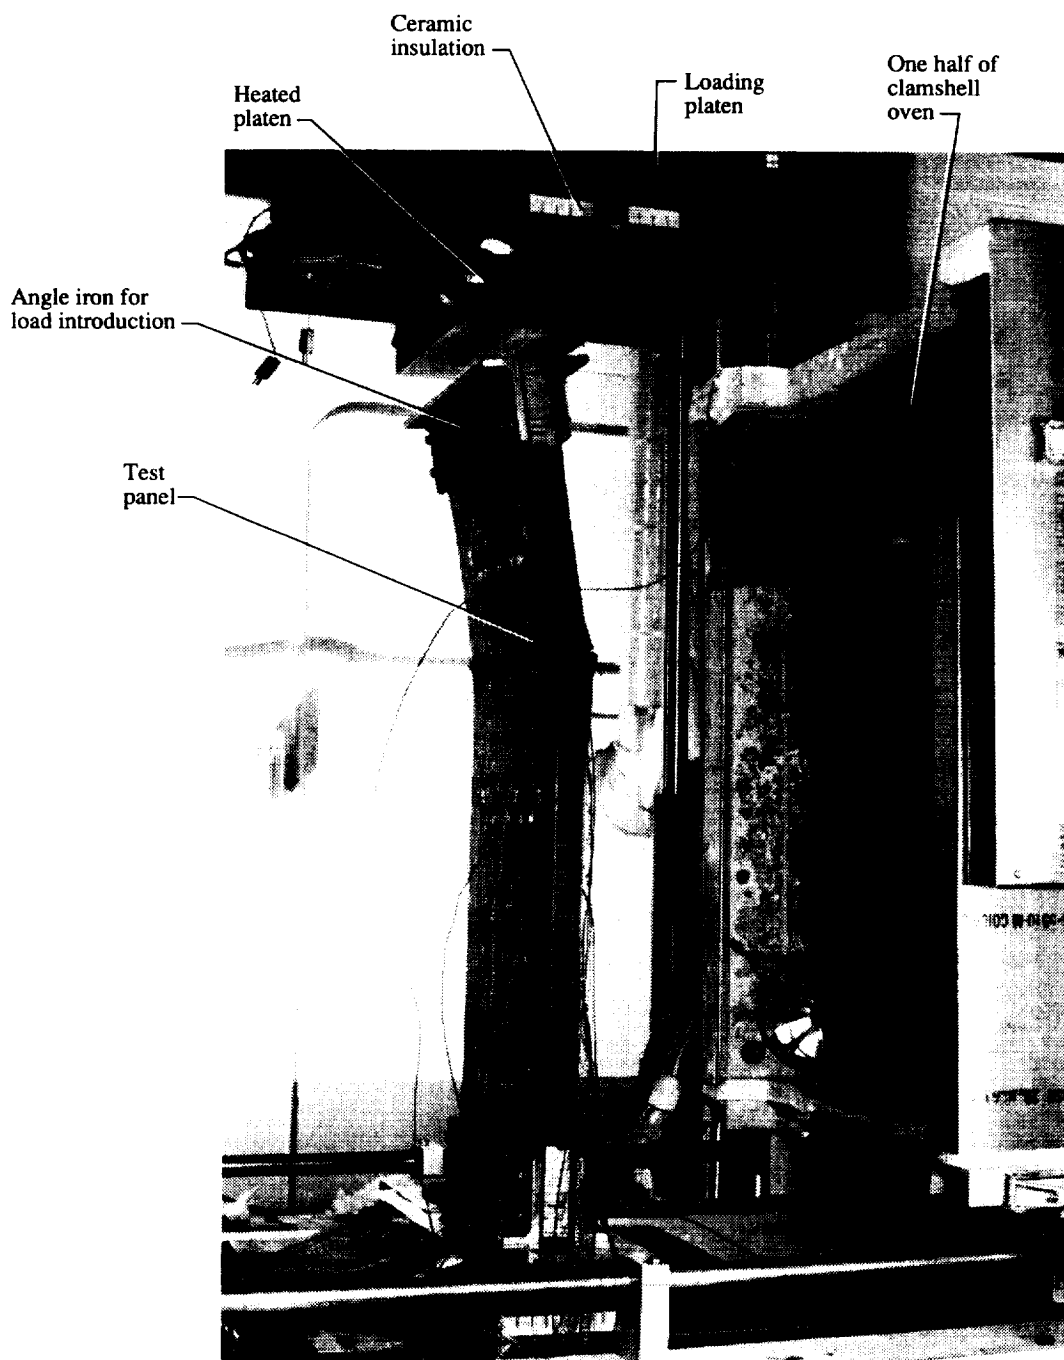
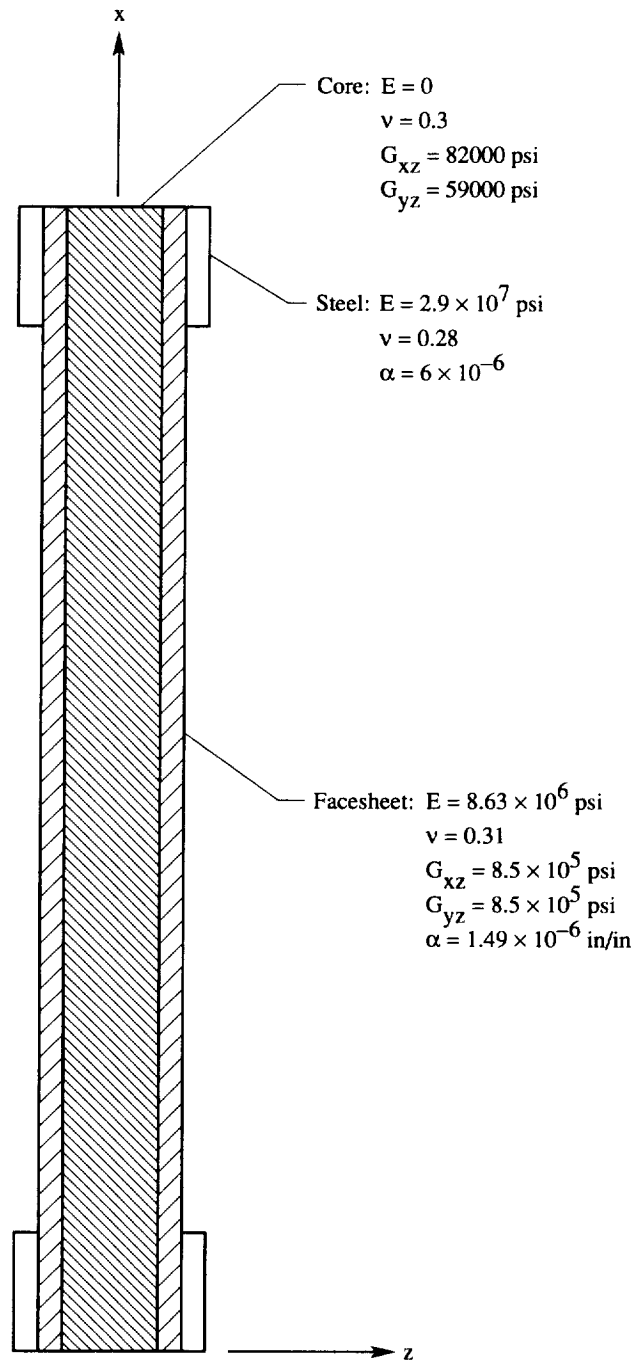
Figure 4. Photograph of failed panel located in test stand.

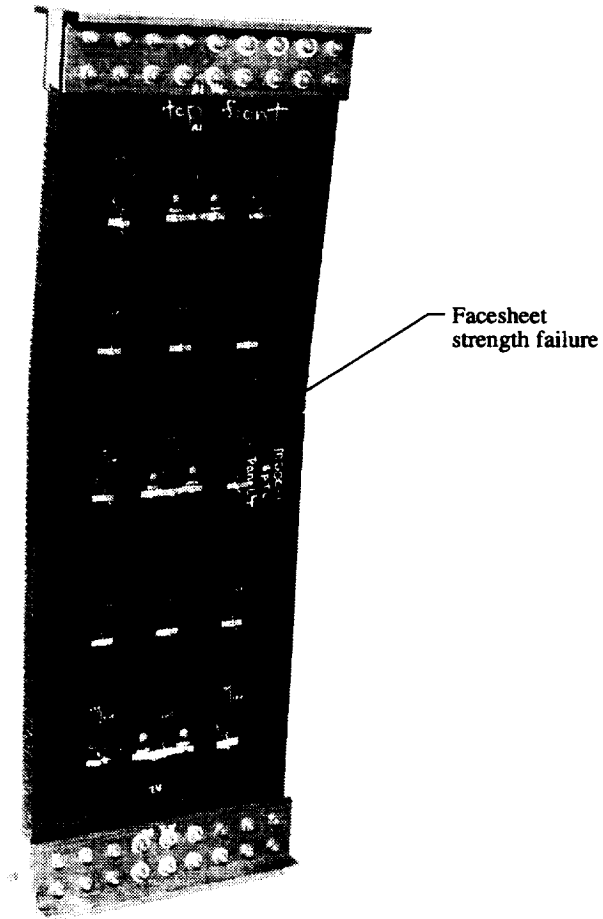
Figure 8 is a photograph of Panel 4 after failure which is typical of the appearance of all panels that failed in the facesheet strength mode. Increasing the test temperature from room temperature to 300°F did not appear to effect the failure mode for the 8-ply specimens. In comparing the failure data of the 8-ply titanium core panels with the 8-ply graphite-polyimide core panels, the effect of the type of core on the structural performance in compression is inconclusive.

Figure 8. Photograph of Panel 4, with 8-ply facesheets, after testing to failure.

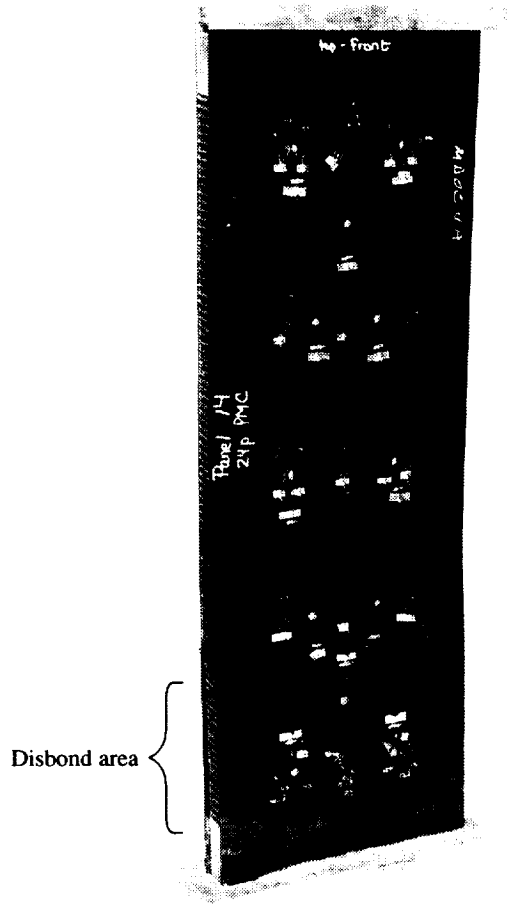
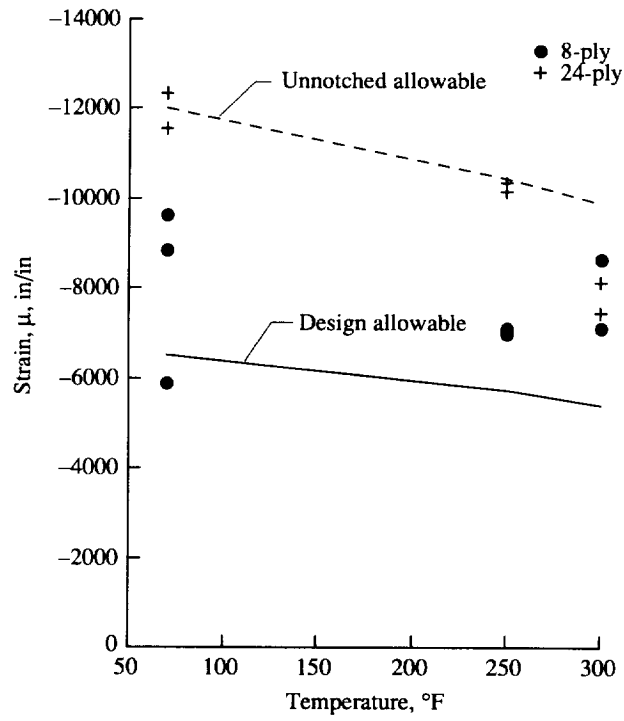
Figure 10. Photograph of Panel 14, with 24-ply facesheets and potted ends only, after testing to failure.

Disbond area

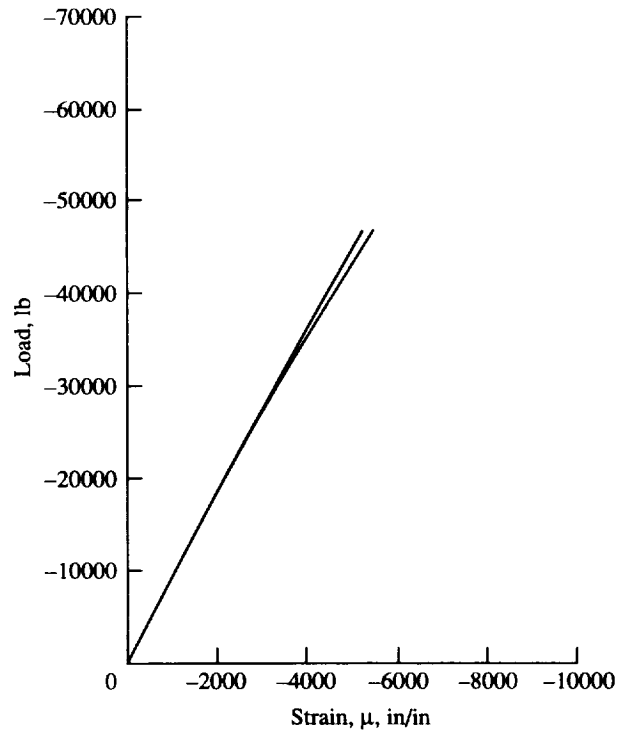
Back-to-back longitudinal strains measured at the center of the panel facesheets are shown with applied load for Panels 1, 5 and 11 in Figures 13-15, respectively. The experimental data shown in Figure 13 for Panel 1 is typical of most of the panels that failed in the facesheet strength mode or disbond mode. From Figure 13 it is apparent that a significant amount of bending was experienced prior to failure. As shown by the figure, back-to-back longitudinal strains diverge with increasing load. This panel bending can be attributed to geometric imperfections as discussed earlier. For Panel 5, Figure 14, bending was negligible, but the panel failed at a much lower load than the other two 8-ply panels tested at room temperature. The data shown in Figure 15 for Panel 11 is typical of the response obtained for all the panels that failed in the buckling mode. The diverging of the back-to-back strain measurements to the point where there is little increase in the load being carried by the panel as the facesheet strains continued to drastically increase and decrease on opposing facesheets is characteristic of panel buckling.

Figure 13. Back-to-back measured strains at center of panel facesheets for Panel 1 having 8-ply facesheets.

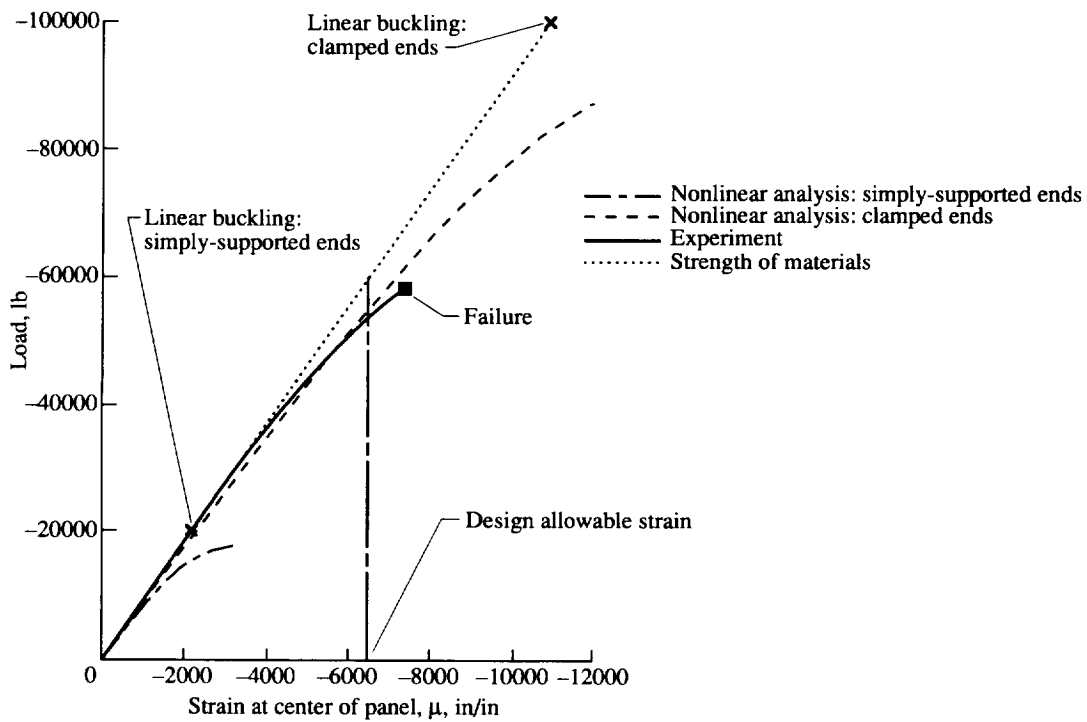
Analysis results are compared to experimental data in Figures 16–17, for Panels 1 and 2, respectively, which were the only two panels that were evaluated for geometric imperfections prior to testing. Shown in Figure 16 are the structural responses obtained for Panel 1. The strength of material approach assumes that the panel is perfectly flat to obtain a simplified linear solution. The linear buckling loads were obtained from the finite element model of the flat panel. The NASTRAN nonlinear structural analysis results include the effect of the geometric imperfections. The simply-supported boundary condition solution and the clamped boundary condition solution represent the two extreme conditions for edge support. Due to geometric imperfections which induce bending, the experimental data, and nonlinear analysis solutions diverge from the linear strength of

materials solution as the load is increased. In comparing the analysis solutions to the experimental data, the nonlinear analysis solution using the clamped boundary condition provides the better estimate of the load being carried by the panel at the design allowable strain value. The strength of materials approach over predicts the magnitude of the strain for a given applied load since it neglects the effect of the geometric imperfection and consequently bending of the panel. Although Panel 1, Figure 16, failed at a strain level greater that the design allowable, the load carried by the panel at failure was less than that predicted using the strength of materials approach primarily because of panel bending. The NASTRAN nonlinear analysis solution assuming the clamped end boundary condition provided the most accurate prediction of the experimental results. For Panel 2, Figure 17, the slope of the experimental curve at low loads is slightly greater than the slope obtained from the strength of materials prediction, indicating a higher than expected modulus of elasticity for the 8-ply laminate facesheets. Also, the panel failed at a load slightly below the design load for the panel.

Figure 16. Room temperature NASTRAN nonlinear composite plate finite element analysis for Panel 1 (Geometric imperfection modeled from first cosine shape buckling mode).

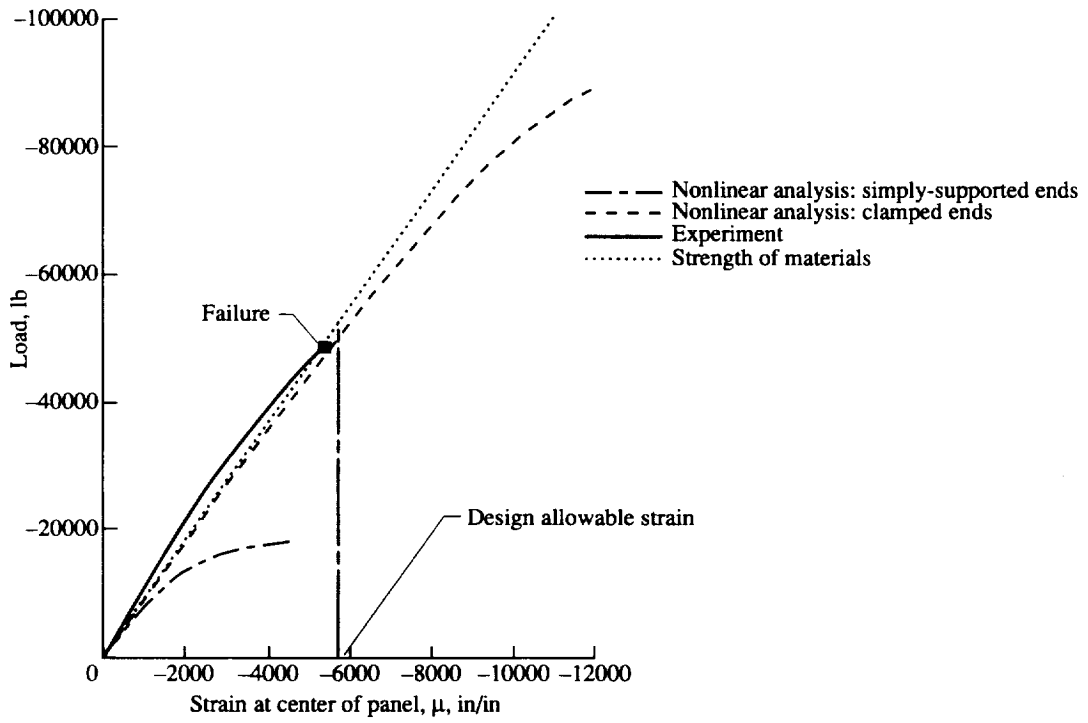
Figure 17. NASTRAN nonlinear composite plate finite element analysis for Panel 2 at 300°F (Geometric imperfection modeled from actual out of plane measurements mapped to nodal points).
