High-field fast-risetime pulse failures in 4H- and 6H-SiC *pn* junction diodes

Philip G. Neudeck[a]
NASA Lewis Research Center, 21000 Brookpark Road, M.S. 77-1, Cleveland, Ohio 44135

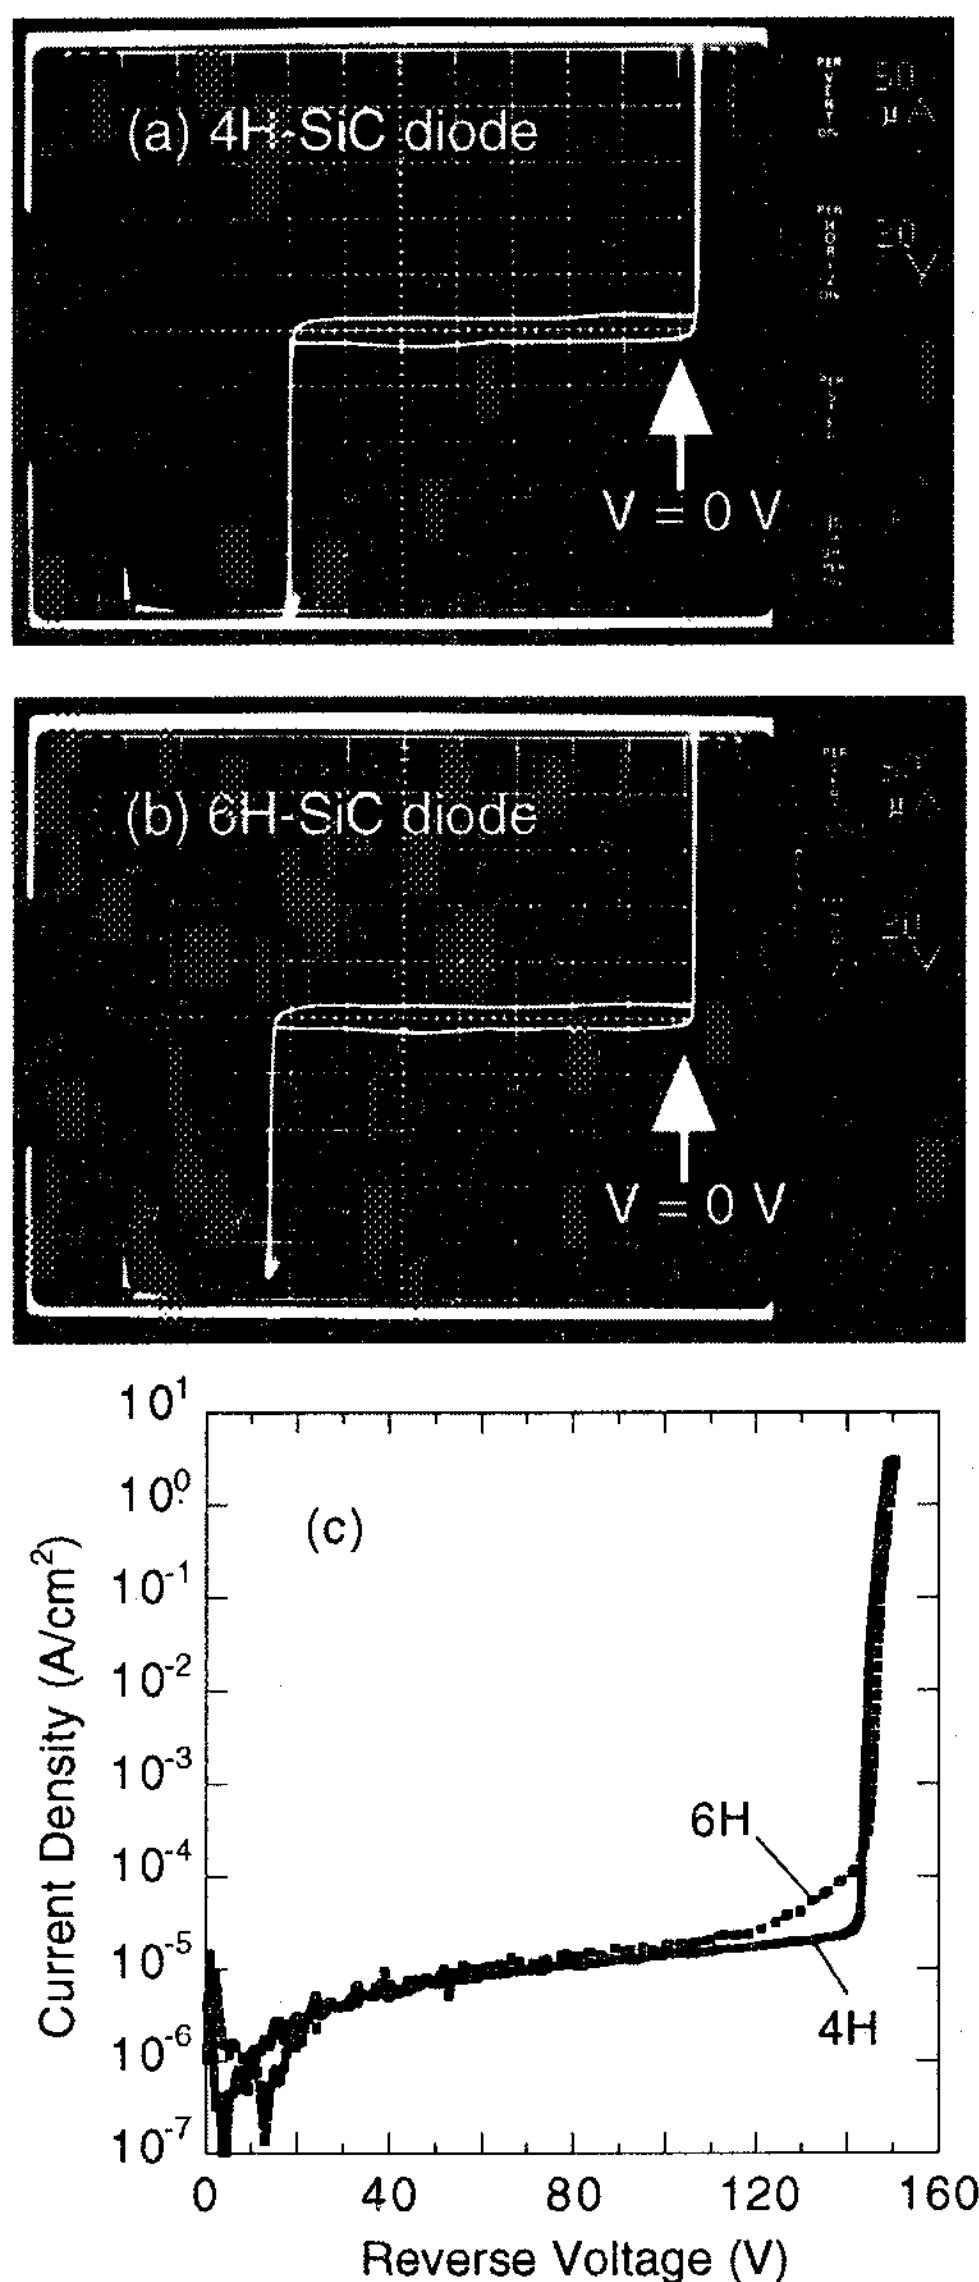
FIG. 2. Typical room-temperature $I-V$ characteristics of 1.96×10^{-5} cm^2 area SiC diodes. (a) Linear 4H-SiC characteristic and (b) linear 6H-SiC characteristic measured with curve tracer. (c) Semilogarithmic reverse characteristics measured with source-measure instrument.

For the well-behaved devices, the reverse breakdown knee voltage varied only slightly as a function of position on the wafer, 140–146 V for the 4H diodes, and 146–149 V for the 6H diodes. This small variation is consistent with doping and thickness nonuniformities that have been observed in similar samples produced by the growth system employed in this work. These dc-measured breakdown voltages are consistent with comparably doped SiC junction breakdowns reported in the literature.[11,12]

The pulse-induced breakdown observed at less than 70% of the dc-measured breakdown voltage is anomalous, since the dc-measured current (Fig. 2) at 100 V was less than 1 μA. Curve tracer characterization immediately following this pulse revealed that the diode had catastrophically failed and became a resistor instead of remaining a rectifying junction. The Fig. 4(c) data indicates junction breakdown occurred in 20 ns or less.

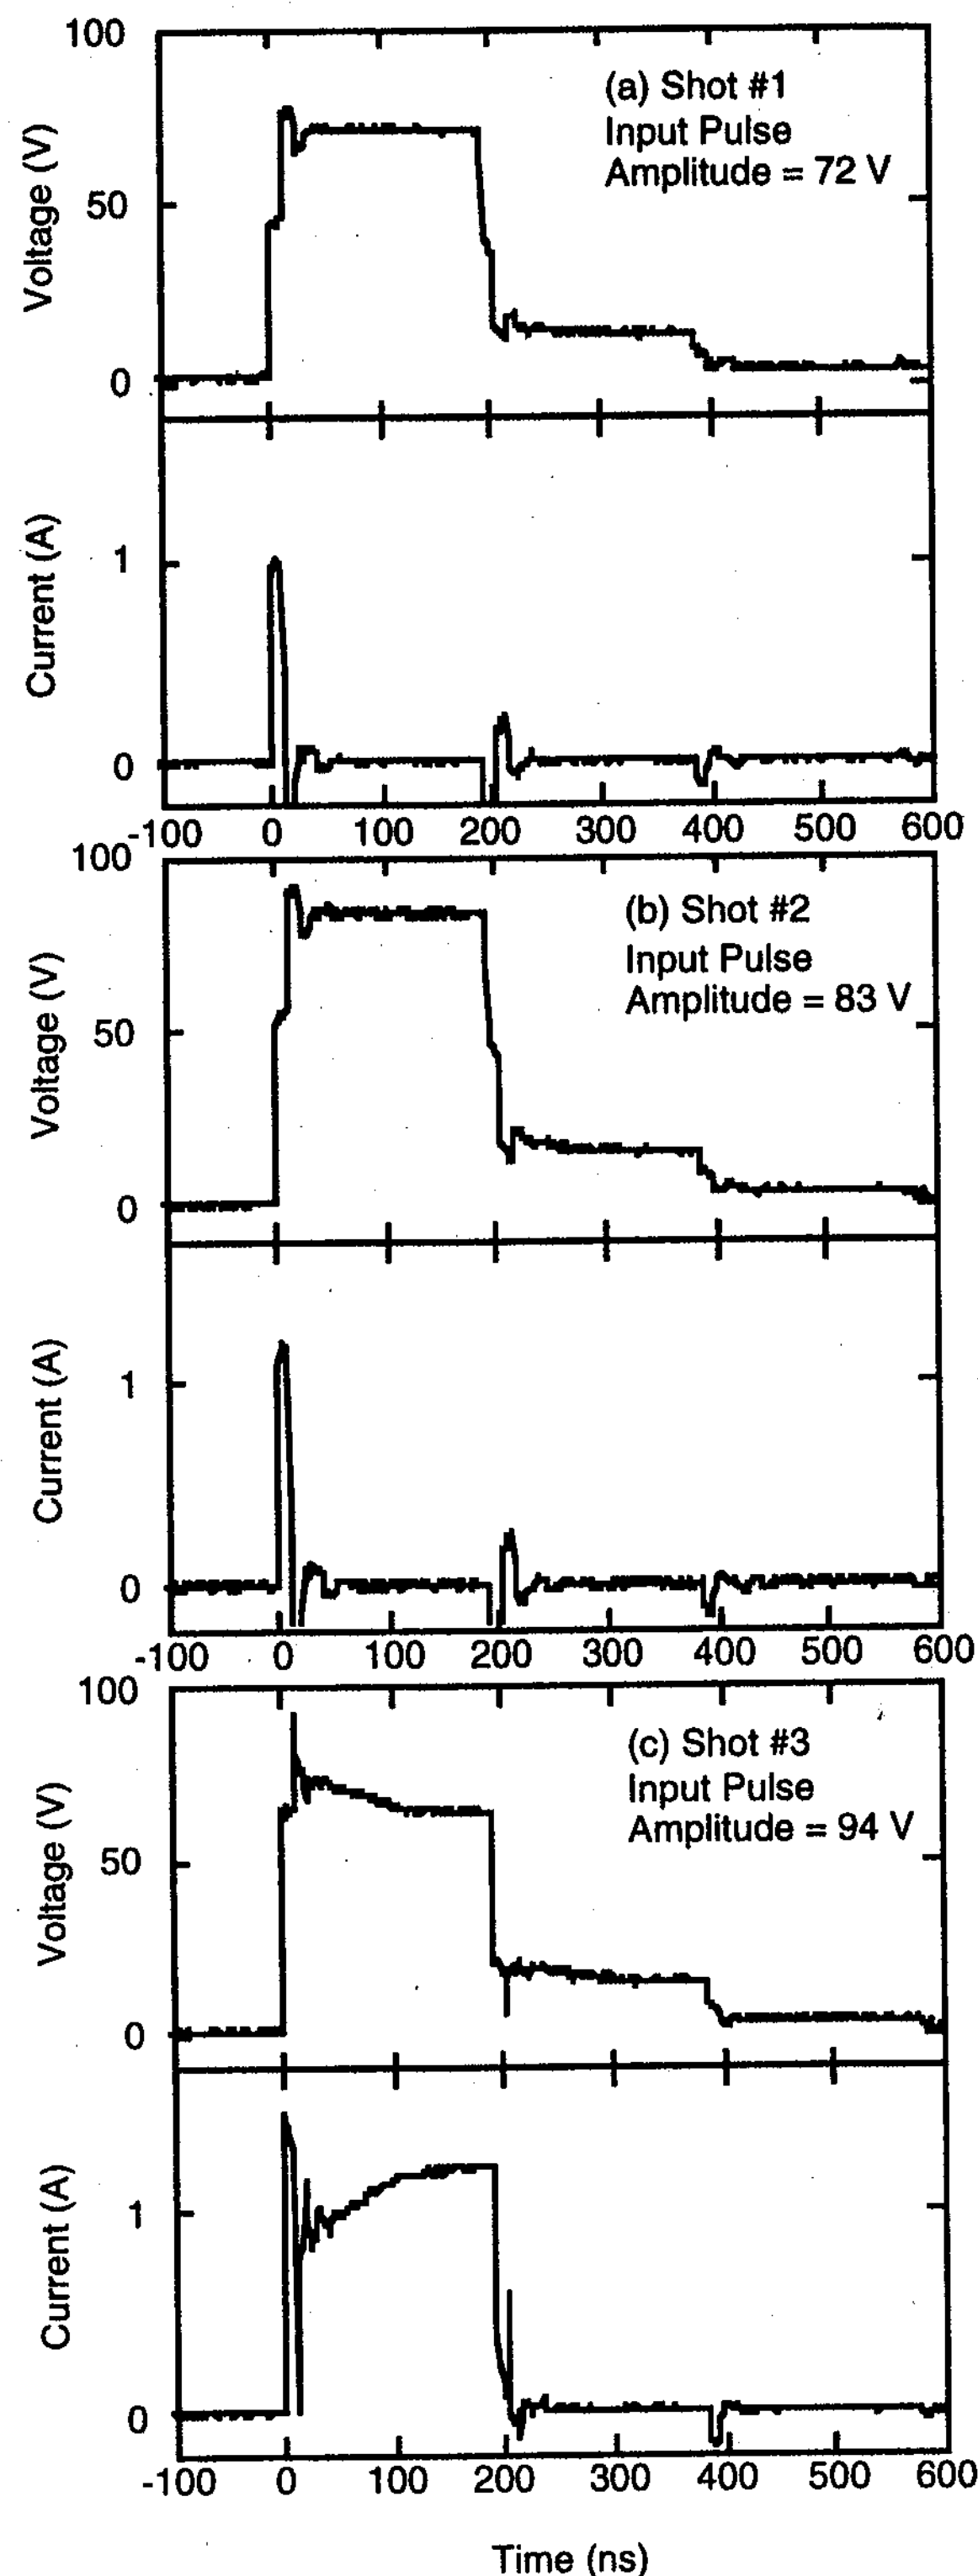
4(a)] to 83 V [Fig. 4(b)]. Since no conduction current is drawn, the amplitude of the device voltage waveform matches the input voltage pulse amplitude. However, when the input pulse amplitude was increased for the third shot to 94 V [Fig. 4(c)], the measured voltage across the device collapsed, while the conduction current shot up.

FIG. 4. Voltage and current transient response of 4H-SiC diode when subjected to 200 ns duration input pulse amplitudes of (a) 72 V, (b) 83 V, and (c) 94 V. The 94 V pulse failed the diode catastrophically, even though dc testing suggests the device should not fail until the pulse amplitude exceeds 140 V. Similar results were recorded for every 4H- and 6H-SiC diode pulse tested in this work.

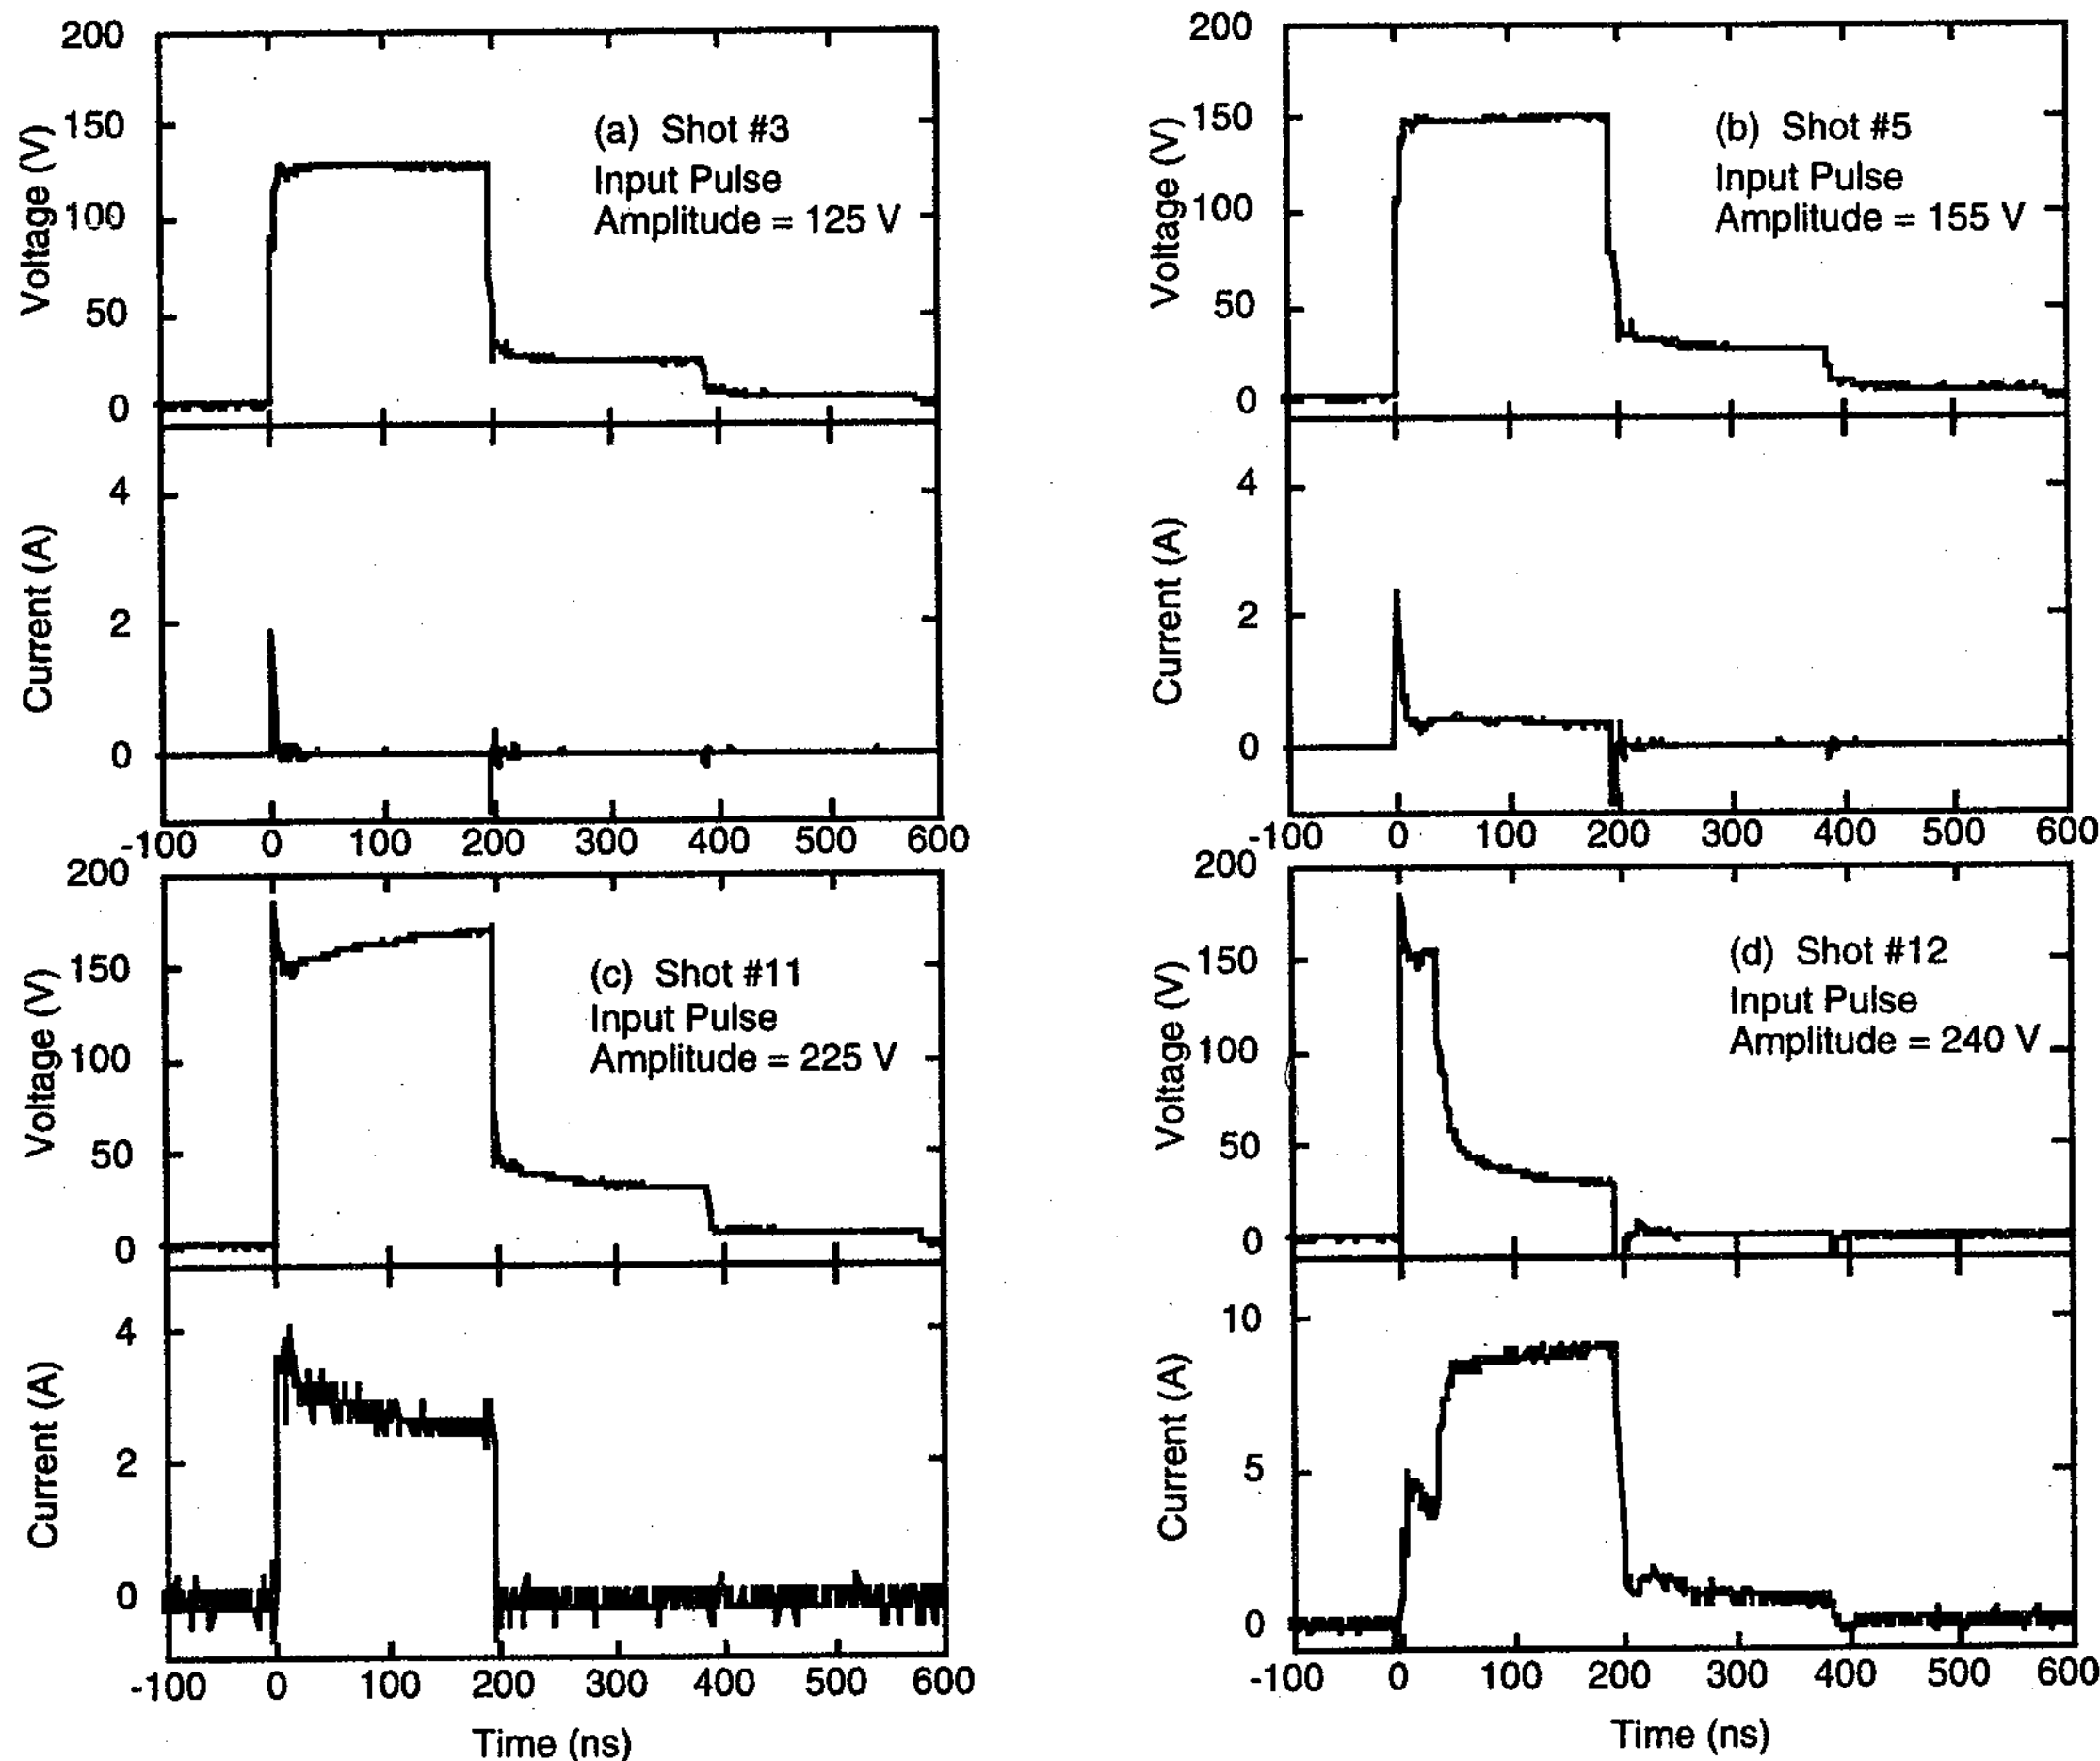
150 V [Fig. 6(a)]. As the input voltage pulse amplitude increased sufficiently beyond 150 V, current flow consistent with the 150 V dc breakdown voltage knee is observed [Figs. 6(b) and 6(c)]. With significant currents flowing through the diode, the measured voltage waveform across the diode clamped in the neighborhood of 150 V, despite the fact that the input pulse amplitude (which can be measured "open circuit" when no device under test is present) had been increased to 225 V in Fig. 6(c). Prior to the 240 V input pulse that failed the diode [Fig. 6(d)], the dc-characteristics measured on the curve tracer between pulses remained unchanged from the initial $I-V$ characteristic. Diode failure occurs at $t=40$ ns in Fig. 6(d), as clearly evidenced by the voltage collapse and increase in current.

FIG. 6. Voltage and current transient response of a 150 V, 10 mA silicon diode when subjected to 200 ns duration input pulse amplitudes of (a) 125, (b) 155, (c) 225, and (d) 240 V. The positive temperature coefficient of breakdown voltage behavior is readily evident in part (c). The 240 V pulse failed the diode catastrophically at $t=40$ ns in part (d).

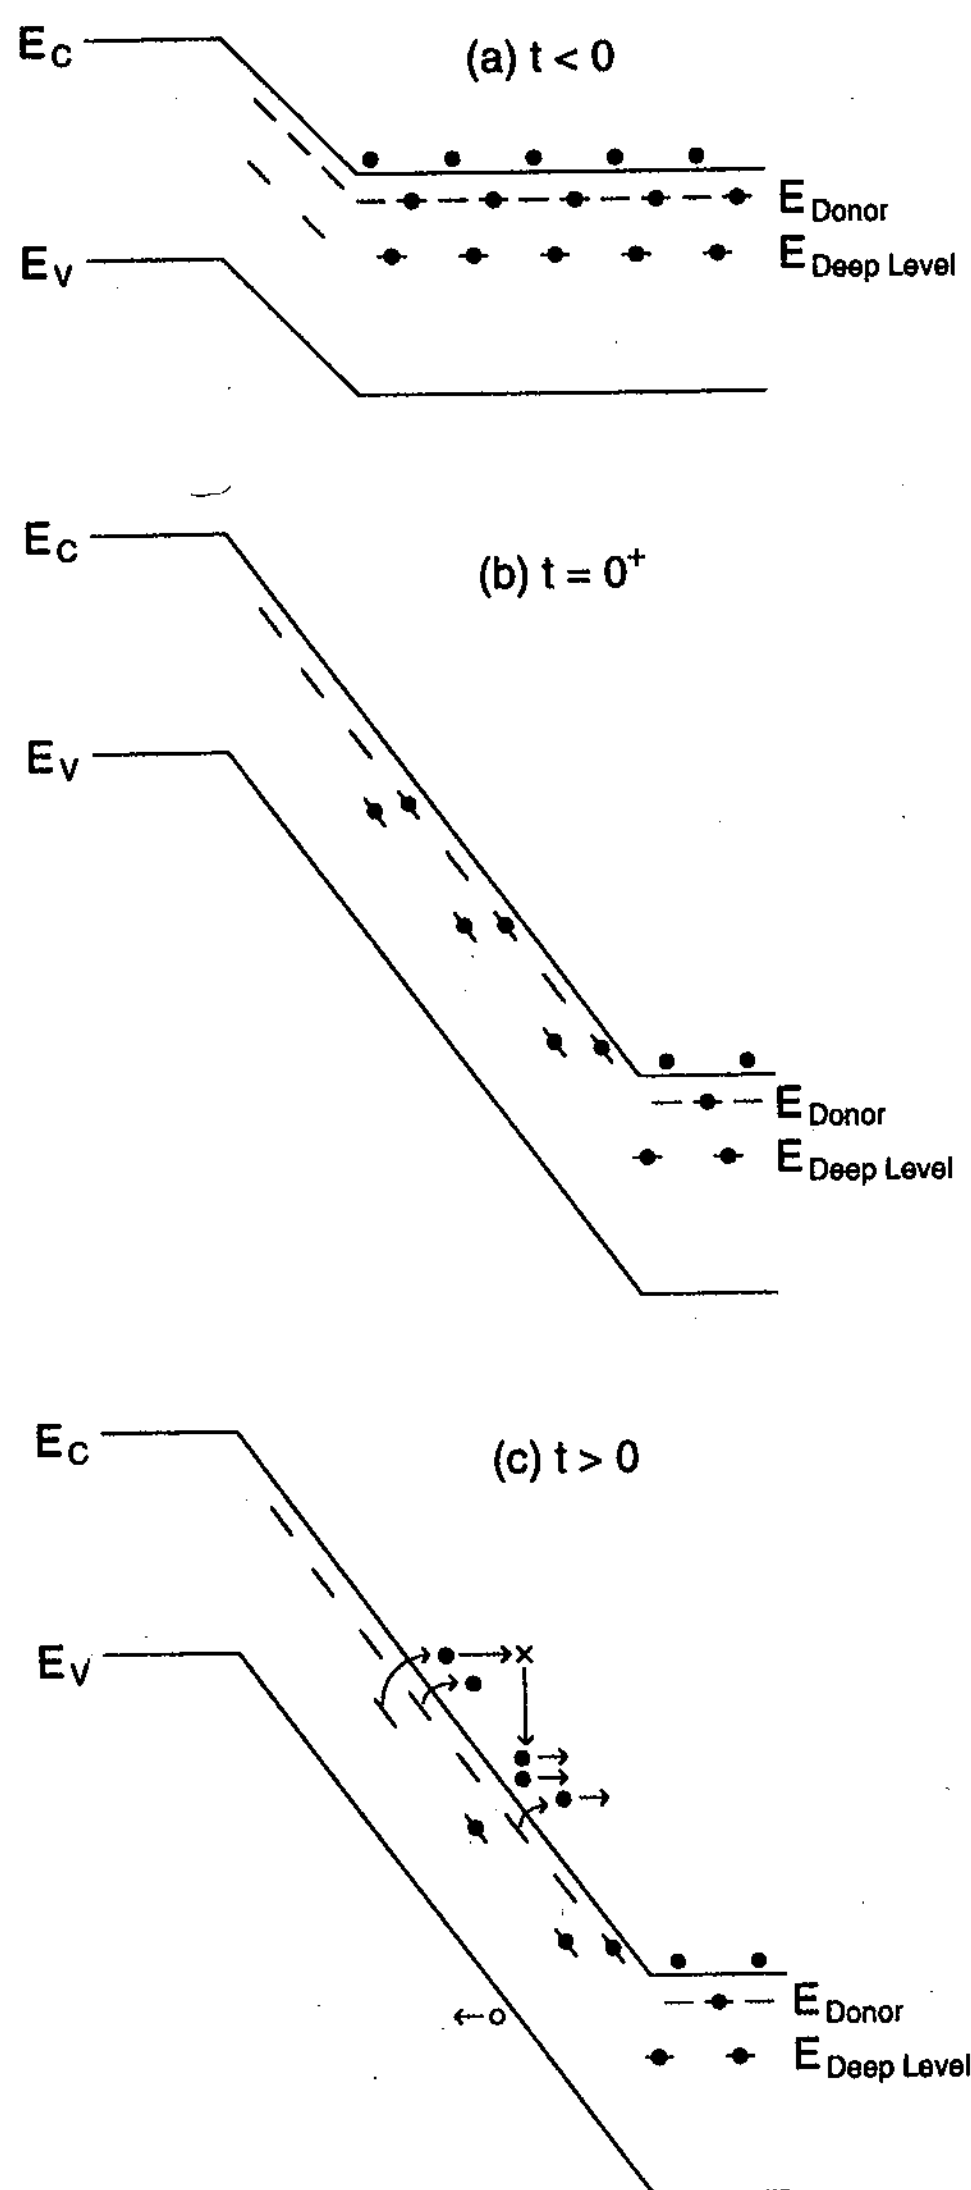
The band diagrams of Fig. 7 illustrate part of our working theory for the fast-risetime pulse instability observed in the SiC diodes of Sec. II C 2. For simplicity, only donorlike centers and electrons in a partially frozen-out n-type region of a junction will be considered in the following discussion. Nevertheless, the basic mechanism can also be applied to various permutations of centers (donorlike and acceptorlike) and carriers in any rectifying junction.

Before bias is applied to the SiC sample, there are a substantial number of carriers occupying un-ionized donors and deep-level defects in quasineutral regions near the depletion region edge [Fig. 7(a)]. When a fast-risetime bias pulse is applied, the emission of trapped carriers does not occur quickly enough to keep up with the expanding depletion region. A significant percentage (perhaps a majority) of carriers remain briefly trapped in the high-field depletion region

FIG. 7. Band diagrams depicting the n side of an arbitrary SiC diode junction (a) at zero bias, (b) with voltage applied at the leading edge of fast-risetime pulse, and (c) at a brief time following the pulse leading edge when dopants and deep levels are emitting carriers into the high-field junction depletion region.

at $t=0^+$ [Fig. 7(b)]. These carriers thermally emit into the high-field depletion region at the worst time [$t>0$, Fig. 7(c)]. The injection of carriers into the high-field region produces an undesired current surge that fails the diode.
