PHYSICAL PROPERTIES OF GLASSES EXPOSED TO EARTH-FACING AND TRAILING-SIDE ENVIRONMENTS ON LDEF

David E. Wiedlocher, Donald L. Kinser, Robert A. Weller,
Robert A. Weeks, and Marcus H. Mendenhall
Vanderbilt University
Nashville, TN 37235

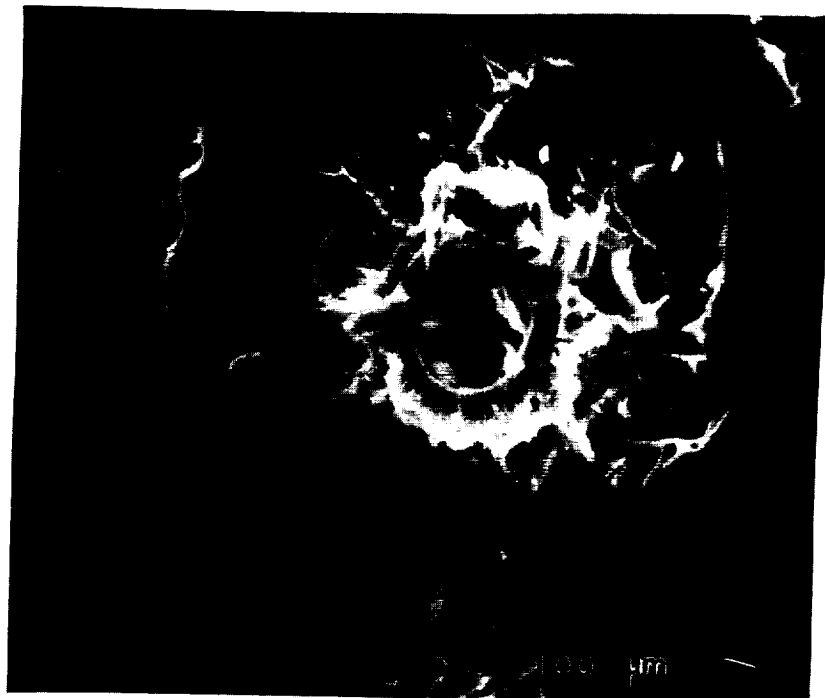
Figure 1. SEM of impact site in Zerodur.

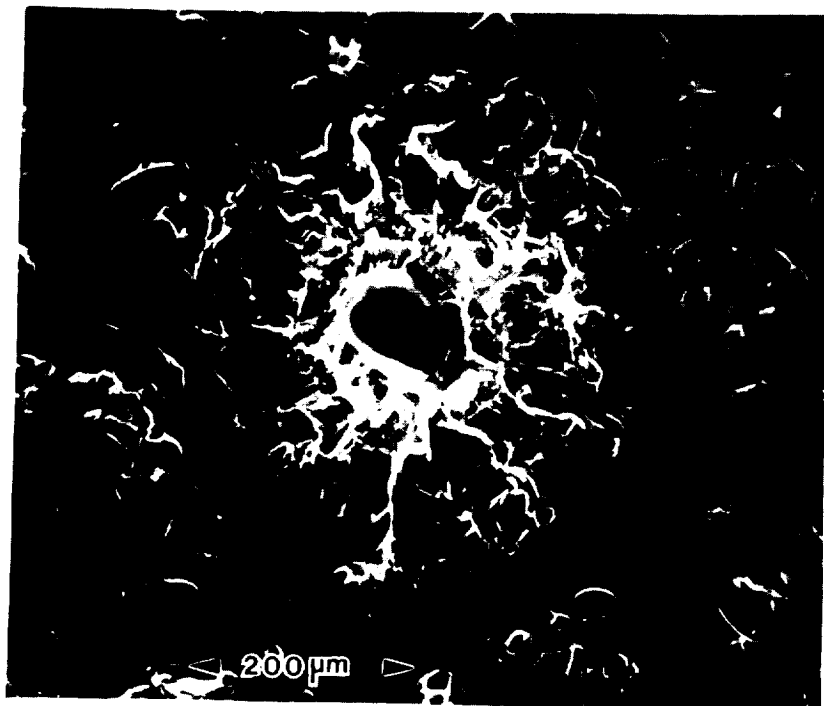
The impact observed on the Pyrex sample may have occurred at an oblique angle.

Figure 4. SEM of impact in Pyrex glass sample.

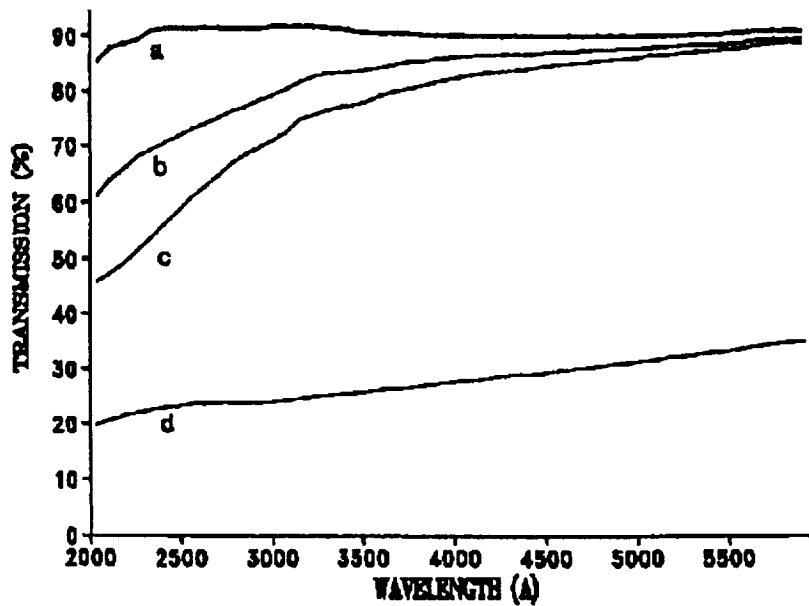
Indirect evidence that the carbon is in the form of hydrocarbon fragments comes from Figures 6 and 9. The optical absorption profile of the carbon coated SiO_2 glass shown in Figure 6 is similar to, but not the same as, that of the two samples exposed on LDEF. The absorption of the carbon-coated sample is larger than that of the exposed samples, and the general form of the absorption curve is clearly different. Referring to Figure 9, we observe that the offsets of the various silicon edges from the SiO_2 surface edge are measures of the thicknesses of the carbonaceous layers. It is significant that the evaporated carbon layer is only about 50-percent thicker than the contaminant layer on the trailing-edge sample. By contrast, the transmission data of Figure 6 show a transmission ratio of approximately 2.2. This difference is the result of the chemical state of the films and is evidence that the contamination encountered in space is not graphite, but a more complex carbon-based material.

Figure 6. Optical transmission as a function of wavelength for SiO_2 samples (a, control; b, Earth facing; c, trailing edge; and d, sputtered carbon).

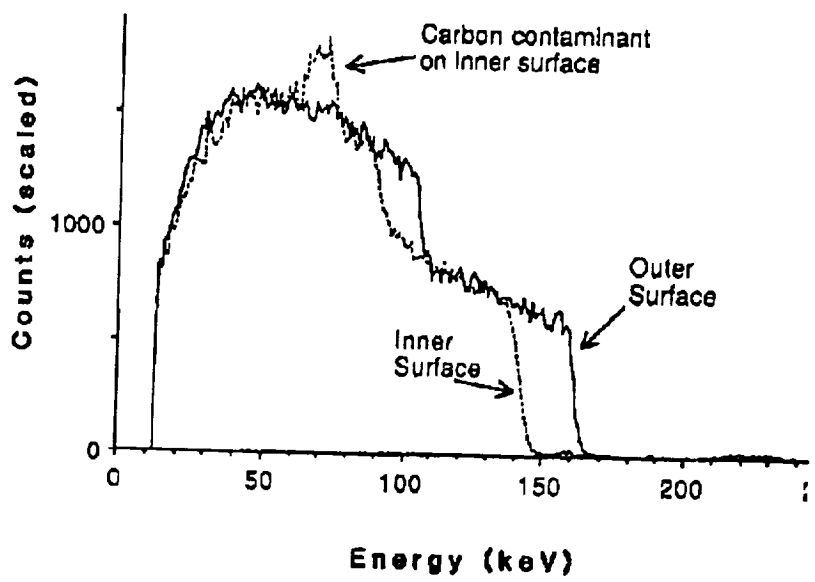
Medium energy backscattering results in Figures 7 and 8 show spectra which were obtained from the exposed and unexposed surfaces of the SiO$_2$ samples. Note the displacement of the surface Si edge on spectra obtained from the unexposed surfaces and the presence of significant peaks

Figure 7. Counts as a function of energy for trailing edge exposure SiO_2.

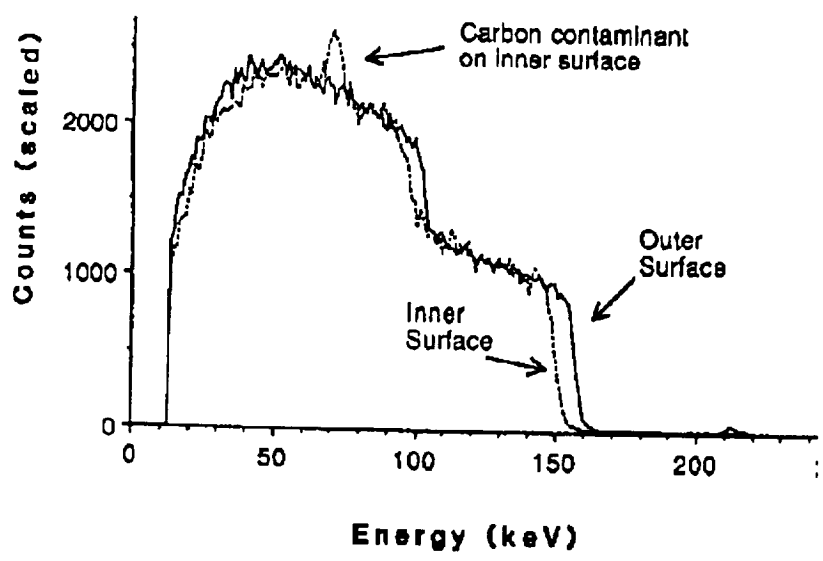
Figure 8. Counts as a function of energy for SiO_2 sample exposed on Earth-facing position.

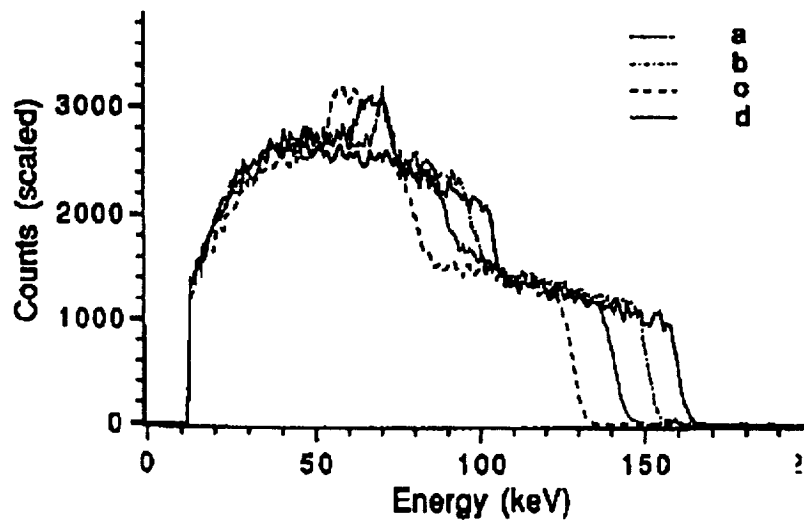
attributable to surface carbon. The Si edge shift in these spectra is caused by the presence of a contaminant overlayer which may be inferred to arise from two surface carbon layers of condensed hydrocarbon fragments. Figure 9 is a composite spectra from an uncontaminated SiO_2 surface, the surfaces of leading edge and trailing edge SiO_2 samples, and the SiO_2 sample supporting an evaporated carbon film. Note the progressive shifts in the position of the silicon edges. Figure 10 shows an expanded view of the contaminated surface of the leading-edge sample. Note the presence of a peak near 215 keV. This indicates the presence of about 10^{15} cm^{-2} of a trace contaminant with a mass near 64 u either at the surface or, possibly, distributed throughout the hydrocarbon film.

Figure 9. Counts as a function of energy for all SiO₂ samples (a, trailing edge, b, Earth facing; c, carbon coated, and d, control).

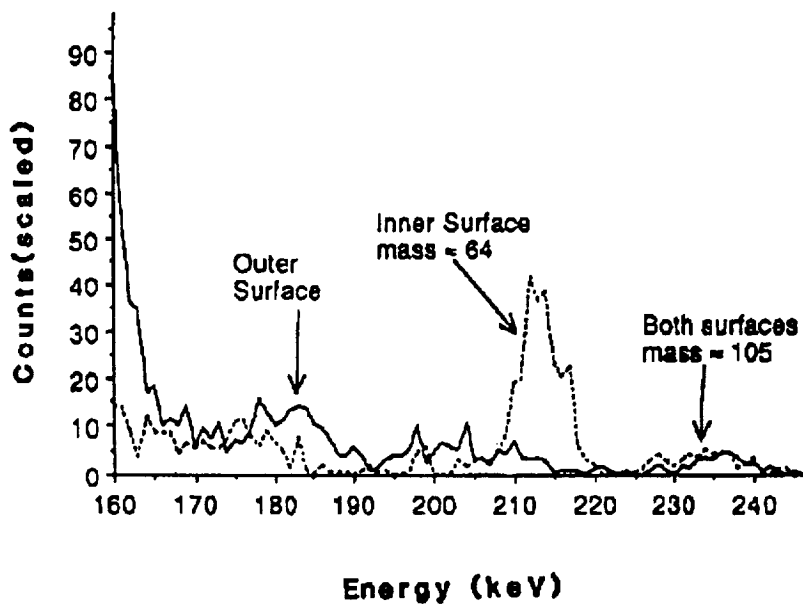
Figure 10. Counts as a function of energy for Earth-facing exposure SiO₂ with peak of 64 u evident.

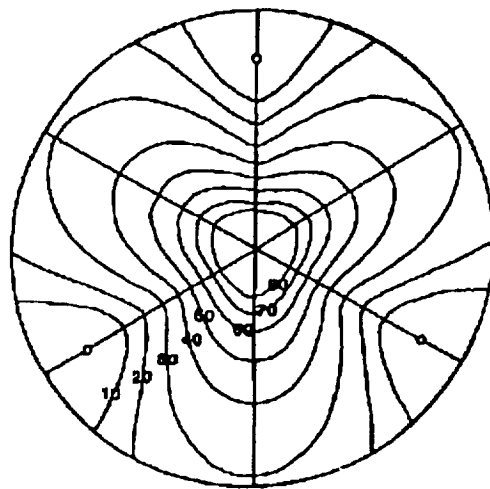
Strength measurements are summarized in Wiedlocher et al. (ref. 12). The symmetric flexure test employed in that work imposed stresses on the surface of the circular sample as illustrated in Figure 13. The highest stress levels occur in the geometric center of the sample. The impact nearest the geometric center occurred at a position where the stress was less than 50 percent of failure stress; thus, we argue that the effect of micrometeorite or space debris impacts experienced in this work reduced the glass strength by less than 50 percent.

Figure 13. Contours of equal stress for three point support centrally loaded disk.
