NOTE ON FLUTTER OF A 60° DELTA WING ENCOUNTERED AT

LOW-SUPERSONIC SPEEDS DURING THE FLIGHT OF A

ROCKET-PROPELLED MODEL

NACA RM L51B28

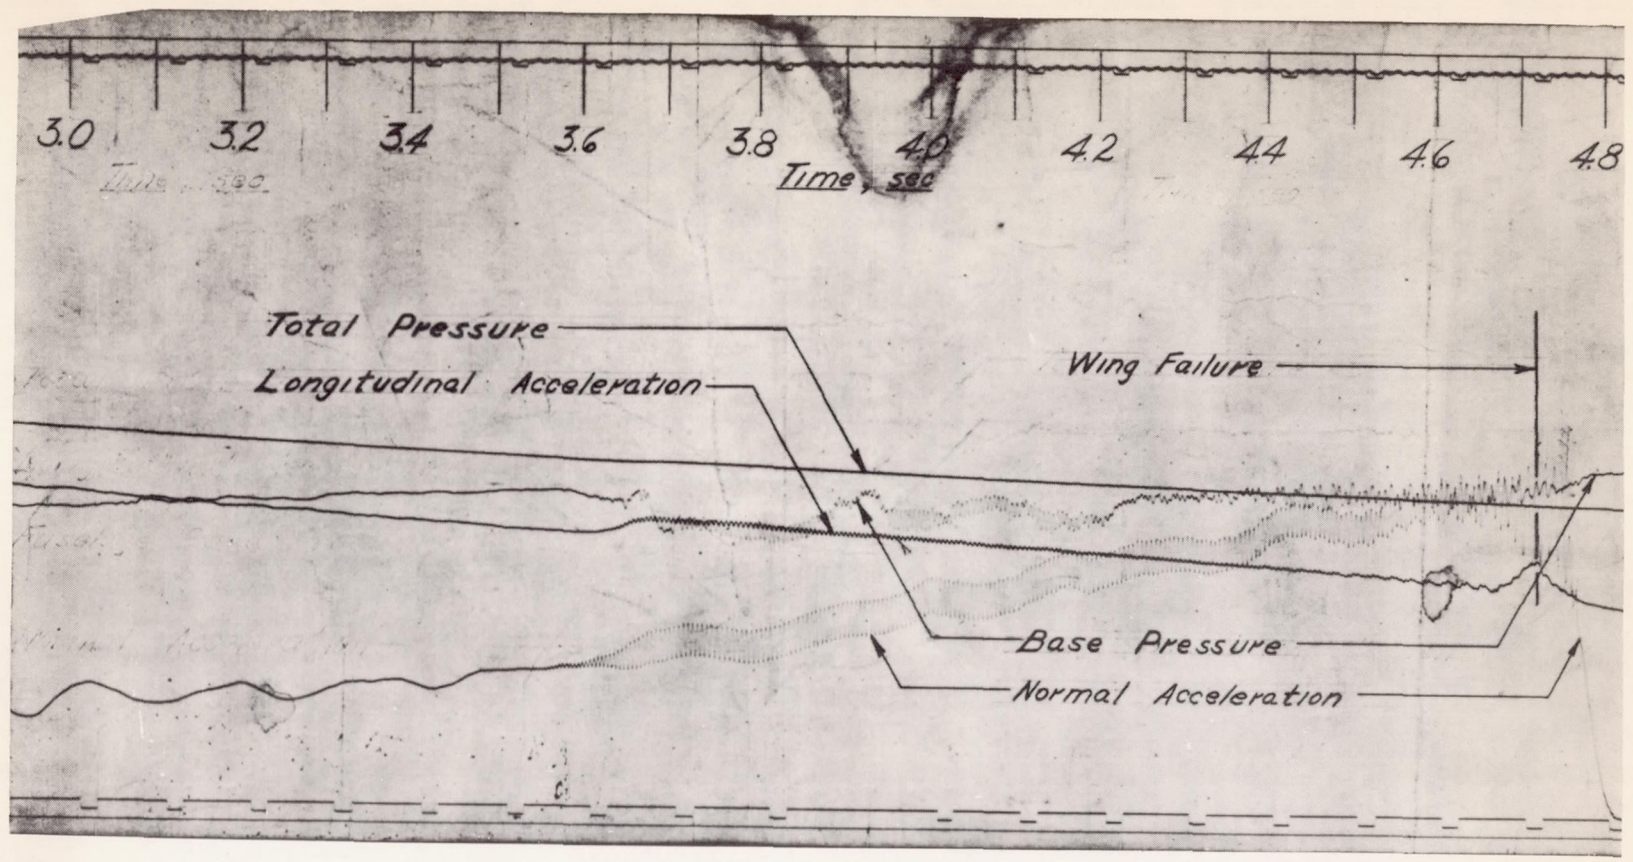
Figure 5.- Portion of telemeter record before and during flutter of flight

A study of the telemetered record of the flight, a portion of which is shown in figure 5, shows that a high-frequency oscillation of the normal-acceleration trace started in the decelerating portion of the flight at a Mach number of 1.11 and continued until structural failure at a Mach number of 0.99. This oscillation commenced at a frequency of 205 cycles per second and decreased to a frequency of 185 cycles per second immediately prior to wing failure. Figure 6 shows a plot of velocity and Mach number against time for a portion of the flight during which the oscillation occurred. This oscillation is believed to have been caused by wing vibration since previous experience has shown that the normal accelerometer will follow wing vibrations (references 2 and 3). Although the limitation of the instrumentation system prevents the accurate determination of amplitude at high frequencies, it may be noted that the amplitude, as recorded, indicates a normal acceleration of approximately ±0.3g. This quantity is believed to be low by a factor of approximately 16, as pointed out in the section entitled "Apparatus and Flight Tests." Thus, the oscillating load may have been in the order of ±5g.
