NACA RM No. E8J22a

VIBRATION SURVEY OF BLADES IN 10-STAGE AXIAL-FLOW COMPRESSOR

II - DYNAMIC INVESTIGATION

January 31, 1949

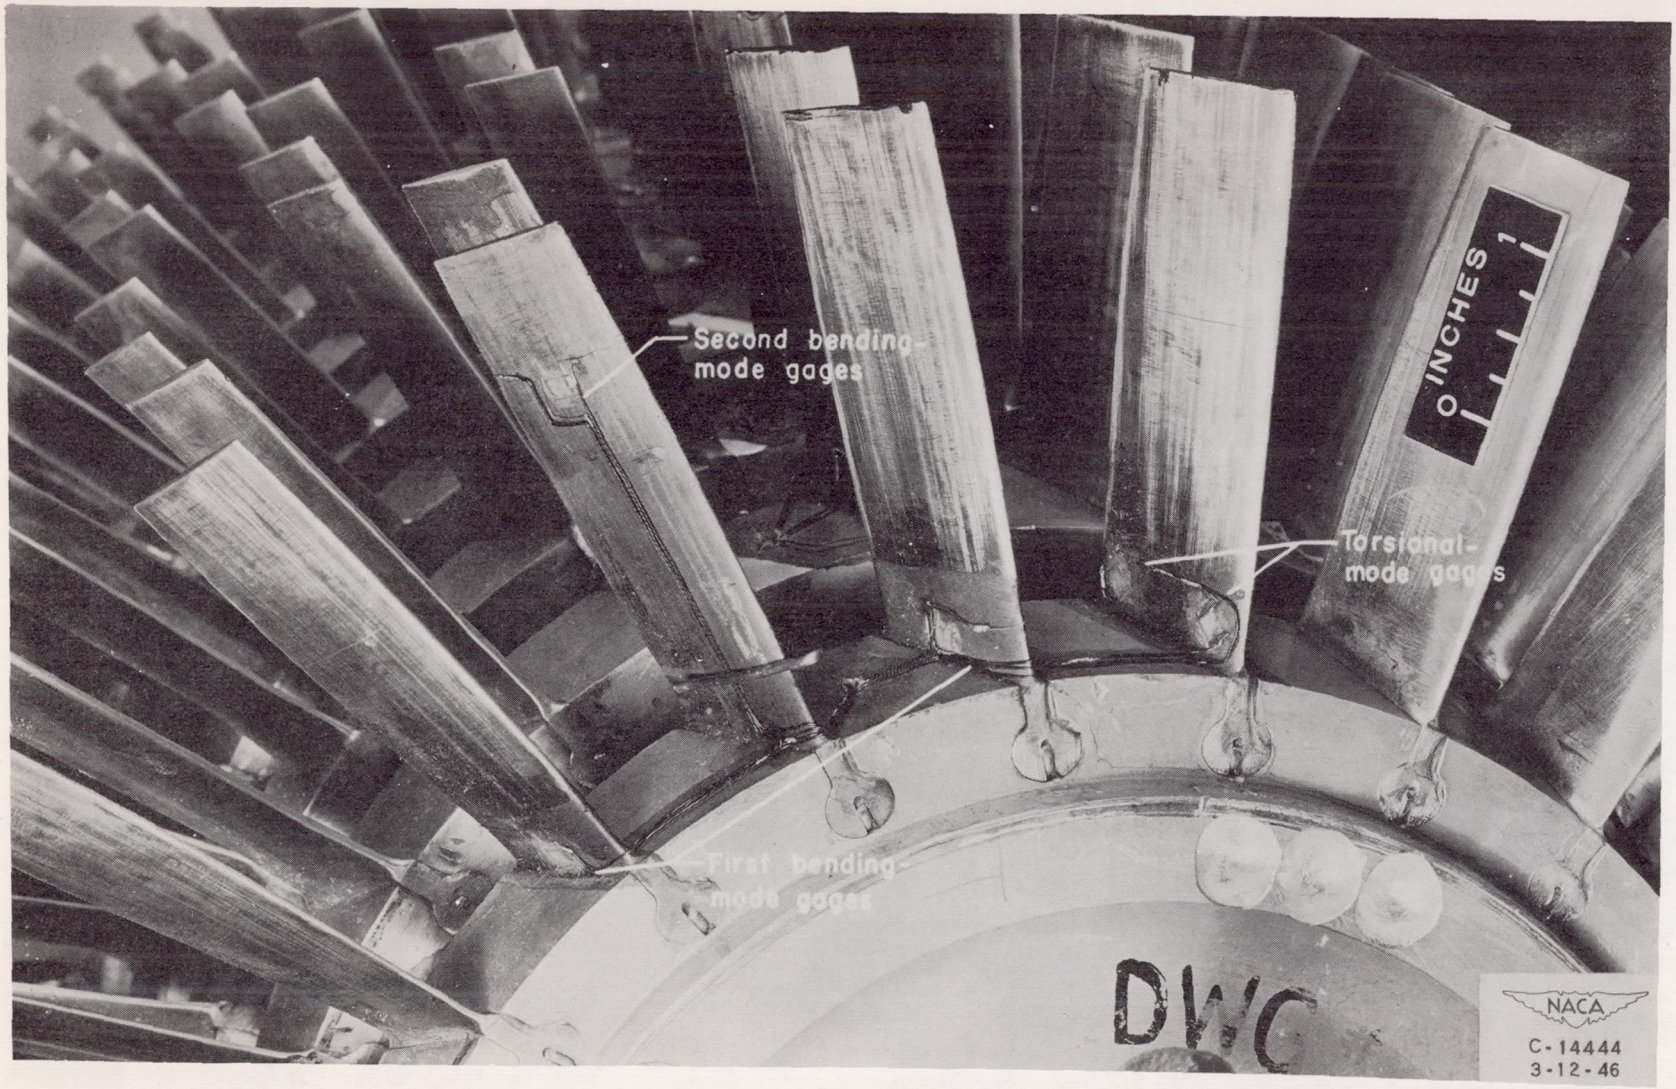
For checking purposes, 36 active strain-gage bridges were mounted on blades of the various stages with at least two bridges per stage. The gages were mounted on the blades with Bakelite cement with the resistance-wire filaments parallel to the direction of maximum compressive and tensile stresses for the mode of vibration in question (fig. 1). Some of the gages were used to detect bending vibrations and others to detect torsional vibrations. The construction of the gages is similar to that outlined in reference 2.

Figure 1. - Strain gages mounted on blades of first stage of 10-stage compressor.

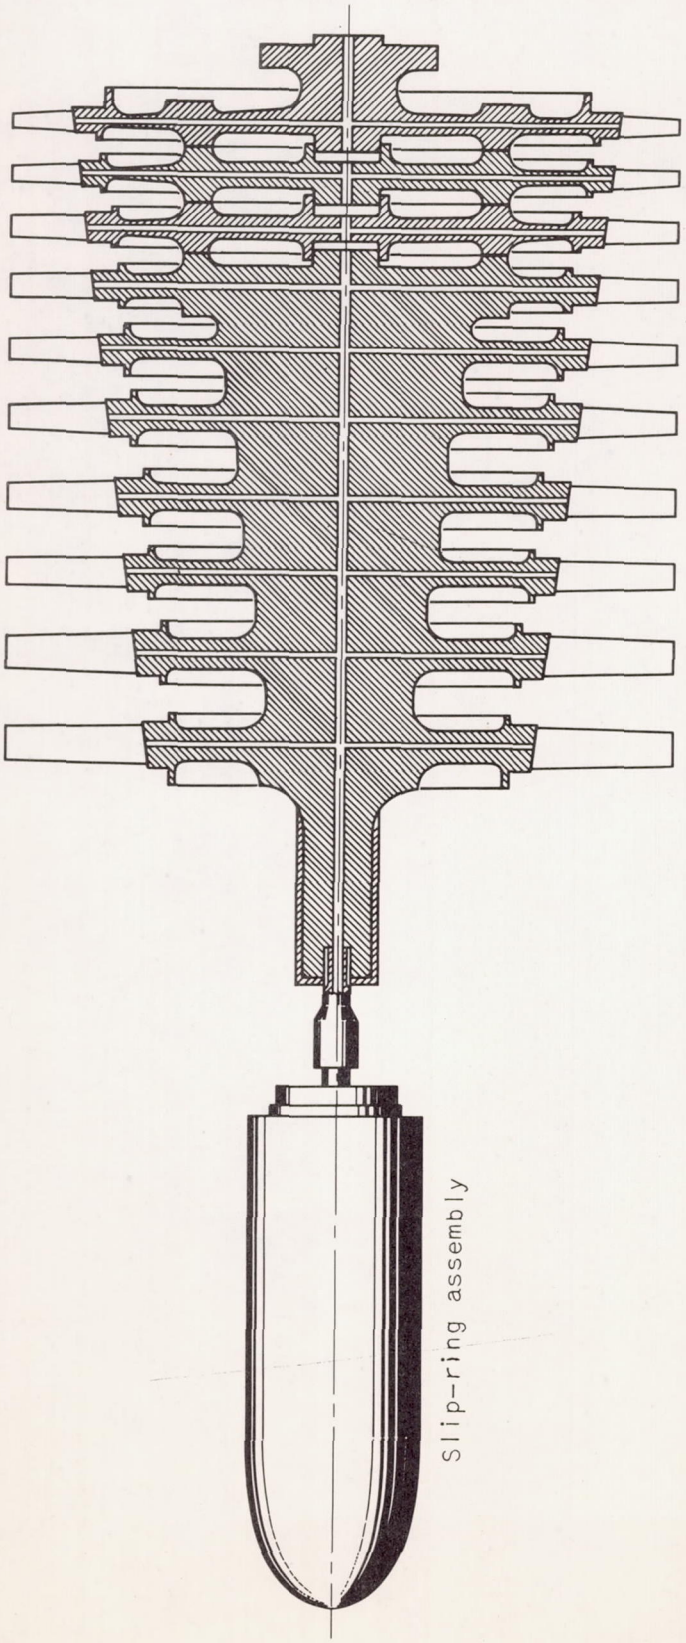
Insulation on the lead wires was safeguarded by smoothing the holes drilled in the rotor and by rounding the junctions of the holes by use of a liquid honing process. The wires were firmly embedded in a ceramic cement that was forced into the holes after the wires were pulled into position and attached to the strain gages. A lead-shielded telephone cable completed the circuit from the slip rings to the instruments located in a control room adjacent to the test cell.

The operating range of the equipment was limited to a compressor speed of 14,000 rpm by lack of driving power, although the compressor is rated at 17,000 rpm. Unfortunately, conclusive data on the last five stages were not obtained because some of the lead wires were thrown out by centrifugal force during the elapsed running time needed to eliminate instrumentation difficulties. The lead-wire failures were attributed to poor adhesion and faulty void filling by the ceramic cement.

Figure 2. - Axial-flow compressor rotor drilled for strain-gage lead wires.

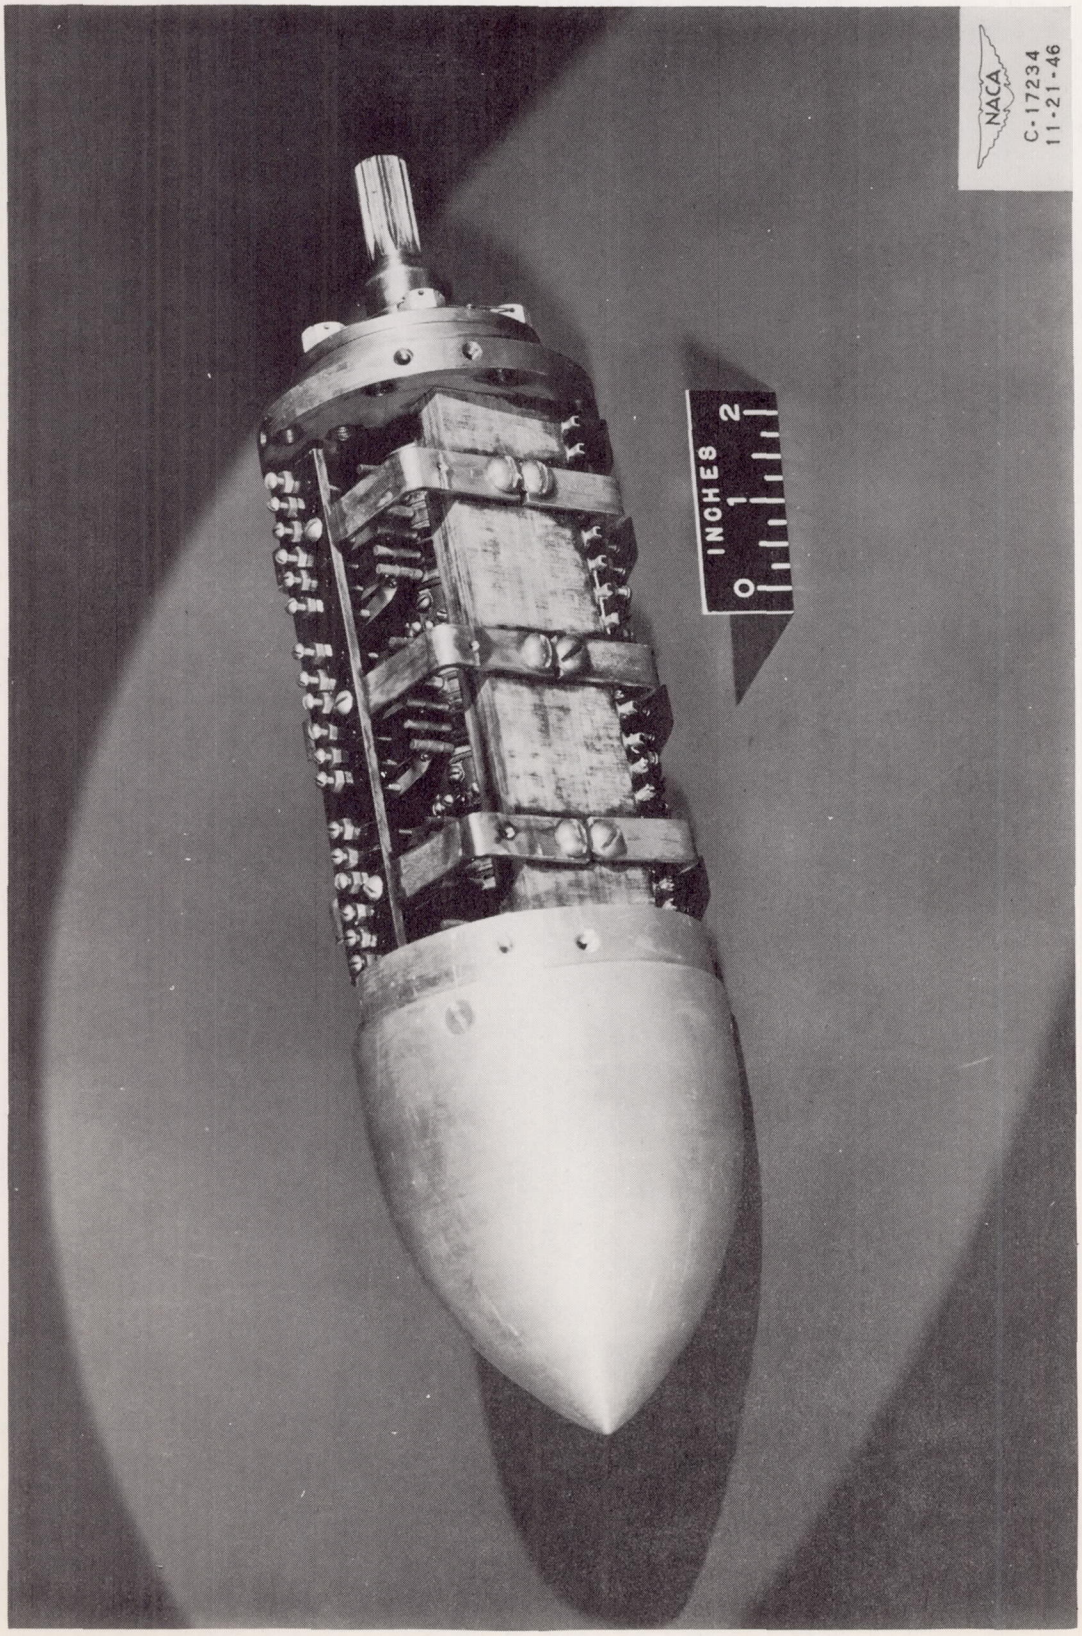
The lead wires were silk-covered, enameled, No. 27 copper wire with three additional coats of thermal-setting varnish. These wires were pulled through holes drilled in the rotor as shown in figure 2 and connected to the slip-ring assembly (fig. 3). A schematic diagram of the strain-gage circuit used for measuring vibratory stresses is presented in figure 4; three circuits similar to the one illustrated were installed, which permitted 12 signals to be recorded simultaneously by the 12-channel amplifier and oscillograph. By means of a special switching arrangement incorporated in the slip-ring assembly, any set of strain gages could be connected to the recording instruments in a few minutes. Strain gages similar to the active gages were used as balancing resistors and were placed on the periphery of the rotor disks with the filaments parallel to the axis of the rotor.

Figure 3. - Slip-ring assembly.

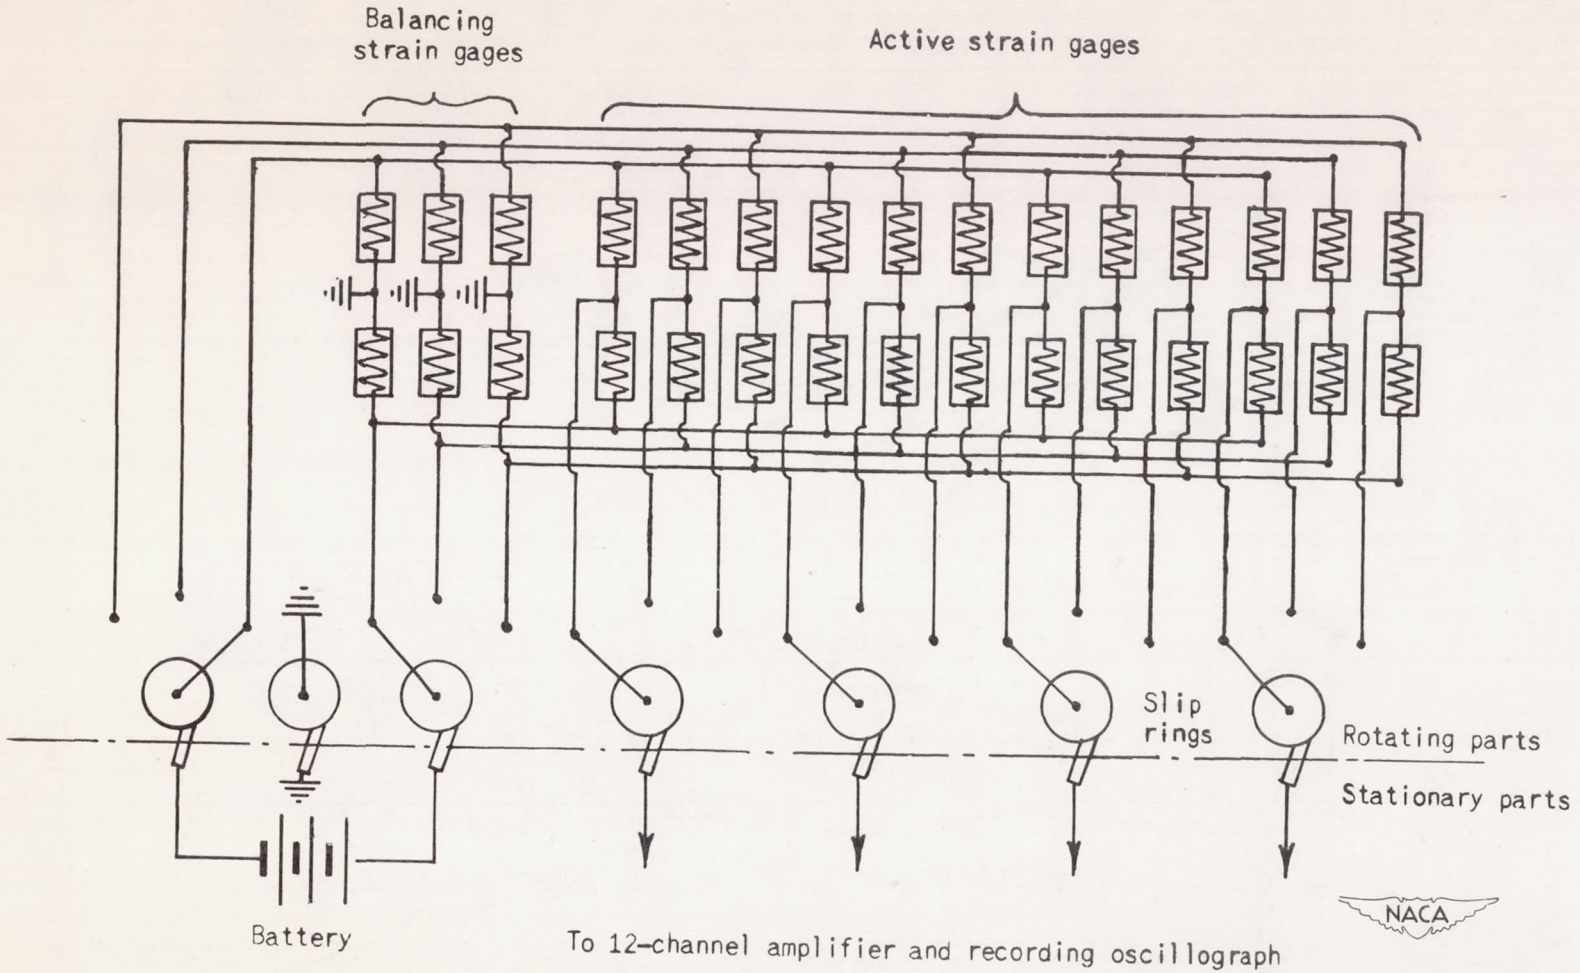
Figure 4. - Schematic diagram of bridge circuit installed on 10-stage axial-flow compressor. Three complete circuits similar to one shown were used in the investigation.

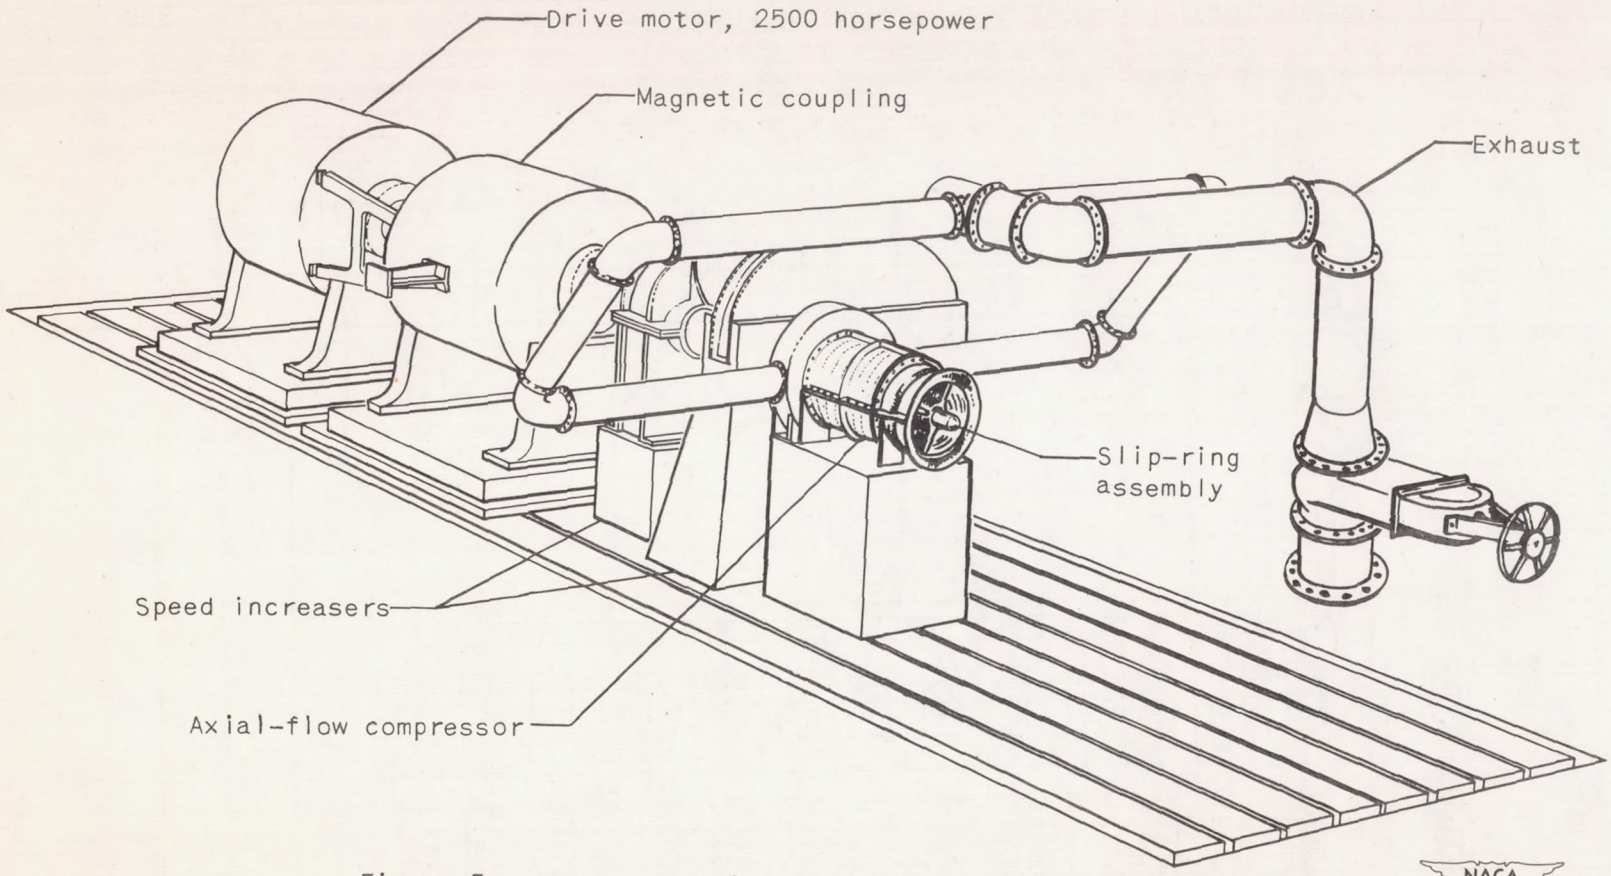
The compressor, tested separately from the other parts of the engine, was driven through a variable-speed magnetic coupling and speed increasers by a 2500-horsepower constant-speed drive motor (fig. 5). The compressor intake was open to the atmosphere but the compressed air was exhausted into a controlled pressure system. The compressor pressure ratio was varied by means of a butterfly valve in the exhaust line.

Figure 5. - Setup for vibration investigation of compressor.

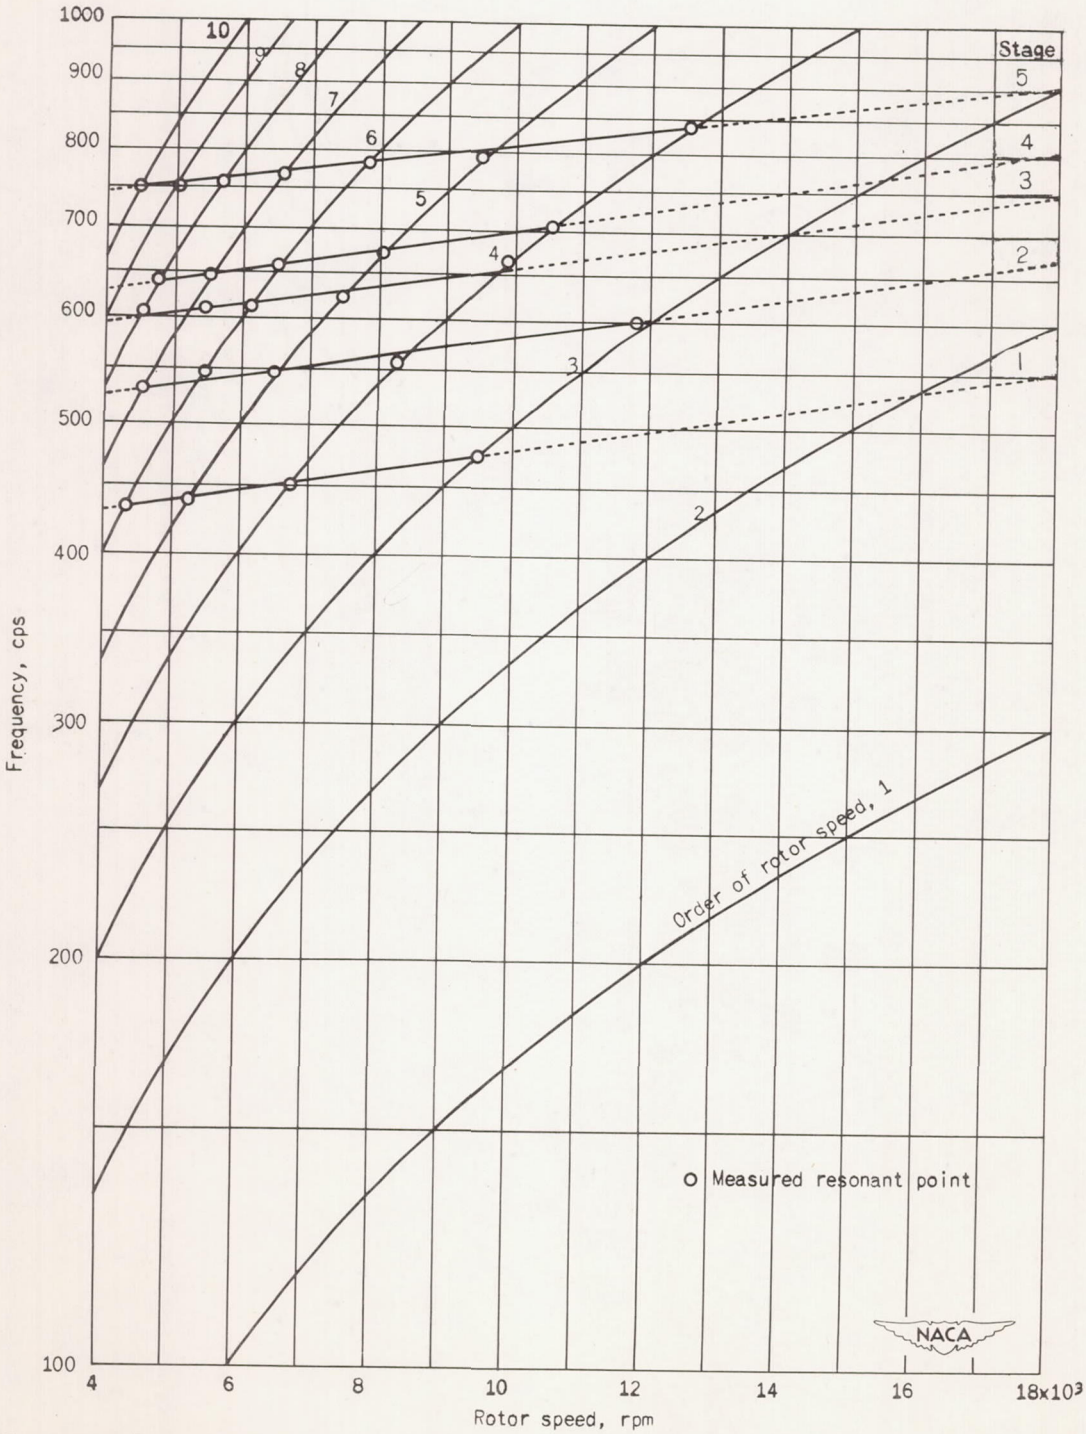
The results of the static frequency measurements made on blades of the compressor indicated that failures experienced in the seventh and tenth stages could have been caused by first bending-mode vibrations resulting from fourth- and sixth-order excitation of the rotative speed, respectively. Critical-speed diagrams illustrating this possibility are included in reference 1. The sources of the fourth- and sixth-order exciting forces have not been learned. Although four bearing supports interrupt the inlet-air stream, it is doubtful that the effect of these supports would carry as far as the seventh stage. No condition exists within the compressor that would cause six equally spaced discontinuities in the air flow.

Figure 6. - Critical-speed diagram of 10-stage compressor showing only first bending-mode frequencies.

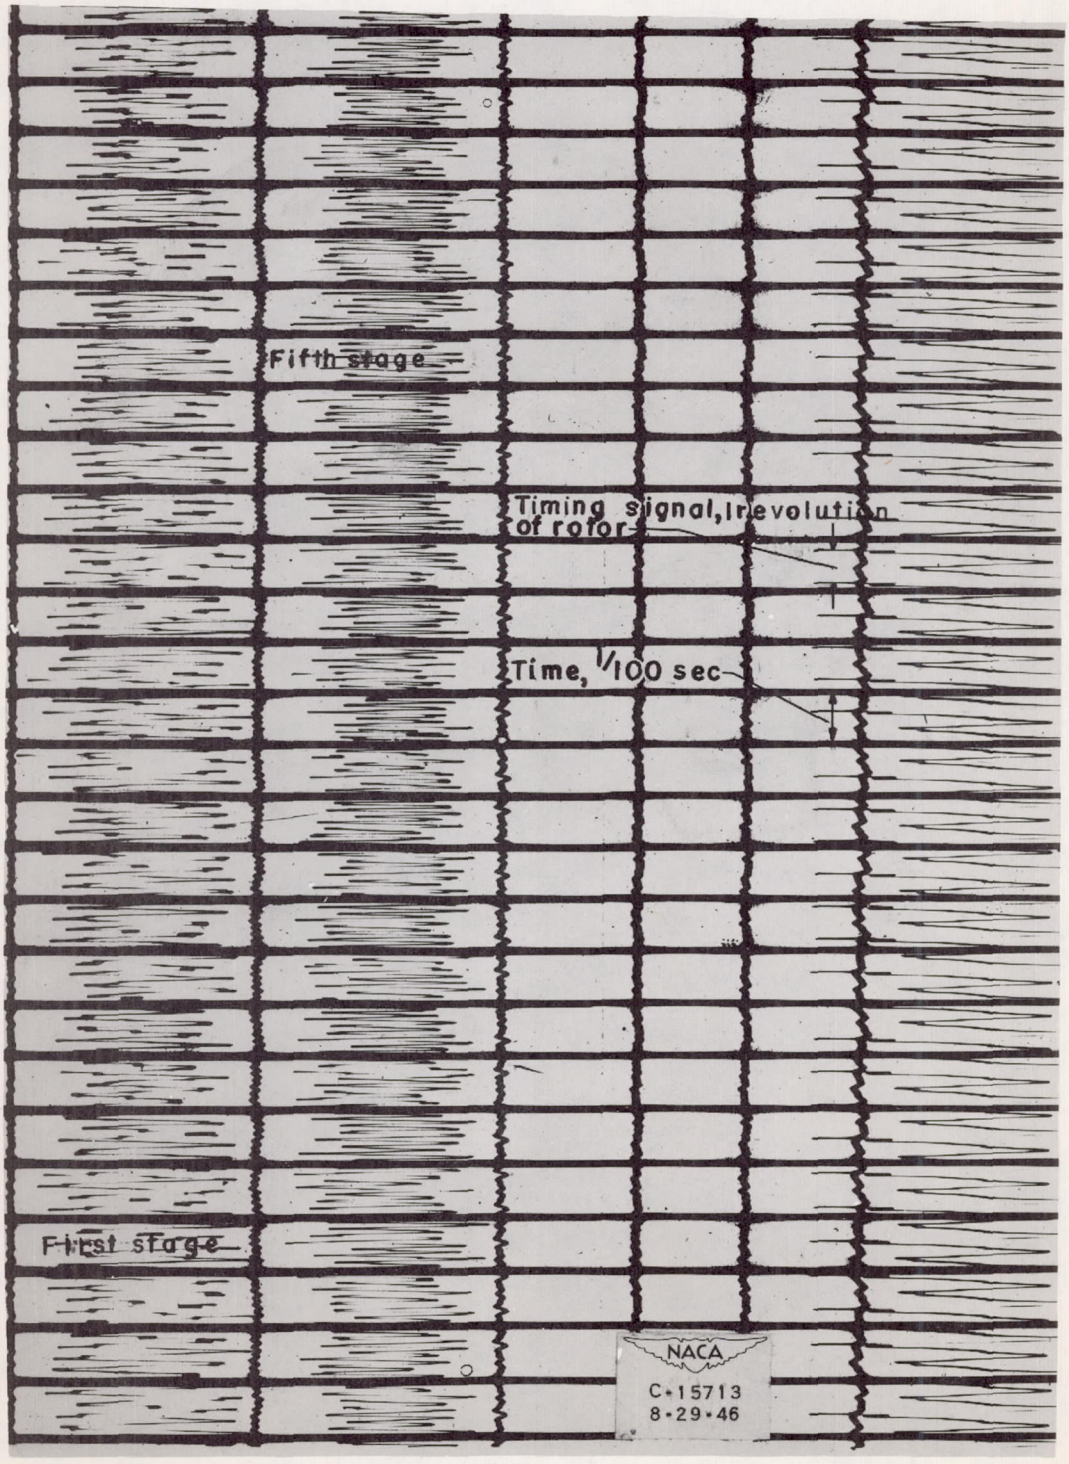
strain-gage signals from first- and fifth-stage blades that happened to resonate at the same rotor speed (9485 rpm). The vibration of the first-stage blade caused by a third-order excitation was 477 cycles per second and the measurements showed a total vibratory stress of 3700 pounds per square inch at the location of the gage. The conditions for the fifth-stage blade were a vibration of 794 cycles per second, a fifth-order excitation, and a vibratory stress of 3000 pounds per square inch. The following table gives the orders of rotor speed that were detected in the form of first bending-mode vibrations of blades in the first five stages:

Figure 7. - Oscillograph record of representative strain-gage signals at rotor speed of 9485 rpm.

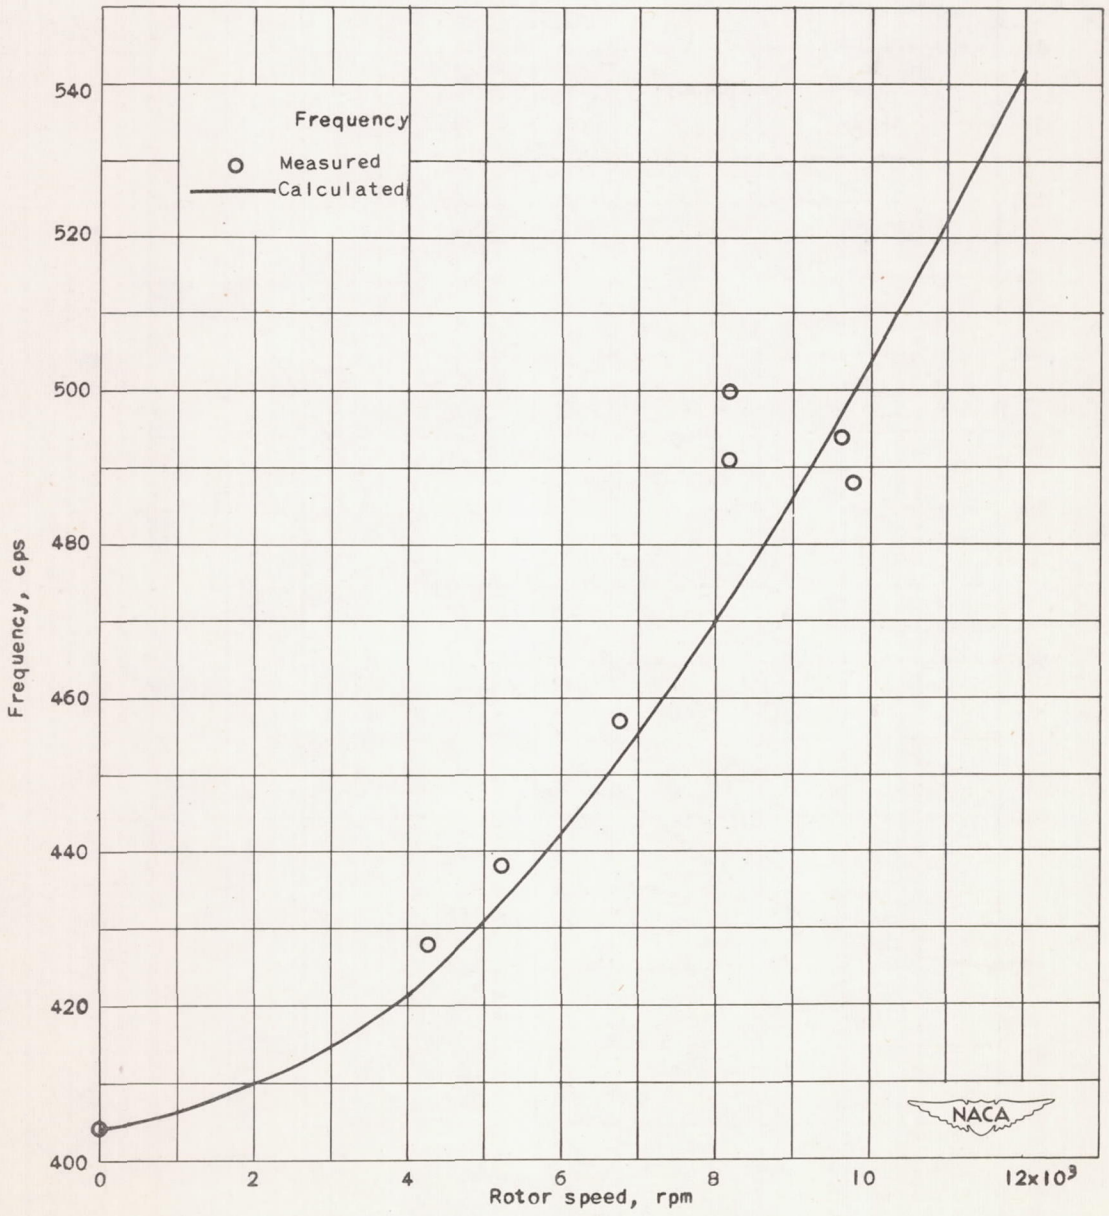
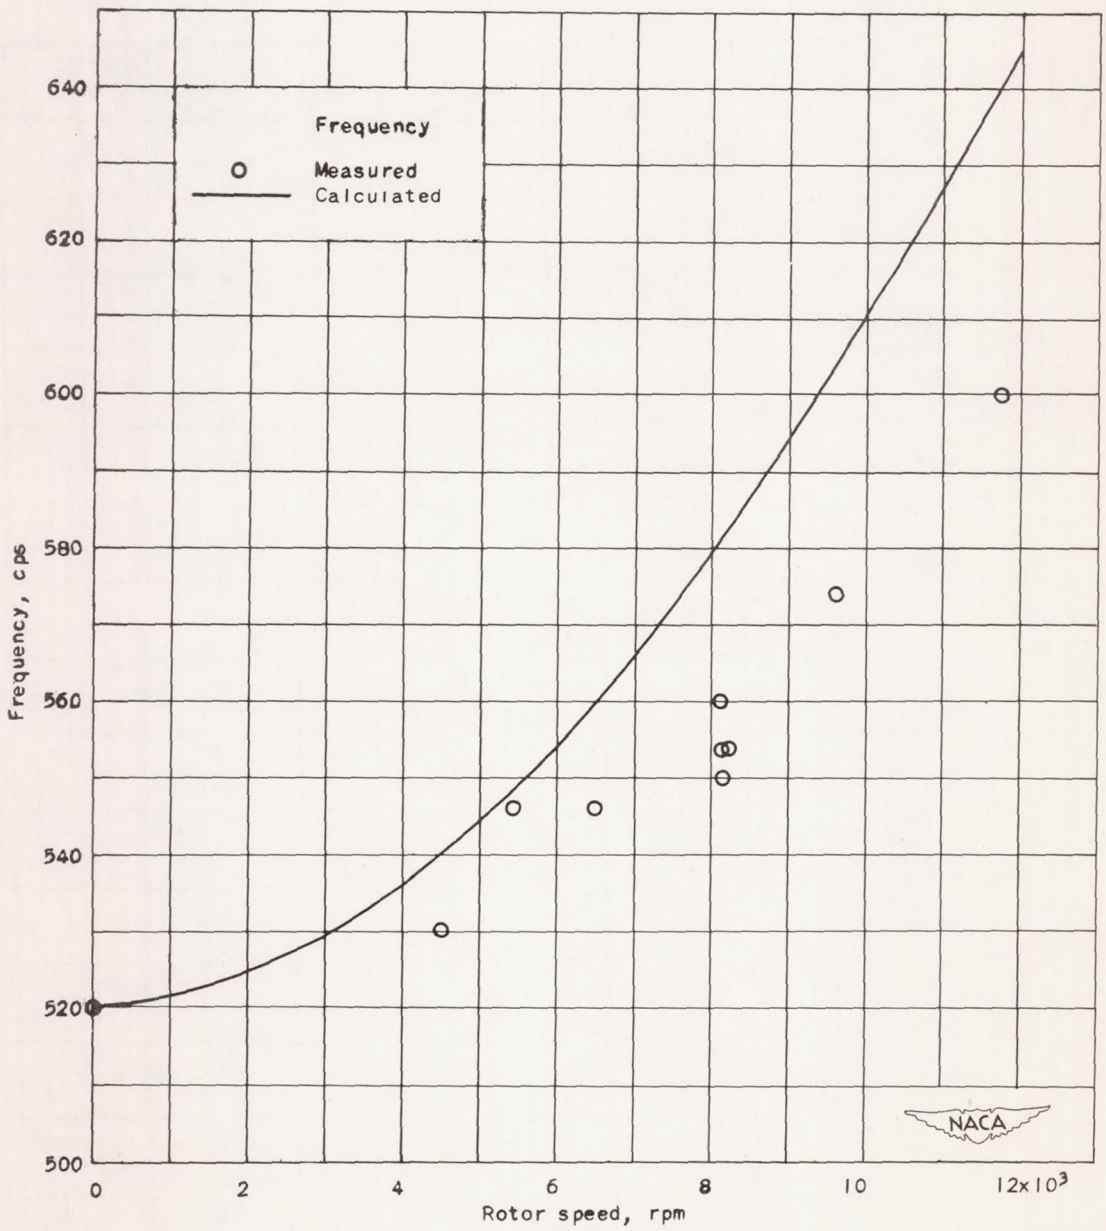
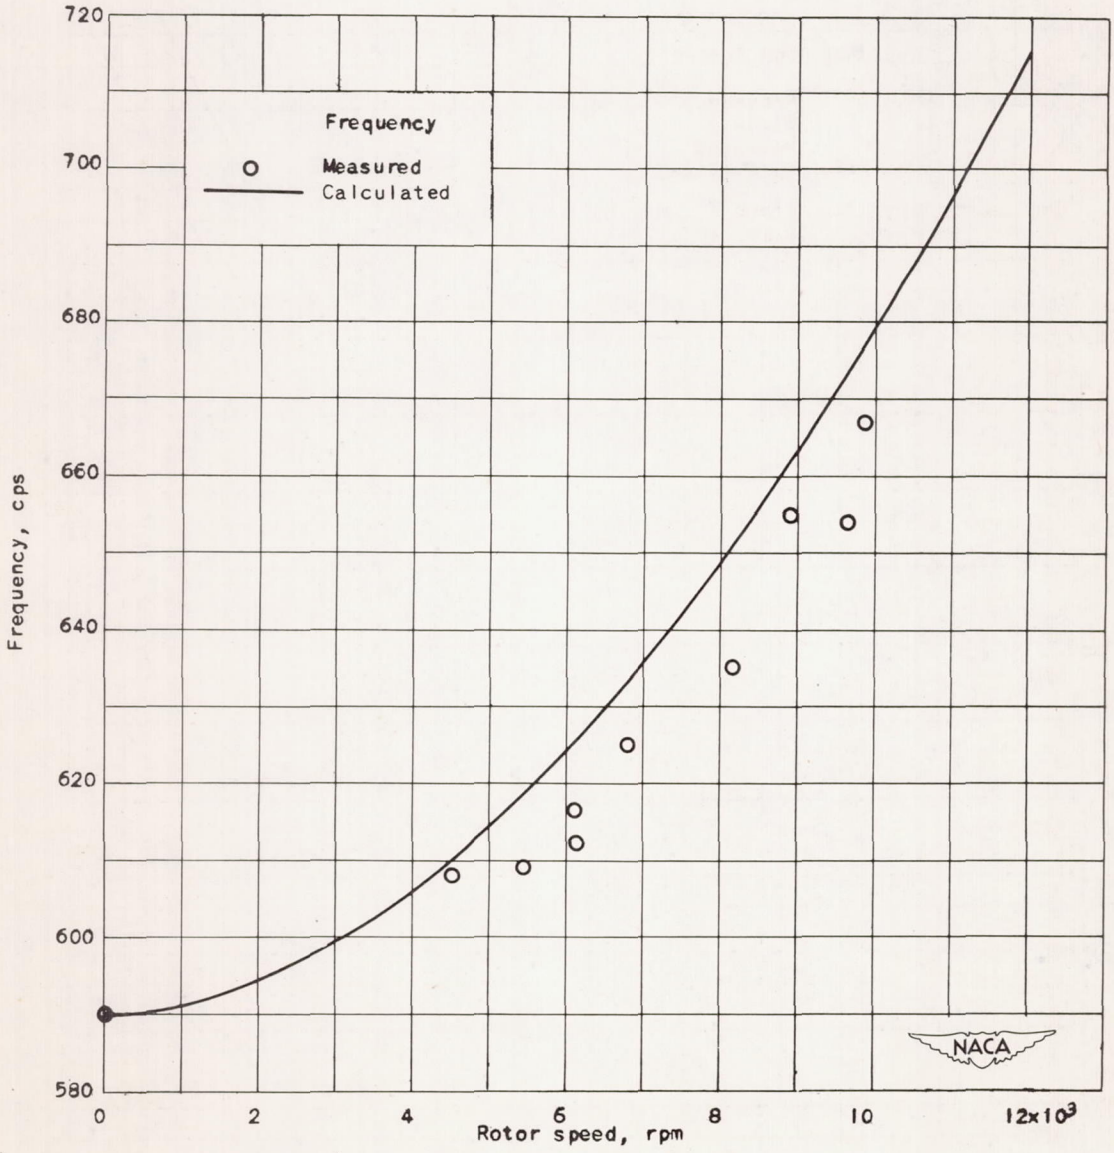
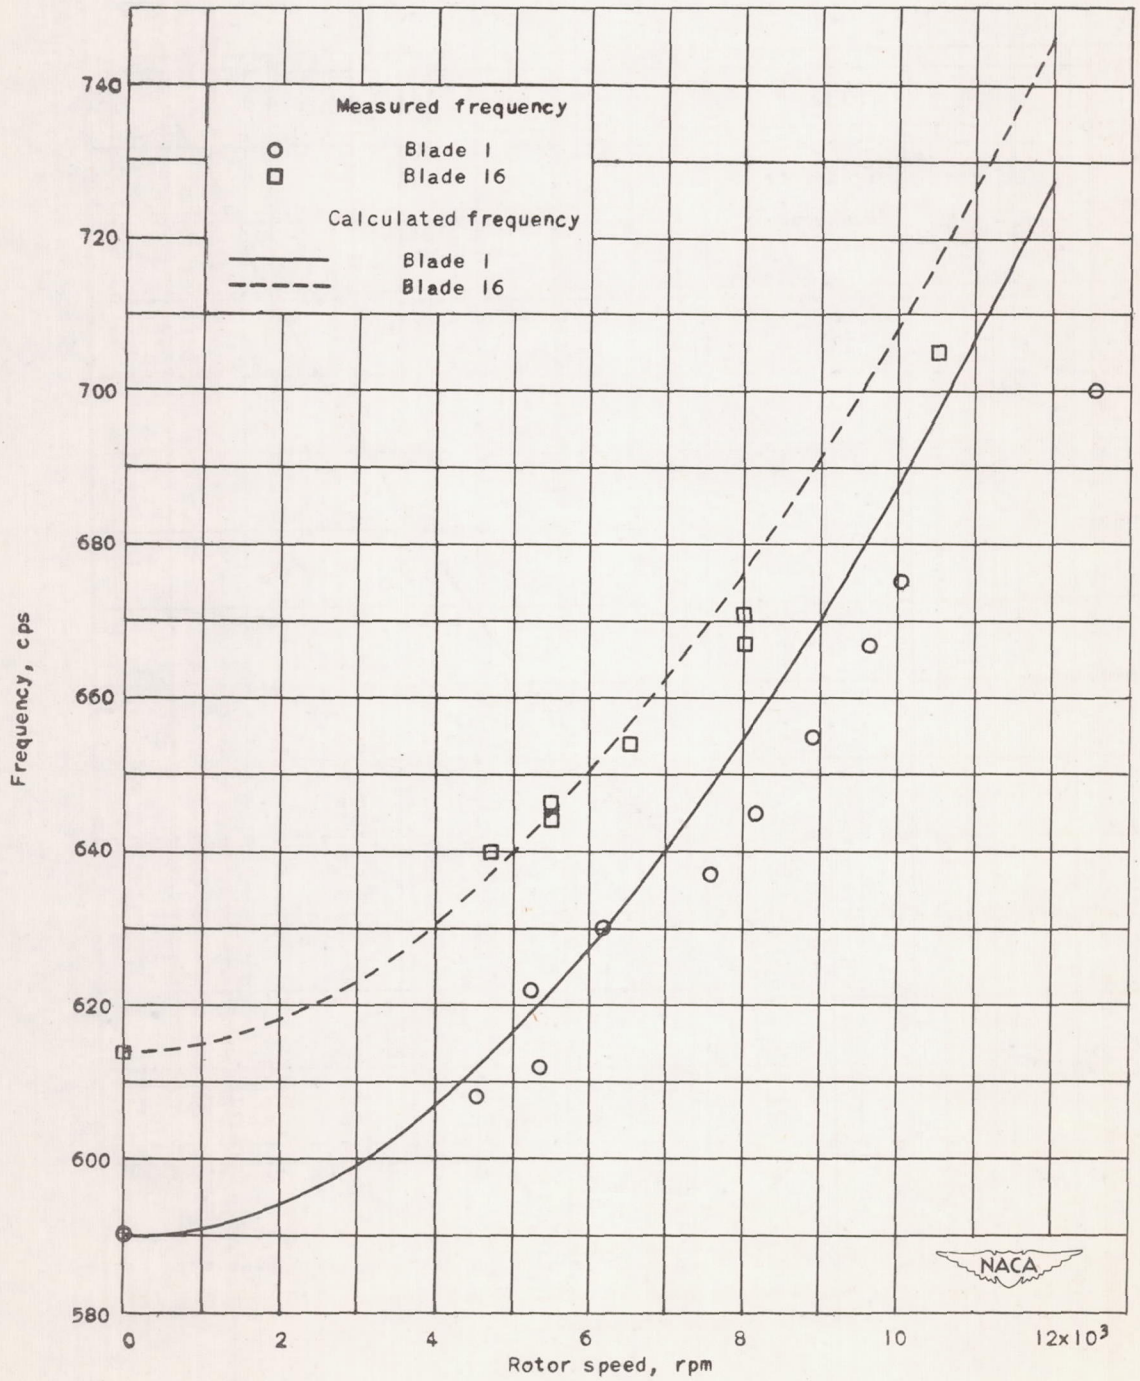
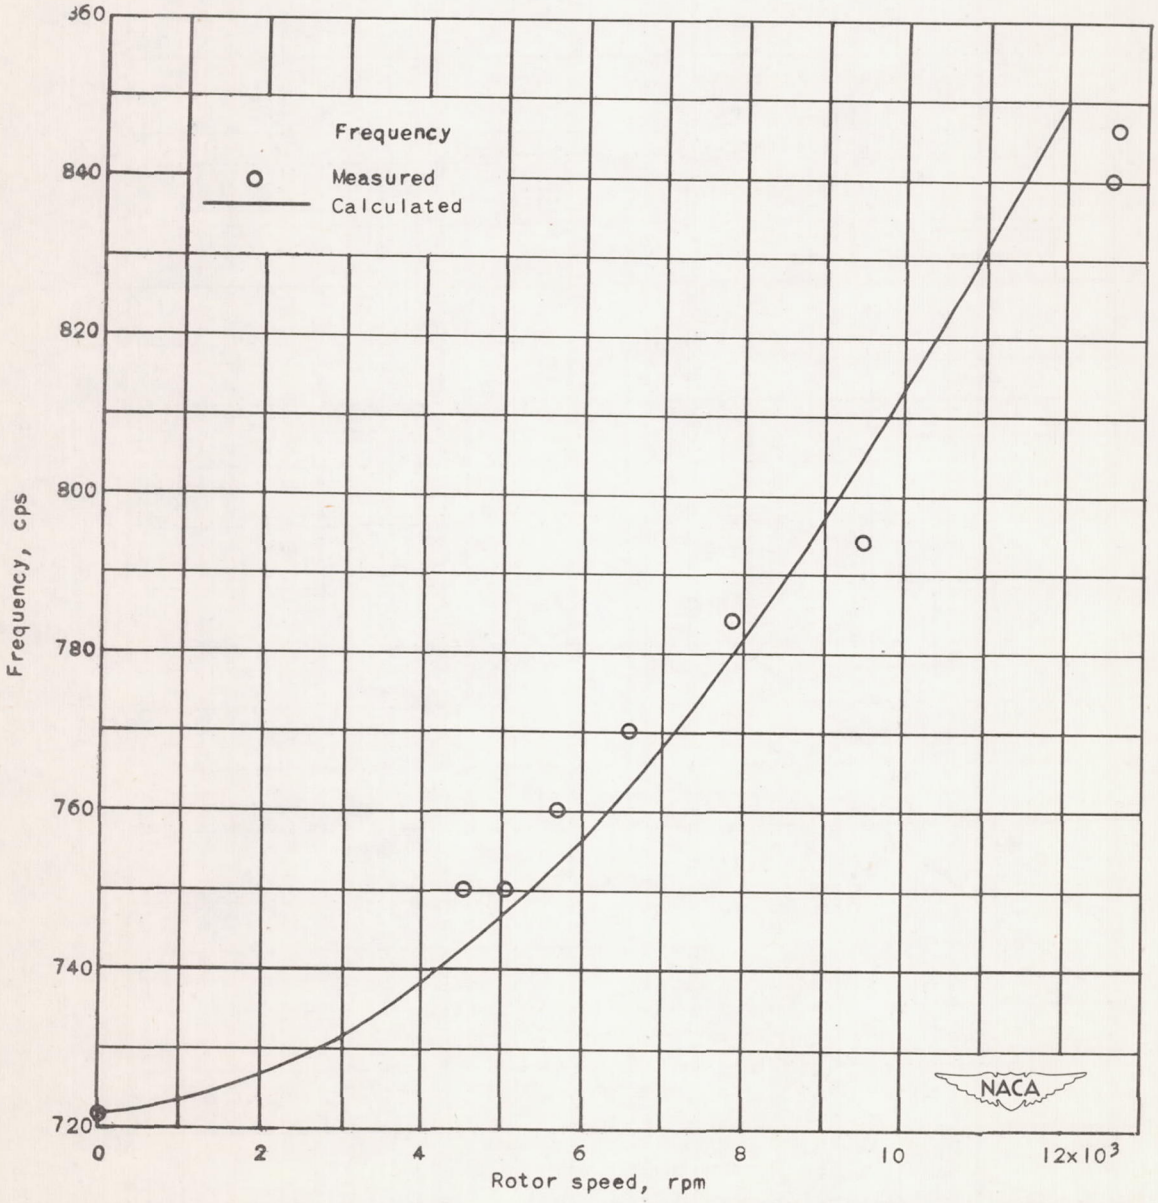
The first bending-mode frequencies, as determined from the oscillograph records, are shown plotted against rotor speed in figure 8. The curves of the statically measured natural frequencies corrected for the effect of centrifugal force in accordance with reference 3 are also shown on the figure. An average line drawn through the experimental resonant points has a slightly lower slope than the calculated line. This discrepancy is probably due to the variance between the fixed blade mount assumed for the calculations and the actual bulbous-root mounting arrangement used throughout the compressor. Also, the assumed deflection curve used in the calculations differs from the true deflection curve of the vibrating blade. Figure 8(d) is of special significance because the natural frequencies of two blades of the fourth stage are plotted. Considerable difference in the natural static frequencies of these two blades can be noted. In reference 1, it is stated that at rated speed (17,000 rpm) the frequencies of all blades might approach the highest blade frequency in the stage because the centrifugal

Figure 8. — Critical-speed diagram showing measured and calculated first bending-mode frequencies.

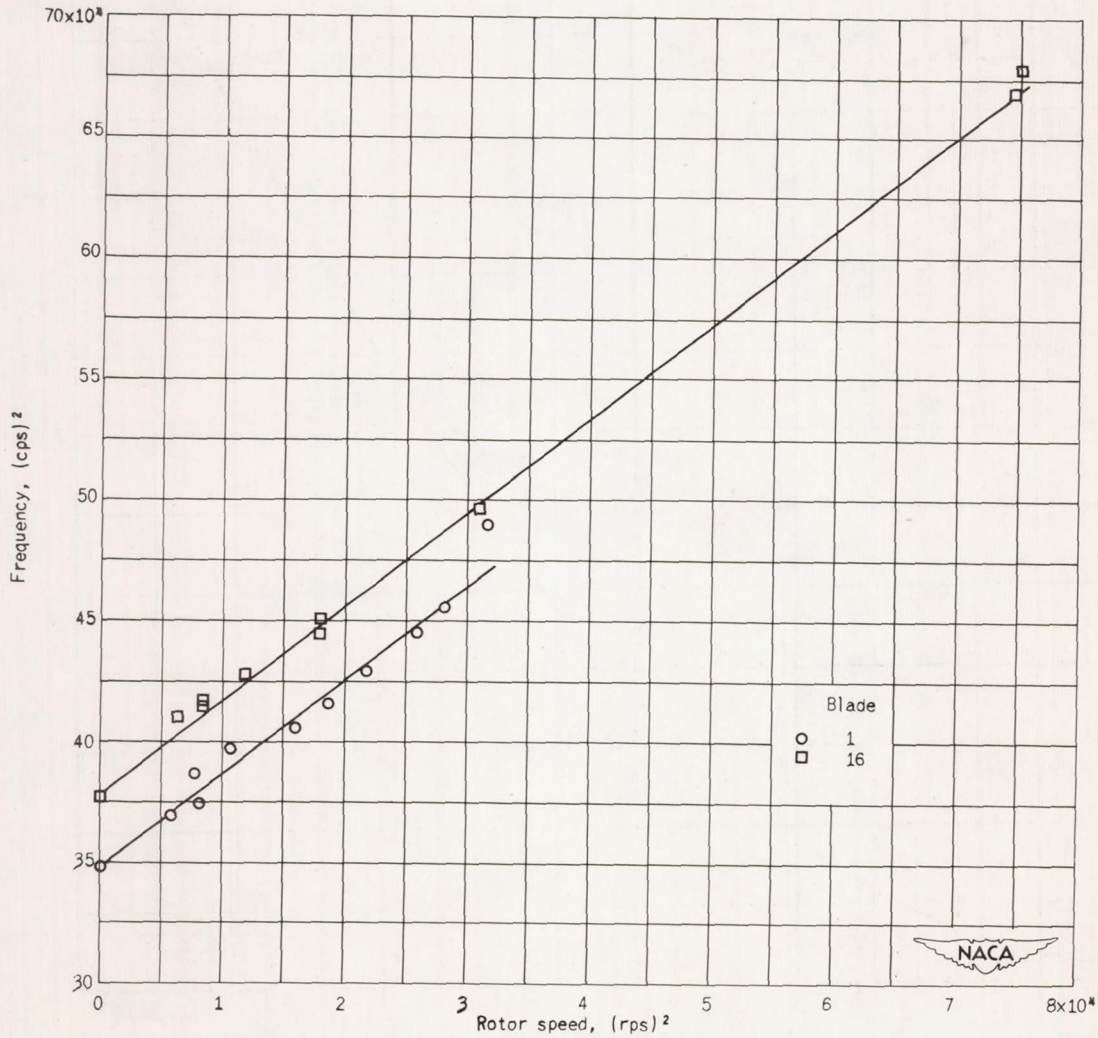
force and thermal expansion raise the frequency by tightening the bulbous blade root. This conclusion, though generally true, is contradicted in the compressor as indicated by figure 8(d) and more clearly by figure 9, which is similar to figure 8 except that different coordinates are used, frequency squared and revolutions per second squared, resulting in straight-line relations. No convergence of lines through data points for the two blades occurs with an increase in speed. This fact was noted in the other stages of the compressor also but the fourth stage was arbitrarily chosen as an example.

Figure 9. – Comparison of measured frequency with values calculated from static measurements. Fourth stage; first bending-mode frequencies.

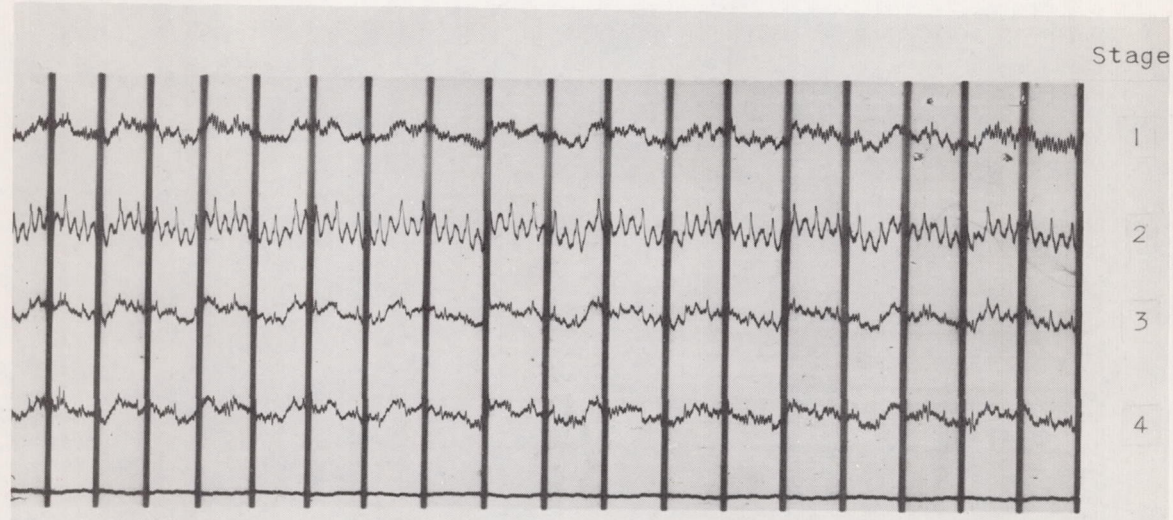
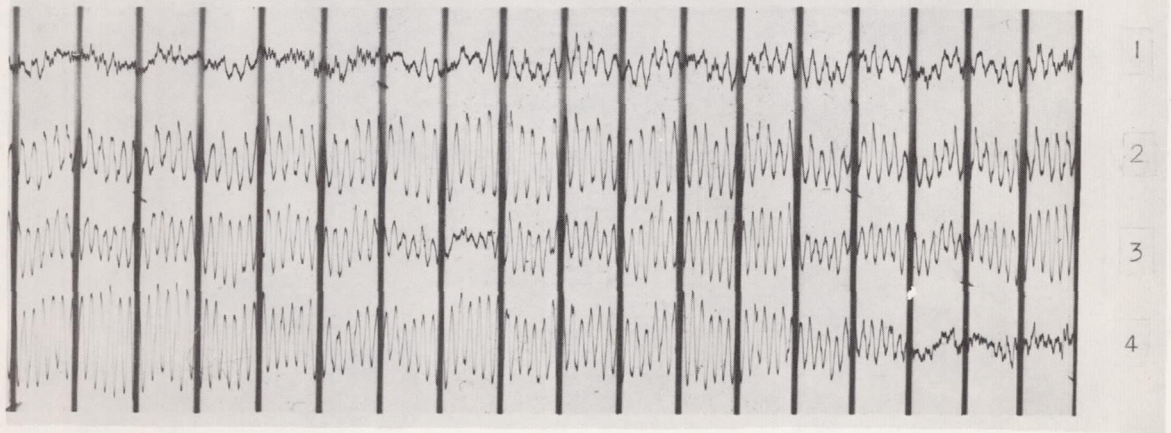
The effect of changing pressure ratio of the compressor by throttling the exhaust is clearly shown in figure 10. All gage signals were taken at the same amplification and rotative speed (8190 rpm) at pressure ratios of 1.17 and 1.54. The rotor speed was so set that the signal from stage 2 would be in fourth-order resonance at a pressure ratio of 1.17. The vibration amplitude of the second-stage signal was more than doubled by the pressure-ratio increase; the third- and fourth-stage blades vibrated at 4.65 and 4.72 orders, respectively, at a pressure ratio of 1.54 and did not vibrate at the low pressure ratio. Furthermore, no correlation was apparent between the high and the low amplitudes of the second-, third-, and fourth-stage signals at a pressure ratio of 1.54. These effects of change in pressure ratio were investigated at several other rotative speeds and the same results observed. All stress measurements were comparatively low but the limited driving power did not permit operation at the rated conditions (rotor speed, 17,000 rpm; pressure ratio, 4.0).

Figure 10. – Effect of varying pressure ratio at rotor speed of 8190 rpm.
