NATIONAL ADVISORY COMMITTEE FOR AERONAUTICS

NO. 882

TESTS OF FLAT PANELS WITH FOUR TYPES OF STIFFENERS

By Alfred S. Niles
Stanford University

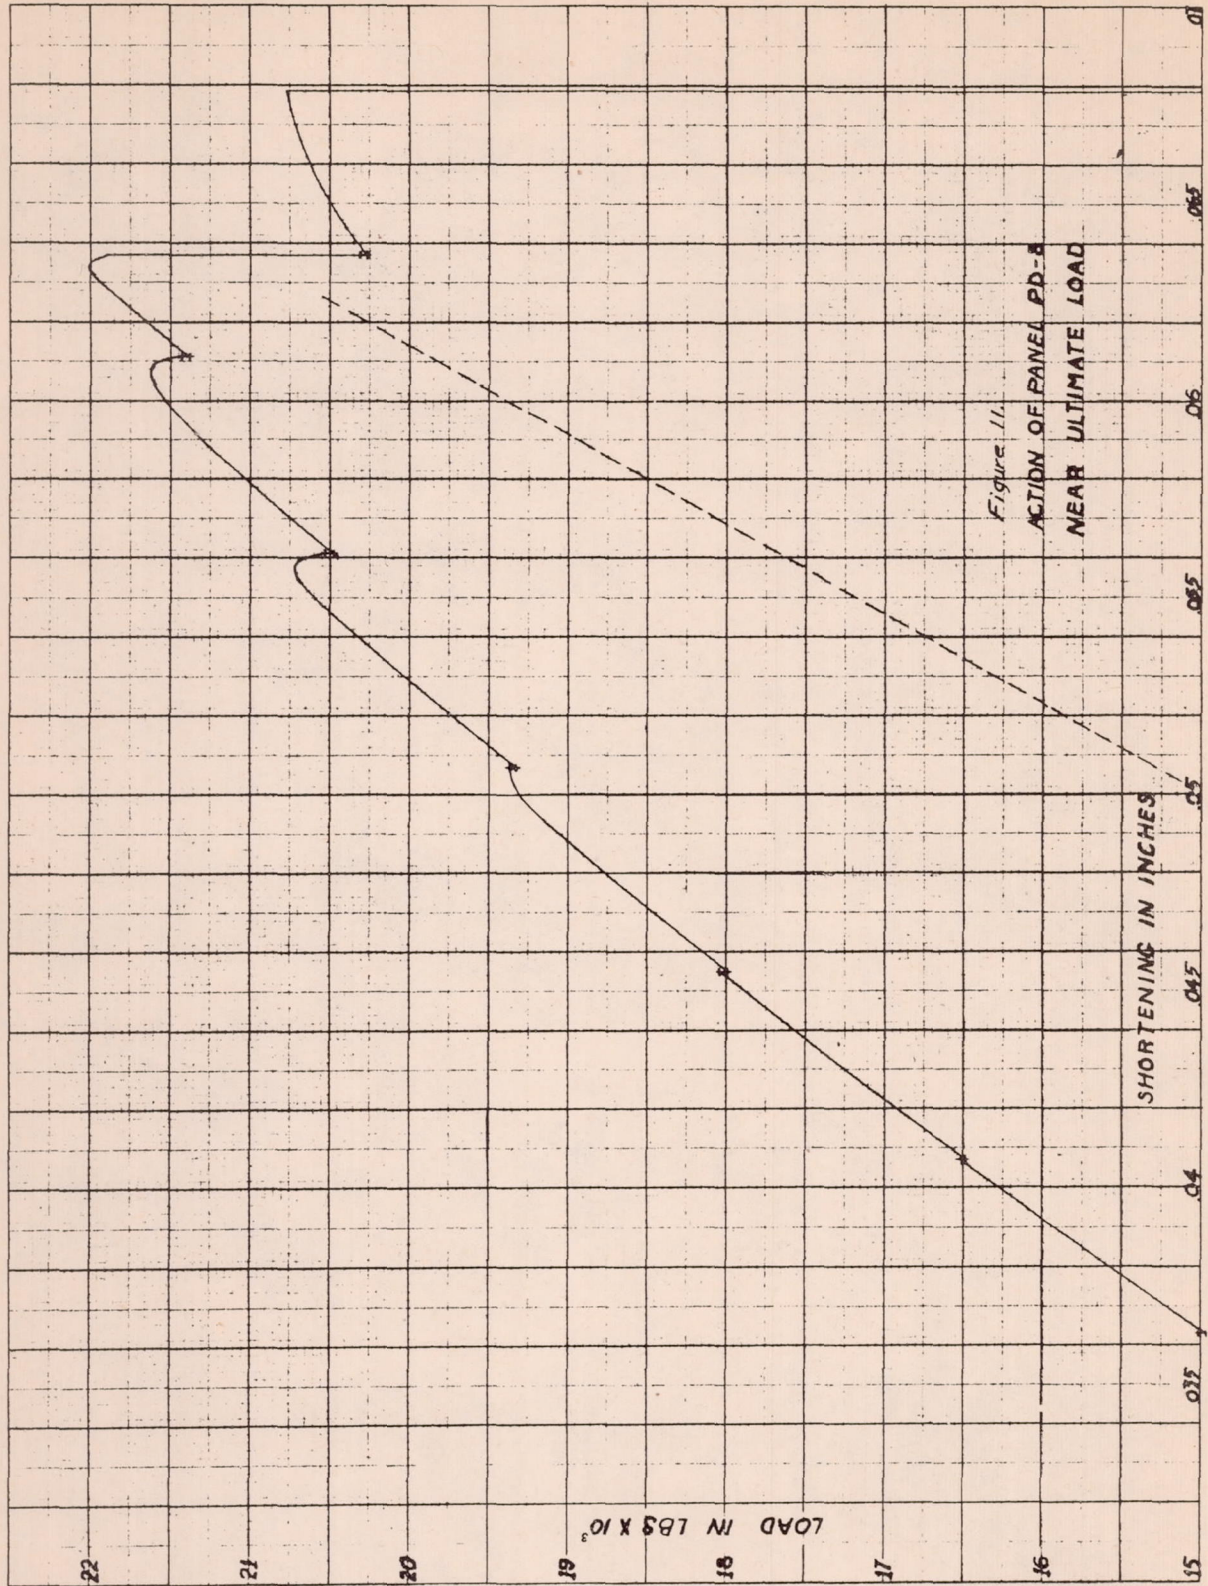
Figure 11.

The failure history of panel PD-8 can thus be read
from the table as follows: The equilibrium load increased
to 20,725 pounds and then gradually decreased to 20,530
pounds, at which point the machine was stopped for readings.
When the readings had been taken, it was found that the load
had dropped to 20,480 pounds. With increase of strain,
the load gradually rose to 21,630 pounds and then slowly
dropped to 21,430 pounds when a new set of readings was
taken. When these readings had been completed the load
had decreased to 21,380 pounds, but with increased strain
it rose to 22,020 pounds and again began to decrease grad-
ually. At 21,895 pounds, however, there was a sudden drop
of load to 20,310 pounds due to some failure in the panel.
After readings of strain had been taken, the equilibrium
load had further decreased to 20,270 pounds. With further
increase of strain the load rose to 20,760 pounds, at which

point there was a sudden failure that caused the load to
drop to 6,200 pounds. The story of this panel failure is
further illustrated by figure 11, which shows graphically
the variation in equilibrium load with increased strain.
In this figure the only fully validated points on the curve

are those plotted from the readings for phases C and D.
The location of the curve between such points is hypothet-
ical, but is believed to be, at least qualitatively, cor-
rect. The broken line in the figure indicates the slope
of the load-shortening curve in the neighborhood of zero
load.

ACTION OF PANEL PD-8
NEAR ULTIMATE LOAD

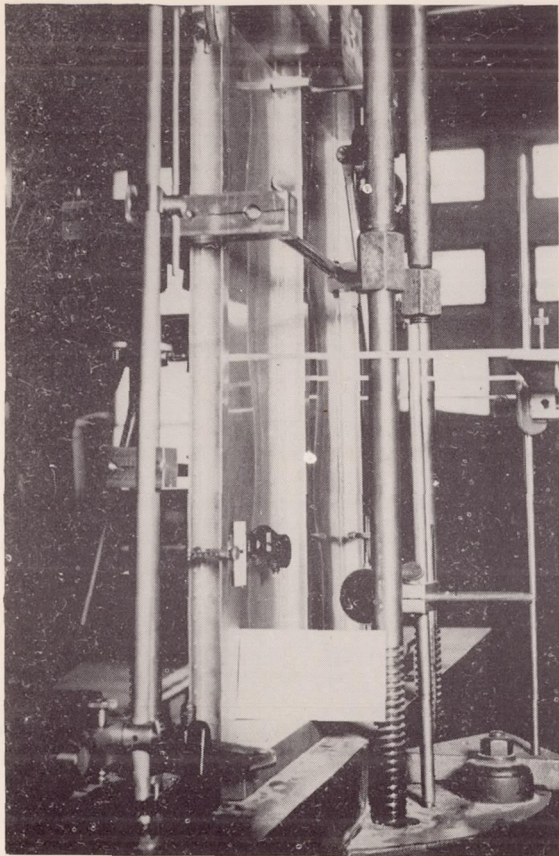
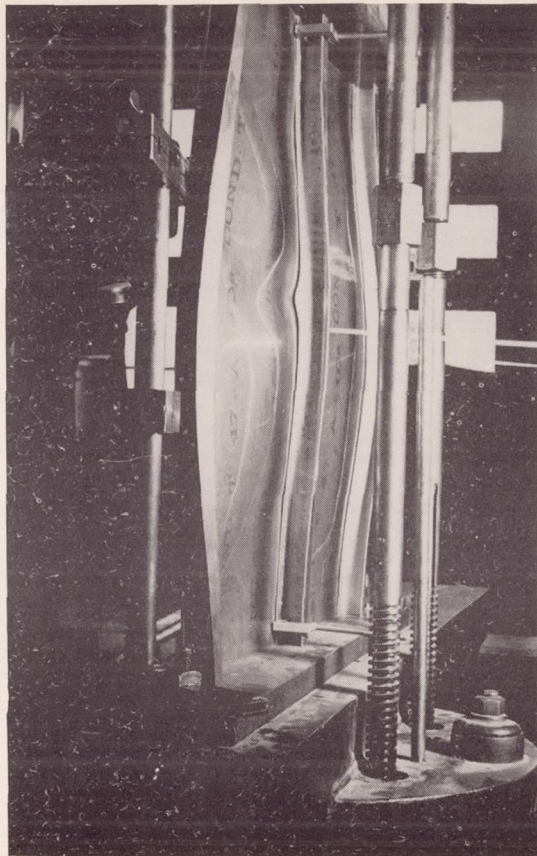
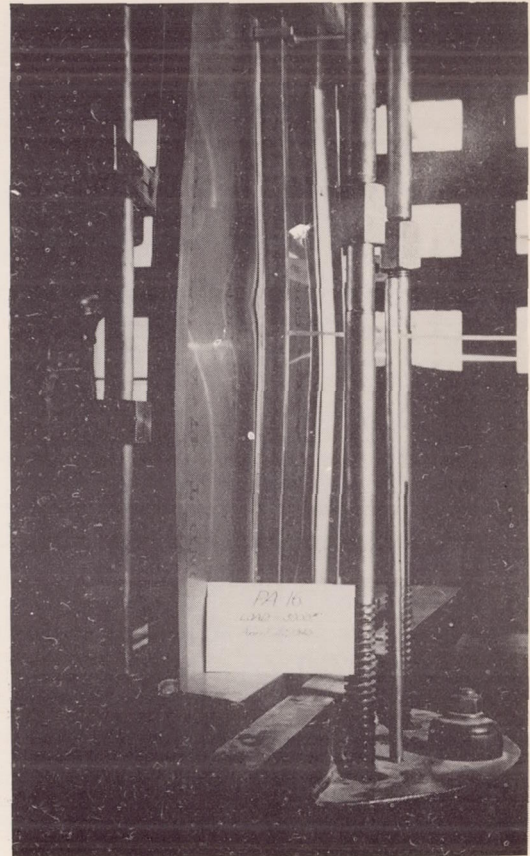
Figure 12.- Sequence photographs panel PA-16.

Because of the difficulty of adequately describing
the appearance of the panels at failure, a set of sequence
photographs was taken of the 10-inch spacing specimens of
the second test group. These photographs are shown in fig-
ures 12 to 15. The panel ready for testing and subjected
to the initial load, usually 3000 pounds, is shown in each
of these figures in (a). In (b) the panel is shown just
after failure, and in (c) the degree to which the specimen
returned to its original state is shown. Figures 16 and 17
are additional views of the failure of panel PD-16, taken
at the same time as the view in figure 15(b). In the
third series of tests (most of the tests of 16-in. panels),
a group of photographs (figs. 18 to 33) was taken to illus-
trate the action of the panels after the ultimate load had
been passed. After the ultimate load had been reached, the
shortening was continued until the load had considerably

In the tests of 24-inch panels, the C section stiffeners uniformly failed primarily in torsion, though in the panels with the wider stiffener spacings (panels PA-14 and PA-16) local buckling was noted as a contributory factor. In this length, the Z section (PB series) also appeared to fail primarily by twisting, though normally with accompanying local buckling. The stiffeners of S and U sections failed normally by local buckling, though twisting was also noticed in a number of the tests.

(a) Under initial load.   (b) Under maximum load.   (c) Under initial load as moving head of testing machine was raised.

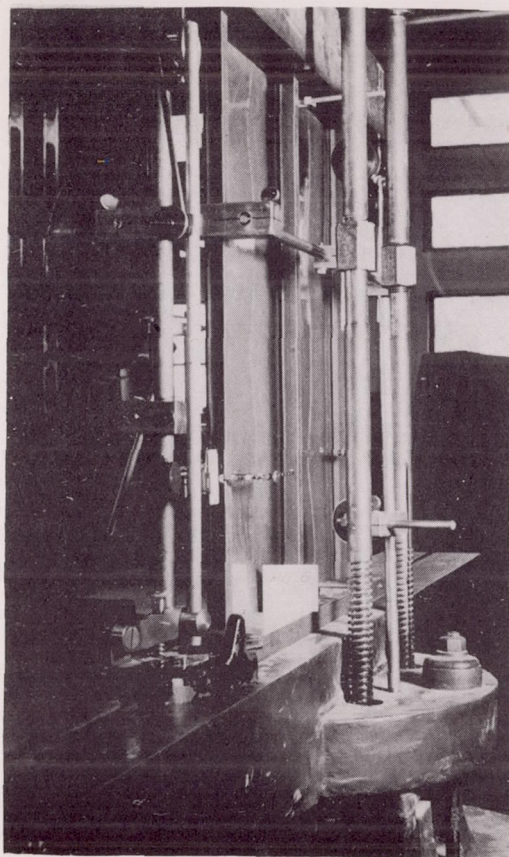
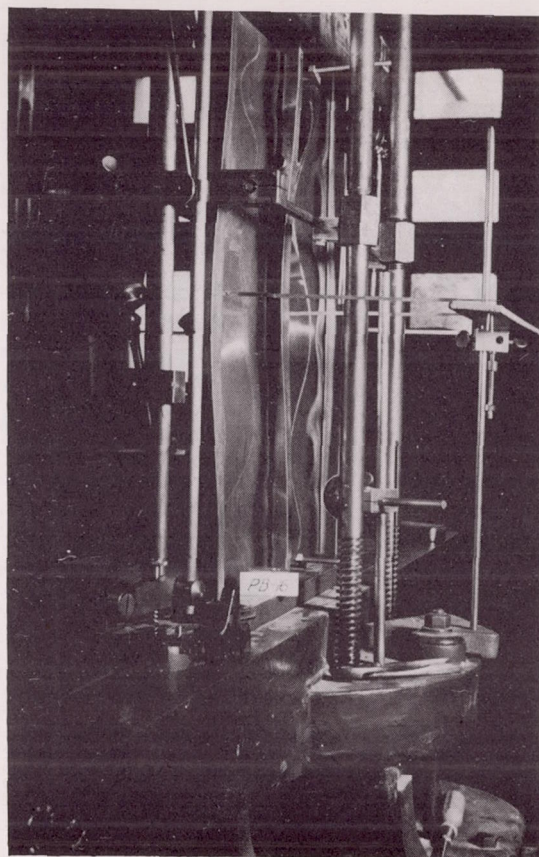
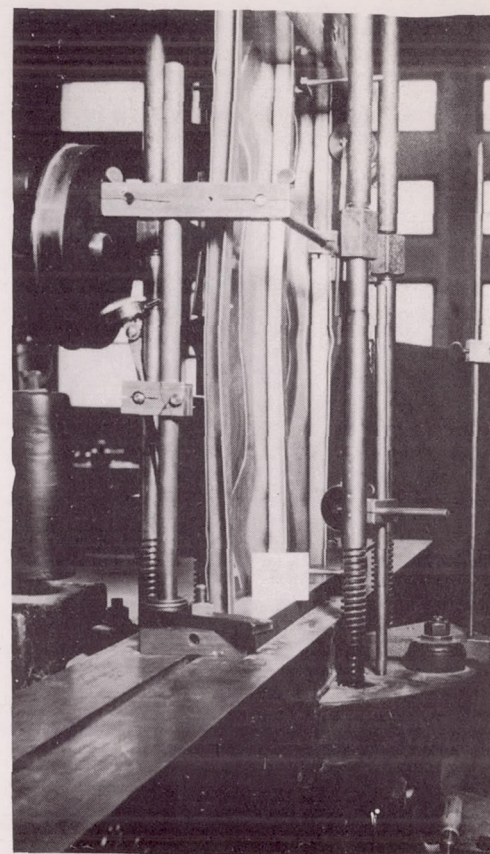
Figure 13.- Sequence photographs panel PB-16.

(a) Under initial load.   (b) Under maximum load.   (c) Under initial load as
                                                          moving head of testing
                                                          machine was raised.

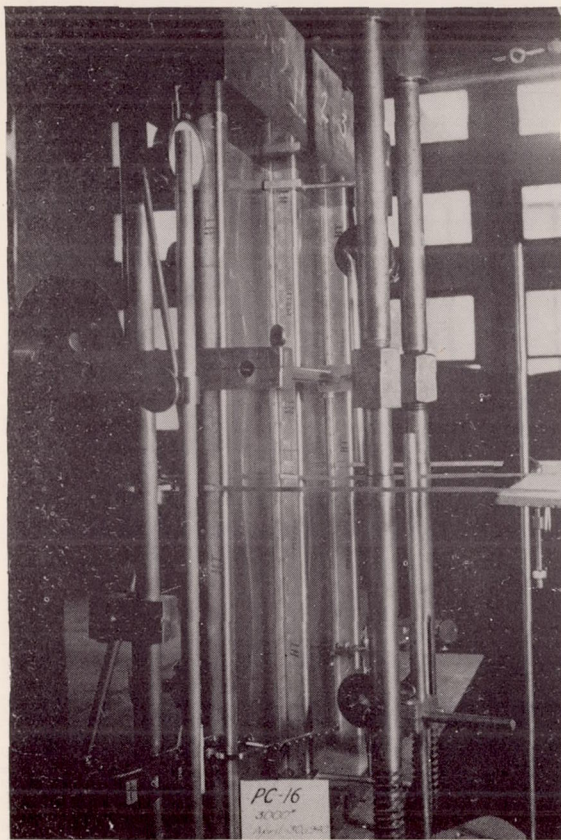
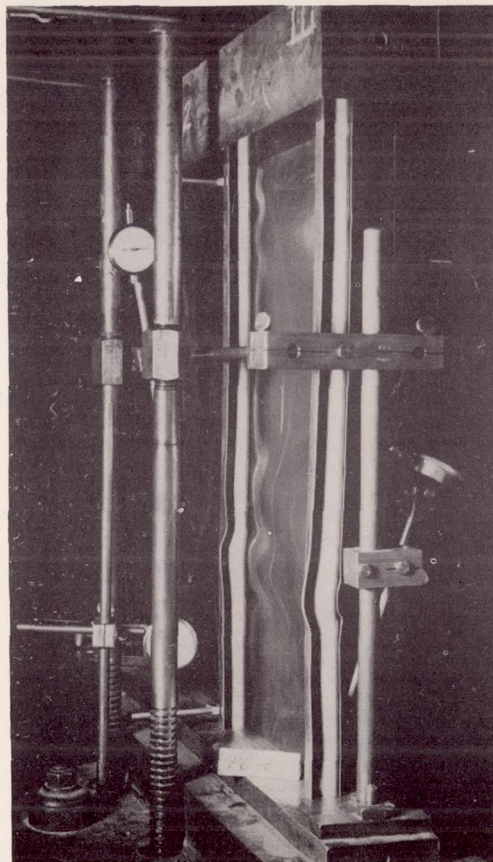
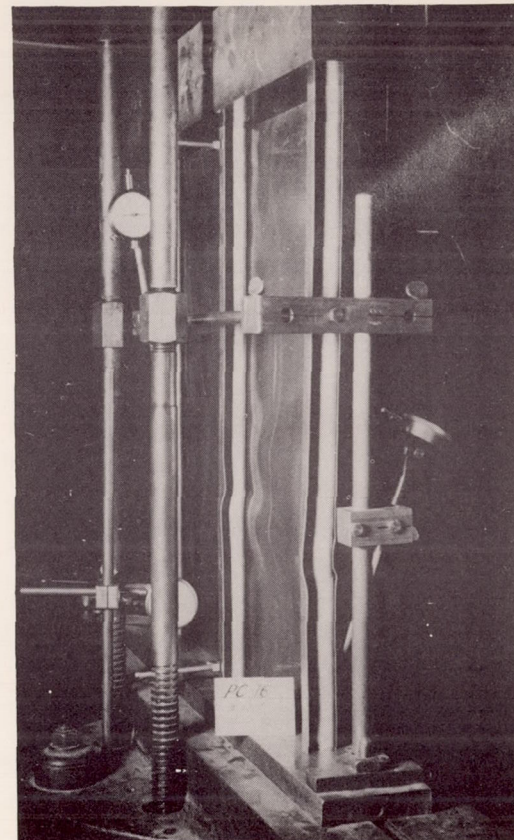
Figure 14.- Sequence photographs panel PC-16.

(a) Under initial load.   (b) Under maximum load   (c) Under initial load as moving head of testing machine was raised.

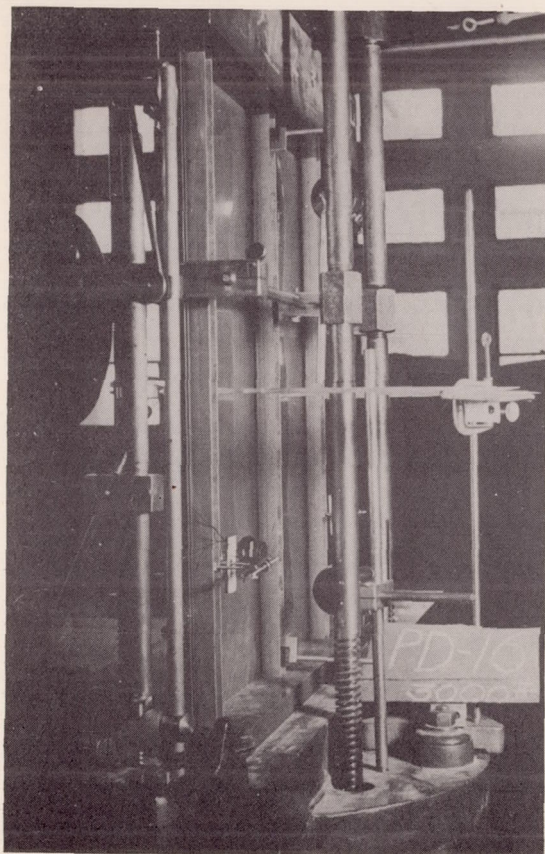
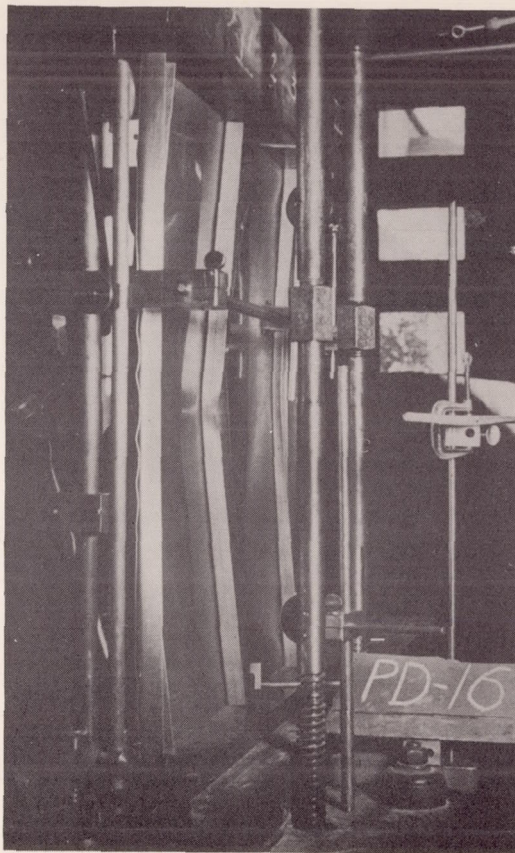
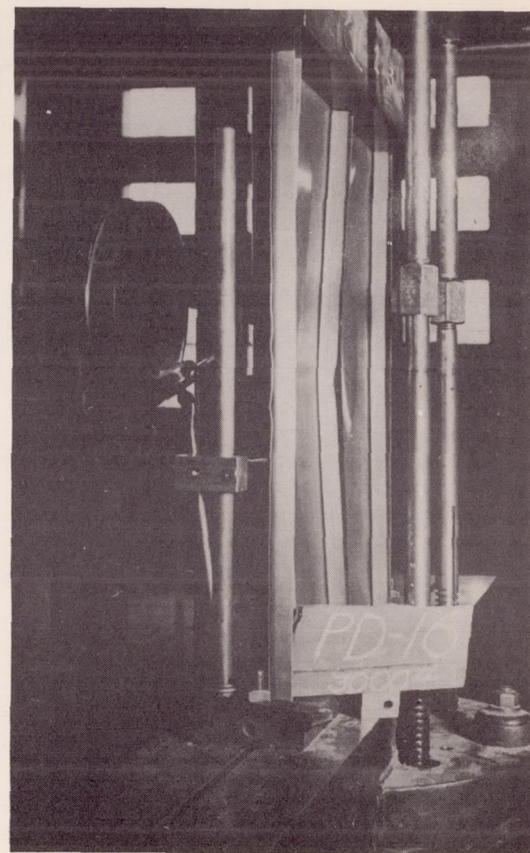
Figure 15.- Sequence photographs, panel PD-16.

(a) Under initial load.　　(b) Under maximum load.　　(c) Under initial load as moving head of testing machine was raised.

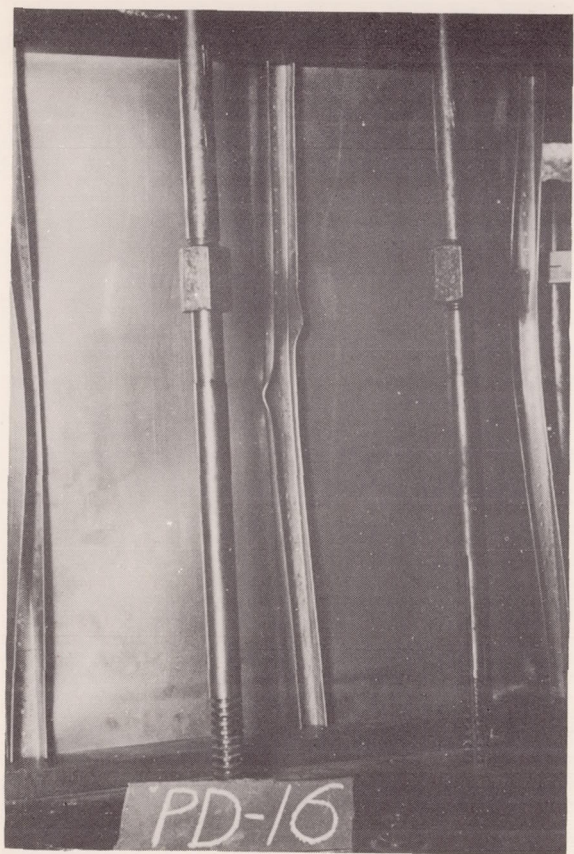
Figure 16.- Panel PD-16 under
maximum load.

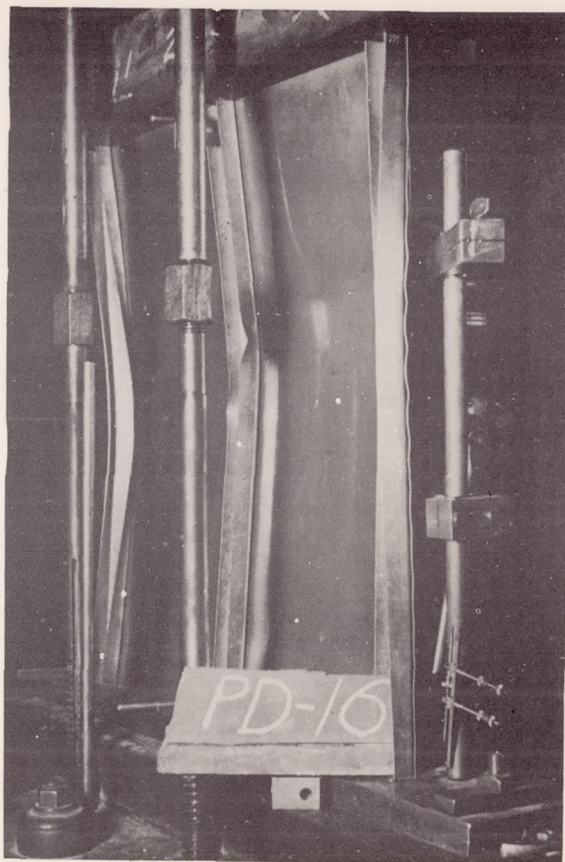
Figure 17.- Panel PD-16 under
maximum load.

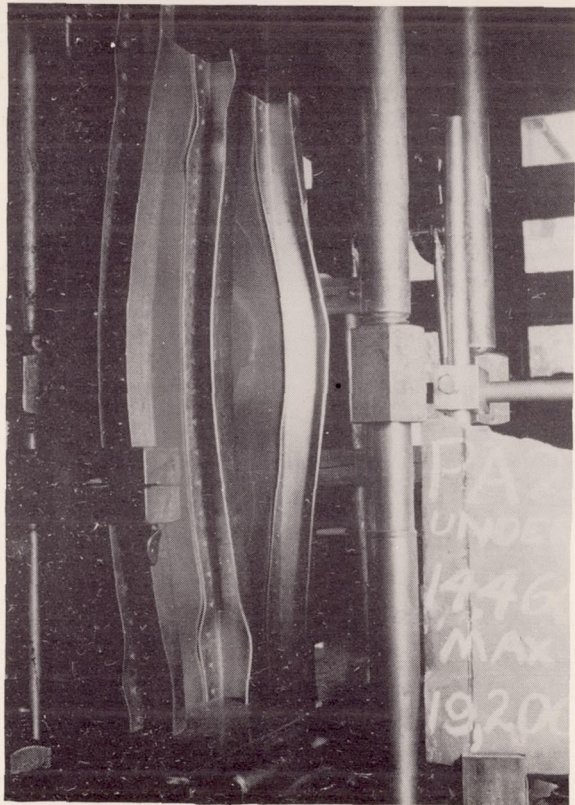
Panel	Load (lb)	Remarks
PA-2	18,300	Stiffener 1 failing torsionally with secondary local buckling. Same action, but not so pronounced in stiffener 3. Stiffener 2 shows local buckling with secondary twist.
	17,300	All deformations much increased and deformation of stiffener 2 now appears primarily torsional and secondarily local buckling.
	15,150	Deformations have been increasing continuously.
PA-4	17,910	Slight noise due to sheet buckling. Stiffener 3 definitely twisting.
	18,360	Stiffener 3 twisting considerably. Stiffeners 1 and 2 show no distress.
	18,330	Stiffener 2 now has a buckle. Stiffener 1 shows no real distress, but is starting to twist.
	17,500	Same deformations more pronounced.
	16,380	Stiffener 1 now badly twisted. Both 1 and 3 are primarily twisting; whereas 2 exhibits primarily local buckling. Stiffener 1 also has a local buckle, but stiffener 3 has none.
	15,500	Loud noise as buckles increase with sudden drop in load.

Figure 18.- Panel PA-2 under
            14,460 pounds
after subjection to 19,200
pounds.

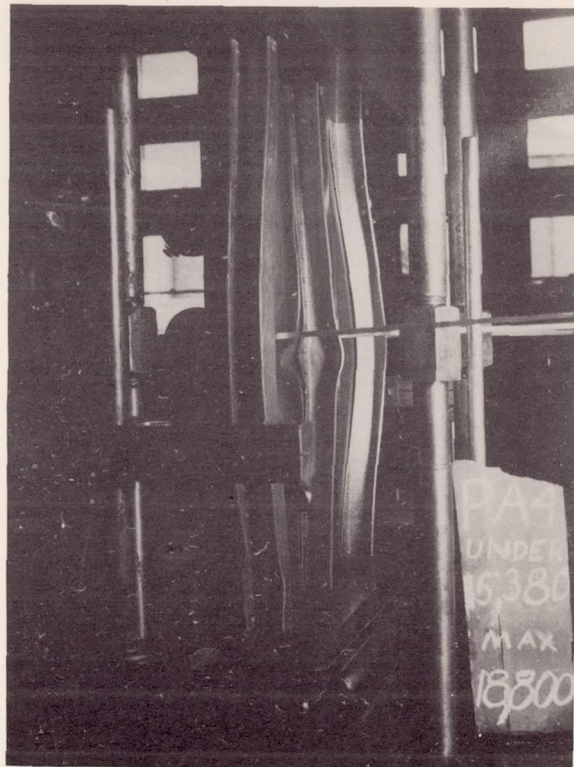
Figure 19.- Panel PA-4 under
            15,380 pounds
after subjection to 18,800
pounds.

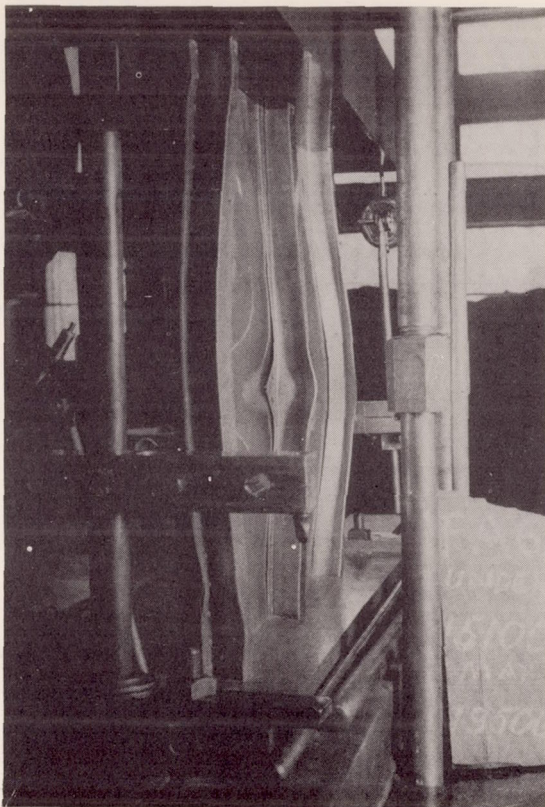
PA-6	19,340	No particular action at maximum load. Stiffener 2 shows signs of buckling of riveted flange. Stiffener shows combination of twisting and local buckling.
	18,320	Stiffener 3 failed with sharp noise. Stiffener 2 is buckled on riveted flange and to less extent on outer flange. It is also somewhat twisted. Stiffener 1 is twisted, but shows no serious local buckling.
	17,020	Stiffener 1 now shows local buckling as well as considerable twist.
	15,820	Stiffener 2 failed noisily.
PA-8	18,970	Edge stiffeners are considerably twisted, but have not failed. Stiffener 2 has failed by local buckling of flanges near midheight.
	17,795	Edge stiffeners showing local buckling as well as twisting.
	16,950	Drop of load probably due to increased buckling of stiffener 2.
	14,420	Stiffener 1 is bearing against testing apparatus. The panel is badly deformed with edge stiffeners twisted and all three buckled locally. No rivets had failed.

Figure 20.- Panel PA-6 under 15,100 pounds after subjection to 19,500 pounds.

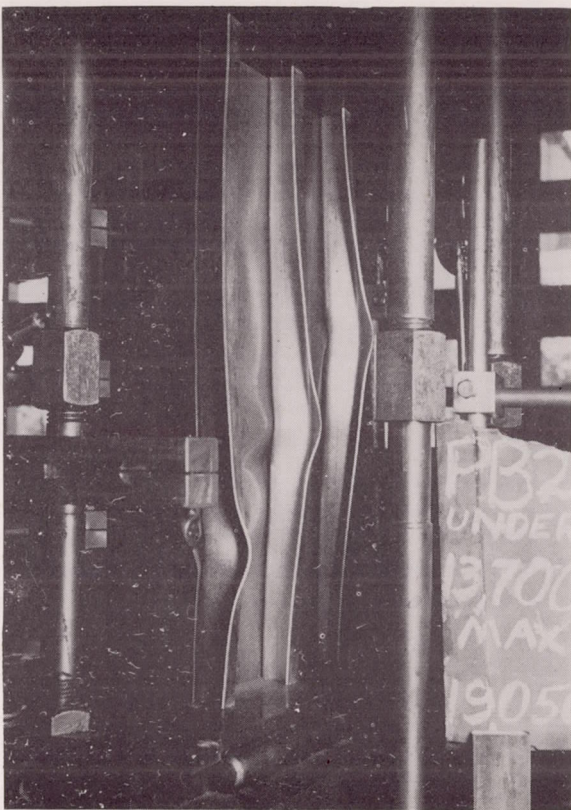
PB-2	18,300	Stiffener 3 appears to have failed, primarily by local buckling.
	17,550	Stiffeners 1 and 2 appear to have failed primarily by local buckling.
PB-4	17,720	Slight noise from sheet buckling, no other change.
	20,660	Stiffener 1 twisting. Stiffener 2 has wavy outer flange. Stiffener 3 has buckle in outer flange.
	17,310	Loud noise with pronounced failure. Stiffener 1 twisted with secondary local buckle. Stiffeners 2 and 3 have fairly large buckles with secondary twisting. One rivet failed on stiffener 3.
PB-6	19,500	(Before max. load.) Outer flange of stiffener 2 buckling locally and appears ready to fail.
	19,180	Buckle in flange of stiffener 2 slightly larger. Stiffener 3 appears to have failed by local buckling of both flanges near midheight. Stiffener 1 shows twist and incipient local buckling. No noise.
	18,140	Same failures more pronounced.
	17,520	Sharp noise due probably to change in buckle pattern of sheet.

Figure 22.- Panel PB-4 under
            13,700 pounds
after subjection to 19,050
pounds.

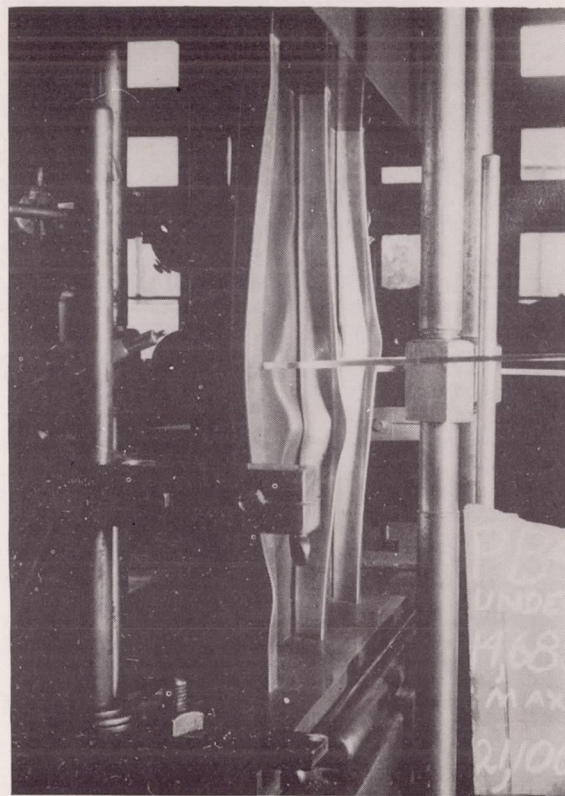
Figure 23.- Panel PB-4 under
            14,685 pounds
after subjection to 21,100
pounds.

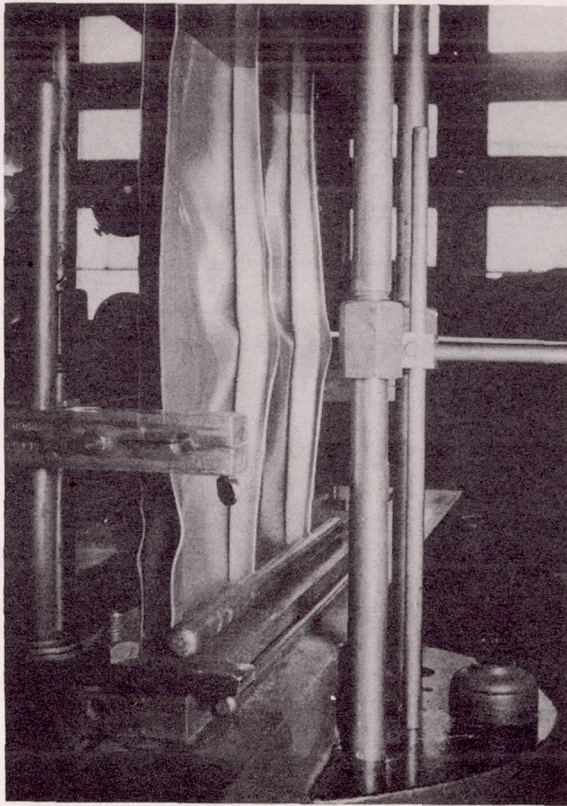
Figure 24.- Panel PB-6 under
14,850 pounds
after subjection to 19,875
pounds.

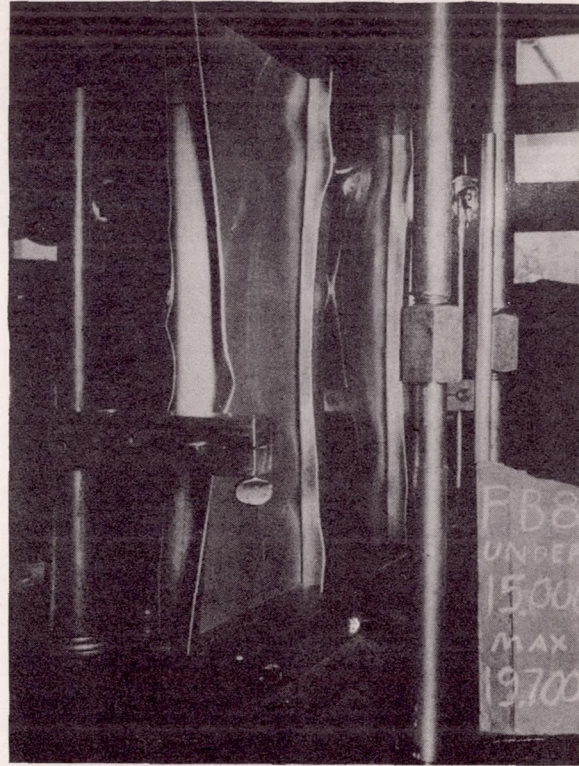
Panel	Load (lb)	Remarks
PB-8	19,100	Noise at failure not loud. Definite local buckling of outer flange of stiffener 1 and incipient failures of outer flanges of stiffeners 2 and 3.
	15,395	Two noises heard before load reading could be taken. Bad local buckling of stiffener 1 and moderate failure of stiffener 2. Stiffener 3 shows distress but is in fairly good shape. Rotation pointer knocked off stiffener 1 in the failure of that stiffener.
	15,140	Stiffener 2 rotated until pointer struck test apparatus. Stiffener 2 also badly buckled, but stiffener 3, although buckled locally, is still holding considerable load.
PC-2	21,800	Buckle forming in stiffener 3.
	20,890	Stiffener 3 appears to have failed by local buckling.
	17,425	Stiffeners 1 and 2 appear to have failed by local buckling. A rivet has failed in stiffener 3.
PC-4	20,750	Stiffener 1 appears to have failed by local buckling with secondary twist.

Figure 25.- Panel PB-8 under
15,000 pounds
after subjection to 19,700
pounds.

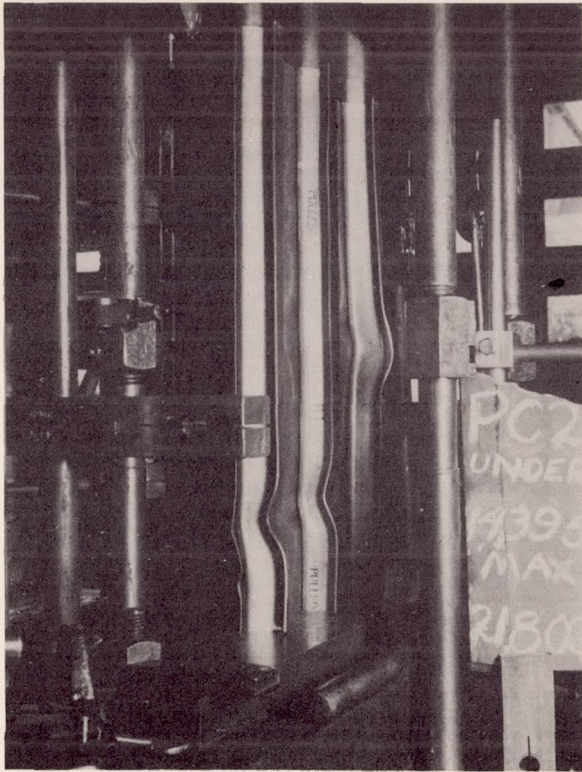
Figure 26.- Panel PC-2 under
14,395 pounds
after subjection to 21,800
pounds.

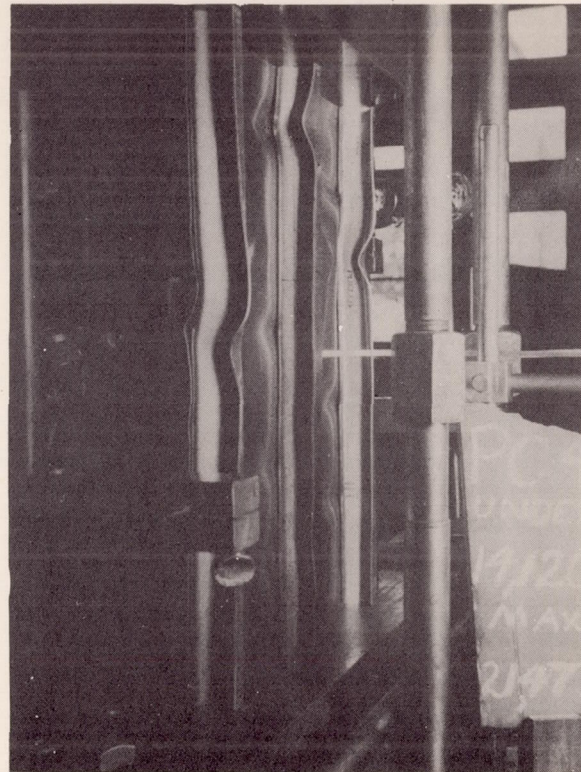
Figure 27.- Panel PC-4 under
14,120 pounds

after subjection to 21,475
pounds.

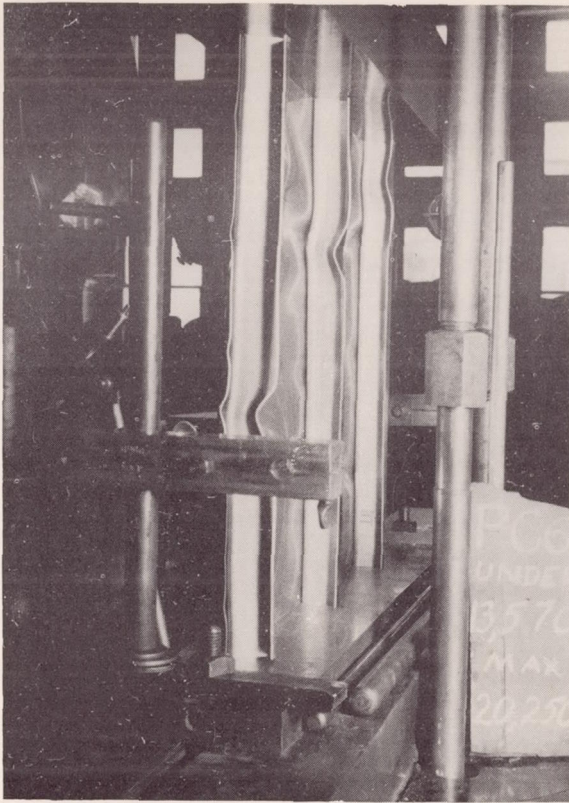
18,580	Stiffeners 2 and 3 show considerable distress, but have not completely failed.
	17,400	Stiffener 2 has failed by local buckling.
	16,600	Stiffener 3 has failed by local buckling with secondary twist.
PC-6	19,985	(Before max. load.) Three waves in outer flange of stiffener 1, one on flange of stiffener 2, no definite buckling of stiffener 3.
	19,550	Failure of outer flange of stiffener 1.
	18,260	Bad bulges in outer flanges of stiffeners 1 and 2. Smaller bulge on flange of stiffener 3.
	16,160	All stiffeners show large buckles.
	13,570	Loud noise accompanied failure. Principal failure that of stiffener 1.
PC-8	20,680	Local buckles in both flanges of stiffeners 1 and 2. None on stiffener 3.
	18,680	Bad local buckling of stiffener 1, moderate buckling of stiffener 2, none on 3.
	16,320	More failure of stiffener 1, but stiffener 3 still holds.
	13,420	Stiffener 3 buckled near upper end. No sudden failure of this stiffener during the test.

Figure 28.- Panel PC-6 under 13,570 pounds after subjection to 20,250 pounds.

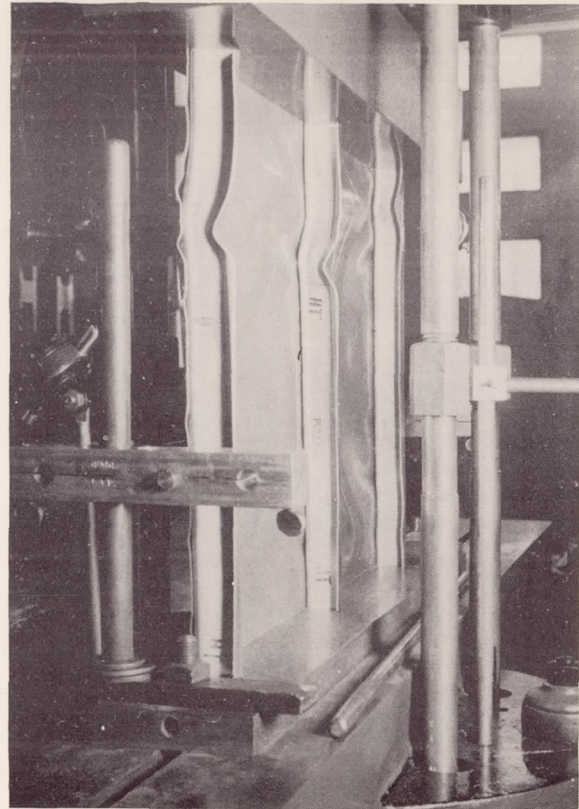
Figure 29.- Panel PC-8 under 13,400 pounds after subjection to 21,490 pounds.

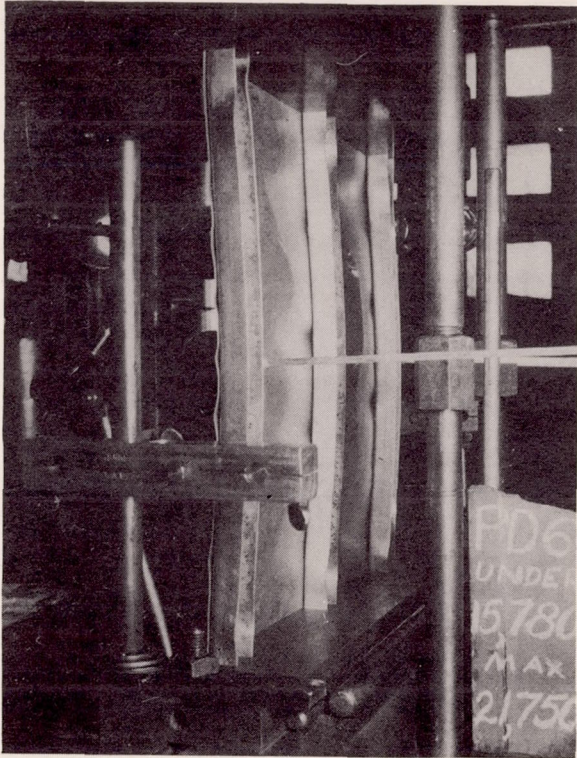
Figure 32.- Panel PD-6 under
15,780 pounds
after subjection to 21,750
pounds.

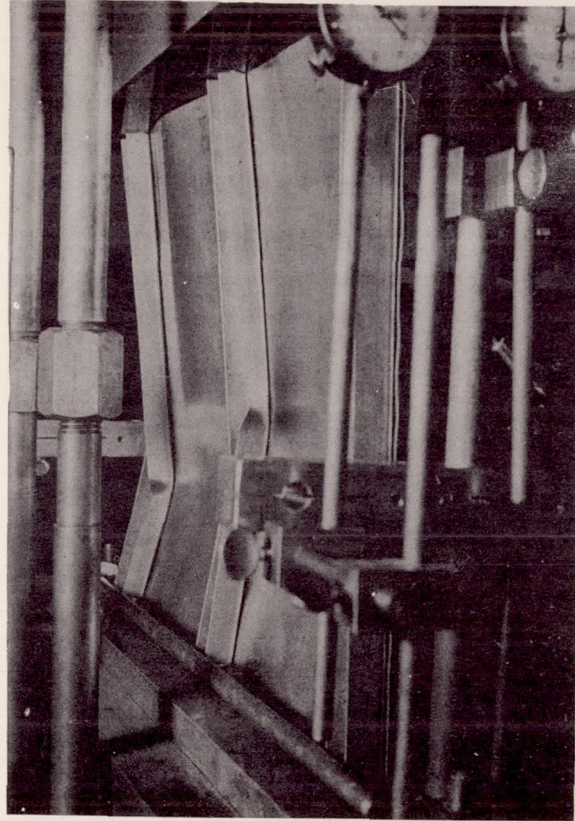
6,200	When the load was 20,760, stiffeners 1 and 2 failed with a loud noise, but stiffener 3 showed no distress. The load dropped to 6,200.

Figure 33.- Panel PD-8 under

6,185 pounds
after subjection to 22,000
pounds.
