NASA Technical Memorandum 105149
AIAA-91-2228

Preliminary Performance and Life Evaluations of a 2-kW Arcjet

W. Earl Morren and Francis M. Curran
Lewis Research Center
Cleveland, Ohio

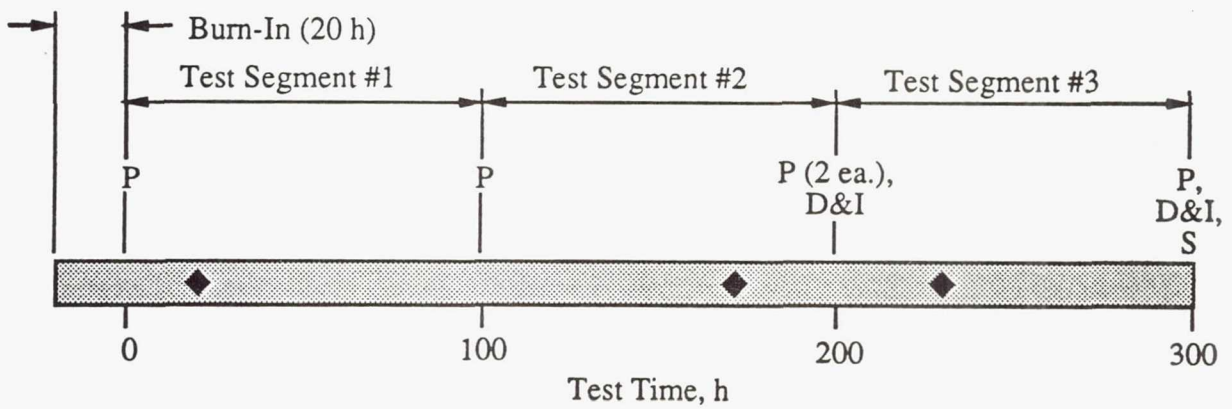
Figure 6. Test Chronology

Thruster Inspections. As shown in Fig. 6, the thruster was disassembled for inspection following the second 100-h endurance test. The overall thruster length was measured prior to disassembly. This was necessary for determination of the arc gap later in the disassembly. The overall length was found to have increased by about 0.56 mm. The length of portion of the anode protruding from the anode housing was also measured. The anode had moved within the tapered seat in the anode housing as indicated by a 0.56 mm increase in the length of the protruding portion. Because the cathode was tied rigidly to the rear of the thruster, movement of the anode within the housing would result in an increase in the arc gap. The movement of the anode within the anode housing could have contributed to the pressure variations observed during the first two test segments by allowing propellant to leak past the tapered seal or by relieving some of the compressive force on the injector seals.

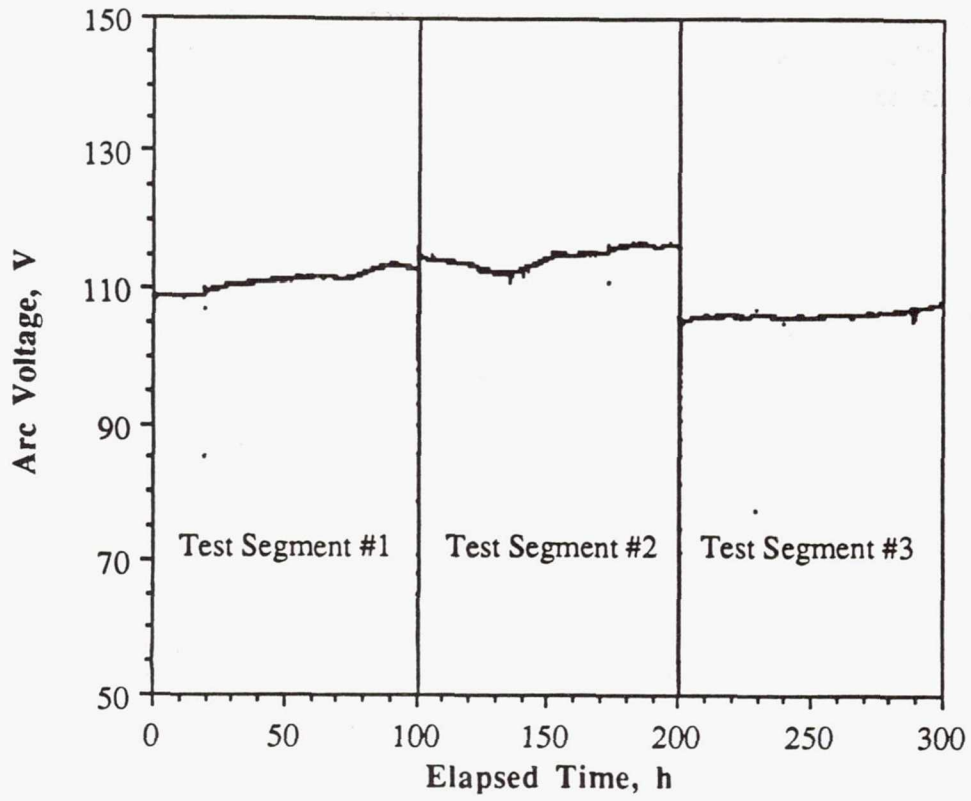
Figure 11. Arc Voltage History

The arc voltage increased during the first 200 h of operation at an average rate of 35 mV/h. As shown in Fig. 11, the thruster experienced periods of increasing and decreasing voltage, although all voltage values fall within a band of ± 2.5 V from the nominal value at that point in the test. This represents a variation of about 2.2% of the average arc voltage measured during the first two 100-h test segments. Arc voltage fluctuations of this magnitude have been observed in previous endurance tests[8,23]. During the third 100-h test the voltage rose at a substantially lower rate. This test segment was also relatively free of the voltage excursions typical of the first two endurance tests. However, the voltage during this test was several volts lower than during the first two test segment due to the constrictor damage sustained prior to this test segment.

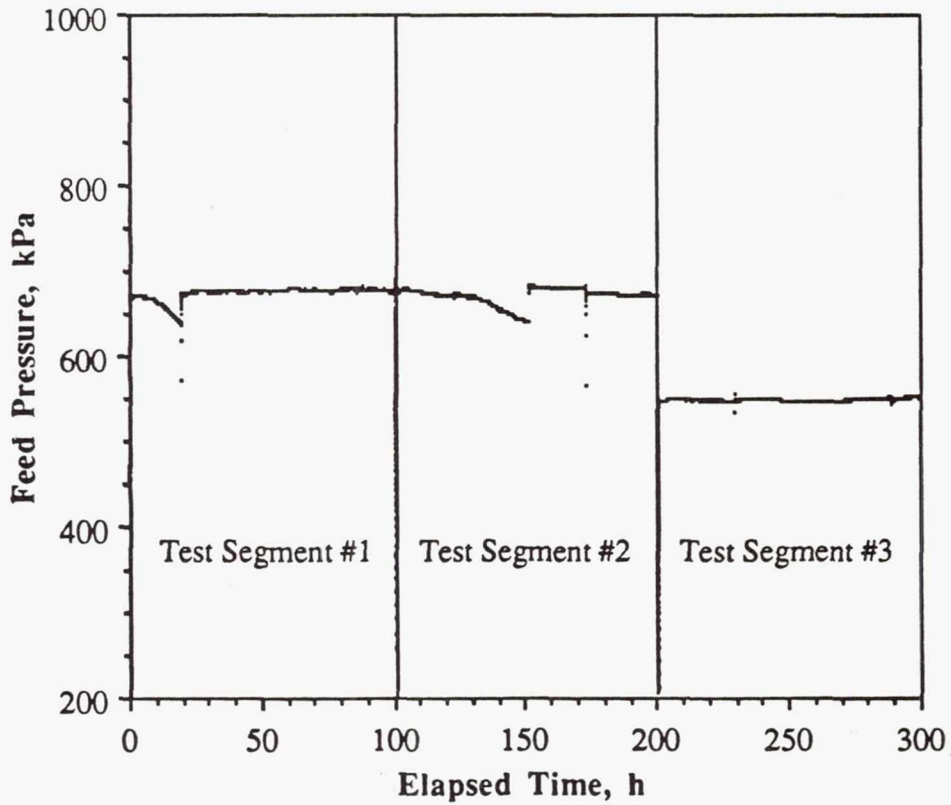
Figure12 Feed Pressure History

During most of the endurance tests the propellant feed pressure remained steady. There were two instances, however, when the feed pressure declined gradually over periods of about 20 h and 50 h during the early portions of the first and second test segments, respectively (see Fig. 12). Either of these trends could have indicated a leak from the thruster pressure vessel, an increase in constrictor diameter, or a leak past the injector disk into the arc chamber. The most serious leak would be from the thruster pressure vessel because this would have been a failure resulting in the loss of performance and, perhaps, the failure of

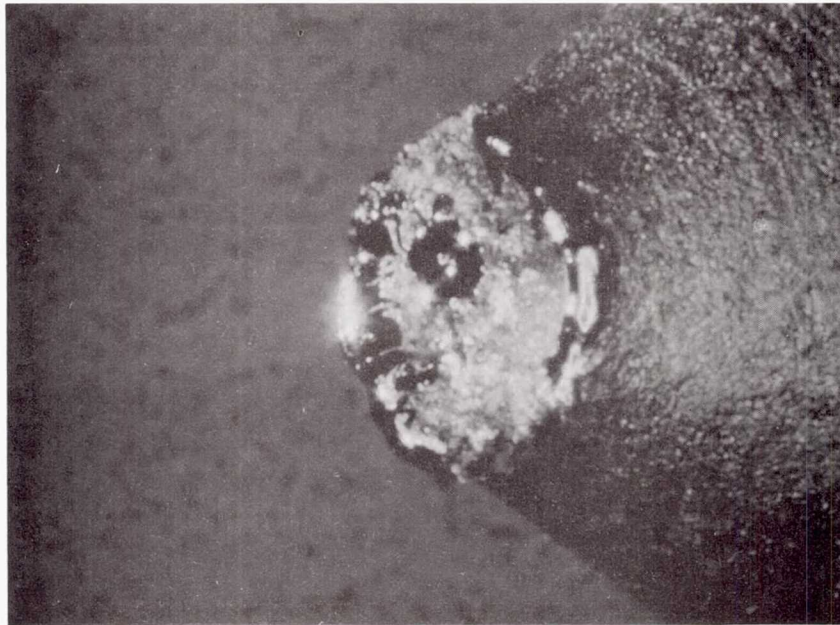
The discrepancy between the measured arc gap and the forward movement of the anode within the housing was explained when the cathode was removed from the thruster for inspection. The tip of the cathode had formed a crater nearly 1.3 mm in diameter with a bulged rim (see Fig. 14). The material on this rim lay outside the original conical envelope by an amount approximately equal to the distance moved by the anode. The axial distance from the original tip location to the crater rim was approximately 0.58 mm. Figure 15 shows a sketch of the cathode tip with the original conical tip shape superimposed for comparison. Of particular interest was the migration of material from the center of the cathode tip to a region outside the original conical shape of the cathode tip. This could have resulted in shorting of the cathode to the anode had the anode not moved forward within the housing. The measured cathode mass loss was approximately 2×10^{-6} kg.

Figure 14. Cathode Tip After Second 100-h Test Segment

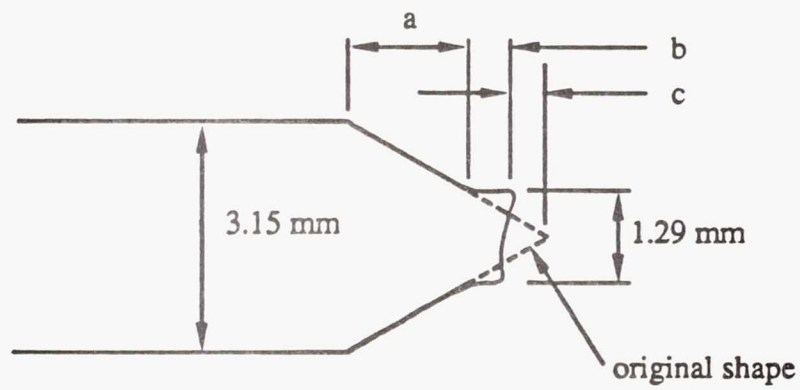
a = 1.60 mm
b = 0.55 mm
c = 0.58 mm

Figure 15. Comparison of Cathode Tip After Second 100-h Test Segment to As-Machined Shape

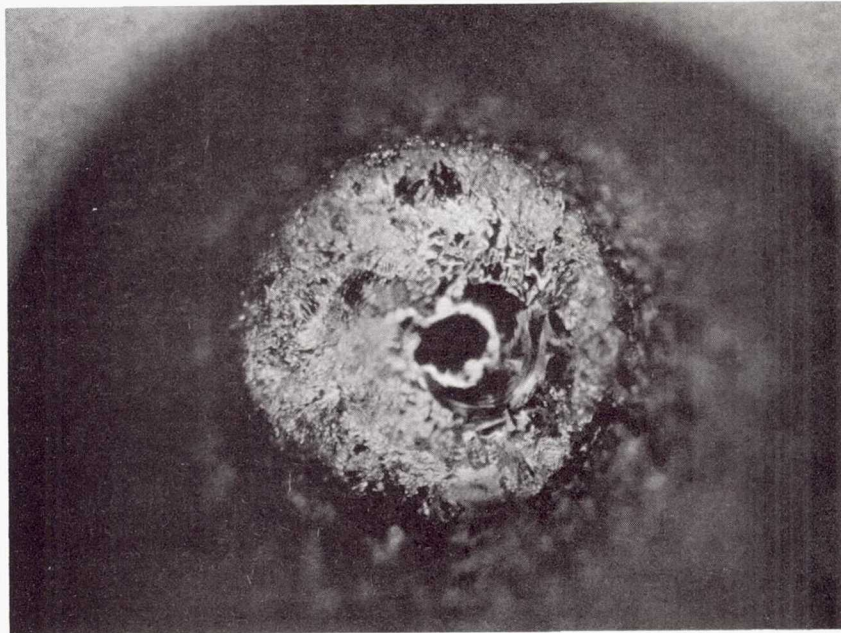
however. Figure 16 shows a photograph of the cathode tip. Figure 17 shows a sketch of the cathode tip profile with the as-machined shape superimposed for comparison. The shape of the tip is similar to that seen during the previous inspection (see figure 14), although the diameter of the crater had increased by 0.06 mm to 1.35 mm. The lip of the crater had recessed 0.20 mm (nominally) from its position after the second 100-h test, for a total tip recession of 0.86 mm from the as-machined tip location. The cathode mass was approximately 1×10^{-6} kg lower than that measured after the second 100-h test segment, for a total cathode mass loss of about 3×10^{-6} kg over the three test segments.

Figure 16. Cathode Tip After Third 100-h Test Segment

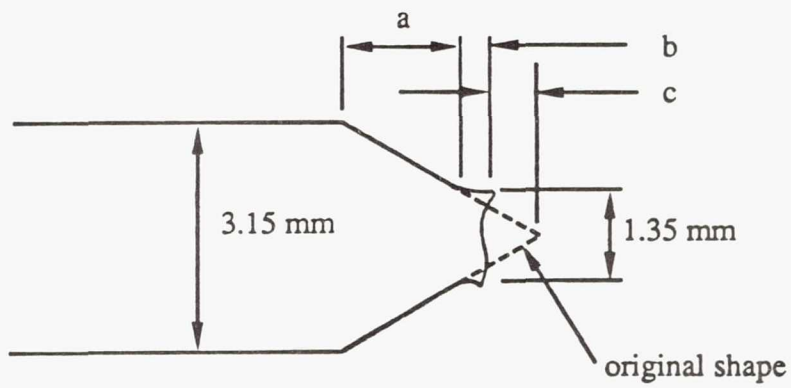
a = 1.56 mm
b = 0.39mm
c = 0.78 mm

**Figure 17. Comparison of Cathode Tip After Second 100-h Test

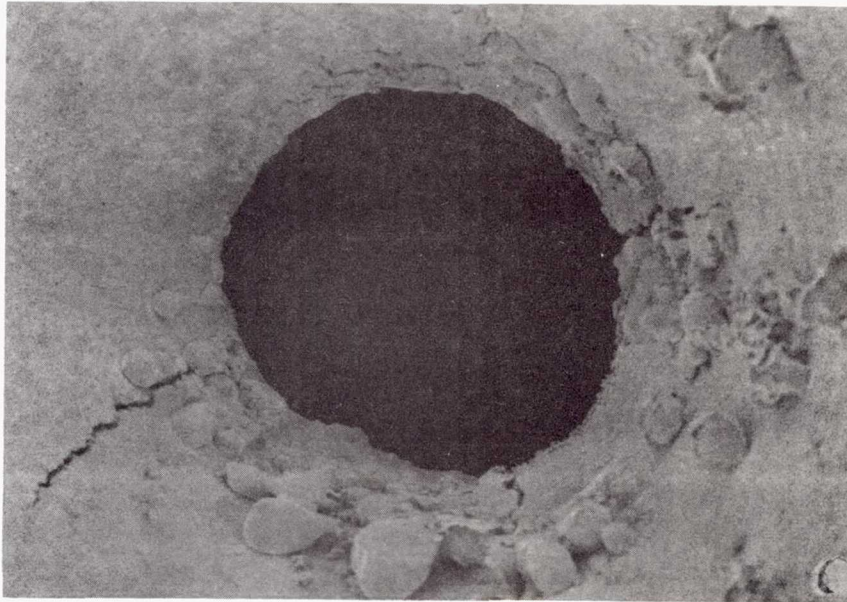
The thruster was disassembled a final time and the anode and cathode tip were sectioned for metalographic analyses. Figure 18 and 19 show two views of the cathode tip. In Fig. 18 the crater rim does not appear to be as dramatically bulged as in Fig. 16 (taken after 300 h of operation, but before the last unsuccessful attempts to restart the thruster). Figure 19 does not display the textured surface within the crater, as does Fig. 16, nor is any distinct molten pool, where arc attachment would have occurred, apparent. Only a few minutes of unstable operation occurred between the conditions identified in Fig. 16 and Figs. 18 and 19. Apparently the arc attachment point was moving about on the surface of the cathode tip, leaving a trail of molten material in its path which solidified as the arc moved on.

Figure 18. SEM Photograph of Cathode Tip After Third 100-h

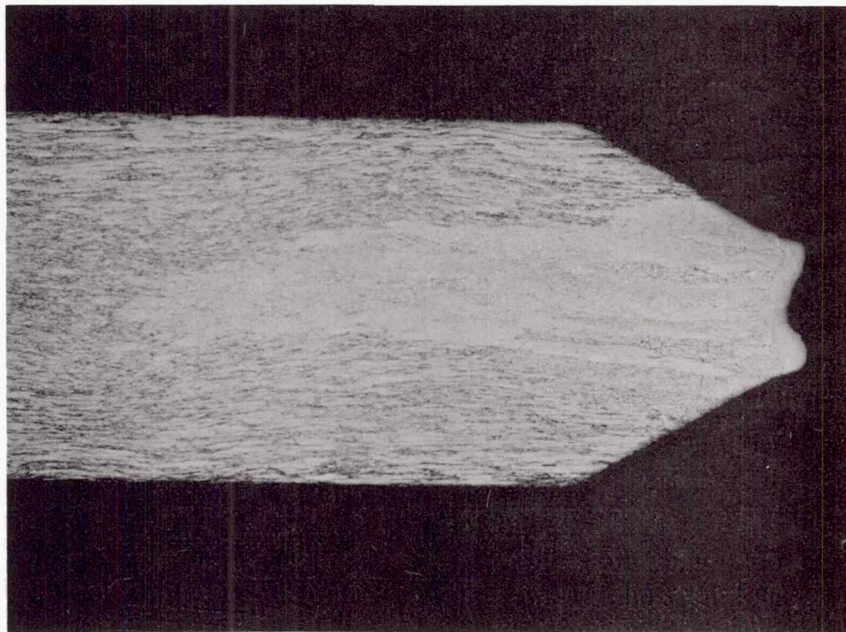
Figure 19. SEM Photograph of Cathode Tip After Third 100-h
