5-kW Xenon Ion Thruster Lifetest

5kW XENON ION THRUSTER LIFETEST

This paper describes the results of the first lifetest of a high power ring-cusp ion thruster. A 30-cm laboratory model thruster was operated steady-state at a nominal beam power of 5kW on xenon propellant for approximately 900 hours. This test was conducted to identify life-limiting erosion mechanisms and thruster design modifications, and to demonstrate operation using simplified power processing. The results from this test are described including the conclusions derived from extensive post-test analyses of the thruster. Modifications to the thruster and ground support equipment, which have been incorporated to solve problems identified by the lifetest, are also described.

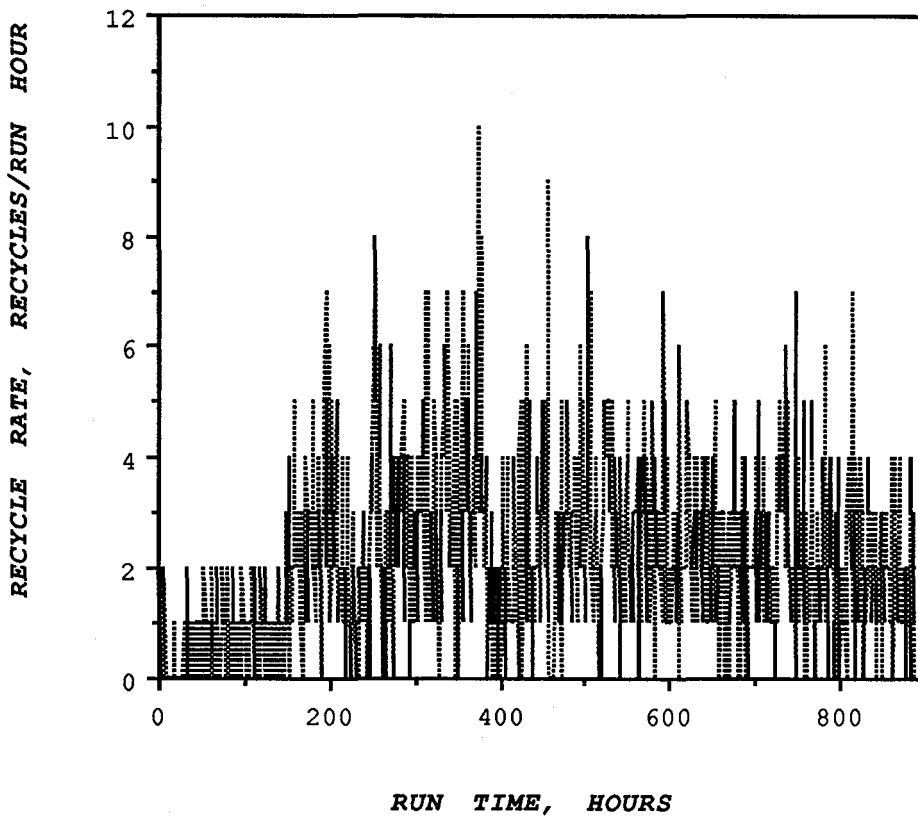
FIGURE 18A. - High-Voltage Recycle Rate
versus Run Time.

ion optics - Figures 18a and 18b show the high-voltage recycle rate, and cumulative number of recycles, for the lifetest duration. Noteworthy is that the recycle rate increased with test time for approximately the first 150 hours in a step-wise fashion, after which a fairly constant rate of 2.4 recycles/hour was observed for the remaining 740 hours. The first 25 hours of testing experienced a rate of 0.2 recycles/hour; the second 25 hours experienced a rate of 0.4 recycles/hour. From hour 50 to 150, the rate was approximately 0.8 recycles/hour, until at hour 151 when the rate jumped by a factor of three to 2.4 recycles/hour. The rate magnitude and rate increase of recycles with time are generally atypically of most extended-duration ground tests of ion thrusters. Typically the arc frequency decreases over the first several hours of a test, during a 'clean-up' period, and then maintains a fairly constant rate of 0.2-0.5 recycles/hour. The low initial recycle rate during this test is believed to be due to the precautions taken prior to the test to insure a 'clean-room' assembly of the thruster. The increase in recycle rate with time may be due to a high arrival rate of graphite from the beam target. This contaminant, in combination with high charge-exchange erosion of the accelerator grid, probably resulted in formation of whiskers. This mechanism however would not appear to explain the step-function increases in recycle rate experienced during the test. Based on pre- and post-test leakage resistance measurements of the thruster, no significant loss in insulation properties was identified which could have contributed to the high recycle rate. Visual observations of the thruster made during the lifetest recycle events were also inconclusive as to an agent. Of several dozen recycles visually observed during the

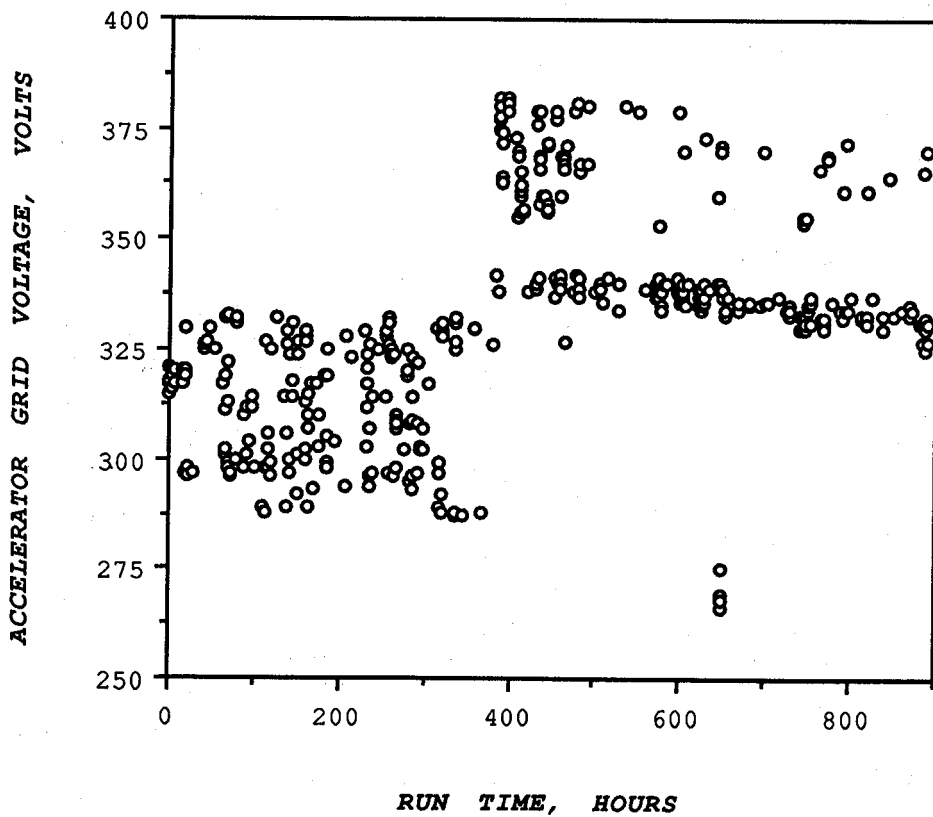
FIGURE 20. - Accelerator Grid Voltage versus Run Time.

The variation in output voltage of the two high voltage grid supplies are shown in Figures 19 and 20. The only manual change in the output voltage of either supply was an adjustment to the limit set-points of the accelerator grid supply at hour 384.3. At that time it was believed the high recycle rate could be due to an enlargement of accelerator grid apertures. This would reduce the maximum permissible R-ratio (lower the backstreaming limit) to near that value obtained when the accelerator supply output voltage was at the lower set-point. However as indicated in Figure 18, no significant reduction in recycle rate was observed with the increase in accelerator supply output voltage.

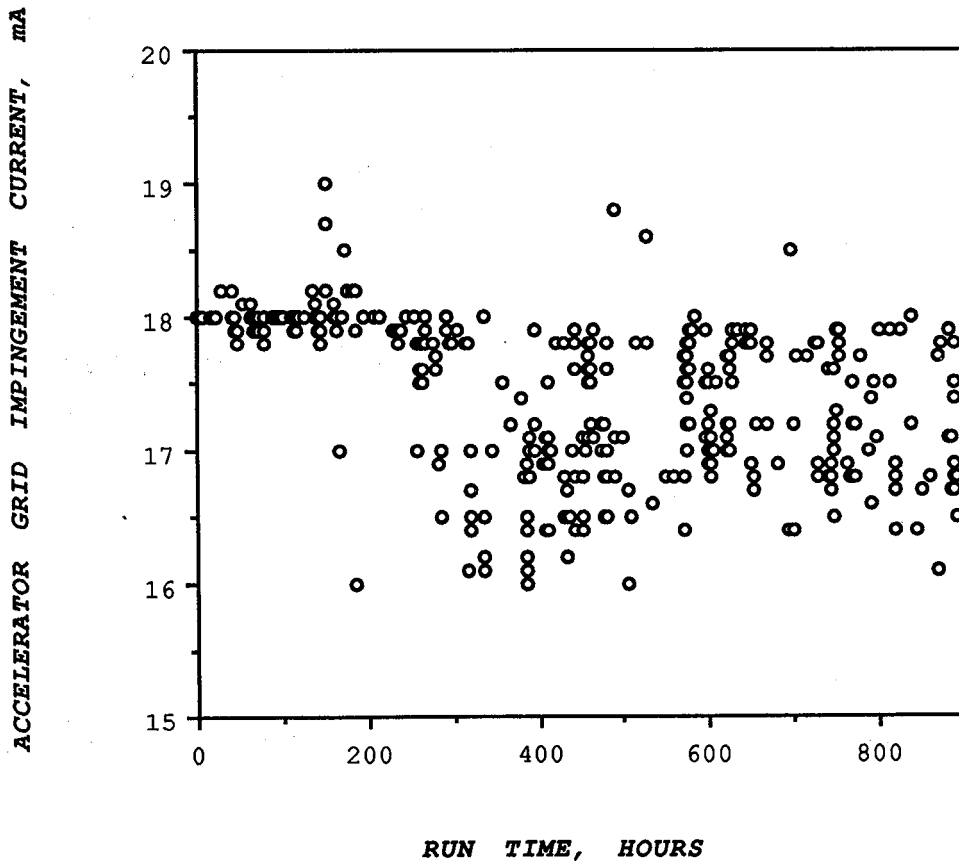
FIGURE 22. - Accelerator Grid Impingement
Current versus Run Time.

Figures 21 and 22 show the time variation of the beam and accelerator grid impingement currents respectively. The beam current variation (+/- 3 percent) follows the variation in the screen supply output voltage. The charge-exchange ion contribution to the accelerator grid impingement current should be proportional to the product of the beam current and the neutral atom density; the accelerator current appears to follow this parameter fairly well. The decrease in average accelerator current after restart on hour 291.5 may be associated with a reduction in direct ion impingement due to improved beamlet focussing due to the screen grid voltage increase. However, the average net-to-total accelerating voltage ratio (R-ratio) was lower after hour 384.3, implying degraded focussing, and a deeper potential well to trap charge-exchange ions, but no commensurate increase in the average impingement current was observed.

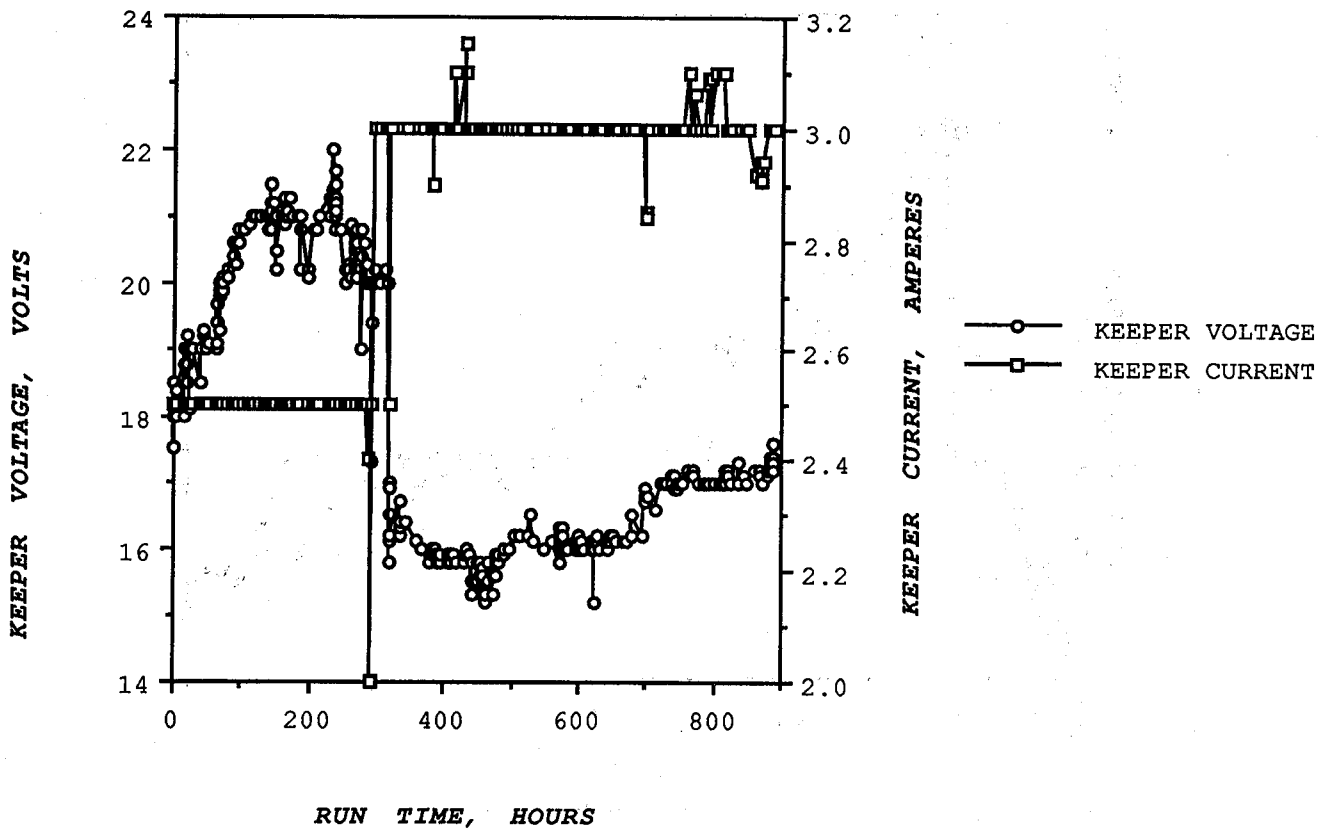
FIGURE 23. - Neutralizer Keeper Voltage
and Current versus Run Time.

neutralizer assembly - The neutralizer performance decayed during the lifetest. For approximately the first 110 hours of the test, the neutralizer keeper voltage monotonically increased (from approximately 18 to 21 volts), after which the voltage stabilized somewhat (Figure 23). During this period the neutralizer mass flow rate was permitted to drift upwards to mitigate the keeper voltage rate of change (Figure

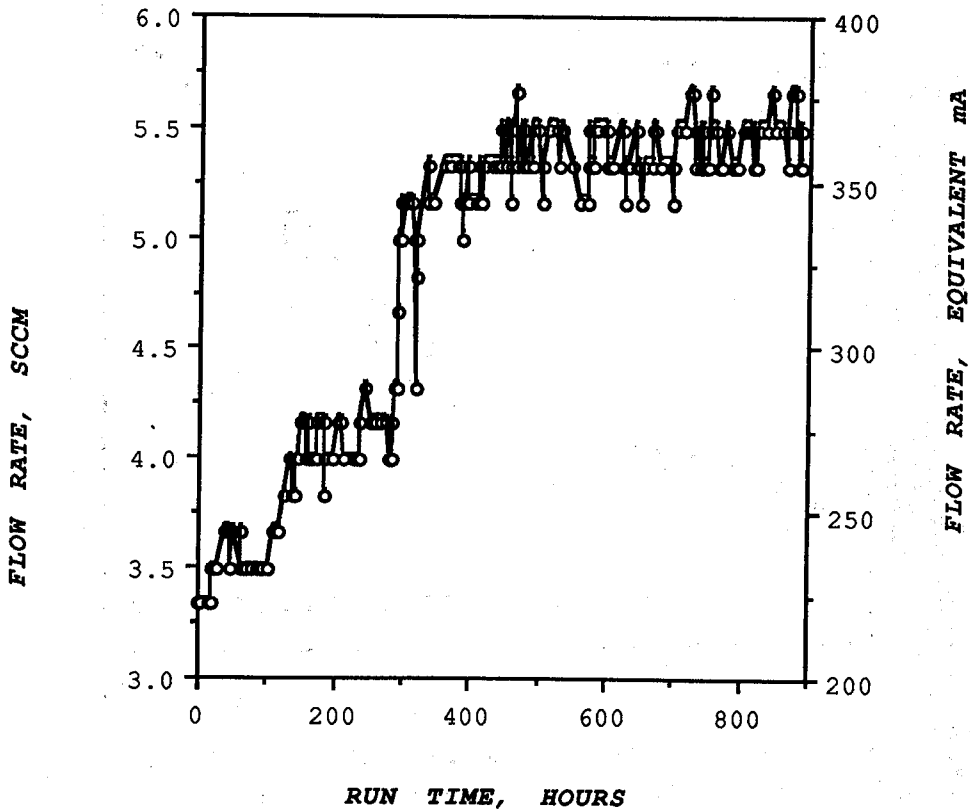
FIGURE 24. - Neutralizer Cathode Propellant
Mass Flow Rate versus Run Time.

24). Also for the duration of the lifetest, the neutralizer common-to-facility ground voltage monotonically increased from approximately -13 to -17 volts (Figure 25). In addition to the voltage increase, at approximately run hour 1.8, low frequency (about 1 Hz) oscillations of the keeper voltage (up to +/- 0.4 V) were observed on the strip chart recorder and metering, and continued (at various amplitudes and frequencies) on an intermittent basis until the keeper power supply problem was identified and resolved at run hour 317.7. During the oscillations, the keeper voltage could be stabilized by small (approximately 10 mA) increases in the propellant flow rate through the neutralizer line, but the oscillations would eventually return.

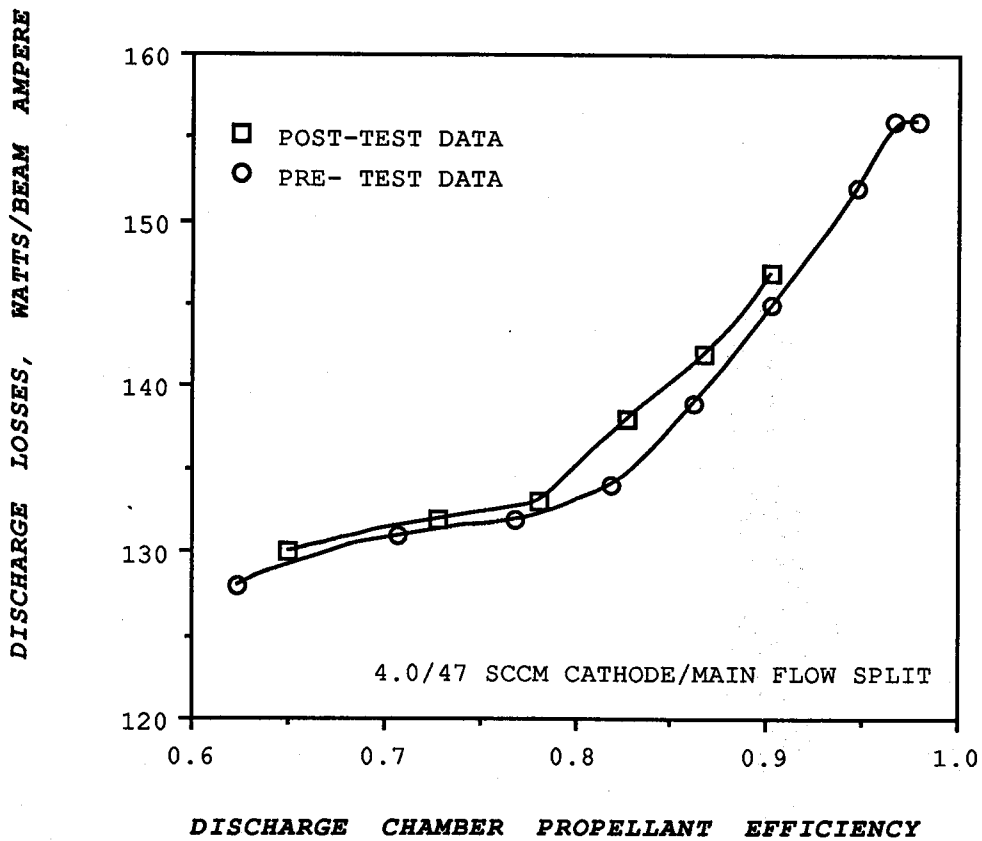
FIGURE 26. - Discharge Losses versus Propellant Efficiency, Pre- and Post-Lifetest Comparison.

discharge chamber and discharge cathode assemblies- A comparison of pre- and post-lifetest discharge chamber performance curves are presented in Figure 26. The curves were obtained by varying the discharge current, at fixed main plenum and discharge cathode propellant flow rates. As indicated, no significant change in the discharge losses or discharge propellant efficiencies were experienced. This was the case despite a measurable increase in accelerator grid apertures during the lifetest.

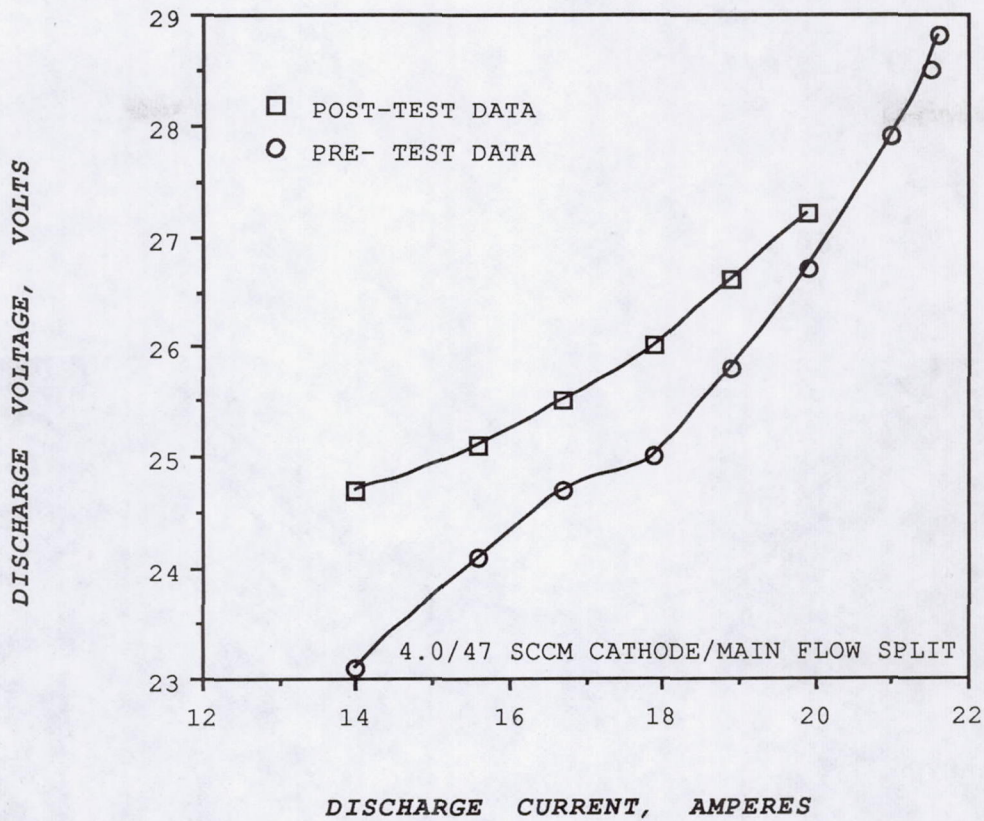
FIGURE 27. - Discharge IV Characteristic,
Pre- and Post-Lifetest Comparison.

Figure 27 presents the current-voltage characteristic data for the discharge before and after the lifetest. Although the discharge voltage after the lifetest is somewhat higher at throttled conditions the data begin to converge at high discharge currents.

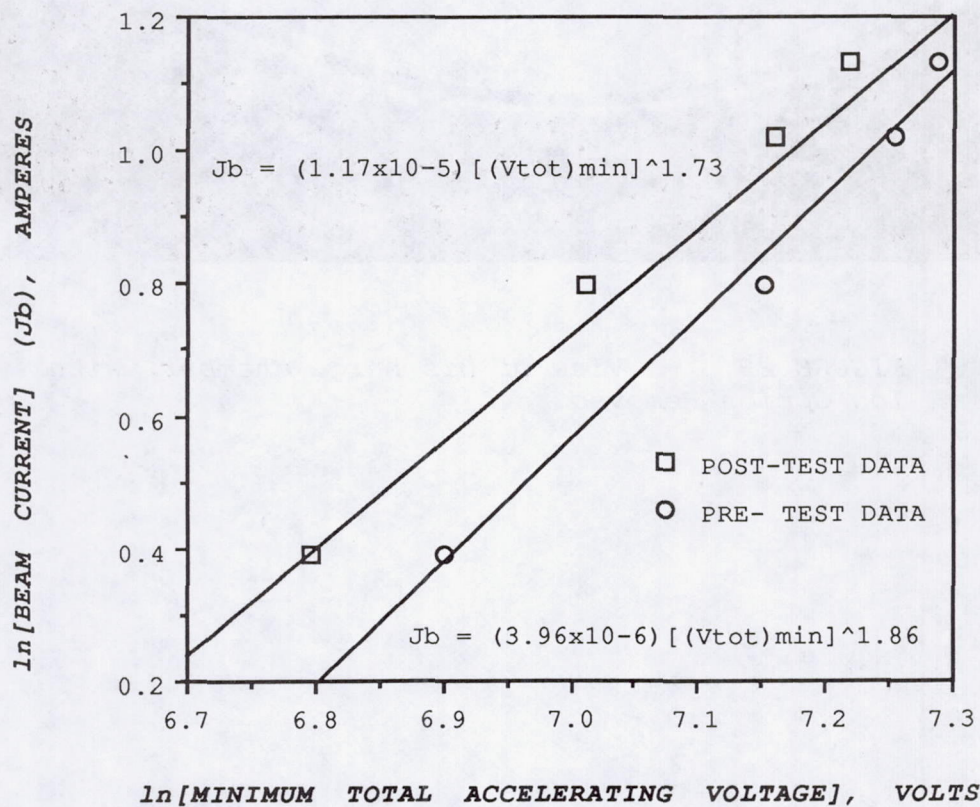
FIGURE 28. - Ion Optics Perveance,
Pre- and Post-Lifetest Comparison.

ion optics - Perveance data taken before and after the lifetest (beam current versus total accelerating voltage) are presented in Figure 28. For a given beam current, the minimum total voltage decreased by an average of approximately 120 V. This increase in perveance is believed to be entirely associated with an increase in accelerator grid aperture diameters, due to ion machining, occurring predominantly at the outer beam edge, which were identified during post-test examination of the grids. No other change in ion optics geometry such as in the cold-gap or alignment was identified.

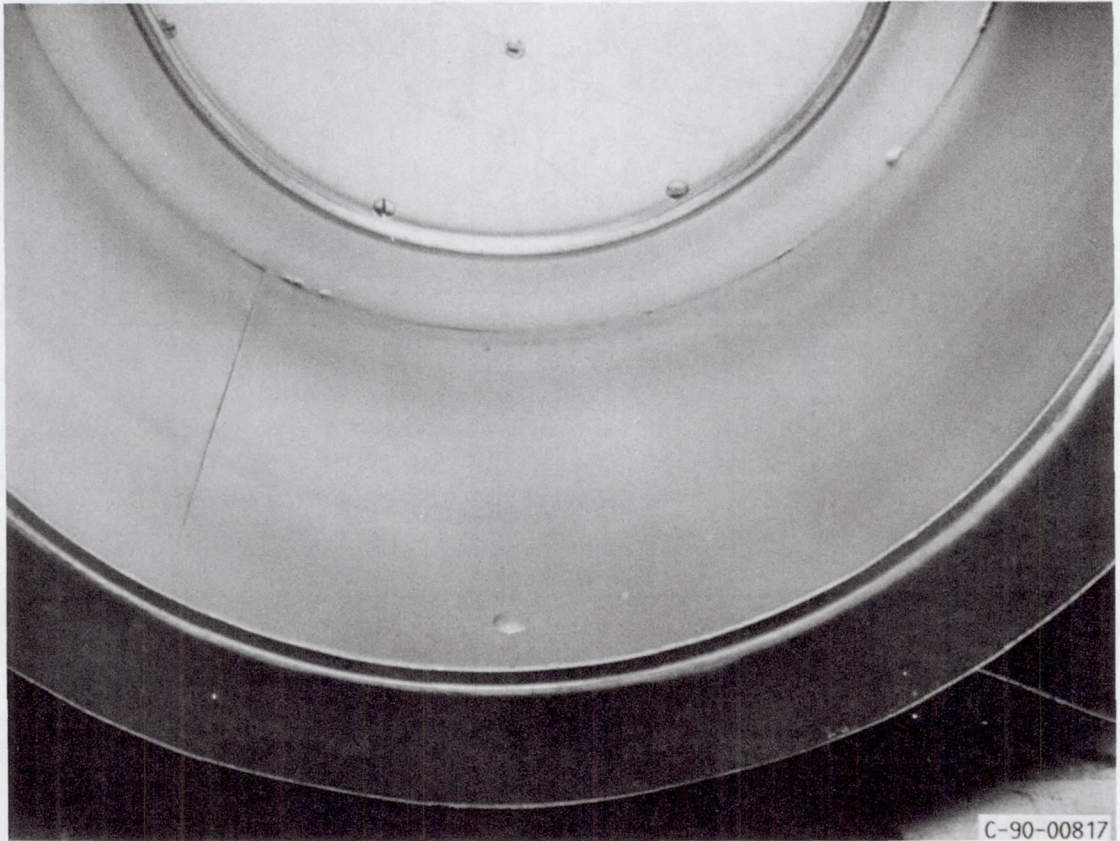
FIGURE 29.   -   View of Discharge Chamber, with
Ion Optics Removed.

- There was negligible deposition, and no spalling of material, on the internal anode surfaces (Figure 29).

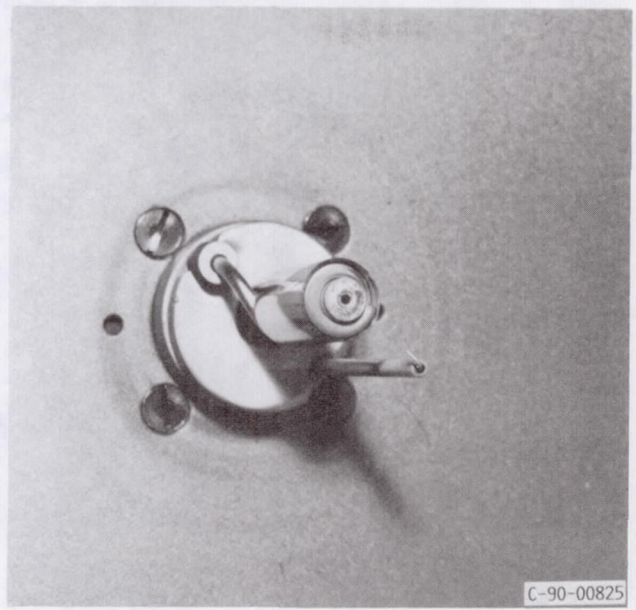
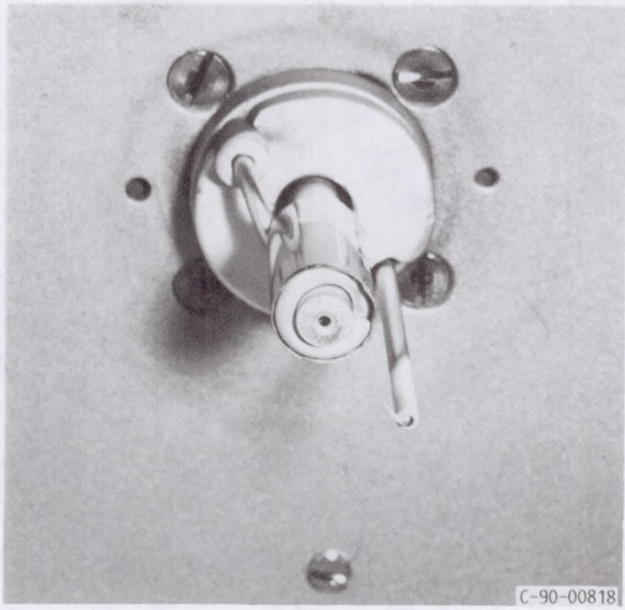
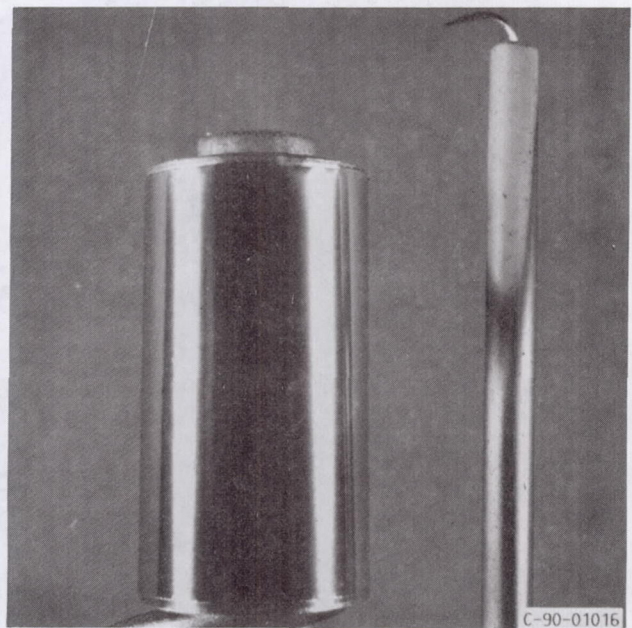
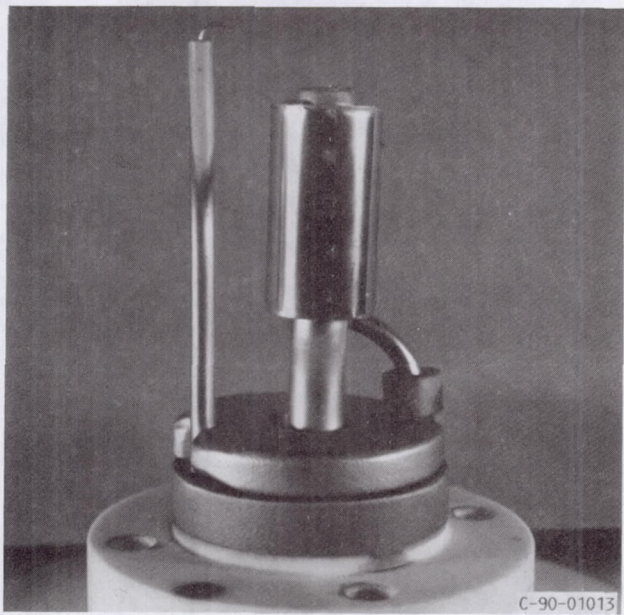
FIGURE 30.   - Post-Lifetest Discharge Cathode
Assembly, Several Perspectives.

lifetest with little or no damage. These undamaged components included most thruster structural elements and insulators, and all wiring. Components which had been damaged extensively were the neutralizer keeper bar and the neutralizer keeper support rod and ceramic insulator. In addition, severe erosion was evident on the downstream surface of the accelerator grid (due to charge-exchange) and on the discharge cathode assembly starting electrode.

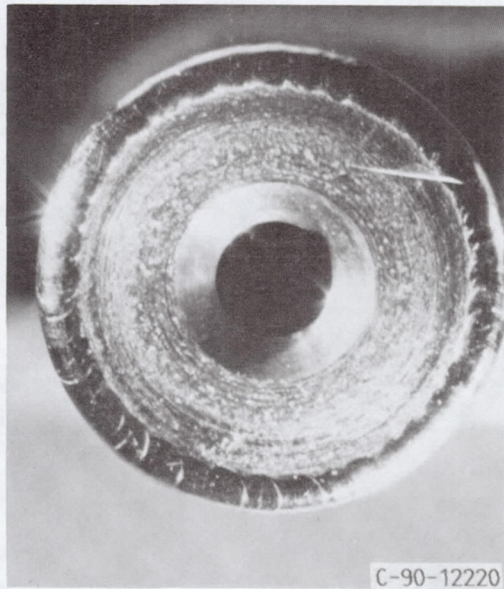
FIGURE 31. – Discharge Cathode Orifice Plate.

The surrounding orifice plate area is roughened, presumably from ion bombardment, to the degree that original machining grooves in the tungsten surface are no longer visible (Figure 31). Most exterior surfaces of the hollow cathode tube and heater assembly appeared to be in prisitine condition, except for a dulled area, possibly due to ion sputtering, on the tube immediately upstream of the heater coils. Within the measurement uncertainty of about 5.1 microns,

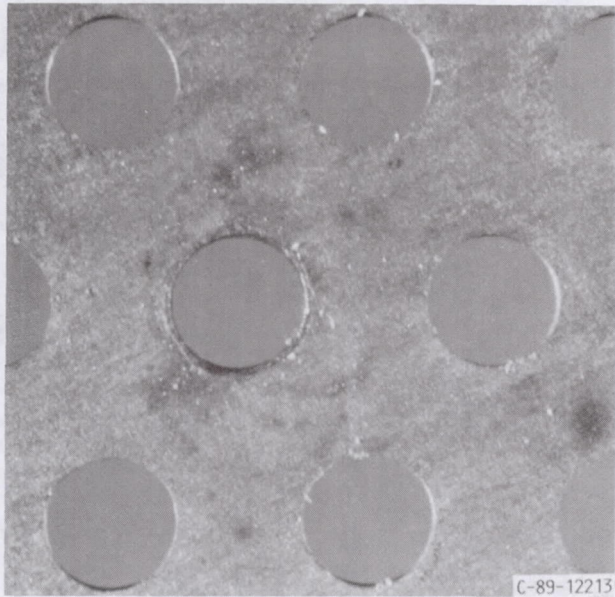
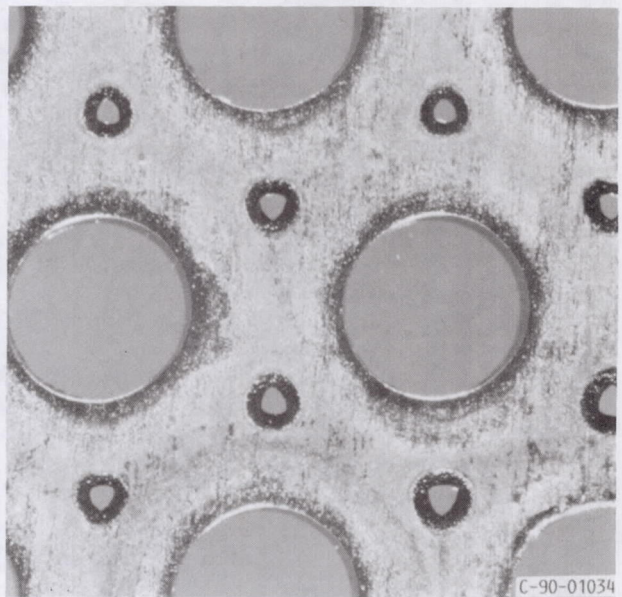
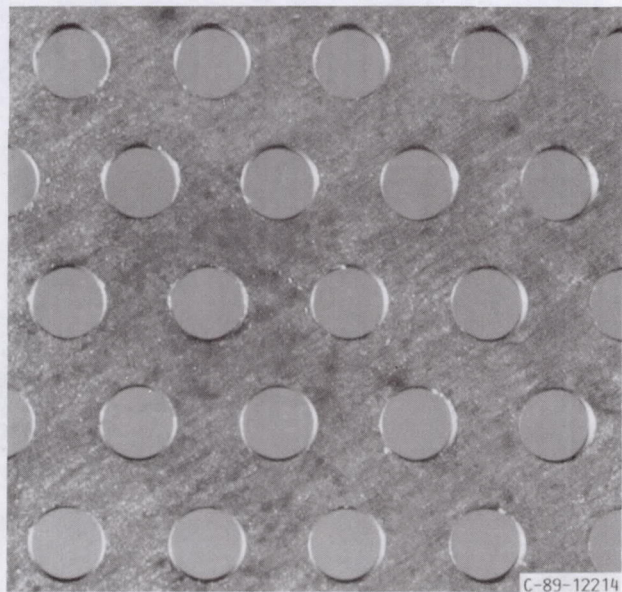
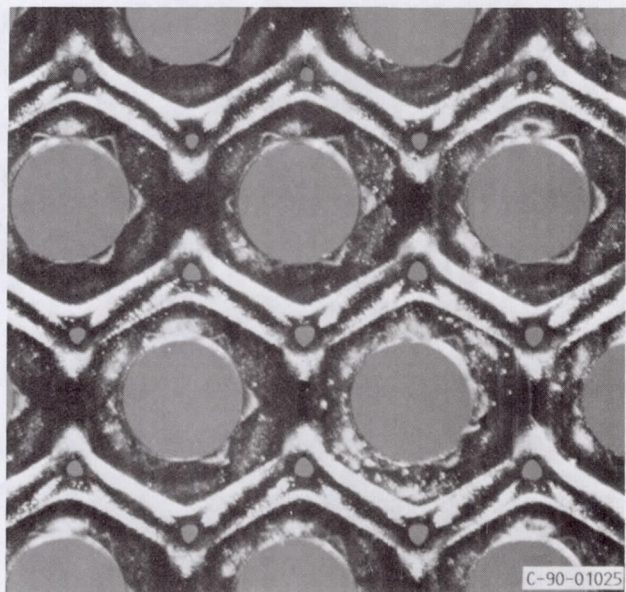
FIGURE 32. - Accelerator Grid, Center Holes.

- The accelerator grid suffered a mass loss of 17.759 gm +/- 0.004 gm over the 956.8 hour test period, consisting of the 890.0 hour 5kW lifetest plus pre- and post-test operation (including 16.0 hours at 5kW, and 50.8 hours at a variety of throttled conditions).

- Charge-exchange ion erosion of the accelerator grid is a primary factor in life limitation. Under the present ground test conditions and 5kW operating point, the accelerator grid would be expected to suffer a catastrophic structural failure as early as 4200 hours. However, in space-like environmental conditions, the accelerator grid lifetime is expected to be in excess of 11,500 hours (see Appendix D). It is imperative that the charge-exchange processes responsible for the high grid erosion be more thoroughly understood, and that the accelerator grid erosion be quantified with high certainty under space-like environmental conditions. To do so will require low-pressure testing at 5kW in helium-cryopump equipped facilities.

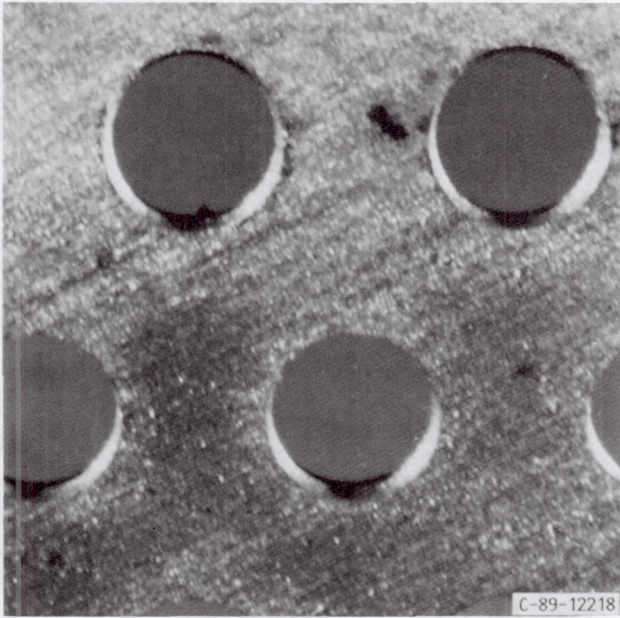
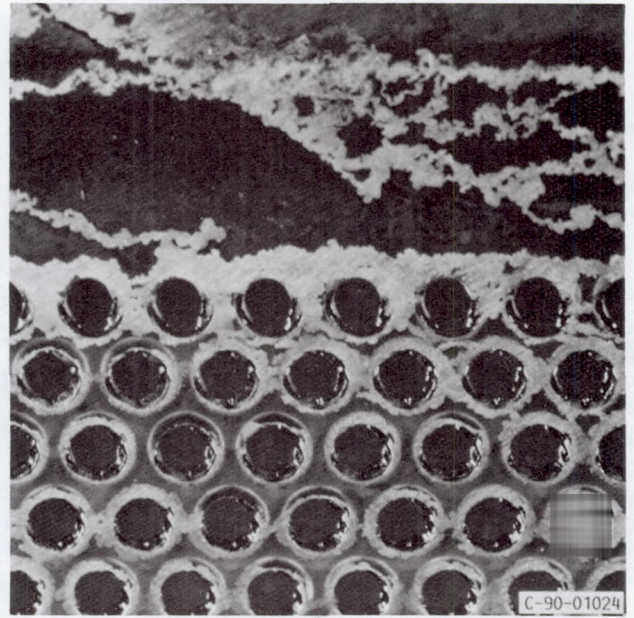
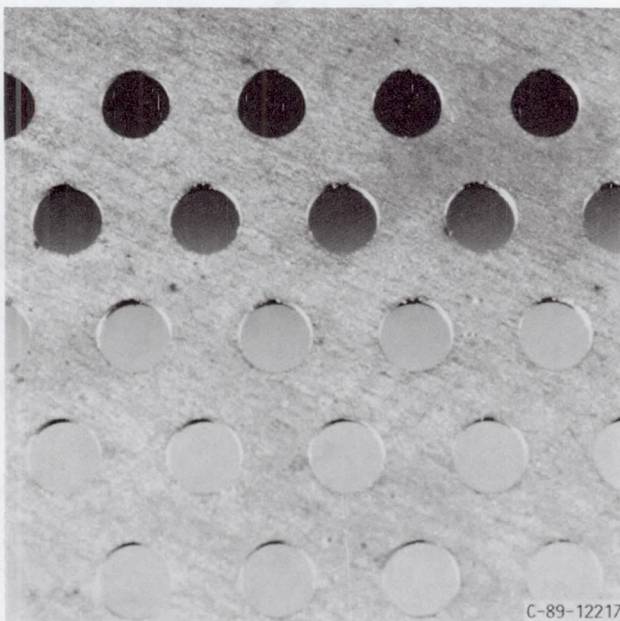
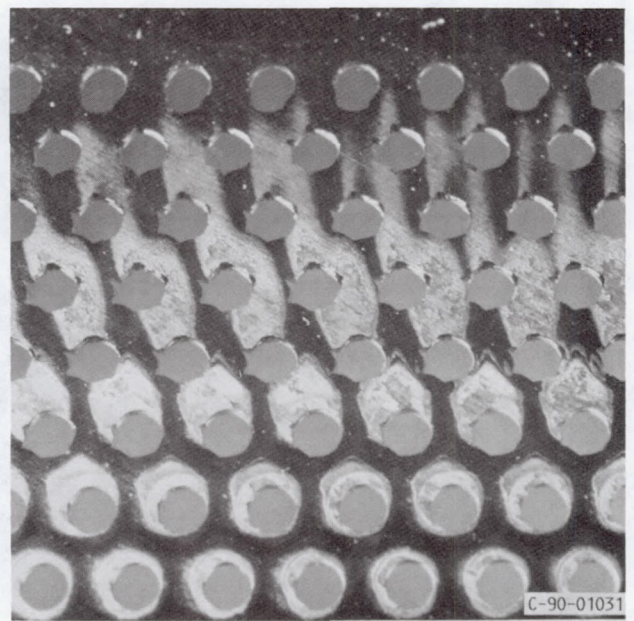
FIGURE 33. - Accelerator Grid, Edge Holes.

survived the lifetest with little or no damage. However, severe erosion was evident on the downstream surface of the accelerator grid due to charge-exchange ion impingement, and on the discharge cathode starting electrode. Based on an interpretation and analysis of the thruster components, the following conclusions can be drawn:

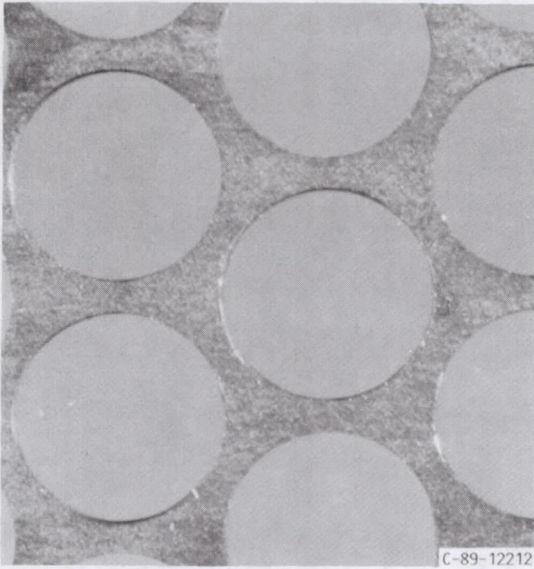
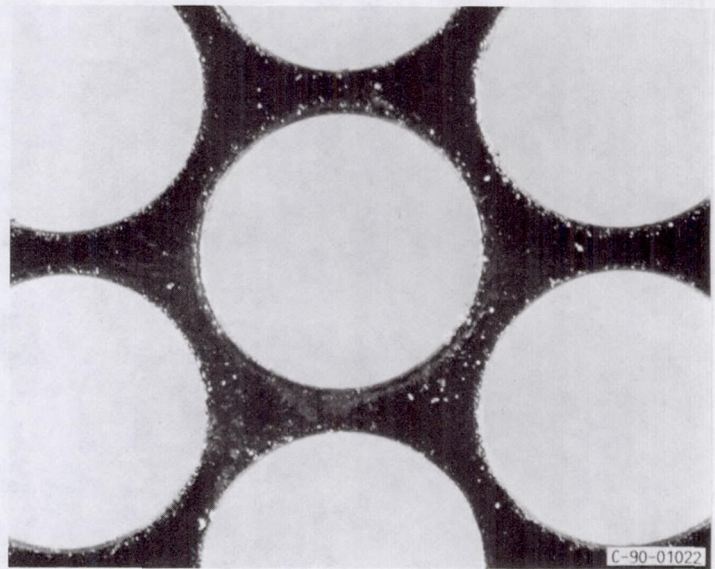
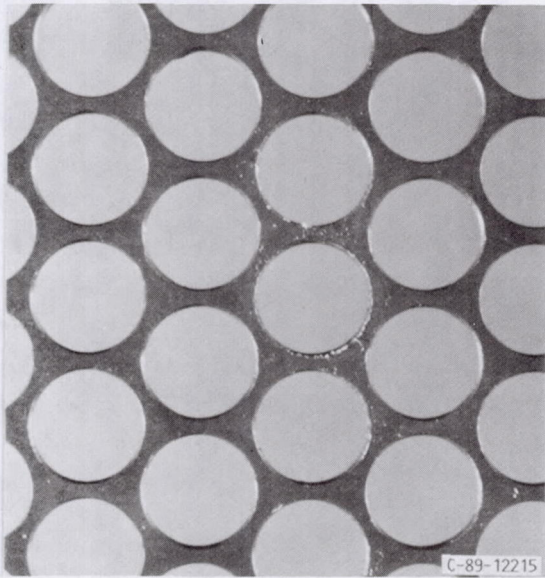
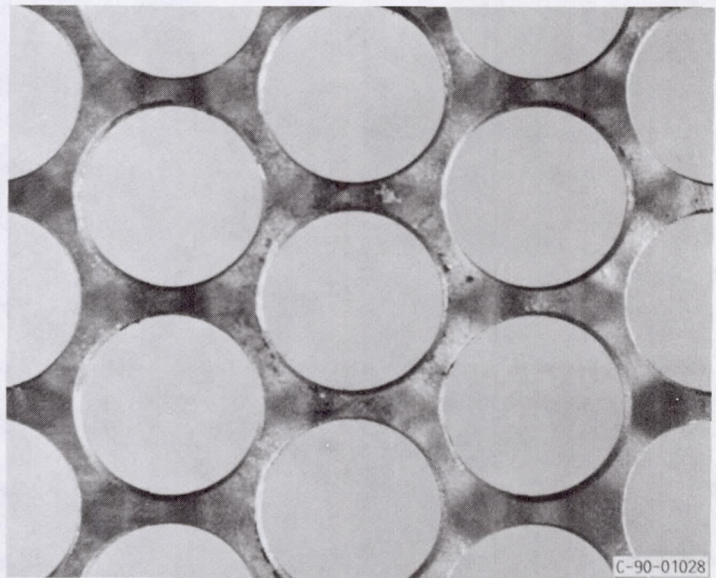
FIGURE 34.   -   Screen Grid, Center Holes.

- Screen grid erosion by discharge ions is not a factor in thruster wearout lifetime. The 5.1 micron thickness measurement uncertainty implies a maximum possible erosion rate of approximately 6 microns per 1000 hours. The screen grid has a beginning-of-life thickness of 360 microns, which should permit at least 35,000 hours of operation before it wears to half thickness. Based on an analysis of the residual facility gases, it was found that the no-load base pressure of 6.7×10^{-5} Pa was due to approximately 50 percent water vapor and 50 percent nitrogen. Reference 10 has shown that the presence of reactive residual gases (including nitrogen and water vapor) can reduce the sputter yield of molybdenum by forming a surface compound that has a lower sputter yield than the base metal. However, the magnitude of this effect with water vapor has not been quantified. Therefore, it was assumed that the water vapor was as reactive as nitrogen. From data of reference 10 and facility effect curves in reference 11, the impact of the reactive residual gases on screen grid erosion during the lifetest is believed to be negligible. This may provide some leverage in addressing the accelerator grid erosion, vis-a-vis operation at higher propellant efficiencies. However this will necessitate improved propellant flow regulation.

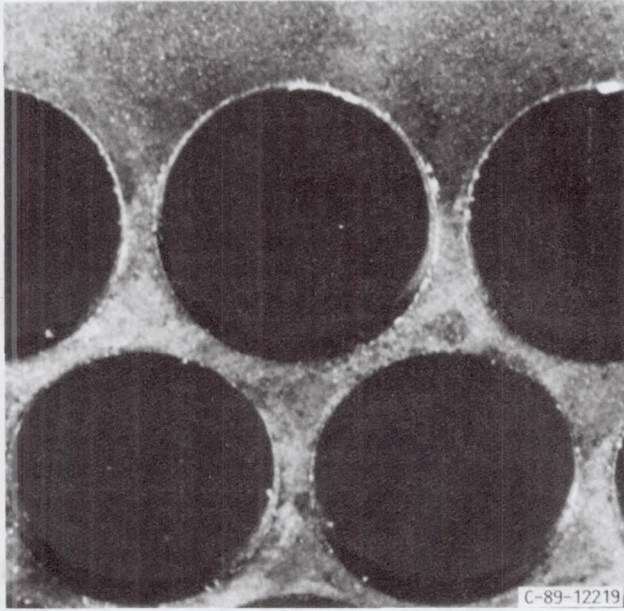
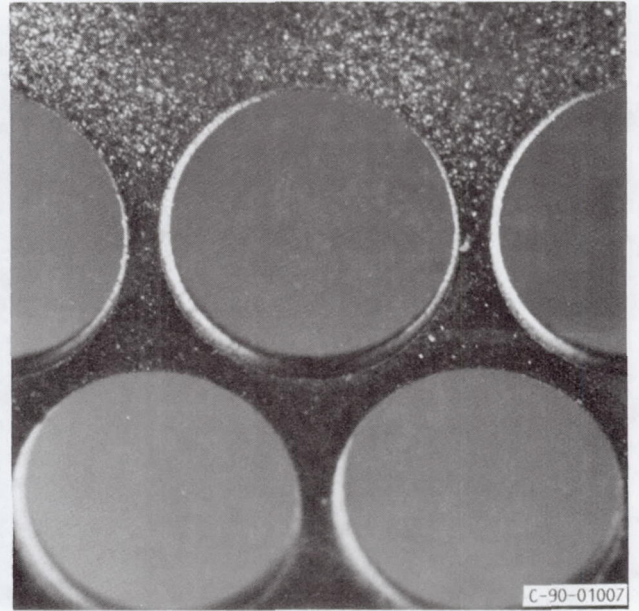
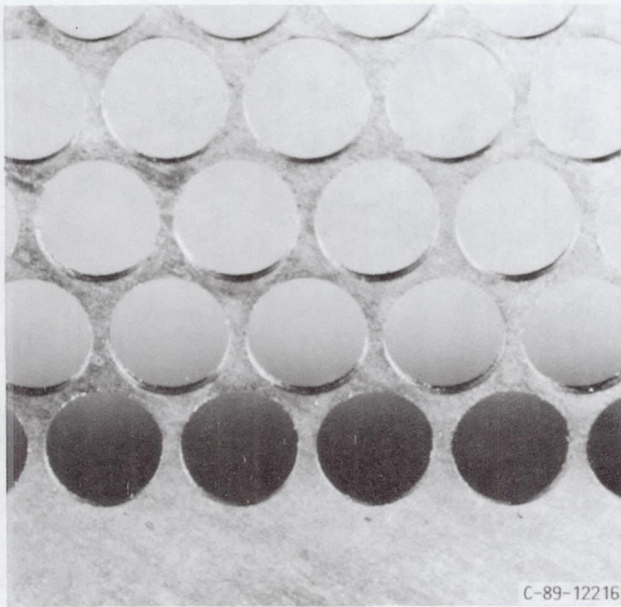
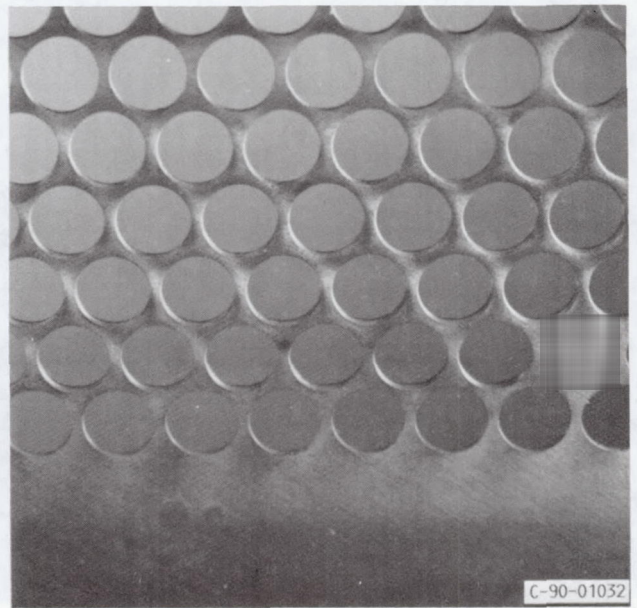
FIGURE 35. - Screen Grid, Edge Holes.

- The screen grid incurred a mass gain of 0.711 gm +/- 0.004 gm over the test period, due to deposition of molybdenum from the accelerator grid erosion (see Figures 34 and 35).

There was no visual evidence of erosion at any location on the screen grid (see Figures 34 and 35) and there was no discernable change in screen grid aperture diameters.

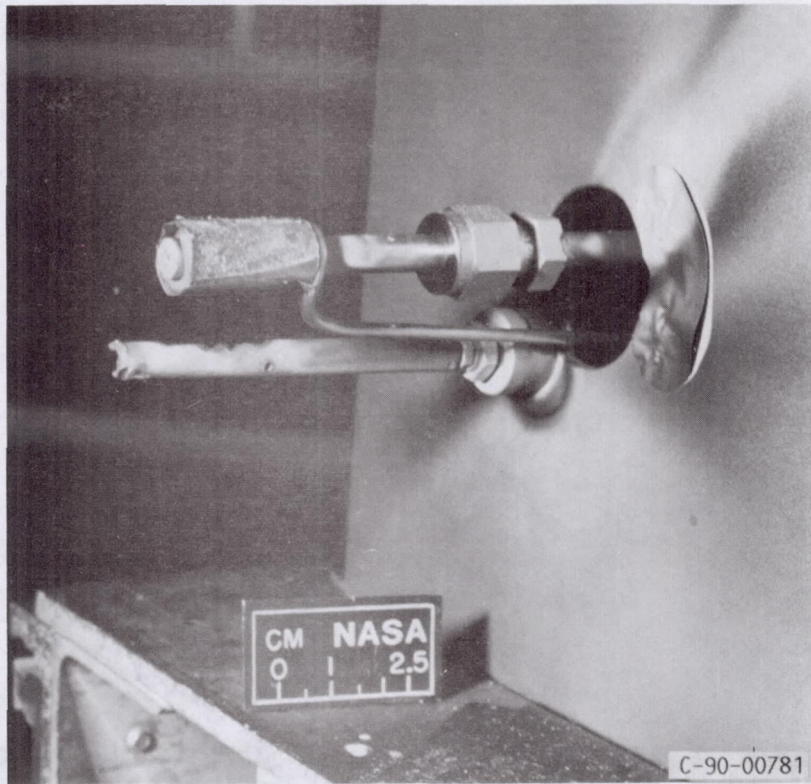
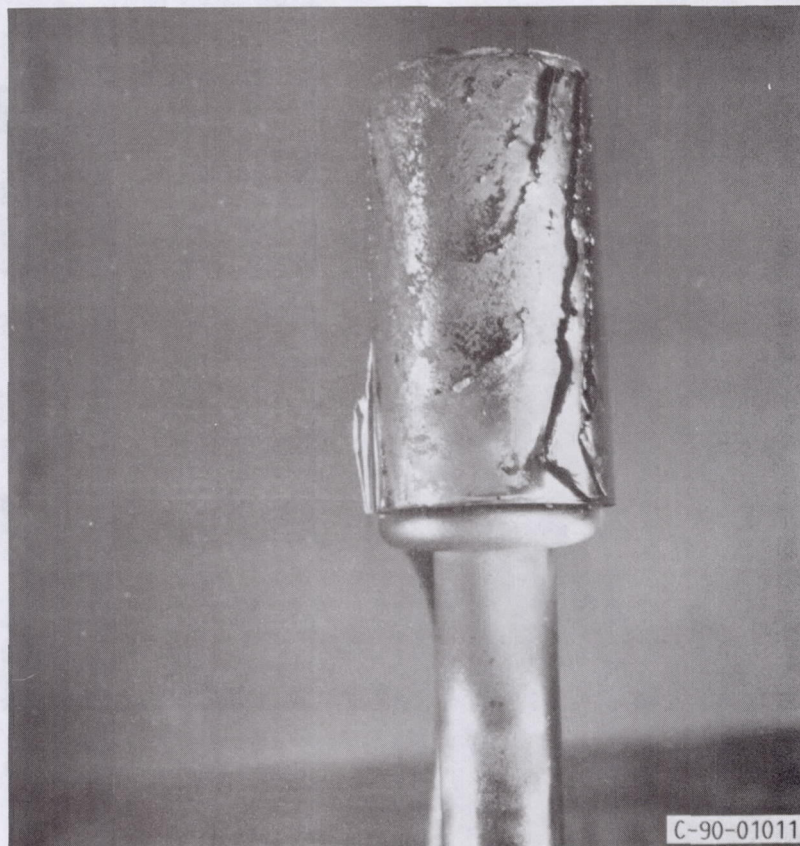
FIGURE 36. - Post-Lifetest Neutralizer Cathode
Assembly, Evidence of Beam Interception.

- The neutralizer keeper bar was severed from the keeper rod, and the rod and ceramic were melted into a eutectic. This damage occurred during restart at hour 890.0, and is believed to be due to a high-voltage, low-current discharge from neutralizer common-to-neutralizer keeper support rod. At that point the closest cathode-to-keeper potential gap was from orifice plate to the keeper rod tip. The current attachment did not occur on the keeper bar, as this component had translated under gravity away from the cathode orifice plate due to the failure of the single point mechanical attachment under repeated thermal cycles.

The poor performance, and performance degradation, of the neutralizer assembly was also a significant problem during the lifetest. The second-generation laboratory model thruster incorporates a neutralizer assembly with a mechanically-robust enclosed keeper structure, similar in geometry to that developed by Hughes for the XIPS thruster[4]. The XIPS neutralizer has demonstrated superior performance in terms of propellant mass flow rate and power requirement to the lifetest assembly, albeit at a lower cathode emission current requirement. Steps are also being taken to address the ion beam interception of the neutralizer including the ability to vary in-situ the neutralizer position with respect to the ion beam.

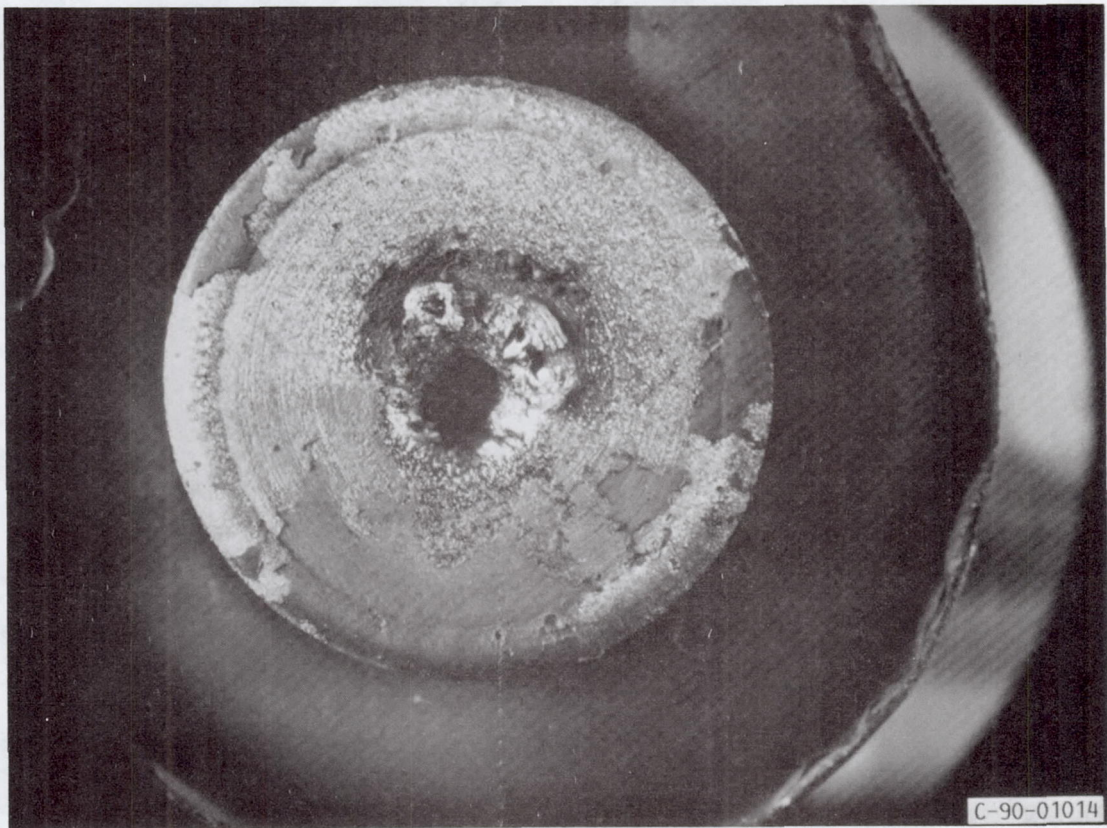
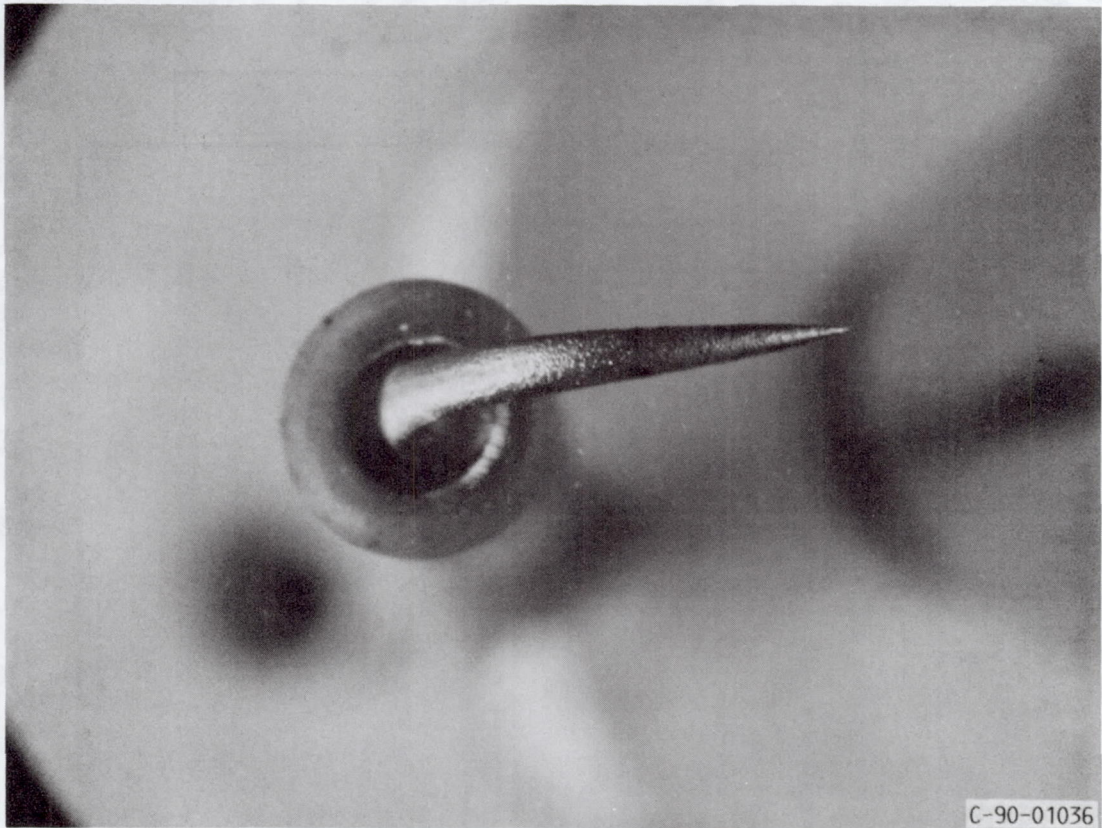
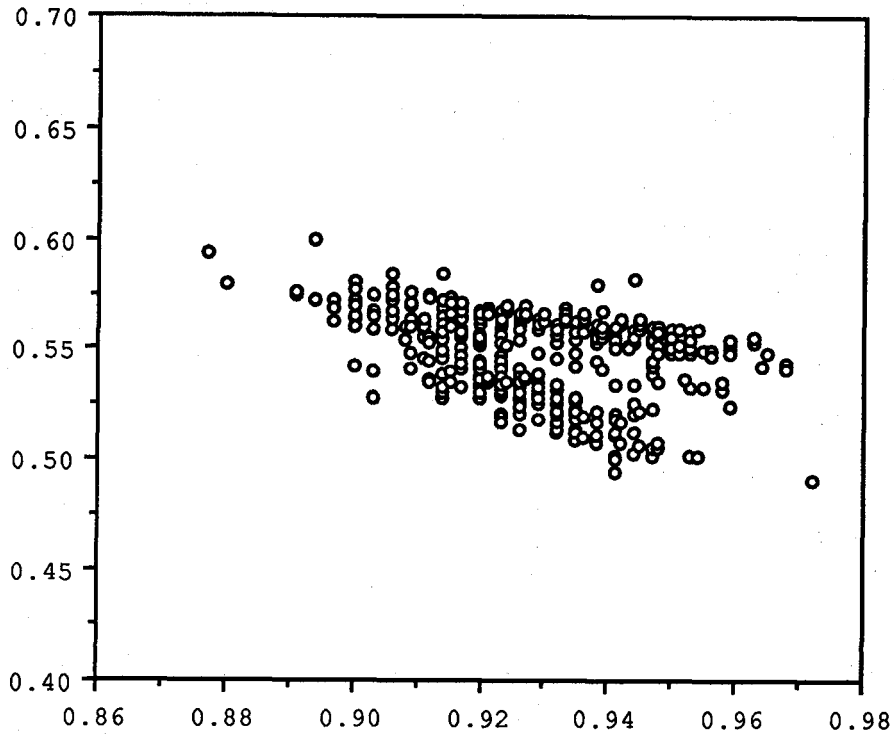
FIGURE 37. - Neutralizer Cathode Orifice Plate.

- Although no performance decay of the discharge and neutralizer hollow cathodes was experienced during the lifetest, the anomalous material formation on the orifice plates necessitates a complete physicochemical analysis of the lifetest cathode materials. The apparent change in discharge cathode insert condition, and the sputtering of the discharge cathode tube also require further investigation.
