5-kW Xenon Ion Thruster Lifetest

5kW XENON ION THRUSTER LIFETEST

This paper describes the results of the first lifetest of a high power ring-cusp ion thruster. A 30-cm laboratory model thruster was operated steady-state at a nominal beam power of 5kW on xenon propellant for approximately 900 hours. This test was conducted to identify life-limiting erosion mechanisms and thruster design modifications, and to demonstrate operation using simplified power processing. The results from this test are described including the conclusions derived from extensive post-test analyses of the thruster. Modifications to the thruster and ground support equipment, which have been incorporated to solve problems identified by the lifetest, are also described.

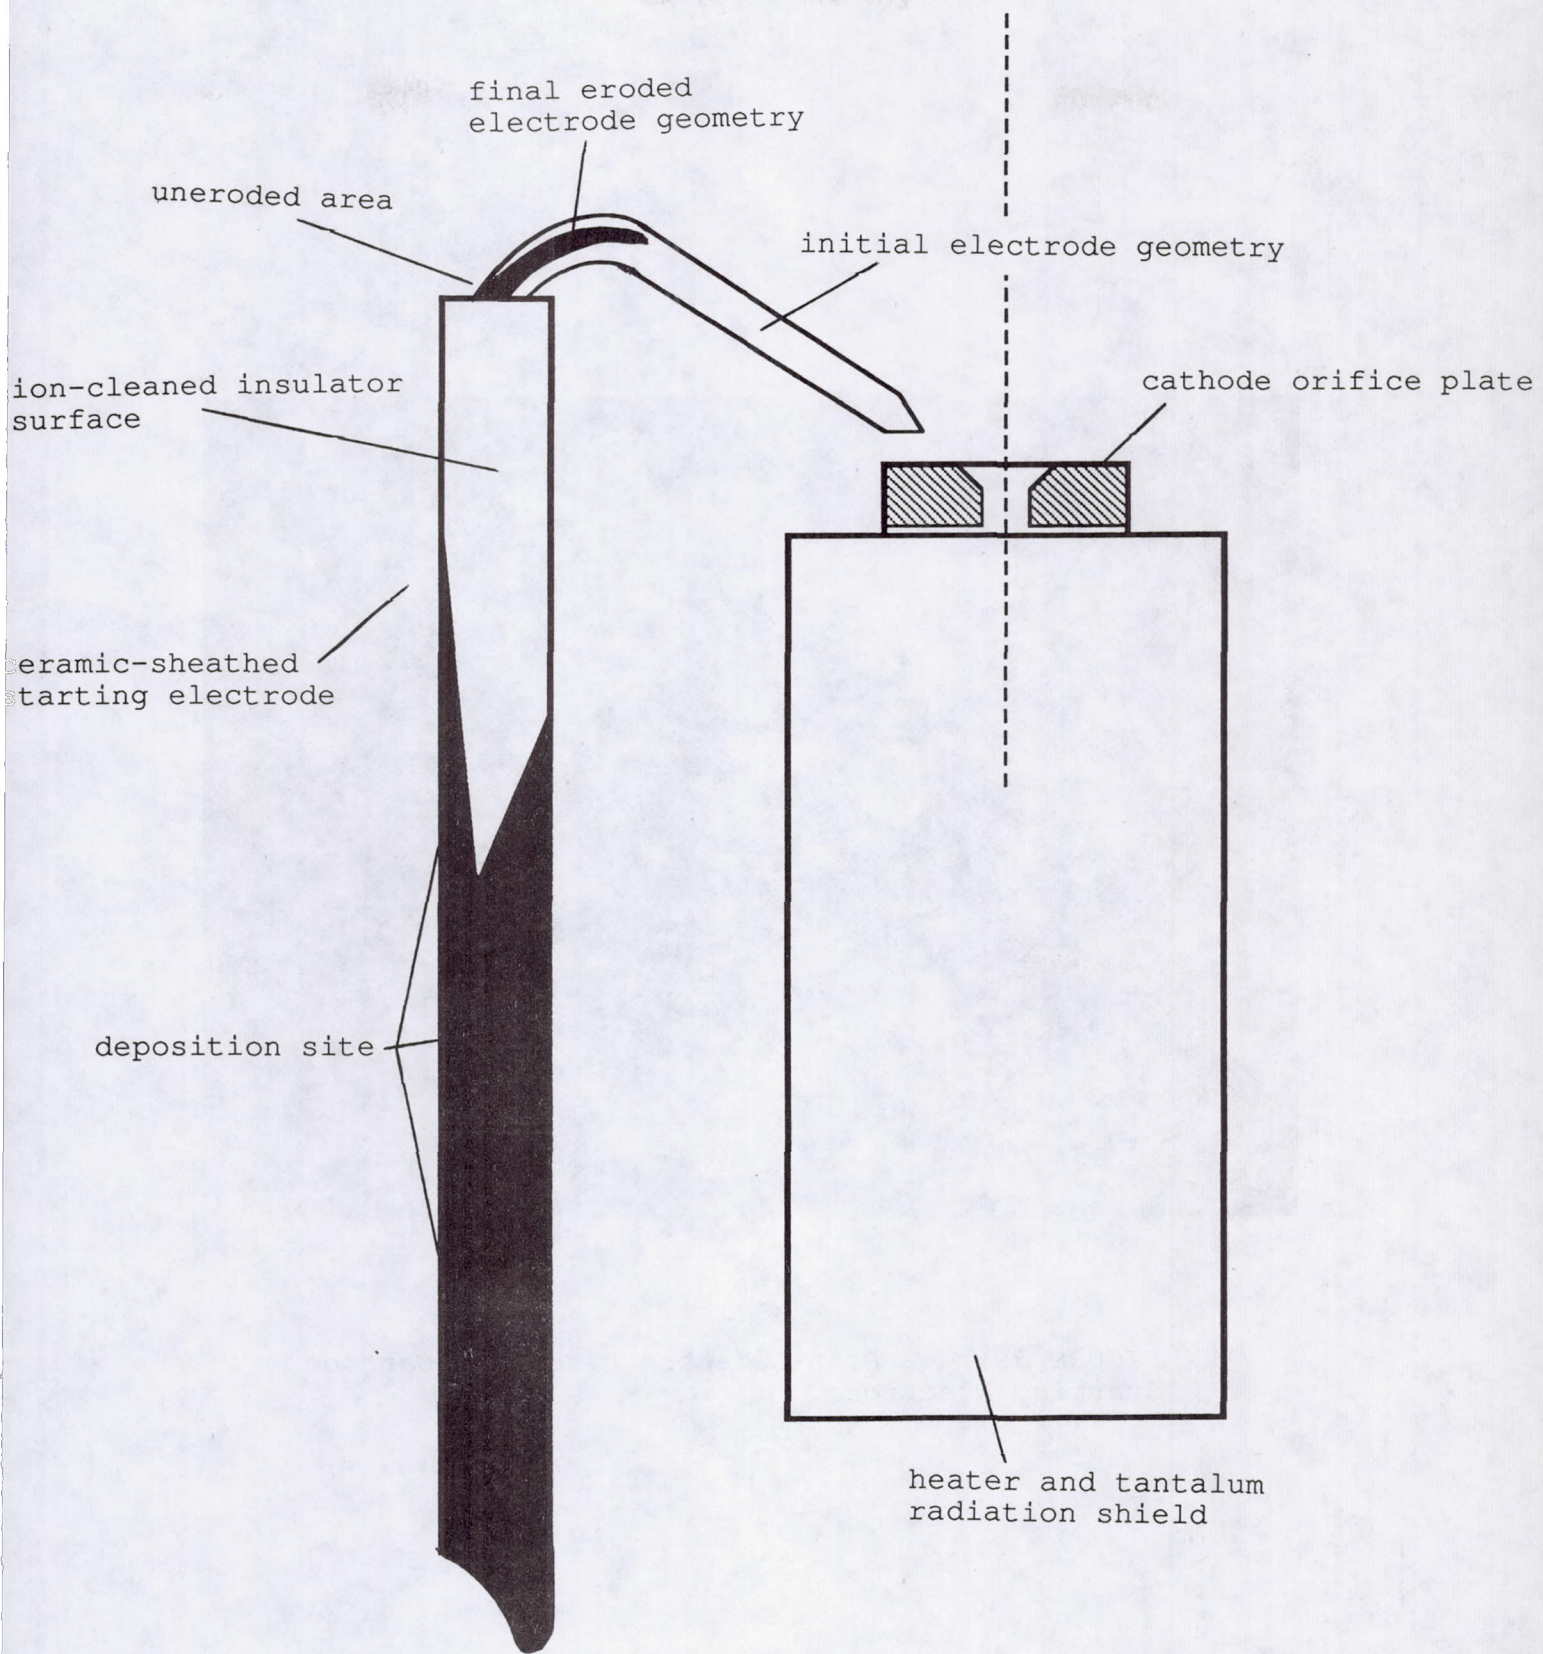
FIGURE 38. — Discharge Cathode Starting Electrode Geometry, Pre- and Post-Lifetest.

As indicated in the text, the stainless steel starting electrode suffered severe erosion over the period of the lifetest. Examination of the post-test geometry of the electrode macroscopically (Figures 38 and 39), and using SEM analysis, indicates that the erosion is due to ion sputtering. The high erosion rate indicates the presence of both a high ion current density, and high mean ion energy (greater than the cathode-to-anode potential difference). It is believed that the erosion of the electrode is such as to thin the diameter over its length. This would explain why no decrease in starting electrode length was observed during the preliminary extended-duration tests. In addition, the geometry of the ion-cleaned and sputter-deposited surfaces on the electrode insulator sheath, and the apparent preferential erosion of the electrode on the cathode-facing side, are highly suggestive of a spherical expansion of energetic ions from the region of the cathode orifice. This phenomenon (energetic ion production by a hollow cathode operating at high emission currents) may be the same as the 'jet ion' production observed and modelled by Friedly and Wilbur[12]. Their data suggest an inverse-square variation in the ion current density with axial position from the hollow cathode; this could in part explain why there was no discernable erosion of the upstream center of the screen grid over the period of the lifetest.
