NASA Technical Memorandum 103242
AIAA-90-2586

Requirements for Long-Life Operation of Inert Gas Hollow Cathodes— Preliminary Report

Timothy R. Verhey
Sverdrup Technology, Inc.
Lewis Research Center Group
Brook Park, Ohio

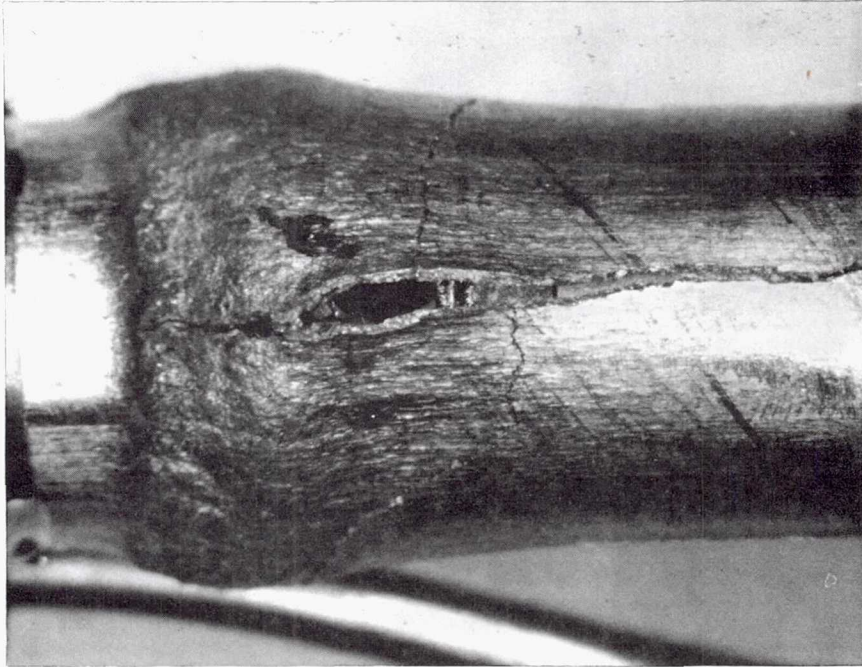
Figure 1. Examples of hollow cathode operational problems. Photo a. shows a tantalum hollow cathode tube that has swelled and cracked due to oxidation. Photo b. displays build up of anomalous material at a cathode orifice which occurred in operation.

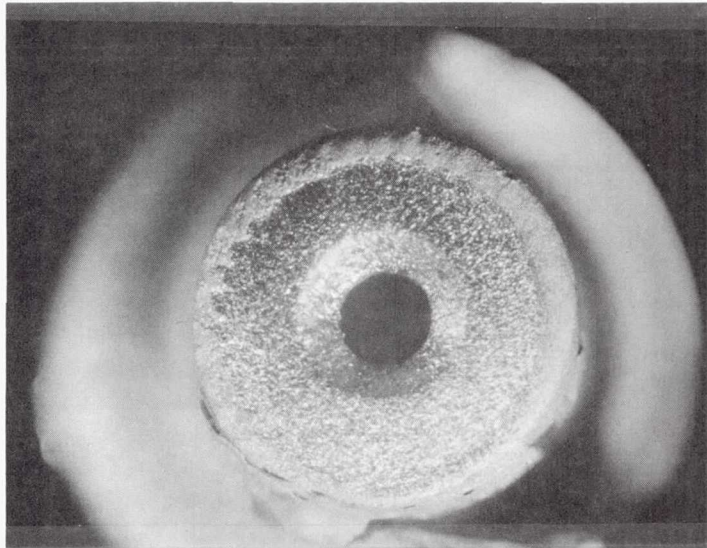
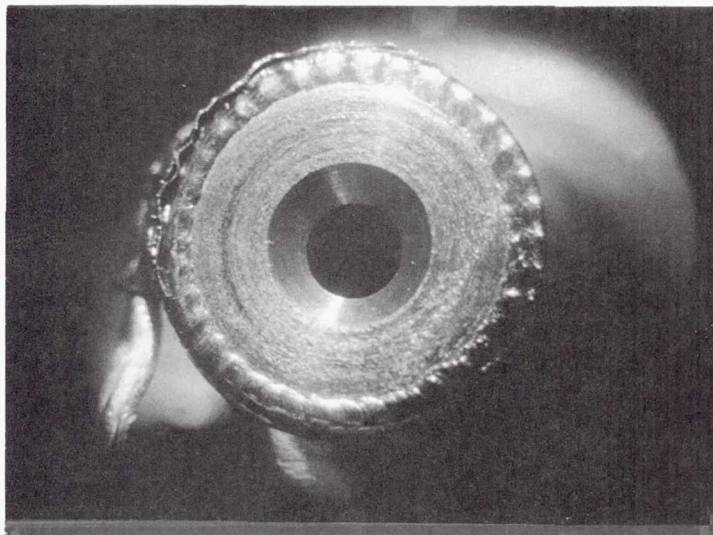
Figure 10. Condition of the hollow cathode orifce
plate. Photo a. is of a cathode orifice plate with
no operational time. Photo b. is the orfice plate
after the 500 hour weartest.

Fig. 10 shows the orifice plate before and after the test. From the figure, it can be seen that substantial texturing of the orifice plate had occurred. It was also found that, over the course of the test, the ignitor electrode had sagged and begun to intercept the cathode plume on one side. Substantial erosion of the ignitor electrode occurred, leading to deposition of the electrode material over the surfaces of the simulator chamber.

An extended wear test of a hollow cathode was conducted in the vacuum facility described. The duration of the test was 504 hours, over two segments. The emission current was set at 23.0 amps. The discharge voltage was initially 15 volts but rose continuously to approximately 21 volts by the conclusion of the test. The temperature of the hollow cathode was a relatively constant 1160 °C over the duration of the test. No component failure was experienced by the completion of the test, but texturing of the orifice plate had occurred.
