THE STRUCTURAL DYNAMICS
ANALYSIS OF THE MAIN INJECTOR
LOX INLET TEE AND ITS REDESIGN

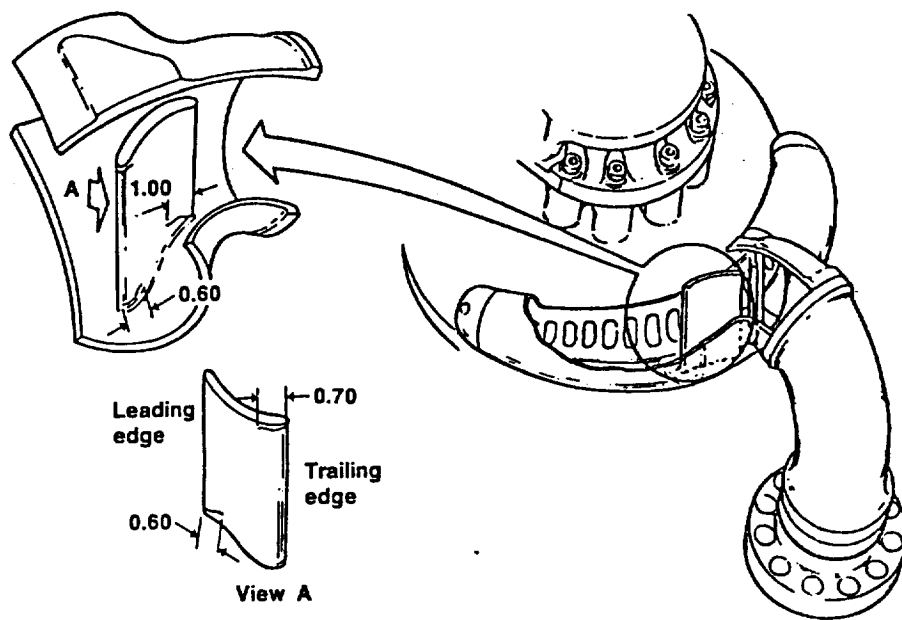
Figure 1

The 4kHz phenomenon was first observed during a ground test of an SSME which contained strain gages at the underside of the LOX inlet tee (see Figure 1). During the mainstage portion of the test, high strains were measured at the inlet tee at a frequency of about 4000 Hz. At this same time during the test, high accelerations were measured at the gimbal bearing. It was hypothesized that the splitter vanes within the inlet tee were the cause (refer to Figure 1). This was later confirmed when a downward shift in the 4kHz frequency was observed in a later test. More ground tests followed. Several tests even exceeded 104% rated power level with no change in the shifted frequency (now, at 3700 Hz). During this time, a detailed finite element model (FEM) of the splitter vanes was created to predict the location and size of a possible crack in the vanes (refer to Figure 2). It was thought that a crack in the

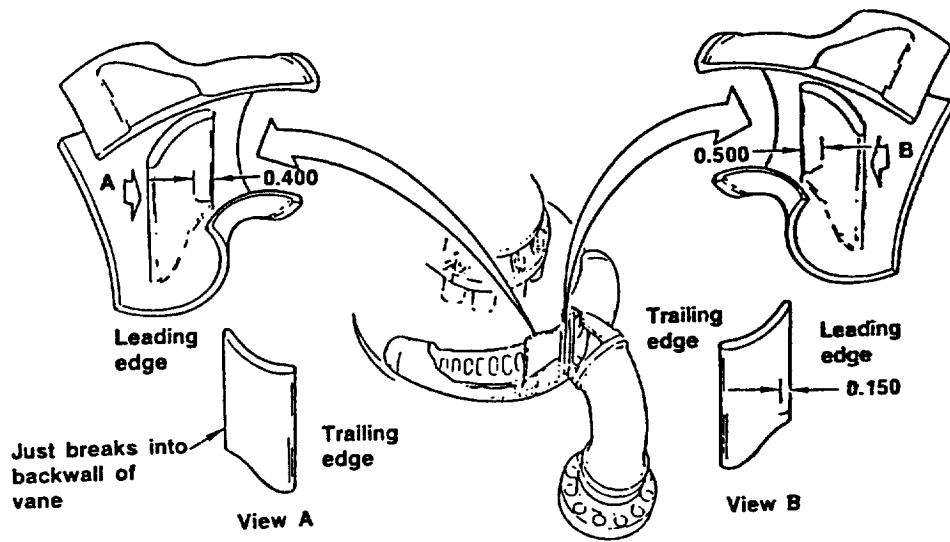
Figure 2

vanes caused the downward shift in the 4kHz frequency. The model showed that a single crack of about .8 inches long, through the vane at its lower leading edge would produce a frequency shift seen on engine test results. When the engine was disassembled, and the elbow cut to expose the vanes, cracks were indeed found on one vane. Figure 3 illustrates the crack locations and sizes. The model predicted and the inspection confirmed that the lower leading edge of the vane was particularly sensitive to cracking. This was judged by the relative size of the cracks seen in Figure 3.

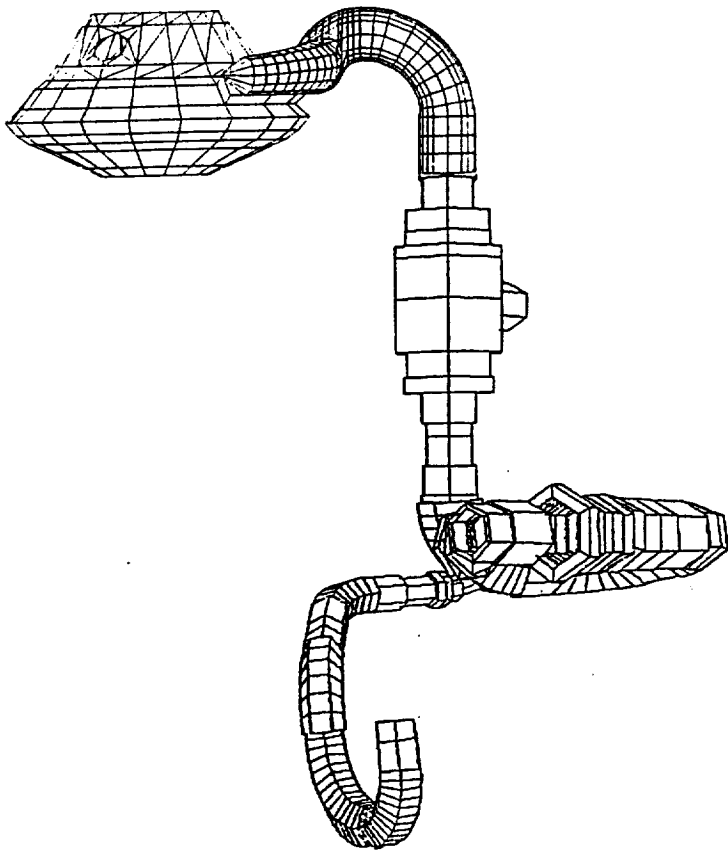
Figure 4

A second engine was also found to have exhibited the 4kHz phenomenon with a sudden downward shift in frequency. This engine was unique in that there was a double shift in the frequency. Inspections revealed that both vanes had cracks present in them with the largest located at the lower leading edges (refer to Figure 4).

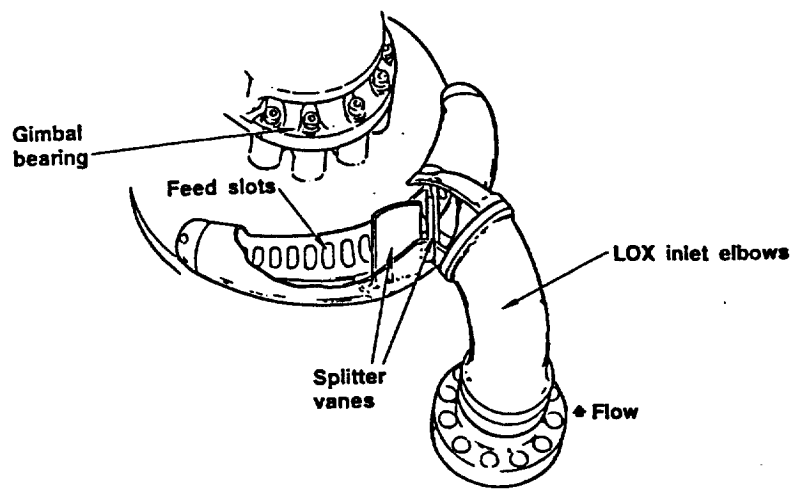
After the natural frequencies and mode shapes were calculated and their comparison to lab test results were favorable, a random vibration response analysis was initiated. A multi-base response analysis was required using the influence coefficient method of excitation. The input included POWER SPECTRAL DENSITY's (PSD's) taken from actual engine ground test data. The results showed that the highest stressed areas in the vanes were located at the lower leading and lower trailing edges. This correlates with visible inspection of the cracked areas of the vanes. A program was written which converted modal stresses to modal strains. The modal strains were used in a parallel random response analysis in order to obtain strains which were compared to measured strains from the ground tests performed earlier. Results from the comparison can be seen on TABLE C. Strain gage two (2) is the gage located directly below the splitter vanes (see Figure 1).

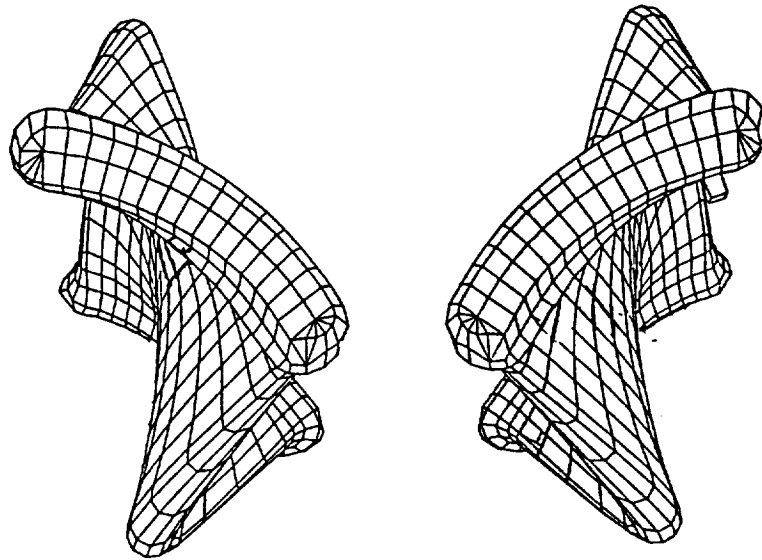
Figure 8

1)   Two dominant vane modes were found near 4kHz, a first bending
     mode of the vanes and a more dominant out-of-phase bending of
     the leading edge and trailing edge of the vanes (refer to
     Figure 8).

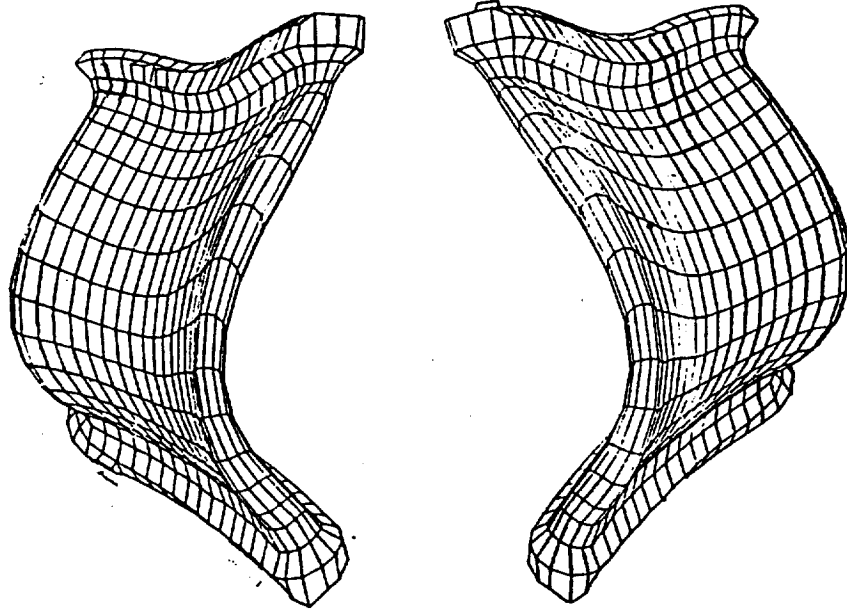
Figure 9

2)   The thrust cone fifth diametral mode, which occurred at 4kHz
     actively participated in the phenomenon by amplifying the energy
     from the splitter vanes. This increased the validity of a
     fluid-structure interaction (refer to Figure 9).
