ELECTRODE EROSION IN STEADY-STATE ELECTRIC PROPULSION ENGINES*

Thomas J. Pivirotto and W. D. Deininger

Jet Propulsion Laboratory
California Institute of Technology
Pasadena, California

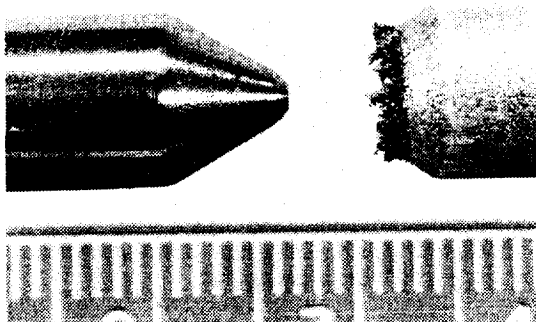
A before and after picture of the cathode tip is shown in Fig. 2. The before picture is actually a second cathode that is identical to the original shape of the test cathode. An oblique view of the test cathode is shown in Fig. 3. Notice that a crater was carved into the cathode tip and a ring of whiskers grew out from the crater rim. The net cathode mass loss over the full 573 hours was 1.95 ± 0.15 gms, for an average loss rate of 3.4 mg/hr. The net volume loss was 0.1 cm^3. Notice, from Figure 1, that the whiskers grew toward the anode and that the minimum electrode gap was 1 mm. It is surmised that at 573 hours into the test, one of those whiskers either touched the anode or got close enough to establish a high current arc between it and anode wall. The rush of current, approximately 200 A, through the whisker melted it and surface tension

Fig. 2: Picture of cathode tip before and after long duration test.

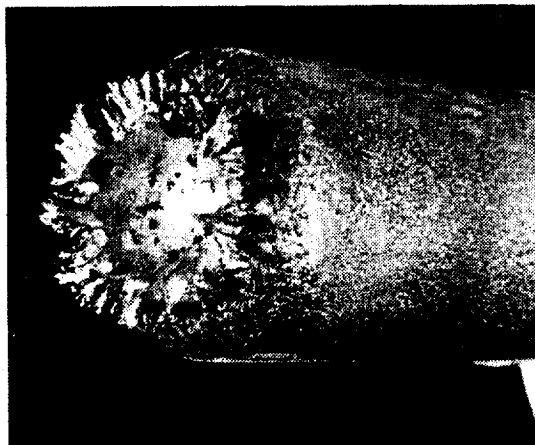
drew the molten tungsten into a ball on the cathode. Such a ball can be seen in Fig. 3 at about 4 o'clock. The DACU detected a terminal voltage of 99.9V and, since the lower tolerance limit was set at 100.0 V, it terminated the test. Based on this supposition, the controlling of whisker growth and/or providing for it in the thruster design becomes a major goal for achieving a longer operational life time. It has been suggested (Ref. 3) that the growth of cathode whiskers may be influenced by power supply ripple.

Fig. 3: Close-up picture of cathode tip after long duration test.

It is believed that the engine malfunction at 573 hours into the test was caused by the growth of whiskers on the cathode tip. It is further believed that these whiskers grew from tungsten vapor created inside the hemispherical crater and convected out

to the rim by a slow fluid flow that was pumped by an electromagnetic induced fluid pressure gradient. To alleviate this problem, it may help to machine a cavity into the cathode tip in order to reduce the amount of vapor available for whisker growth. It has also been suggested that the growth of whiskers may be influenced by ripple in the arc voltage/current. If so, a ripple-free power supply may be what is needed.

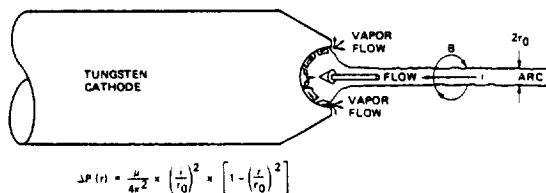
the cathode tip and centered on the arc centerline. This flow would stagnate on the cathode tip and then flow radially outward over the cathode emitting surface, resulting in the transport of tungsten vapor from the molten emitting surface to the rim of the crater where recrystallization, in the form of whiskers, may have occurred. This concept, shown schematically in Fig. 5, is based on the following considerations. The result of the interaction between the axial arc current and its own azimuthal magnetic field is an inward-directed radial body force. To balance this body force, a radial pressure gradient is set up such that the gas pressure on centerline is higher than the ambient pressure. This pressure difference, $\Delta P(r)$, is taken from Ref. 5 and is given by:

Fig. 5: Proposed cause of cathode tip cratering.

Here, μ is the permeability, i is the total arc current, r_0 the local arc radius and r the radial space variable. The pressure on the arc centerline, relative to ambient, is obtained by setting $r = 0$. The observed arc radius was about 0.75 mm; hence, for a current of 200 A, ΔP was about 18 mm Hg. As is shown in Figure 5, the arc radius must bulge out near the cathode since, due to thermionic emission considerations, the cathode surface area required to feed the arc was much larger (41 mm^2) than the 1.8 mm^2 arc cross-sectional-area. Because of this bulging out, to approximately a radius of 2.5 mm, ΔP, near the cathode surface was reduced to about 2 mm Hg, resulting in an axial pressure gradient of about 32 mm Hg/cm, assuming the ambient pressure was constant. It was this axial gradient that may have driven a flow of very hot gas toward the cathode surface and it then would have convected the tungsten

vapors radially out along the emitting surface, resulting in the deep, symmetric cavity. Additionally, as the arc radius bulges out, an axially directed electromagnetic body force component would have developed, further enhancing the flow of hot gas toward the cathode tip. This additional flow would have turned radially outward along the cathode emitting surface, because of symmetry, and would have added to the convection of tungsten vapor toward the crater rim. These vapors are presumably convected out to the rim of the crater where, apparently, the temperature is low enough to promote epitaxial growth of the whiskers from the tungsten vapor.

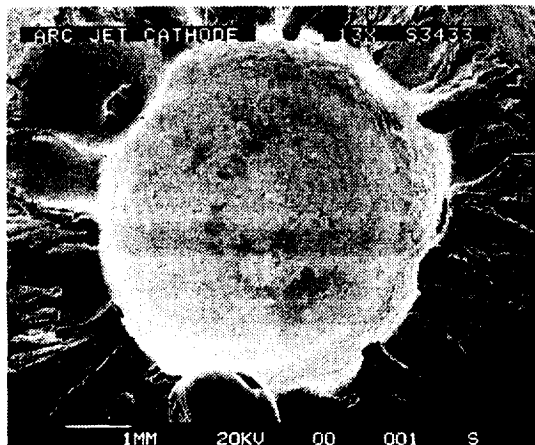
As is also shown in Fig. 5, the arc root is connected to the cathode surface through a multitude of dancing micro-arcs since the gas conductivity near the surface is severely limited by the gas temperature which must be in near equilibrium with the surface temperature. The surface temperature can't, on average, be much different from the melting temperature of tungsten (3400°C). Because of the low conductivity the current must be carried across this layer by high current density micro-arcs. Fig. 6 is a head-on view of the cavity and shows that over 90%

Fig. 6: SEM picture of cathode emission surface.

of the cavity surface is covered with pits caused by the micro-arcs. These individual micro-spots can be more clearly seen in Fig. 7. The spot diameter appears to be about 10 μm and is surrounded by splashed tungsten, clearly indicating the presence of molten tungsten. The reason for these spots dancing over the electrode surface is discussed in Ref. 6. Using data from Ref. 7, at the melting point the tungsten vapor pressure is 17 mtorr, the evaporation rate is 2.28 x 10^{-4} gm/cm^2-sec and the thermionic emission is 479 A/cm^2. Ignoring the tungsten redeposited as whiskers and taking the total loss as 1.95 gms and the total run time as

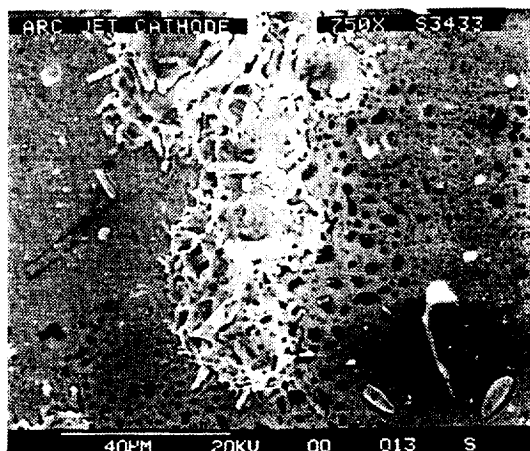
Fig. 7: SEM picture of arc micro spots.

573 hours, we get an average vaporization rate of 9.5 x 10^{-7} gm/sec. Dividing this by the arc current results in a tungsten loss of 4.3 x 10^{-3} μg/coulomb. This result should be compared with the measured loss of 3 x 10^{-2} μg/c and the calculated loss of 10^{-2} μg/c found in Ref. 6. The pressure at the cathode tip was probably higher in the current experiment than it was in Ref. 6 and that may be the reason for the reduced loss.

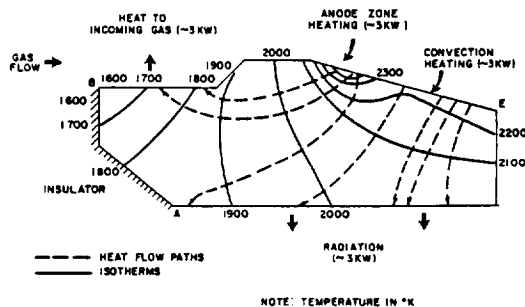
Fig. 8: Results of calculations of heat flow and isotherms in nozzle block.

The anode/nozzle of a 30-kW class radiation-cooled arcjet must be allowed to operate at elevated temperatures in order to directly dissipate the engine waste heat. This waste heat amounts to about 10% of the total engine power (Ref. 8). An attempt was made to calculate the heat transfer path and resulting isotherms, through the nozzle, in Ref. 8. The results of these calculations are shown in Fig. 8. Note

that the maximum temperature is at the anode arc root and that it can be as high as 2500 K. The rest of the nozzle inner surface is between 2200 and 2300 K and the constrictor is at 2000 K. The outer surface temperature of the arcjet engine shown in Fig. 1 was measured at a point one cm aft of the exit plane with an IR radiometer. The results of this measurement are shown in Fig. 9. The measurement shows a temperature of 2050°C whereas the calculation of Ref. 8 gives 2050°K or 1777°C, a difference which could be because the model used hydrogen as propellant

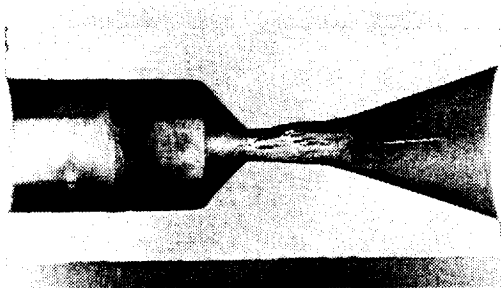
After completion of the long duration test and subsequent attempt at a restart the anode-nozzle was sectioned and the less damaged half was ground flat and smooth. A picture of this half is shown in Fig. 10. The lower contour of the constrictor

Fig. 10: Sectioned anode block after 573 hours of accumulated run time.

was undamaged and clearly shows the erosion pattern caused by the long duration test. This contour was carefully measured and the results plotted on a large scale and compared with the original pre-test shape. As can be seen in Fig. 10, the erosion starts at about 1 mm into the constrictor. The constrictor radius then starts increasing at an ever-increasing rate for the next 6.5 mm, is then constant at 3.0

mm for the next 4.0 mm and then slowly blends into the 19° half-angle cone. The erosion ends about 4 mm into the expansion nozzle. By performing a graphic integration on the data, the amount of tungsten eroded was determined to be 0.071 cm^3 or 1.37 gms. A careful inspection of the nozzle contour part of this plot indicates that the eroded material may have been deposited on the nozzle wall starting about 11 mm from the exit plane. The thickness of this deposited layer increased linearly and reached about 0.2 mm at the exit plane. The volume and mass of this layer was calculated to be 0.075 cm^3 and 1.45 g. Note that these determinations are at best an estimate since they involve very small changes in radius, 0.5 mm for the constrictor and 0.2 mm, maximum, for the nozzle. This result suggests that most of the material, evaporated from the constrictor wall, flowed downstream in the laminar boundary layer and redeposited on the cooler downstream wall of the expansion nozzle and also that there is little net mass loss due to normal operation.

By weighing the nozzle before and after the long-duration test, and subsequent damage, a net loss of 2.4 g was found. This loss must have occurred, primarily, when the constrictor was damaged during the attempted restart. This damage can be seen as a pit in the constrictor wall in Fig. 10. Note, in Fig. 10, that the pit appears to start on a crack in the tungsten wall. That pit may have occurred early in the restart, when the nozzle was still relatively cold. Note also that the plenum chamber walls, though stained, were not affected by the long test duration. The machining marks are still visible on the 50° half angle cone wall.

These results suggest that the anode/nozzle suffered no damage that was directly due to the arc during normal operation. However, due to the high operating temperatures, most of the constrictor wall and the sharp corner between constrictor and expansion nozzle did evaporate at the rate of approximately 6.6 x 10^{-7} g/s or 3.0 x 10 $^{-3}$ µg/c. Also, using a Scanning Electron Microscope, the walls of the nozzle where the arc was expected to terminate was studied. No unusual effects could be seen except for a greater depletion of thorium from the area.

The downstream portion of the constrictor was eroded, probably by evaporation at high temperature. This area of the anode could be better cooled by increasing the radiating surface emissivity, by regeneratively cooling and/or by applying heat pipes to this area.
