NASA TM-86512

DEVELOPMENT AND TEST OF ADVANCED COMPOSITE COMPONENTS

Center Director's Discretionary Fund Program

June 1985

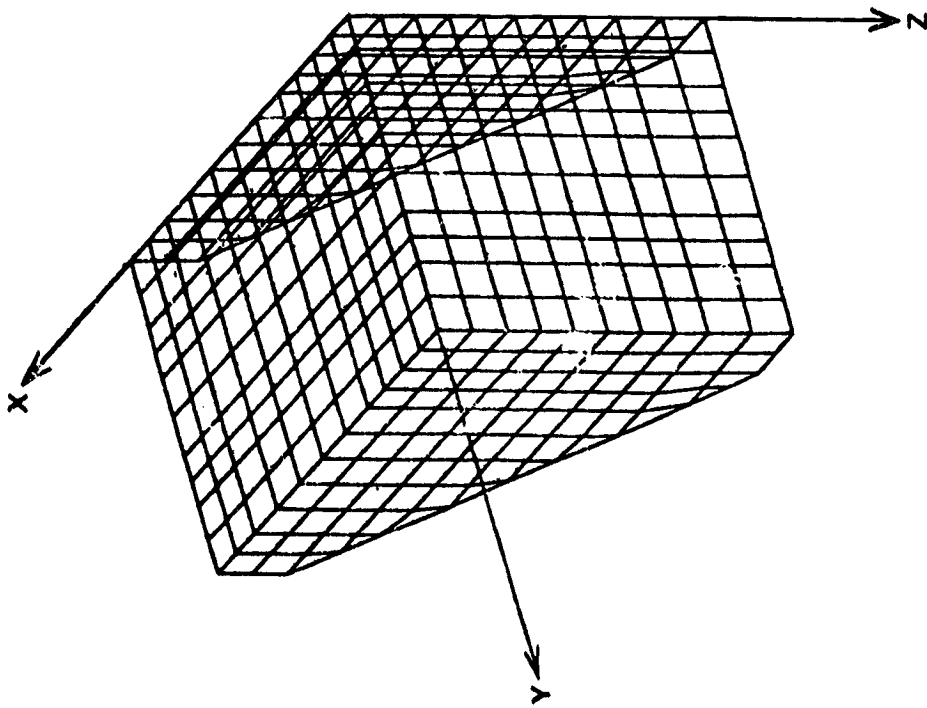
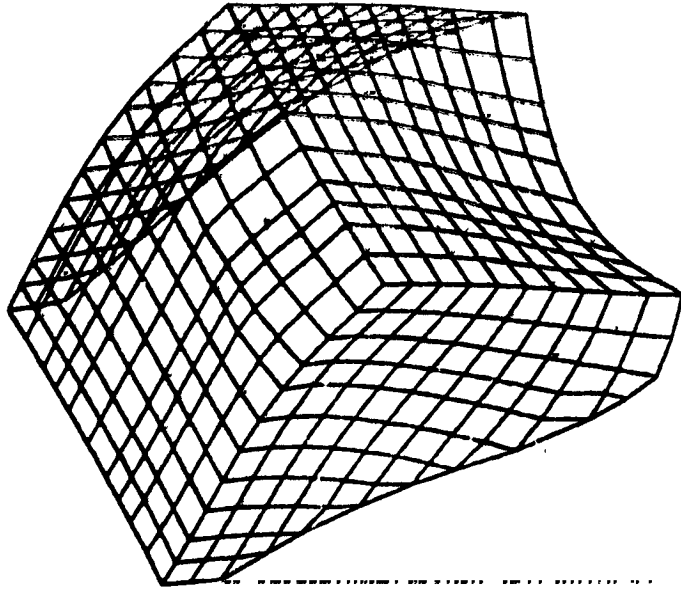
Figure 7. Bathtub fitting finite element model.

The finite element method and classical lamination theory were used to perform the analysis. A finite element program (SPAR) was used in an uncoupled format to calculate laminate in-plane force resultants (N_x, N_y, N_{xy}) and moment resultants (M_x, M_y, M_{xy}). These were then input into a laminate point stress analysis program (SQ5) to calculate surface strains, which were compared with test strain gage data. The finite element model is present in Figure 7.

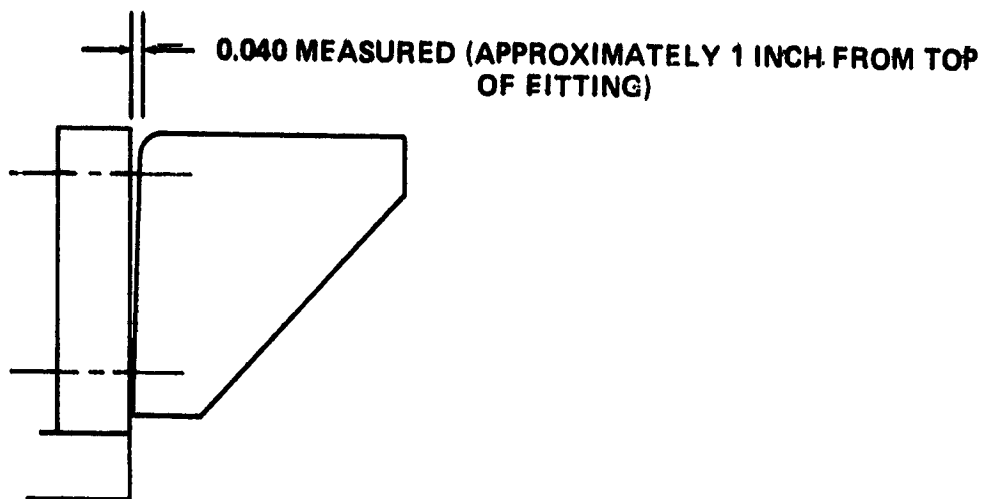
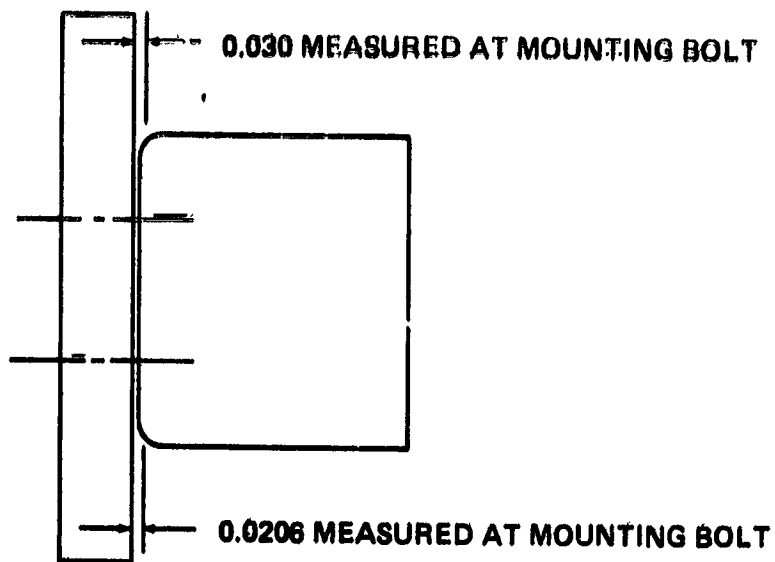
Figure 10.   Bathtub fitting mounting anomaly for Specimen 27M10003 SN1.

The test specimen, 27M10003 SN-1 did not have fillet inserts. When the specimen was installed into the test fixture, there were gaps between the specimen and the test fixture. The procedure used for attaching the specimen was as follows: the two lower bolts were torqued first, then the two top bolts. After torquing, the gaps between the specimen and the mounting surface were measured. Figure 10 illustrates the condition that existed.

0.030 MEASURED AT MOUNTING BOLT

0.0206 MEASURED AT MOUNTING BOLT

0.040 MEASURED (APPROXIMATELY 1 INCH FROM TOP
OF FITTING)

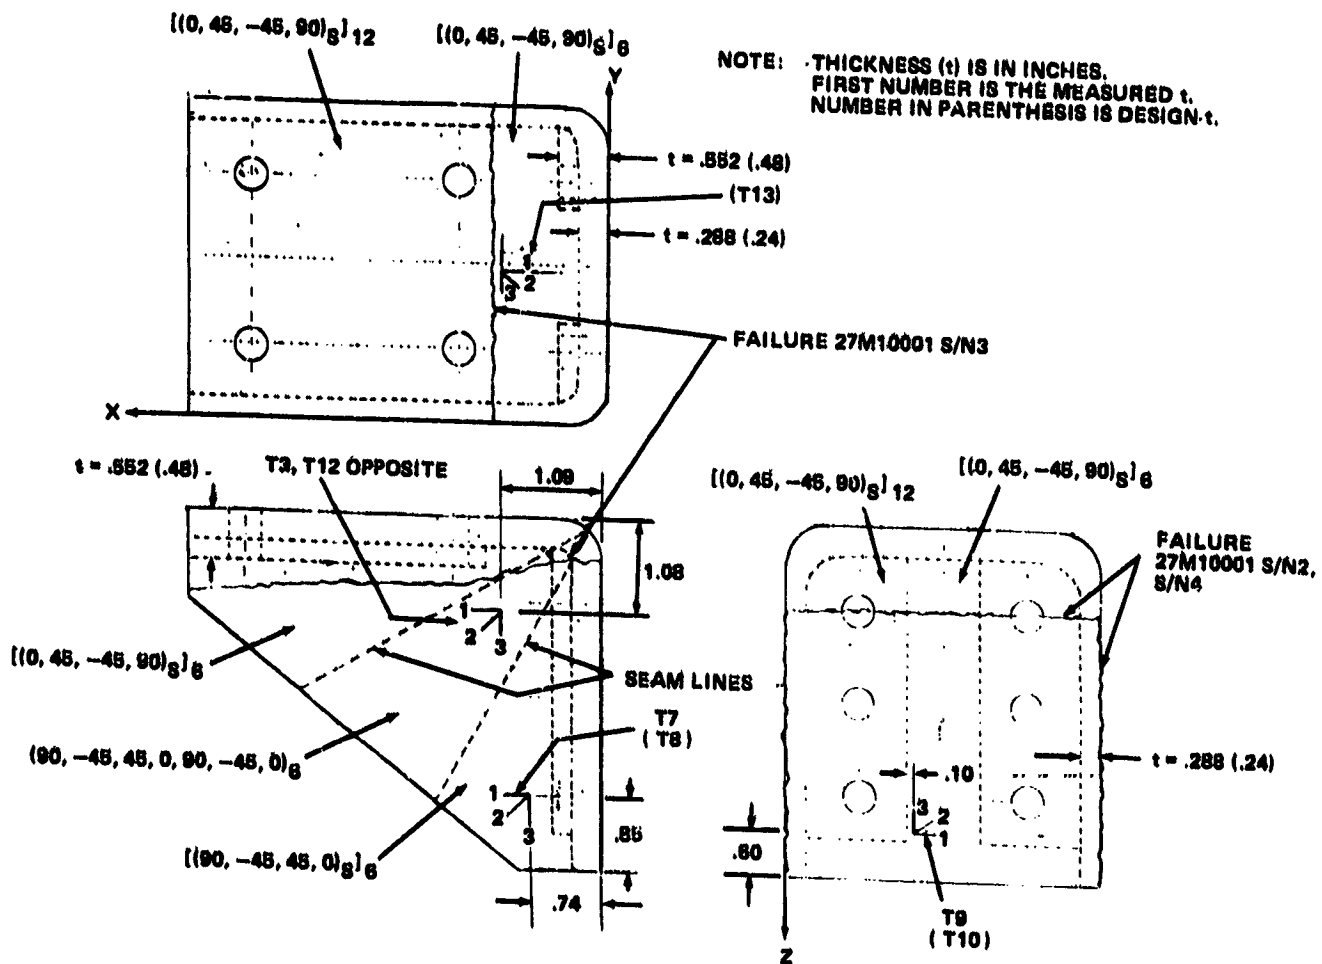
Figure 11. Strain gage and failure locations.

There was a problem with the kapton backing used for the first test, S/N 3, and 66 percent of the 82 channels did not provide data suitable for evaluation purposes. Kapton was not used on any of the following tests, and the number of channels was reduced to 39 for S/N2 and S/N4. Channels 1T13 and 3T13 were lost on S/N2, and channel 1T13 was lost on S/N4. Also, other strain gage locations were not optimal. They were located either too close to free edges or too close to the seams of the laminate layup. Data for three of these locations are presented in Tables 6 through 8. Location of these strain gages is presented on Figure 11. On the remaining fittings, it was decided to reduce the number of channels to 9 (3 rossettes) and to place the strain gages in locations where failures occurred.

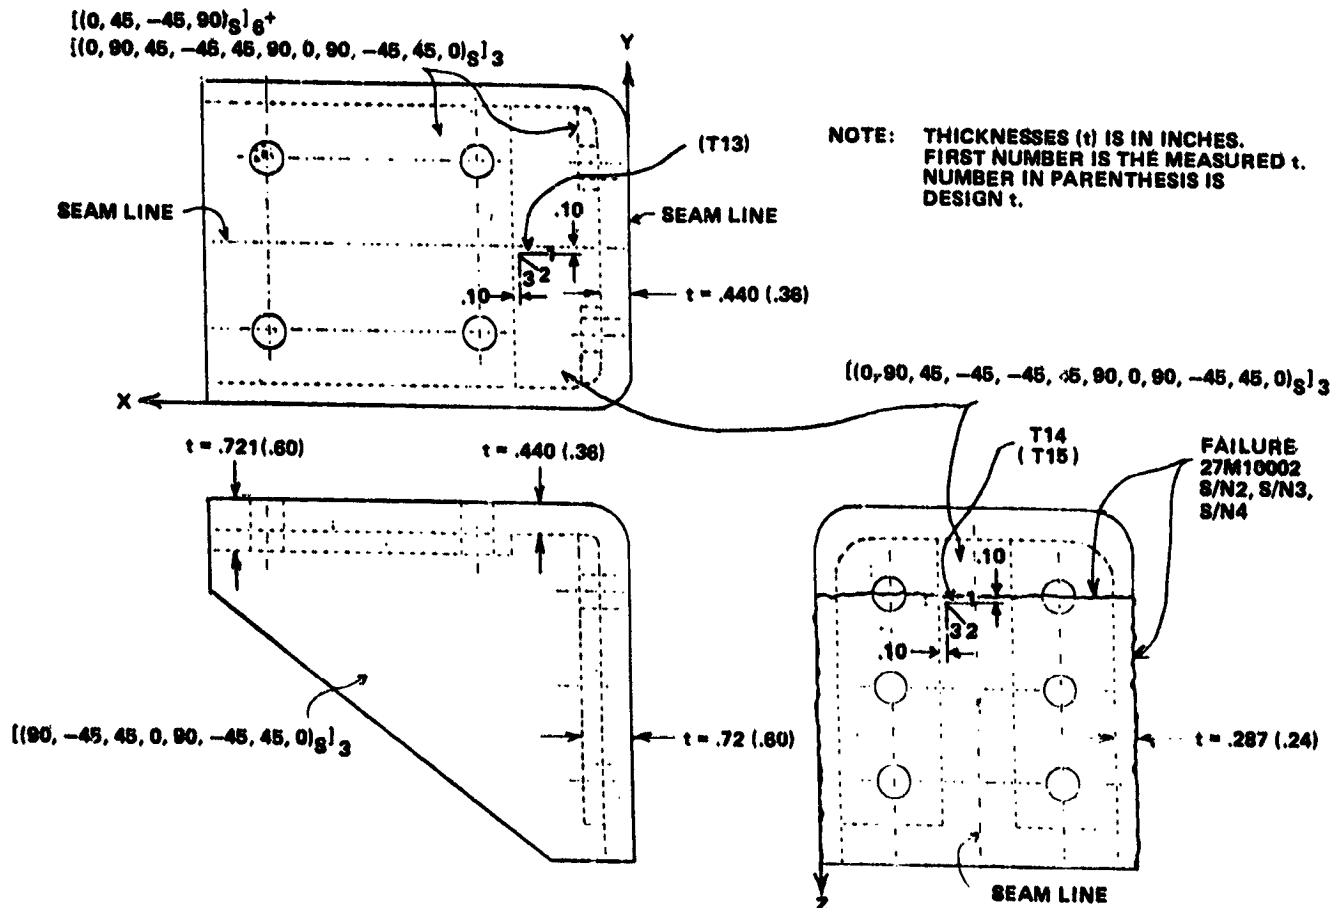
Figure 12. Strain gage and failure locations.

Tables 9 through 11 present strain gage test data. Tables 12 and 13 present comparison of test and analytical results. Locations of strain gages are presented on Figure 12. The three fittings failed across the bolt holes on the x-face at an average load of 4321 lb. This was the highest average failure load of all four test configurations.

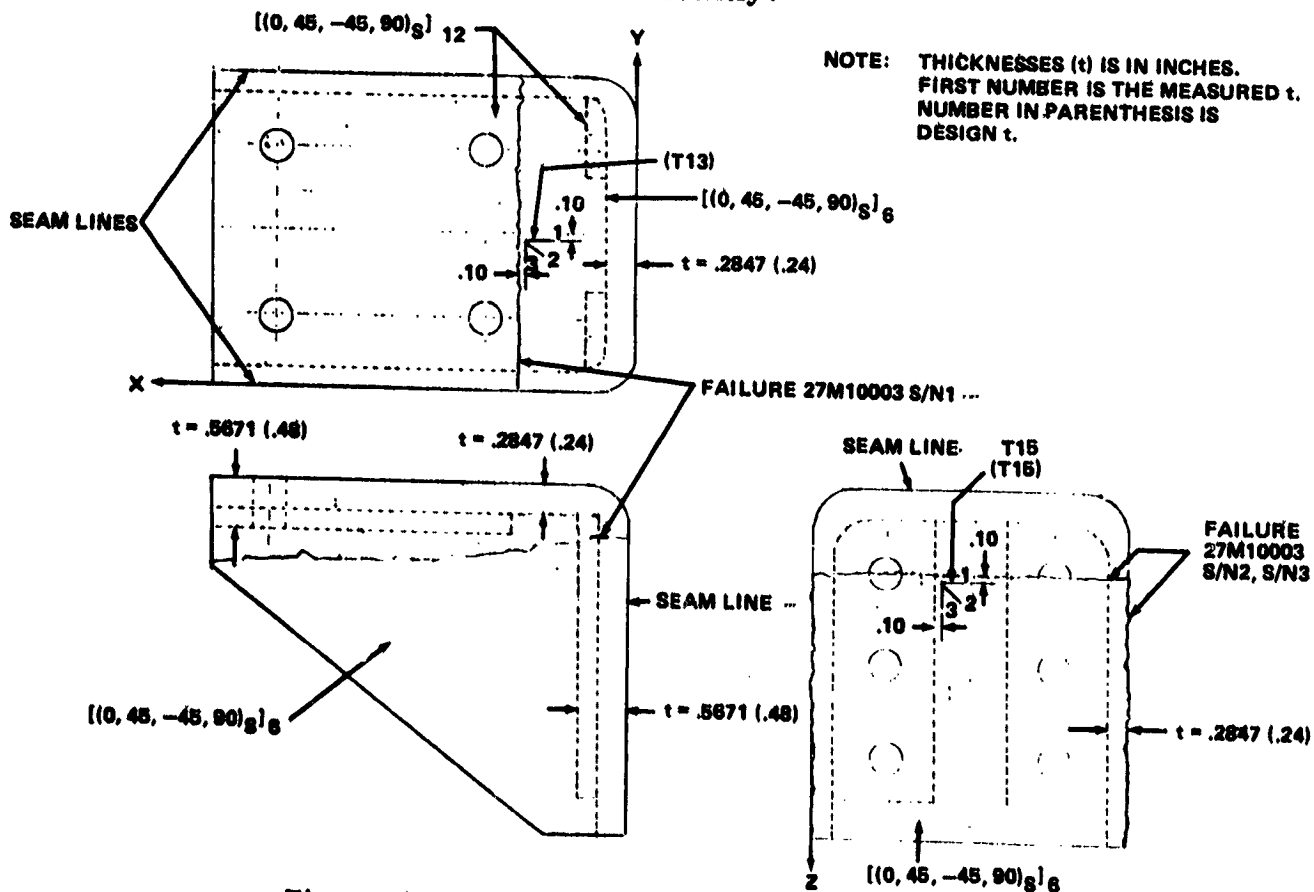
Figure 13. Strain gage and failure locations.

Tables 14 through 16 present strain gage test data. Tables 17 and 18 present comparison of test and analytical results. Locations of strain gages are presented on Figure 13. S/N2 and S/N3 failed across the bolt holes on the x-face at an average load of 3463 lb. S/N1 was not retrofitted with a radius insert and failed across the bolt holes and stiffener on the z-face at a load of 2229 lb.

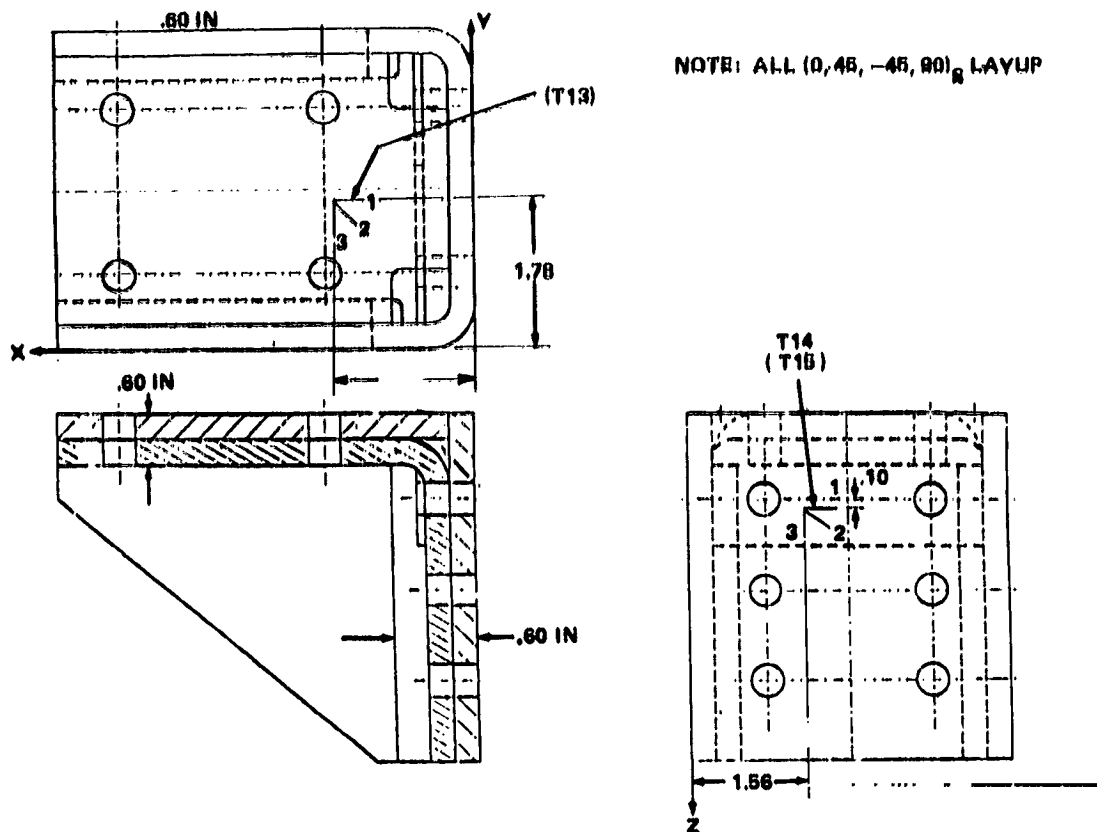
Figure 14.   Strain gage locations.

Tables 19 through 21 present strain gage test data. Tables 22 and 23 present comparison of test and analytical results. Locations of strain gages are presented on Figure 14. The fittings were made by bonding three laminated pieces together with Hysol EA-934. The two fittings failed along the bond lines at an average load of 3126 lb. Hysol EA-934 has an ultimate shear strength of 3100 psi. However, based on the bonding area of the sides (y-face) alone, the bond failed at 143 psi.

27M10009 failed at the lowest load even though it was the thickest of all four designs. Bonding three sections together with Hysol EA-934 was not a good design. However, this could also have resulted from faulty fabrication.

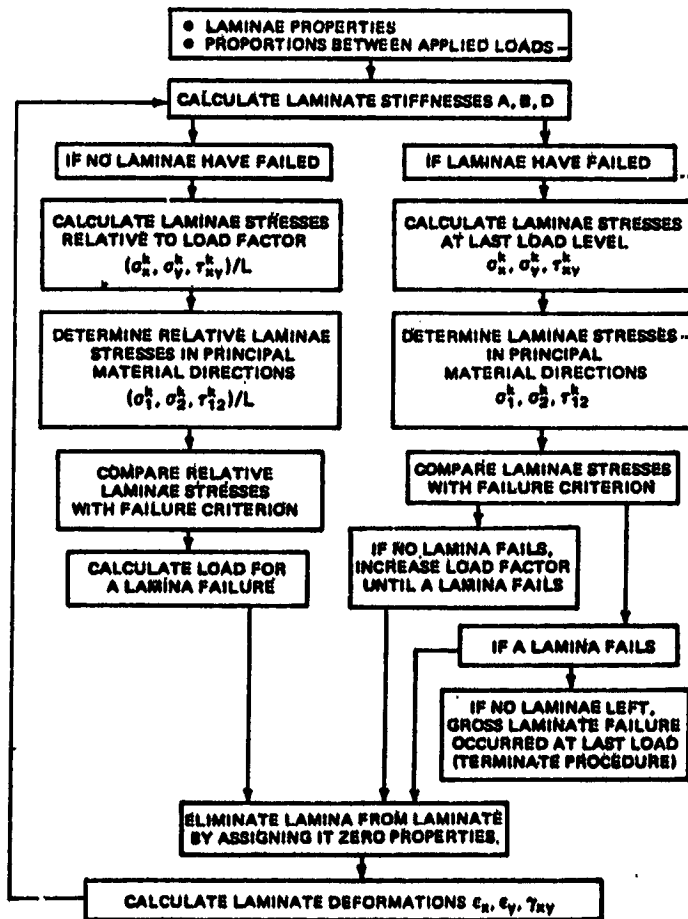
Figure 15. Progressive failure analysis.

EP42 does not have the analysis capability to redistribute loads if one or more lamina fails prior to gross failure of the laminate. Both SPAR and SQ5 perform linear analysis. The overall behavior of the laminate is nonlinear if one or more lamina fails prior to gross laminate failure. To perform adequate analysis, a 3-D finite element program that performs progressive failure analysis is required. Such a progressive failure analysis is presented in Figure 15.
