Mechanism of Strength Degradation for Hot Corrosion of α-SiC

James L. Smialek and Nathan S. Jacobson
Lewis Research Center
Cleveland, Ohio

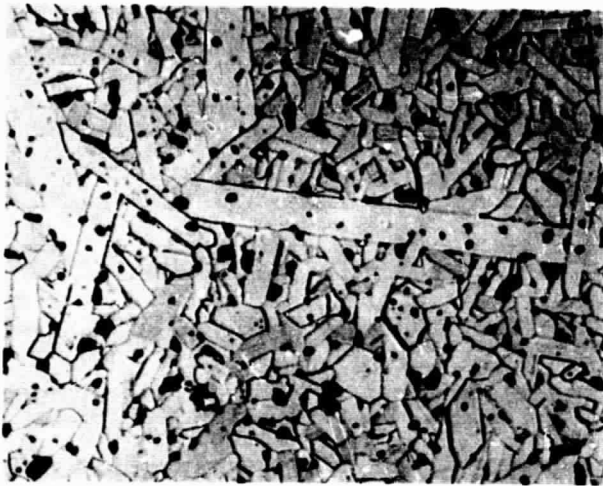
The material used in this study was injection molded and sintered α-SiC[*] which was doped with boron and carbon. The microstructure of this ceramic, shown in Fig. 1(a), consists basically of equiaxed ~10 μm grains and lenticular grains with an aspect ratio of about 10 to 1. A dispersion of porosity and inclusions, which were previously found to be titanium and 3 percent free carbon, is also evident.[14] Test specimens 0.25 by 0.5 by 2.5 cm were cut from 5.0 cm long as-received bars and ground on 45 and 15 μm diamond wheels. The microstructure after grinding, Fig. 1(b), indicates that surface damage (pullout) was on the order of 10 μm. This surface finish is believed to be more than adequate to produce fracture strength values which are not controlled by surface grinding flaws. The basis for this conclusion lies in a previous study which found no strength increases for Si_3N_4 when polished to a degree finer than 600 grit (i.e., ~15 μm surface finish).[15]

(a) Lenticular and equiaxed grains in a polished and etched sample (optical).

Figure 1. - Microstructure of as-recieved α-SiC.

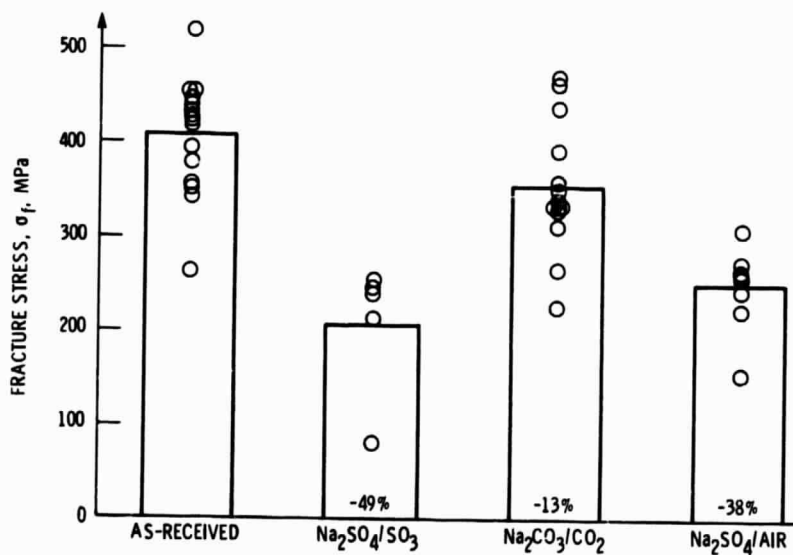
The average flexural strength (modulus of rupture, MOR) of the corroded samples is shown in Fig. 2 along with the values for the as-received material. All the samples were tested in the 15 μm diamond polished condition. The individual data points have also been plotted to give a realistic picture of the spread in the MOR data and the overlap between treatments. The most severe strength degradation (49 percent) occurred in the case of Na_2SO_4/SO_3, followed by 38 percent for Na_2SO_4/Air, and 13 percent for Na_2CO_3/CO_2. The as-received strength value of 409 MPa compares reasonably well with published values for this material of 335, 365, and 425 MPa.[16-18]

Figure 2. - Effect of 1000 °C/48 hr hot corrosion on 4-pt bend strength of α-SiC; samples ground to 15μm finish before strength test.

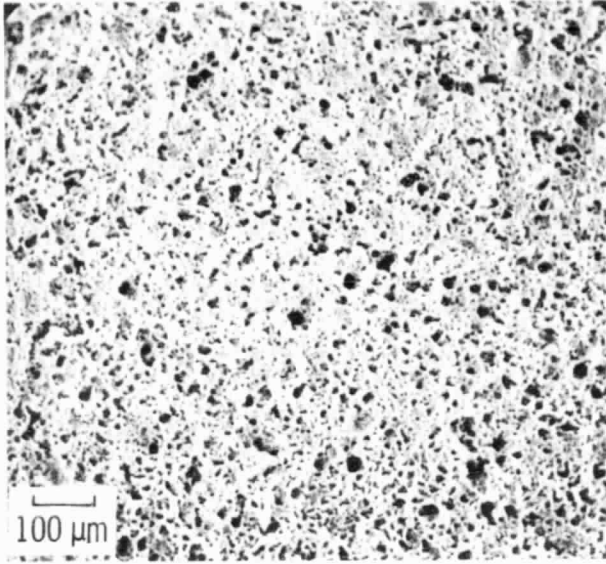
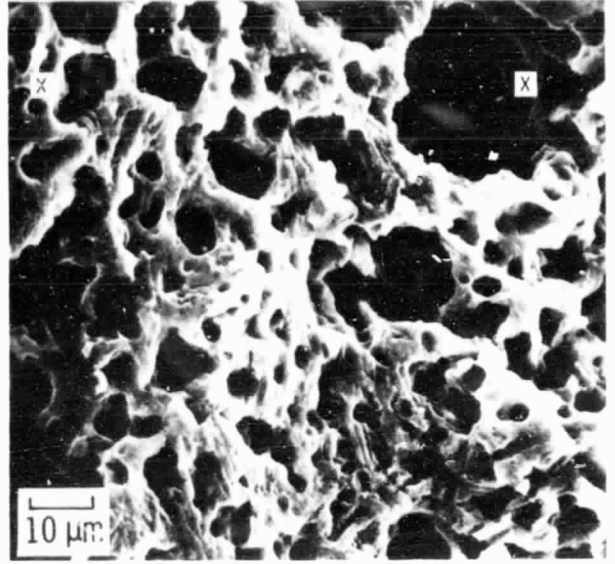
Although the amount of corrosion product was up to twenty times that of simple oxidation (table II), this could still not account for enough uniform surface recession to cause this degree of strength reduction. The explanation lies in the morphology of the corrosion attack rather than in the amount. From the previous study it had been concluded that the principal mechanism of attack was through pitting.[14] This effect is shown in Fig. 3 for Na_2SO_4/SO_3 (acidic) corrosion. Here the widespread uniform pitting of a severe nature is readily apparent after the scale had been removed by the HF treatment.[**] Some measure of the severity of the pitting attack was obtained from stereopair measurements across the trace designated as X-X in Fig. 3(b). This profile shown in Fig. 4 indicates a pit depth of at least 70 μm, with deeper pitting suggested but not resolvable from the micrographs.

(a) Uniform pitting observed over large areas.

(b) Detail of (a) showing honeycomb pit structure.

Figure 3. - Pitting attack morphology after Na_2SO_4/SO_3 corrosion (scale removed by HF dissolution).

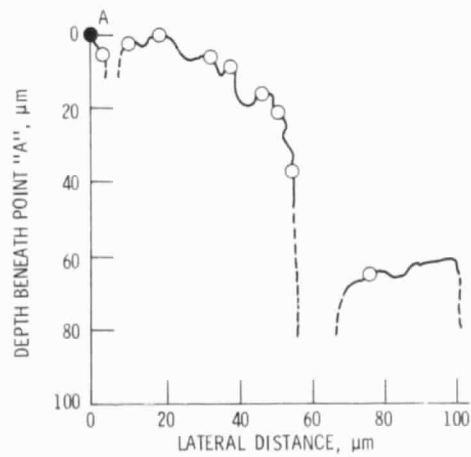
Figure 4. - Pit depth profile obtained across
the trace X-X (Fig. 3(b)) by stereopair
measurements.

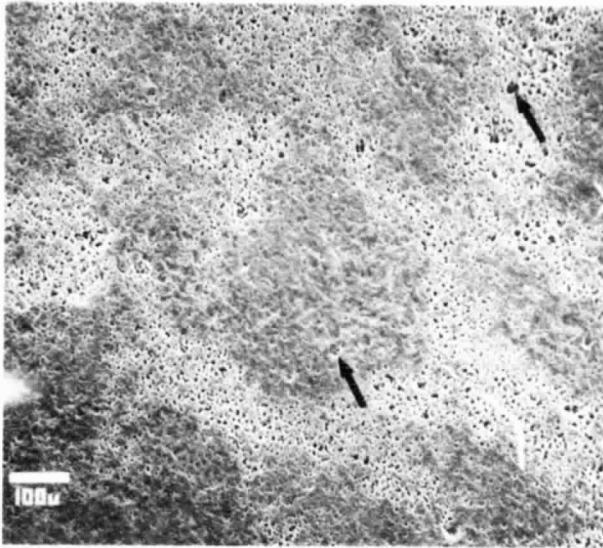
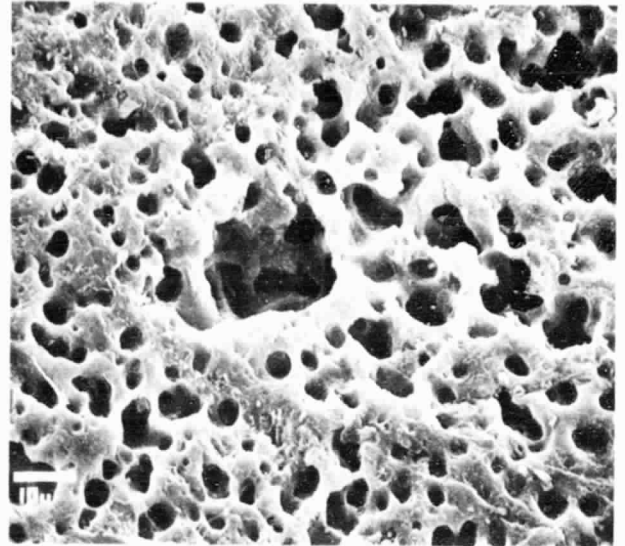
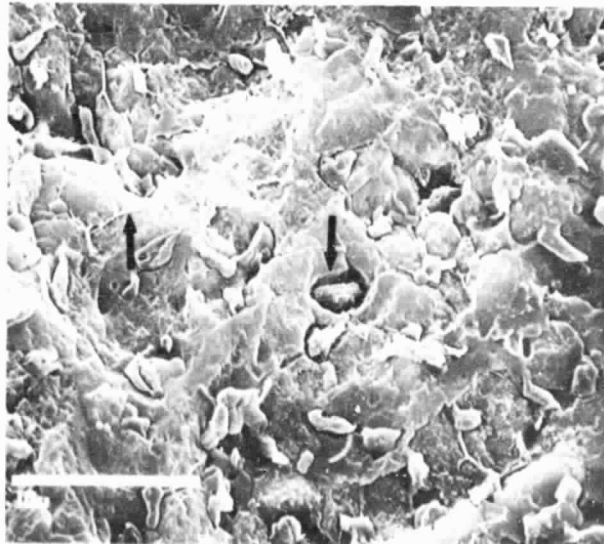
The SiC morphology after Na_2CO_3/CO_2 (basic) corrosion and scale dissolution in HF is shown in Fig. 5. Figure 5(a) shows a coarse cellular network of corrosion pits which is nonuniformly distributed over the sample surface. The pits comprising these cell boundaries (Fig. 5(b)) exhibit the honeycomb structure similar to the Na_2SO_4/SO_3 case. The region at the center of the cells, however, is quite flat by comparison (Fig. 5(c)). These areas also exhibit ~0.1 μm grain boundary films and partially consumed particles (arrows). Both of these features are believed to be excess carbon (graphite), as found in previous studies by windowless SEM/EDS, electron microprobe, and STEM/EELS.[14,19]

(a) Nonuniform cellular network of pits.

(b) Honeycomb pit structure in a cell boundary.

(c) Grain boundary films, inclusions, and absence of pitting in center of
cells.

Figure 5. - Pitting attack morphology after Na_2CO_3/CO_2 corrosion (scale removed by HF dissolution).

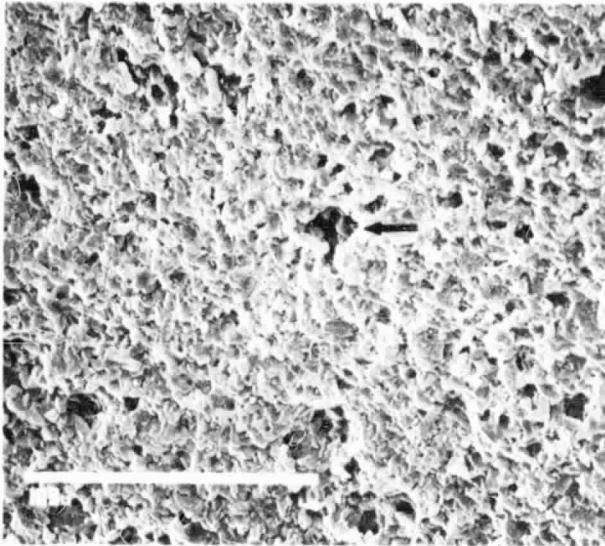
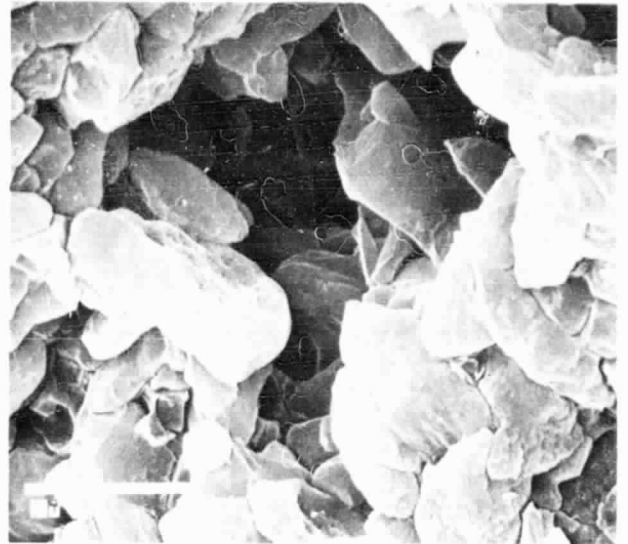
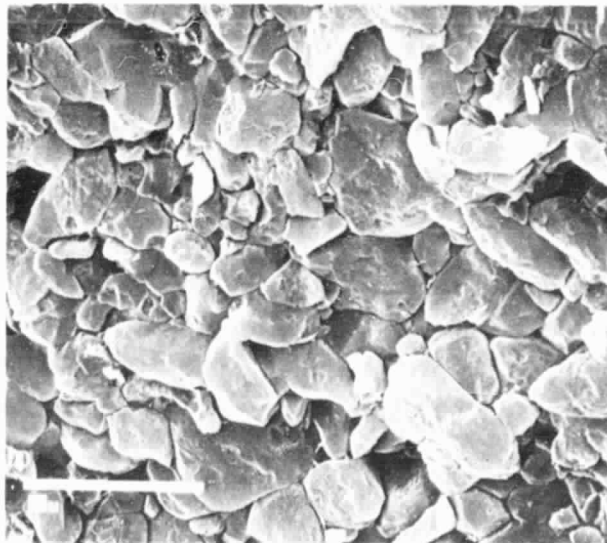
The Na_2SO_4/Air treatment can neither be classified as acidic or basic because its SO_3 equilibrium pressure is undefined.[14] However it was chosen for study because it produces attack morphologies and product chemistries similar to those obtained in a burner rig study, which is a closer approximation to the environment of a gas turbine.[20] This attack morphology shown in Fig. 6 is somewhat similar to that for the Na_2CO_3/CO_2 case in that considerable nonuniformity in the degree of surface pitting was produced. Although no distinct cell patterns were observed on this sample, some areas showed deeper pits, (arrow in Fig. 6(a)). This pit had a very granular nature (Fig. 6(b)) as did the surrounding areas even though they were quite flat (Fig. 6(c)). Other samples were found to have the thin (~0.1 μm) grain boundary films identical to those found in the Na_2CO_3/CO_2 case.

(a) Nonuniform distribution of pits.

(b) Honeycomb pit structure in deeply pitted region.

(c) Granular appearance in nonpitted region.

Figure 6. - Pitting attack morphology after Na_2SO_4/Air corrosion (scale removed by HF dissolution).

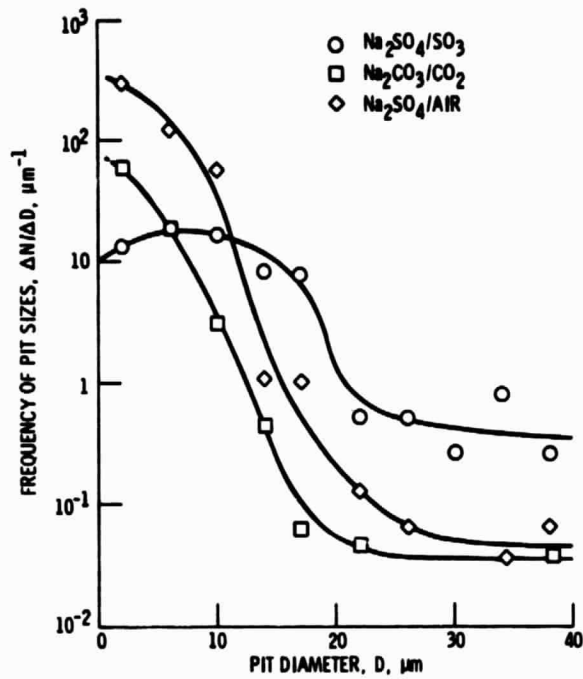
It is clear from the last three figures that the attack morphology can vary considerably depending on the corrosion conditions. One feature believed to be crucial in determining the degree of strength degradation is the size of the pit and the frequency of occurrence of pits of a given size. An attempt to quantify such a description of the attack morphology is shown in Fig. 7. These curves (histograms) were obtained by measuring the diameters of all the pits observed in a total area of ~0.1 mm^2. This data was arranged in order

Figure 7. - Histograms of pit diameters for various corrosion conditions, (0.1 mm² sampling area; pit diameter interval ΔD = 4μm).

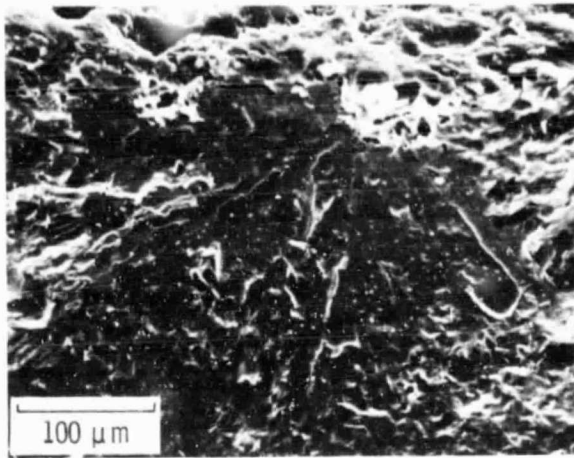
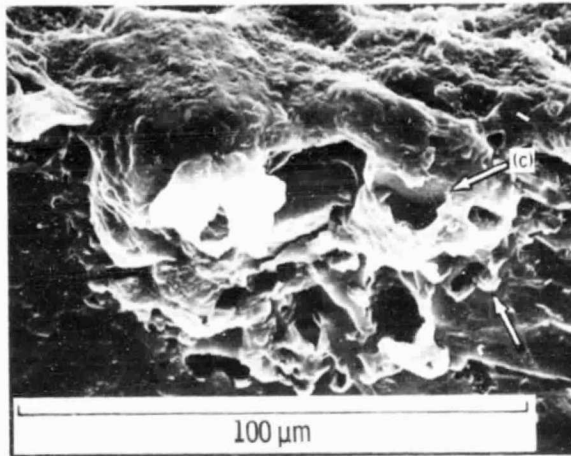
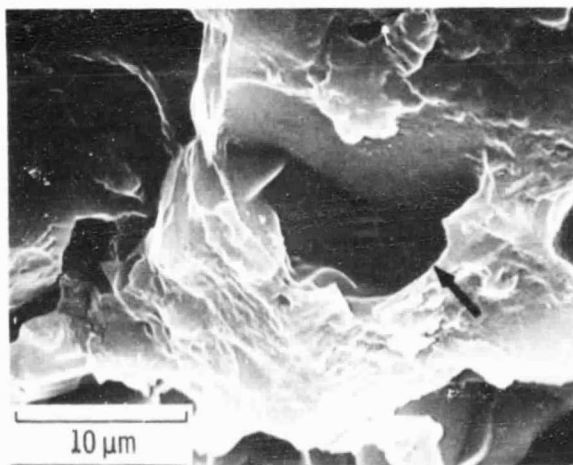
Often the fracture sections exhibited optically reflective mirror-like regions which contained directional fracture lines pointing to the fracture origin at the tensile surface. It is believed that these reflective regions are large, plate-like SiC grains (as in Fig. 1(a)) which cleaved transgranularly. Such features had been observed previously in fracture sections of the same material and were occasionally found to be failure origins as well.[21] In many instances these mirrors existed near the fracture origin and crack lines within the mirror eminated radially from the origin. An example is shown in Fig. 8(a) for a Na_2SO_4/SO_3 sample whose scale was polished to a 15 μm finish before fracture. The flaw was indeed a corrosion pit still filled with oxide (Fig. 8(b)) which contained numerous pores. A rim of porosity in the SiC also existed near the periphery of the pit as indicated by the arrows. The smooth internal surfaces of the scale porosity, Fig. 8(c), was consistent with the previous observation of gas evolution and bubbles entrapped in the scale.

(a) Radial fracture lines in mirror pointing to pit.

(b) Corrosion pit filled with oxide.

(c) Detail of bubble in scale.

Figure 8. - Corrosion pit fracture origin after Na_2SO_4/SO_3 corrosion (scale polished to 15μm finished before fracture; σ_f = 81 MPa, pit depth = 56μm).

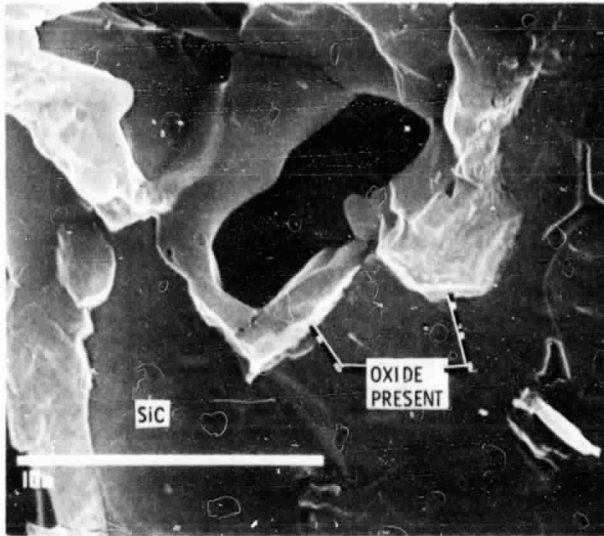
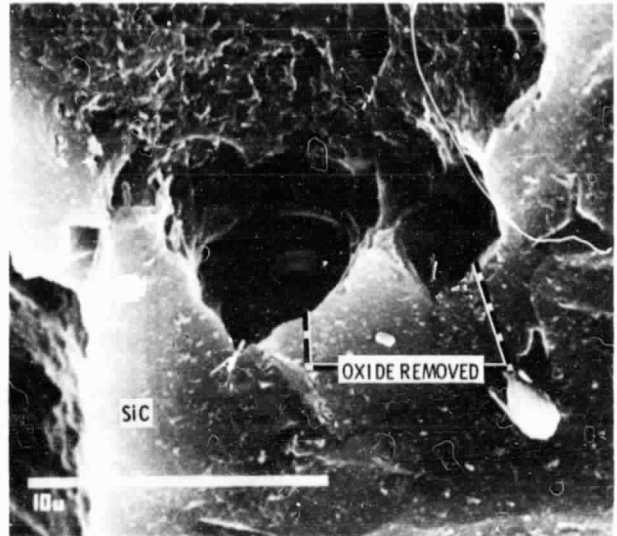
The material in the fracture origin was conclusively identified as oxide by electron microprobe oxygen mapping. However the resolution of this technique was not high enough to identify the exact scale-SiC interface. This was accomplished by HF dissolution of the corrosion products and reexamination, as shown in Fig. 9 (detail of the right edge of the pit in Fig. 8(b) before and after dissolution). It can readily be seen that the brighter regions in relief of Fig. 9(a) were part of the scale and that the cavity here was a gas bubble in the scale which formed only a few micrometers from the interface. Thus bubble formation is likely to play a key role in the pitting mechanism. The SiC in contact with the oxide showed a very rough surface texture after scale removal (Fig. 9(b)).

(a) As-fractured.

(b) After scale in pit removed by HF dissolution.

Figure 9. - Bubble formation at the scale-SiC interface (from Fig. 8).

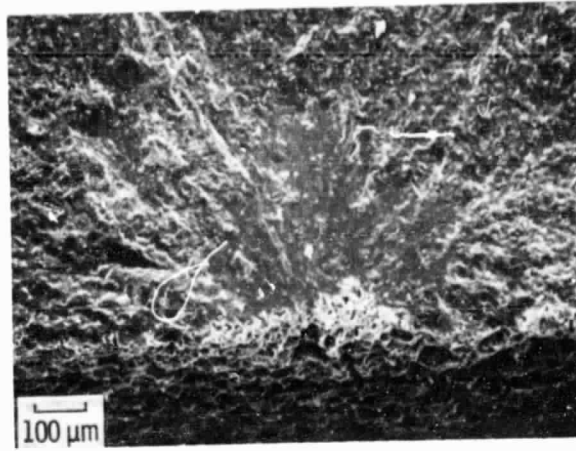
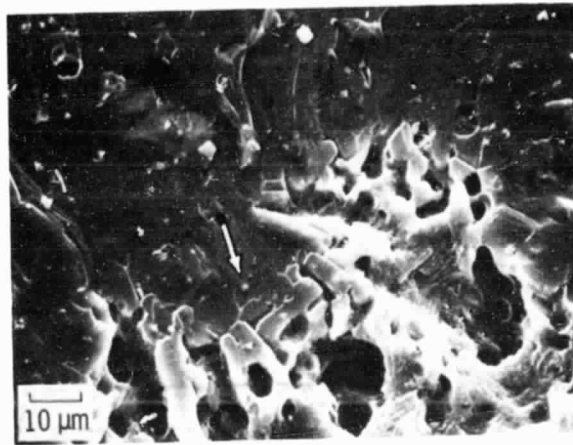
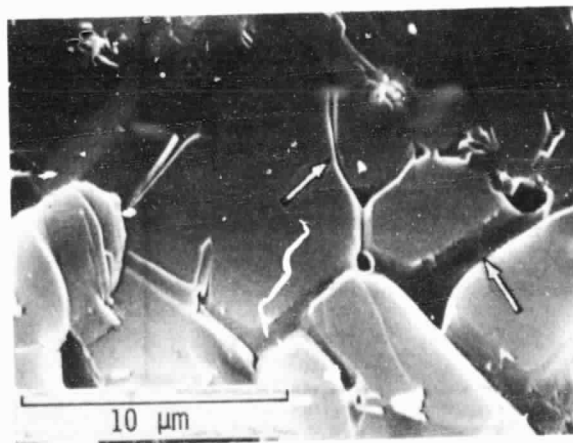
The fractographs of a Na_2SO_4/SO_3 treated sample whose scale had been removed by HF dissolution are shown in Fig. 10. Again radial crack lines were found to eminate from the origin (Fig. 10(a)). At higher magnification, (Fig. 10(b)) the familiar honeycomb pit structure was observed at the fracture origin, proving again that a corrosion pit initiated failure. The details of the corrosion front (arrow in Fig. 10(b)) is shown in Fig. 10(c). Connected intergranular porosity can be seen to form ~10 μm ahead of the pit. This implies that selective oxidation/corrosion of the grain boundaries is another important factor in the overall pitting mechanism. In this case the pit depth including the grain boundary attack region was found to be ~133 μm.

(a) Radial crack lines pointing to origin.

(b) Honeycomb corrosion pit at origin.

(c) Preferential grain boundary attack ahead of pit (arrow in (b)).

Figure 10. - Corrosion pit fracture origin after Na_2SO_4/SO_3 corrosion (scale removed by HF dissolution; σ_f = 190 MPa, pit depth = 133 μm).

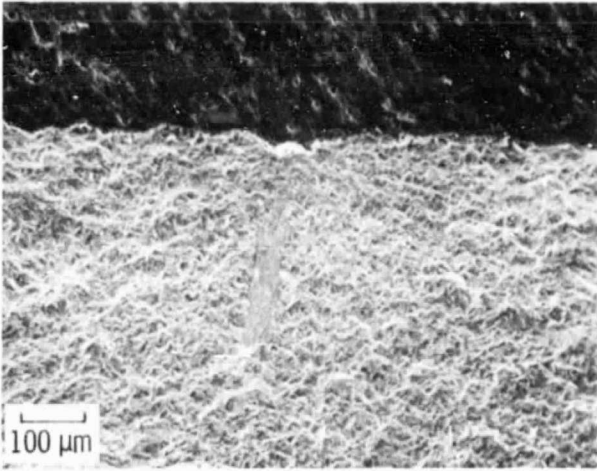
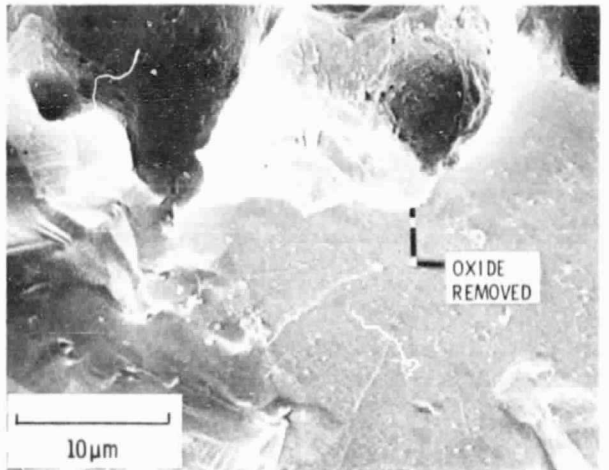
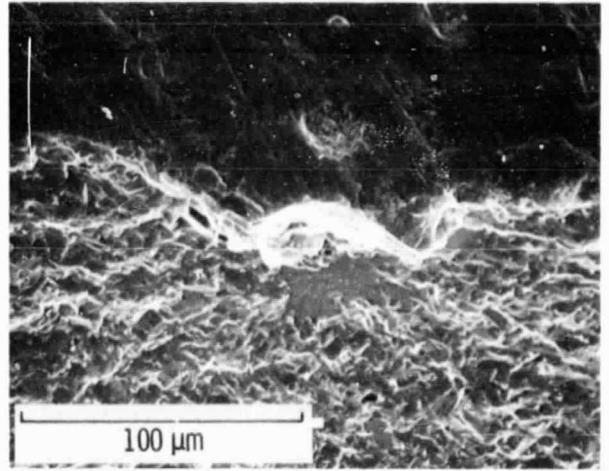
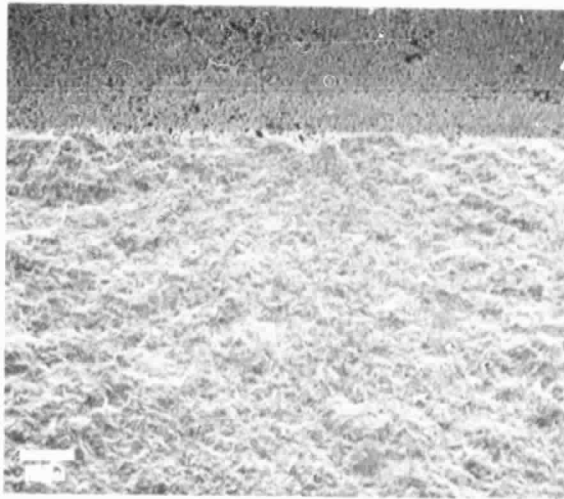
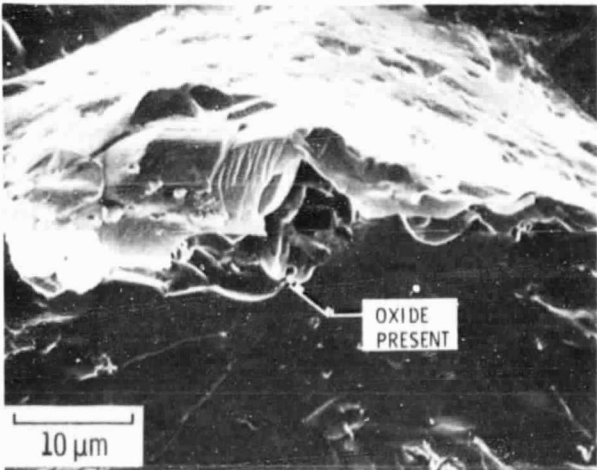
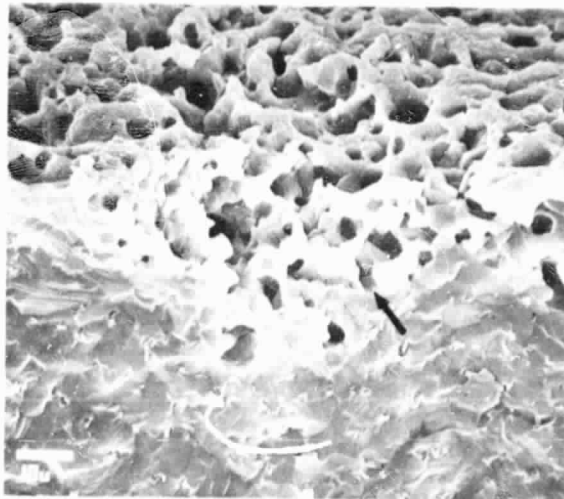
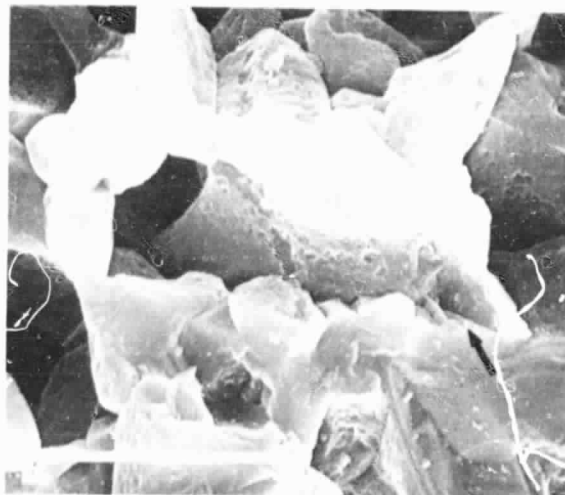
Fractured specimens previously corroded in Na_2CO_3/CO_2 also exhibited corrosion pits as the common failure origin. An example of such a pit is shown in Fig. 11. A small flat mirror-like feature was located at the origin; within this feature and beyond were radial crack lines having the corrosion pit as the focal point (Figs. 11(a) and (b)). The top (tensile) surface of the specimen shows a number of ~20 μm entrapped bubbles which had been exposed by the polishing treatment. The scale-SiC interface shown in Fig. 11(c) exhibited a smaller amount of porosity than the Na_2SO_4/SO_3 samples. The position of the exact interface (arrows in Figs. 11(c) and (d)) was determined by removing the scale through HF dissolution. This treatment revealed the pocked-marked structure typical of the cell boundary pitted regions of the corroded surfaces (Fig. 5(b)). It should also be pointed out that the interface is much smoother and the pit much shallower (~45 μm) than those observed for Na_2SO_4/SO_3 corrosion. No indication of deep gain boundary attack was found.

(a) Radial crack lines pointing to origin.

(b) Residual scale overhang at fracture origin.

(c) Detail of scale-SiC interface of pit.

(d) Same as (c) after scale removed by HF.

Figure 11. - Corrosion pit fracture origin after Na_2CO_3/CO_2 corrosion (scale polished to 15μm finished before fracture; $_f$ = 334 MPa, pit depth = 45μm).

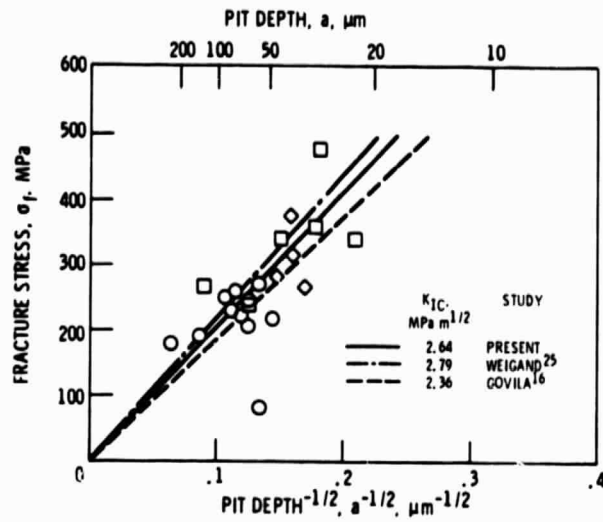
where Z is the flaw shape parameter (elliptical integral) and Y is a geometric factor.[22] Accordingly, the fracture strength is plotted as a function of pit depth in Fig. 13 for all the cases where a corrosion pit was successfully identified as the failure origin. Despite the considerable scatter, the expected overall trend of decreasing strength with increasing pit depth was apparent.

The factor Z/Y in Eq. (3) can be determined to be 0.785 from Ref. 22 or 0.783 from Ref. 23 for a semicircular crack (a/c = 1). Thus the "σ_f" versus "a" behavior can be predicted for various K_{IC} values as shown by the lines in Fig. 13. The 2.64 MPa·m$^{1/2}$ curve falls near the middle of all the data and is consistent with the observation that the average a/c = 0.96±0.45, i.e., near unity. The curve predicted for K_{IC} (CNSB) = 2.79 MPa·m$^{1/2}$ and the curve measured by controlled semicircular flaws also fall well within the scatter band of Fig. 13.[16] This latter curve was used to calculate a K_{IC} value of 2.36 MPa·m$^{1/2}$. The agreement between these curves or equivalently between the fracture toughness values is consistent with the conclusion that corrosion pitting controlled the fracture strengths and was responsible for the observed strength degradation. Also, the deepest pits causing failure were found for the Na_2SO_4/SO_3 samples and were 90 μm on average, resulting in an average strength of 213 MPa. The fractography data for Na_2CO_3/CO_2 and Na_2SO_4/Air was sparse by comparison. However it was still found that the average pit depths causing failure were considerably smaller, 54 and 40 μm, and the average strengths were accordingly higher, 332 and 307 MPa, for Na_2CO_3/CO_2 and Na_2SO_4/Air, respectively.

Figure 13. - Correlation of fracture strength with corrosion pit depth; O Na_2SO_4/SO_3 corrosion, □Na_2CO_3/CO_2 corrosion, ◇Na_2SO_4/AIR corrosion; lines refer to values predicted assuming semi-circular flaws and K_{IC}'s indicated.
