FRACTURE SURFACE ANALYSIS IN COMPOSITE AND
TITANIUM BONDING: PART I. TITANIUM BONDING

K. A. SANDERSON AND J. P. WIGHTMAN

APRIL 1985

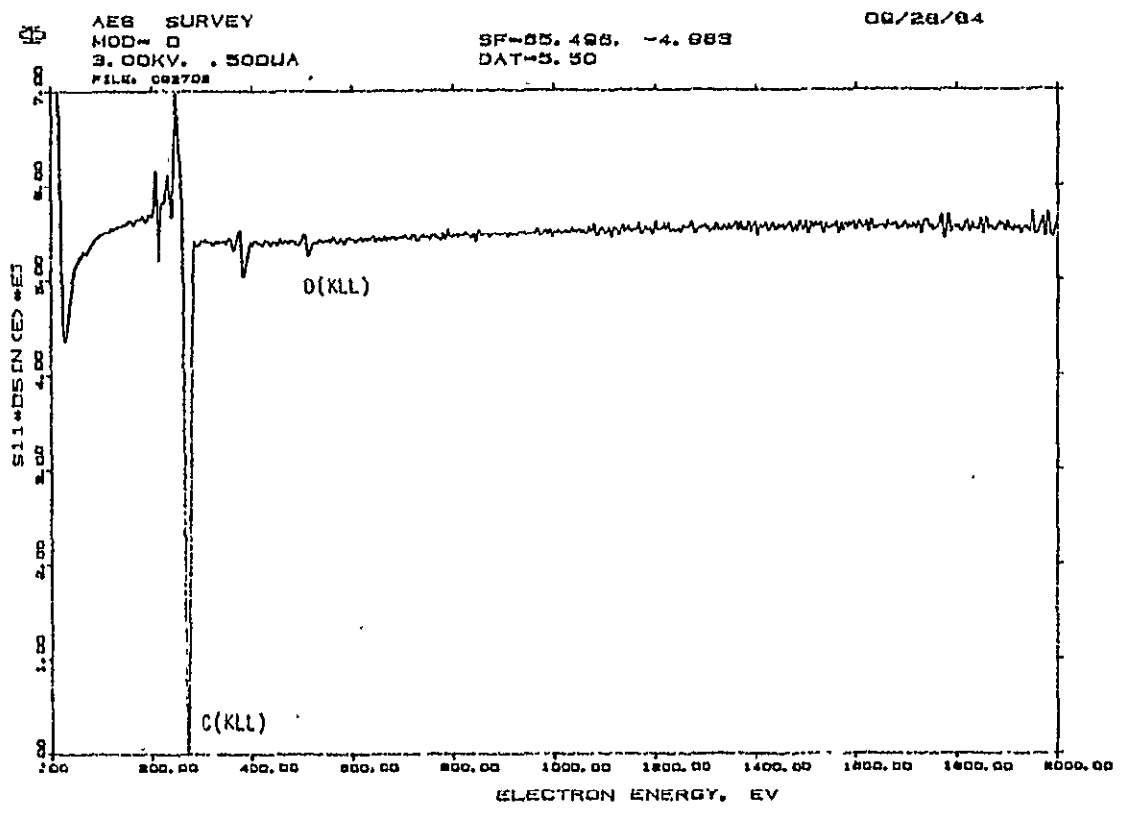
Figure 12. AES Spectrum of One Fracture Surface of Sample No. PPQ-B-3.

The Ti 6-4 adherends in Set I were pretreated with five different processes (see Table III) and bonded with PPQ. The effect of different pretreatments on lap shear strength was studied. The AES spectrum for one of the fracture surfaces of Sample No. PPQ-B-3 is shown in Figure 12 and the major peaks are due to carbon and oxygen. The kinetic energy (K.E.) values of the major Auger peaks are listed in Table V. No titanium signal was observed in the Auger spectrum (see Figure 12) consistent with the apparent cohesive failure mode of this sample (see Table V). The XPS results of the fracture surfaces are listed in Table VI. Both fracture surfaces labelled A and B were analyzed by XPS for this sample. The reproducibility of the XPS technique is gauged from the consistency in the values for both the binding energy (B.E.) and the atomic fraction (A.F.) of each observed photopeak on both fracture

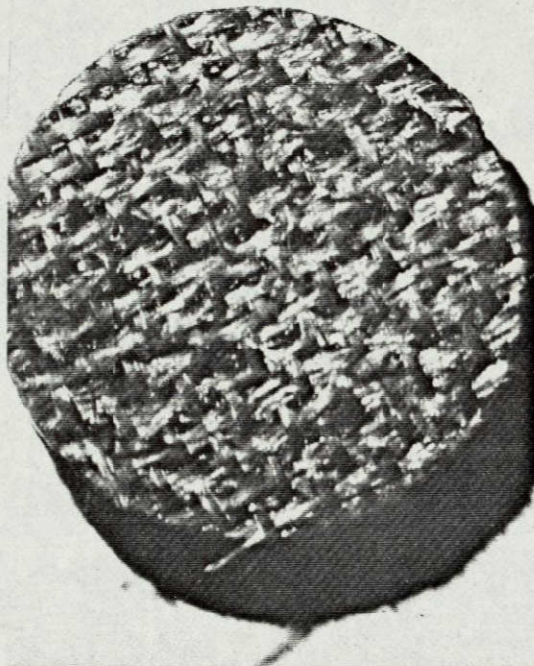
Figure 13. Optical Photomicrograph of One
        Fracture Surface of Sample No.
        PPQ-B-3

surfaces. The high binding energy oxygen 1s photopeak at 532.0 eV is attributed to the PPQ adhesive as well as the nitrogen 1s photopeak. The characteristic photopeaks of PPQ are discussed below in Section C. No significant amount of titanium was detected on either surface again consistent with the AES results and hence with fracture in the cohesive mode. The silicon and calcium are most likely due to exposed scrim cloth which is seen in the optical photomicrograph in Figure 13 and more clearly in the SEM photomicrograph in Figure 14.

The SEM/AES/XPS analysis of samples in Set I support the different fracture modes. For example, the high lap shear strength samples are associated with cohesive.failure (PPQ-B-3) when no Ti photopeaks were observed in either the AES or XPS spectra.

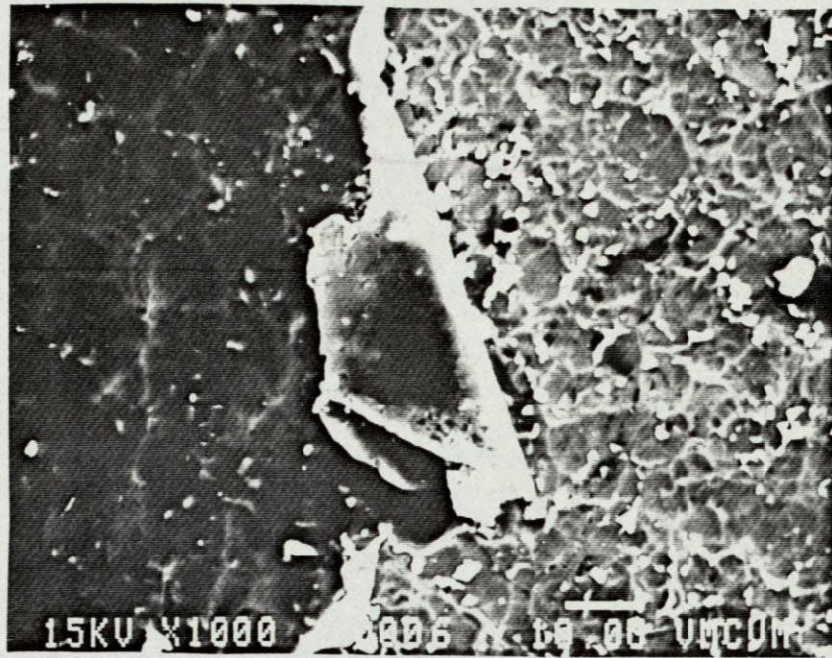
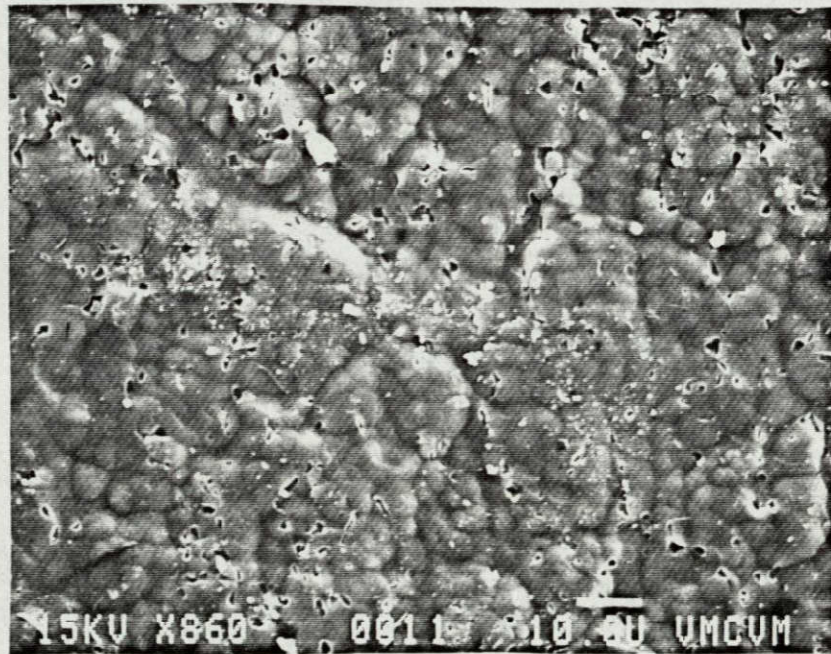
Figure 15. SEM Photomicrographs of Sample No. PPQ-C-5

The AES (see Table V) and XPS (see Table VI) results for Sample No. PPQ-C-5 which apparently failed interfacially are in marked contrast to the results for Sample No. PPQ-B-3 just discussed above. A significant titanium Auger peak is noted in Table V for one of the fracture surfaces which is consistent with the apparent interfacial failure. The detailed XPS results listed in Table VI for the two fracture surfaces indicate significant differences between the two surfaces. The fluorine 1s photopeak is observed on the adhesive failure surface (AFS) but not on the metal failure surface (MFS) which is surprising since fluorine is a residual contaminant on the Ti 6-4 surface following the Pasa-Jell process (32). An oxygen 1s photopeak was observed at approximately 532.0 eV for both the MFS and AFS. If clean interfacial failure had occurred, the oxygen 1s photopeak on the MFS would have been detected at 529-530 eV. Therefore, a residual layer of polymer less than 5 nm thick must be on the metal failure surface shifting the oxygen 1s photopeak to the higher binding energy of 531.8 eV. A significant Ti 2p3 photopeak is observed on the MFS but not on the AFS. This result is interpreted

to mean that if a residual adhesive film remains on the AFS, its thickness does not exceed 5 nm. Further, with the absence of a Ti photopeak on the AFS, the locus of failure is assigned to the primer/oxide interface rather than within the oxide layer in which case a Ti signal should have been observed on both the AFS and MFS (43). The XPS results for titanium are consistent with the SEM photomicrographs shown in Figure 15; that is, the MFS appears to show areas of exposed Ti 6-4 whereas the AFS appears only to show adhesive. However, such conclusions concerning the locus of failure cannot be based solely on SEM photomicrographs but rather in combination with the surface sensitive XPS technique. The source of sulfur on both fracture surfaces is not known. The presence of lead has been reported previously (32,48). Hill et al. (32) noted that the lead had no significant effect on the bond strengths of the lap shear samples at Boeing. Furthermore, Jen (49) has reported the detection of lead from the XPS analysis of polymer coated glass fibers. It is suggested that solvent(s) used in the synthesis of polyphenyl quinoxaline is the source of the lead. However, the possible effect of lead observed as a trace residual on failure mode remains unanswered.

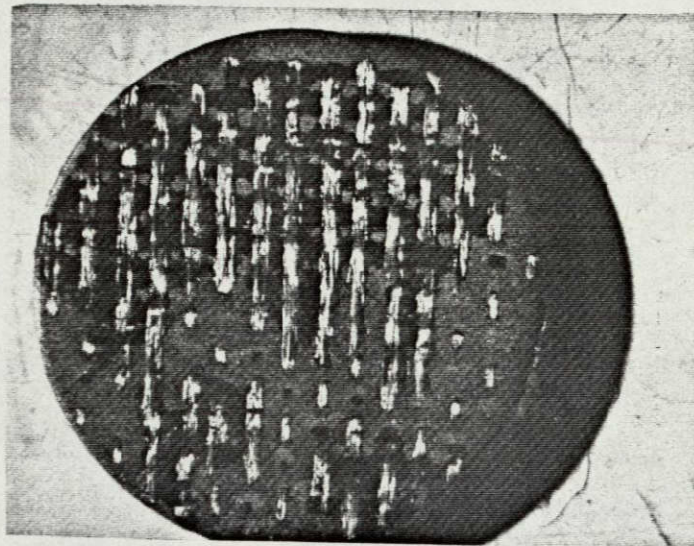
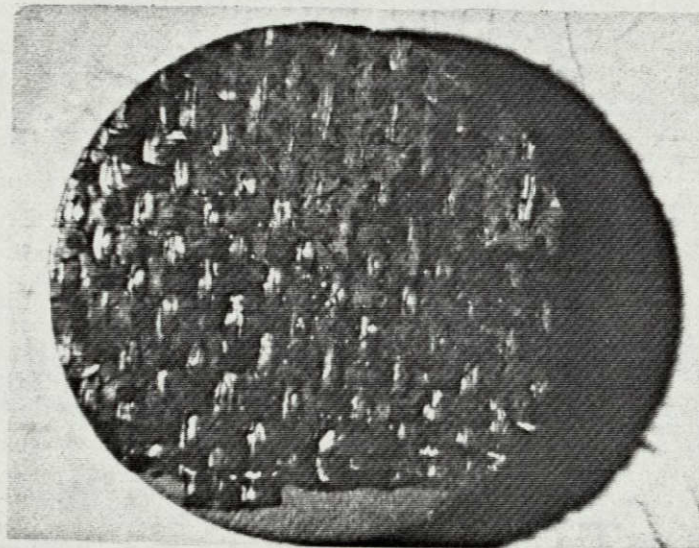
Figure 16. Optical Photomicrograph of Sample No.
PPQ-M1-B5 Fracture Surfaces

No AES results for Sample No. PPQ-M1-B-5 were obtained. The XPS results for PPQ-M1-B-5 are found in Table IX. The results indicate the absence of titanium on either fracture surface. However, by simple inspection of the two failure surfaces as seen in the optical photomicrographs in Figure 16, one would classify this fracture as mixed mode failure. Metal visually appears to be present on a part of the MFS but the XPS results show an absence of titanium. A possible explanation is that there is a coating of adhesive greater than 5 nm on the adherend surface. This explanation can be further supported by the high oxygen 1s binding energy of 533.1 eV on the MFS indicative of a polymer (PPQ) coating. This result demonstrates convincingly the power of the XPS technique is defining the locus of failure in adhesive bonding. Trace amounts of fluorine and calcium were observed on the MFS. No boron or lead was detected on either failure surface.

Variations in the lap shear strengths of the samples in Set II are attributed to the modification of the PPQ in combination with different pretreatments. XPS analysis showed no titanium on either fracture surface of PPQ-M1-B-5 therefore failing in the cohesive mode by XPS analysis hence giving the highest lap shear strength. PPQ-M1-E-7 and G-7 failed in the mixed mode giving lower lap shear strengths. Furthermore, the lap shear strengths of Set II were approximately one-half those of Set I pretreated in the same manner. Therefore, the addition of boron powder to PPQ appears to reduce the lap shear strength of Ti 6-4 bonded with the modified adhesive.
