NASA Contractor Report -172438

DESIGN, FABRICATION AND TEST OF COMPOSITE CURVED FRAMES FOR HELICOPTER FUSELAGE STRUCTURE

SIKORSKY AIRCRAFT

October 1984

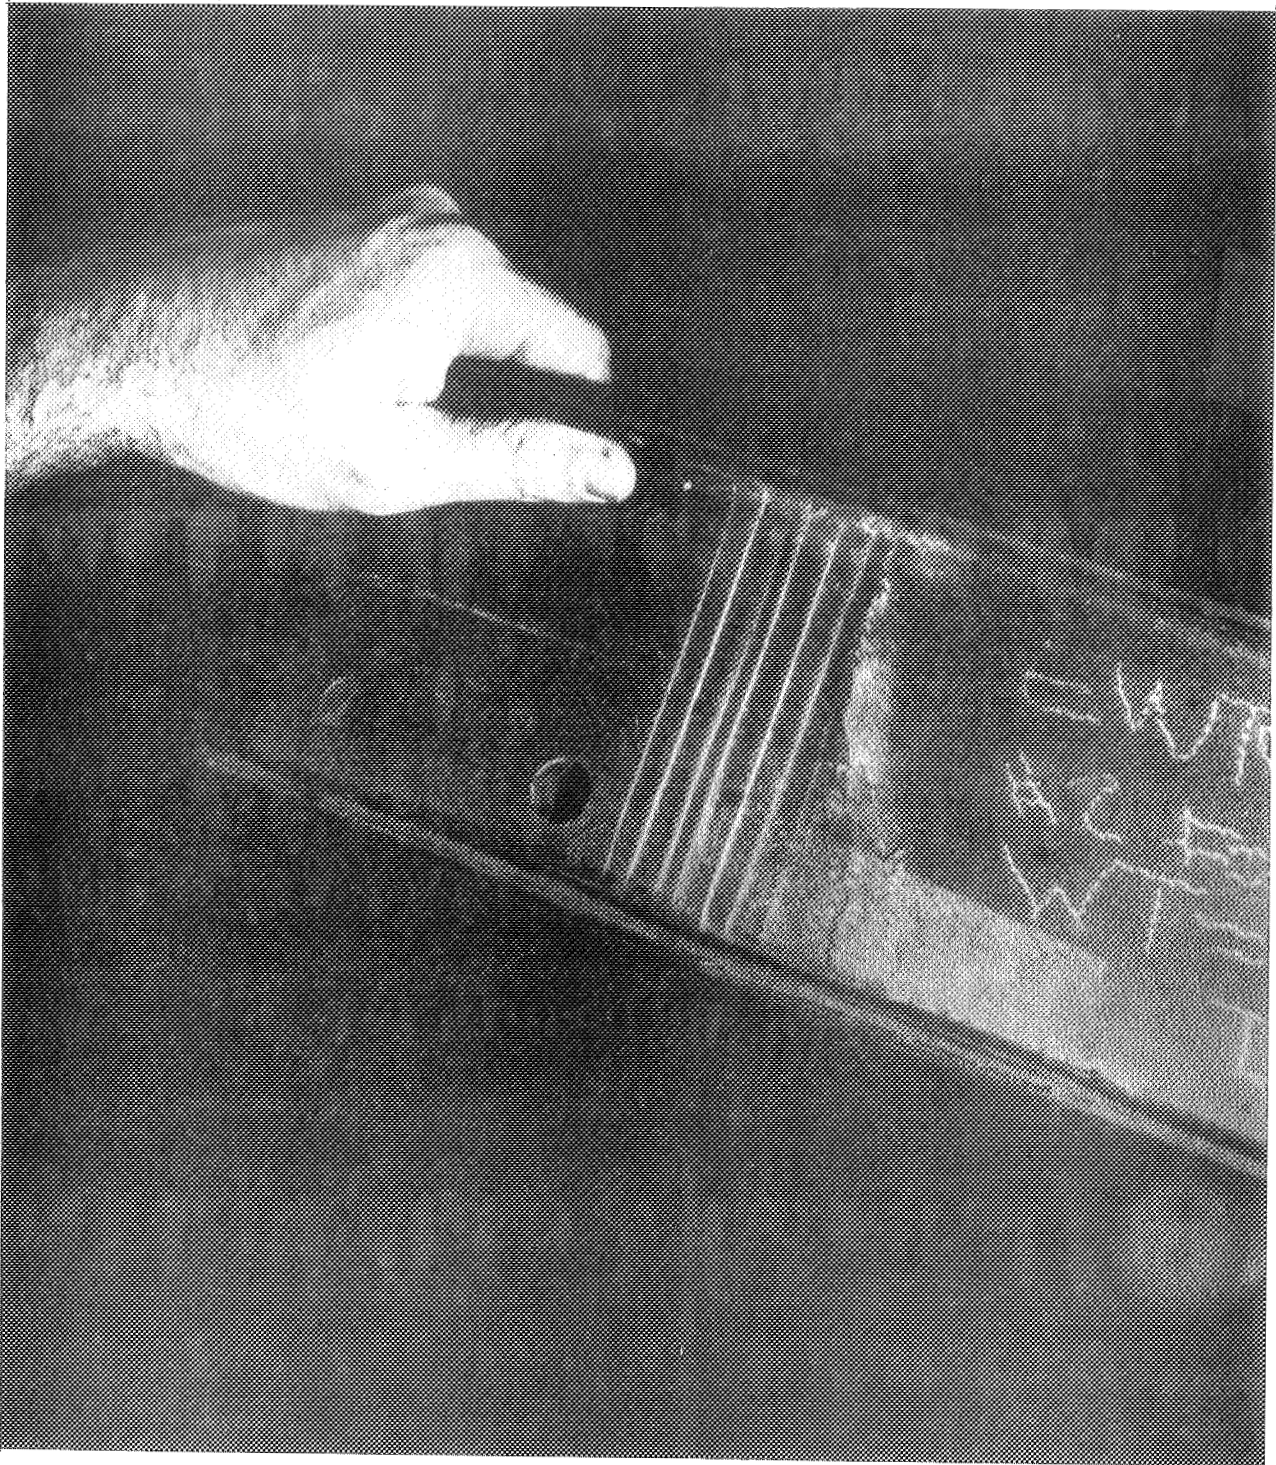
Figure 31. Fracture – Straight Section –
Composite Curved Frame –
Specimen No. 2 Rev. C

Reinforced frame specimen No. 2 (Rev. C) was statically loaded to fracture. At 101% design load, the frame fractured in the straight constant section near the loading pads. A photograph of the fracture is shown in Figure 31. The fracture, in the constant section, was thought to be a crippling type of fracture.

5. The fractures of Frame Specimens Number 2, Rev. C and No. 3, Rev. D, in the straight section were not caused by crippling as originally believed. The cause of fracture was due to transverse strains through the flange thickness. The analysis, design and testing of the honeycomb beams substantiated the transverse strain effects.

The added reinforcement on the third frame was believed to have lowered the stresses in the straight section and prevent what was thought to be a crippling type of fracture. Since the frame straight section fractured at a lower load than frame specimen number 2, a study was conducted to investigate the behavior of frames 2 and 3.

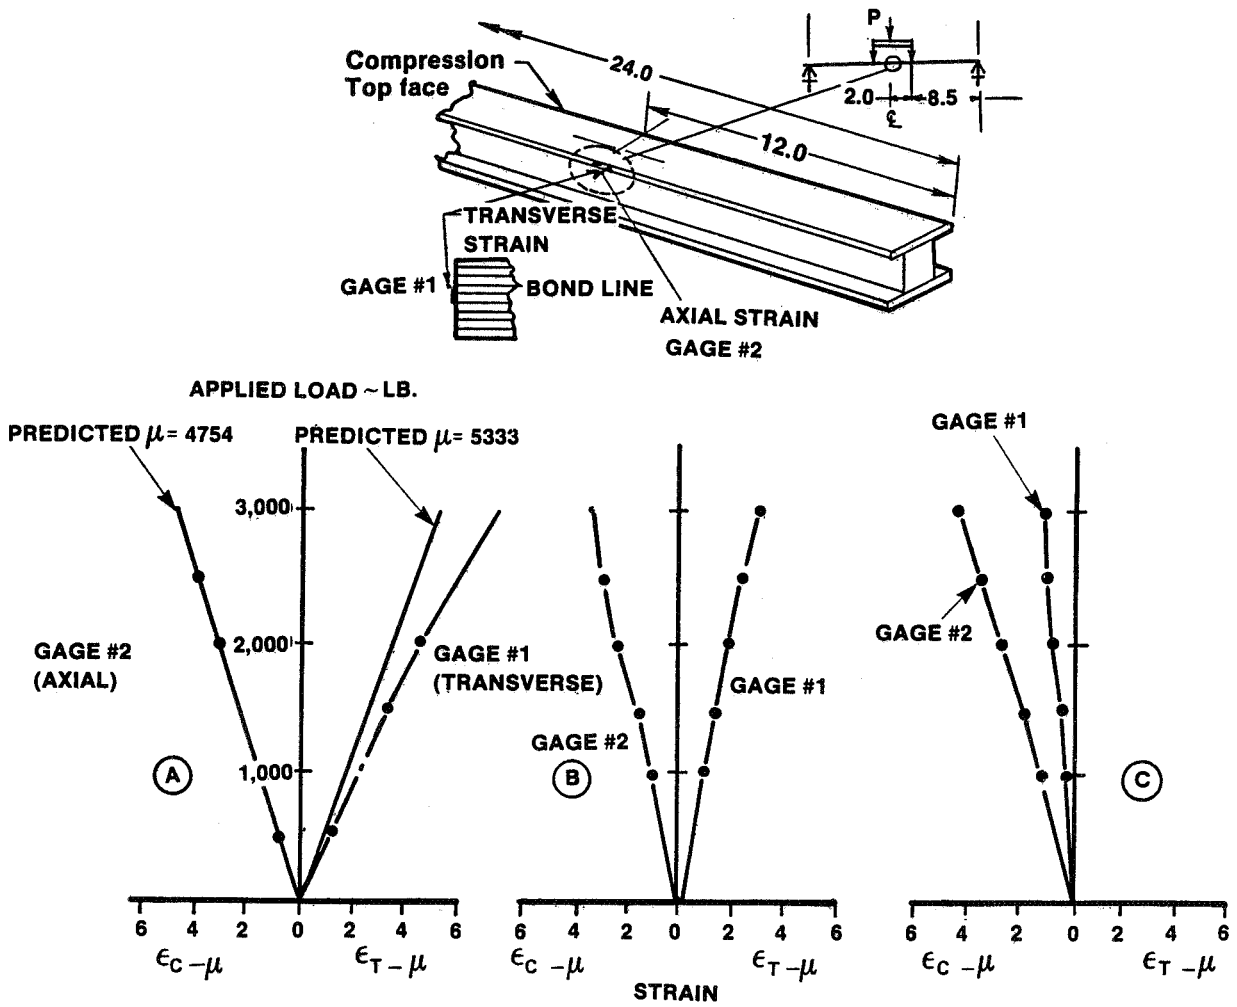
Figure 39. Element Test Results Confirm Edge (Peel) Effects

A prediction of the axial compression strain (ε_c) and the transverse tensile strain (ε_T) on the thin edge of the graphite/epoxy face was made for configuration A prior to strain gaging each honeycomb beam and testing. At a load P, of 3000 lbs., the bending moment M, in the 4 inch test section (see Figure 39) is (3000/2) x 8.5 = 12,750 in. lbs. The compression load is:

The transverse tensile stress in the epoxy at the overall axial compression stress of 48,021 psi, was estimated to be 8000 psi, based on the 3-D analysis. Assuming a modulus of 1.5 X 10^6 psi for the epoxy resin, the strain ε_T, would be 8000/1.5 X 10^6 = 5330μ in./in. The predicted strains are shown in Figure 39.

Two small strain gages were bonded to the edge of the compression face of the honeycomb beams as shown in Figure 39. Each gage had a gage length of .79 mm (0.031 inches). All beams were loaded by four point bending to fracture.

The strain gage data for each honeycomb beam configuration is shown in Figure 39. The transverse gage substantiated the 3-D finite element analysis.

1) A combined axial and transverse strain caused the fractures in the straight sections of frames 2 and 3.

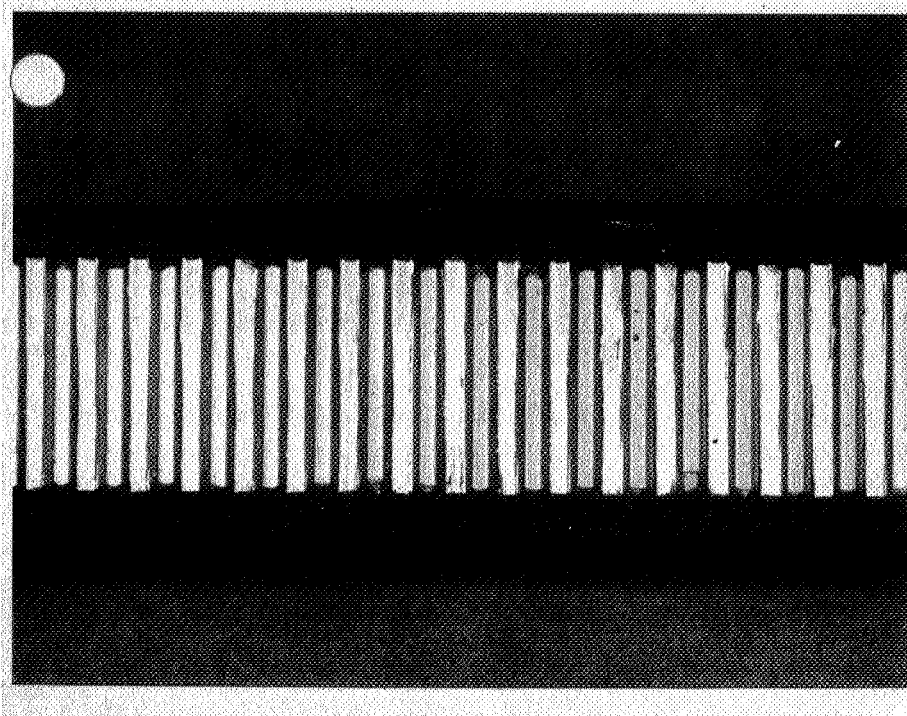
Figure 40.   Fractured Compression Face of Honeycomb
             Beam Configuration B

A fracture in the compression face was obtained, as shown in the photo of Figure 40, for configuration B. The fracture was similar to the frame fracture shown in Figure 30.

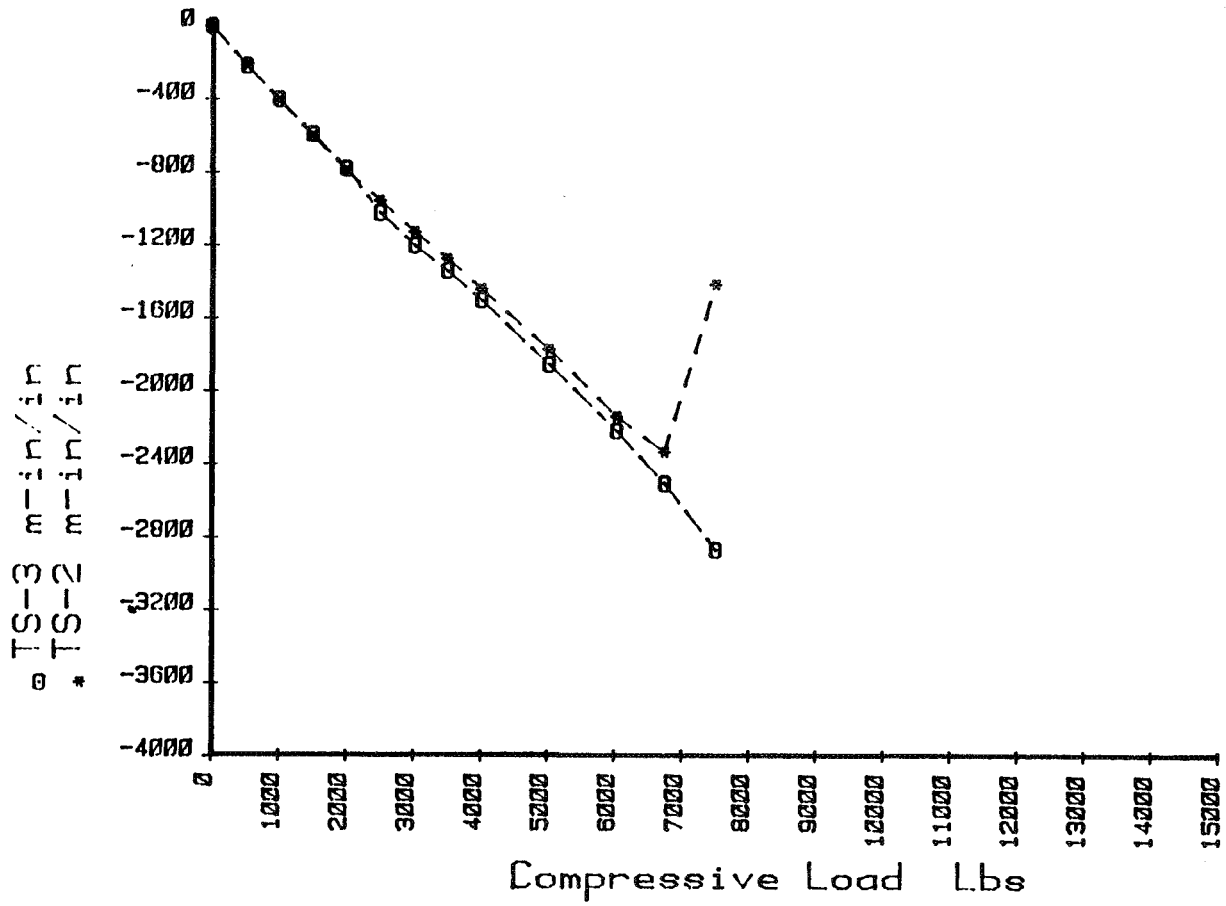
Figure 41 Specimen No. 4 Rev. E,

The instability that developed is indicated by the strain plots in Figures 41 and 42 of gages TS-2 and TS-3 on the compression caps of both frames. Gages TS-5 and TS-6 on the beaded stiffener of both frames, Figures 43 and 44 also indicated instability. These plots were developed by the Hewlett Packard 9825-T desk top computer and 7225A graphics plotter as each test was in progress.

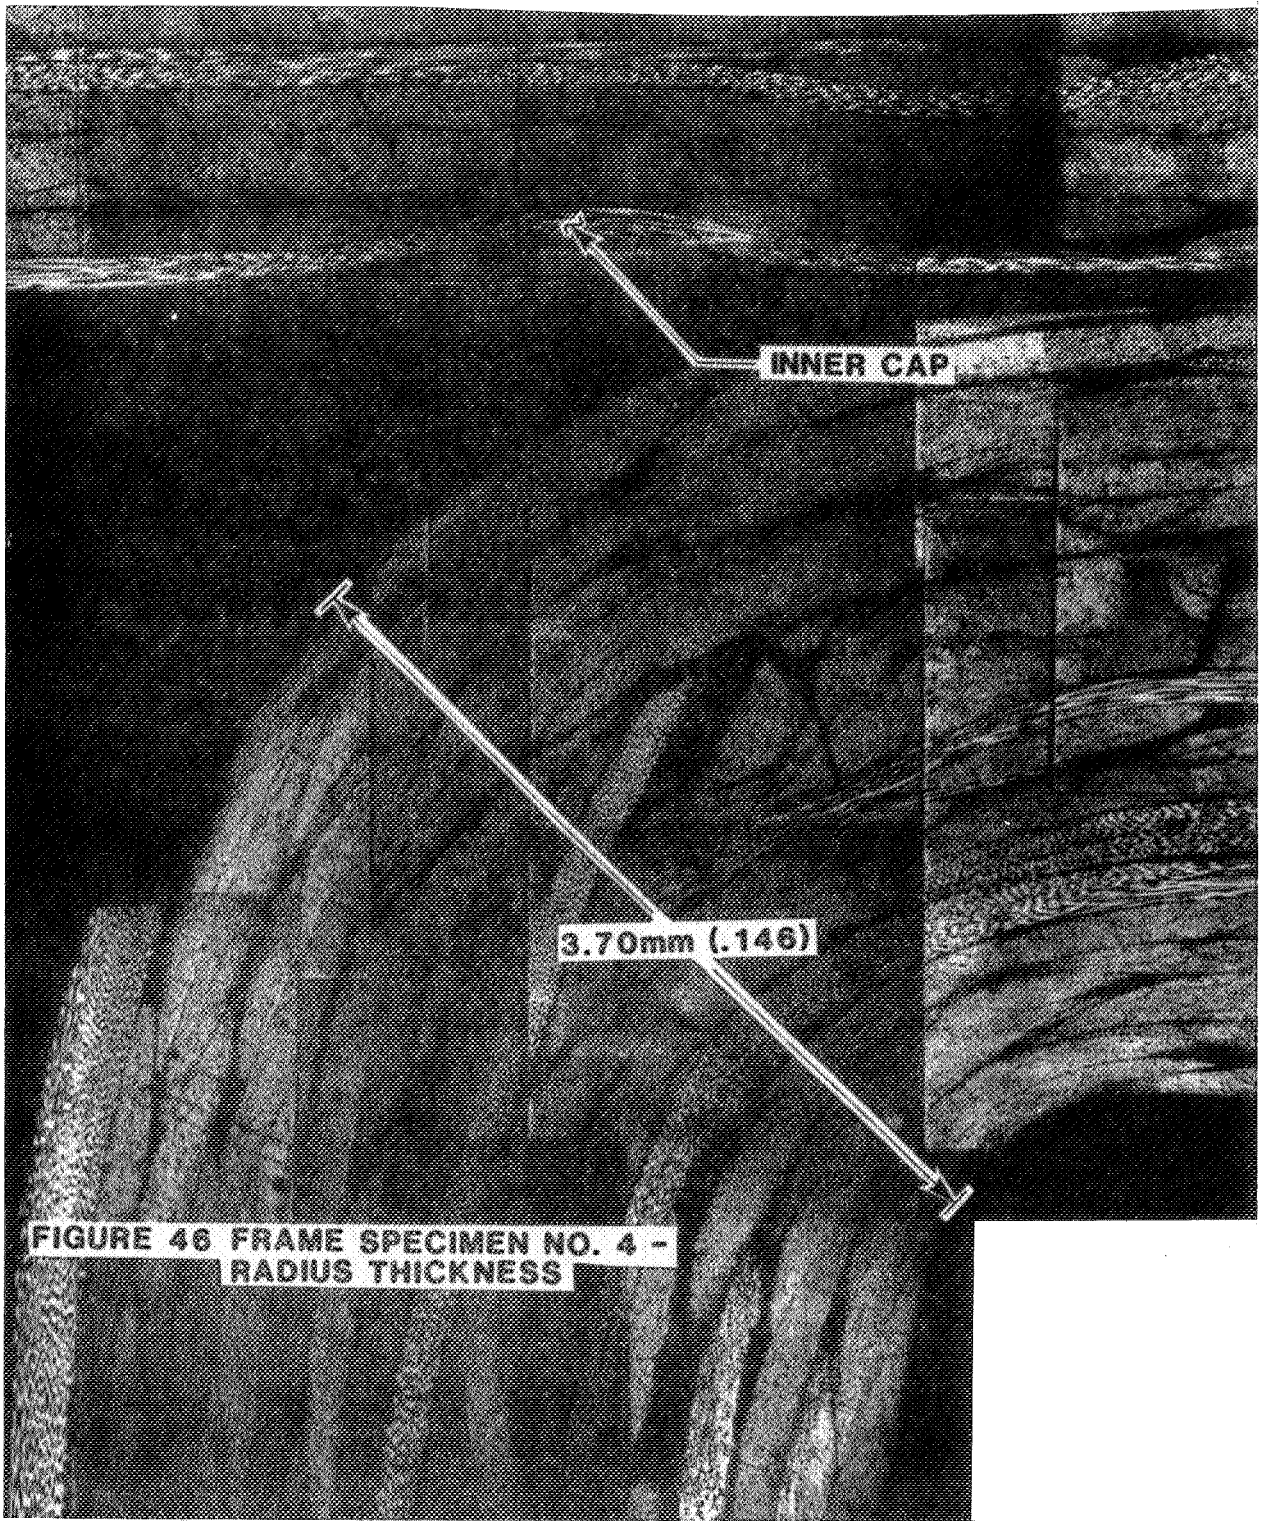
FIGURE 46 FRAME SPECIMEN NO. 4 - RADIUS THICKNESS

From the microphotographs there appears to be a difference in the thickness of the lay-up in the radius of each frame. If the effective modulus of the lay-up is assumed approximately equal for each frame, then the load at which the strains of each bead started to deviate would be a function of the square of the thickness through the radius. Table VI summarizes the load at strain deviation of the stiffeners and the measured thickness in the transition. Figure 48 is a plot of load at bead strain deviation as a function of the radius thickness squared.

The differences in the thickness of the stiffener/web/cap radii appear to be caused by the method of laying the ply materials into the channel mold. A teflon tongue depressor was used to position each ply into the corners of the mold. Several people, laying-up a total of twelve channels (two for each frame) would result in uneven pressure being applied with the tongue depressor to the corners of the mold.

6. The fractures of Frame Specimens Number 4 and 5, Rev. E, in the curve, were caused by the bead stiffeners becoming unstable. Although the lay-up in the radius was similar to Revision C requirements, the overall thickness was less or equal to Revision B requirements, and this caused the stiffener to become unstable. Stiffener strains were low.

3. A study is recommended to determine criteria for the design of the interface between frame webs and caps in a curved frame structure. Also a method of fabrication is recommended to provide required thicknesses through the interface.

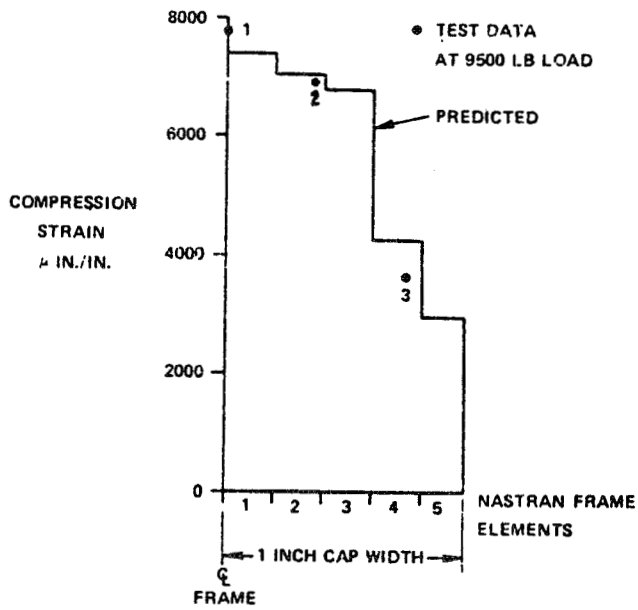
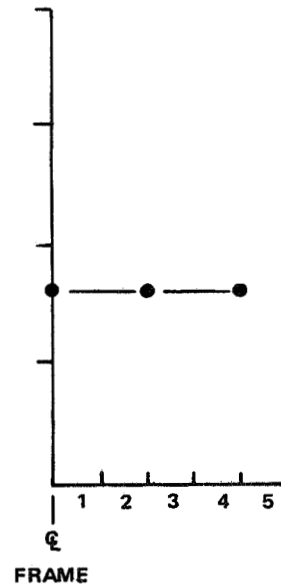
Figure 49.   Compression Cap Strains Across Half Cap Width —

Axial strain distributions, across the flange, were obtained in the curved and straight sections during testing. The correlation with the NASTRAN analysis for the curved section is shown in Figure 49A. The strains in the straight section during testing are shown in Figure 49B.

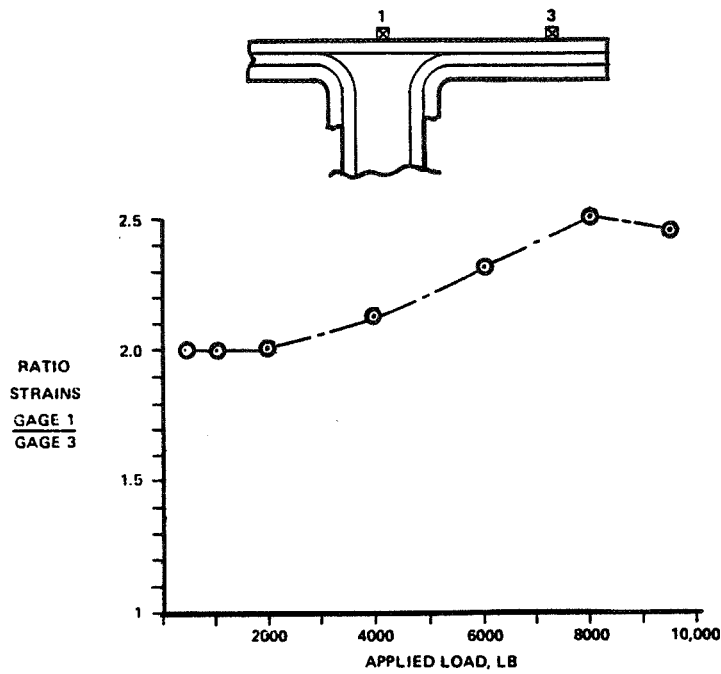
Figure 50. Axial Strain Ratio Increases with Applied Load

There were some questions on whether the peaking of the axial stress distribution would be reduced as the load went past the nonlinear load strain region. A measure of the effect would be the ratio of the gage 1 (at the centerline) to gage 3 (most outboard) strains. These ratios are presented in Figure 50 and indicate an increase in the axial strain ratios. This increase is opposite to that which would be expected for metals where plastic relief would reduce strain ratios.

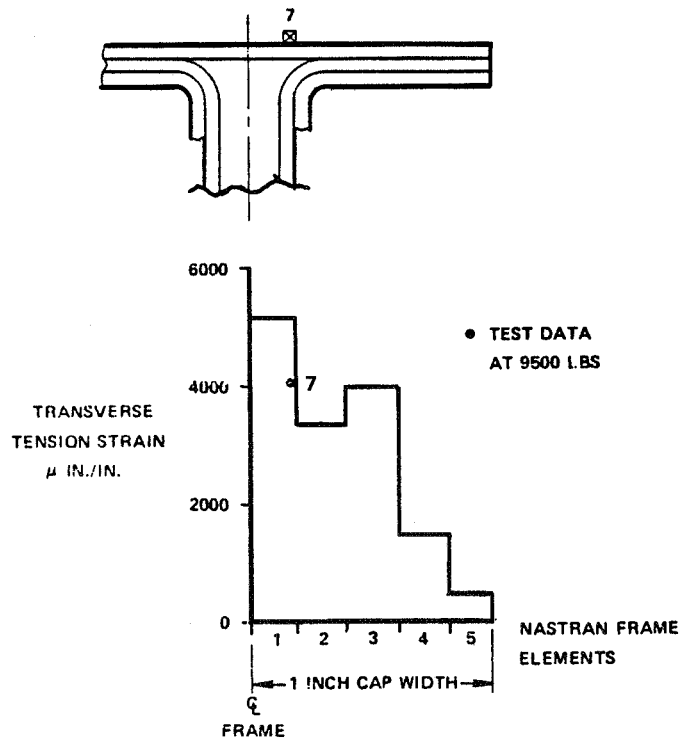
Figure 51. Transverse Bending Strain
(Tension Side)

The transverse strain was measured at gage no. 7. The NASTRAN-predicted and the test-measured strains are shown in Figure 51. The analysis appears to adequately predict the induced transverse stress.

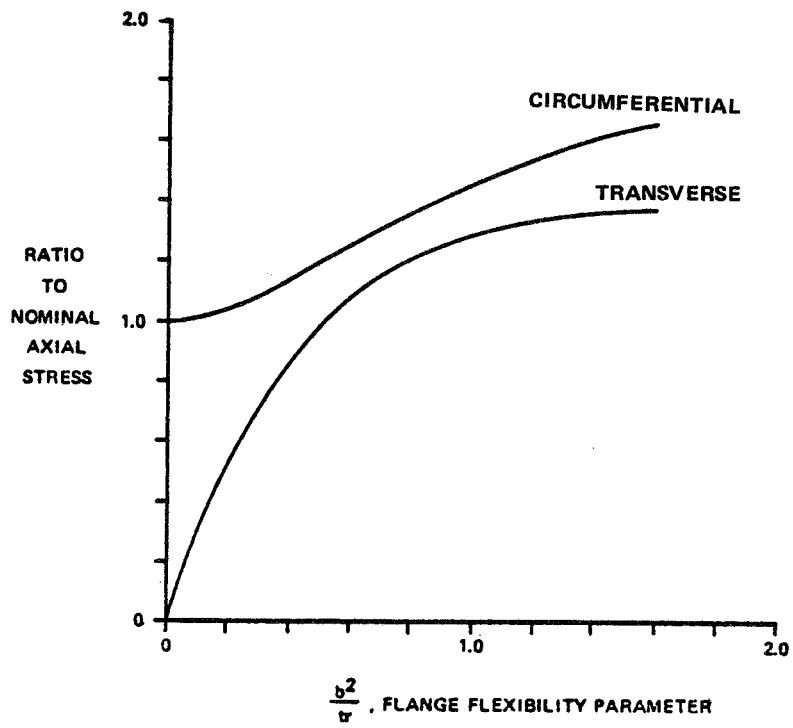
Figure 52. NASTRAN Analysis, Aluminum Frame

The calculated ratios of maximum axial and maximum transverse-to-nominal axial stress are plotted in Figure 52. The NASTRAN results are similar to the Bleich values shown in Figure 1. The axial ratios are almost the same, but the NASTRAN values are well below the Bleich predictions for transverse bending.

The analysis and test data (Frame No. 2, Rev. C) relate to a flange flexibility value of .225. However, it should be noted that the flange axial modulus, for the composite frame, is over twice the transverse modulus. A comparative summary of the NASTRAN analysis, Bleich analysis and Composite Curved Frame test results is presented below.
