DOE/NASA 0017/3
NASA CR-165494
DDA EDR 10672

CERAMIC APPLICATIONS IN TURBINE ENGINES

Progress Report for 1 July 1980 to 31 December 1980

Detroit Diesel Allison Division
General Motors Corporation

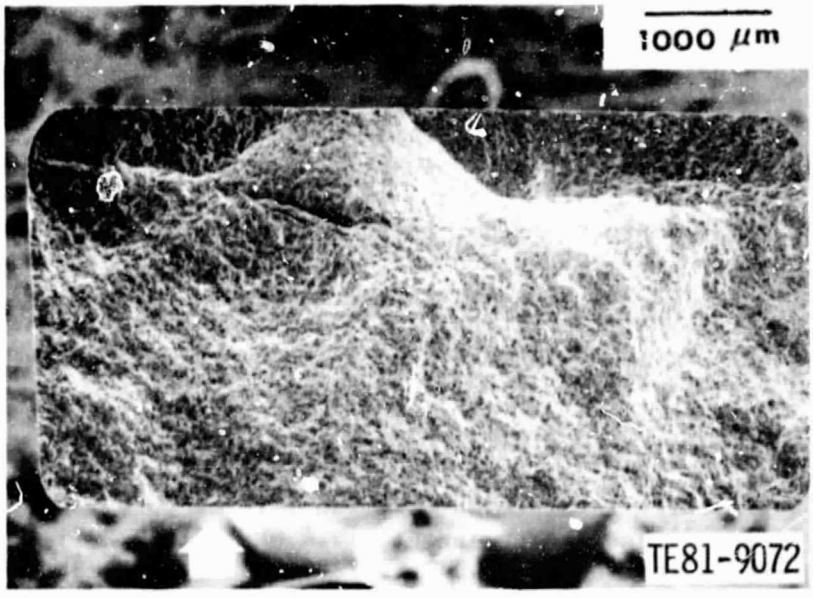
The average room temperature MOR (four-point loading) strength for the as-fired surface condition was 182.10 MPa (26.41 ksi), with a standard deviation of 12.41 MPa (1.80 ksi). The MOR strength of machined bars was 291.95 MPa (42.34 ksi), with a standard deviation of 36.78 MPa (5.33 ksi). All specimens failed from surface sites in both as-fired and machined materials. A typical fractograph of a failure origin is shown in Figure 13.

Figure 13. Scanning electron microscope (SEM) fractograph of an Annawerk reaction-sintered SiC (CS-600), 1900°F-configuration vane qualification test bar. Failure probably started at surface side indicated by white arrow.

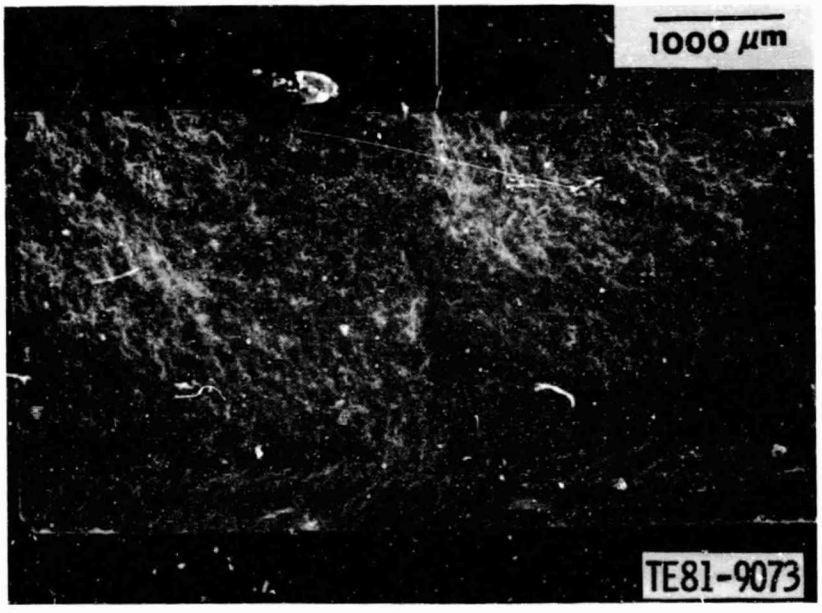
The pressureless sintered Si_3N_4 from NGK-Locke had an average density of 2.90 g/cm^3, very large interconnected pores, and an MOR strength at room temperature of 355.94 MPa (52.63 ksi). Tests at 1050°C (1922°F) showed a decrease in strength from the room temperature value. The average strength at 1050°C (1922°F) was only 252.33 MPa (36.60 ksi), with a standard deviation of 19.09 MPa (2.77 ksi). All failures of the specimens originated in surface sites. A typical example is shown in Figure 14.

Figure 14. SEM fractograph of an NGK-Locke sintered Si_3N_4, 1900°F-configuration vane qualification test bar tested at 1050°C (1922°F).

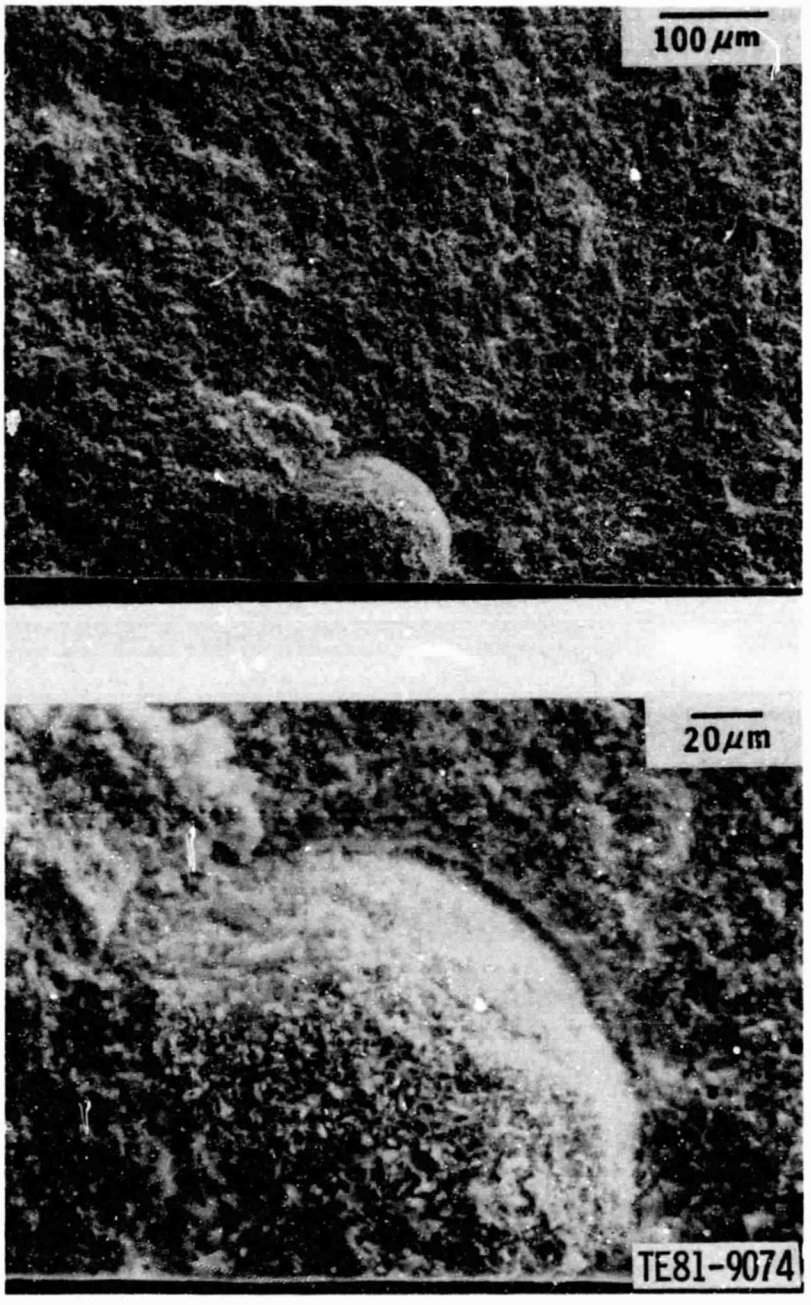
The average room-temperature MOR strength in the machined condition is 368.28 MPa (53.41 ksi), with a standard deviation of 22.47 MPa (3.26 ksi). Internal pores and a large ball-type inclusion about 100 μm in diameter were found to be the strength-controlling defects. The ball inclusion, shown in Figure 15, is of the same composition as its surrounding matrix but is poorly bound to the matrix.

Figure 15. SEM fractographs of an NGK-Locke sintered Si_3N_4, 2070°F-configuration plenum inner annulus test bar. The initial flaw is a large ball-type inclusion.

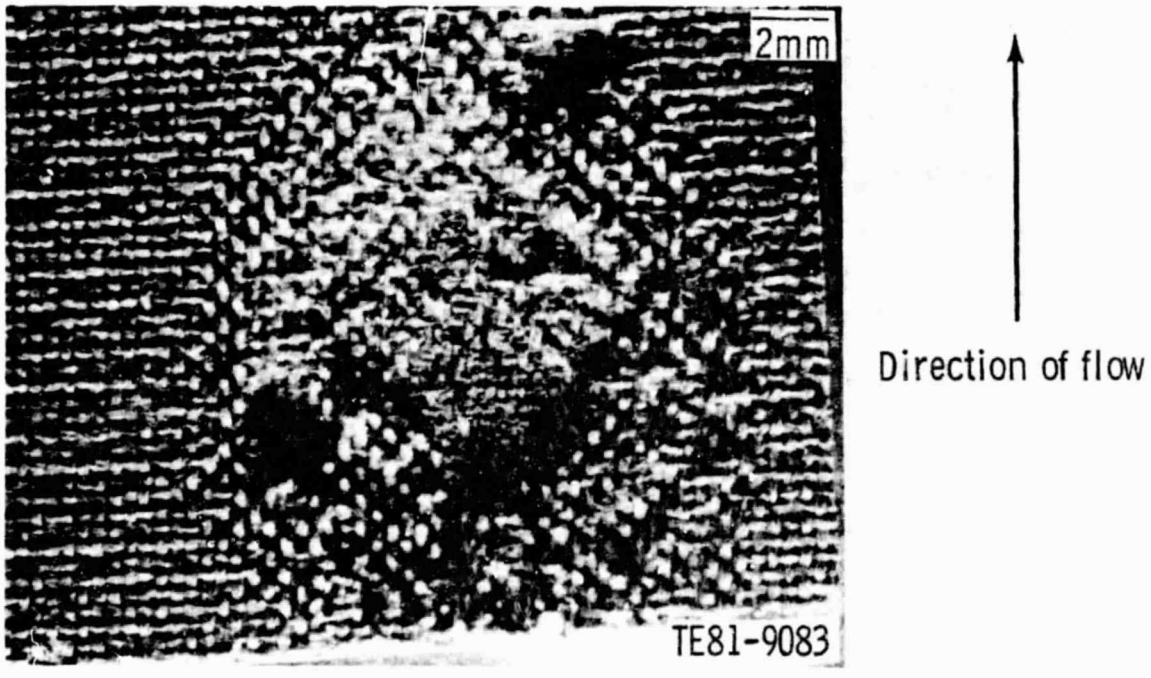
Figure 24. 0.38 mm (0.015 in.) square weave--moderate erosion, 30 min, 45° angle (X5).

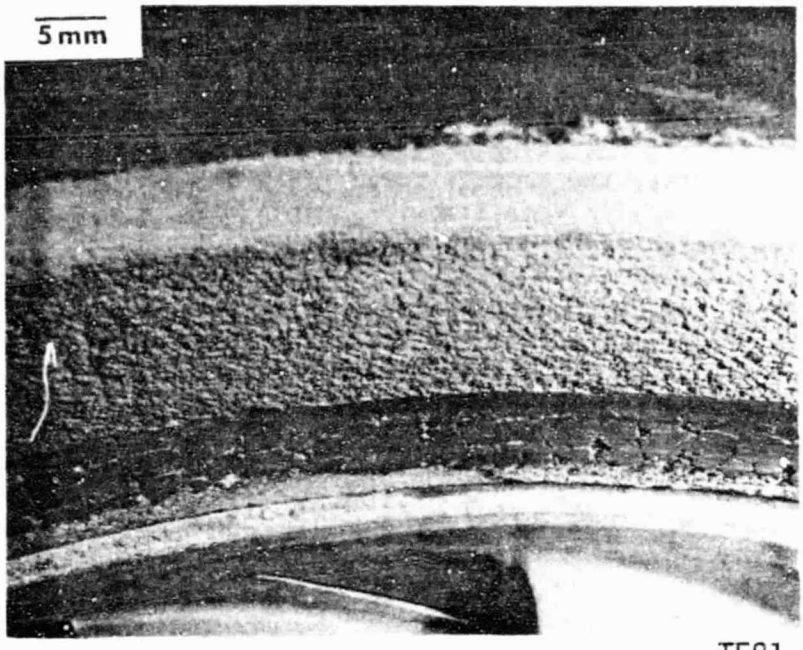
A plasma-sprayed zirconia/eccosphere system of 14/86% composition was used as an abradable turbine rotor shroud tip seal for engine C-1. This turbine was a metal-bladed system. Results of rig tests and engine running of this composition are shown in Figures 34 and 35. Formation of a slight glaze can be seen in the rig abradability coupon (Figure 34). Engine test results after approximately 40 hr of testing show moderate glazing and metal transfer resulting from shroud-to-rotor interference, as seen in Figure 35. Slight erosion effects were becoming noticeable at this time. The depth of rub was 0.25 mm (0.010 in.), with a comparable amount removed from the blade tips.

Figure 35. Plasma-sprayed zirconia/eccosphere system, engine C-1 nozzle shroud rub, Mar-M247 blade tip (X2).

rial appears to be removed by a crushing action. In this type of action the rotating blade tip crushes the zirconia/eccosphere mixture and the resultant debris is flushed out of the rub path. Densification at the surface also occurs as part of the crushing action. As the proportion of zirconia in the mixture increases, the void percentage decreases and the material tends to densify under the moving blade tip. Under these conditions a glaze similar to the scar seen in Figure 30 for a ceramic-blade tip appears. The glaze may be acccompanied by metal transfer, as shown in Figure 35, for a metal-blade tip. It should be noted that the compositions of the two systems are vastly different, the ceramic-blade system having a significantly higher percentage of zirconia. If it follows that engine testing will result in poorer performance than the rig tests indicate, as was the case for the metalbladed system, then improvement is needed for the ceramic system as well as for the metal one. Recent developments in the field of rub energetics have led to a new understanding of the fundamentals of the rub mechanism, and possibly explain the phenomena observed in the foregoing tests.

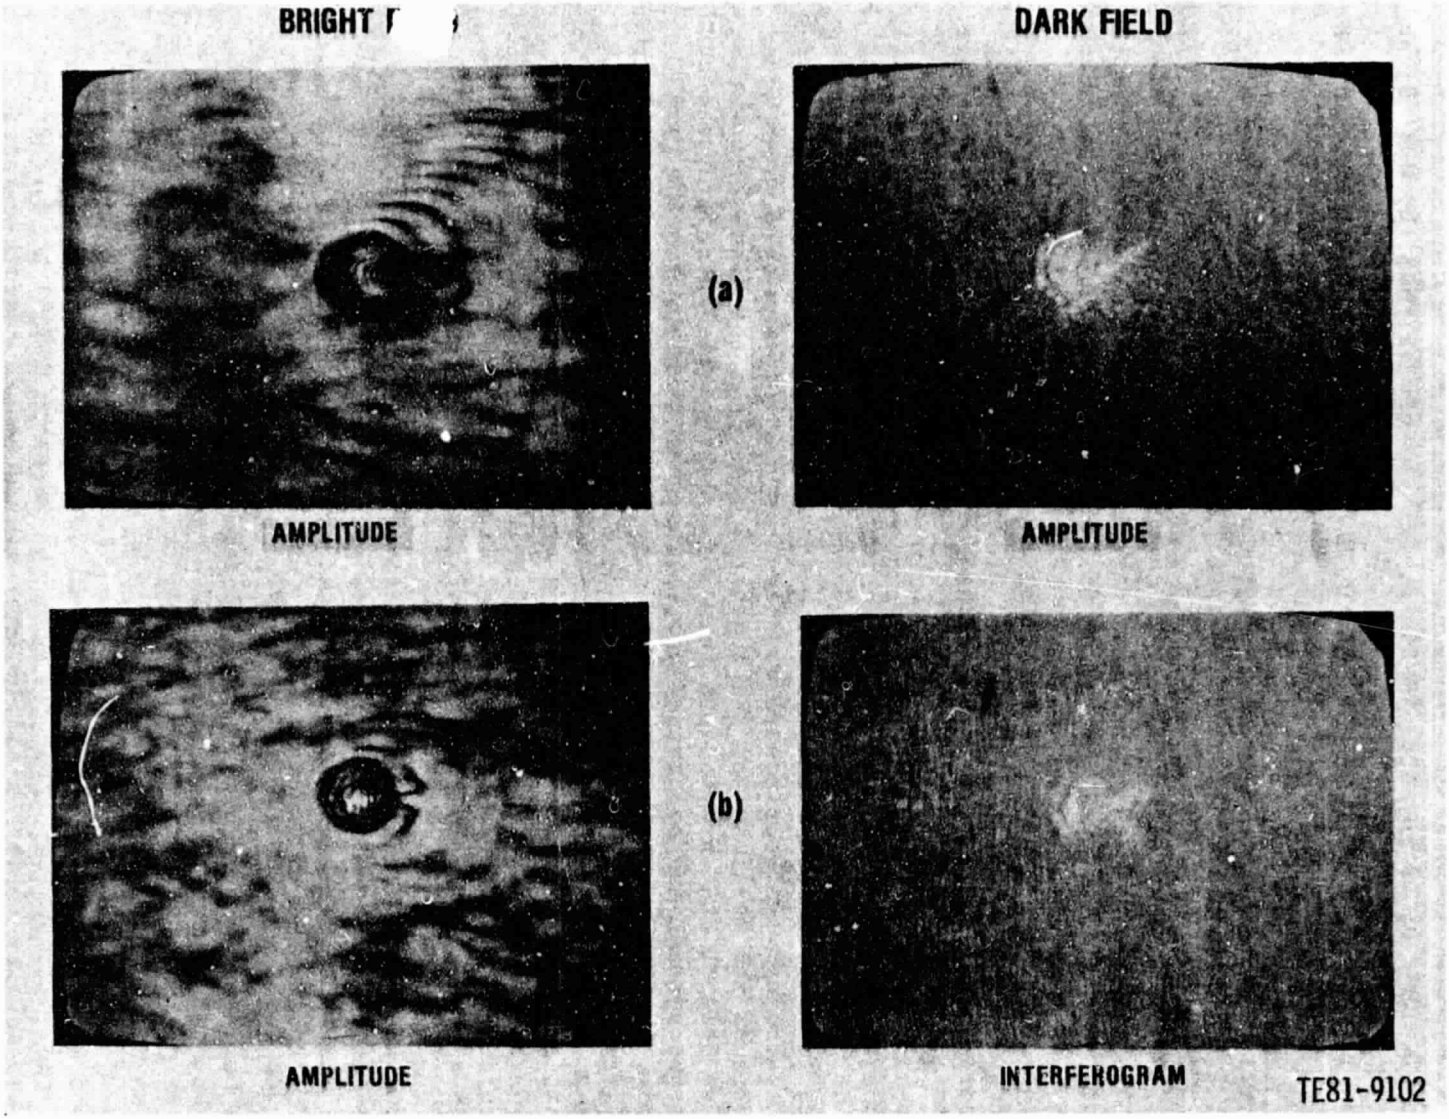
Figure 44 shows acoustic micrographs of detected holes RB1 and α1 in both the bright and dark field modes. The image of the holes in the bright field shows a lighter center. This is due to the sound being focused when propagating across the curved surface at the bottom of the hole. The holes also have a brighter center in the dark field mode. Again, this is a result of focusing that occurs when sound is refracted at the bottom curved surfaces of the hole.

Figure 44. Acoustic micrographs of hole 1 in (a) reaction-bonded silicon carbide and (b) alpha silicon carbide penetrameters in step 1.

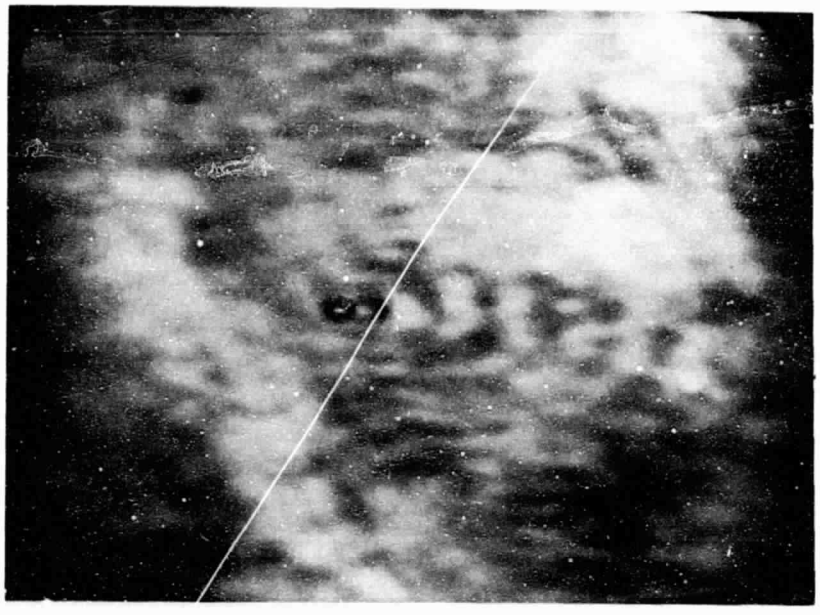
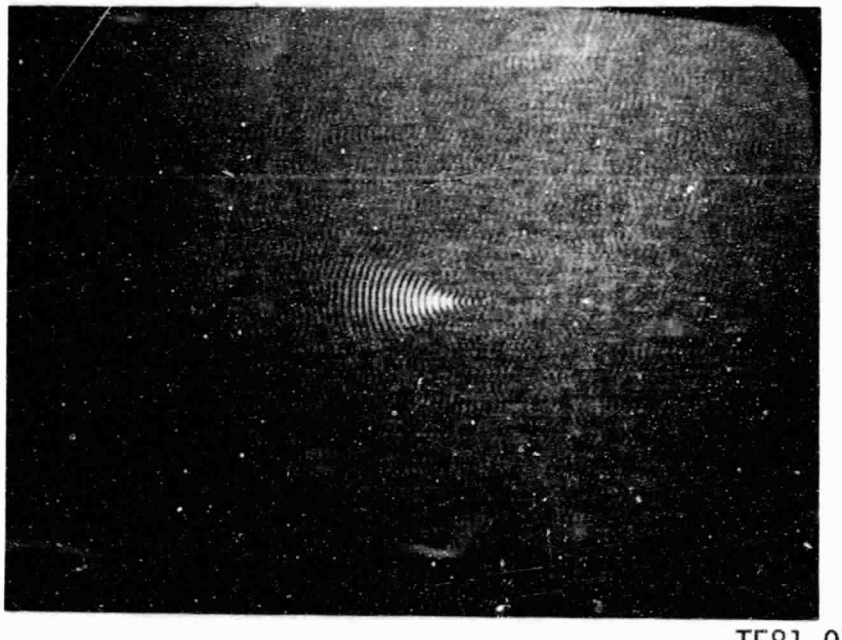
Acoustic micrographs (Figure 45) of hole RB7 in step 4 show that it is readily detected against the background structure in both the bright and dark field modes. In the amplitude mode the hole appears as a shadow with a ring pattern emanating from it. These rings are believed to be due to interference between the bulk skimming wave (horizontal component of the incident bulk wave) along the surface of the specimen and the scattered wave from the flaw. These rings are always present, but are visible only when constructive interference occurs and contrast between the background and flaw signal is high. In the dark field mode the flaw produces a bright, cometlike tail and stands out well from the background structure. The spacing between the fringes is the wavelength at 100 Mhz for surface wave propagation in this material.

Figure 45. Acoustic micrographs of hole 7 in reaction-bonded silicon carbide penetrameter in (a) bright-field amplitude and (b) dark-field interferogram mode in step 4.

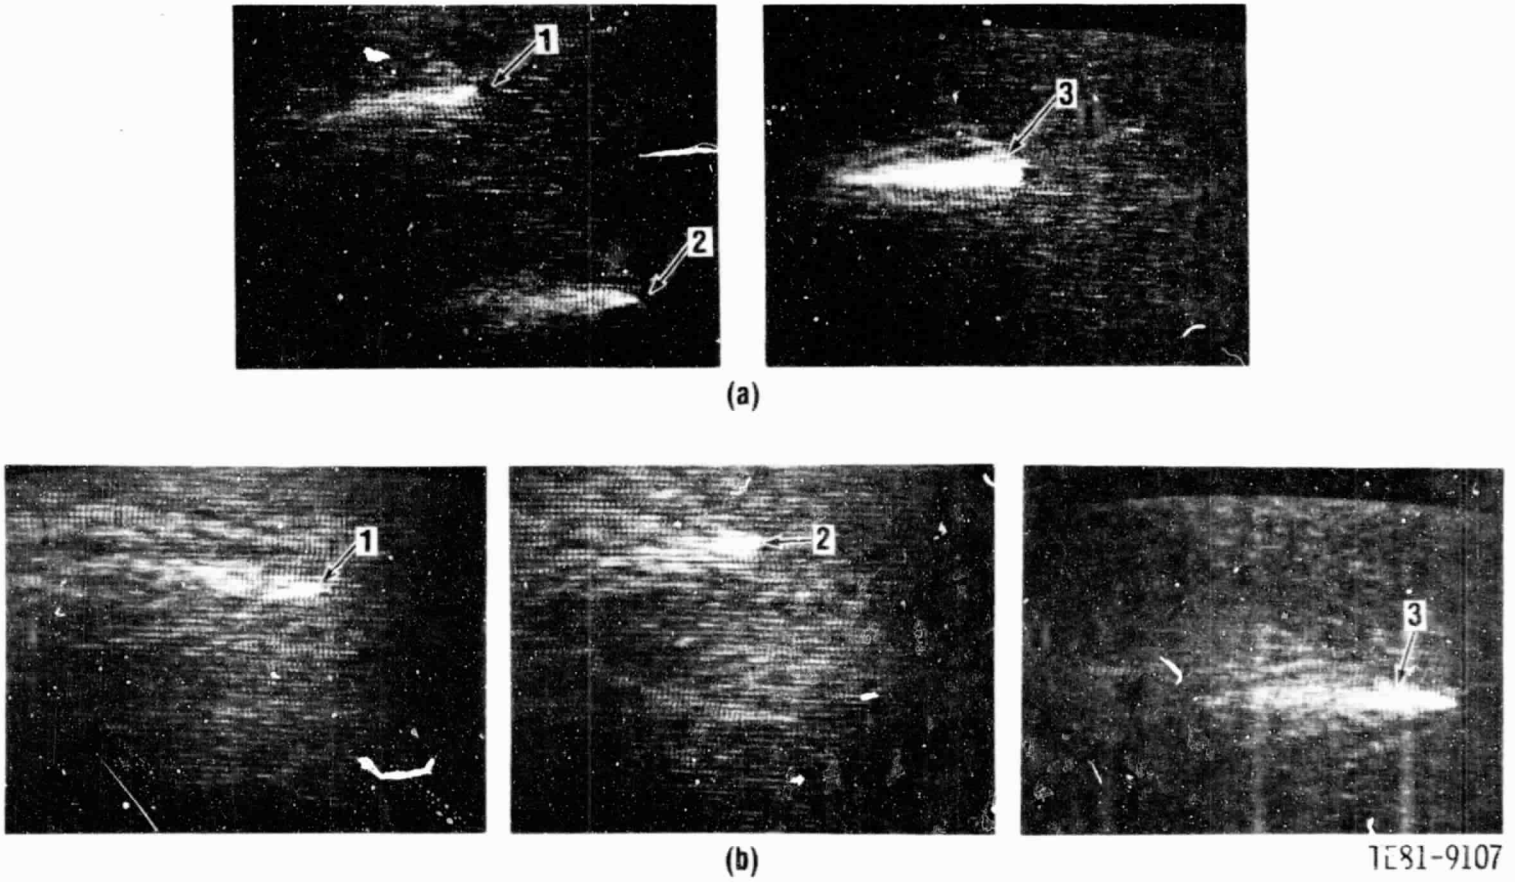
All 23.54- and 13.73-N (2.4- and 1.4-kg) indentations were easily detected and imaged (Figure 49) with excellent discernibility in the dark field interference mode. The 4.91-N (0.5-kg) indentations could be detected and visualized on the TV monitor but could not be imaged on a Polaroid film with sufficient contrast. The 0.98-N (0.1-kg) indentations could not be detected. The acoustic micrographs clearly show the variability in the images of the 23.54- and 13.73-N (2.4- and 1.4-kg) indentations. Scanning electron microscopy (SEM) analysis of the indented surface of 23.54-N (2.4-kg) specimens showed variable damage around each indentation. Similar observations were made for 13.73-N (1.4-kg) load indentations. These variabilities are related to the local microstructural properties that govern both the surface and subsurface indentation-induced damage. Figure 49 also shows that the intensity of the backscattered energy is greatest in the center and least at the edge. It appears that the crack (indentation) has similar acoustic properties to a plane wave oscillator.

Figure 49. Dark-field acoustic interferograms of three Knoop indentations each for (a) 23.54-N (2.4-kg) and (b) 13.73-N (1.4-kg) loads in Type A specimen.

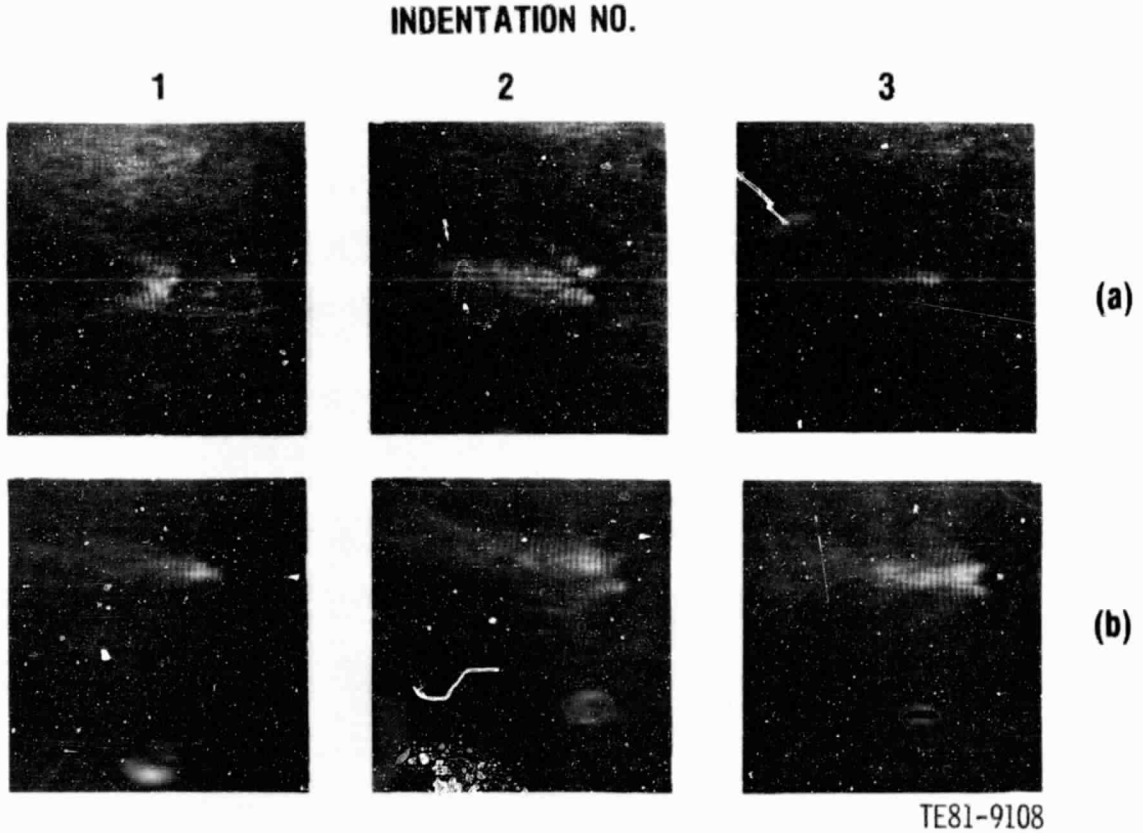
Figures 50, 51, and 52 show the dark field (backscattered) acoustic interferograms of 23.54- and 13.73-N (2.4- and 1.4-kg) indented specimens. The variation in the magnitude of the backscattered energy from indentation to indentation both within a specimen and between specimens is evident for all indentation loads. Surprisingly, however, the fringe spacing or wavelength (λ) is almost constant, suggesting that the acoustic mode conversion due to the interaction between the incident acoustic beam and flaw remains similar. It has also been found that small rotations (Figure 51) of the specimen have significant effects on the defect image. It appears, therefore, that the scattering characteristic of the two edges of the indentation may be different. Note that

Figure 50. Dark-field interferograms of three 23.54-N (2.4-kg) load Knoop indentations in specimen 22.0369 (a) and 22.0379 (b) without removing the indentor-induced surface damage.

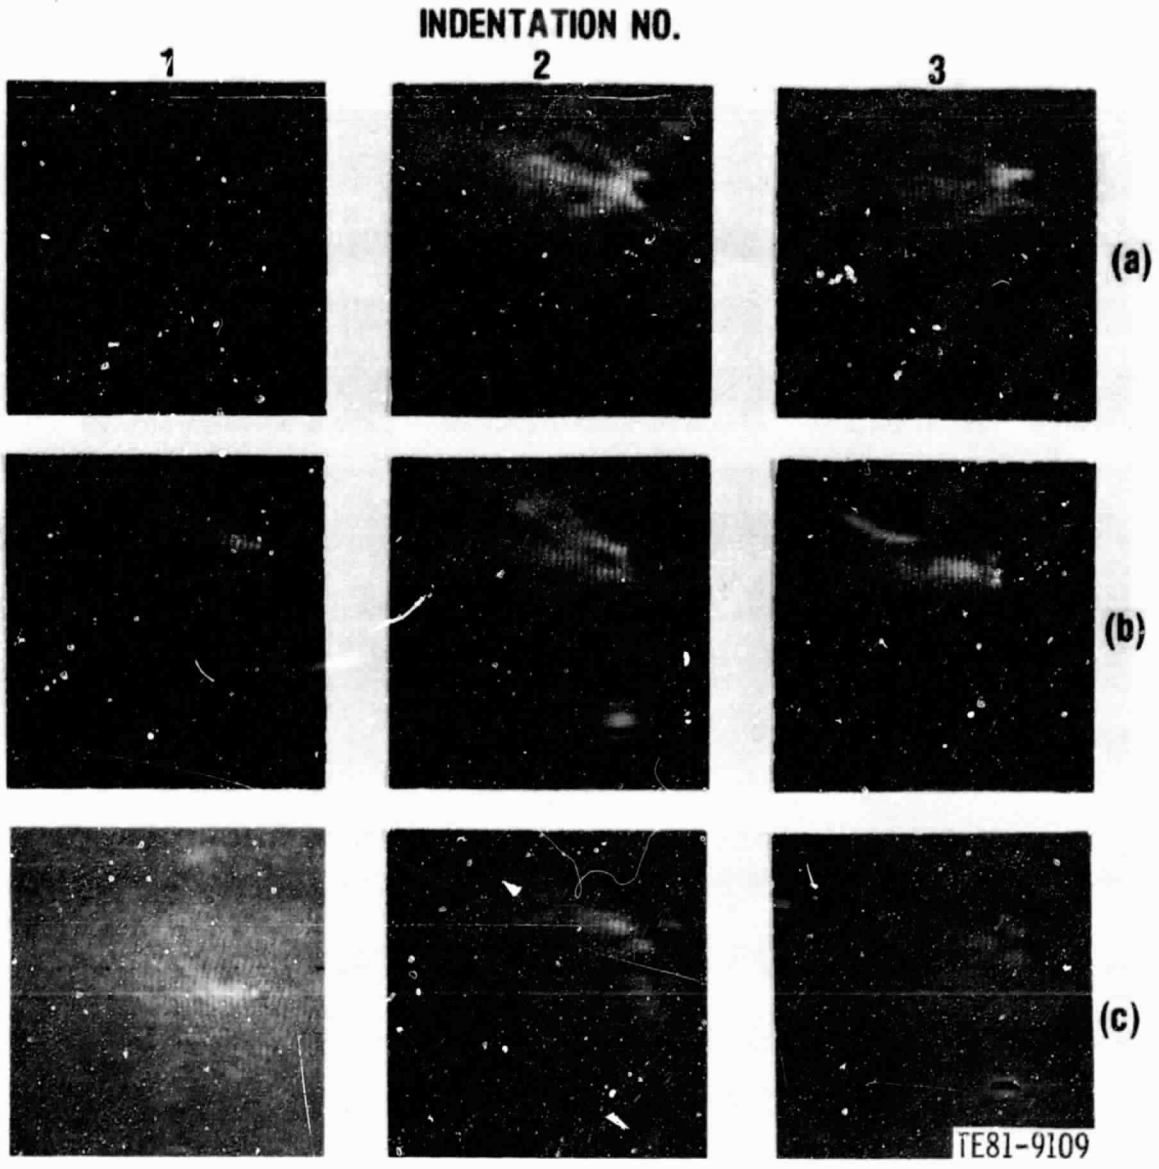
Figure 51. Dark-field interferograms of three 23.54-N (2.4-kg) load Knoop indentations in specimen 22.0383: (a) without removing surface-induced indentation damage, (b) surface as (a) except after rotating specimen 180°, and (c) after removing surface damage and oriented as (a).

All three indentations in specimen 22.0383 were detected even after the indentor-induced surface damage was removed by diamond polishing. Both the surface and subsurface damage produced by the Knoop indentor are believed to contribute to the acoustic signal and image. Figure 52 shows a similar kind of variability in detection of the 13.73-N (1.4-kg) indentation in the dark field interferogram mode. All three indentations in specimen 22.0343 were also detected after the surface damage caused by indentation was removed. The 4.91-N (0.5-kg) indented specimens were also evaluated, and indentations along with other naturally occurring flaws were detected. However, no micrographs were possible because of poor photographic quality.

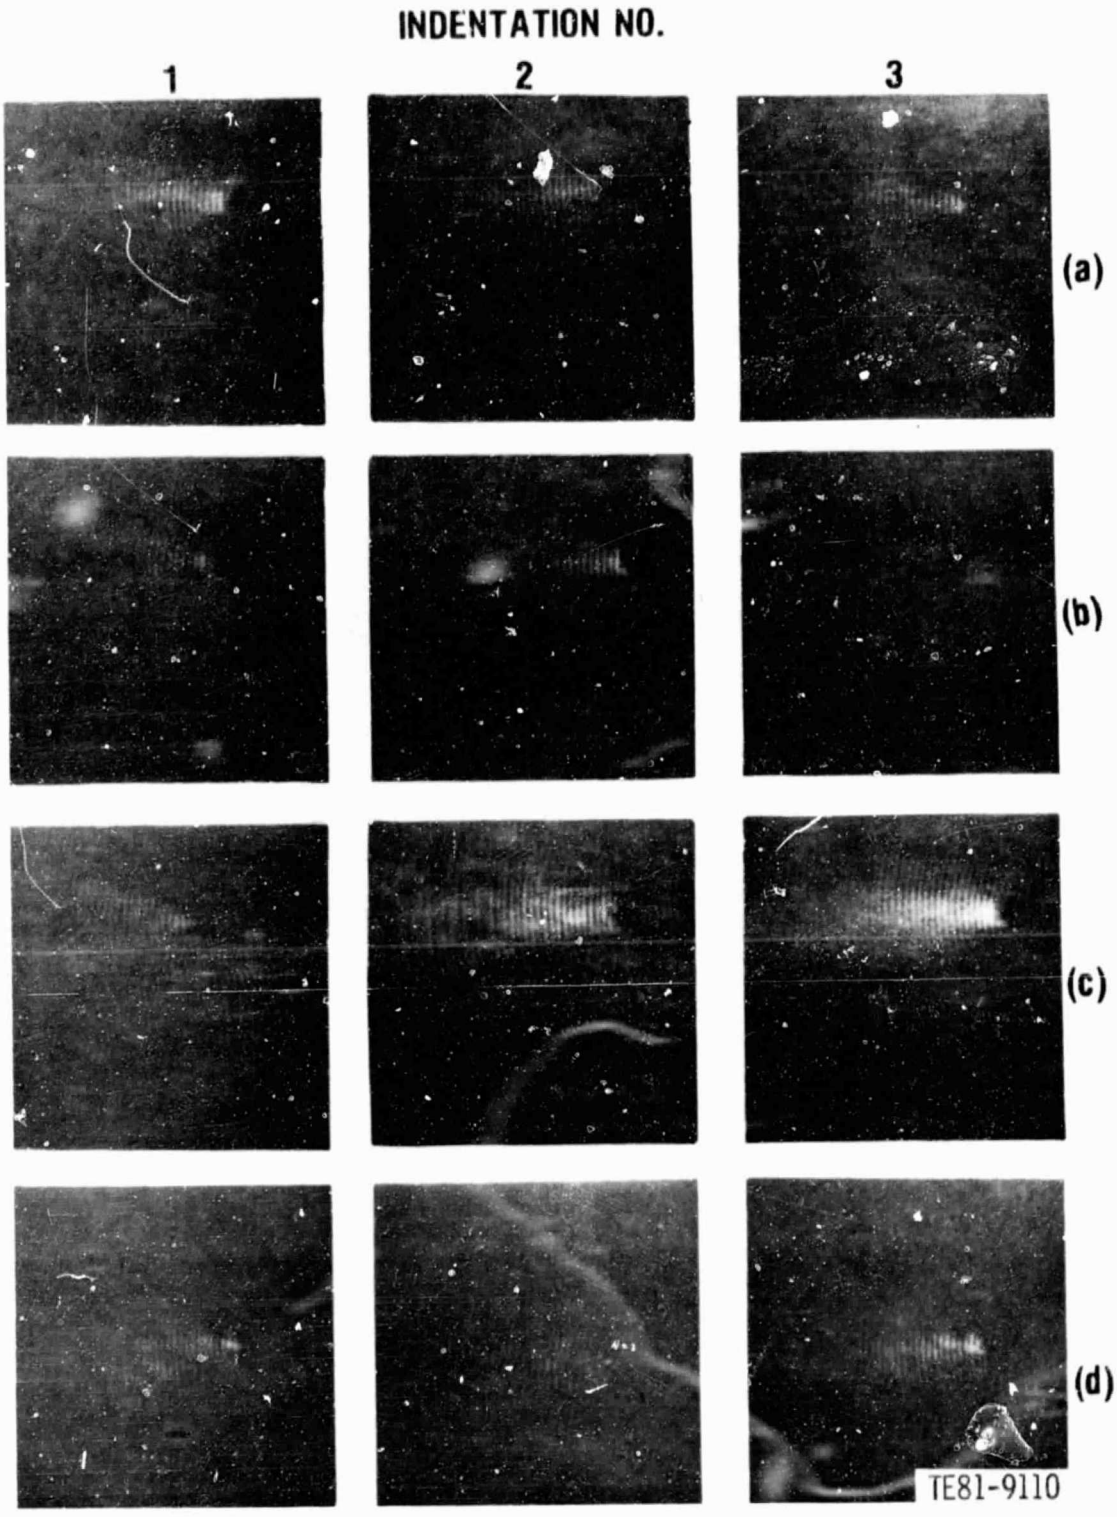
Figure 52. Dark-field interferograms of three 13.73-N (1.4-kg) load Knoop indentations each in specimen 22.0385 (a), 22.0399 (b), 22.0343 (c) without removing indentation damage, and 22.0343 (d) after removing indentation damage.

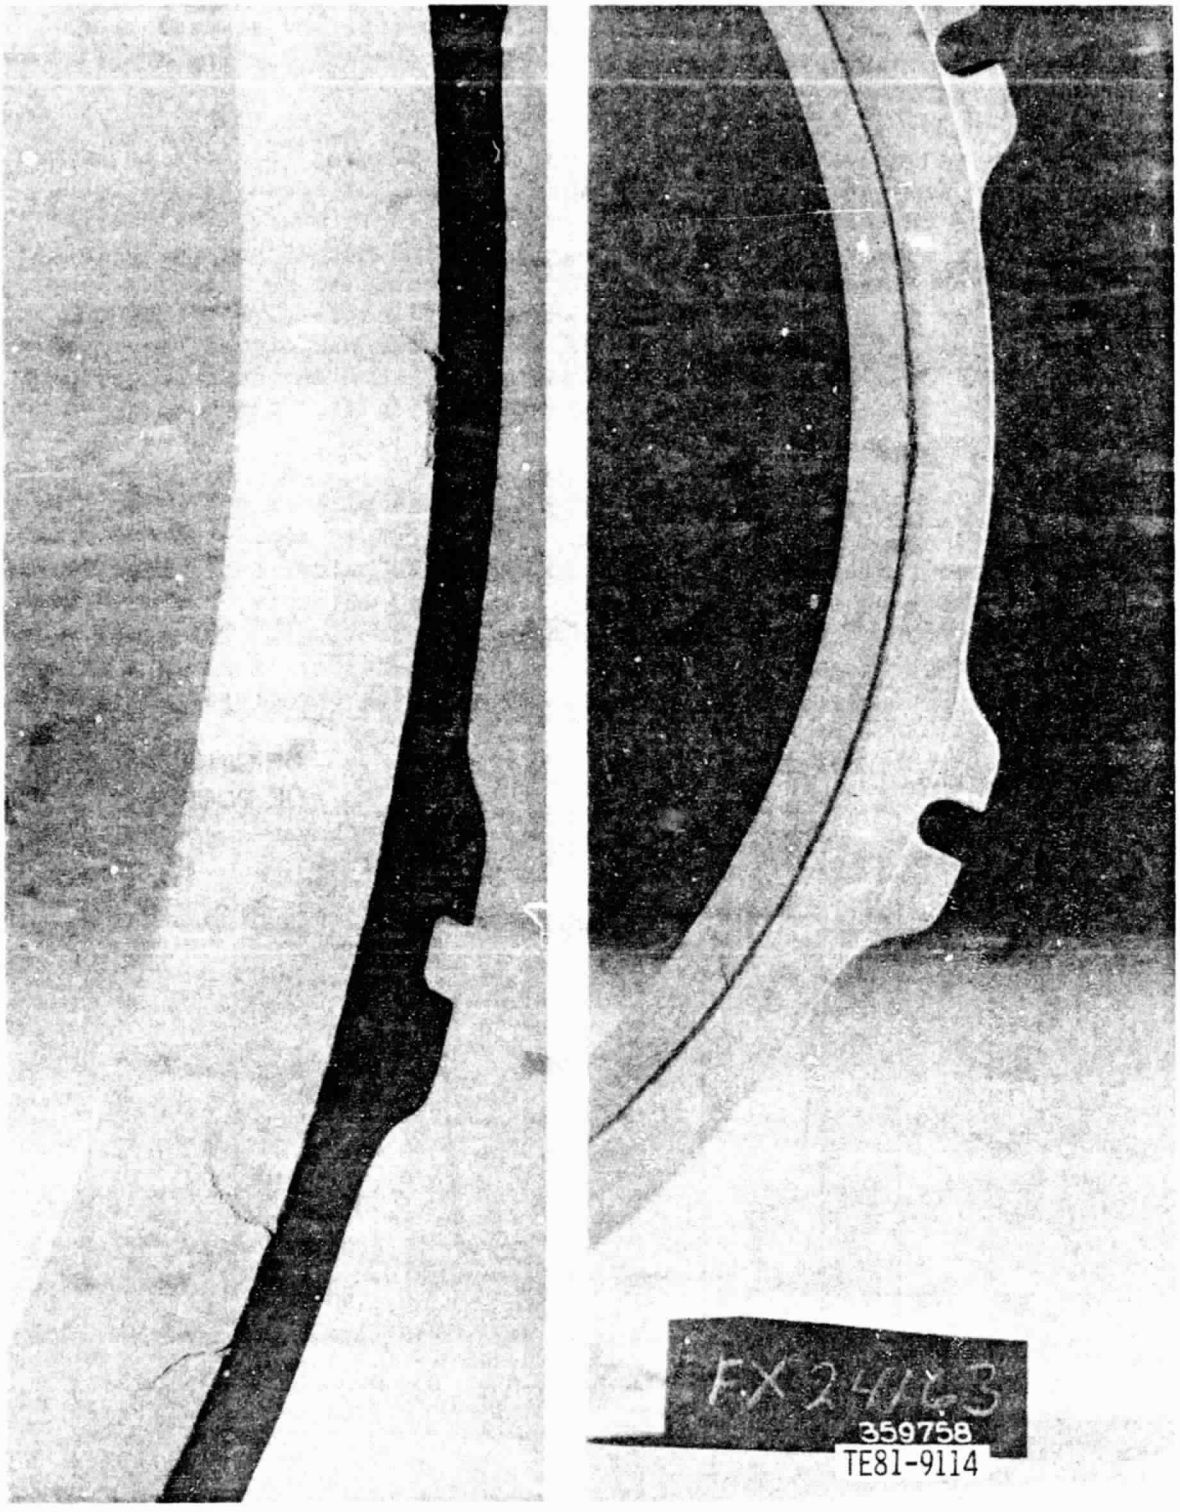
Figure 56. Shroud ring cracks due to improper clamping in green machining.

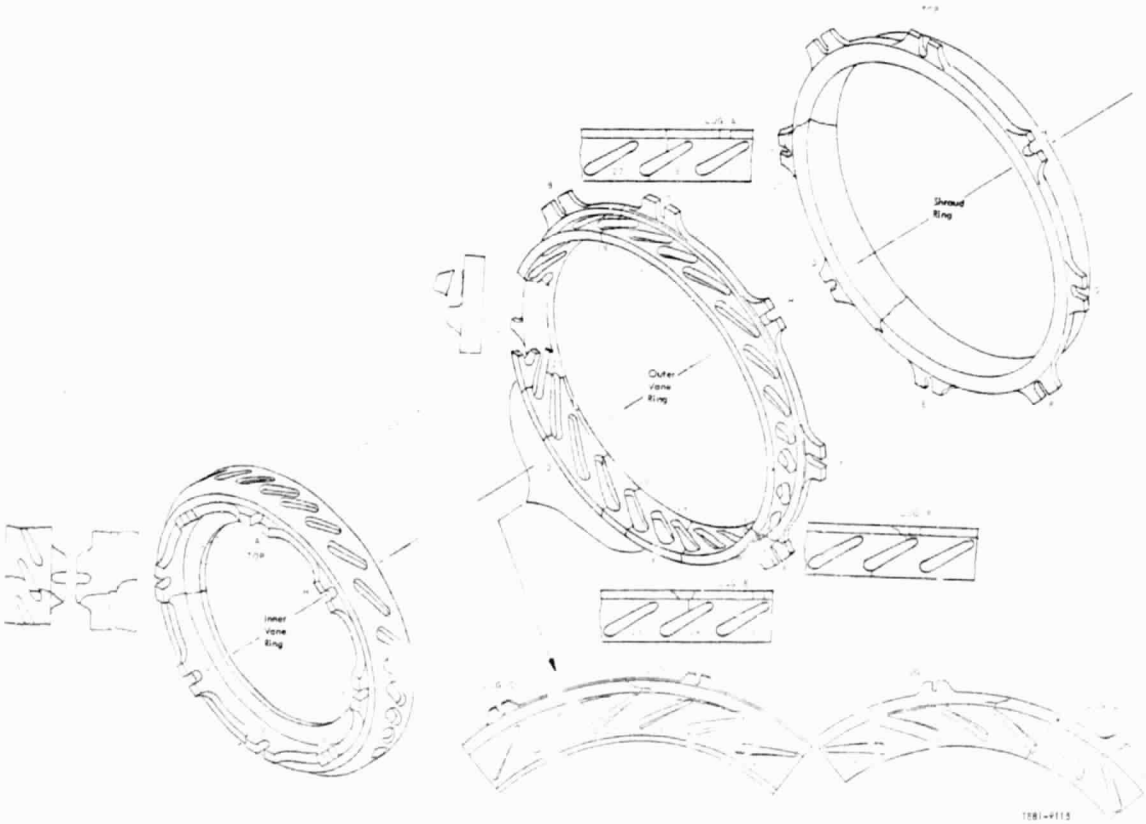
Figure 58. Thermal shock rig test failures (rig S/N 95, BU 1).

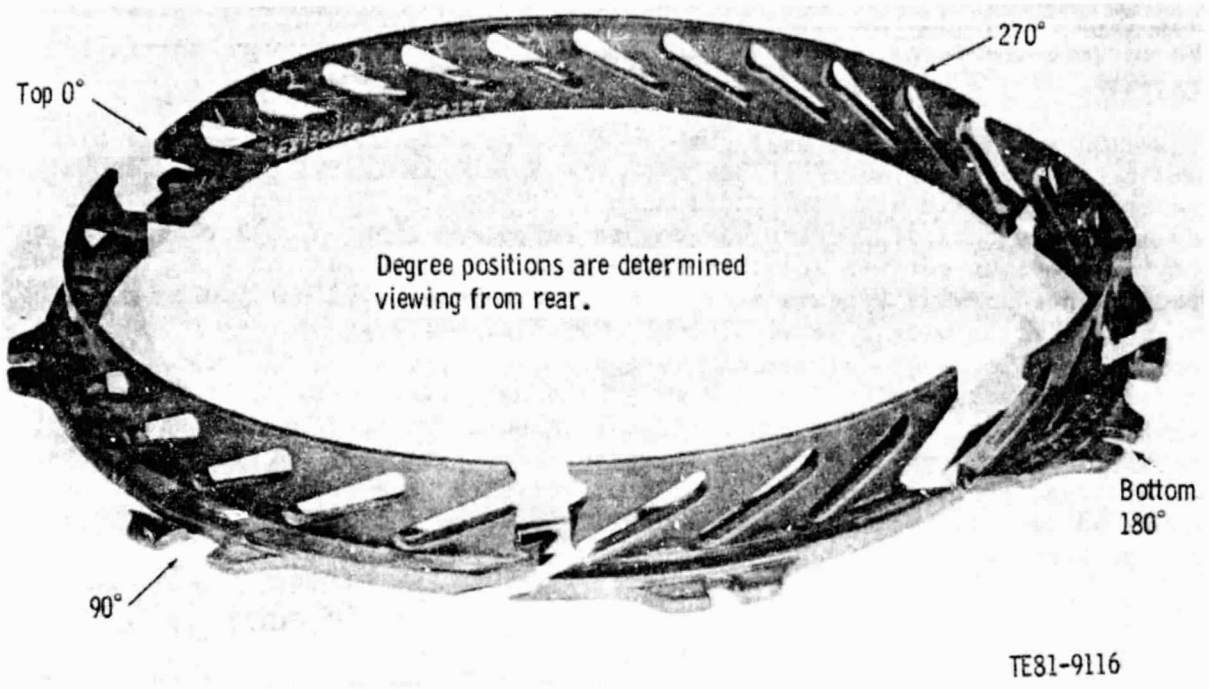
Figure 59. Failed outer vane support ring, thermal shock rig S/N-95, BU 1. Degree positions are determined by viewing from rear.

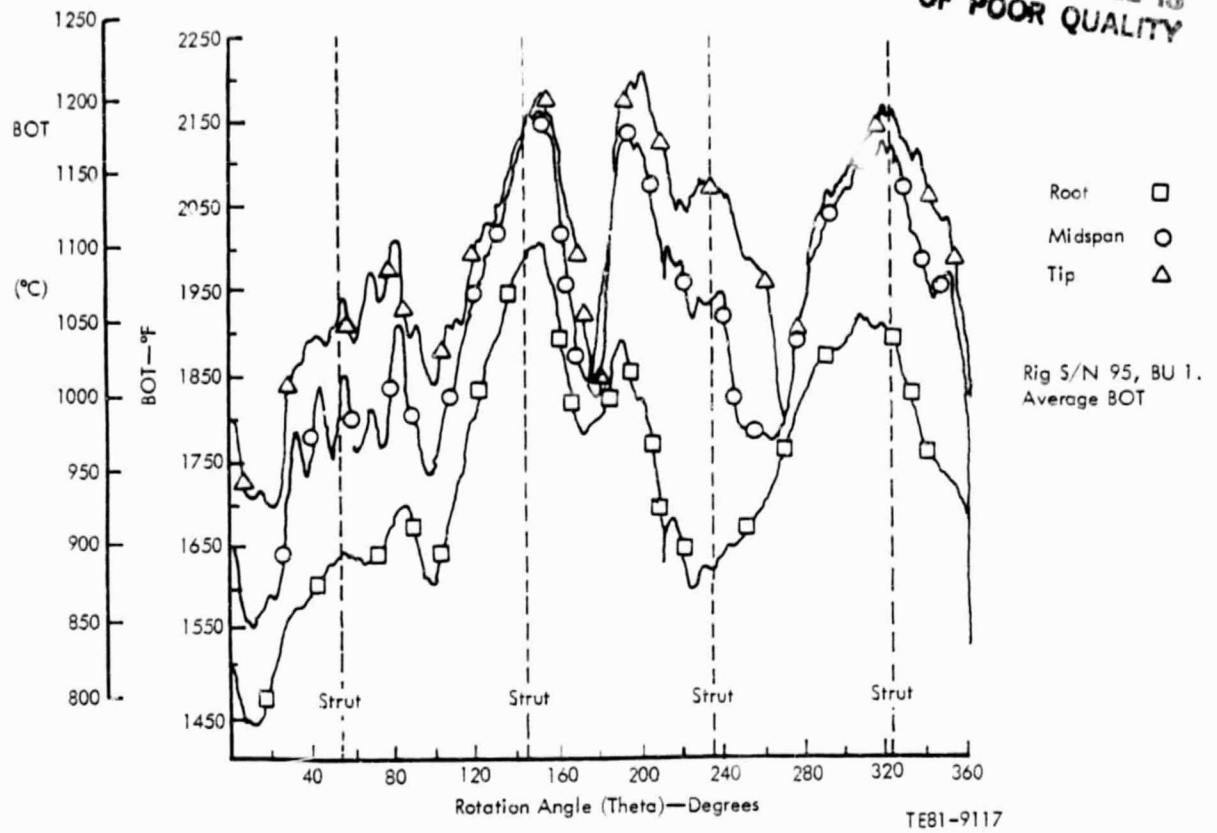
Figure 60. Survey of 2070°F-configuration gasifier nozzle exit showing circumferential temperature gradients.

Figure 60 presents nozzle exit gas temperatures measured at a burner outlet temperature (BOT) of 1027°C (1881°F). The four dips in the circumferential temperature profile are very pronounced. Examination of the test hardware revealed that this distortion was due to secondary flow through the clearance between the four ceramic strut shells and the four openings in the plenum and plenum inner annulus (Figure 61a). This gap is 1.96/1.45 mm (0.077/0.057 in.) in hot operation with a metal plenum. Calculations suggest that this clearance would allow 4.75% of the combustion air to bypass the burner. Depending on the degree of localized mixing of this bypass flow, this amount is sufficient to account for the circumferential temperature profile distortion. Figure 61b shows the revised design in which the clearance gap is blocked with ceramic rope packing held in place by a retainer. The effect of the design rework on the gas path temperature profile will be evaluated in the next reporting period.

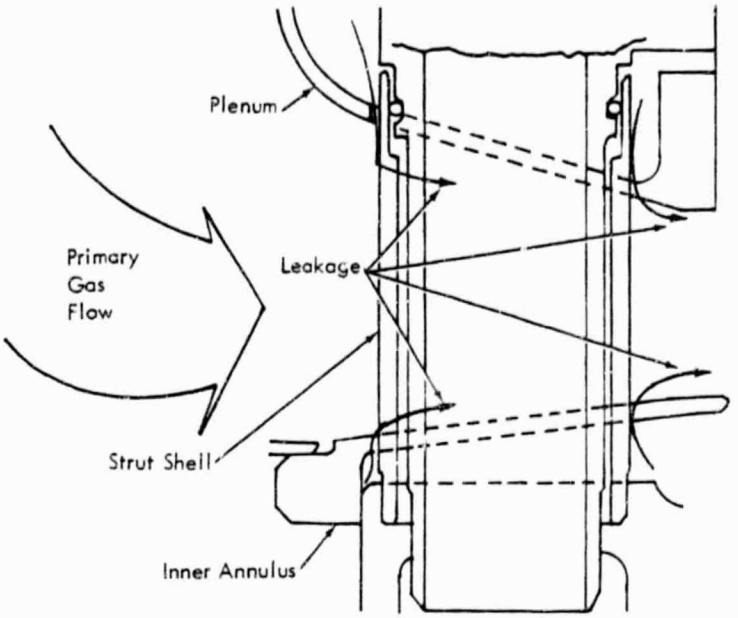
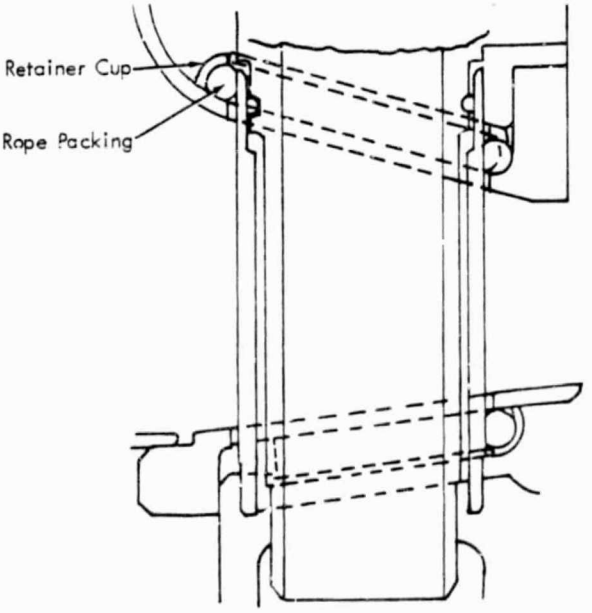
Figure 61. Plenum/inner annulus/strut bypass leakage and design changes.

(a) Original 2070°F-Configuration Design

(b) Plenum/Inner Annulus Strut Leakage
Design Change

Design changes were made to correct this condition. The clearance between the metal alignment peg and the ceramic alignment lug was increased to accommodate thermal distortion of the metal ring. Additionally, the block crossarm cooling circuit design changes, described in the design development section, will cause the inner and outer surfaces of the metal ring to be surrounded with cooling air. This will tend to nullify the effects of uneven heating from the gas path and reduce metal ring thermal distortion. Finally, the ceramic rope packing added to stop the plenum/strut shell leakage should improve the circumferential temperature profile and reduce the uneven heating of the metal support and thus the thermal distortion of the metal ring. These design changes are in progress and will be evaluated during the next reporting period.

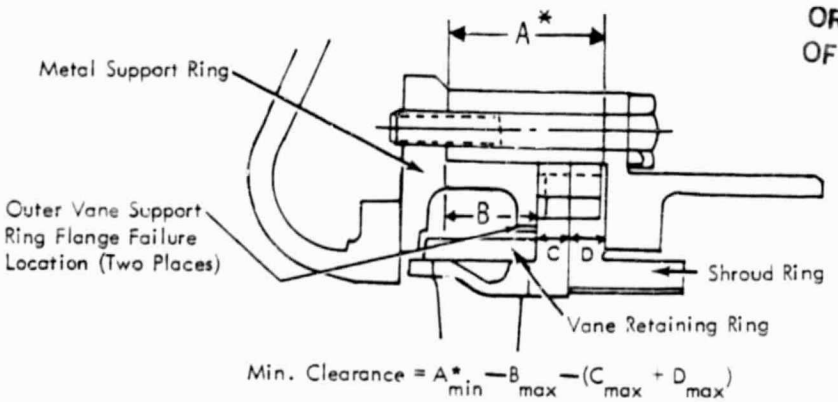
The flange fractures on the ceramic outer vane support ring were found to be the result of inadequate axial clearance between the metal shroud assembly and the outer metal support ring in the hot rig operating condition. The measured axial clearance was at the print minimum that would result in 0.015 mm (0.006 in.) clearance on a transient heat-up. This minimum clearance was probably consumed when the metal shroud assembly operated at the cooler temperature caused by the water-cooled structure on the thermal shock rig. The ceramic rings showed evidence of contact stress failure at the two flange failure origins. The two metal rings also had evidence of localized contact, with burnishing at the point of ceramic ring failure. Figure 62 illustrates how the outer metal shroud assembly (dimension "A") would be made smaller by cooler operation, resulting in a reduction in the minimum clearance of 0.015 mm (0.0006 in.) and a metal-to-ceramic interference. The metal shroud operating temperature has only to decrease by 20°C (68°F) for this interference to occur.

Minimum Clearance		
	Print	Rig S/N 95 BU 1 Measured Dimensions	Rig S/N 2 BU 29 Measured Dimensions
Build	0.279 mm (0.011 in.)	0.279 mm (0.011 in.)	0.406 mm (0.016 in.)
Transient	0.015 mm (0.0006 in.)	0.015 mm (<0.0006 in.) Failure Condition	0.142 mm (0.0056 in.)
Operation	0.150 mm (0.0059 in.)	0.150 mm (<0.0059 in.)	0.277 mm (0.0109 in.)
Ring Fracture	—	Yes	No

*Dimension "A" on rig S/N 95 did not thermally grow as much as on engine or rig S/N 2 due to cooler part temperature.

This situation was corrected as a result of the block crossarm cooling system redesign. Figure 63 shows how providing a cooling passage for the strut and containment ring cooling flow removed the axial interference. Axial positioning of the outer ceramic rings is now accomplished by the vane retaining ring

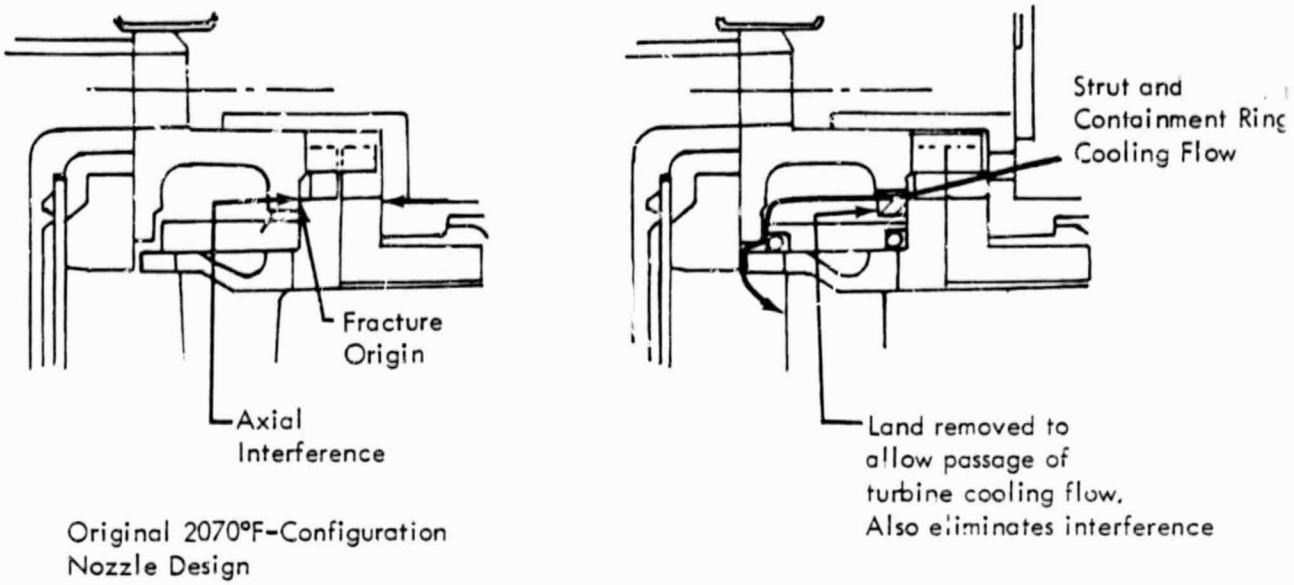
Figure 63. Design change to eliminate outer vane support ring flange failure.
