DOE/NASA 0017/3
NASA CR-165494
DDA EDR 10672

CERAMIC APPLICATIONS IN TURBINE ENGINES

Progress Report for 1 July 1980 to 31 December 1980

Detroit Diesel Allison Division
General Motors Corporation

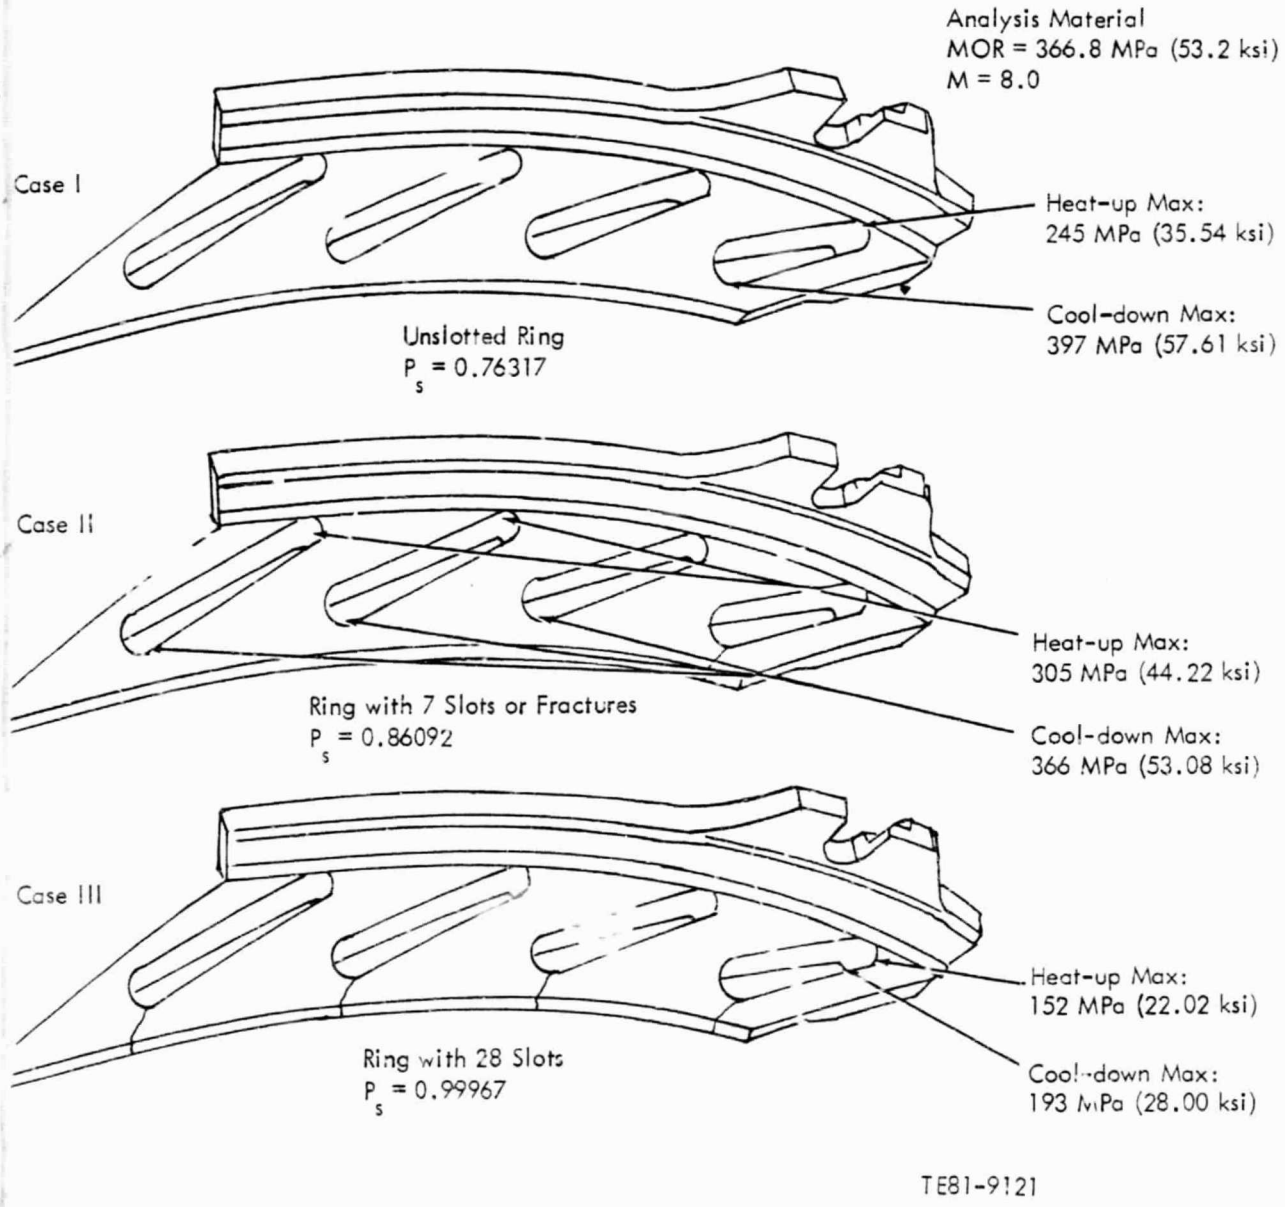
Figure 64. 2070°F-configuration ceramic nozzle outer support ring fracture analysis.

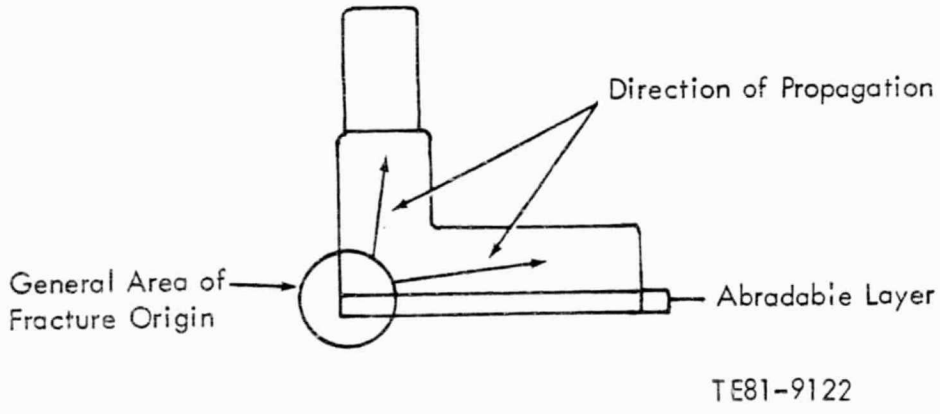
Figure 65. Axial fracture in 2070°F-configuration shroud ring.

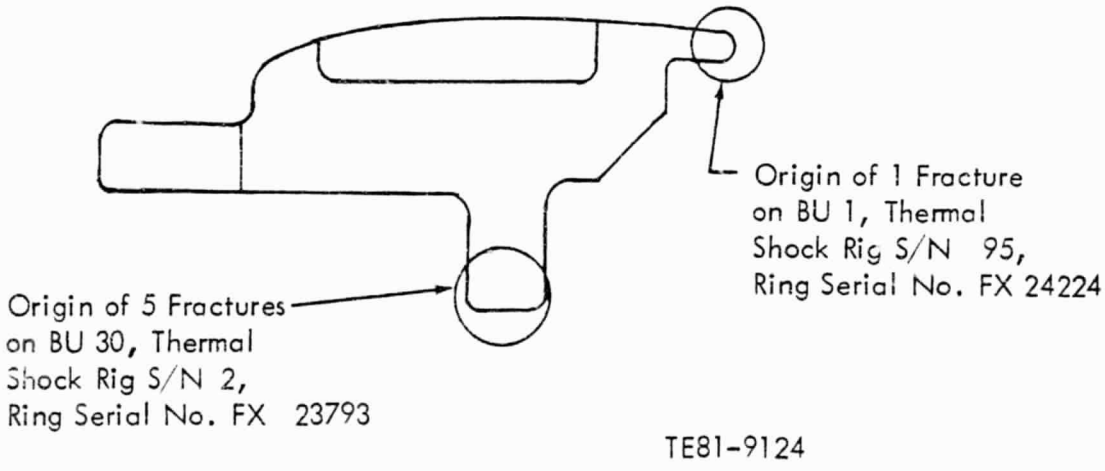
Figure 67. Fracture locations on failed inner vane support ring.

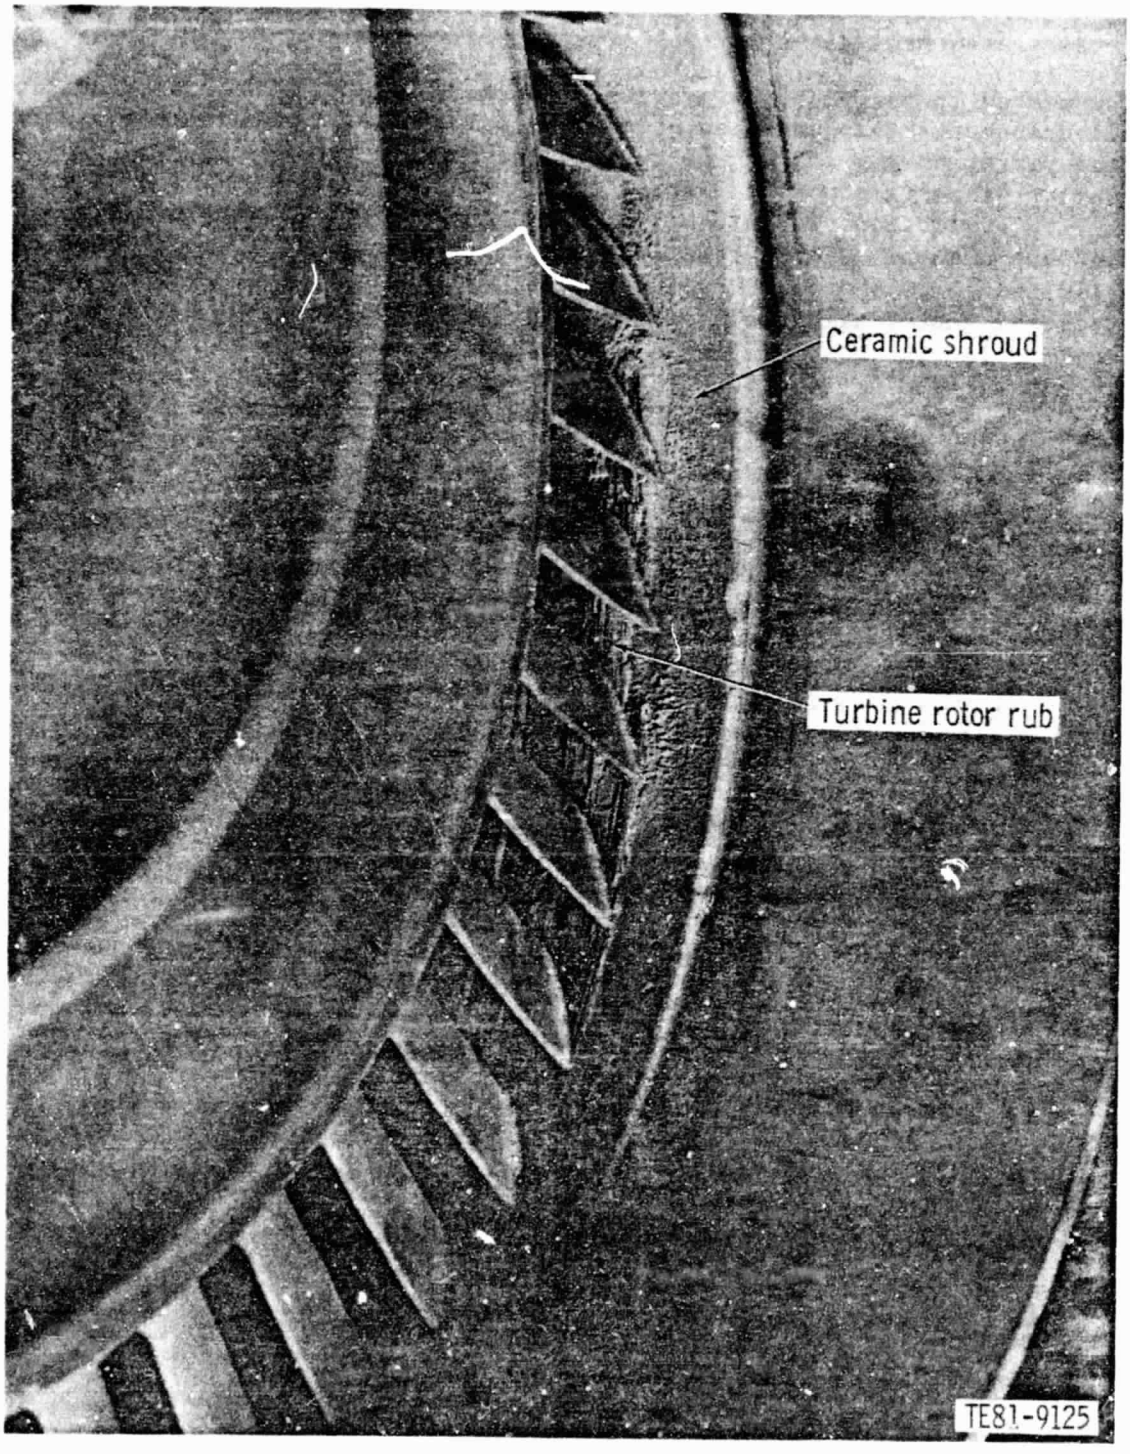
Figure 68. Ceramic turbine shroud after rotor rub (engine C-4, BU 6).

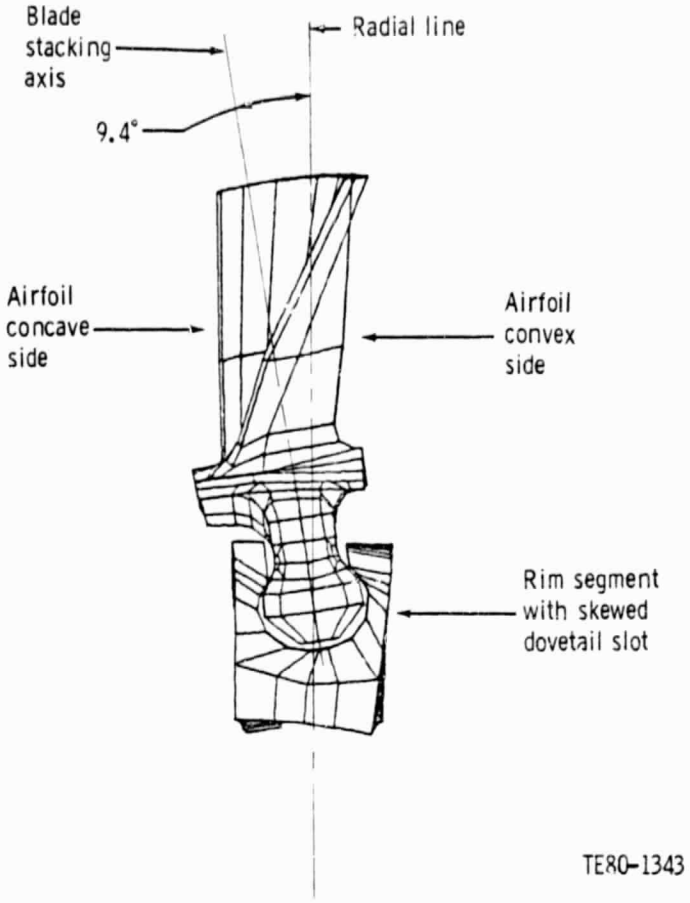
Figure 72. Slot rotation one.

1. Broach rotation 0, no change from the engine blade mounting configuration;
2. Broach rotation 1, a slot rotation of 9.4° toward the concave airfoil surface, as shown in Figure 72;
3. Broach rotation 2, the 9.4° slot rotation plus a 4.7° tilt of the slot that provides a radial stack of the airfoil tip and hub section centers of gravity.

The effect of spin test on blade reliability in the 3-sec acceleration condition has been established for each slot position (Table VIII). It appears that the alternate slot positions evaluated will not improve airfoil reliability by spin proof testing up to 43,250 rpm (117%), and testing above that speed will result in more than 10% loss in proof test. Further rotation or tilting of the slot does not seem practical because locally high stresses could result from abnormal contact points in the attachment.

Further study is warranted, but analysis of skewed mounting slots is being discontinued at the present time. Currently, the approach to improving overall blade reliability centers on design of a new airfoil with reduced hub setting angle and improved attachment stress distribution. If airfoil stress distribution cannot be improved in transient conditions, improved material strength will be a more significant factor in providing blade reliability.

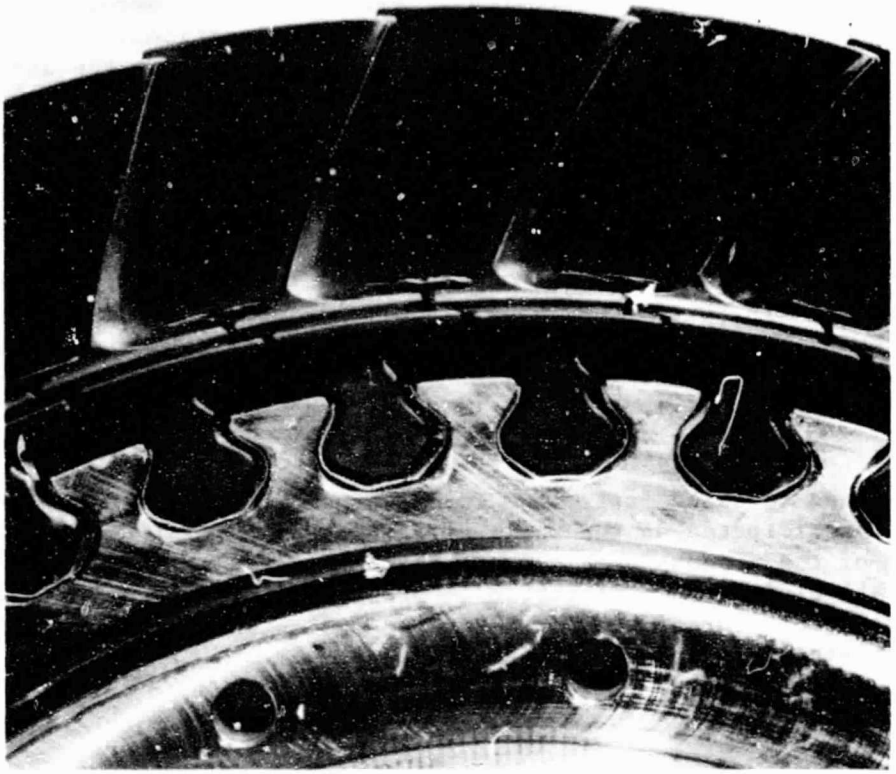
Figure 73. Ceramic-blade rotor prior to coverplate installation.

With rivet procedures established and proof-tested blades available, the first rotor build was initiated. Blades and compliant layers mounted in the disk prior to installation of blade retaining plates are shown in Figure 73. These plates are retained with rivets installed through the holes shown. This partial assembly with blades wedged outward was made to permit measurement of blade tip radii and platform seal radii. Some variations in specified radii at the seal and tip were shown to exist on the blades, apparently as the result of errors in fixturing that produce blades of correct tip radius at the stacking axis only. The blade tip is short near the trailing edge, but long near the leading edge. Runout with a typical blade is 0.13 mm (0.005 in.) at the tip and 0.19 mm (0.0075 in.) at the platform lip seal. This condition was felt to be acceptable for initial spin testing and hot simulator testing.

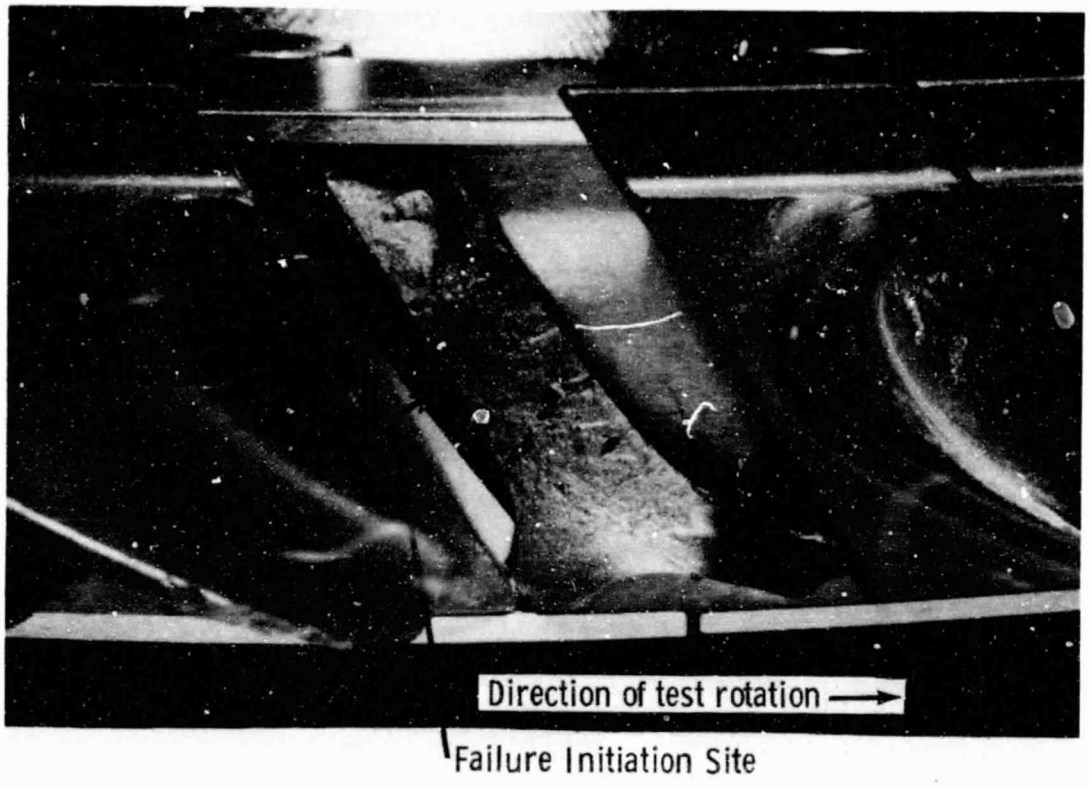
Figure 75. Ceramic blade failure, rotor assembly spin test.

A single blade failed and only minor damage was incurred by the other 39 blades. The failed blade, lower portion, is shown in Figure 75 as installed in the rotor and after removal from the disk. The fracture originated in the stalk region above the attachment. The origin was on the surface and a flaw cannot be found with microexamination. This location corresponds to the zone of maximum calculated stress in the blade stalk and had been an initiation

An extensive failure investigation was initiated immediately after the assembly test and has broadened as information becomes available. This situation is particularly interesting since the failed part had been previously spin tested to 110% speed and then failed at 93% speed and a flaw is not apparent at the surface failure origin.

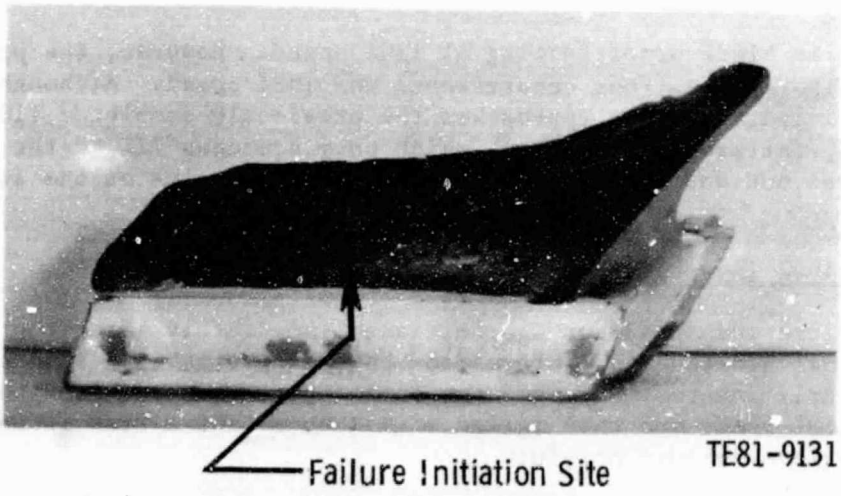
blades were individually spin tested to 110% engine speed, with 42 (81%) passing. From these a rotor was assembled and tested to 93% engine speed, when one blade fractured, causing minor secondary damage to several others. Some of the observations made regarding this test included failure upon retest at lesser load; known lower part strength than bar strength; failure in the stalk (above attachment), which is only a secondary stress level area; and the appearance of a glassy layer on the blade surface after preoxidation to recover strength loss realized with machining. Because of these results, numerous material evaluations, special mechanical tests, examination of the failure surface of many blades and test bars, examination of the finite element analysis, and a statistical examination of the test sequence were initiated. It has been shown that the variations in the attachment method (compliant layers, dovetail slots, system friction, etc.) can produce a significant failure probability upon retest, even at reduced speeds. Sixty-two blades have now been spin tested to 117% rotor speed, with 48 being qualified. These will undergo a second 117% spin early in the next report period, followed by a rotor spin test at 108% speed to yield a rotor with a high probability of survival upon engine operation at 100% speed.

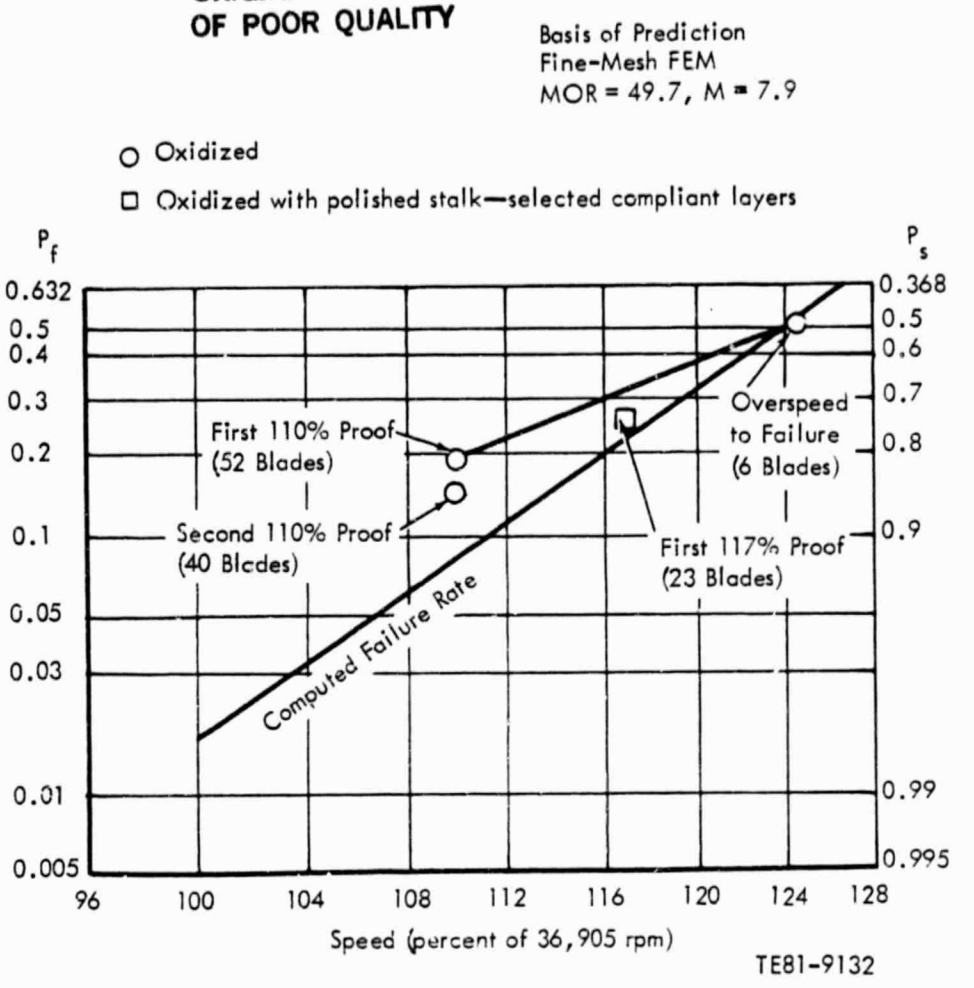
Figure 76. Reliability of 2070°F-configuration blades.

For ease in discussion a summary of spin test data is presented in Table IX. By using these data, the failure rates for some of the tests have been determined and are presented in Figure 76 for comparison with the computed failure rate speed. The following observations are made:

These results obviously do not reflect a simple proof test.

A plausible model to explain this phenomenon is that the "proof test stress level" is not constant from test to test, but is itself a random variable defined by an unknown distribution. The cumulative probability of failure of the parent population of blades is described well by a Weibull distribution in terms of rotational speed based on blade material strength data. Inasmuch as many factors could influence the value of proof-test level, it is assumed that this random variable is normally distributed about the nominal proof-test speed.

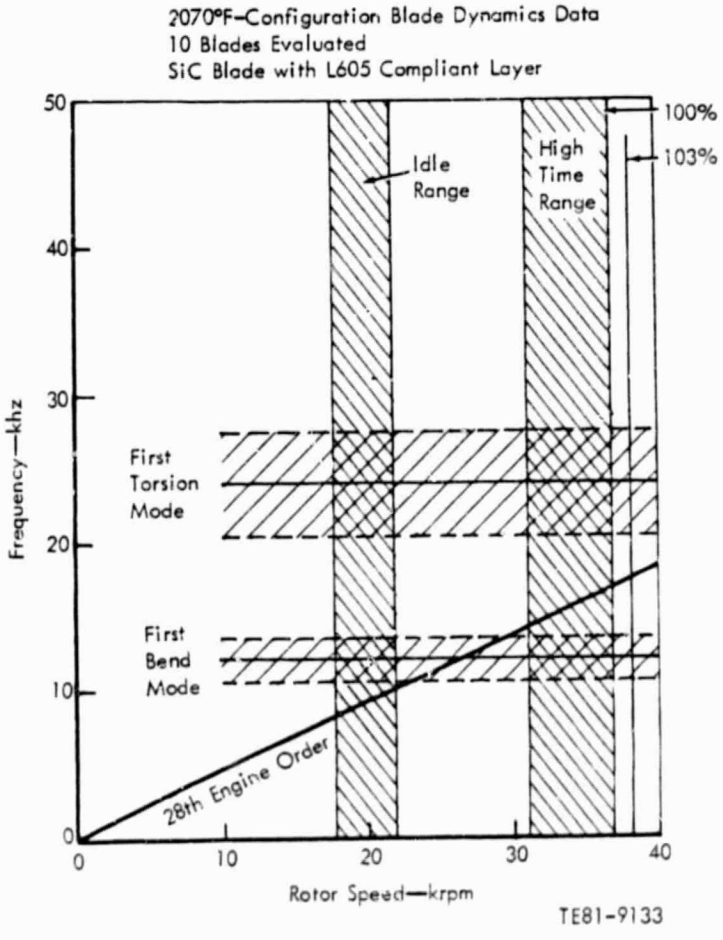
Figure 77. Measured 2070°F-configuration ceramic blade dynamic characteristics.

The data are also shown versus engine rpm in Figure 77. The frequency range shown is 3 standard deviations in measured data. Interference with mean fundamental mode and vane passage frequency is at 26,000 rpm. This is slightly lower than computed with a "fixed" blade attachment, which indicates a similar interference at 29,000 rpm in Figure 78. This reduced frequency probably indicates reduced fixity in the test case (which is felt to simulate the engine loading and structural damping). Study of the data continues and additional testing is planned, but the nominal result is essentially as anticipated.

Study of data obtained also indicates that blade frequency in the first two modes is only slightly affected by changes in base load over the range evaluated. Further, changes in compliant layer material or repeated loading and unloading of the base ram to improve compliant layer seating had minor effects on frequencies.

An unexpected result of this testing was the multiple frequencies observed in the first and second modes, i.e., a single blade responds at more than one frequency in the fundamental mode and in the second mode. This phenomenon is being studied further and more testing is planned.

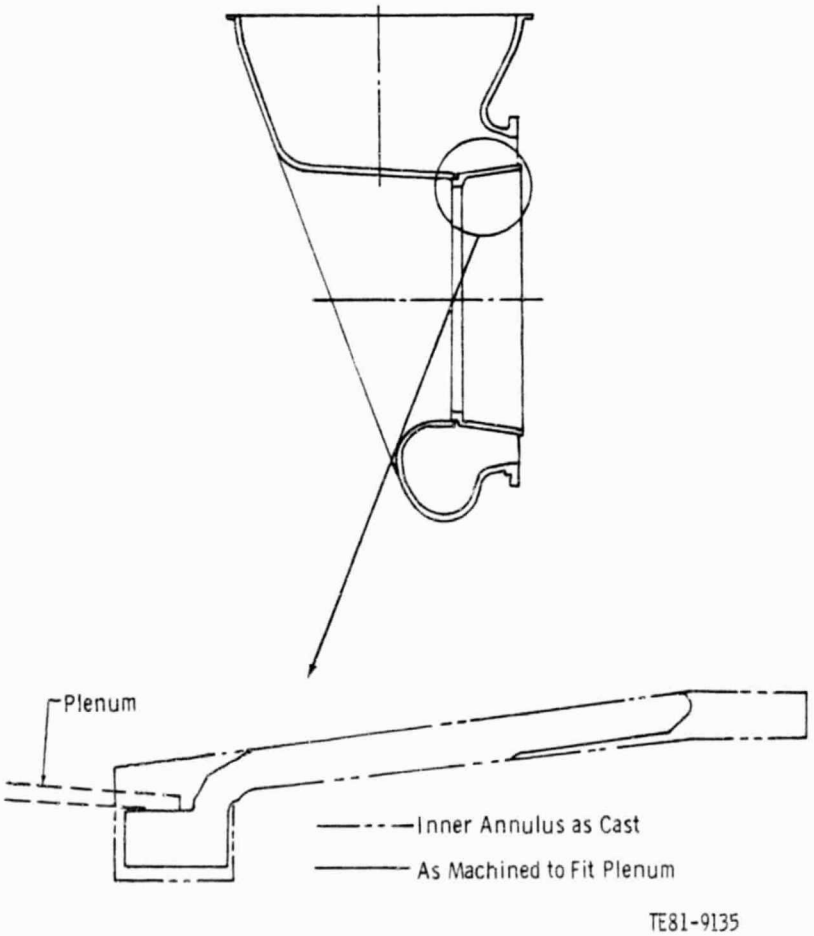
Figure 79. Location of plenum's deviation from drawing.

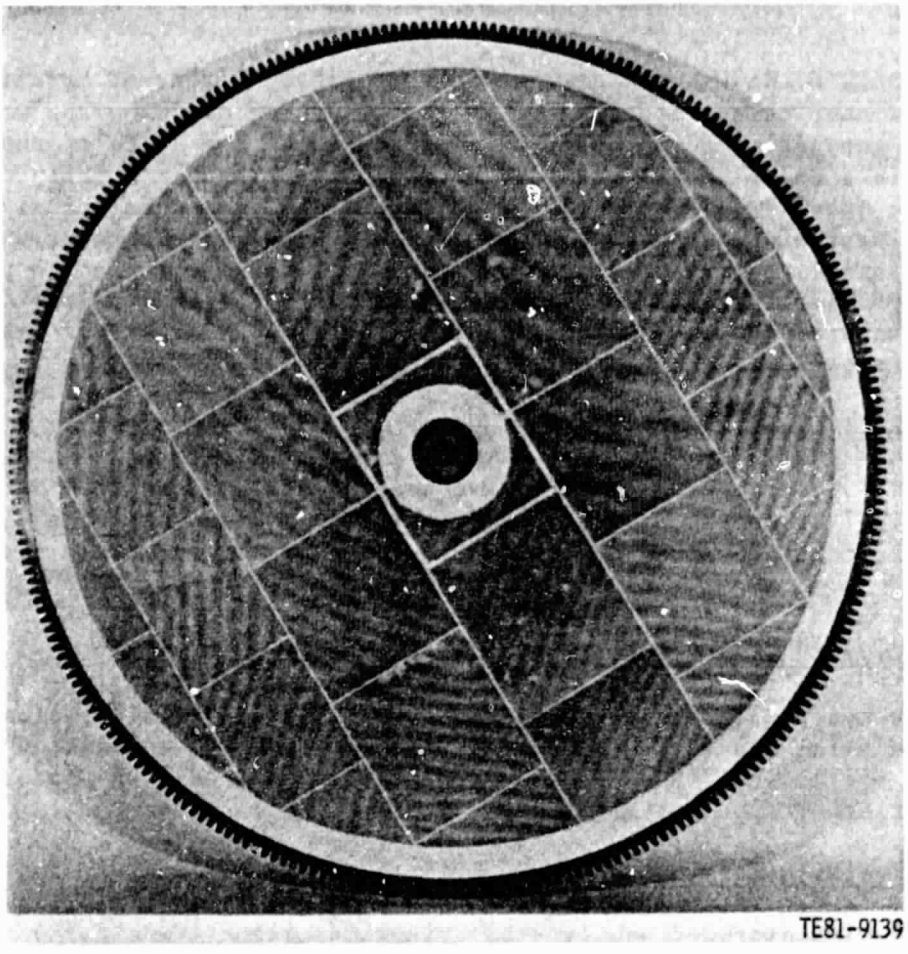
Figure 83. NGK-Locke extruded regenerator disk.

A second disk with extruded equilateral triangular magnesium alumina silicate (MAS) matrix supplied by NGK-Locke was tested at gas inlet temperatures up to 642°C (1186°F). This disk was a cemented mosaic of 36 rectangular pieces, as shown in Figure 83. The solid ceramic support hub cracked loose from the matrix between the cement and matrix. Since the joint was still quite tight and the crack was not observed until the disk had cooled, the crack probably occurred on cool-down. Higher expansion rates of the MAS matrix and hub make expansion match more difficult and transients more of a problem. NGK will investigate hub material and cement changes.

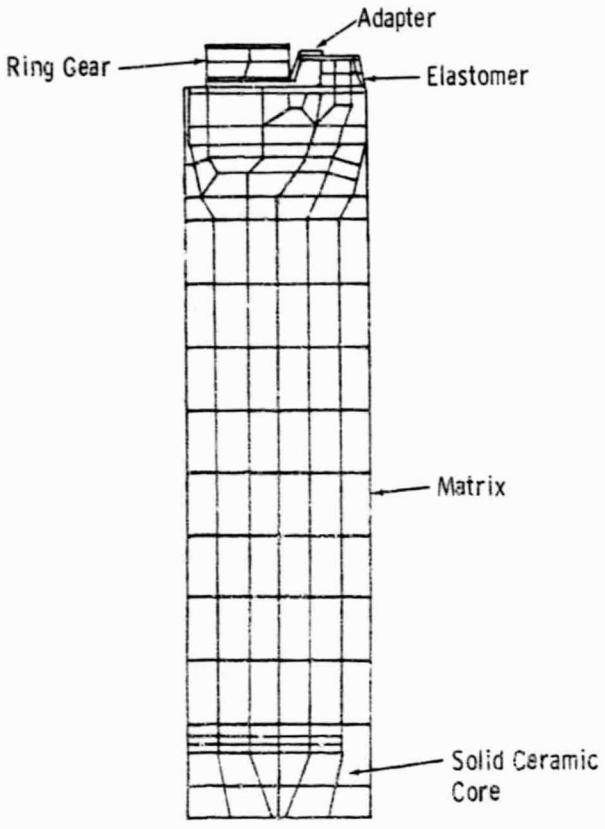
Figure 84. Finite element model.

Since two of the failures occurred within a few corrugations of the hub/matrix interface, some explanation was sought for the actual occurrence of high stress in that region. Previously, only axisymmetric pressure loading had been applied to a finite element model consisting of axisymmetric elements (Figure 84). The resulting radial and tangential normal stresses at the matrix/hub interface were small. Non-axisymmetric load distributions that had been previously applied to this model were much less concentrated and localized than mechanical load distributions occurring in the actual system.

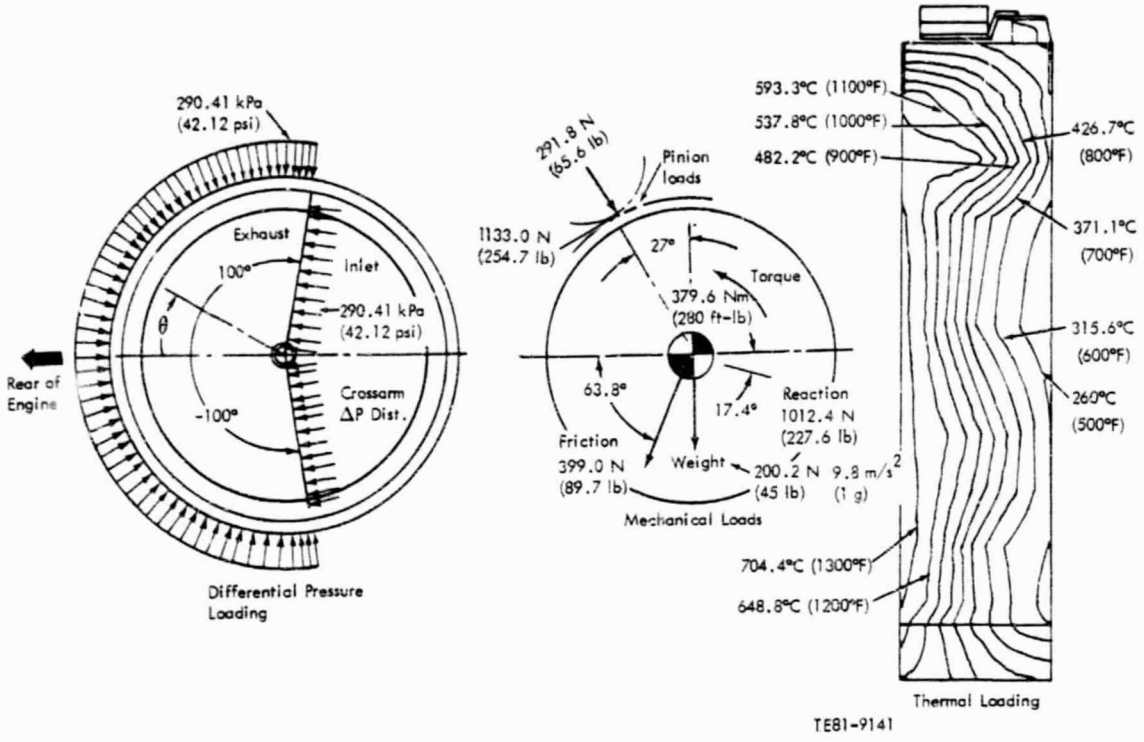
Figure 85. Differential pressure loading.

To remedy these deficiencies, an analysis was made by summing a large number of "harmonic" solutions to obtain a reasonable simulation of the actual complex mechanical and pressure load distributions. As shown in Figure 85, non-axisymmetric pressure distributions are caused by pressure drop across the cross-arm seals. The mechanical loads are due to the pinion drive gear force, the friction drag on the seals, and the weight.

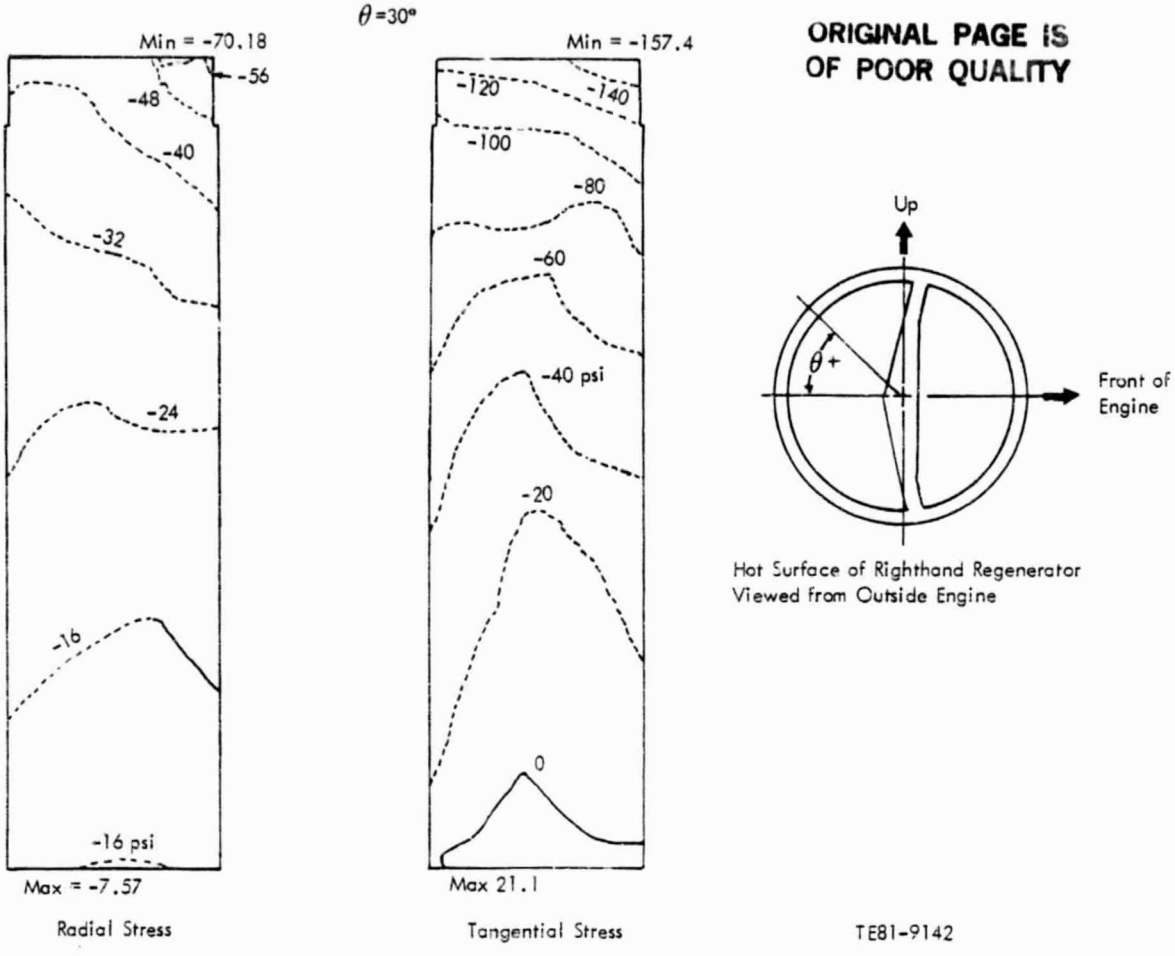
Figure 86. Matrix stresses.

The highest normal stresses predicted by the detailed analyses were predominately compressive, due to pressure, and primarily confined to the low-pressure rim of the core. Figure 86 shows radial and tangential isostress plots at a circumferential location in the model near where the peak values of these stresses occurred. The peak radial and tangential stresses occurred at the inboard edge of the interface between the elastomer and the matrix. The highest value of the radial stress was 492 kPa (71.2 psi), and the maximum tangential stress was 1112 kPa (161.2 psi). The circumferential variation in radial and tangential stress at the location of the maxima is shown in Figure 87.

The two core failures that occurred in the vicinity of 26.7 cm (10.5 in.) radius were in a region of relatively high radial stress. A statistical analysis of available strength data indicated that the radial stress was in a much more critical relationship to strength than the tangential stress.

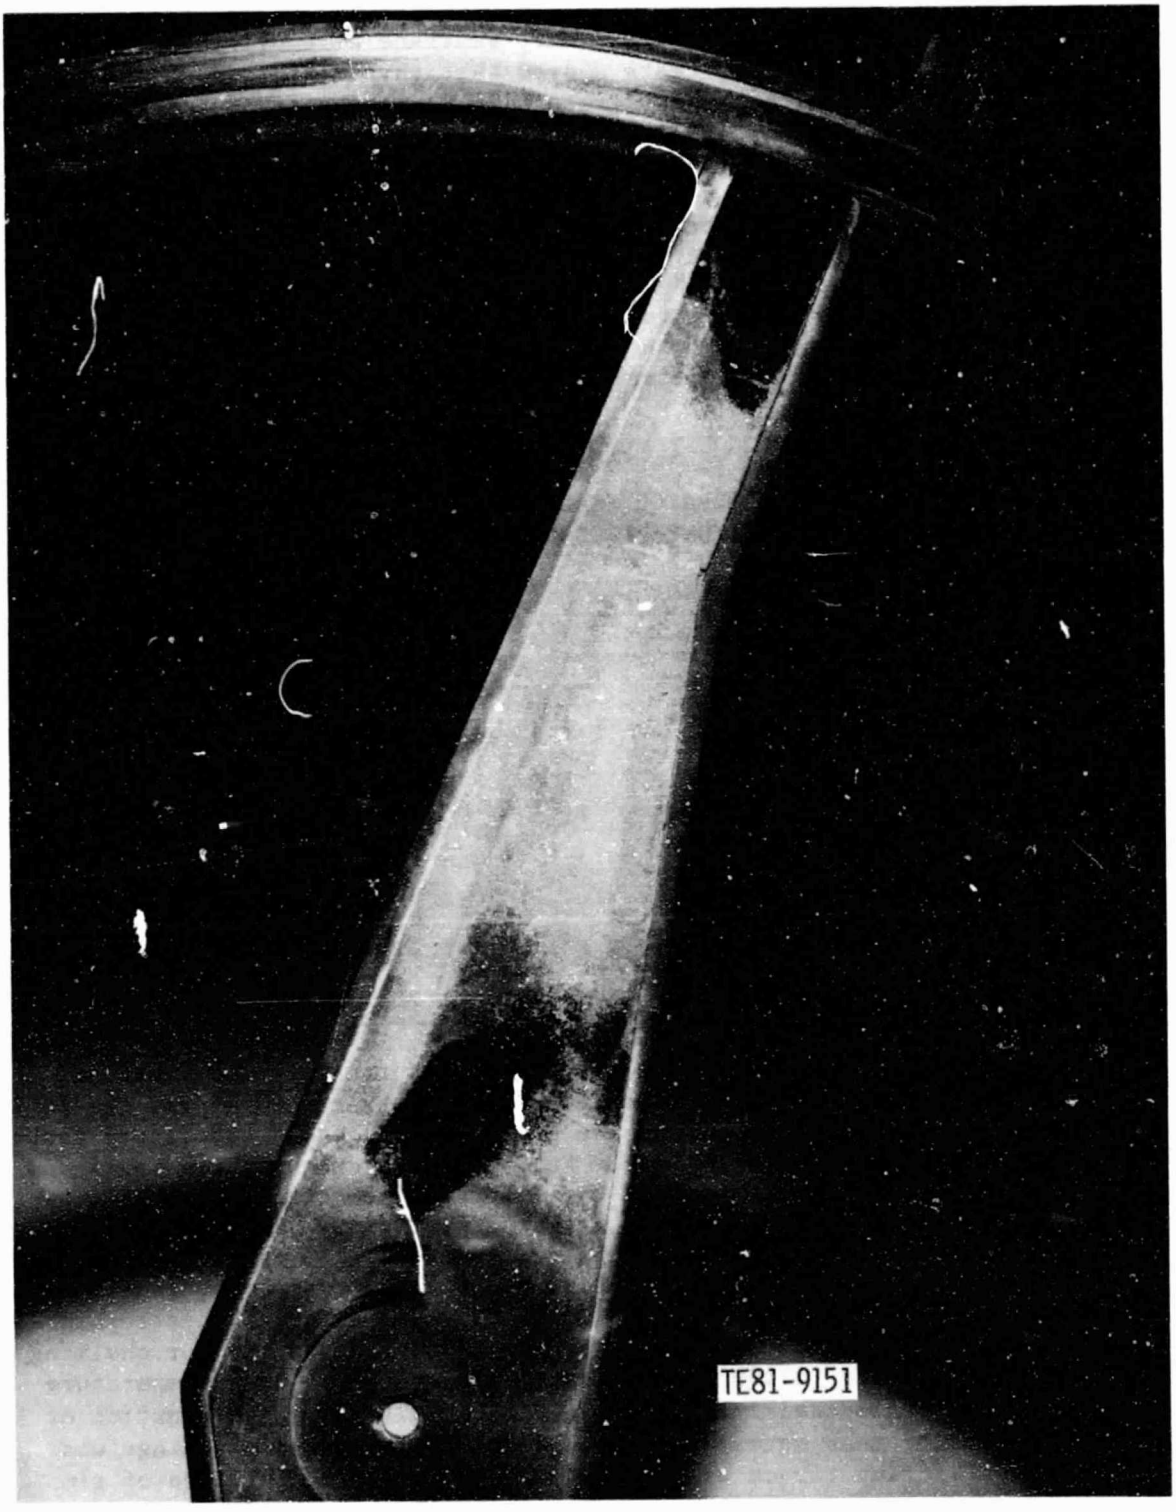
Figure 96. Wearface chalking after 50 hr of 982°C (1800°F) rig testing (negative crossarm).
