NASA
Technical
Paper
2153

Buckling and Failure Characteristics of Graphite-Polyimide Shear Panels

Mark J. Shuart and
Jane A. Hagaman

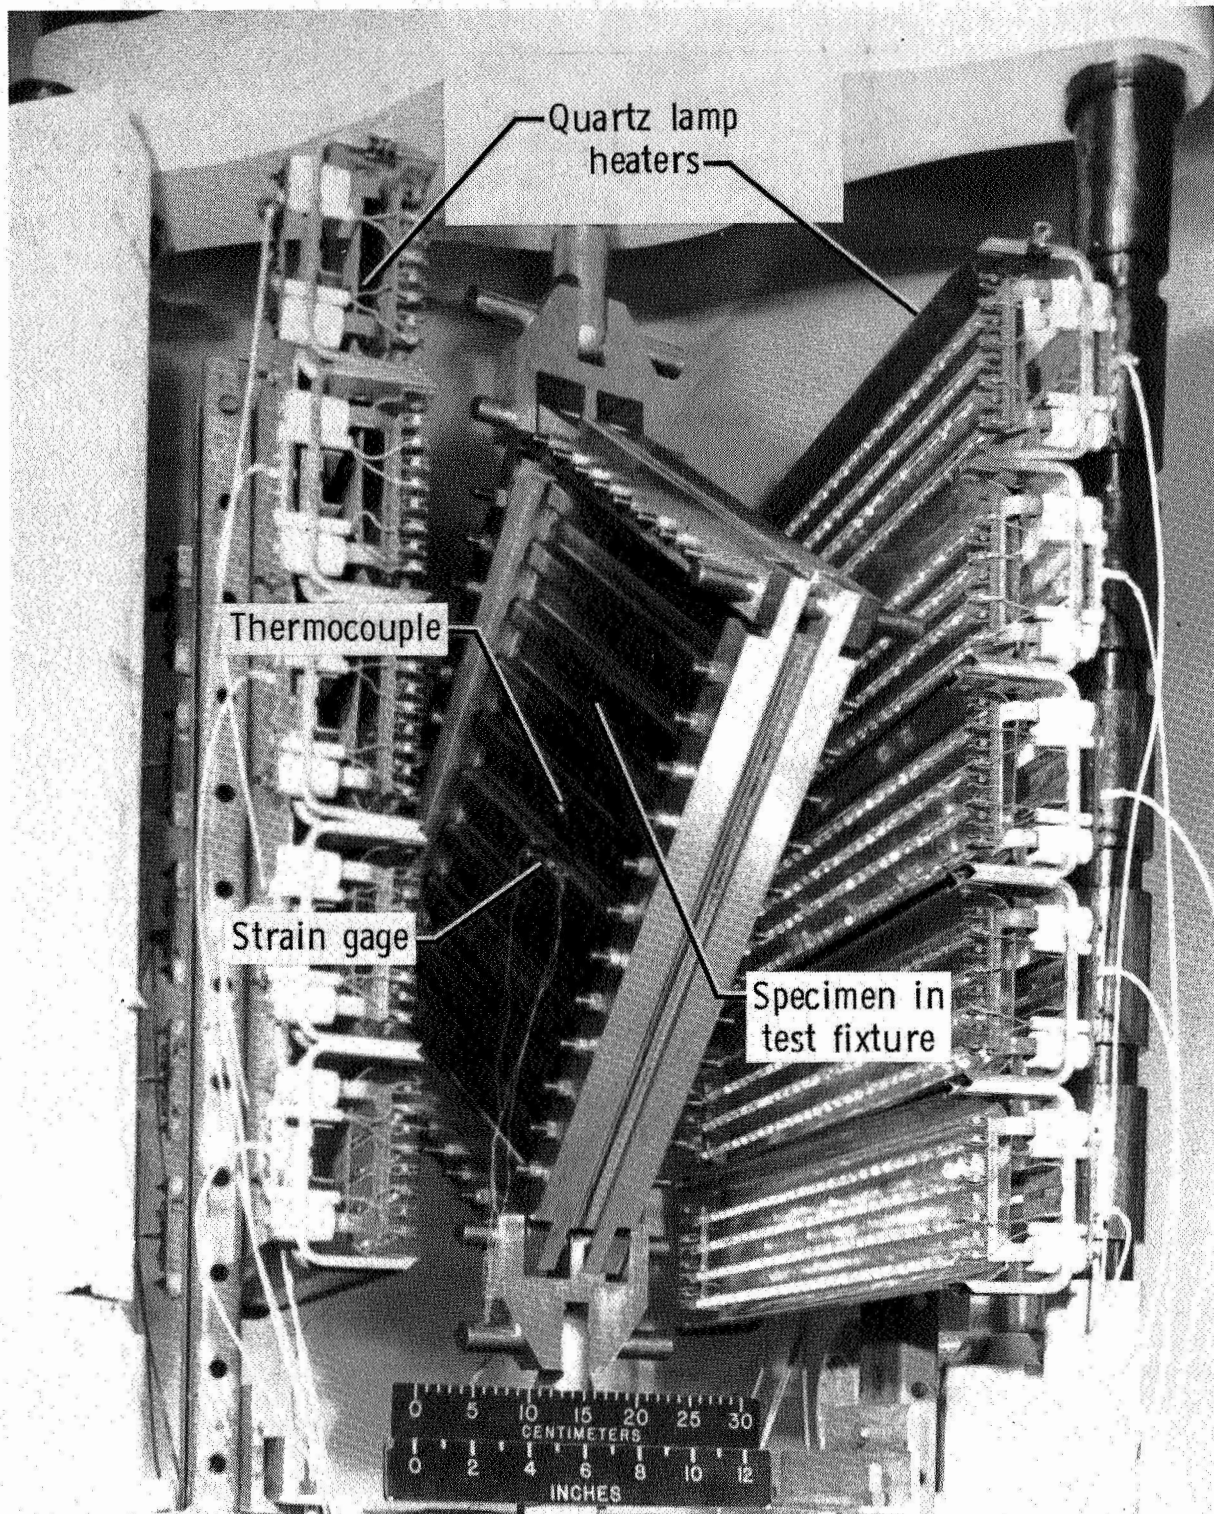
Figure 4.- Test apparatus.

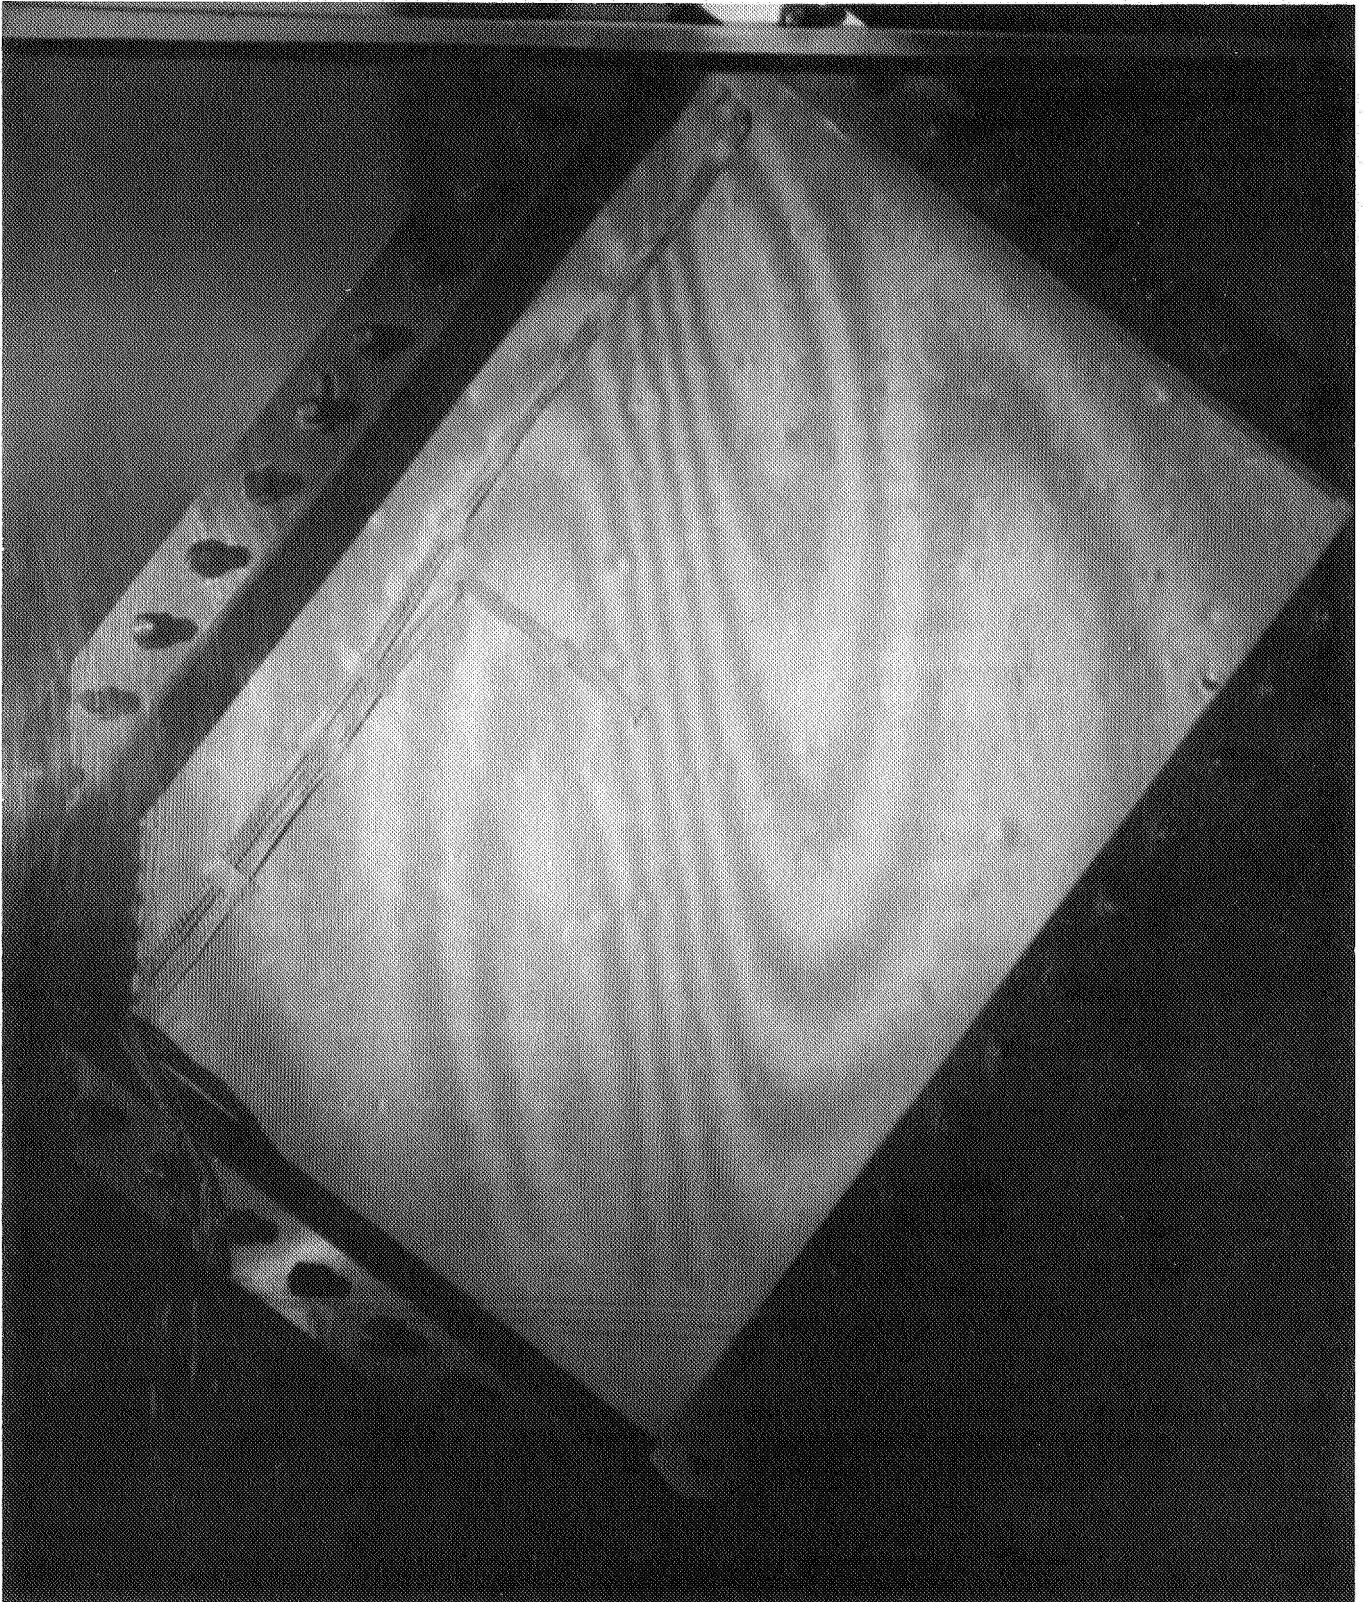
Figure 5.- Moiré-fringe pattern of unstiffened skin buckling mode prior to failure.

For tests at room temperature, the moiré-fringe technique was used to monitor out-of-plane deflections. A typical moiré-fringe pattern of the skin buckling mode

prior to failure is shown in figure 5. The moiré-fringe technique was not used for the elevated temperature tests.

buckling mode (fig. 7), which agrees with experiment as shown in figure 5 (the buckling mode shape did not change during the test). The analysis predicted a blade-rolling mode for the blade-stiffened panel and a local or short wavelength buckling mode in the unstiffened region (fig. 8) between the reinforcements and the start of the stiffened skin for the hat-stiffened panel.

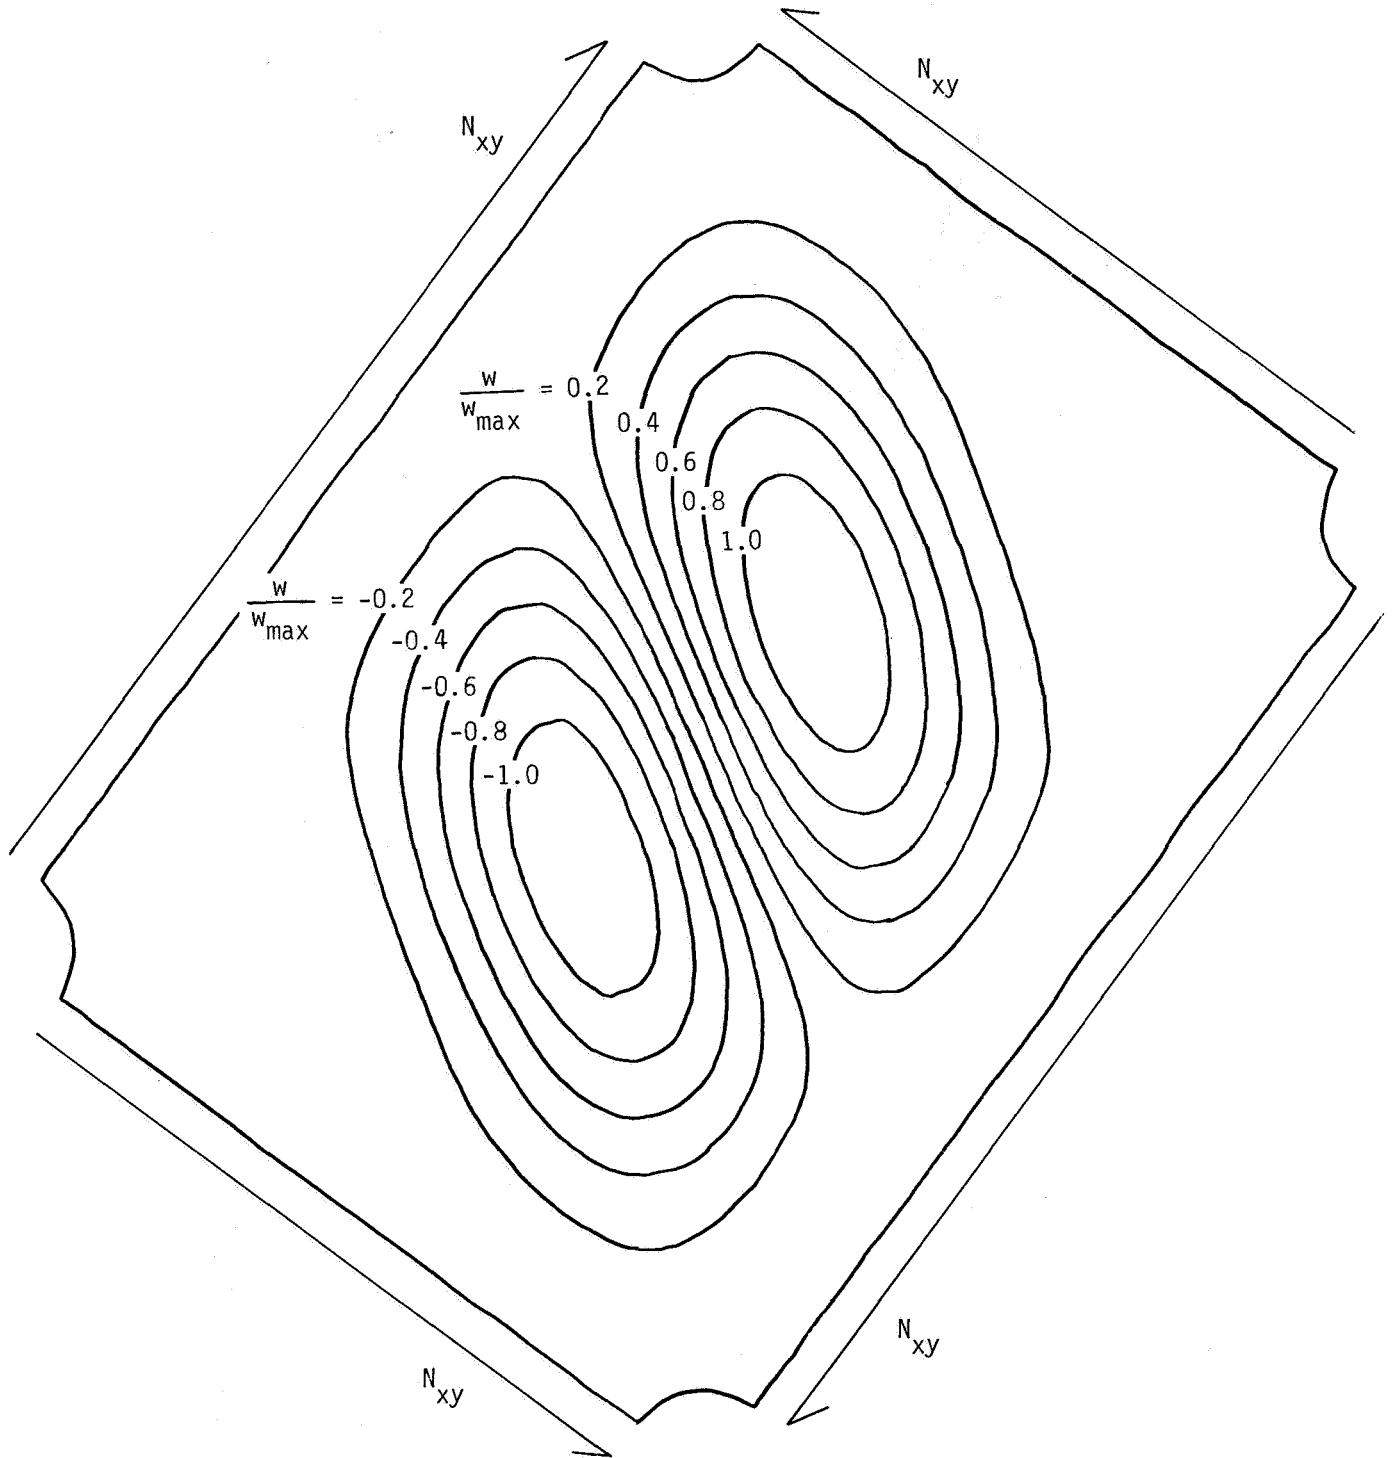
Figure 7.- Predicted normalized out-of-plane-displacement w contours for lowest
buckling mode.

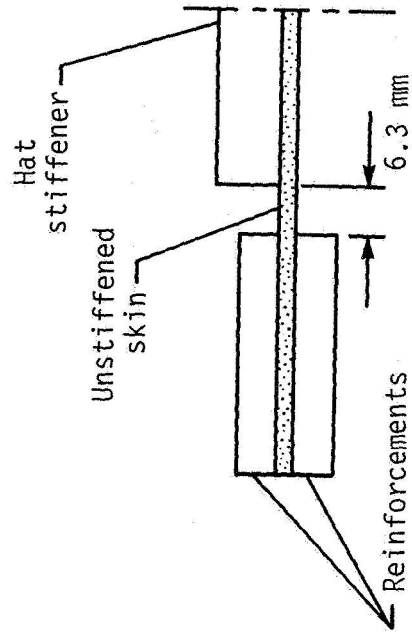
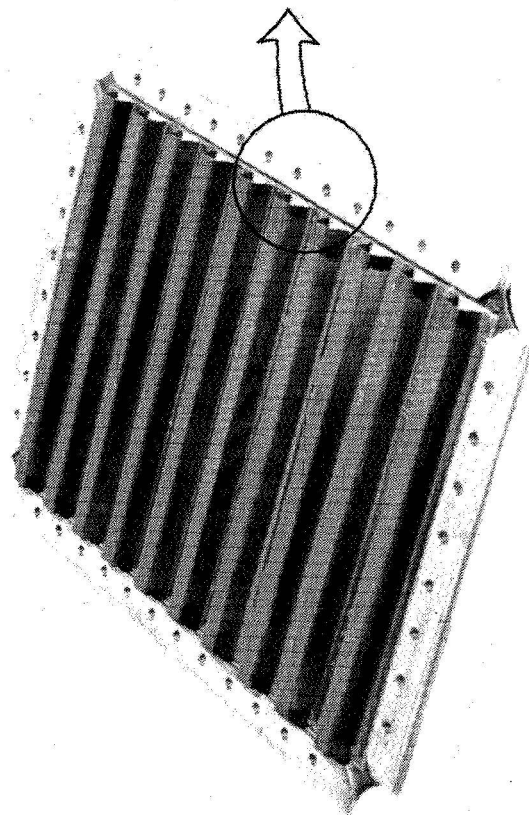
Figure 8.— Detail of hat-stiffened panel edge showing unstiffened skin region near reinforcements.

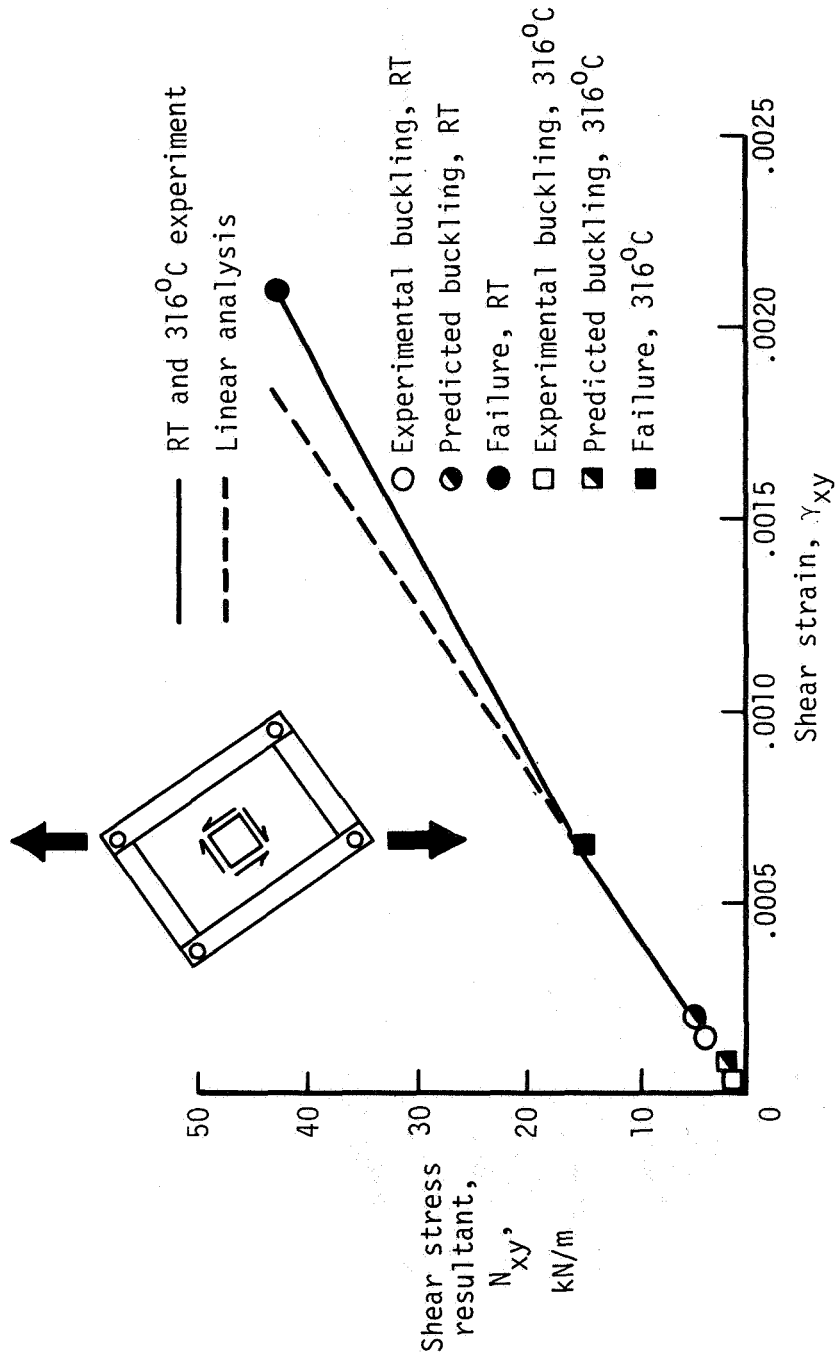
Comparison of experimental and analytical results.- Typical data for shear stress resultant plotted against shear strain for unstiffened, blade-stiffened, and hat-stiffened panels are shown in figures 9, 10, and 11, respectively. Predicted buckling results are also shown in the figures. For all panels, the initial slope of the experimental curve agrees with the linear analysis. For the unstiffened panels, the room-temperature buckling data and analytical results (tables 1 and 2) agree. Differences between experimental and analytical results for the tests at 316°C may have been because of the thermal stress state at this temperature caused by the mismatch of coefficients of thermal expansion (see section "Analytical results"). For the hat-stiffened panels, the difference between room-temperature and 316°C results (fig. 11) may be attributed to the nonuniform temperature distribution caused by convection heat transfer discussed previously.

Figure 9.— Typical shear-stress-resultant—shear-strain behavior for unstiffened panels.

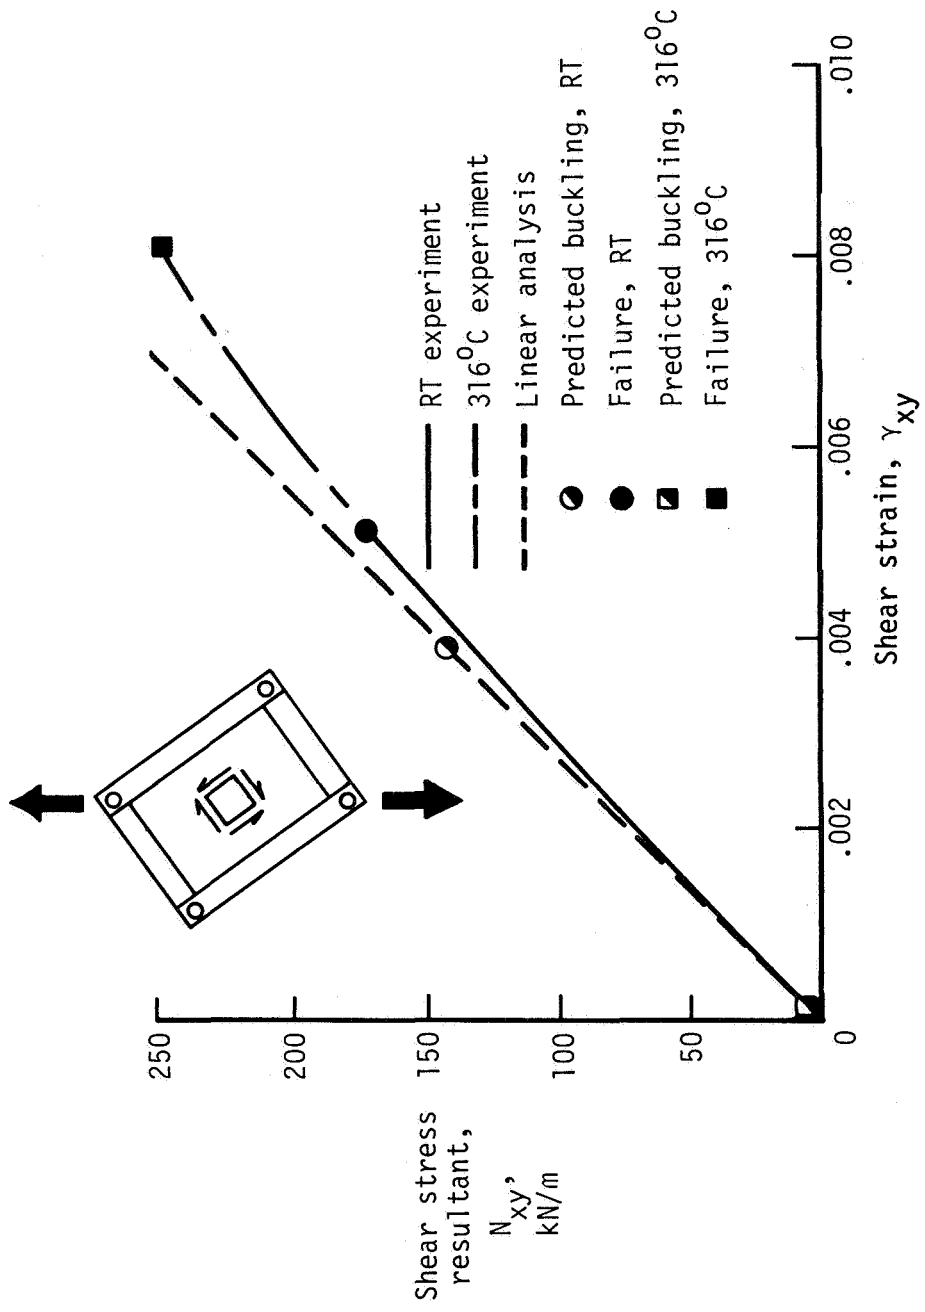
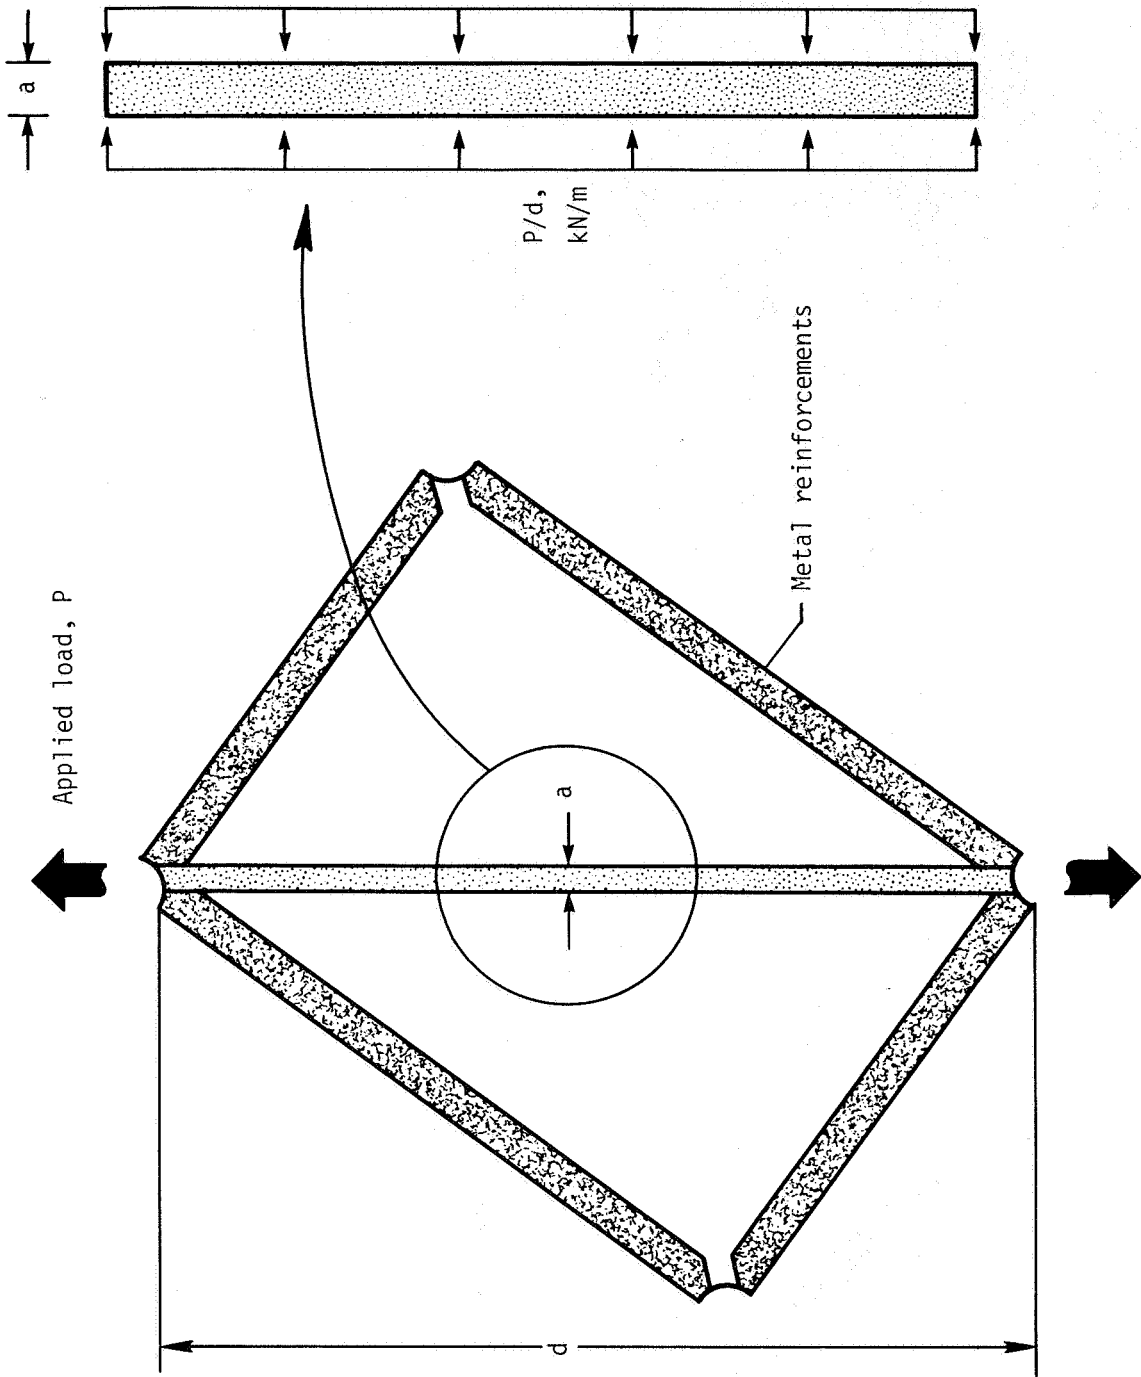
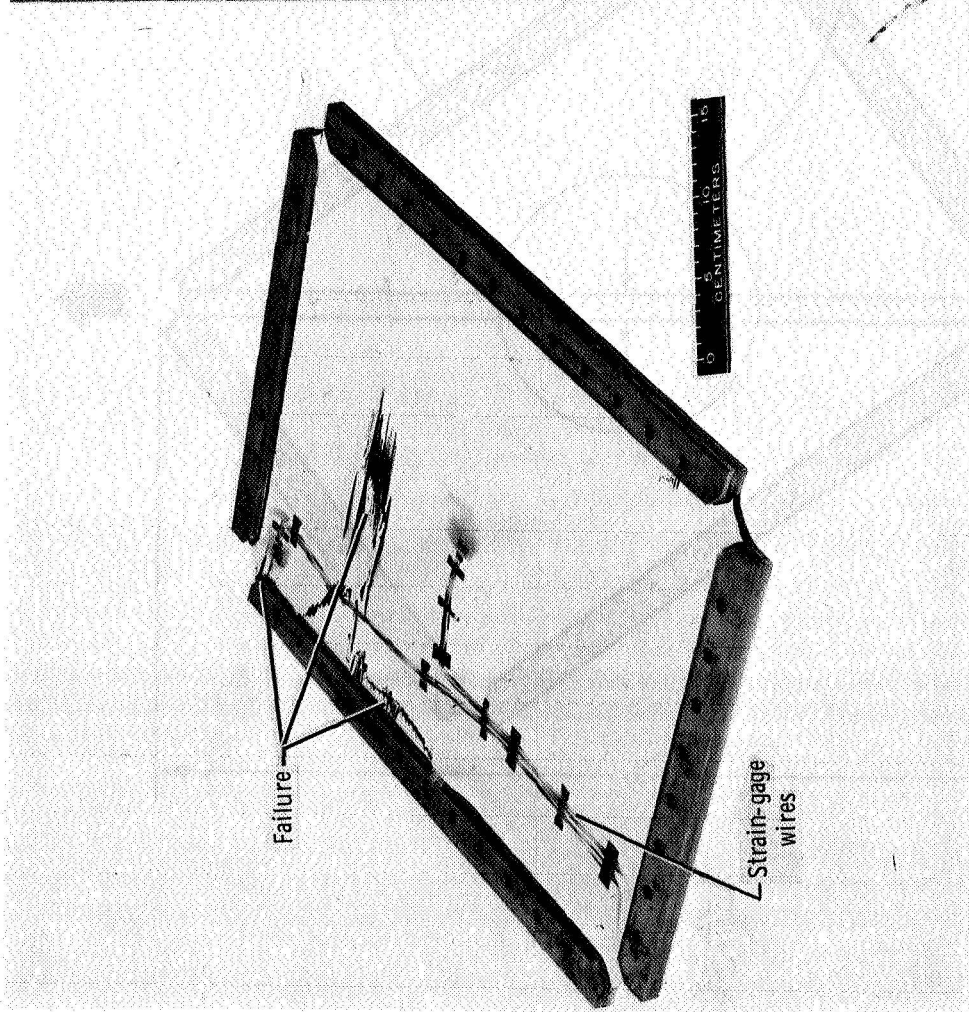
Figure 10.— Typical shear-stress-resultant—shear-strain behavior for blade-stiffened panels.

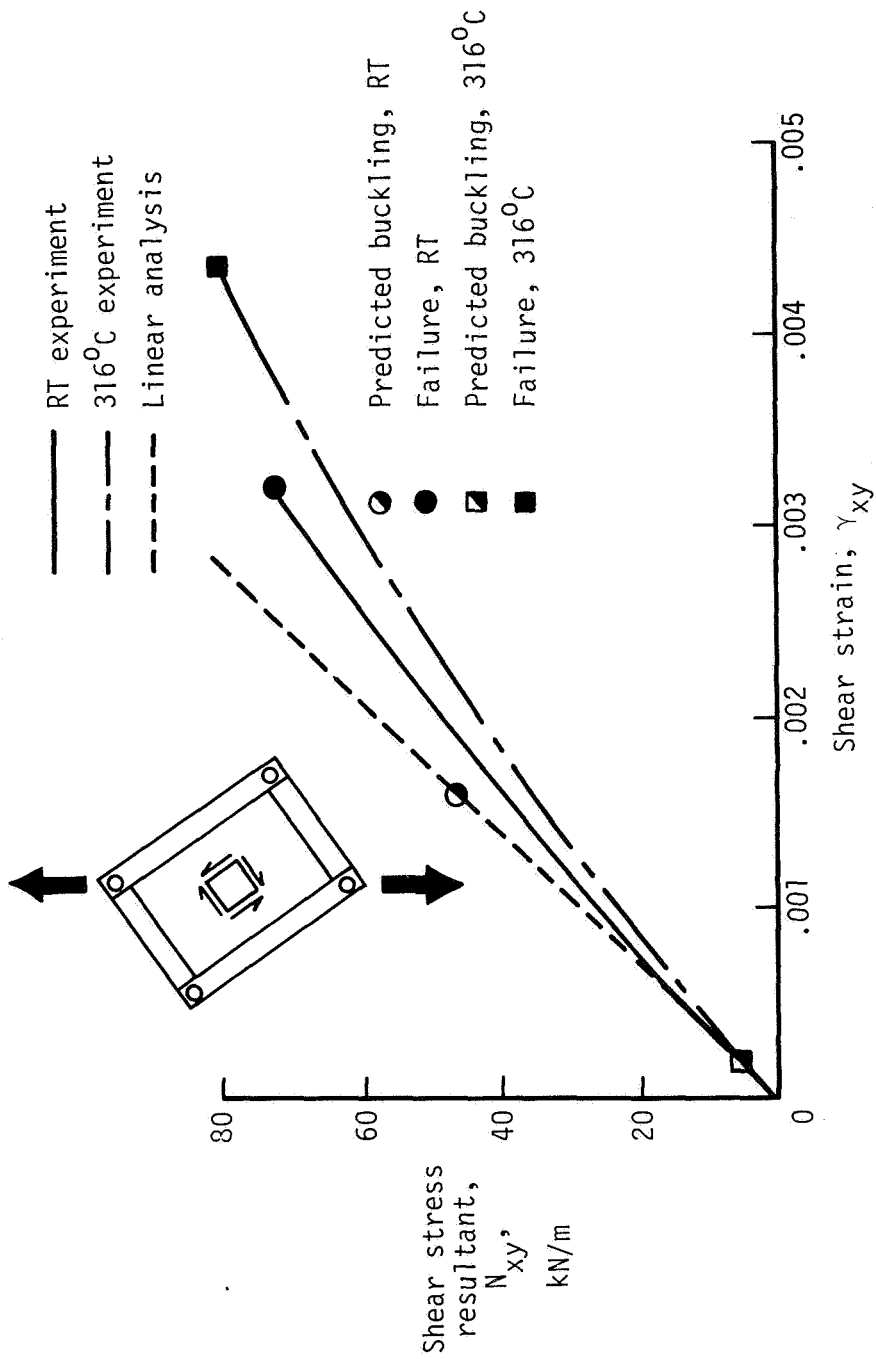
Figure 11.- Typical shear-stress-resultant—shear-strain behavior for hat-stiffened panels.
